Visual Asbestos Inspection

SITE ADDRESS: 32 Charles Street Killara NSW 2071

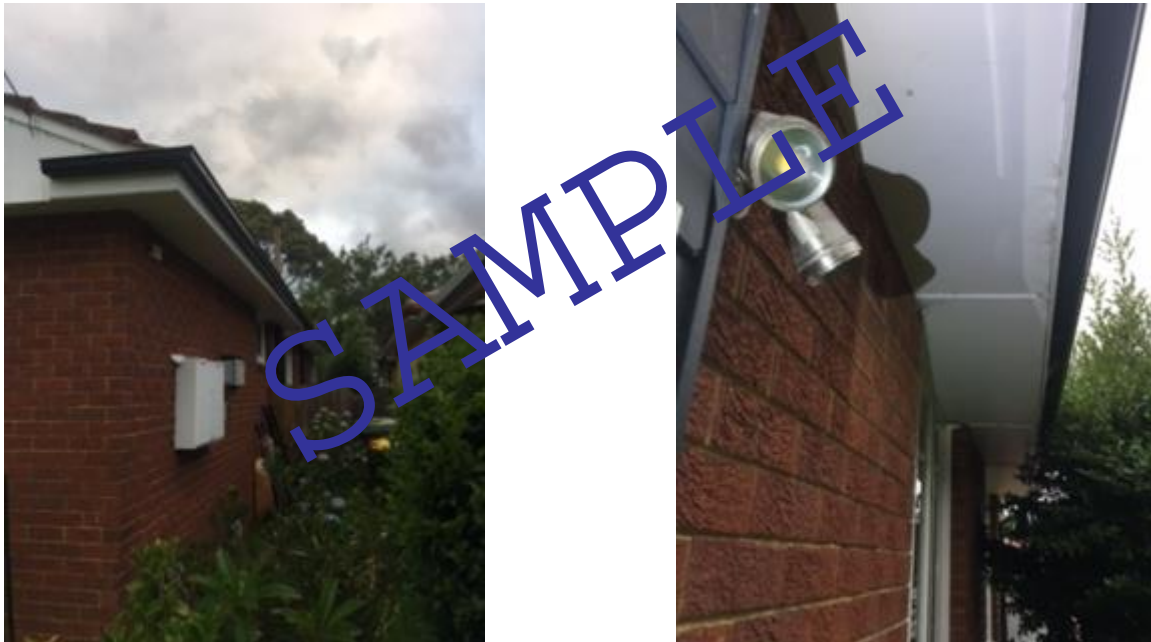
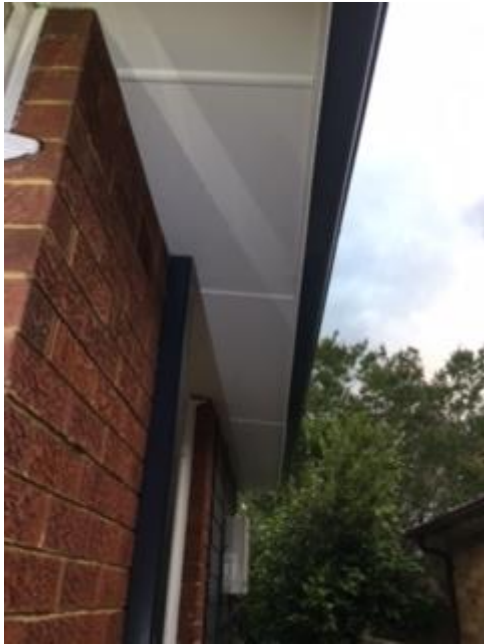
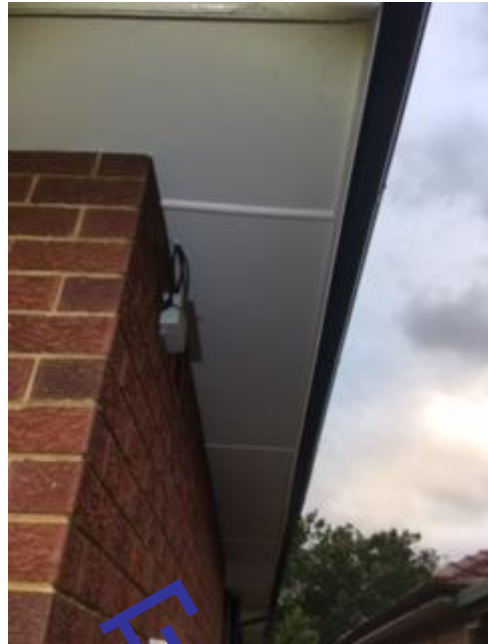
- The eaves around the entire house seem to be of a consistent material which could be asbestos related sheeting, due to the age of the building and the fact that timber battens have been used to cover the ends of sheets, to be certain a sample would be required to be removed and sent off to a lab for testing and confirmation if in fact the eave lining (soffit) are in fact asbestos sheeting.

These images are Western eave linings, which will need to be tested for asbestos.

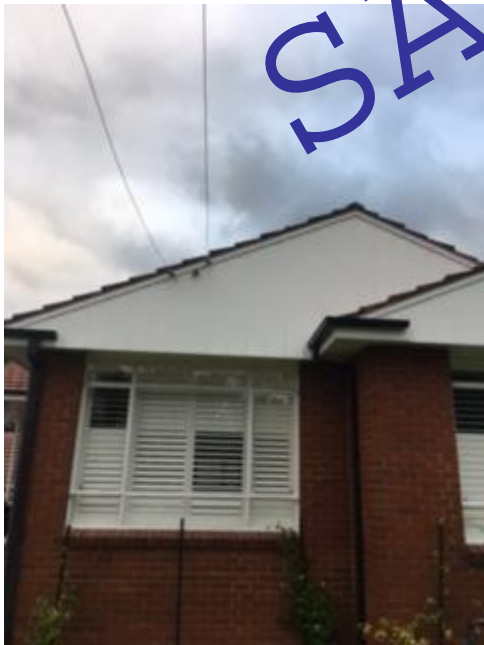
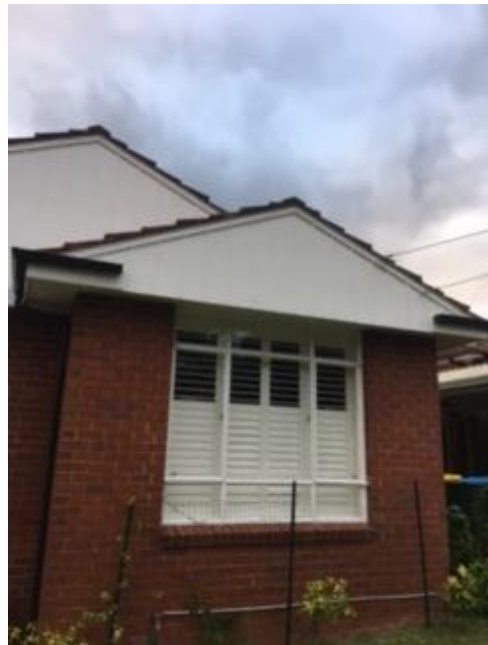
- Roof gable has been clad in a material that appears to be timber linings, without removing a sample we cannot be certain that this material is not asbestos, but on the basis of our experience and knowledge of the time that this home was built in, there is a small possibility that the gable linings are in fact asbestos, and a sample will need to be taken and tested by a lab before a definitive answer can be given and confirmed whether or not this material is or is not asbestos.

These two photos are the front Northern gables to the house, which are sheet material and need to be tested for asbestos.

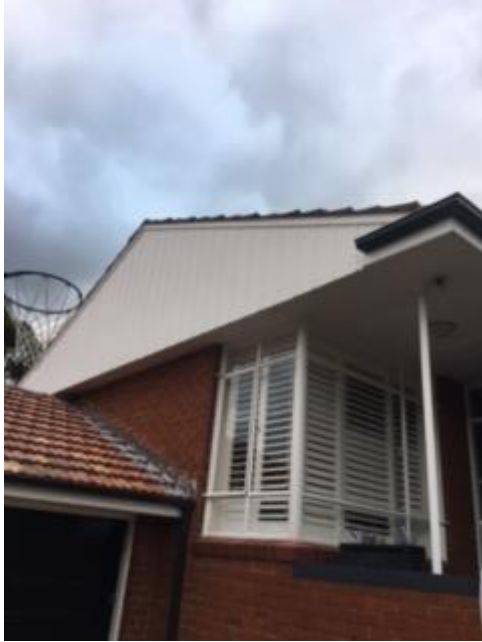
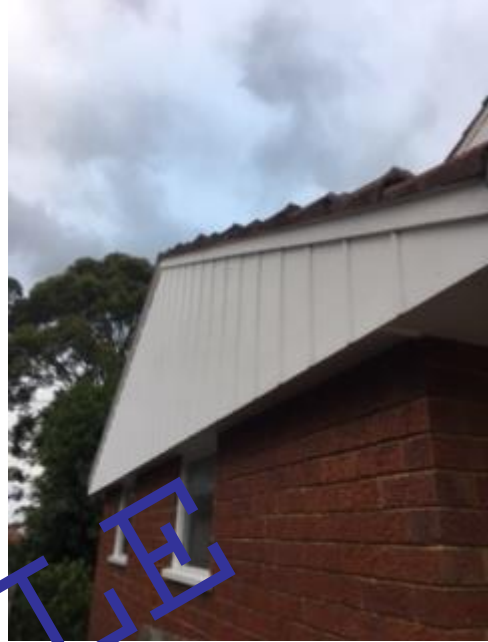
These two photos show the two gables on the East side of the property, which are sheet material and need to be tested for asbestos.

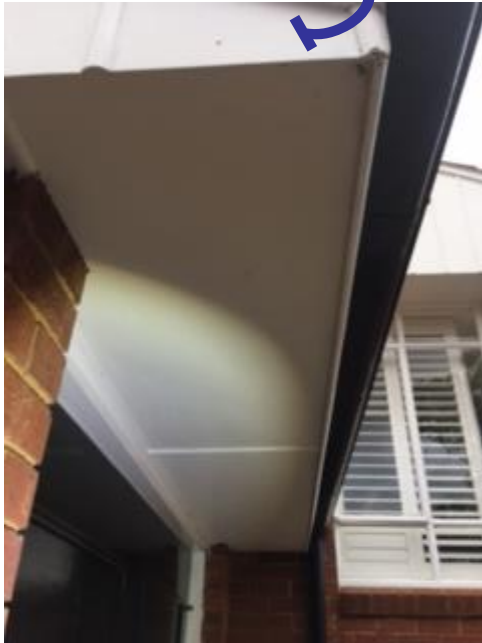
This photos shows the eave in front of the garage, which is sheet material and needs to be tested for asbestos.

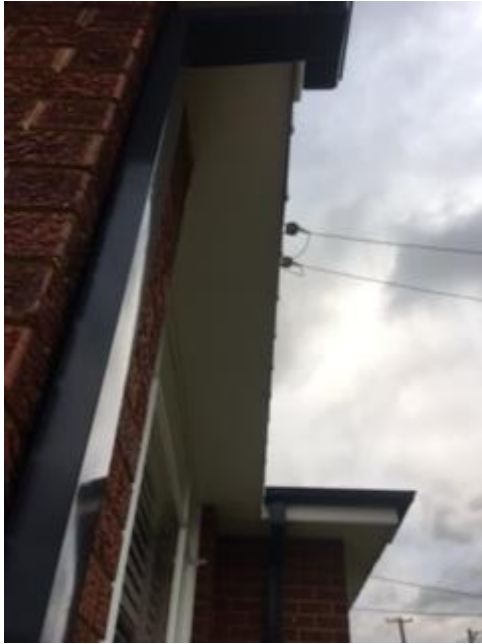
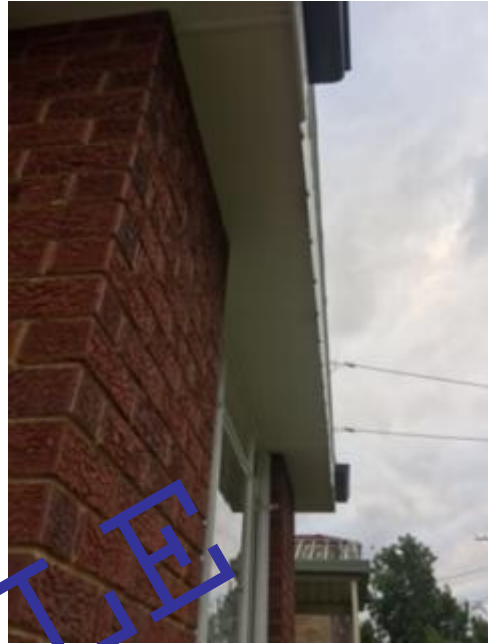
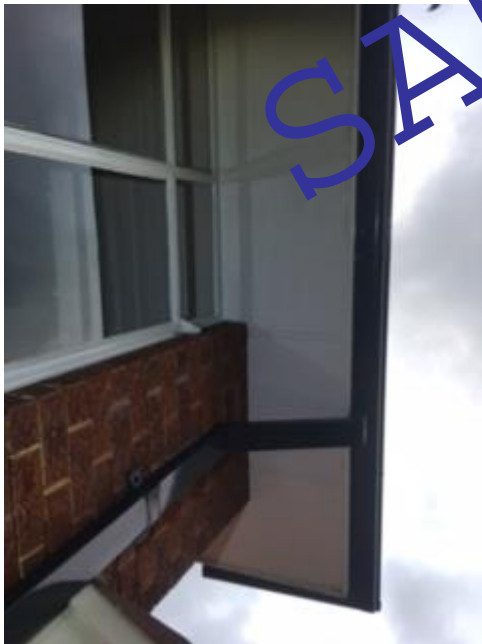
These photos show the eaves on the Northern elevation of the building, which need to be tested for asbestos.

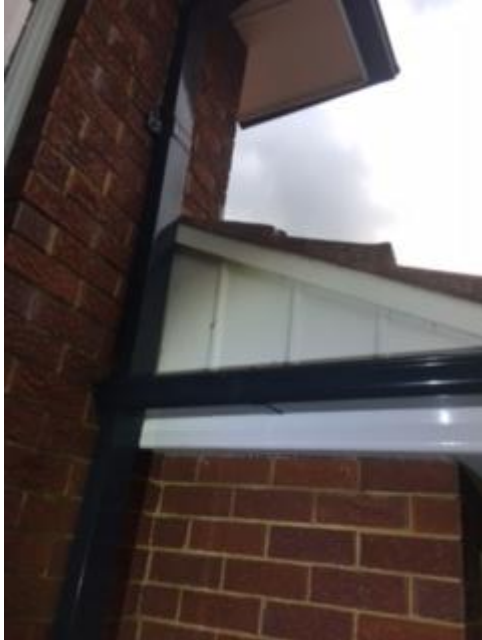
This photo shows the small gable to the Western elevation of the garage, which needs to be tested for asbestos.

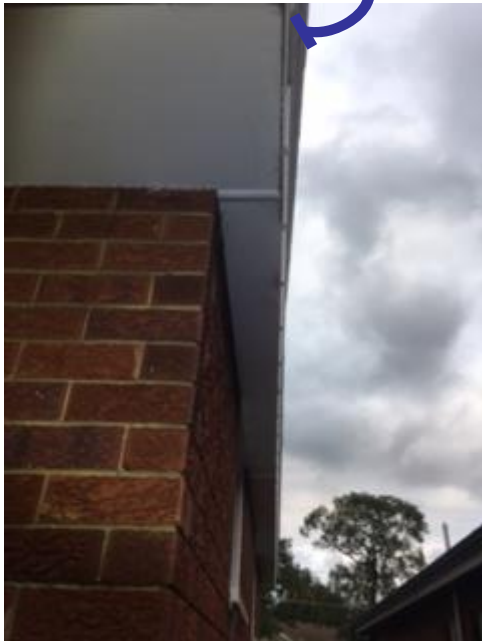
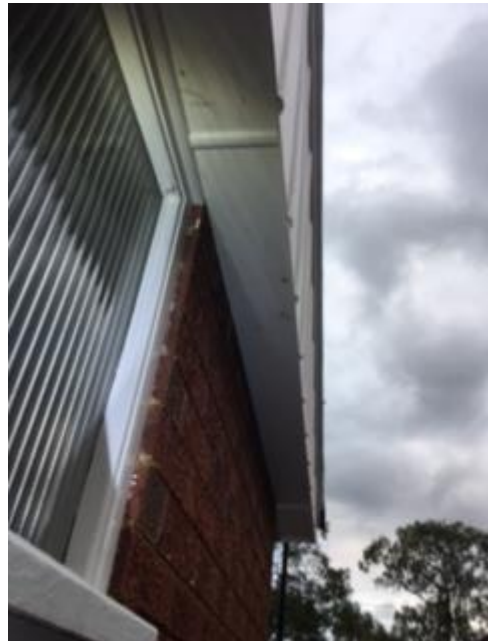
These two photos show the narrow eastern eave to the garage, which will need to be tested for asbestos.

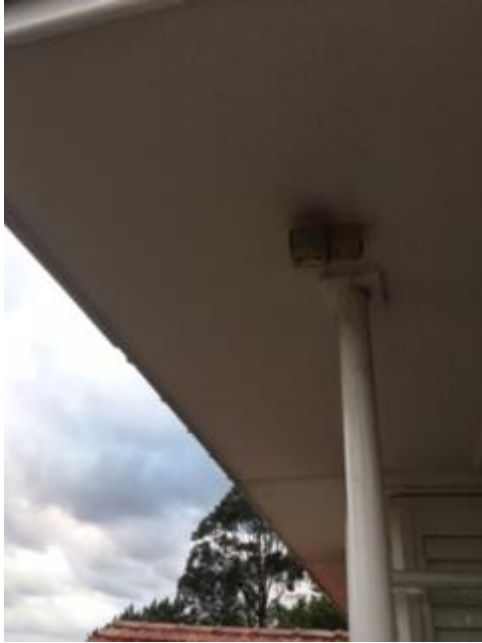
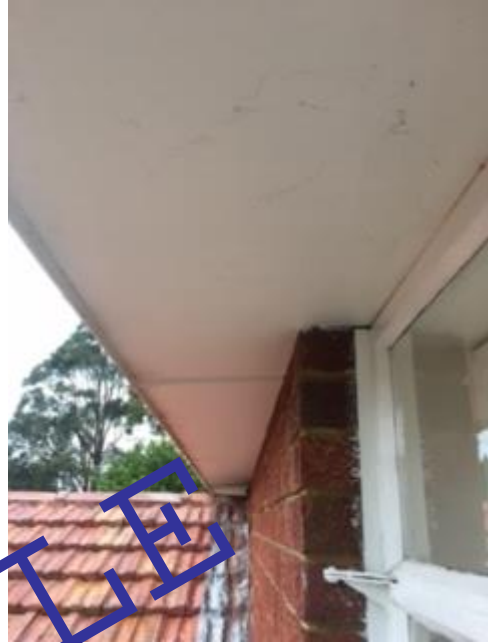
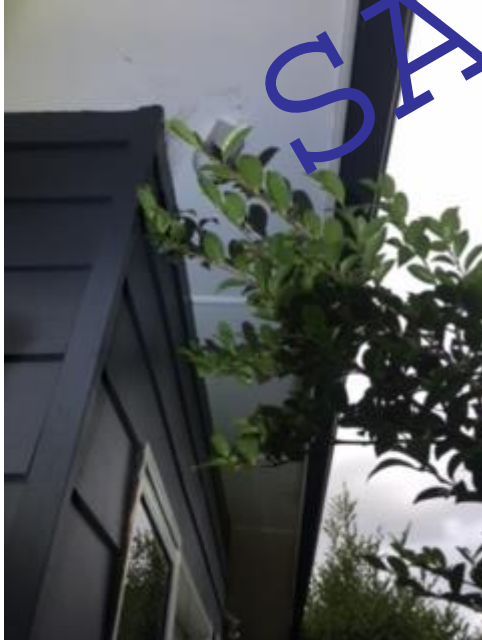
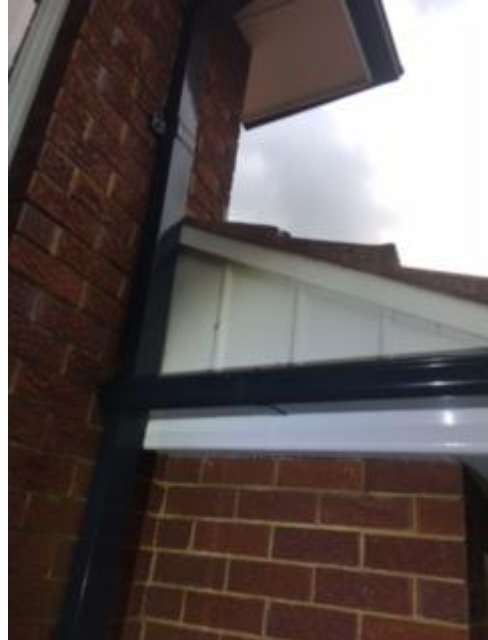
These pictures show the Eastern eaves to the house, which will need to be tested for asbestos.

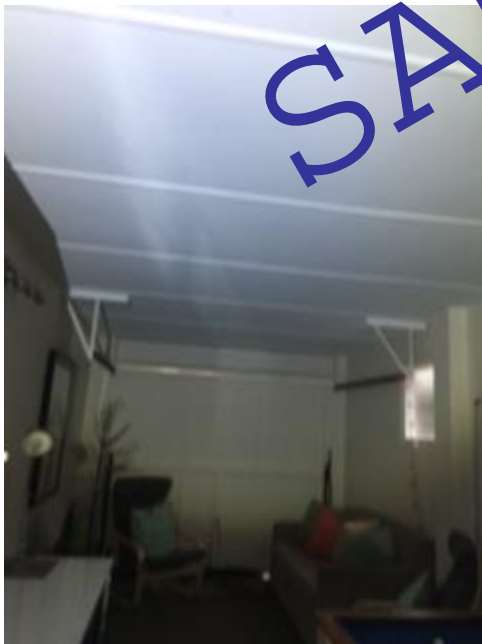
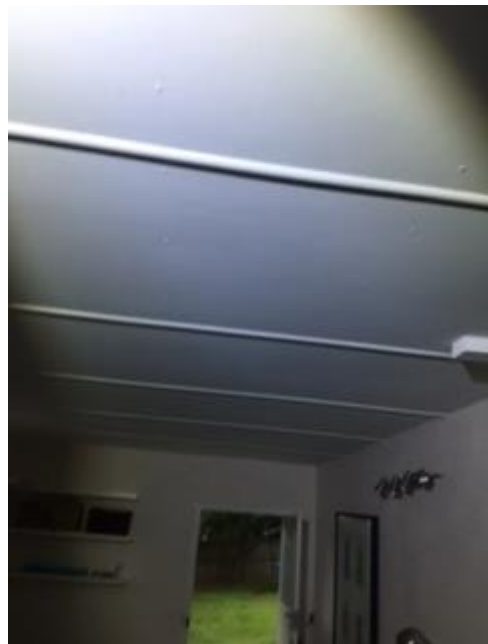
- The ceiling linings of the garage seem to be of a consistent material which could be asbestos related sheeting, due to the age of the building and the fact that timber battens have been used to cover the ends of sheets, to be certain a sample would be required to be removed and sent off to a lab for testing and confirmation if in fact the lining (soffit) are in fact asbestos sheeting.

These two photos are taken from opposite ends of the garage ceiling, which will need to be tested for asbestos.
