Dilapidation Report , Birchgrove

Job No: 93007

22nd March 2017

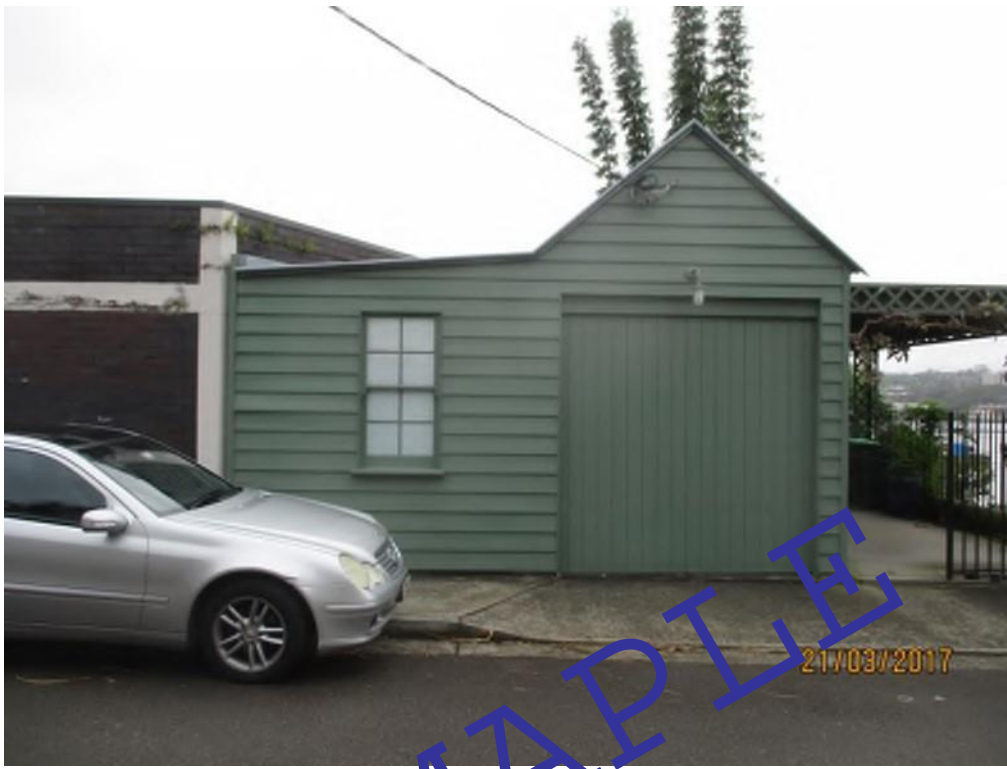
Garage Street Elevation

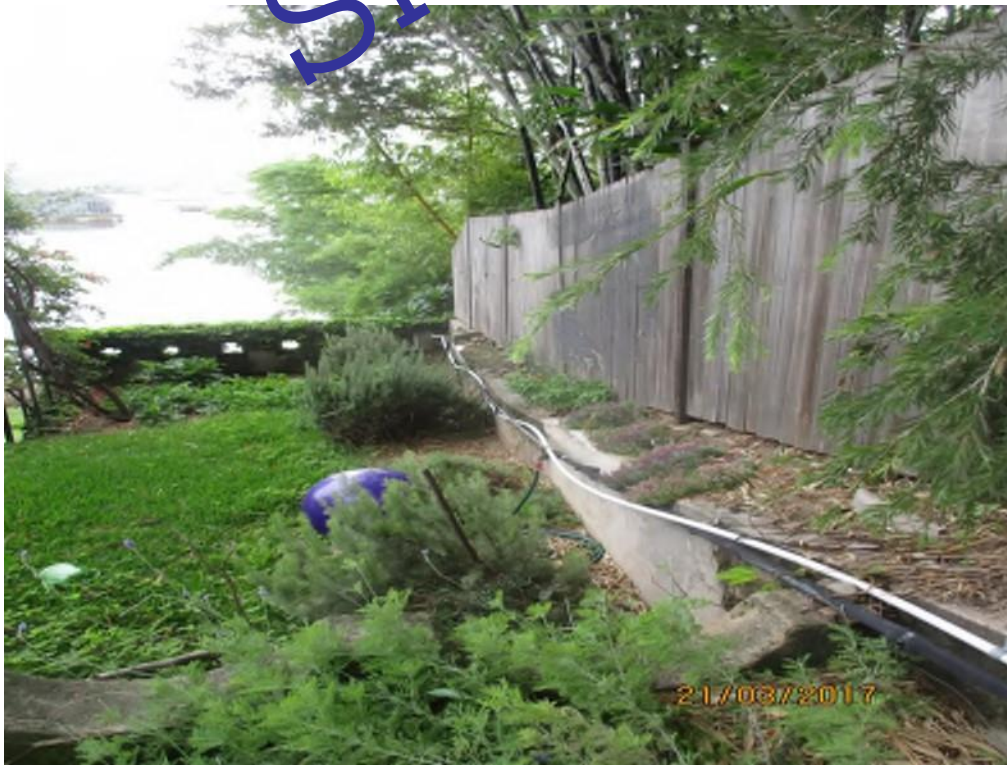
Retaining Wall supporting No 25 viewed from No 27

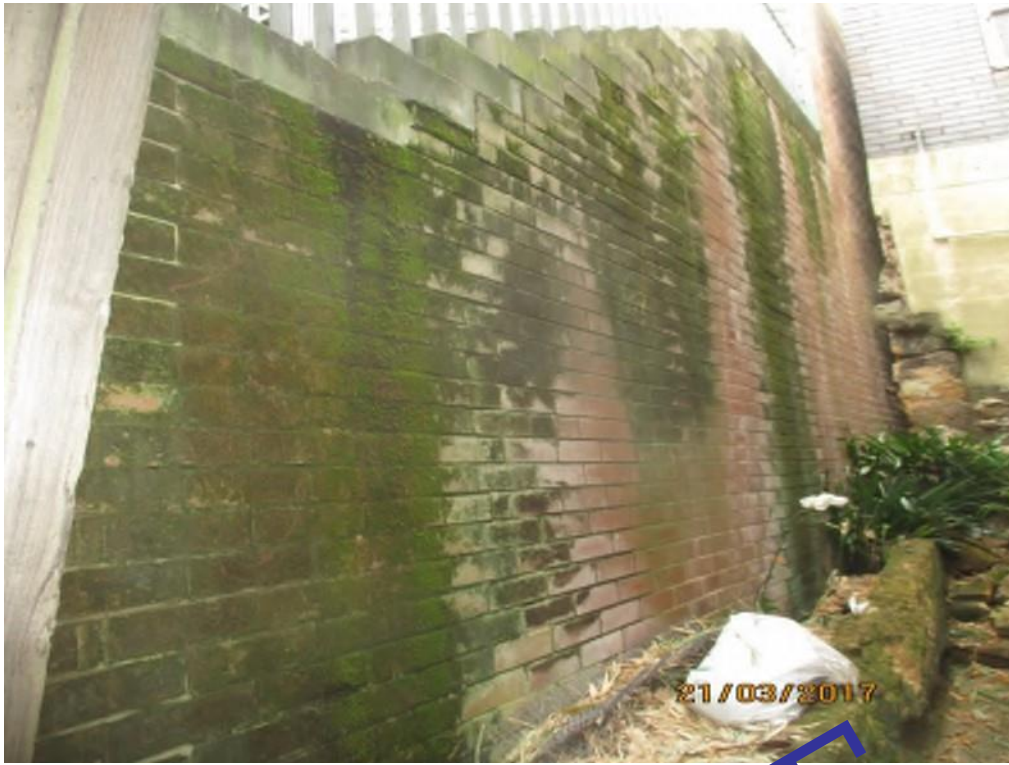
Garage and stair boundary support wall viewed from No 17

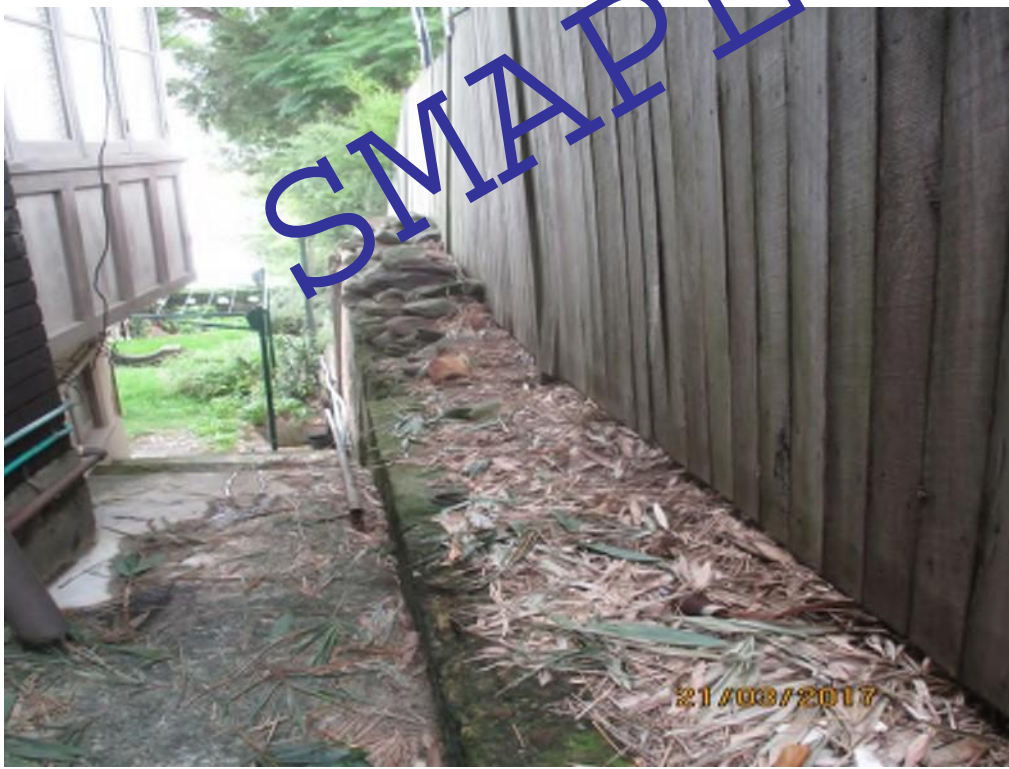
Retaining Wall supporting No 25 viewed from No 27

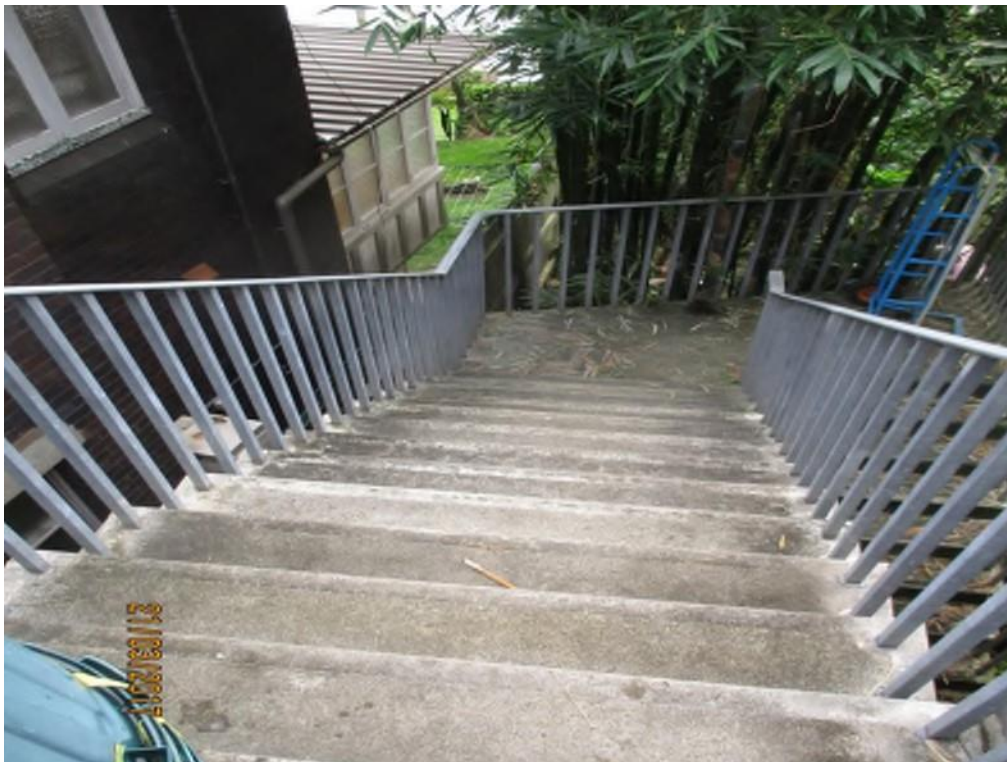
Access Stairs from upper level

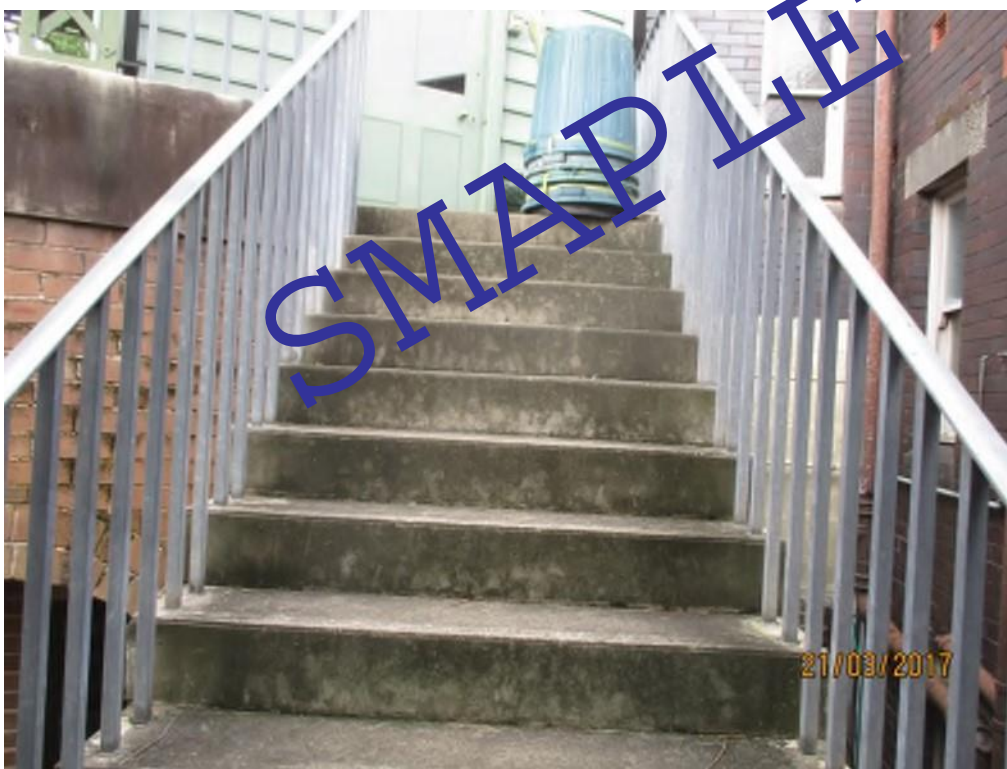
Access Stairs from mid height landing

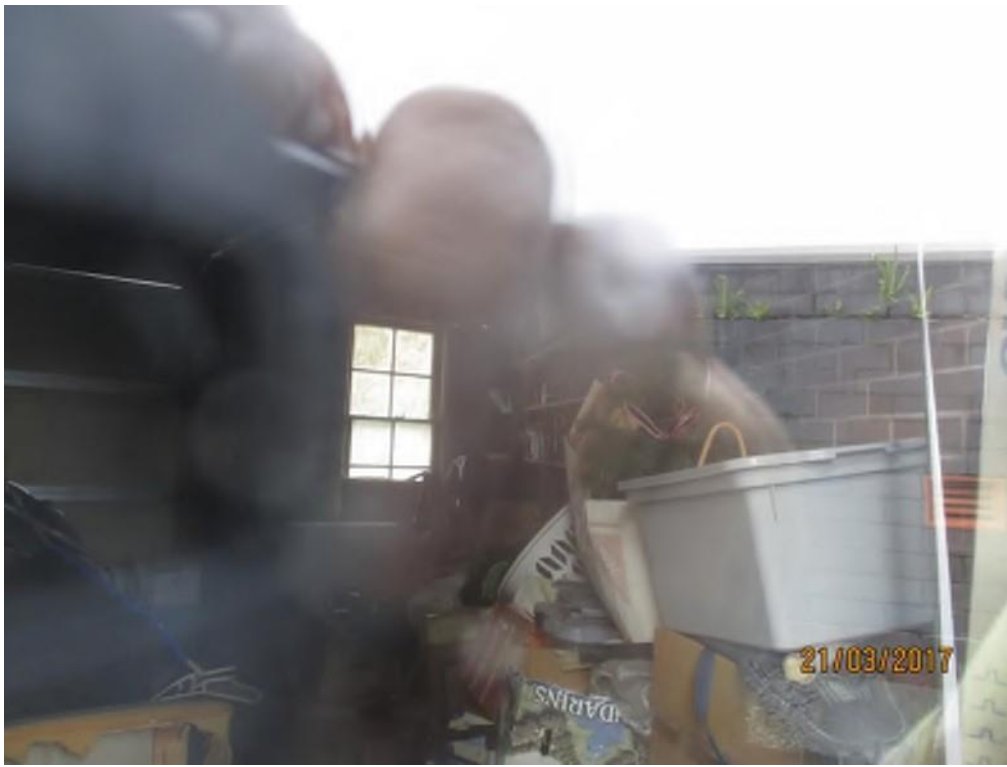
Garage interior. Garage was inaccessible

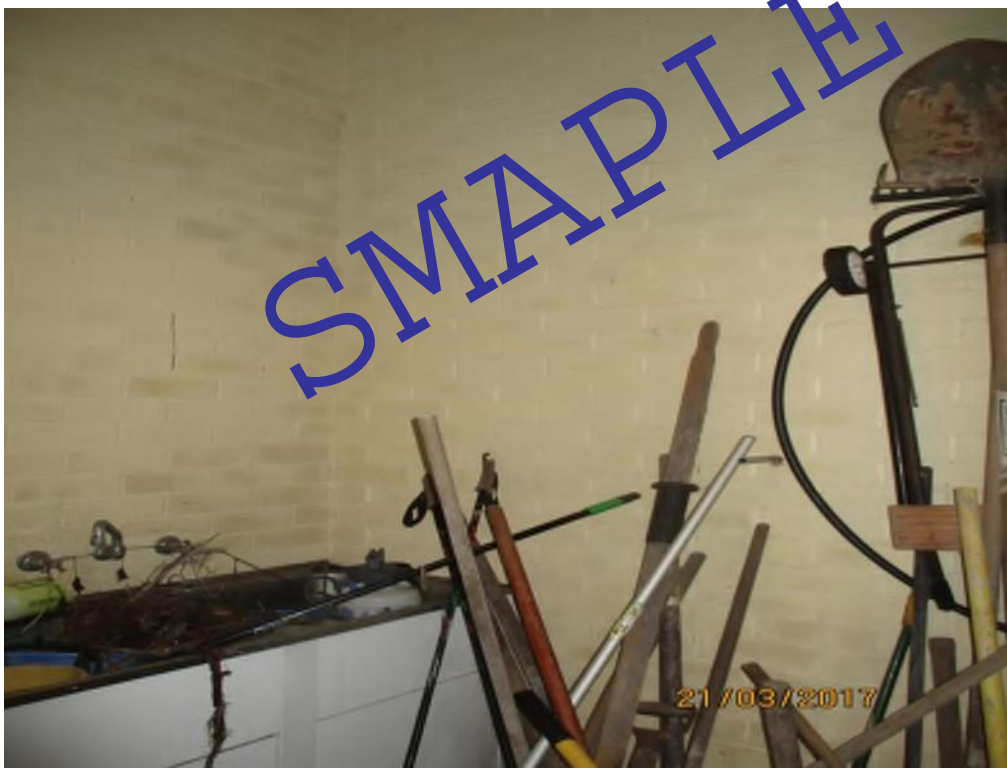
Room under garage slab

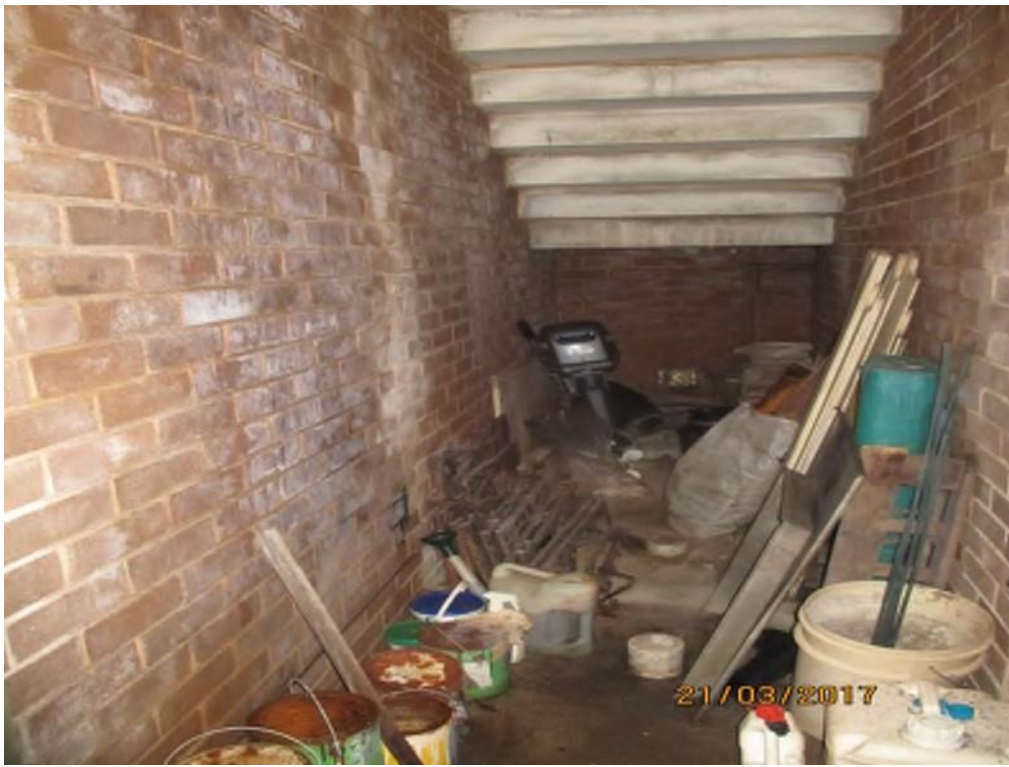
Room under stairs

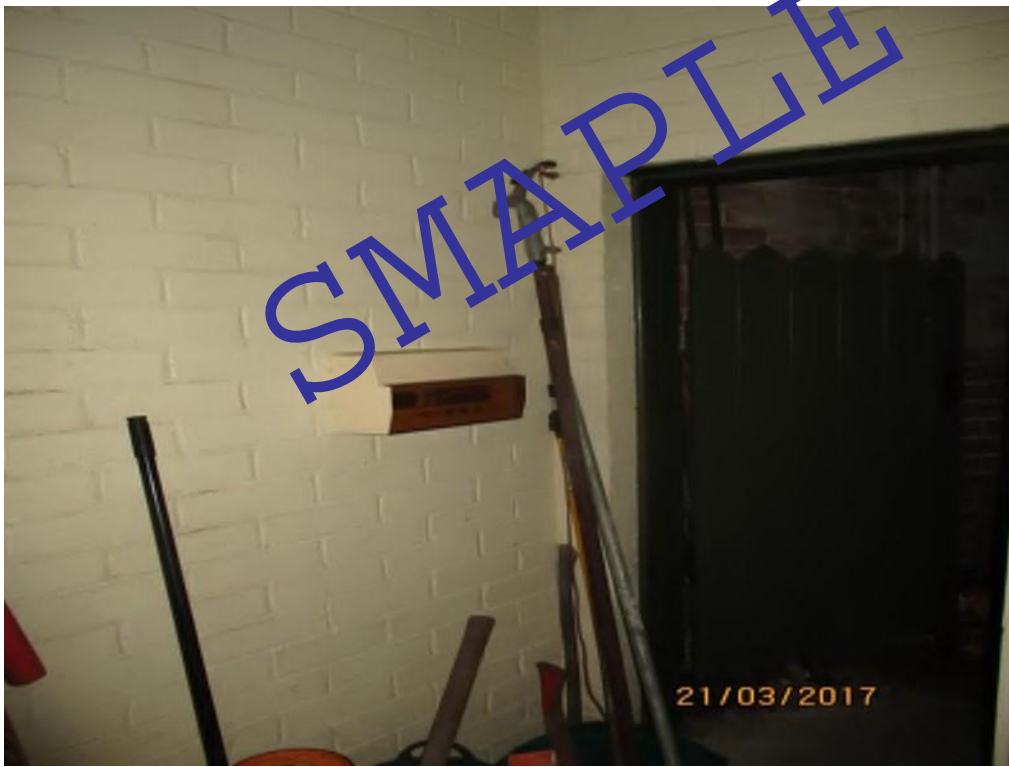
Room under stairs

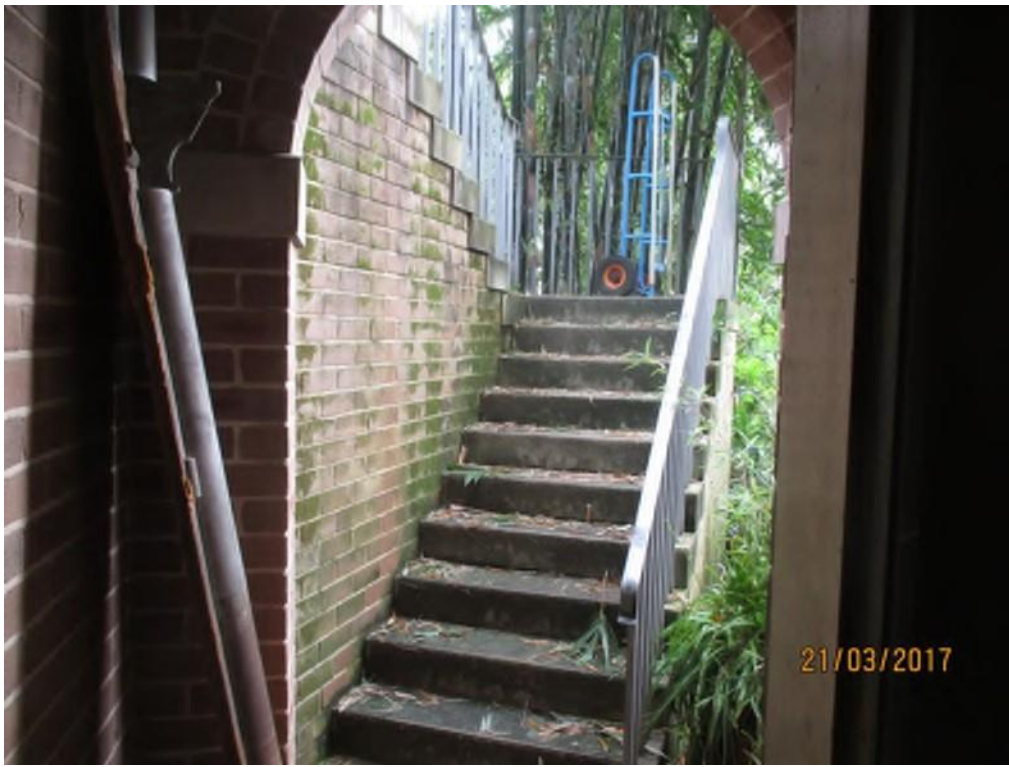
Lower Level Stairs

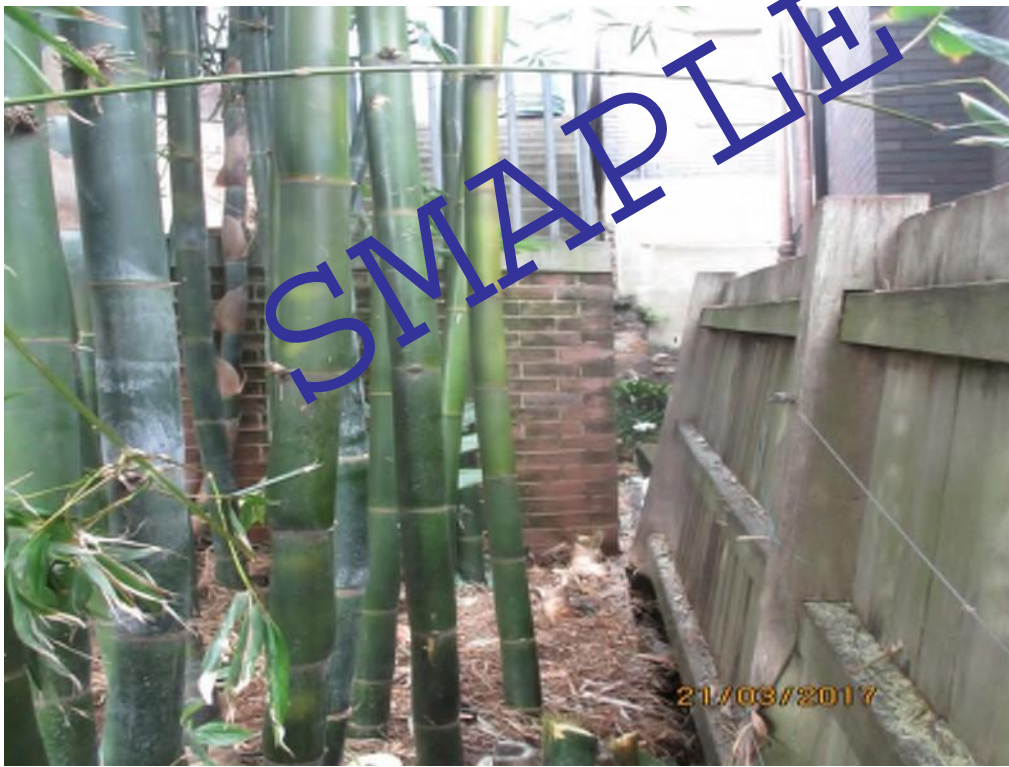
Displaced Fence

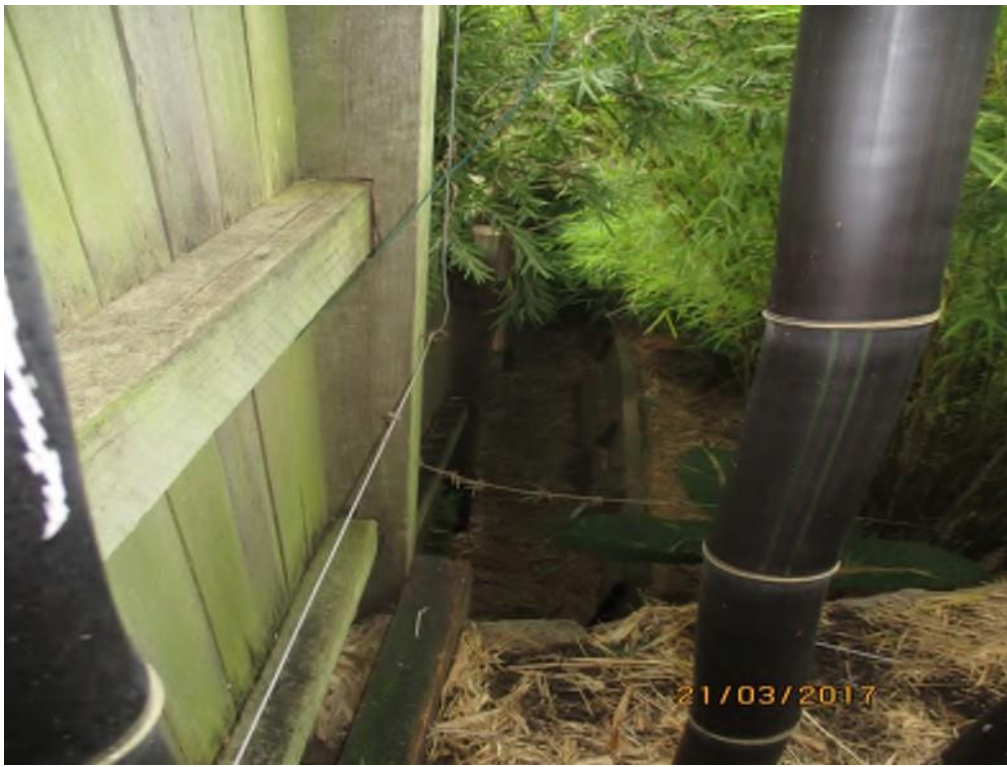
Log Retaining wall located off common boundary

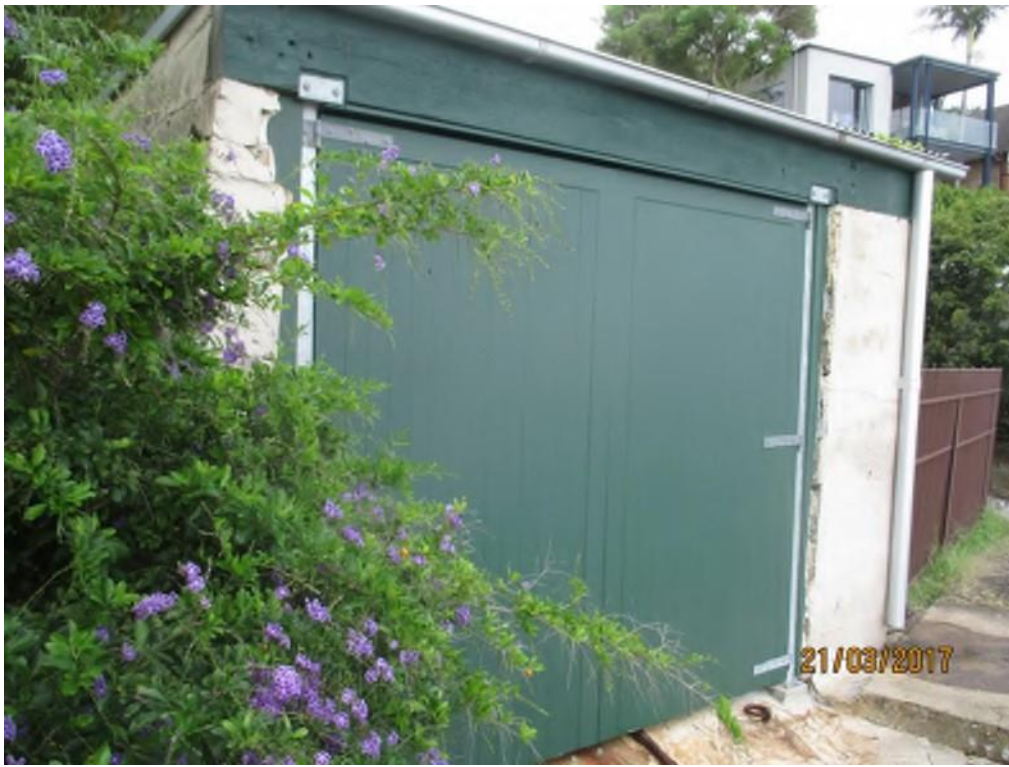
View of boat shed to No 27

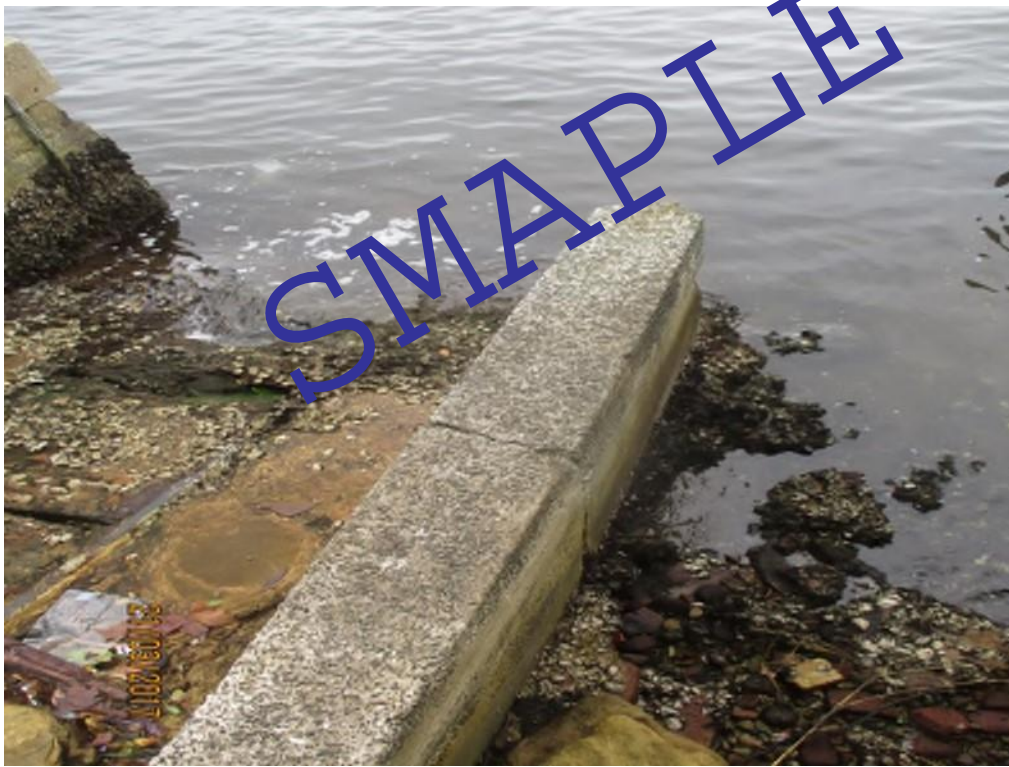
Boat Harbour -Boundary Wall

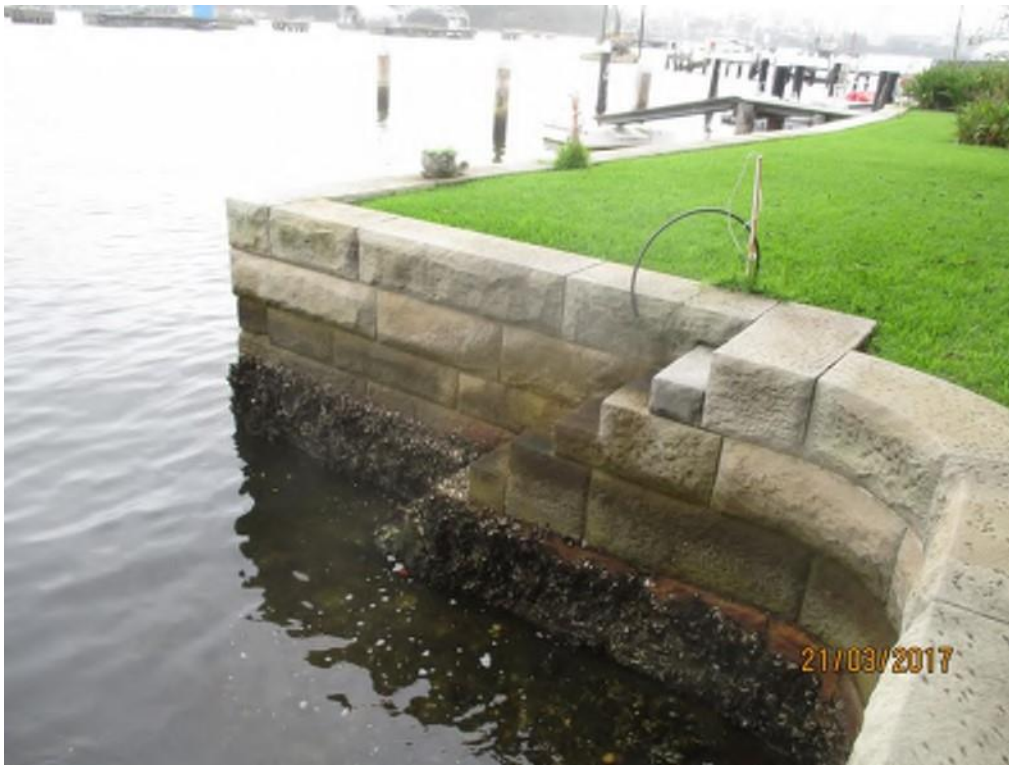
Boat harbor Wall

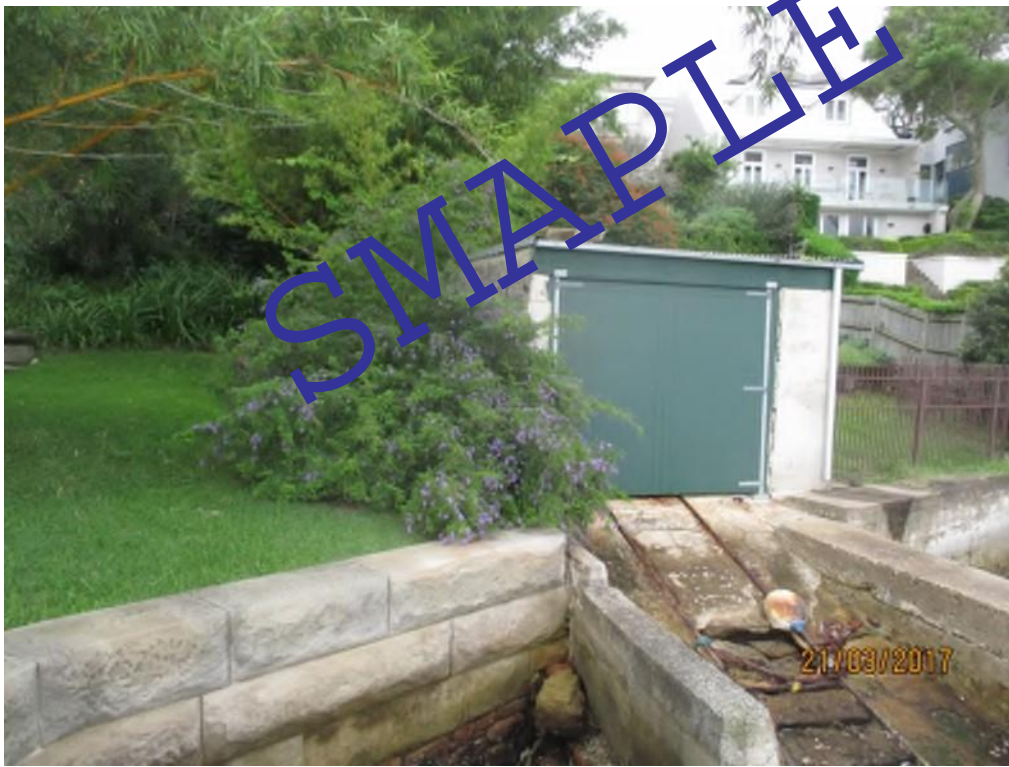
Slipway walls

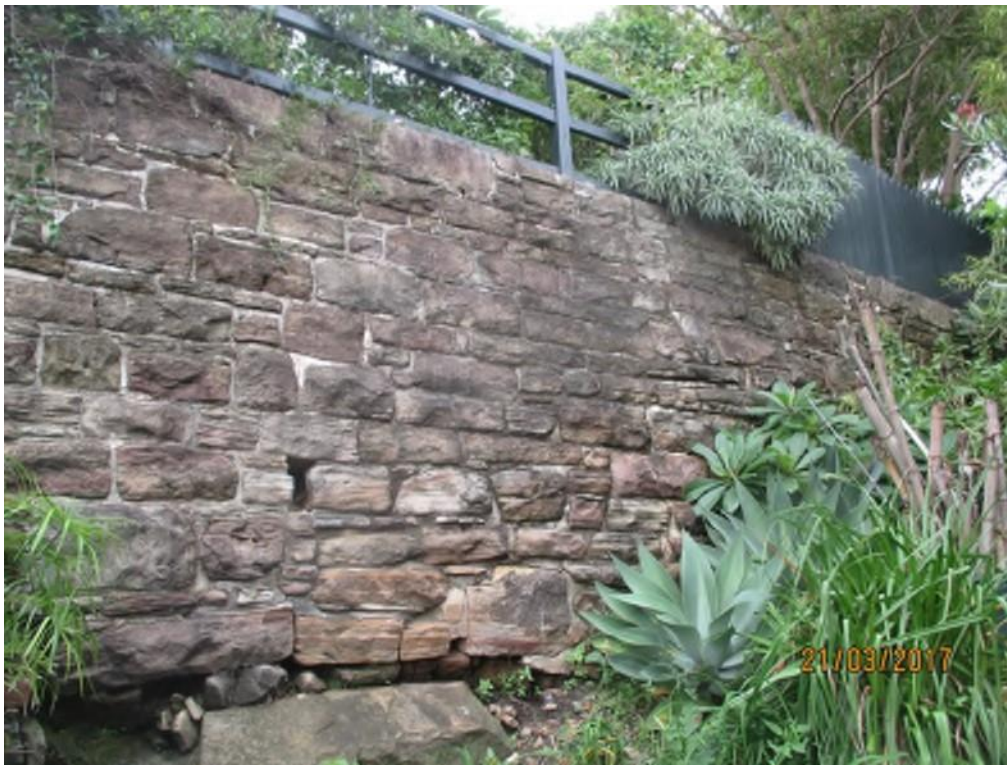
Retaining wall for tiered landscaped wall

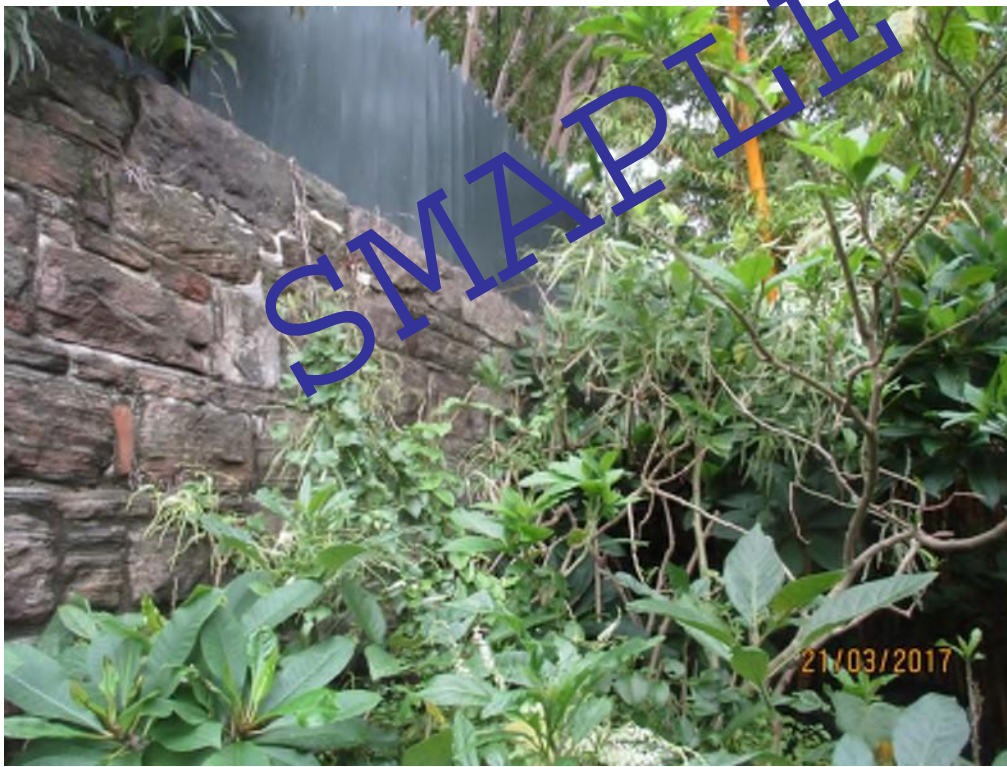
Retaining wall for tiered landscaped wall

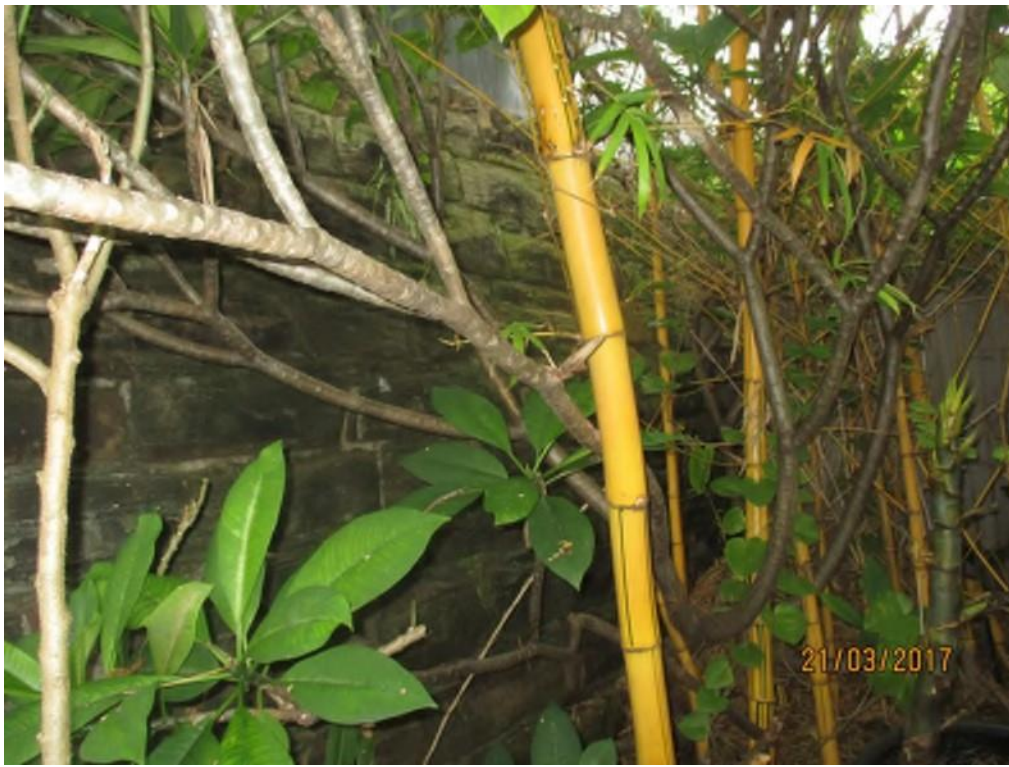
Retaining wall for tiered landscaped wall
