# Residential Pre-Purchase Building Inspection Report

Complies with Australian Standard AS 4349.1-2007 Inspection of Buildings Part 1: Pre-Purchase Inspections Residential Buildings - Appendix C

Client: Yew Chin Lim
Property Address: A1003 20 Levey Street Wollicreek
Date of inspection: 09/10/2015

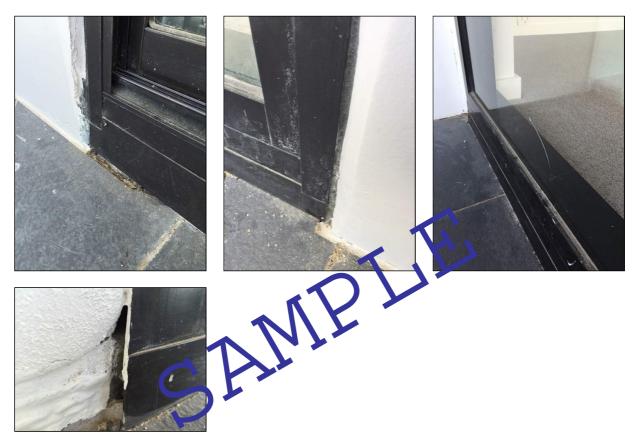
**Details:** The entry point with in the building at the junction of the aluminium windows and masonry columns are highly likely due to the poor sealant and poor floor tiling carried out

**Defect Rating: Major Defect**
