Residential Pre-Purchase Building Inspection Report

Property Address: 120 Womerah Avenue Darlinghurst

Date of inspection: 27/10/2016

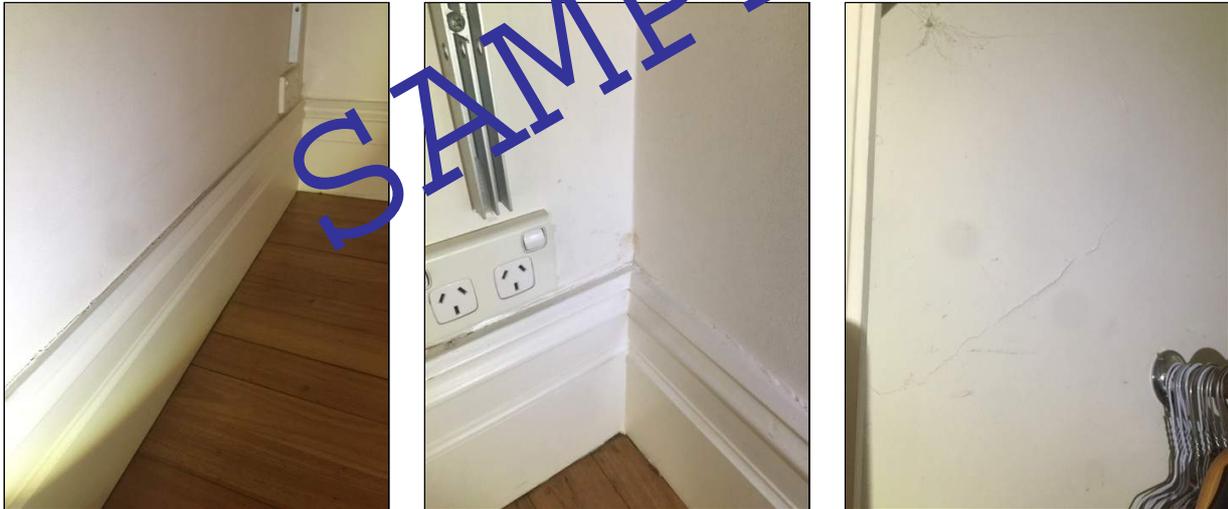
Location : Minimal defects found within this house

Dampness and/or staining of the wall linings/ skirting, Bulging linings, Minor cracks to plaster linings - Typical settlement cracks found within a building, .

,Bulging of linings was identified, and should be assessed by a carpenter to determine why the linings have been detached.,Minor cracks were seen within the internal wall linings due to normal settlement and can be left as is.

Defect Rating: Minor Defect

A licenced building contractor should be engaged to determine the cause(s).

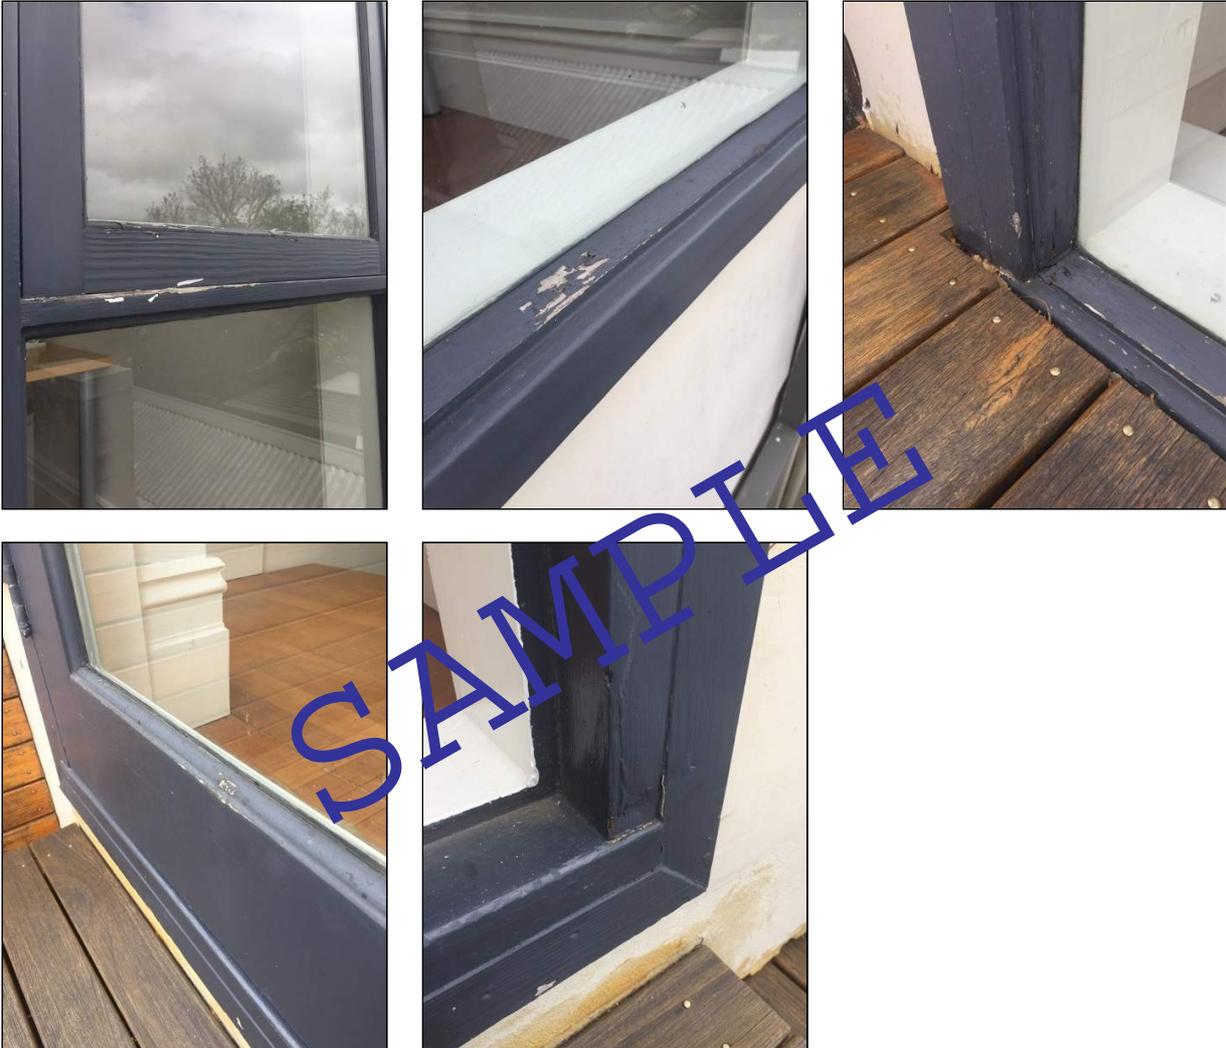
One or more window/door units require maintenance, Evidence of minor rotting, ., Weather damage evident to external door(s)

One or more windows require maintenance carried out to maintain the operation and foundation of the external windows/doors ,
Evidence of minor rotting
Repairs and re-painting is required by a good painting contractor to preserve the timber members , ,
External door(s) are damaged due to not being adequately protected from the elements.

Defect Rating: Minor Defect

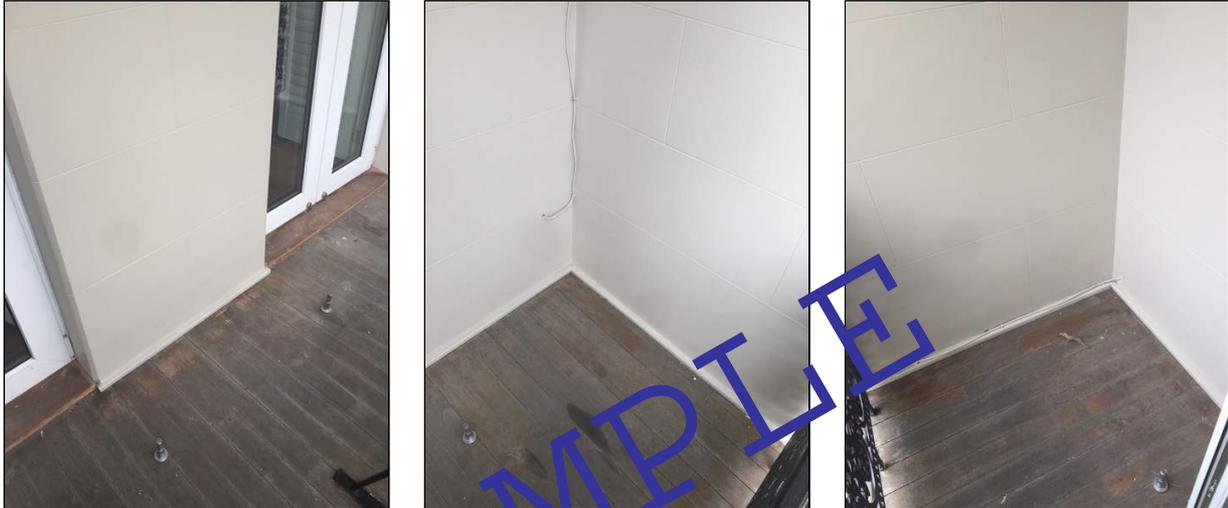
Defect Rating: Minor Defect

Accurate diagnosis of the cause and extent of the damp problem is very important, specialist advice must be sought.

Further investigation is required by a bricklayer or a damp proof specialist
