Residential Pre-Purchase Building Inspection Report

Complies with Australian Standard AS 4349.1-2007
Inspection of Buildings Part 1: Pre-Purchase
Inspections Residential Buildings - Appendix C

Property Address: 12 Loombah Road Dover Heights

Date of inspection: 17/06/2017

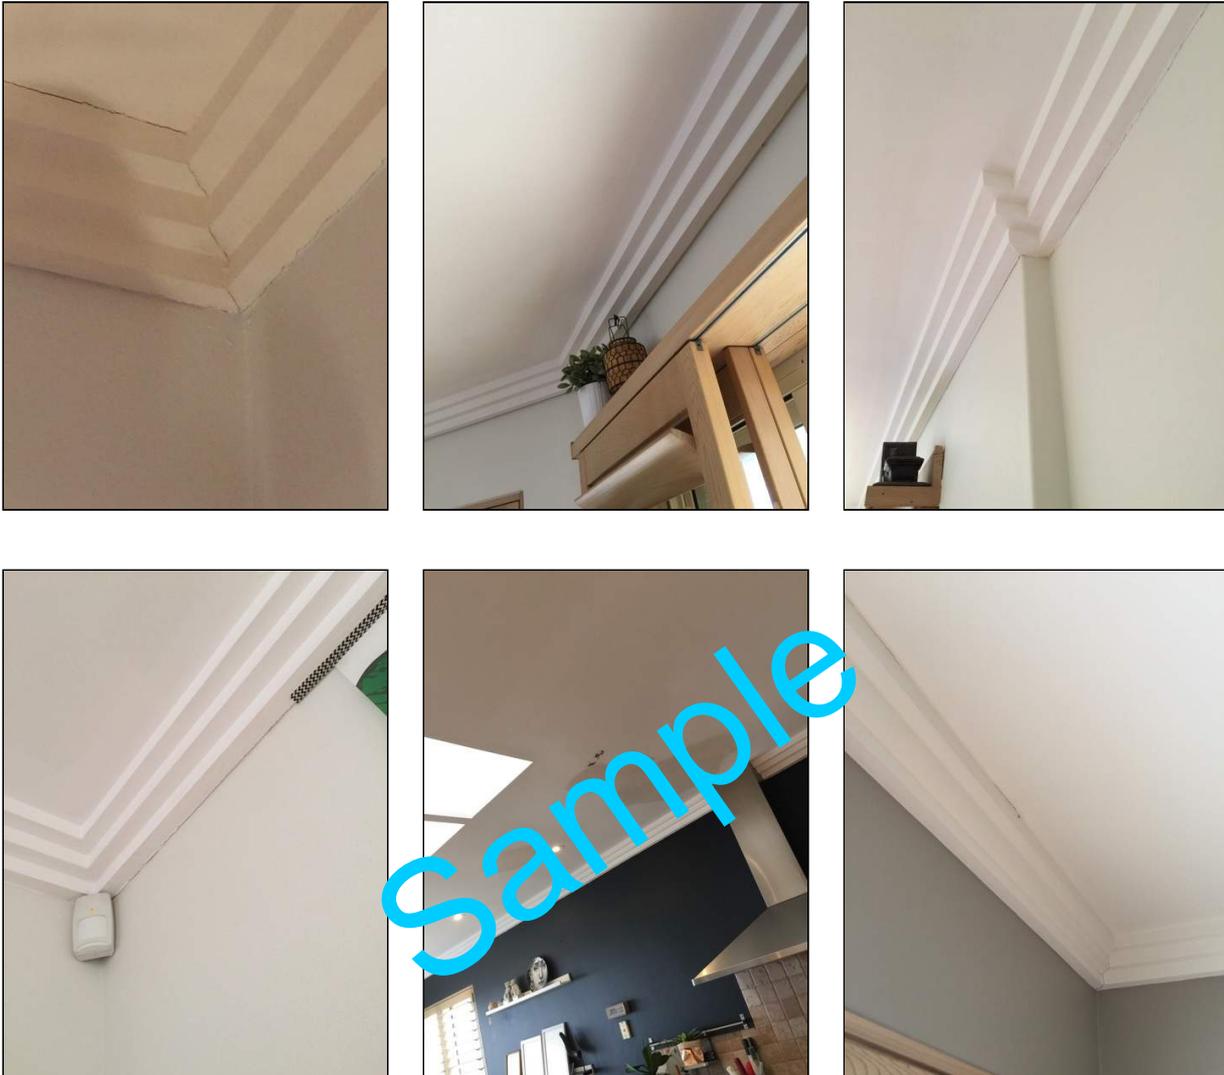
There is imperfections in the ceiling, it appears to be old moisture stains within the ceiling / cornices

Location Kitchen ceiling is affected by water entry, I recommend a flood test be carried out as I could not see an obvious water entry point within the roof

Defect Rating Further investigation

A painter can repair and make good these issues quickly and inexpensively

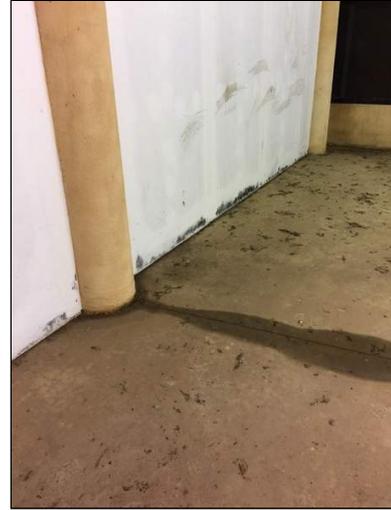
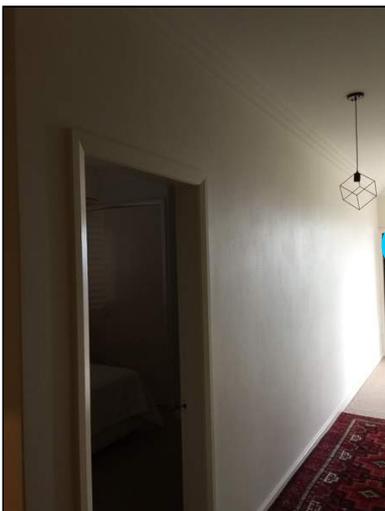
Dampness and/or staining was identified as a result of :

Defect Rating Further investigation

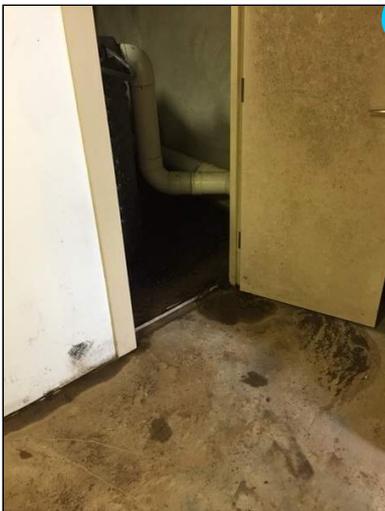
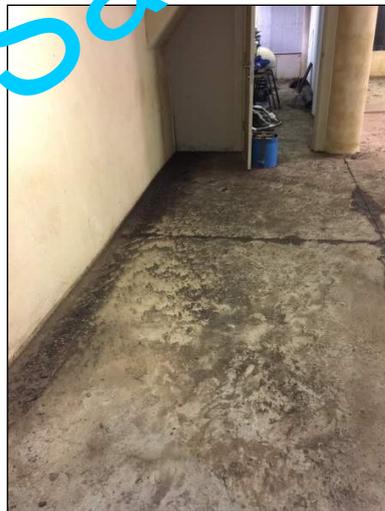
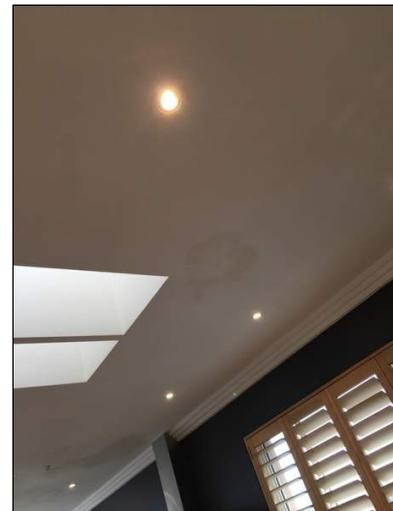
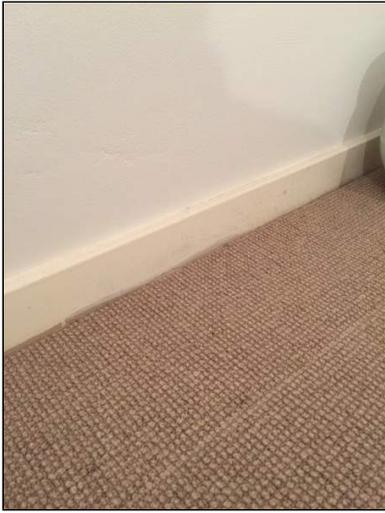
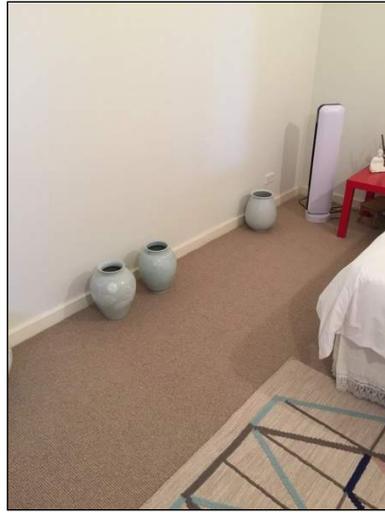
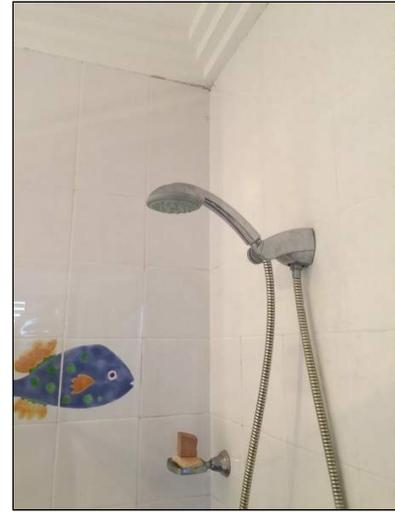
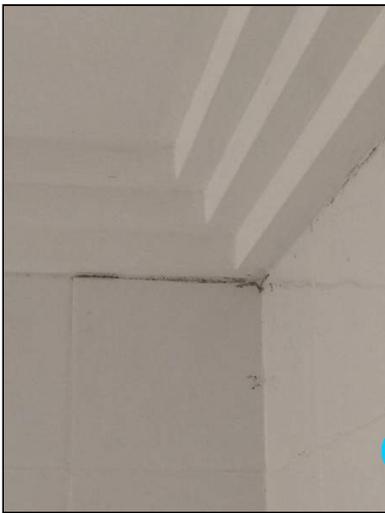
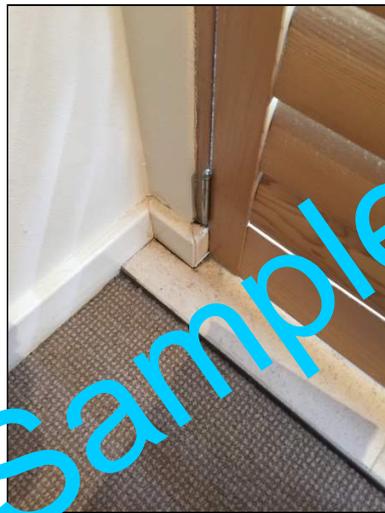
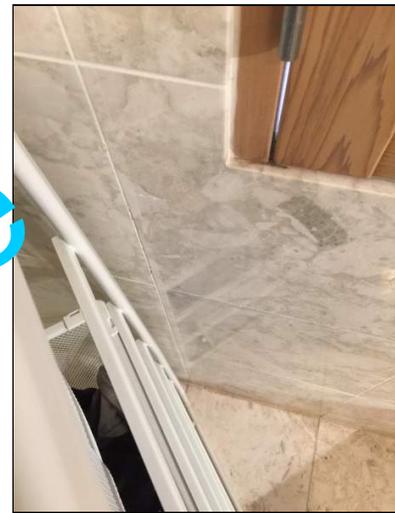
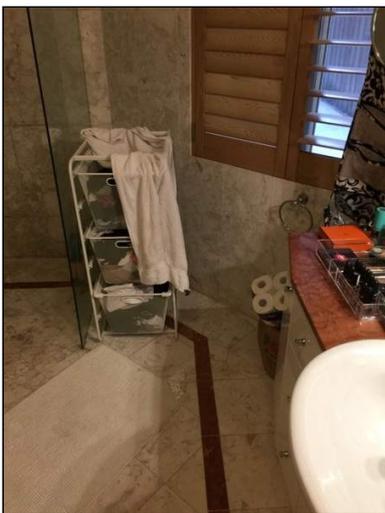
Question Are all internal habitable rooms free of damp problems, including rising/falling damp, condensation, horizontal penetrating dampness?

Defect Rating Further investigation

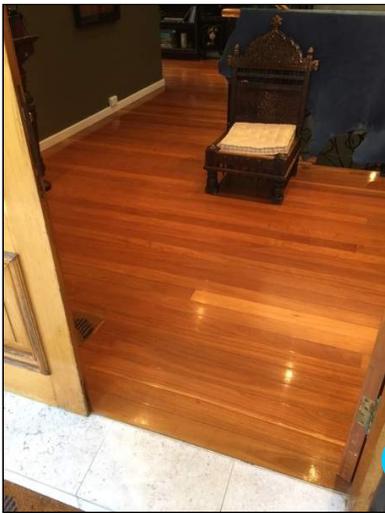
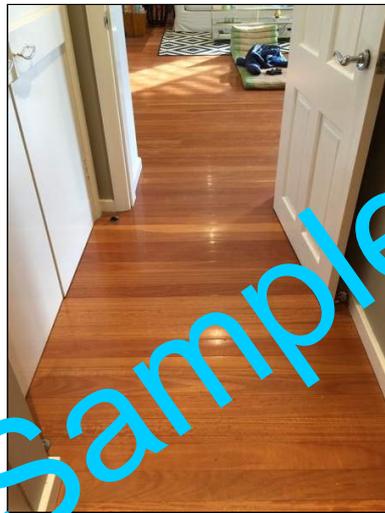
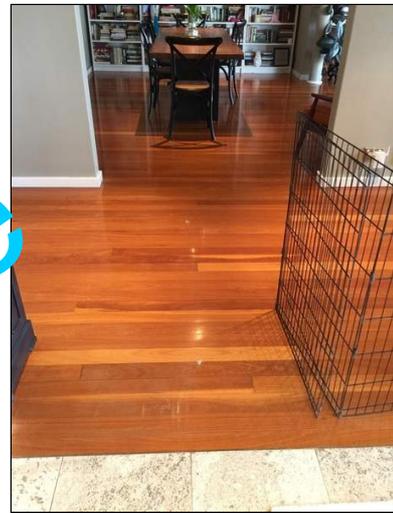
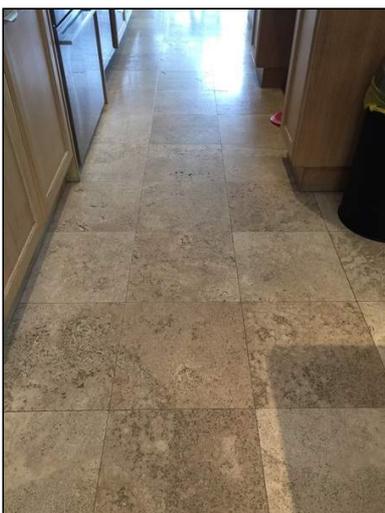
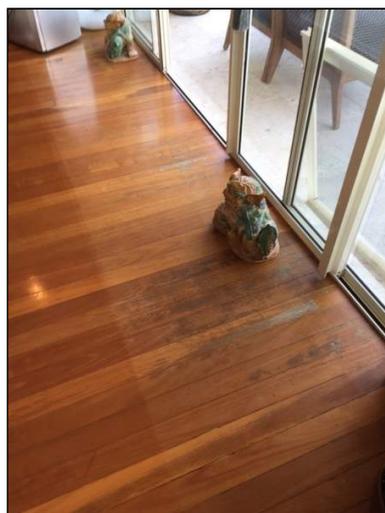
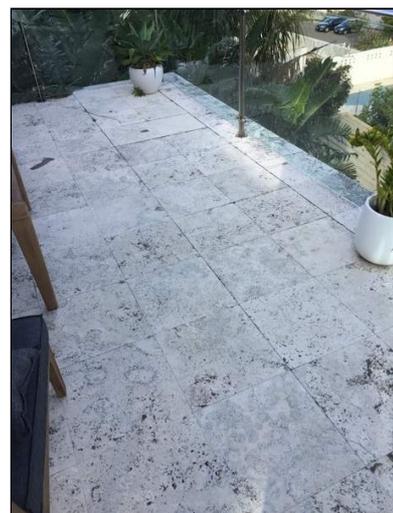
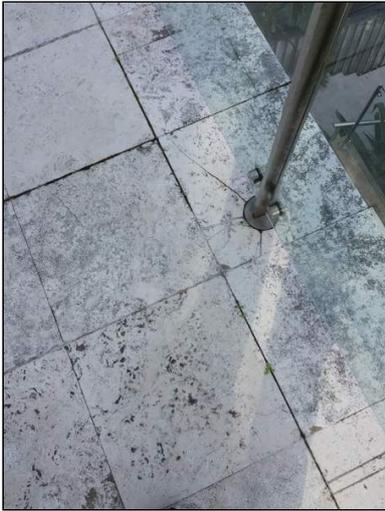
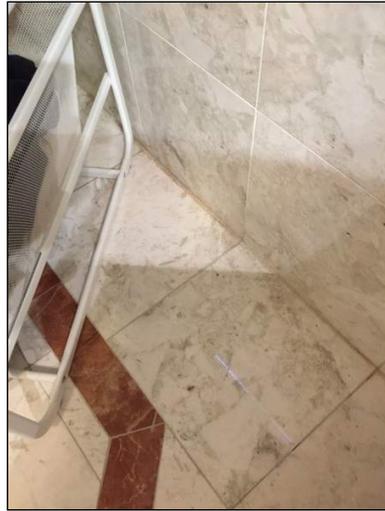
Floors; Are floors free of movement such as spring, bounce and or cracking, are they free of dampness/staining and other damage?

Defect Rating Minor Defect

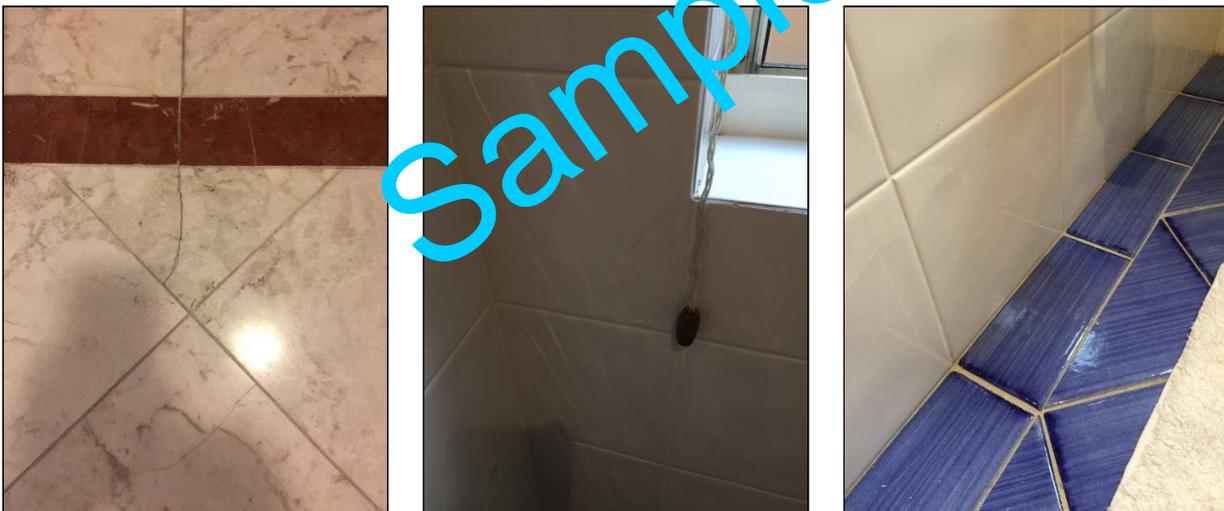
Question Bathrooms/WC; Are the BATHROOM wall & floor tiles free of cracks, drumminess, or loose/missing grout/sealant?

Defect Rating Minor Defect

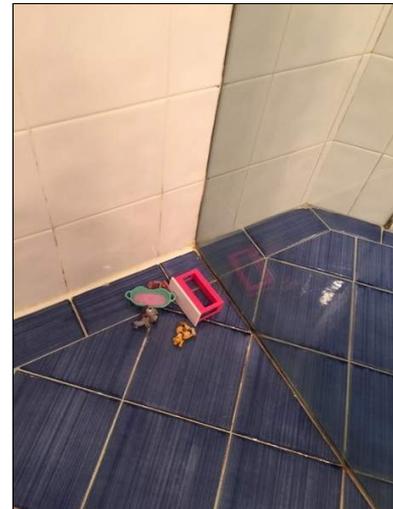
Question **Bathrooms/WC; Is the shower screen free of defect or damage?**

Answer **Inadequately sealed at floor/wall junctions**

Defect Rating Minor Defect

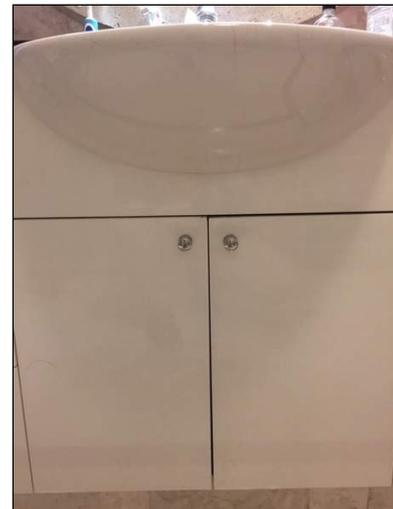
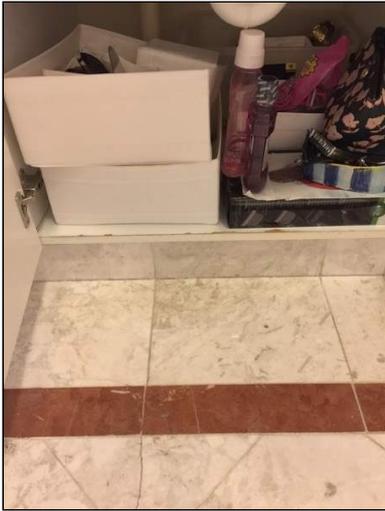
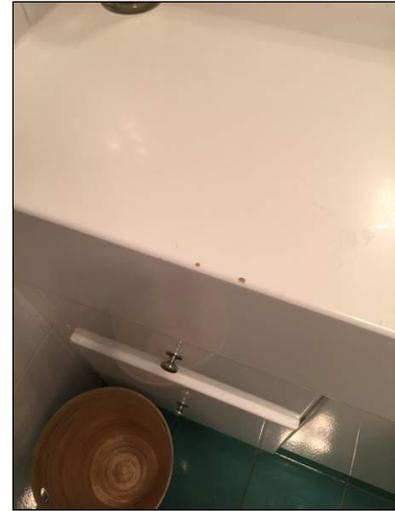
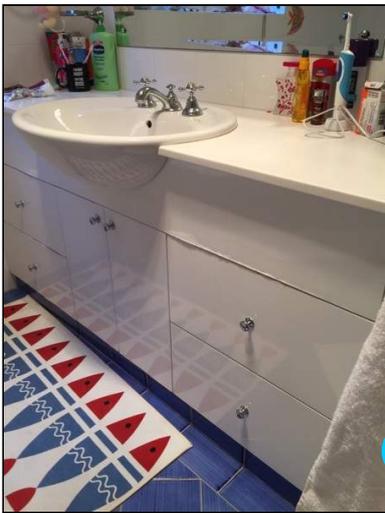
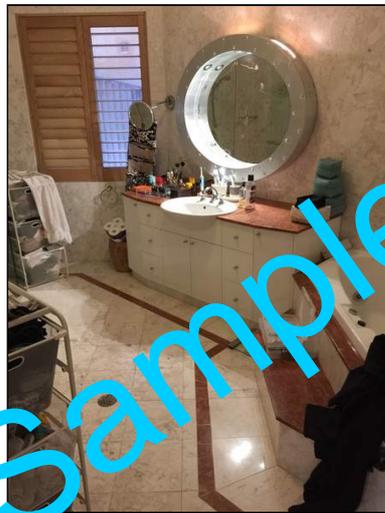
Question **Bathrooms/WC; Around the shower, is it free of signs of leaking/seepage?**

Answer **Water damage along adjacent wall - Suspected membrane failure**

Defect Rating Minor Defect

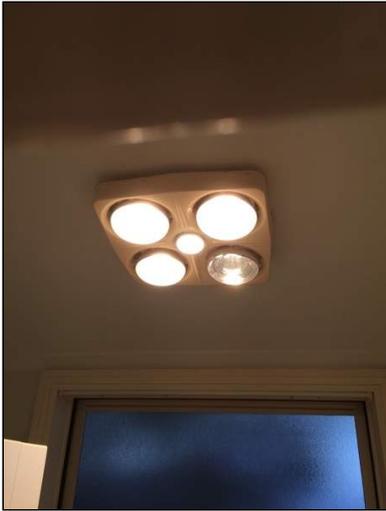
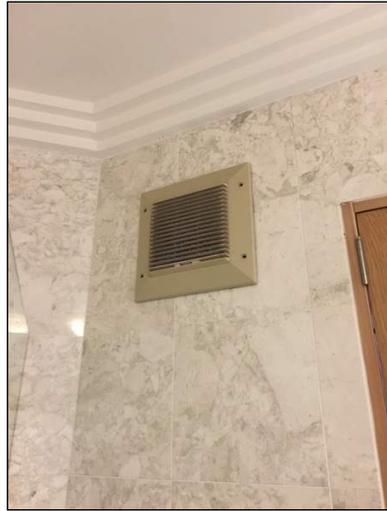
Question Bathrooms/WC; Is the room free of condensation damage?

Defect Rating Minor Defect

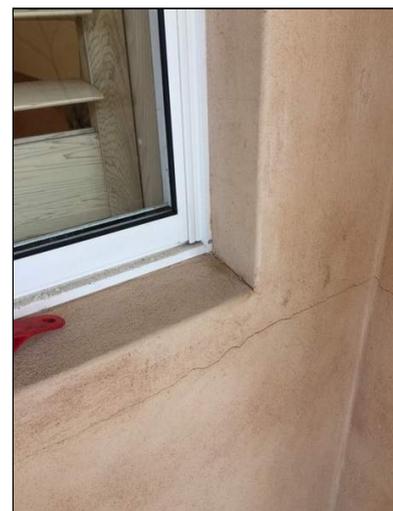
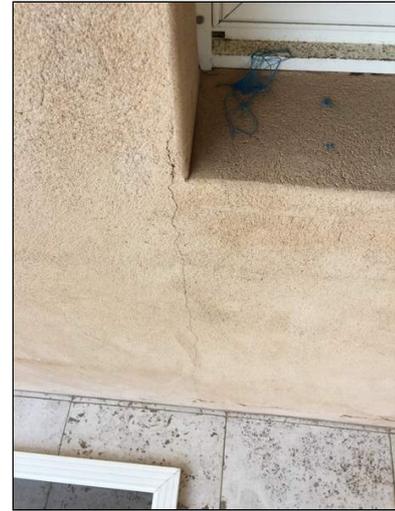
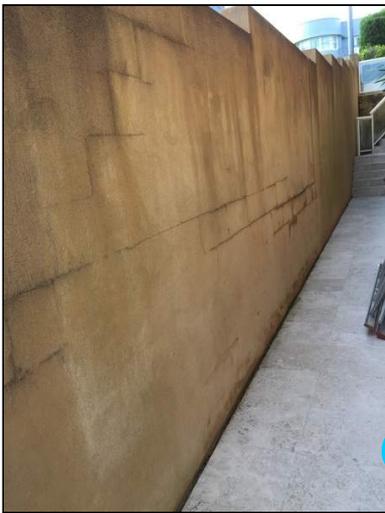
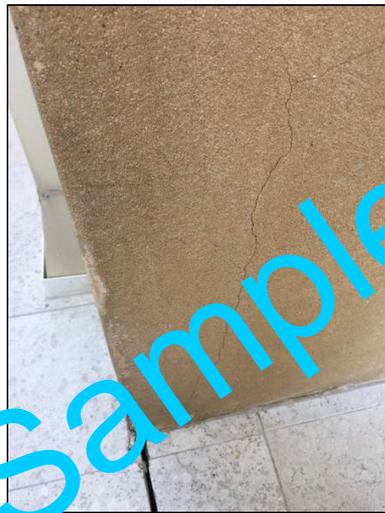
Question External Walls; Are all walls/wall cladding free of defect/damage, and is the paint/coating maintained?

Answer Weep holes covered

Defect Rating Minor Defect

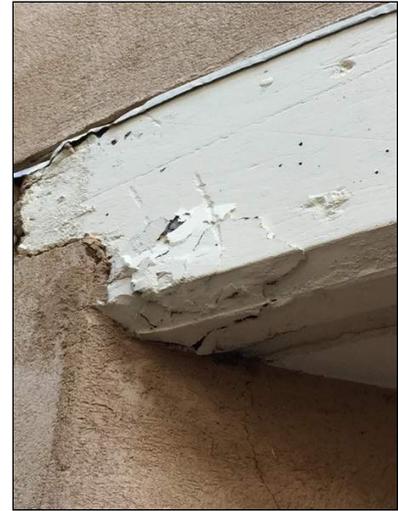
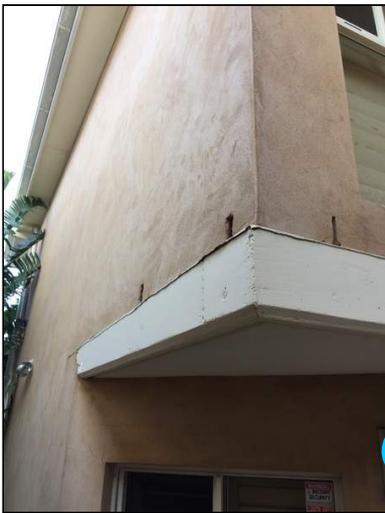
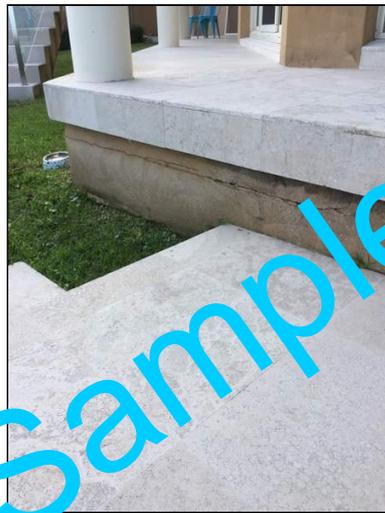
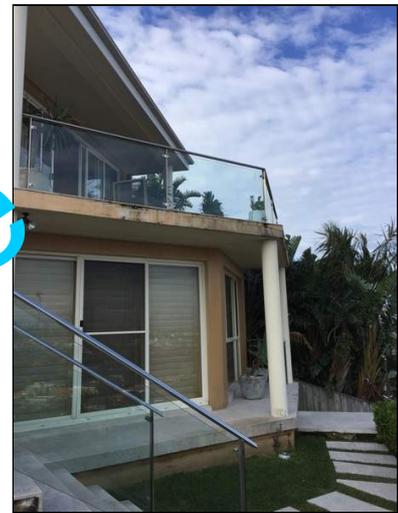
Defect Rating Major Defect

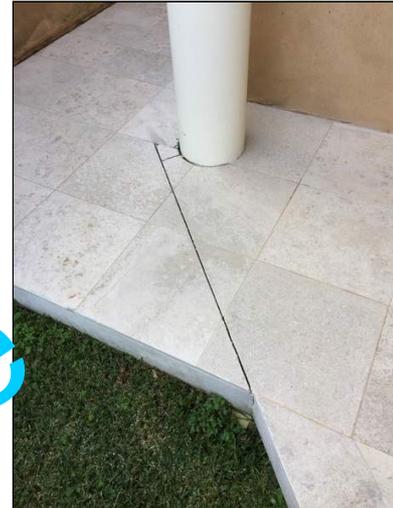
Question Retaining walls; For walls over 700 millimetres high, do they appear structurally sound, and free of decay?

Answer Minor cracking evident

Defect Rating Minor Defect

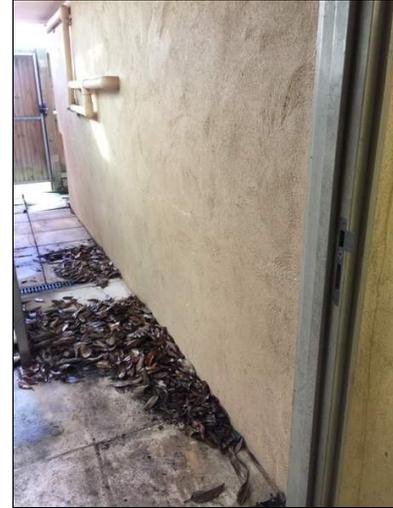
Question Are there expansion joints present in the external floor finishes

Defect Rating Minor Defect

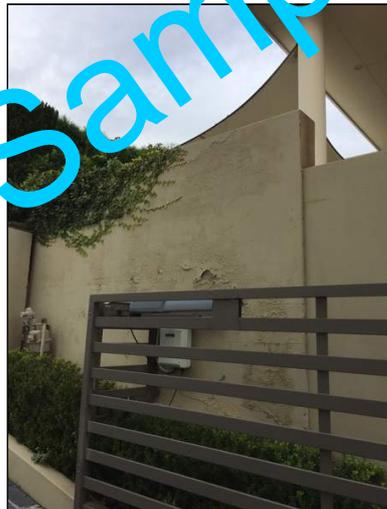
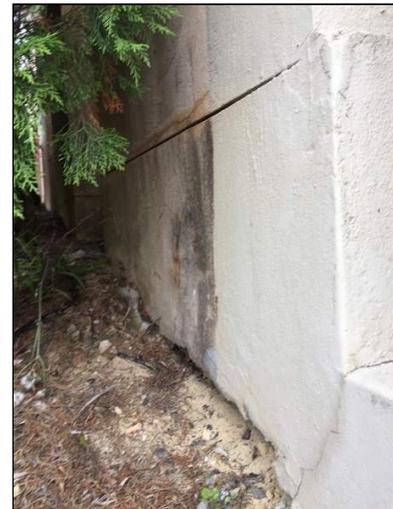
Question Are there expansion joints present in the external walls ? (Every 5.5m a expansion joint or control joint should be installed)

Defect Rating Minor Defect
