Residential Pre-Purchase Building Inspection Report

Property Address: 16 Second Avenue Willoughby

Date of inspection: 17/05/2017

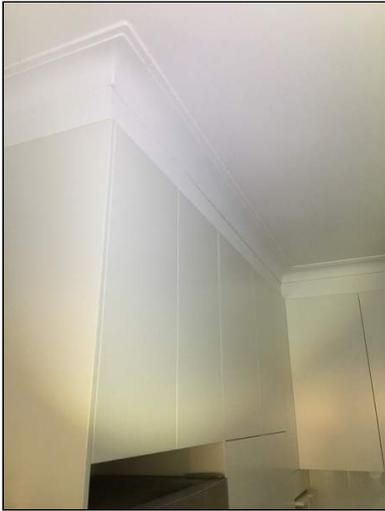
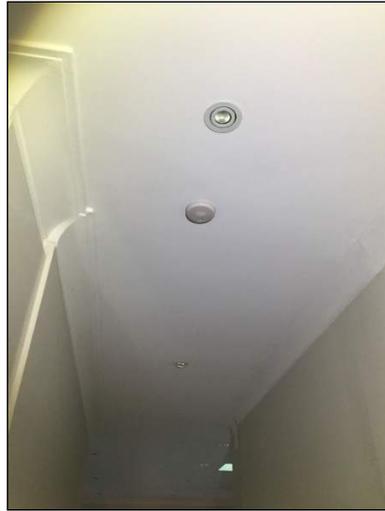
Answer **Slight cracking to ceiling joints & cornices**

Minor cracks evident at the plasterboard ceiling joints, these cracks are not structurally significant.

1. Some sagging of the plasterboard ceiling is evident in places.
2. Minor defects found within the plasterboard ceiling linings
3. Minor cracks found in the cornices and wall junctions
4. Minor cracks found in the cornices and ceiling linings

Defect Rating Minor Defect

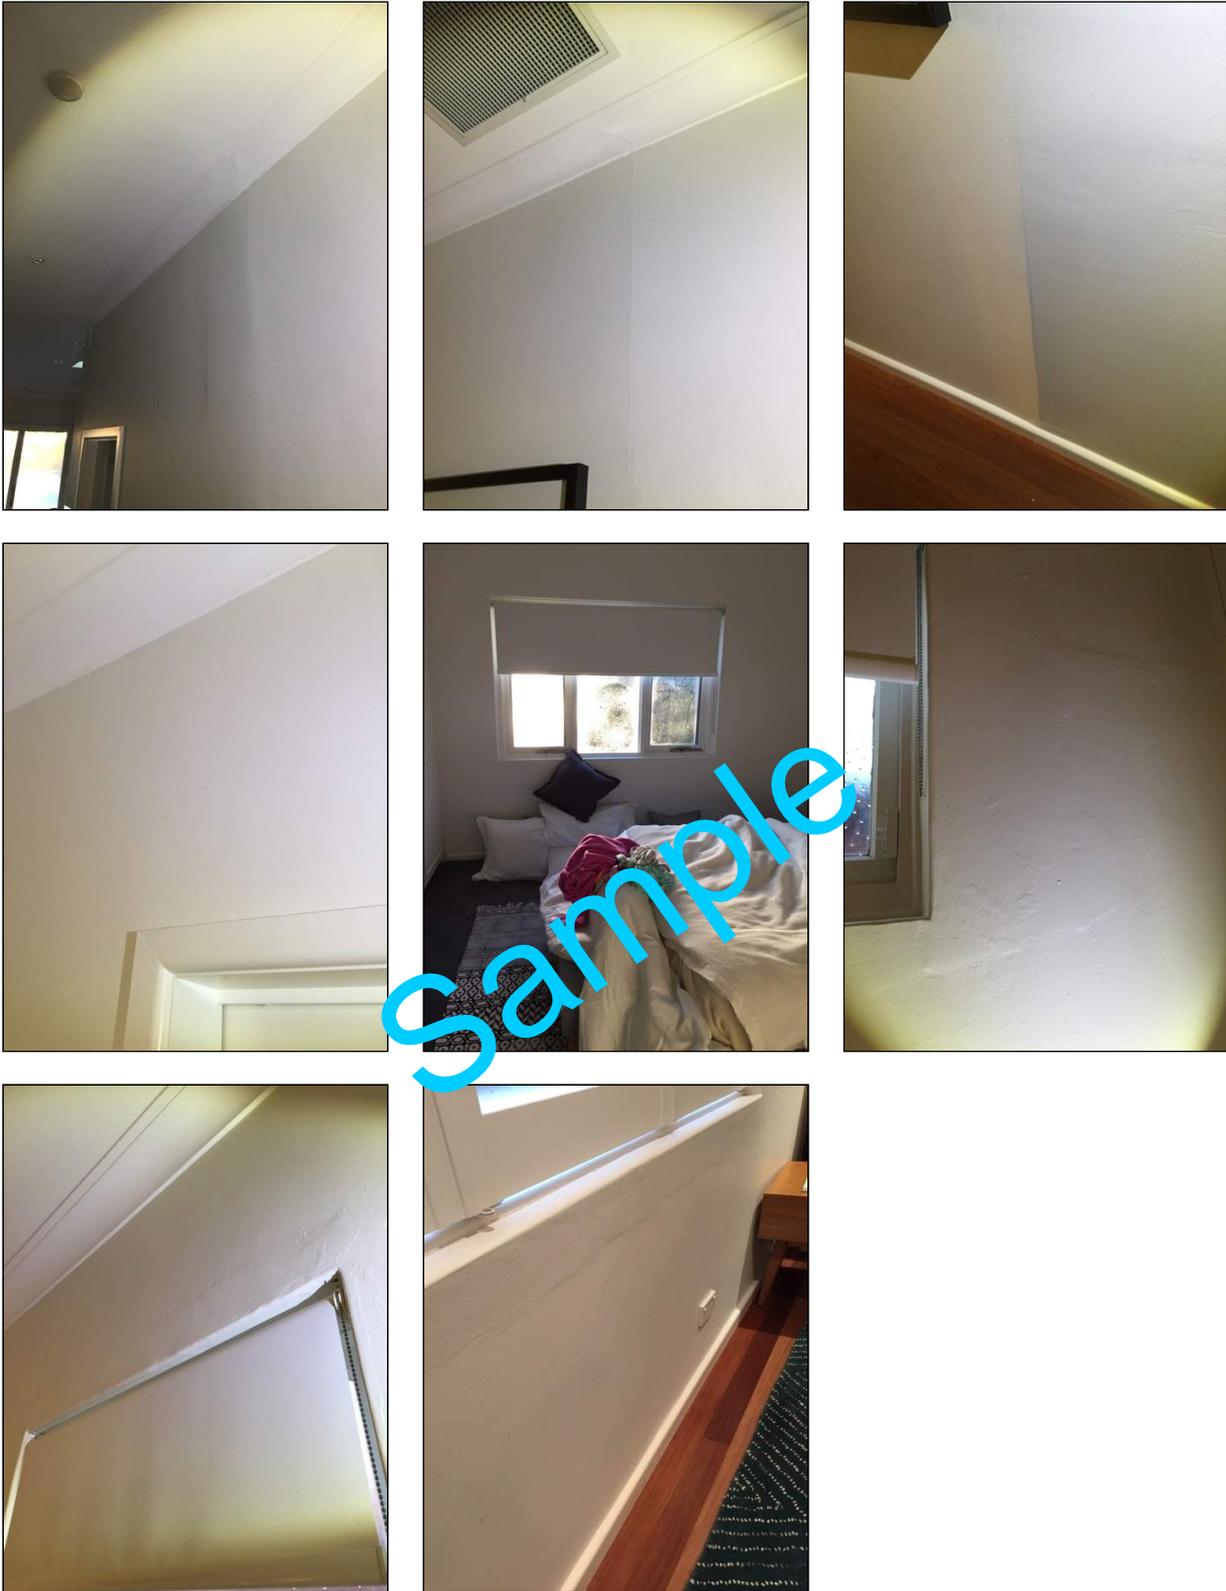
Question Walls; Are the wall linings free of bulging, nail popping, cracking, dampness/staining, vertical distortion and other damage?

Answer **Minor cracks to plaster linings - Typical settlement cracks found within a building**

Minor cracks were seen within the internal wall linings due to normal settlement and can be left as is.

Defect Rating Minor Defect

Hairline cracks in the wall linings are normal and they are normally fixed up by a painting contractor when a house is repainted. A normal life cycle for painting a house internally is every six to ten years.

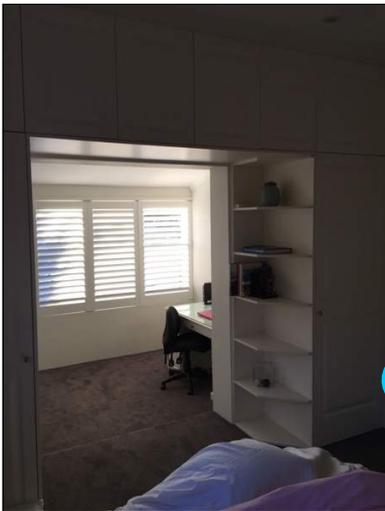
Location The walls may not be watertight, as the walls were originally built with no cavity, which could allow moisture to travel through the walls and into the new internal space within the house

Defect Rating Minor Defect

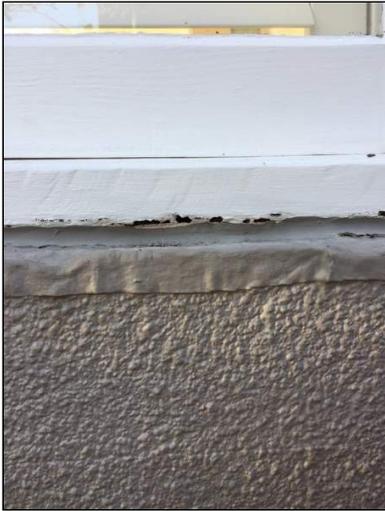
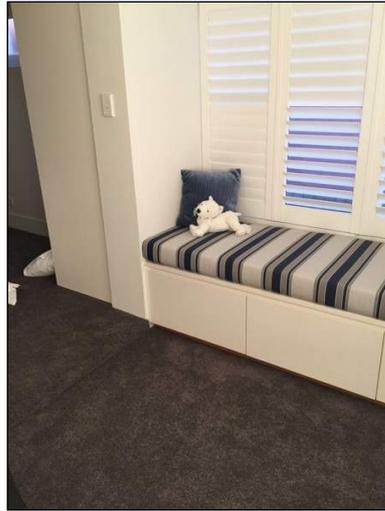
Answer Evidence of minor rotting

Evidence of minor rotting found within the external doors / windows

Defect Rating Minor Defect

Repairs and re-painting is required by a painting contractor to preserve the timber members

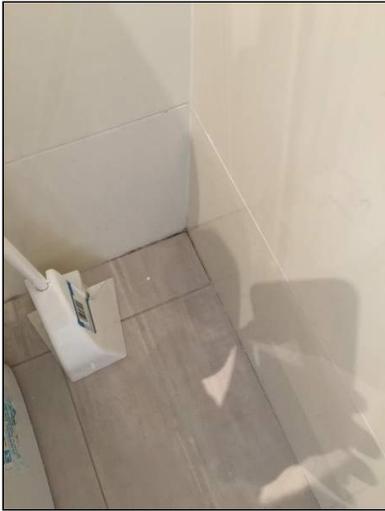
Question Bathrooms/WC; Are the BATHROOM wall & floor tiles free of cracks, drumminess, or loose/missing grout/sealant?

Answer Gaps/defective sealant

Defect Rating Minor Defect

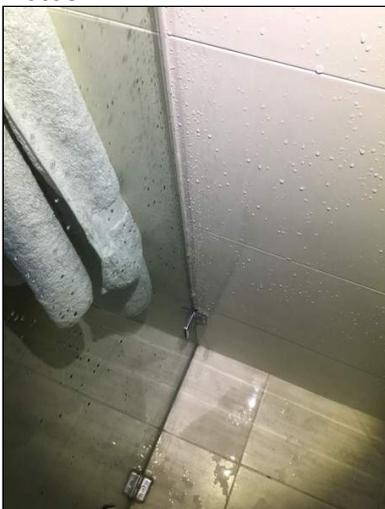
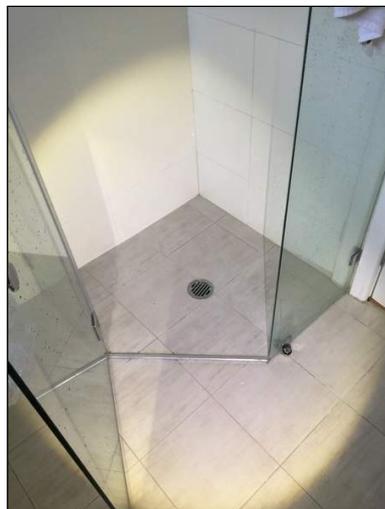
Question Bathrooms/WC; Is the shower screen free of defect or damage?

Answer Showerscreen and tile junctions needs to be cleaned and re-sealed

Defect Rating Minor Defect

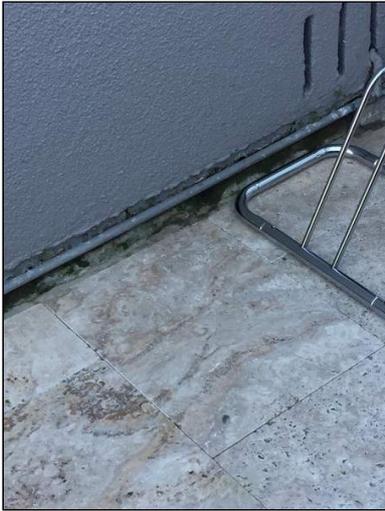
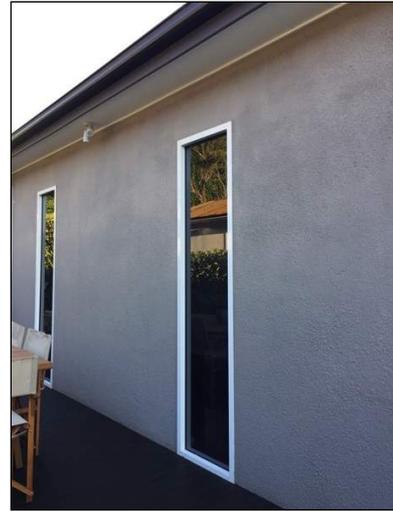
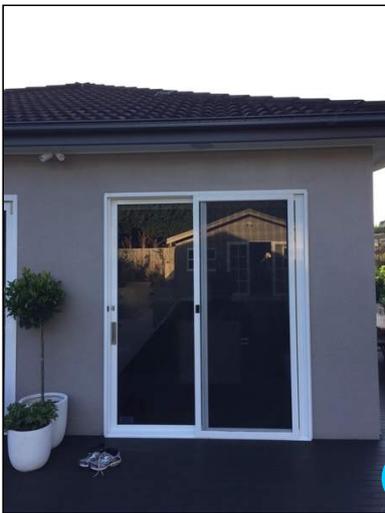
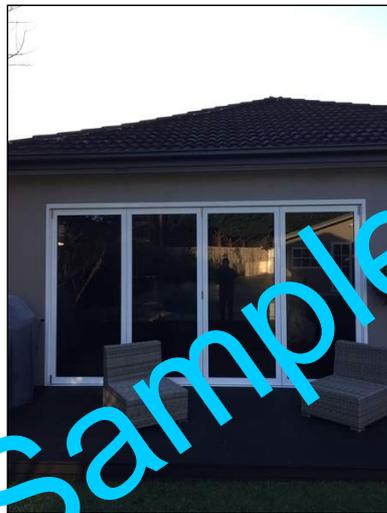
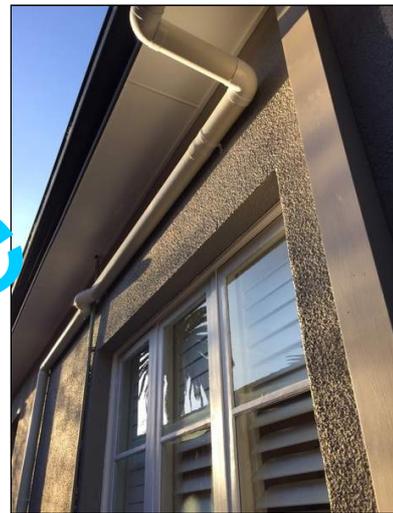
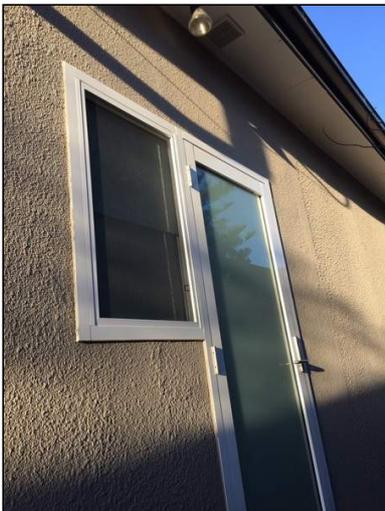
Question External Walls; Are all walls/wall cladding free of defect/damage, and is the paint/coating maintained?

Answer **Rising damp/salt residue on lower walls**

Defect Rating Minor Defect

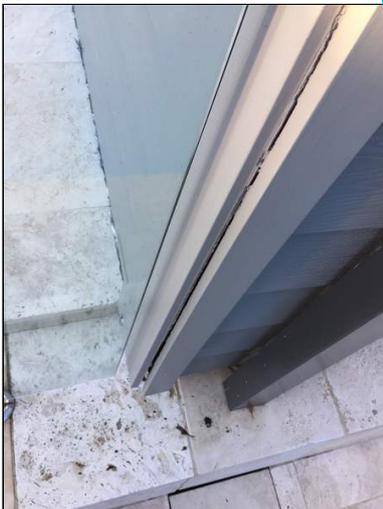
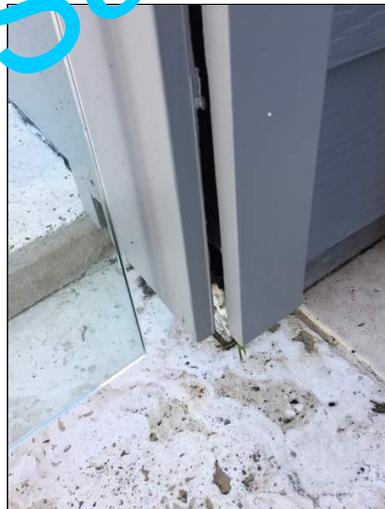
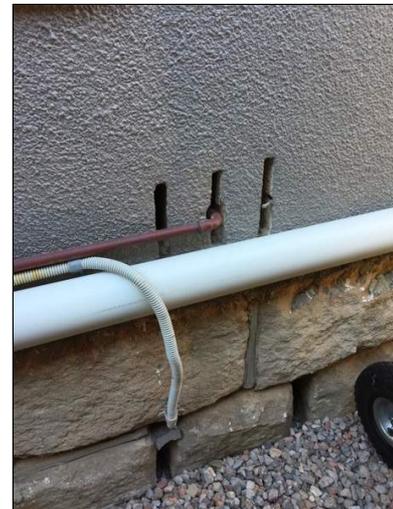
Wall Cladding Flashing & DPCs; Does the wall cladding have suitable flashings and damp proof course, and is it free of dampness damage?

Defect Rating **Minor Defect**

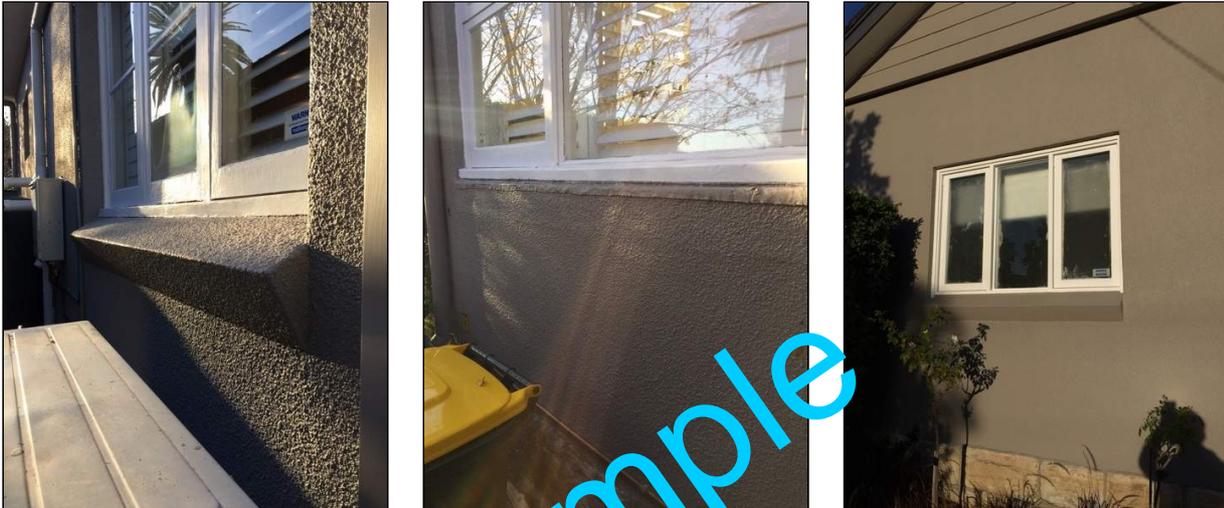
Question **Walls & doors / window junctions, do suitable flashings, mouldings, and sills exist and are they free of defect/damage?**

Answer **Missing weep holes above or below windows or doors**

Defect Rating Minor Defect

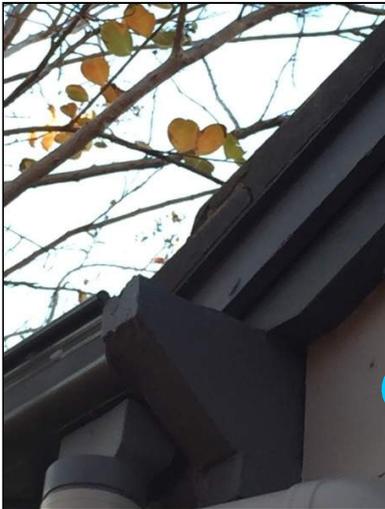
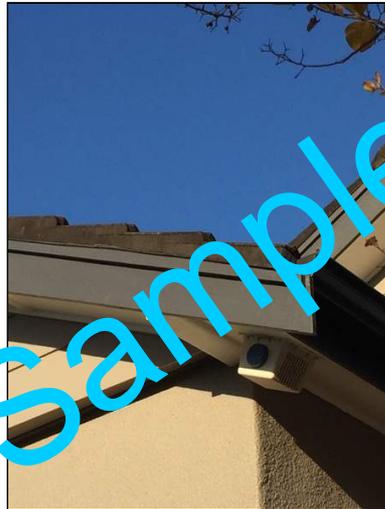
Question Eaves/fascias/barges; Are they free of corrosion/decay, and do they appear to be sufficiently rigid?

Answer **Fascia - fungal decay**

Defect Rating Minor Defect

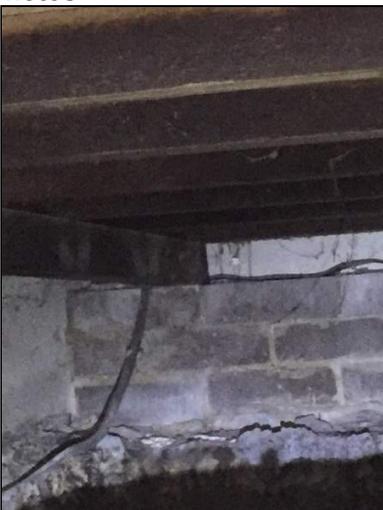
Question Timber floor; Are bearers and joists free of deflection and sag, and free of cracks, corrosion, water stains, decay?

Answer Sag in bearers/joists is evident

Defect Rating Minor Defect

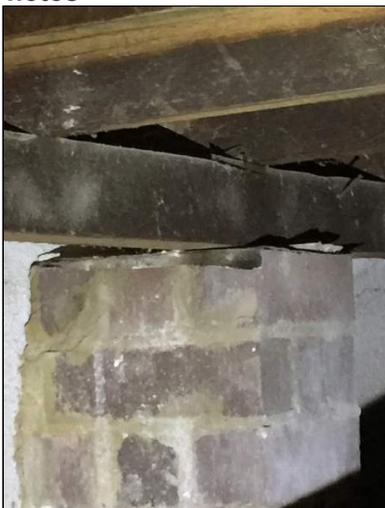
Question Timber floor; Do columns/posts appear to be structurally sound, with undamaged ant cappings, and free of cracks, corrosion, decay?

Answer **Missing/damaged ant cappings**

Defect Rating Major Defect

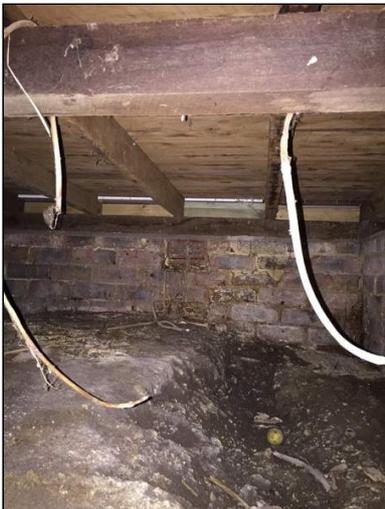
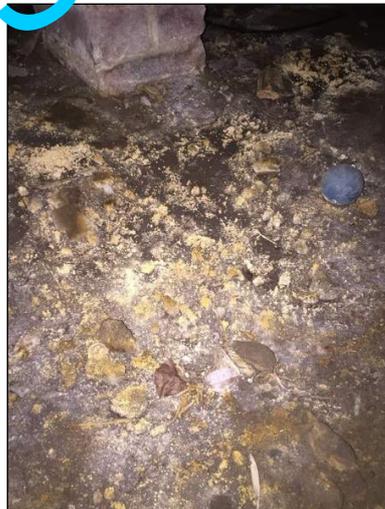
Question Timber floor; Does the sub floor area appear to be adequately ventilated, and free of dampness?

Answer **Inadequate ventilation within the sub floor areas inspected**

Minor Defect

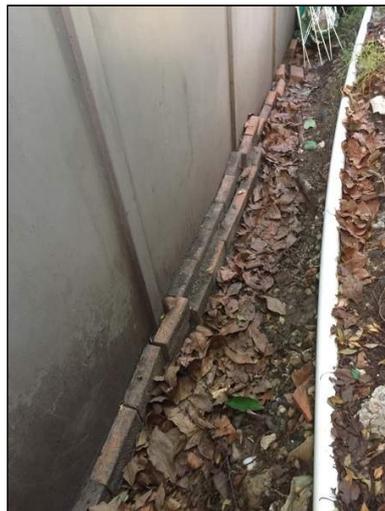
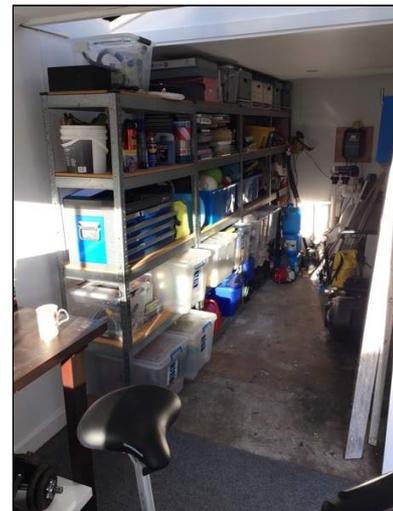
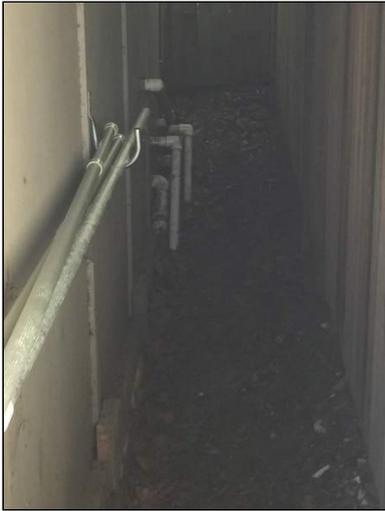
Question Detached Buildings; Garden Sheds/Workshop, do the buildings appear structurally sound and free of defects/damage?

Answer Downpipes not connected

Defect Rating Further investigation

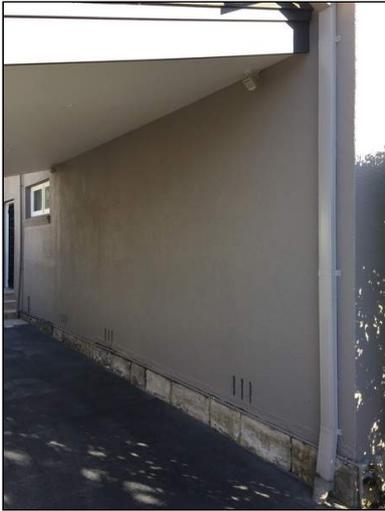
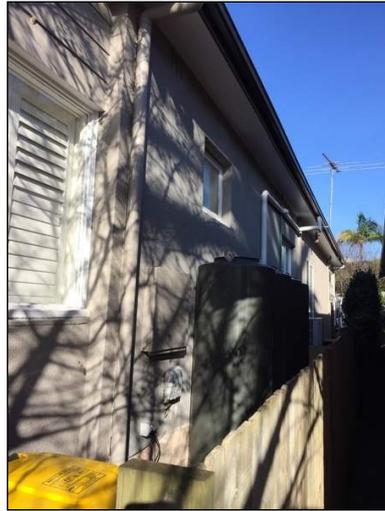
Question Are there expansion joints present in the external walls ? (Every 5.5m a expansion joint or control joint should be installed)

Answer No

Details Minor defect
