# Dilapidation Report

## 14/9 Goomerah Crescent Darling Point

18<sup>th</sup> May 2017

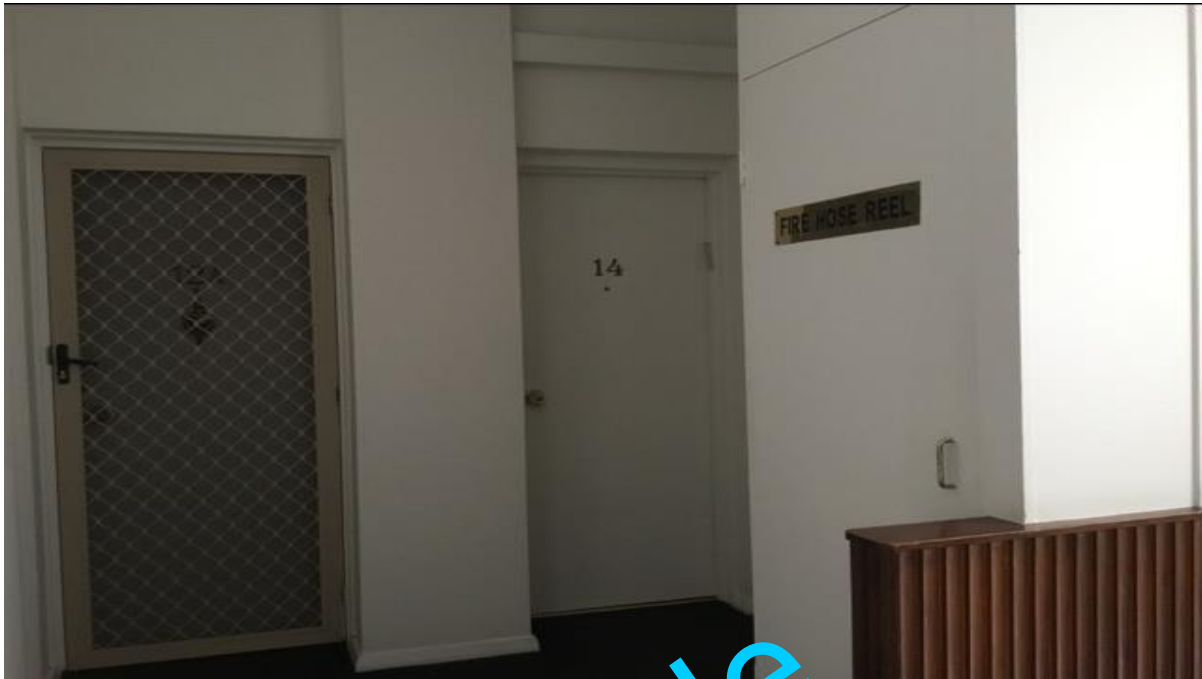
Image of the Front Door, Apartment No 14  
(Located below apartment 24 Goomral, C-Darling Point)

No Structural or superficial damages found within this area at the time of this inspection.

I inspected the walls, Floor, ceilings and all surrounding surfaces.

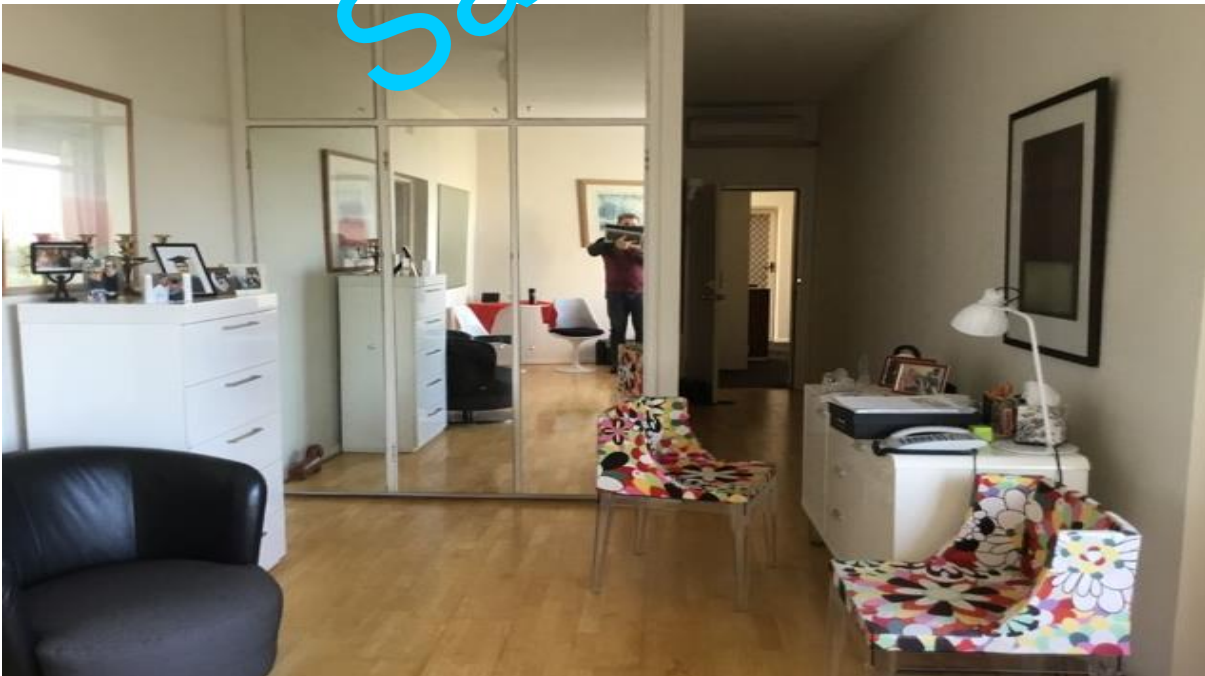
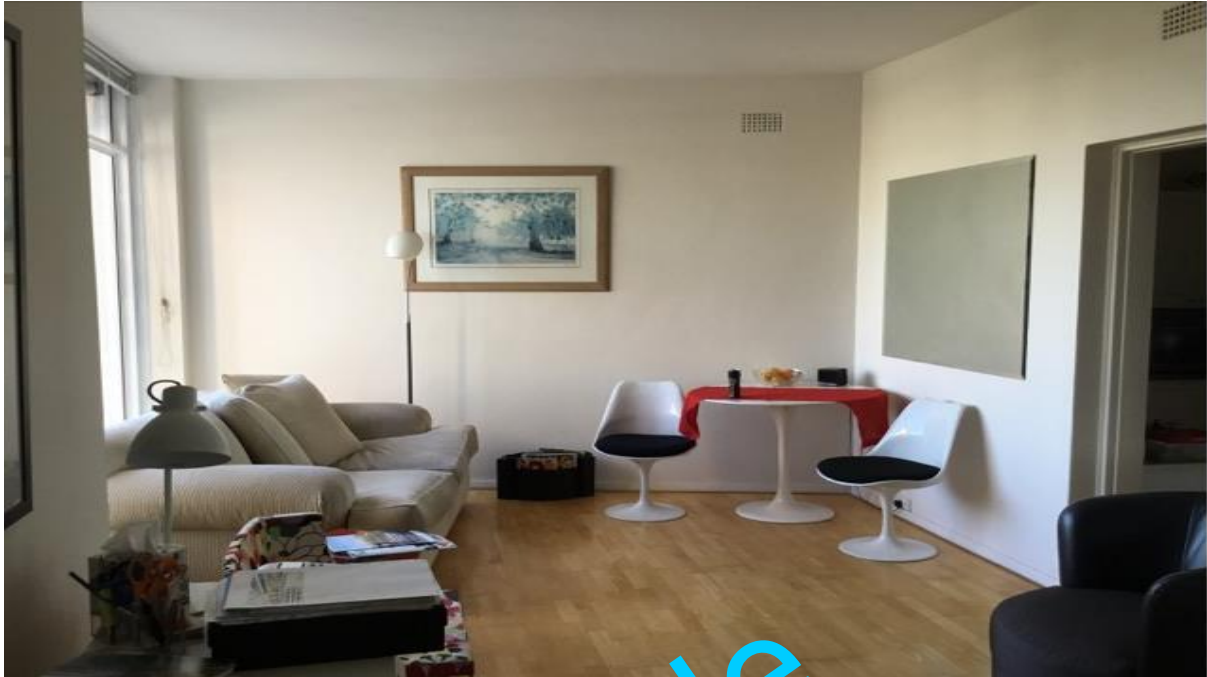
Image of the Entry Door / Hallway / Living and Dining room

The ceiling within the building is the floor of the above apartment No 24

I inspected all elements within this room and I have not sighted any Structural nor minor cracks or imperfections within the walls, floor and ceiling.

I have been advised that the entire apartment has been recently renovated and I confirm no defects are seen nor noted throughout the apartment.

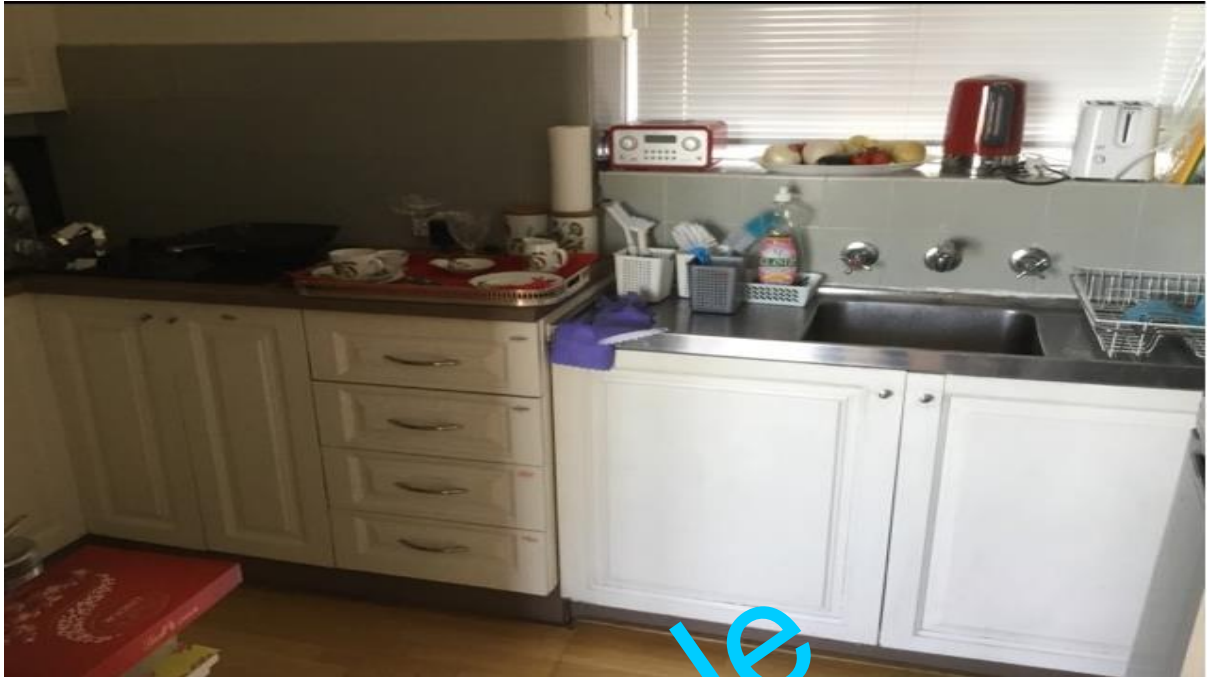
Image of the Kitchen

I inspected all elements within this room and I have not sighted any cracks or imperfections within the walls, floor and ceiling.

I have been advised that the entire apartment has been recently renovated and I confirm no defects are seen nor noted throughout the apartment.

I have inspected all plumbing and electrical fittings and service lines together with the wall linings / splash back, no leaks nor settlement cracks are present within this room and fitout.

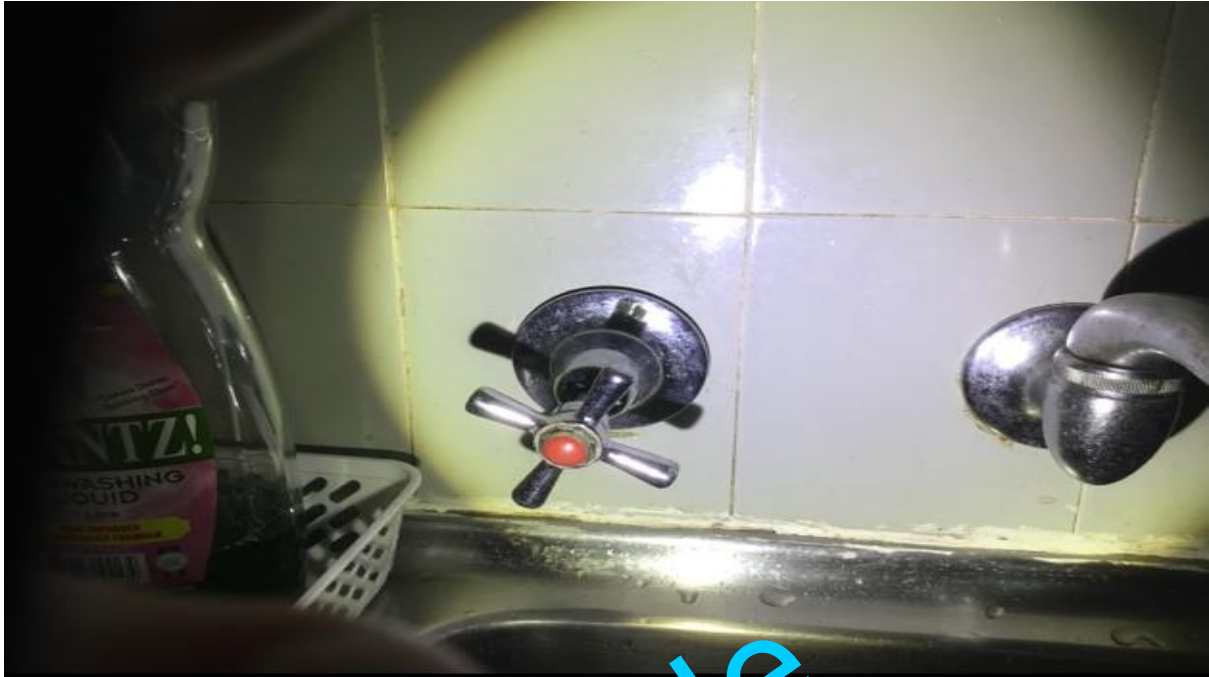
Image of the Kitchen “Splash back tiles”

I inspected all elements within this room and I have not sighted any structural cracks or imperfections within the walls, floor and ceiling.

I have seen and photographed a minor crack in the splash back tiles as seen adjacent / above the hot water tap

I have tested and noted that the wall tiles are slightly drummy when struck with a metal object such as a coin, the wall tiles are firm fixed in place

I have inspected all plumbing and electrical fittings and service lines and no leaks nor settlement cracks are present within the plumbing lines

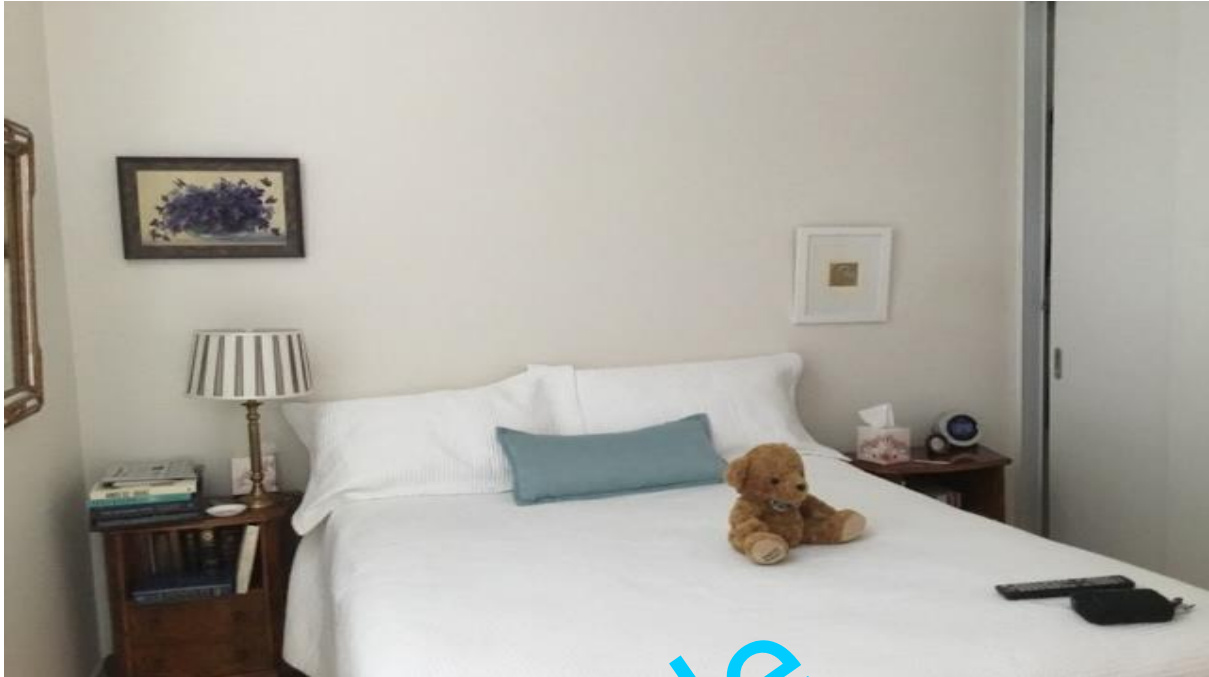
Image of the Master Bedroom

I inspected all elements within this room and I have not sighted any cracks or imperfections within the walls, floor and ceiling.

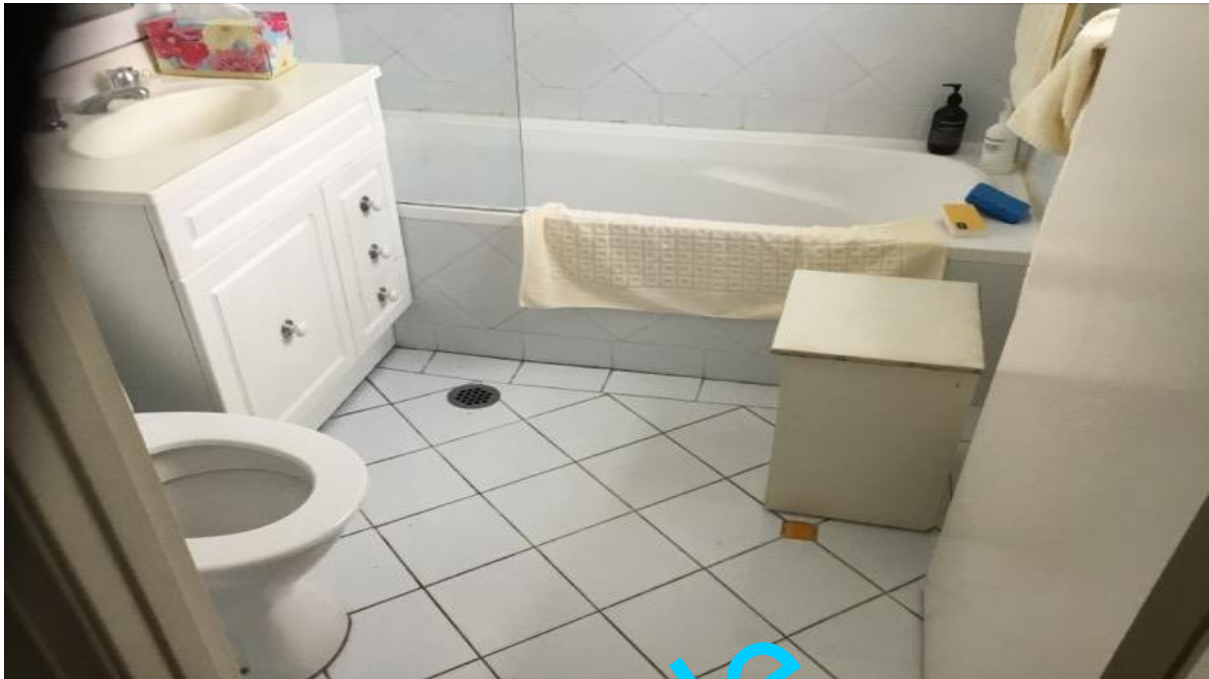
Image of the Bathroom / Ensuite

I inspected all elements within this bathroom and I have not sighted any structural cracks or imperfections within the walls, floor and ceiling.
