Residential Pre-Purchase Building Inspection Report

Complies with Australian Standard AS 4349.1-2007

Property Address: 22 Redan Lane Mosman

Date of inspection: 05/03/2021

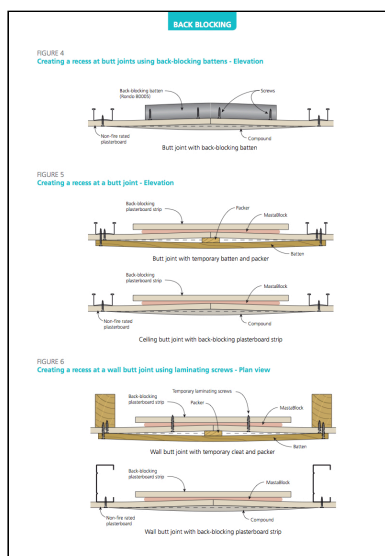
1. Sagging of the plasterboard ceilings in various locations
2. Minor defects found within the plasterboard ceiling linings
3. Minor cracks found in the cornices and wall junctions
4. Minor cracks found in the cornices and ceiling linings

Any cracks in the ceiling linings that have roof access above could have been created by a service contractor or owner when accessing the roof void, making the cracks within the ceiling non-critical.

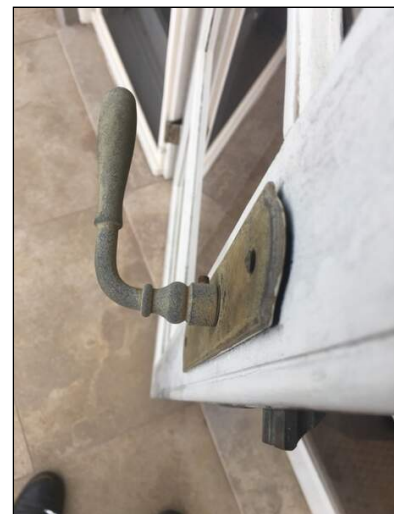
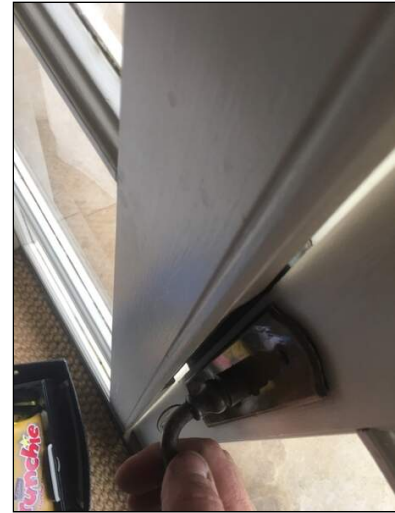
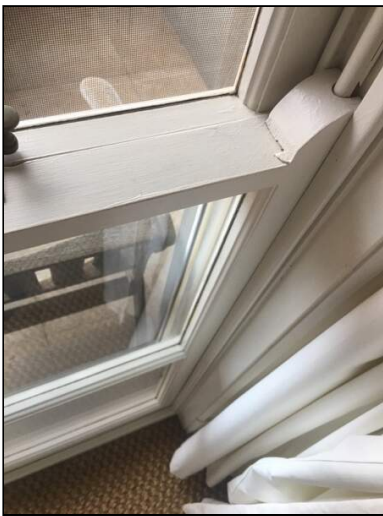
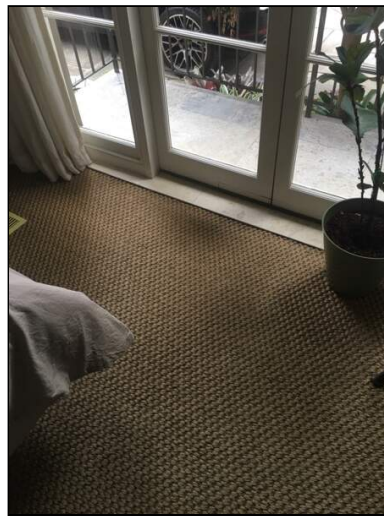
Question D. 8. Internal Doors & Frames; Do all doors and hardware operate freely and not bind on frames and are they free of decay/corrosion and other damage?

Answer **Weather damage evident to external door(s)**

Answer Missing door hardware

Defect Rating Minor Defect

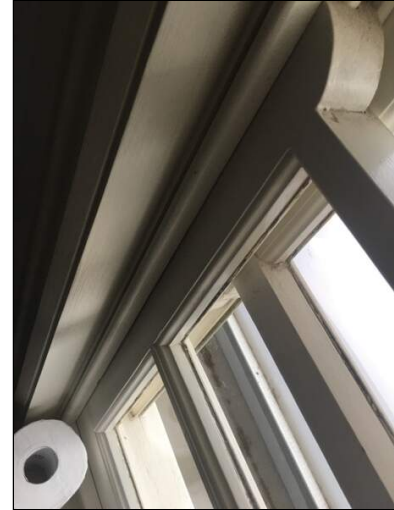
D. 10. External windows & doors (Timber framed); Are all windows free of broken/cracked glass, damage to putty, staining/decay, or do they operate freely?

Hardware Missing

Defect Rating Minor Defect

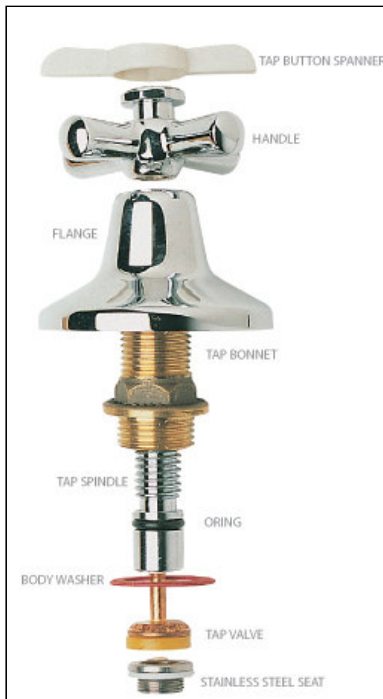
The kitchen sink and taps were in acceptable condition at the time of inspection

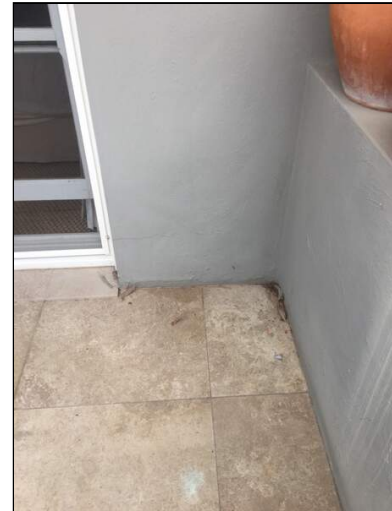
Question **D. 59. External walls (Non-Structural elements assessment) Are all walls, wall cladding and soffit linings free of defect / damage, and are the paint / coatings maintained?**

Answer **Weep holes covered**

Defect Rating Minor Defect

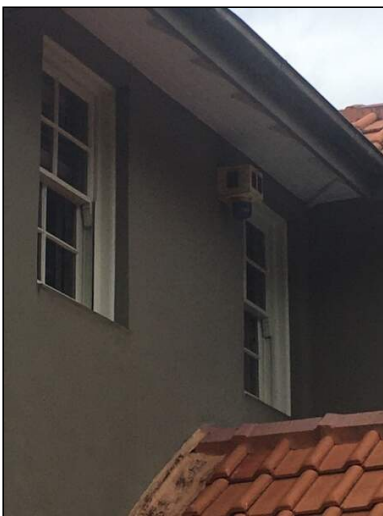
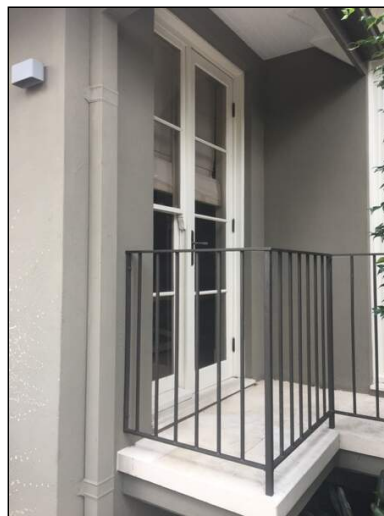
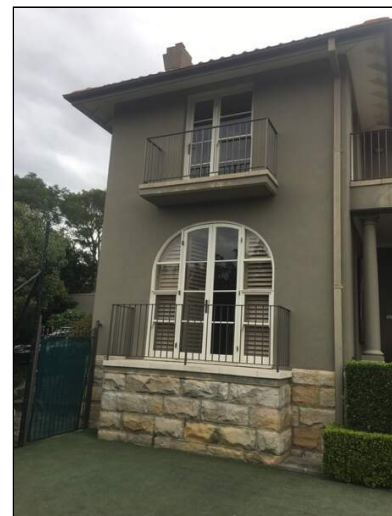
Question **D. 60. External "Walls & Doors/Windows"**

Answer **Missing weep holes above/below the windows or doors**

Defect Rating Minor Defect

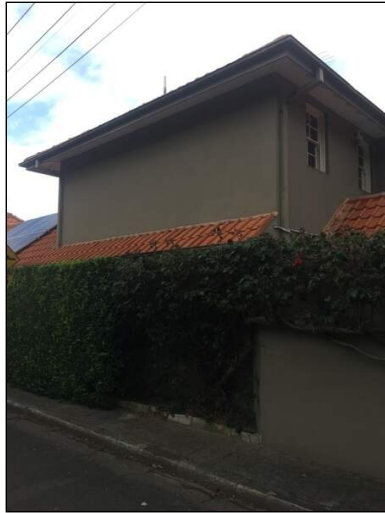
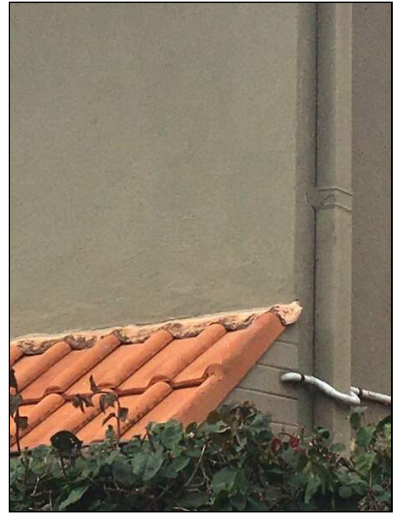
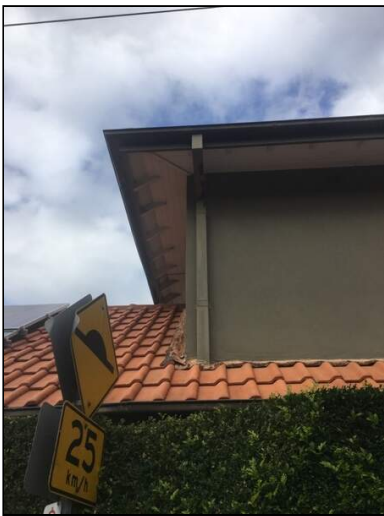
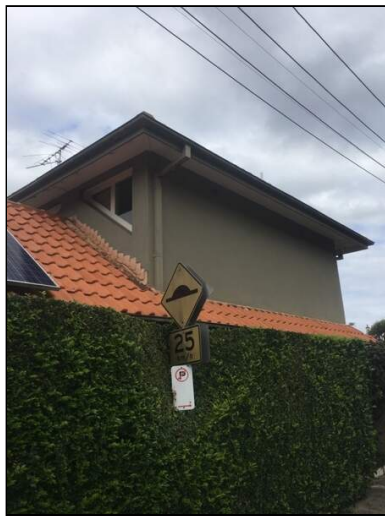
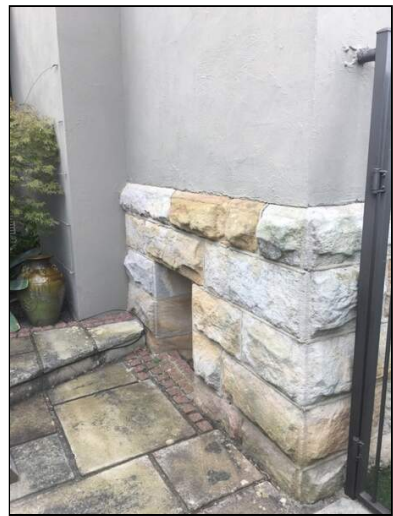
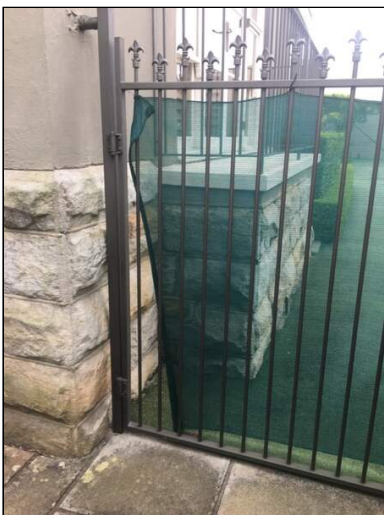
Question D. 61. Wall Cladding "Flashing & DPCs"

Answer I cannot see a damp proof course / flashing evident at the BASE of the external walls within this property

Defect Rating Minor Defect

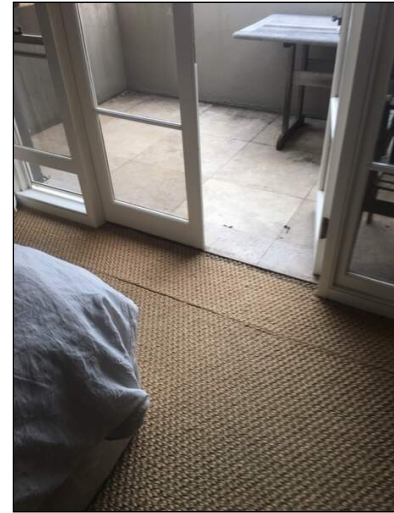
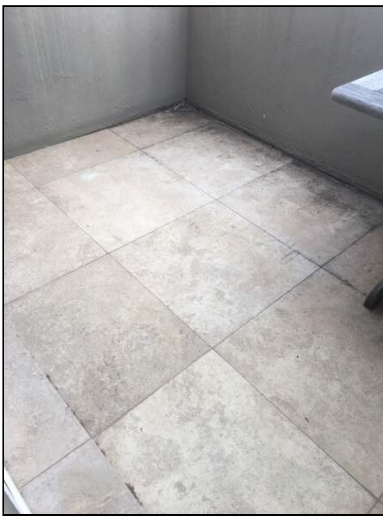
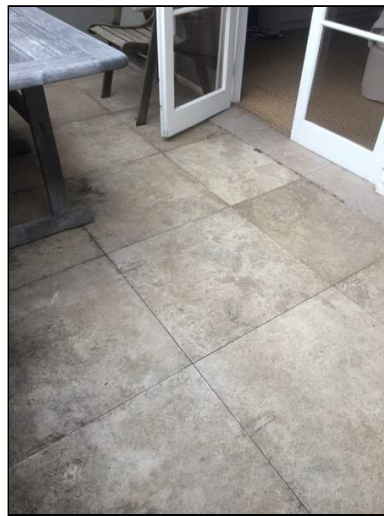
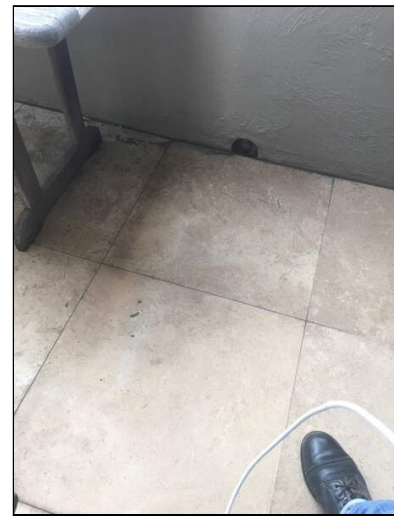
Question D. 65. Balconies / Verandas / Suspended "Floors & Walls"; Do they appear structurally sound, free of defects?

Defect Rating Minor Defect

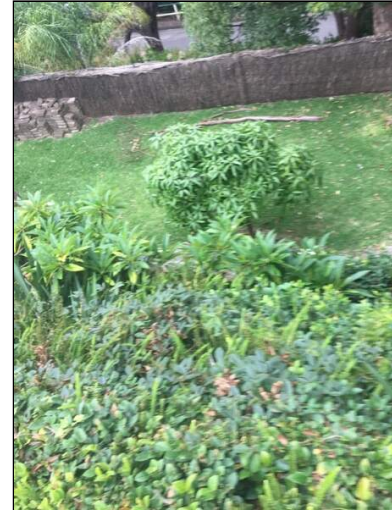
D. 66. Balconies / verandas / patios / decks / suspended floors / retaining walls; Are handrails and / or balustrading installed where a fall is greater than 1m?

Defect Rating Safety Hazard

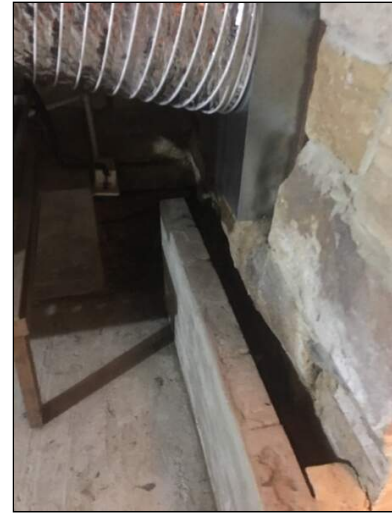
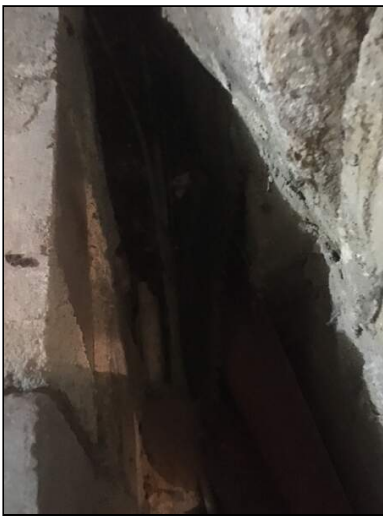
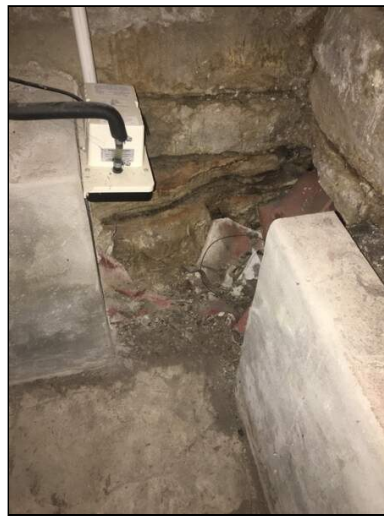
Defect Rating A second inspection is recommended once access is provided (Subfloor access is very important for any property with a timber floor structure)

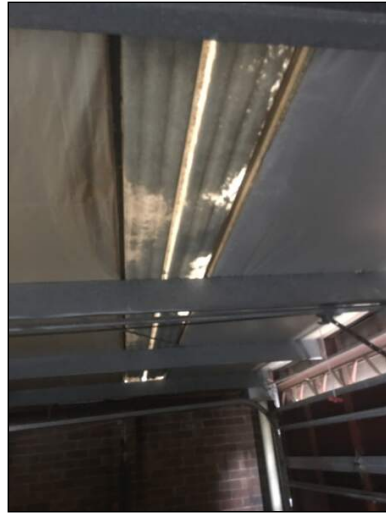
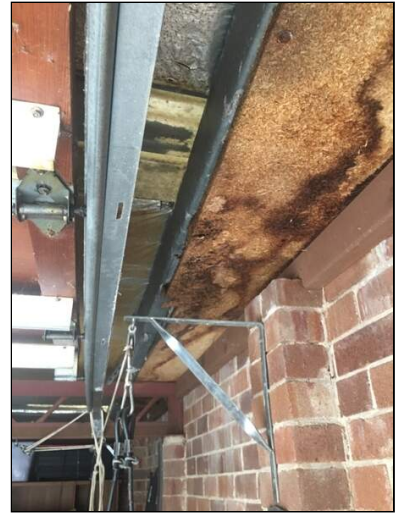
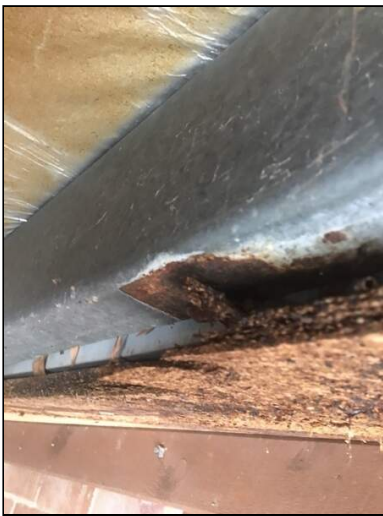
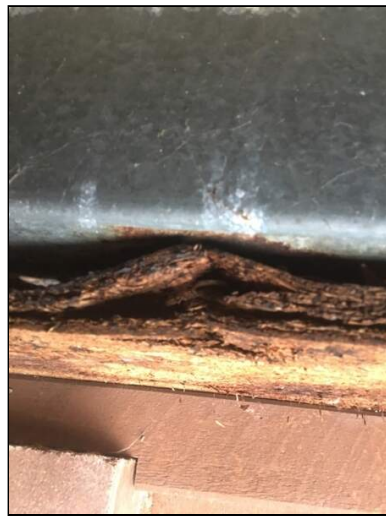
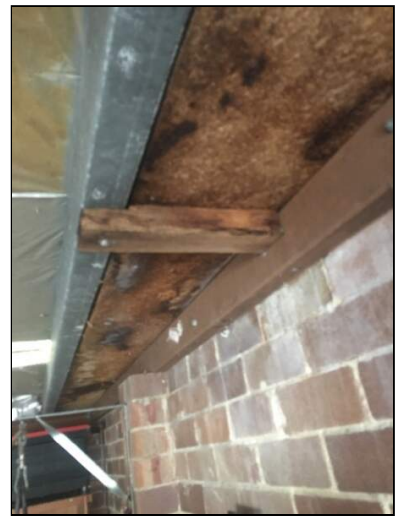
Defect Rating General Comment / minor defects

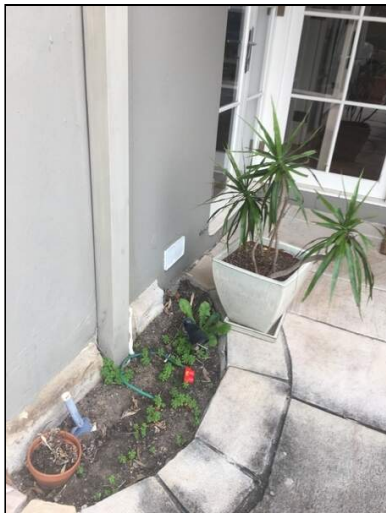
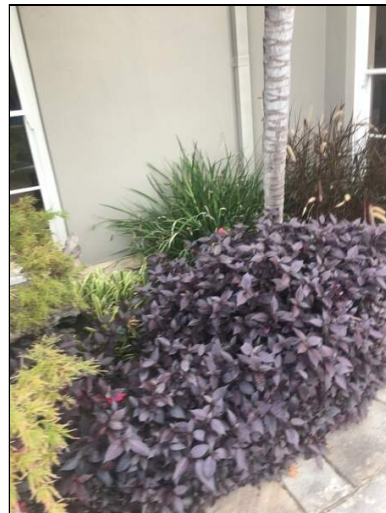
Defect Rating Minor Defect

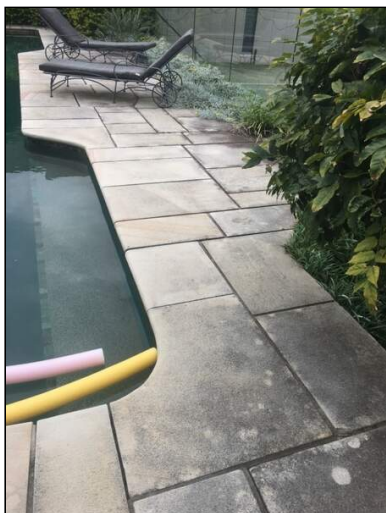
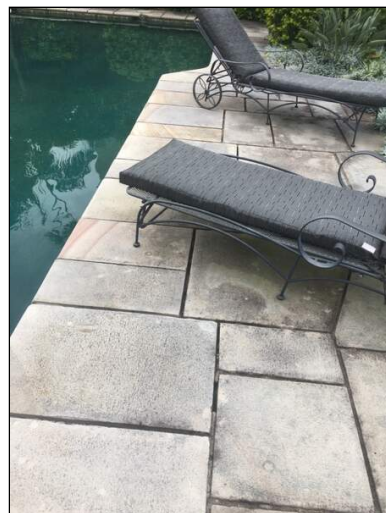
Answer **Summary Of Defects / Issues within the pool area**

Defect Rating Compliance Report should be reviewed and considered by the prospective buyer
