SITE ASSESSMENT & ADVICE

Site Address: 6.08 & 6.09 of 8 Elizabeth MacArthur Drive Bella Vista NSW 2153

Report Type: General-Purpose Building Defect Report

Date of Inspection (s): 13/04/2023

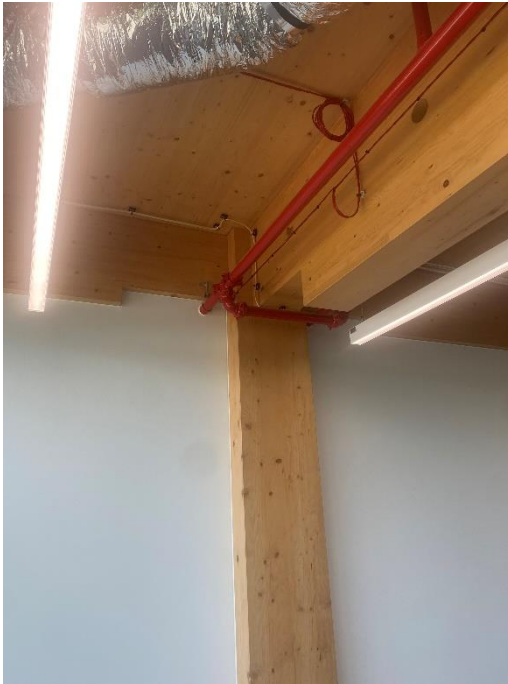
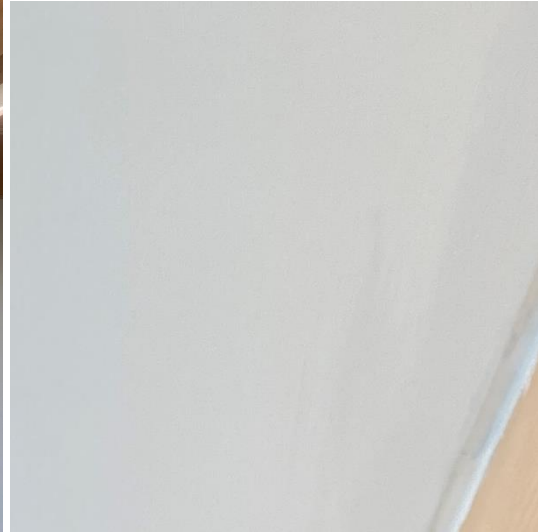
3. Where the plasterboard meets the timber beam and timber column, it has been poorly prepared and finished by the plasterer and painter, additional coat of paint required.

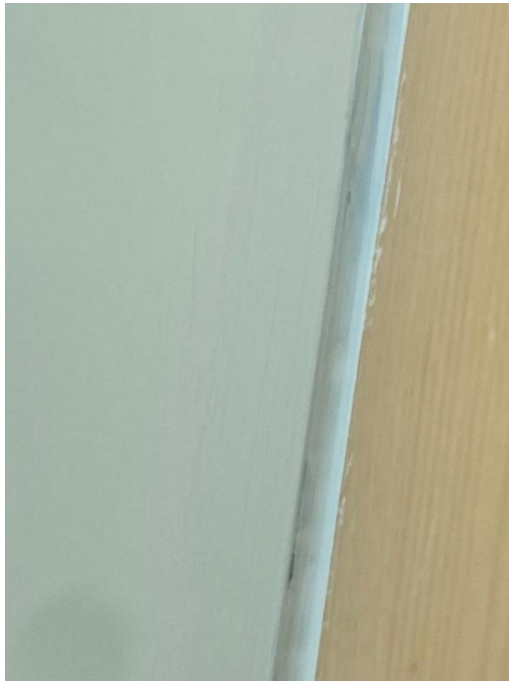
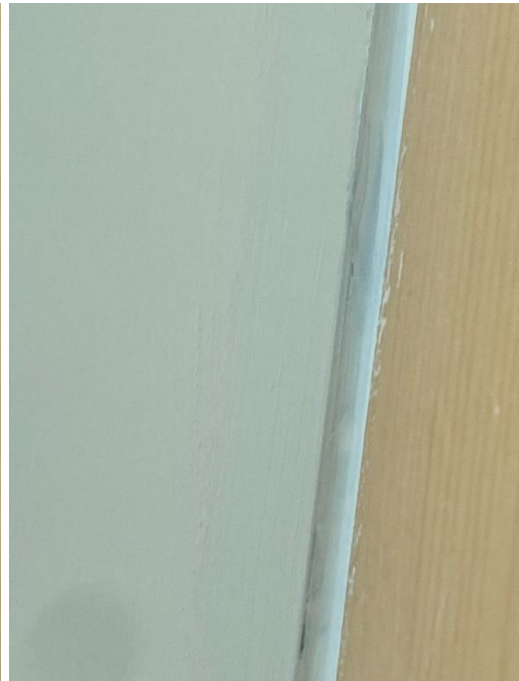
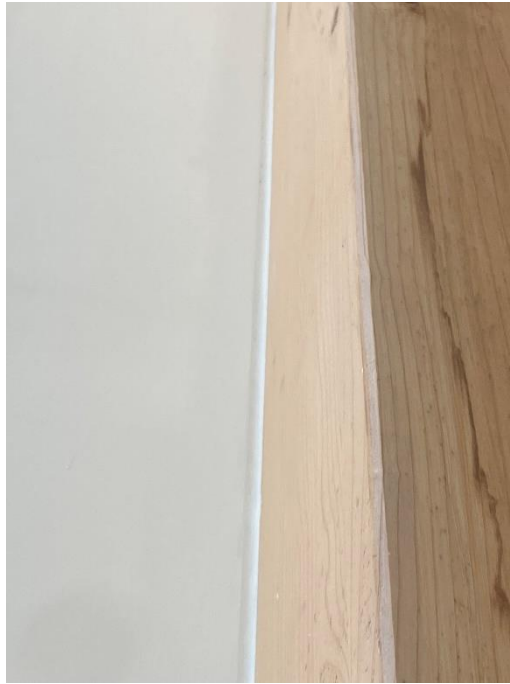
4. All walls and column junctions have been filled with mastic; however, they have been inadequately painted running up and down the wall and column junctions.

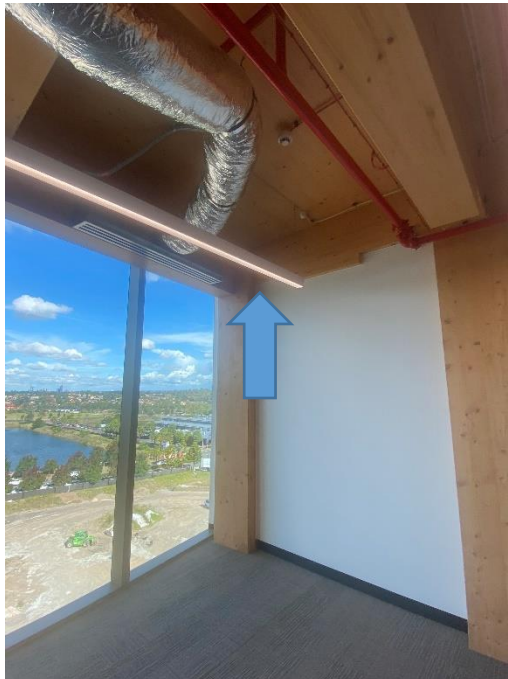
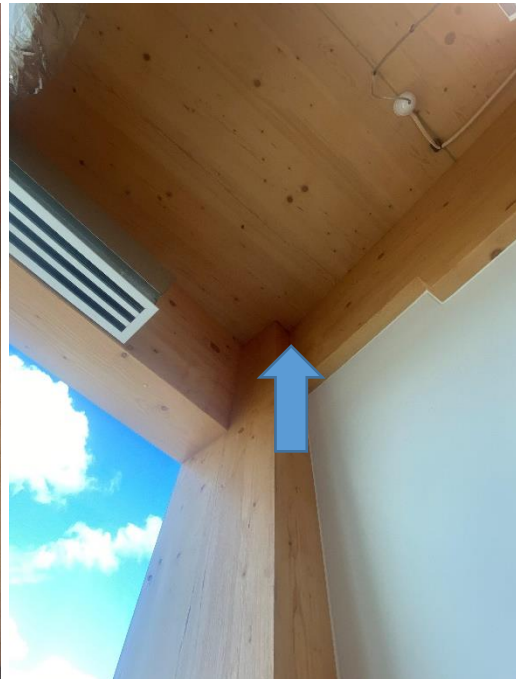
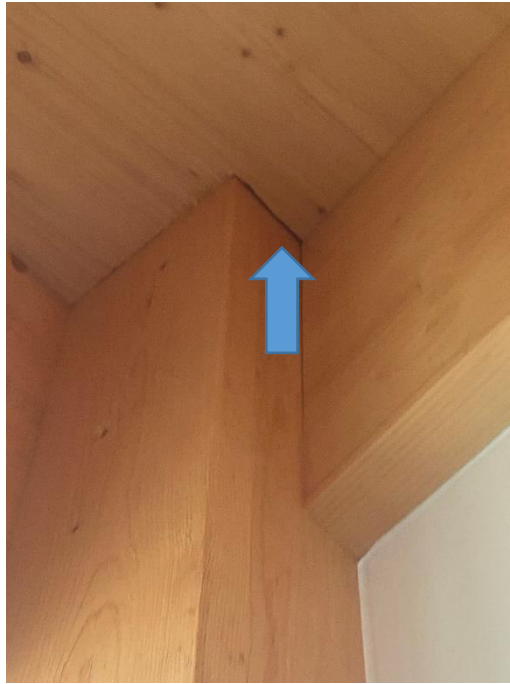
7. The ceiling and column junction has excess gaps due to poorly cut and installed timber panelling.

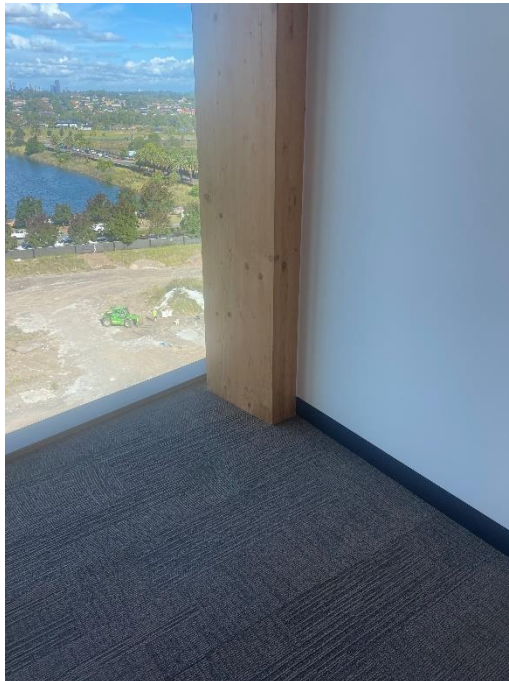
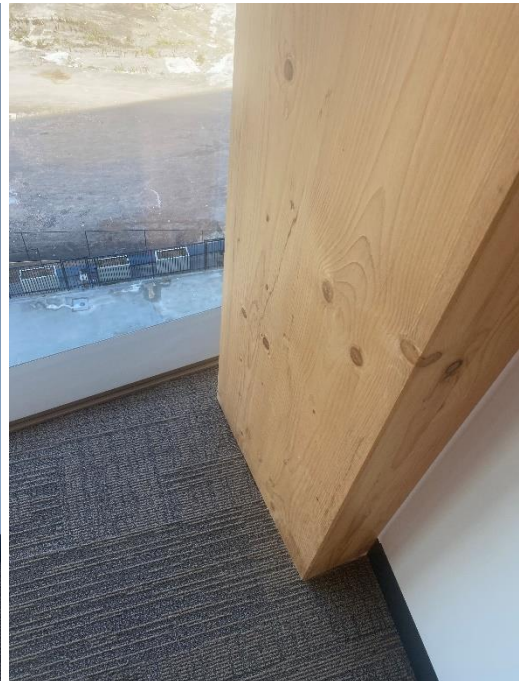
8. The columns have been cladded in timber and the columns are course and inadequate, as a person running their hand down the timber could easily splinter their finger.

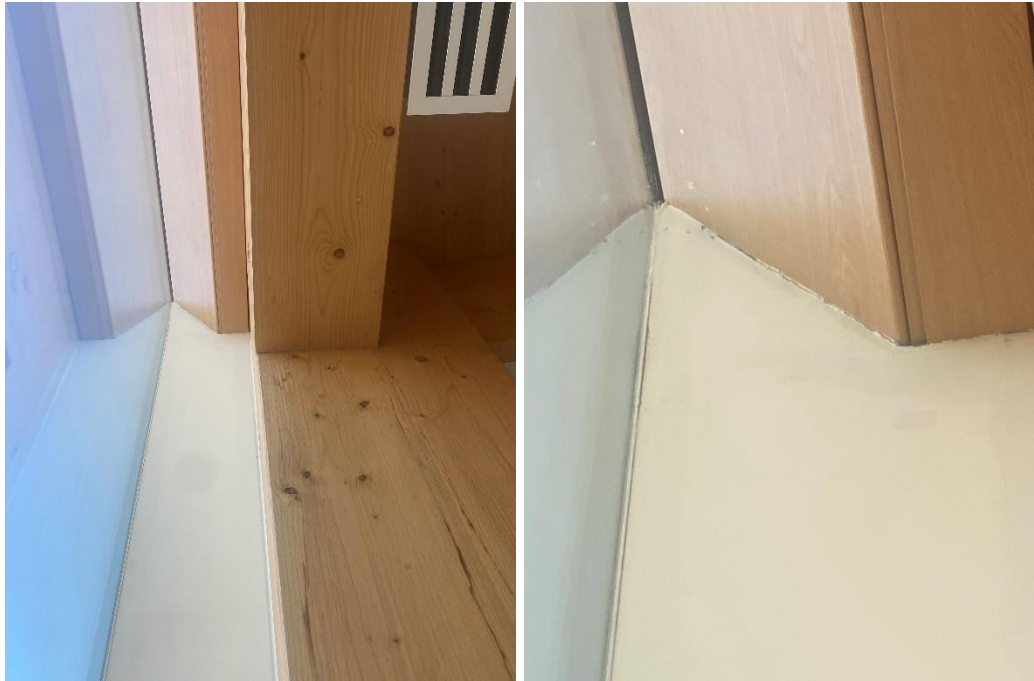
11. Poorly prepared plasterboard and excess mastic on the timber bulkhead and wall junction.

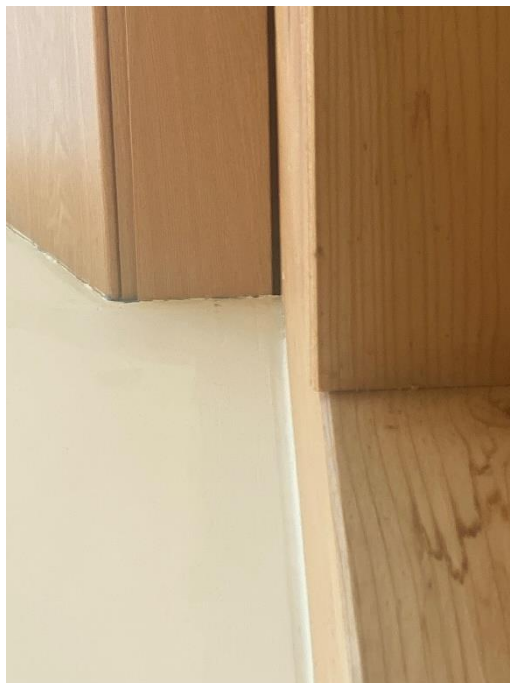
12. Excess gaps found between beam and bulkhead, poorly installed carpentry panelling.

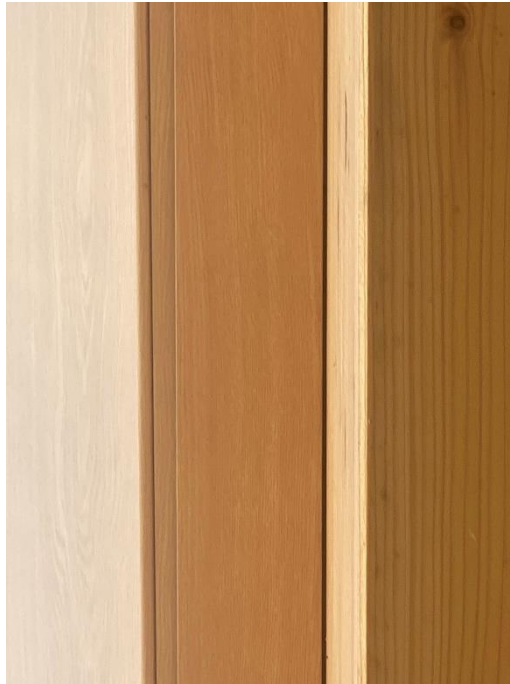
13. Inconsistent gaps and quirks between vertical bulkhead and horizontal beam and pelmet detail.

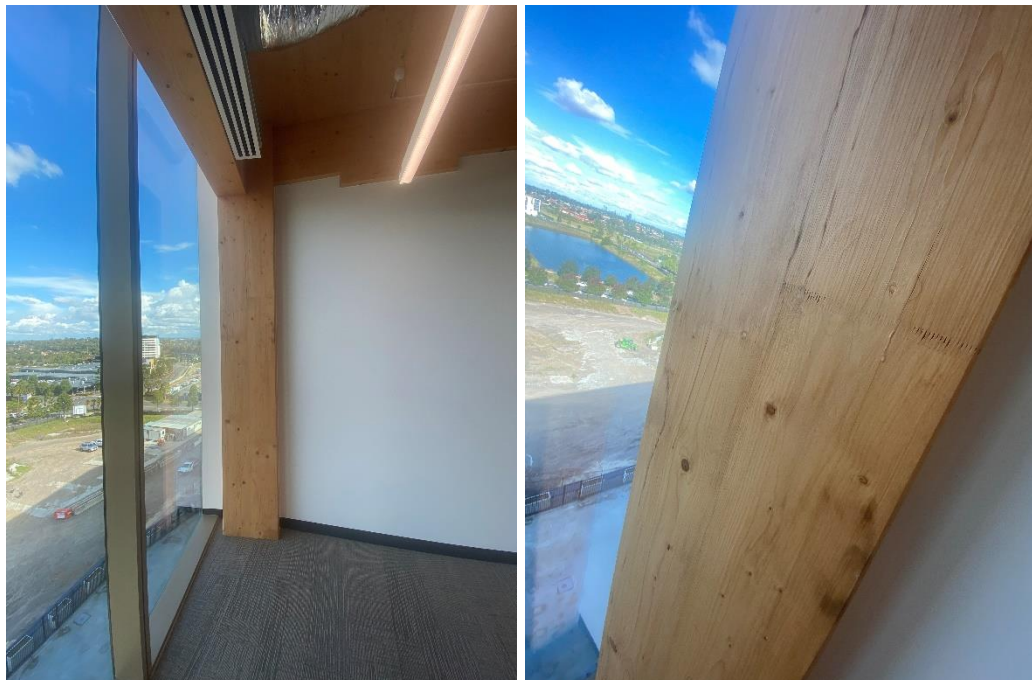
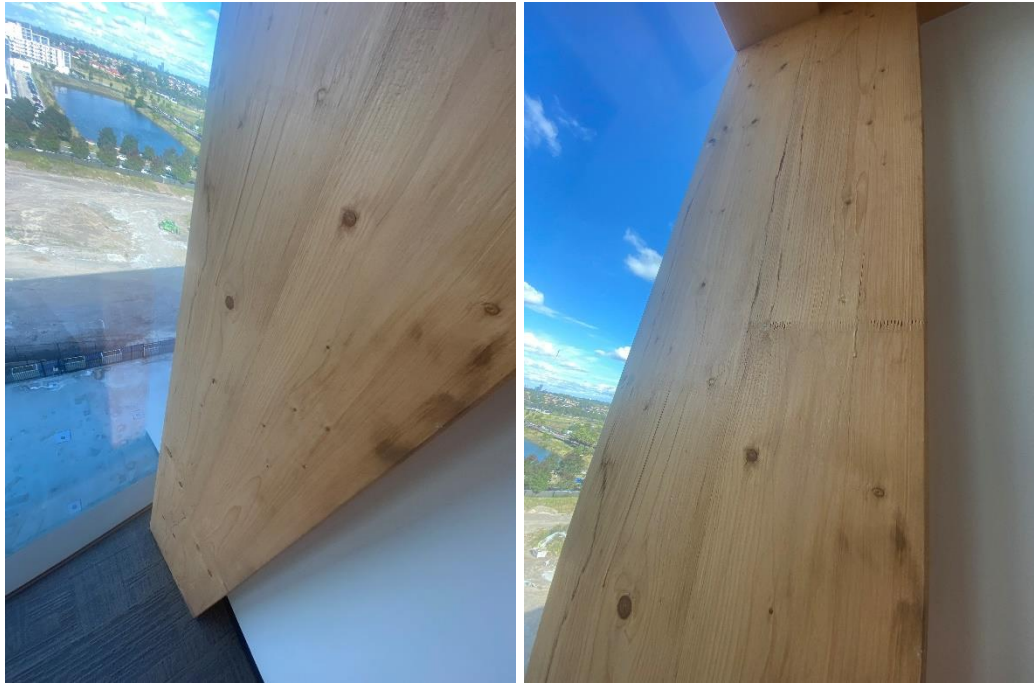
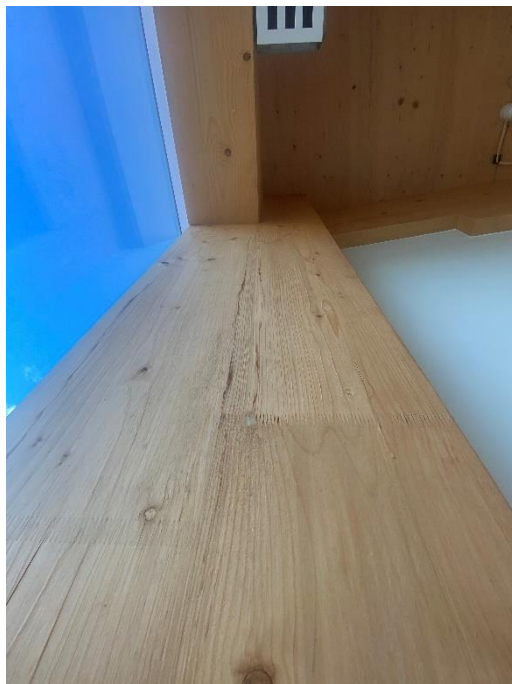
14. Column cladding is coarse, and inadequate finish achieved by the painter; sand, fill and re-clearcoat the timber in order to achieve a smooth finish, with any cracks in the timber concealed.

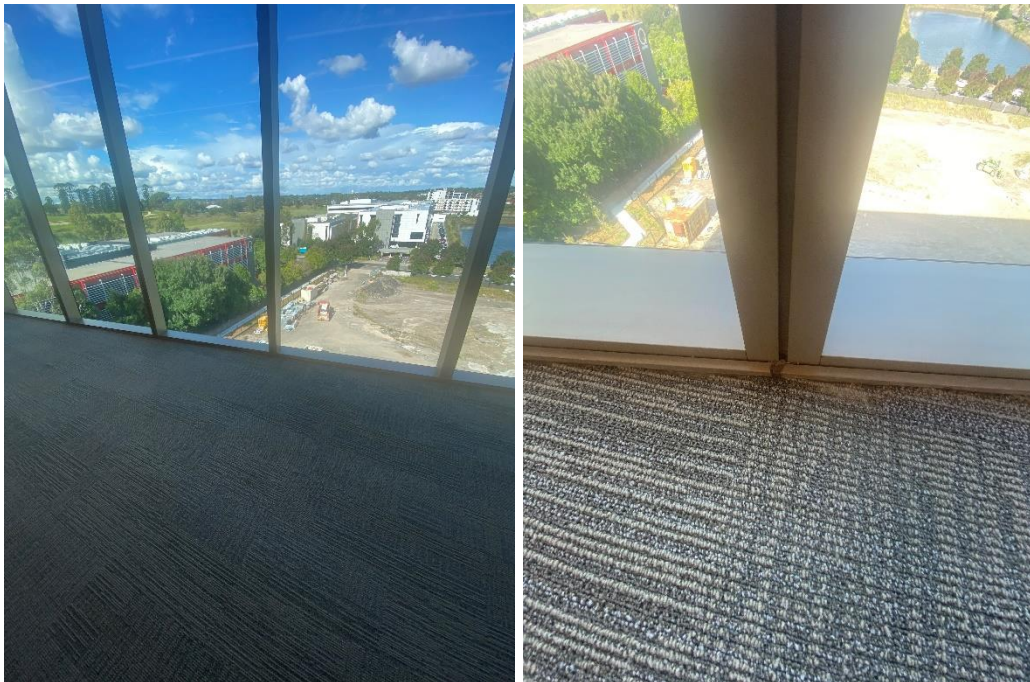
16. Window beading has been inconsistently treated with a painted construction sealant and non-painted construction sealant applied in various locations. A consistent finish should be achieved by having the sealant in a natural colour or having it painted one consistent colour.

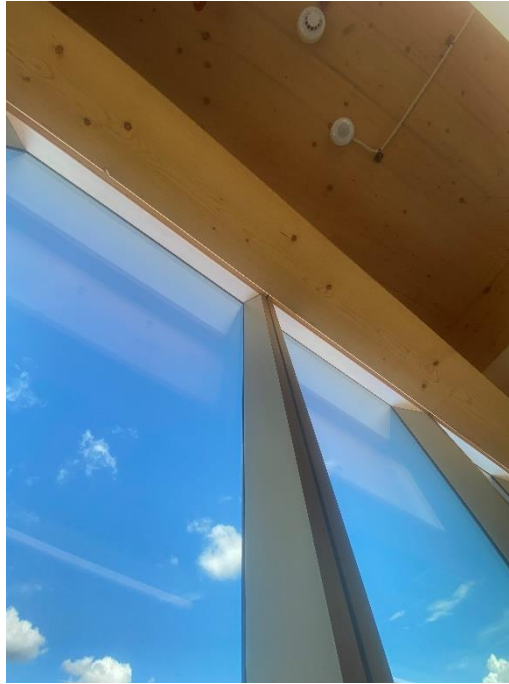
17. Missing silicone / mastic on the window blade and horizontal pelmet junction.

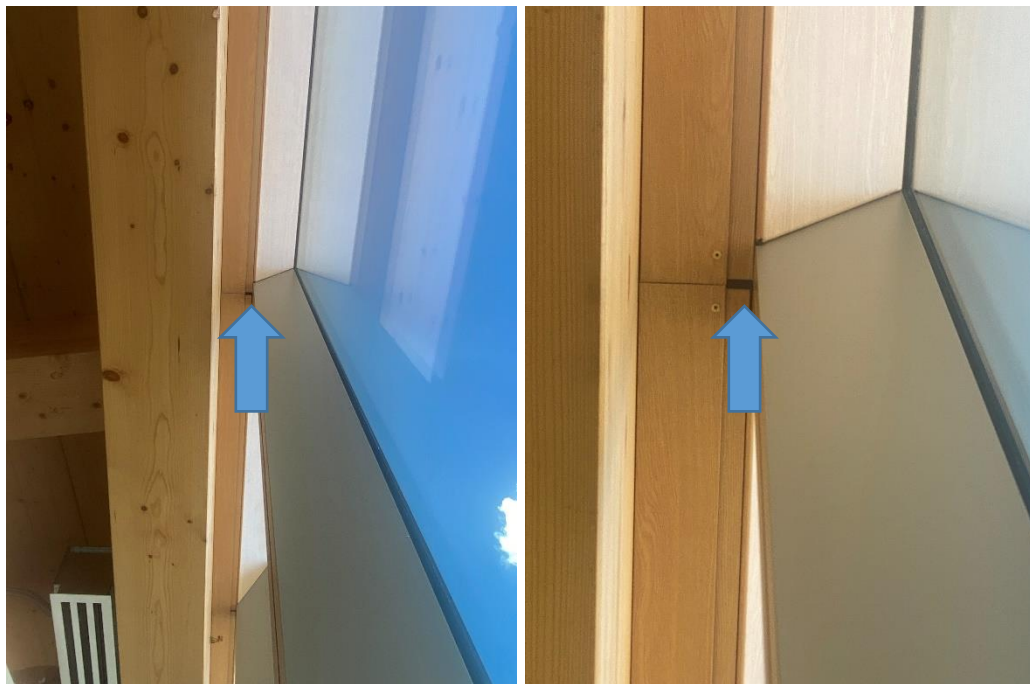
18. Excessive gaps seen within the horizontal pelmet where it meets the vertical window blade.

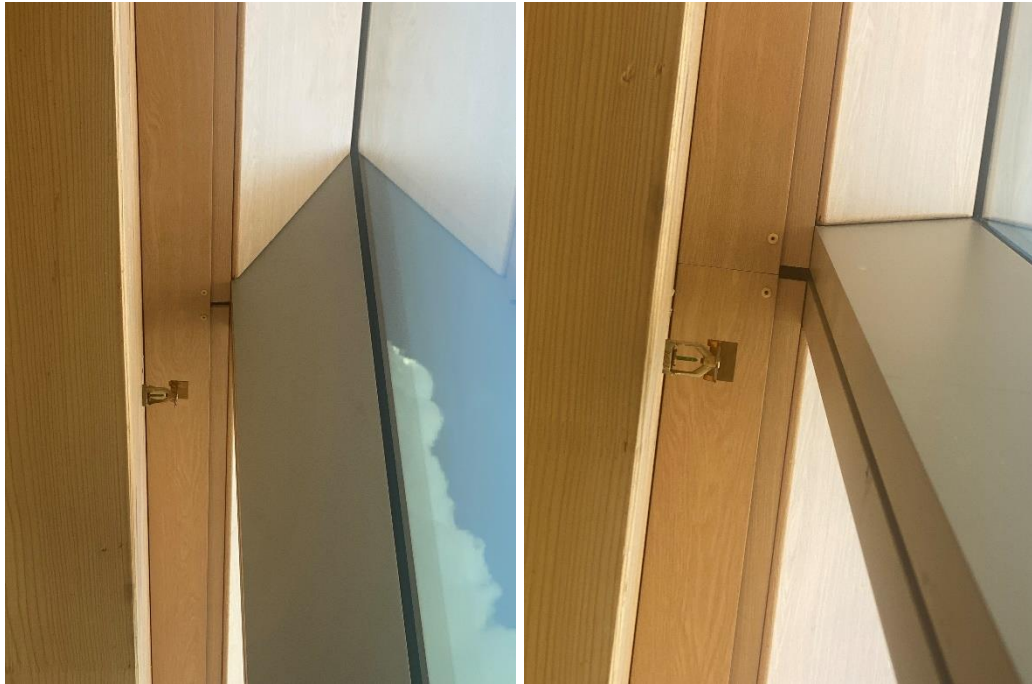
19. Moving along the window front, in various locations, the earlier defect is repeated in various window blades and horizontal pelmet junctions.

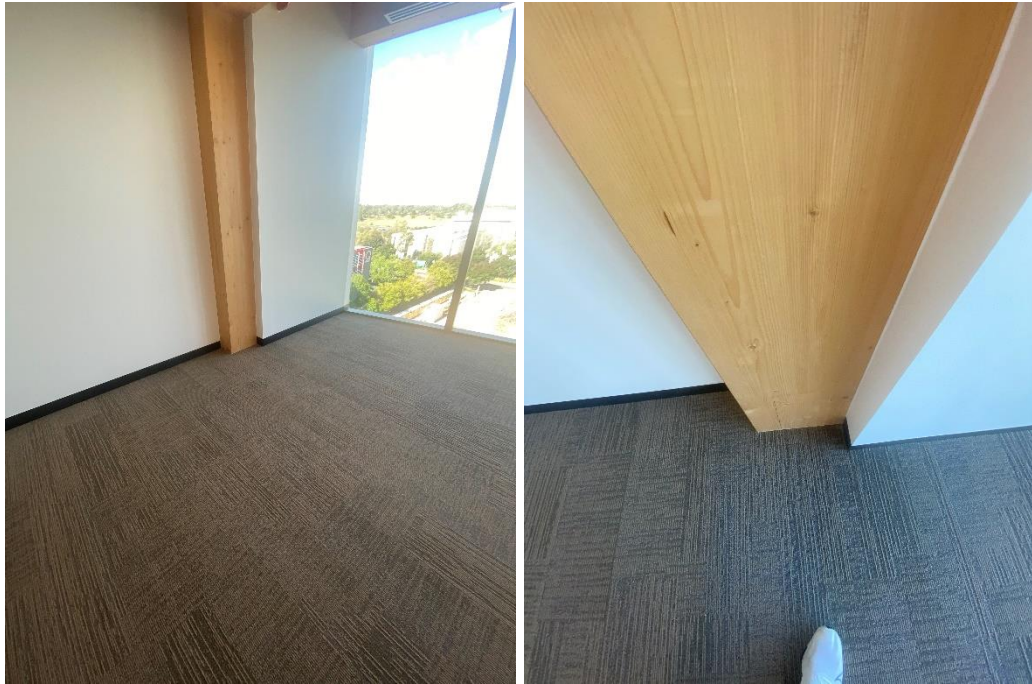
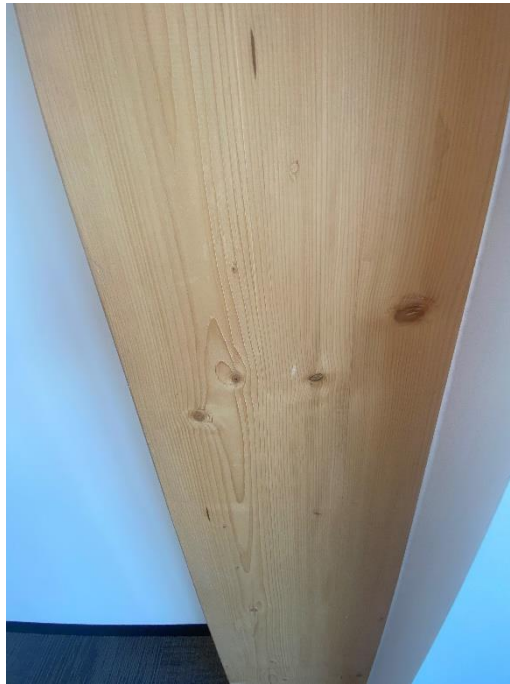
25. Columns have been poorly prepared and clear sealer has been prematurely applied to a coarse timber column.

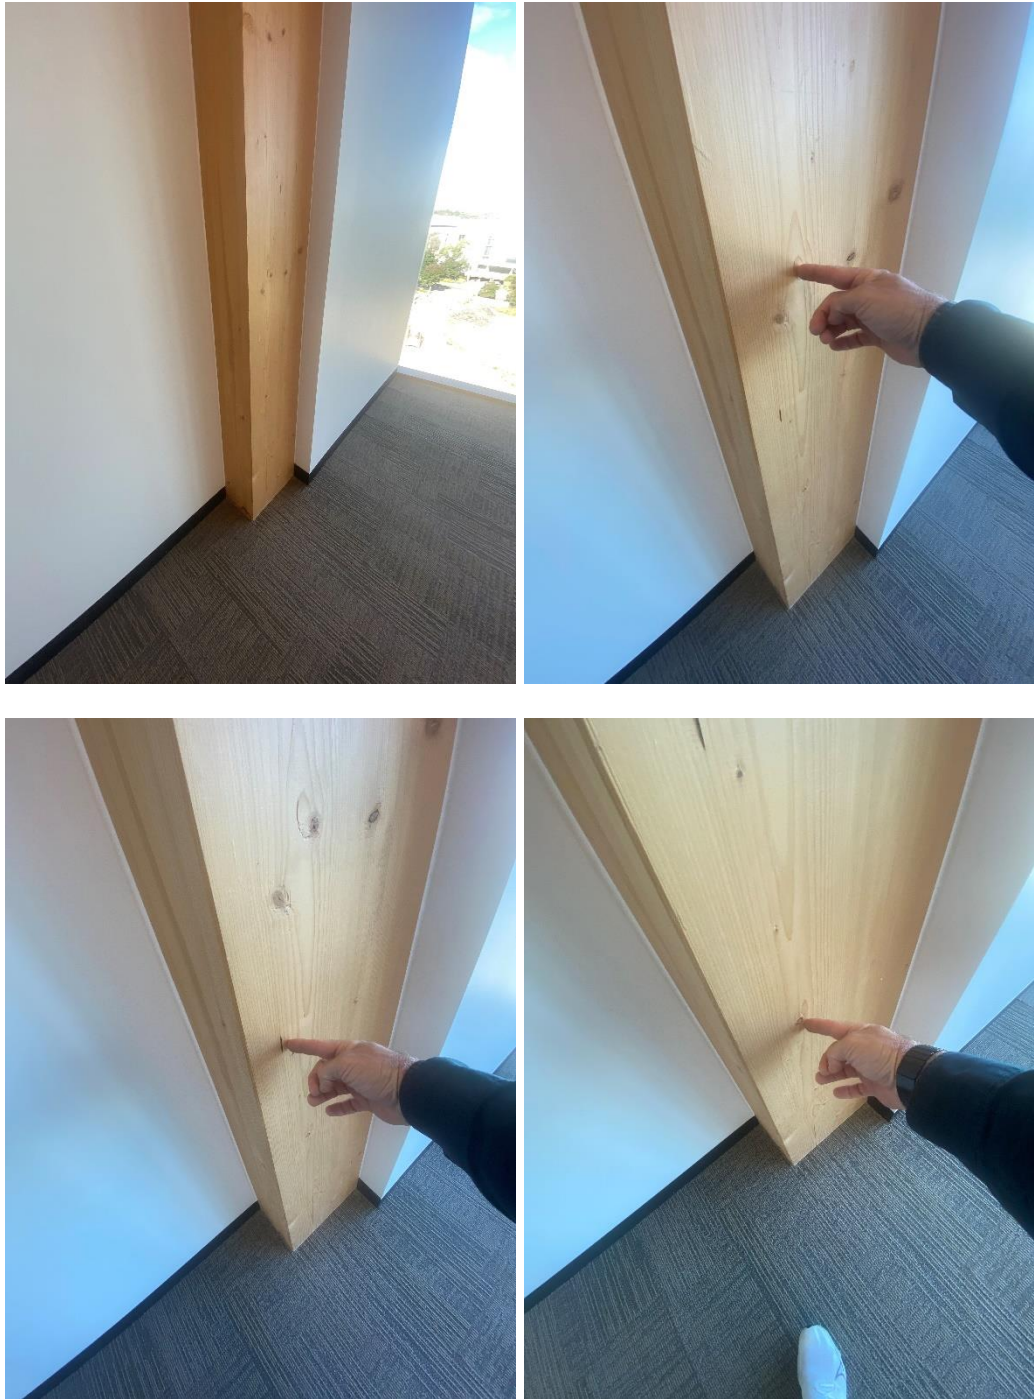
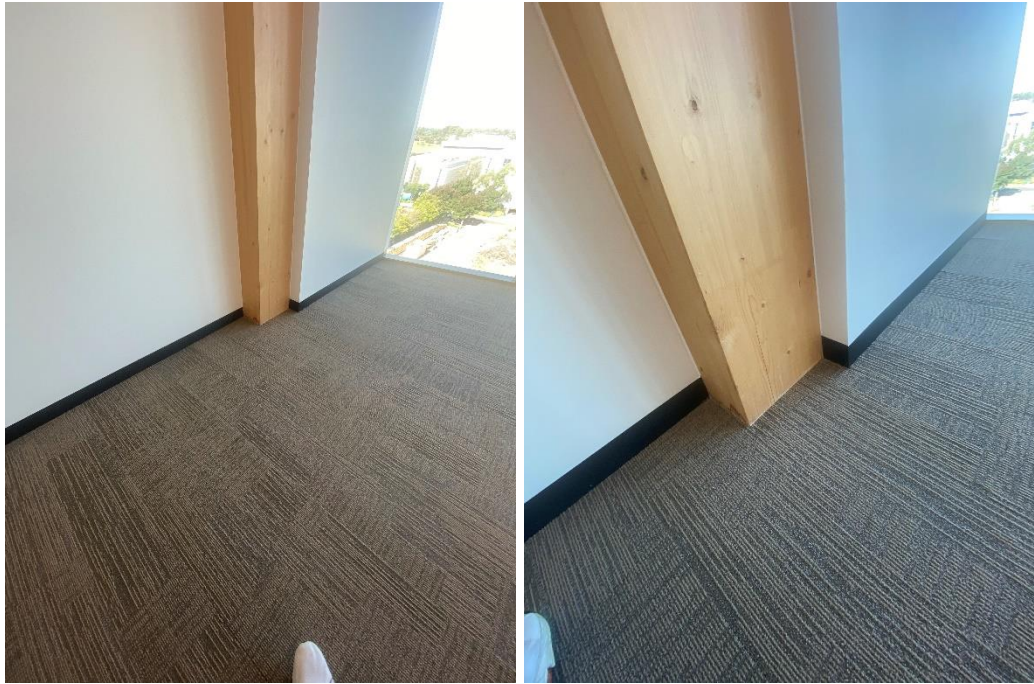
26. Column has a number of cracks within the timber which need to be filled or the timber replaced due to excessive nail holes still seen to be protruding through the timber column.

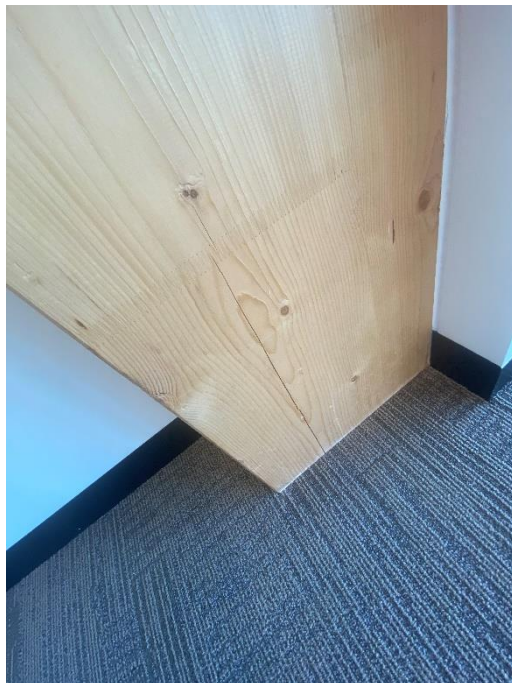
27. Timber column split, new timber panel required.

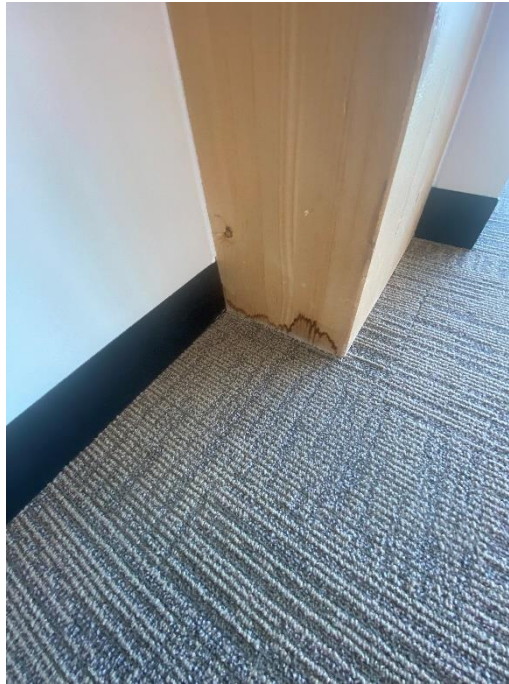
28. Timber column has water stains located at the base of the column, these need to be removed or a new timber panel needs to be installed.

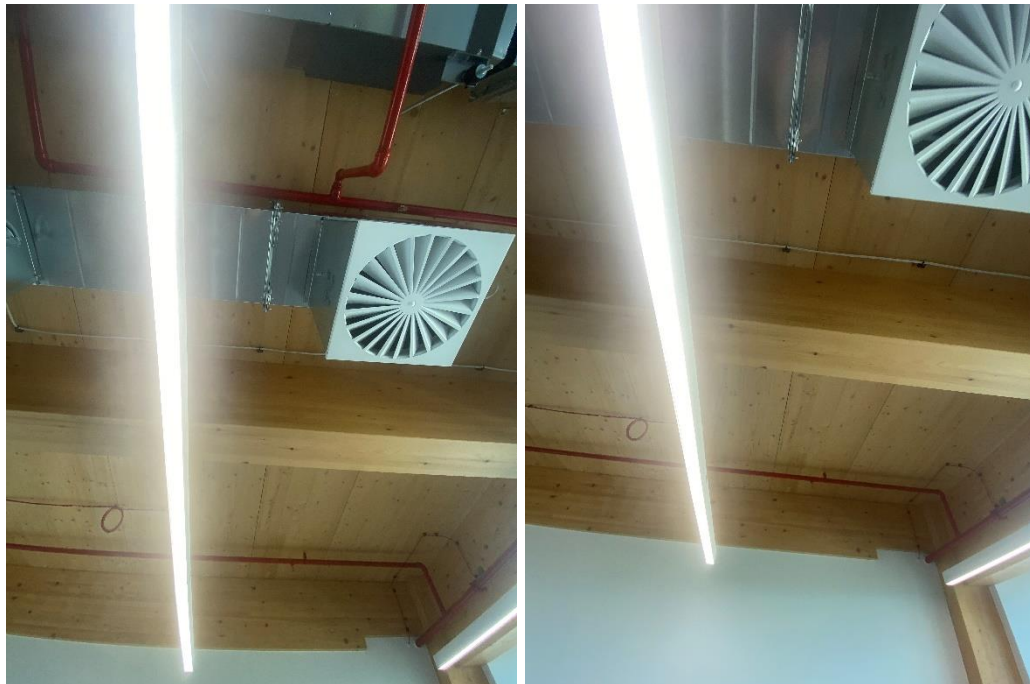
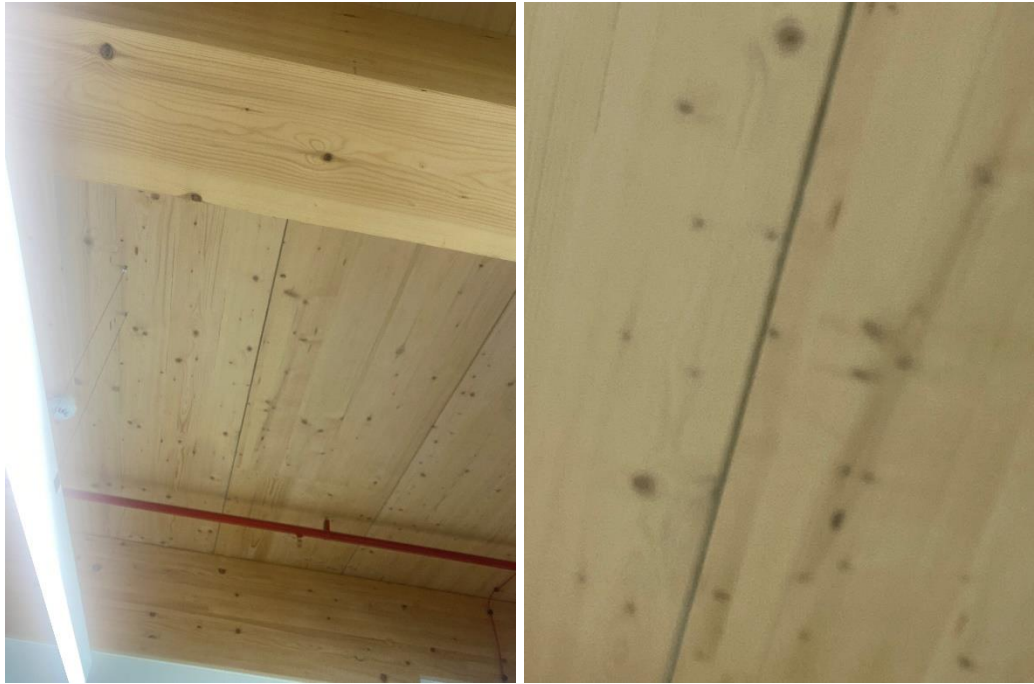
29. The ceiling timber linings are abutting each other with no mastic or sealant visible. There are a number of ceiling panels which actually have the ceiling glue bleeding through the timber ceiling panel junctions. The excess glue or mastic needs to be removed, this defect is found in the Northeast corner.

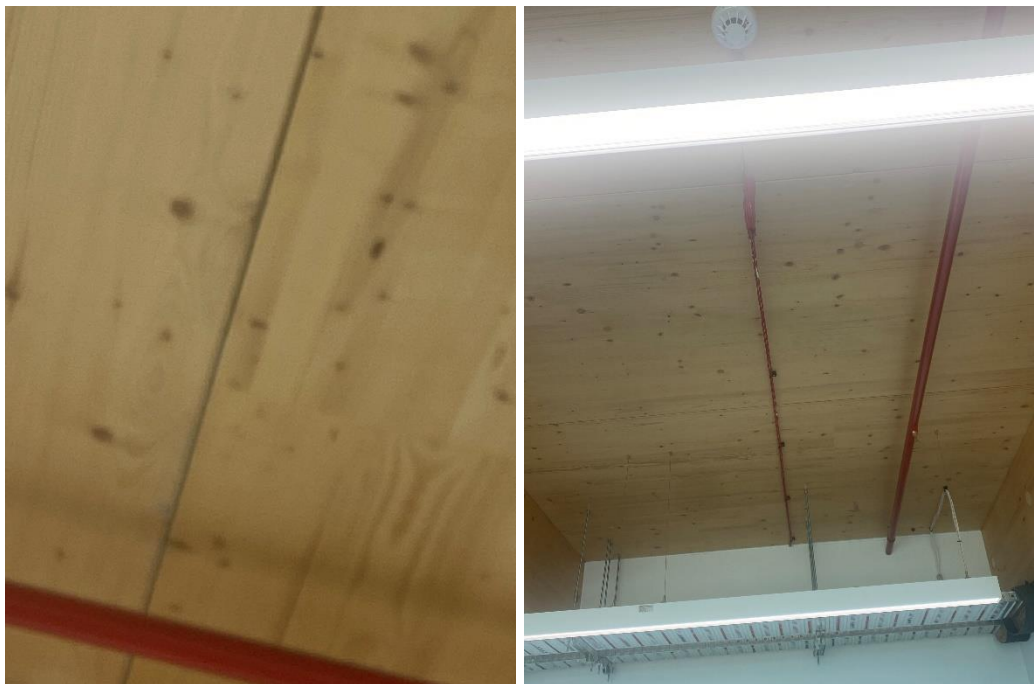
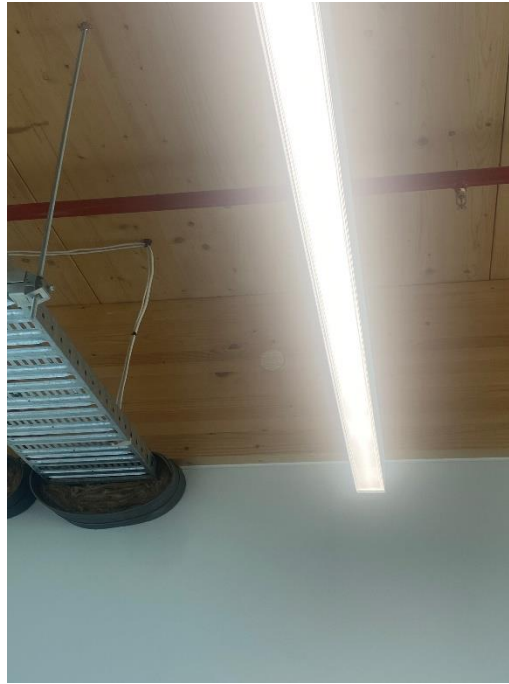
30. The ceiling timber linings are abutting each other with no mastic or sealant visible. There are a number of ceiling panels which actually have the ceiling glue bleeding through the timber ceiling panel junctions. The excess glue or mastic needs to be removed, this defect is found in the Southwest corner.

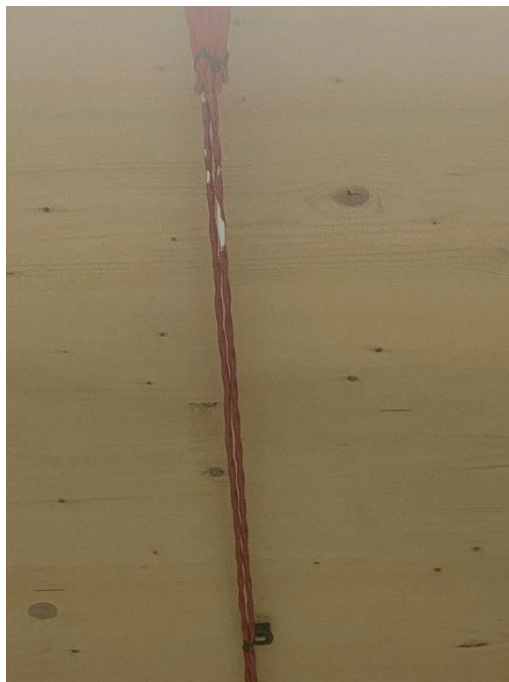
31. There is, randomly found throughout the entire property, paint splash marks on the electrical cables, as seen within the image below, there is a white smear of paint and / or plaster on the red cable on the ceiling elevation.

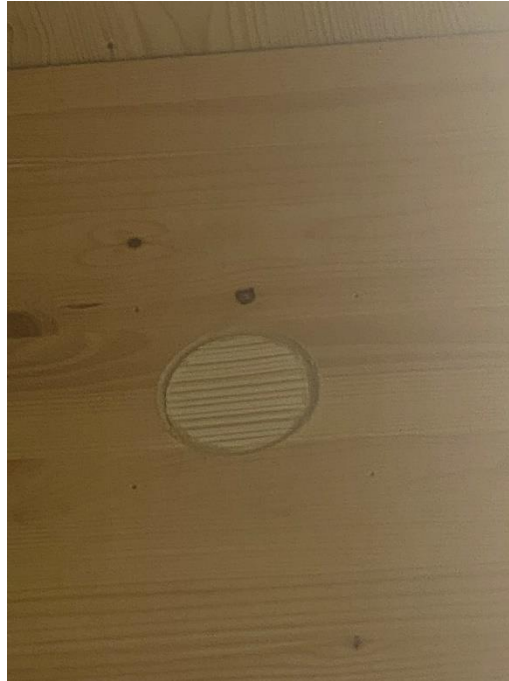
32. Randomly found throughout the property are considerable holes within the timber beams which have been plugged up with timber which has a different grain and colour which do not match the beam, as seen within the image below. There are examples through the entire property that they have carried out good matching timber plug work within the beams but there are also poorly executed timber plugs installed.

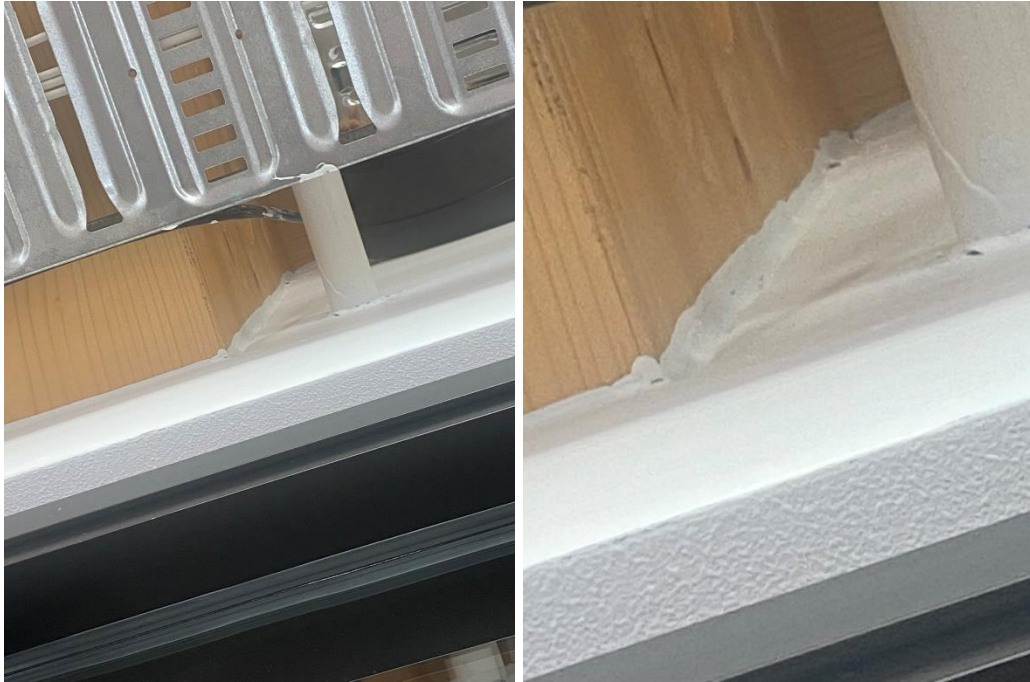
41. Above the aluminium window frame, the dropdown beam ceiling and wall junction has excess mastic which needs to be removed and the timber cleaned down.

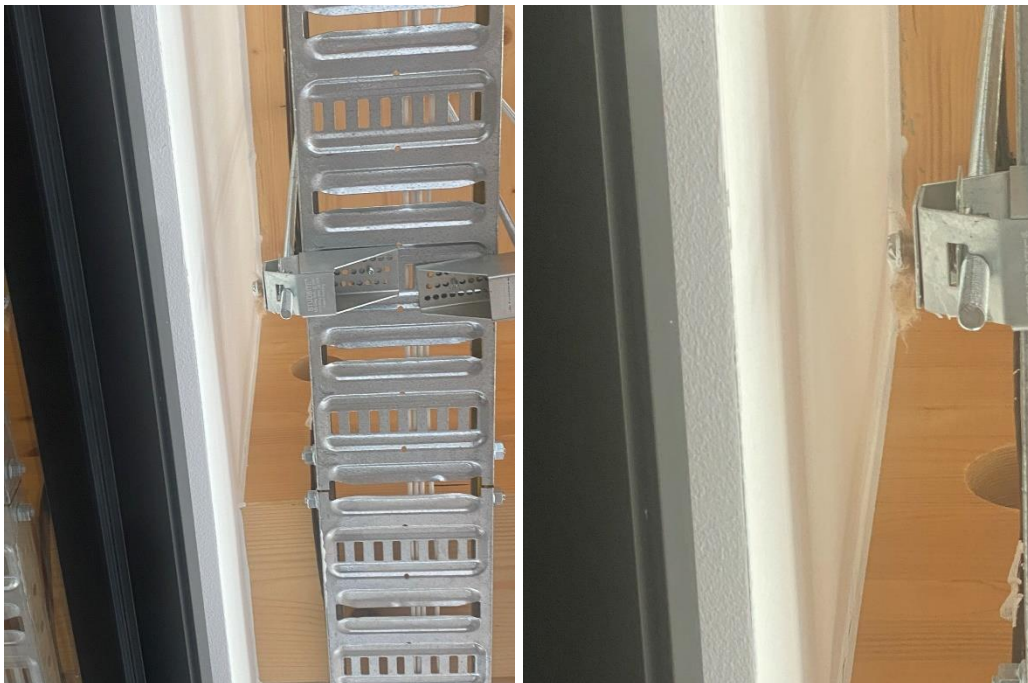
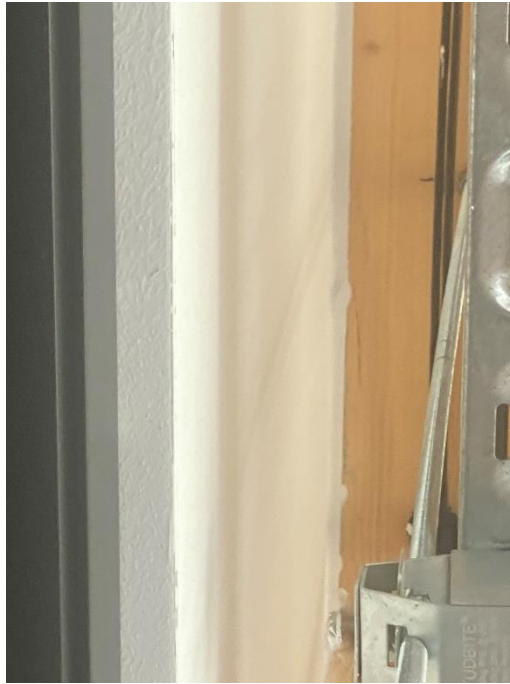
42. Above the aluminium frame shopfront, the mastic sealing the wall and ceiling beam junction has been poorly applied and excessive quantities of silicone is found on the timber ceilings and timber beams.

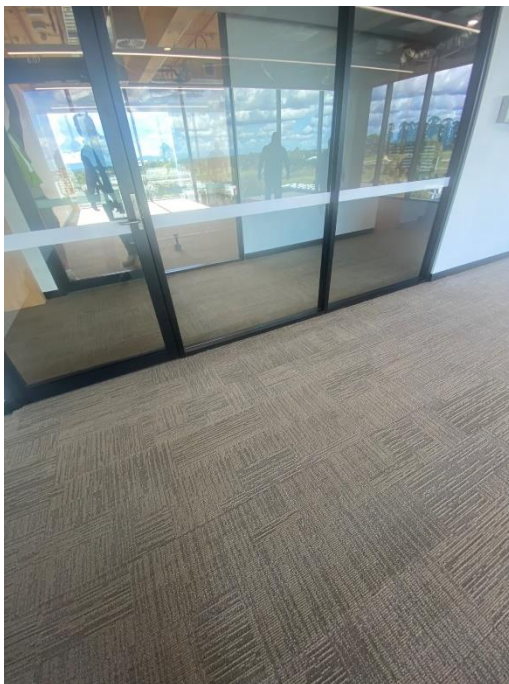
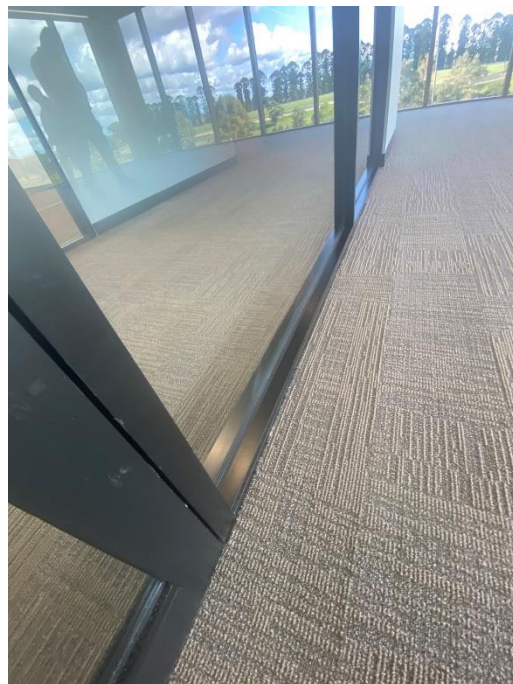
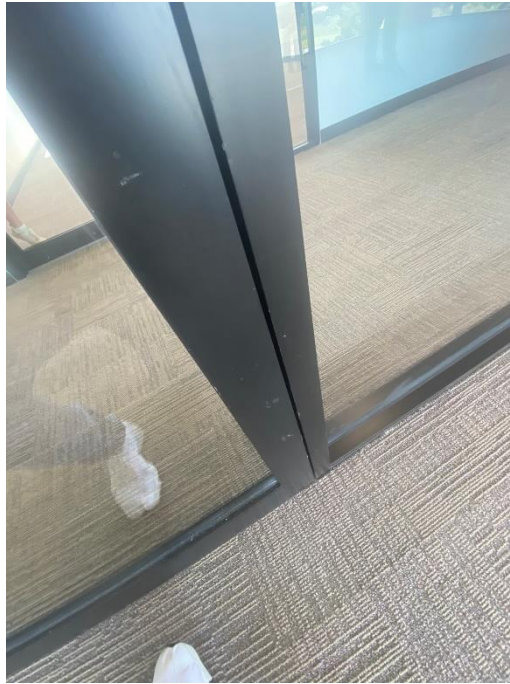
7. Entry aluminium door and adjacent fixed glass window frames have scratches within the powder coating.

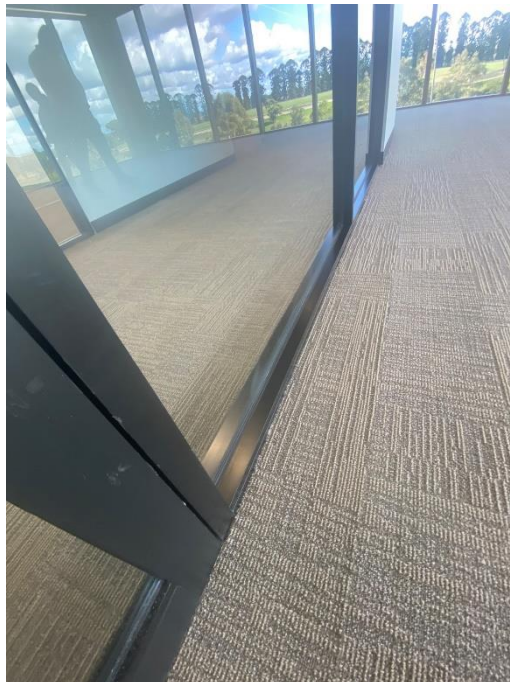
8. Cement marks and building debris found on the black window frame and excess silicone / debris on the glass window pane, internally within the office suite.

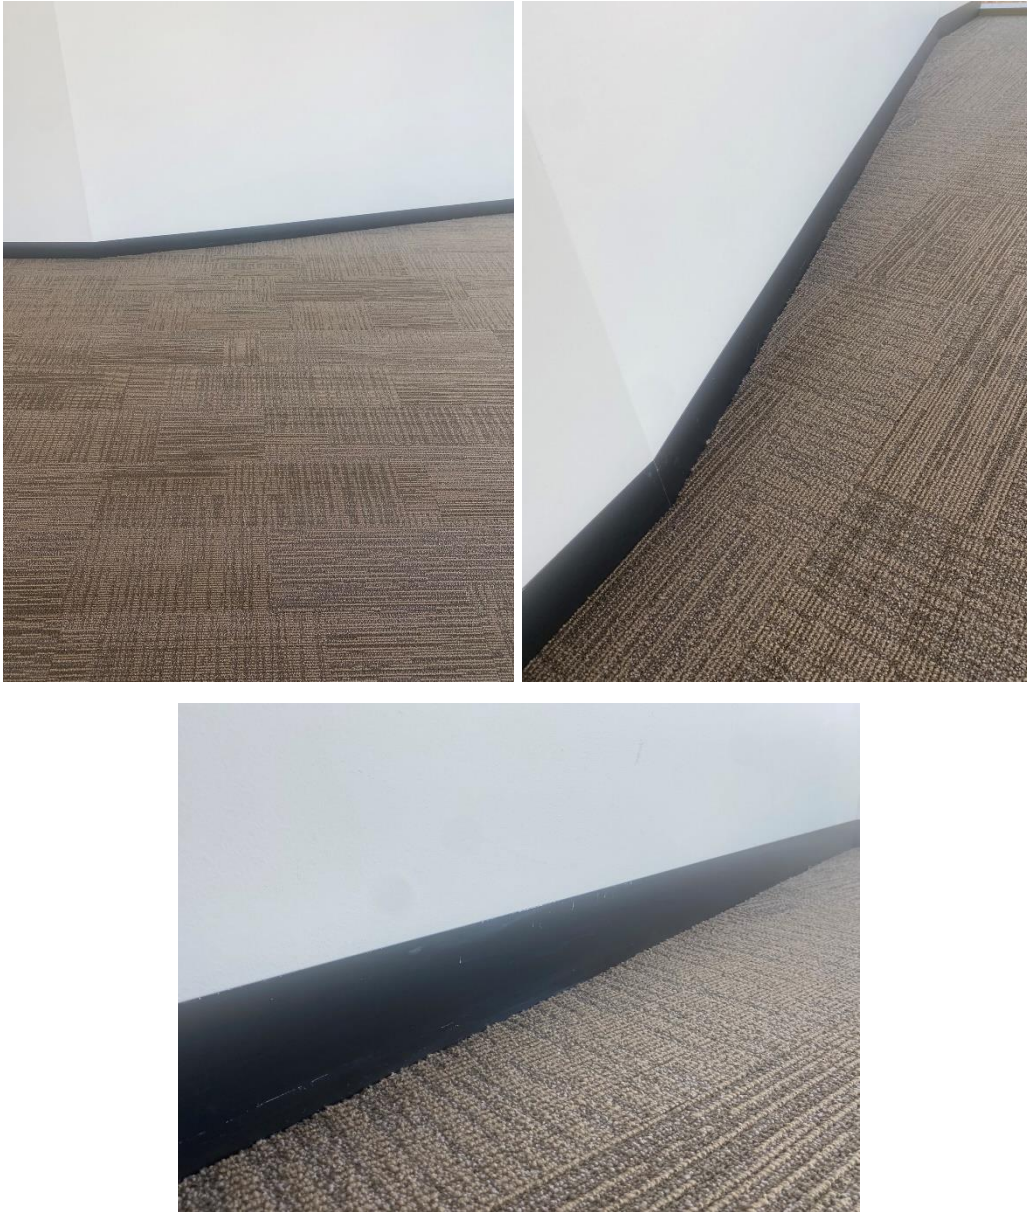
13. Paint marks seen on the black skirting boards that need to get removed.

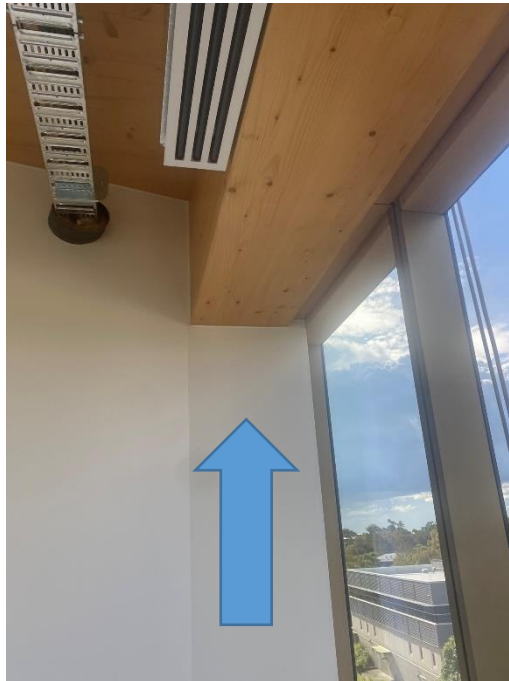
14. Inadequate paint application on the wall, final coat required on order to achieve a consistent application and finish within the painted surface / wall.

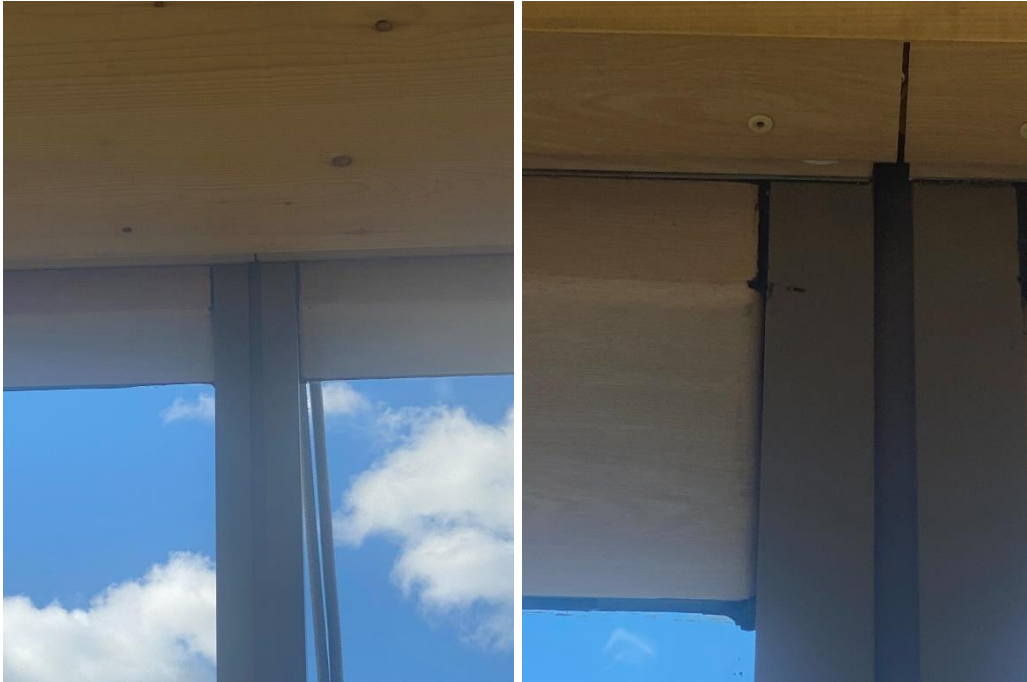
16. Horizontal pelmet and window junctions have a combination of mastic and no mastic applied. Consistency should be achieved, e.g., mastic everywhere or no mastic anywhere.
