SITE ASSESSMENT & ADVICE

Site Address: 6.08 & 6.09 of 8 Elizabeth MacArthur Drive Bella Vista NSW 2153

Report Type: General-Purpose Building Defect Report

Date of Inspection (s): 13/04/2023

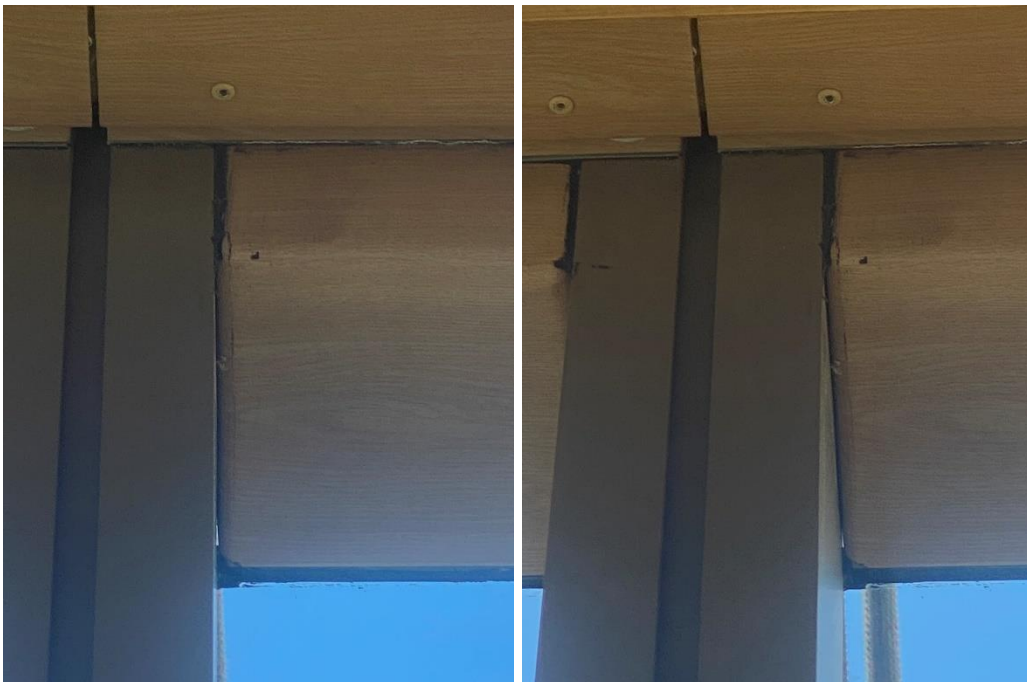
17. Whilst walking along the window front, there were a number of window blades and horizontal pelmet junctions having the same defect as the prior defect, and should the builder choose to leave the mastic in place it also needs to be cleaned up in order to have minimum mastic and a consistent straight line between each material (window frame and horizontal pelmet).

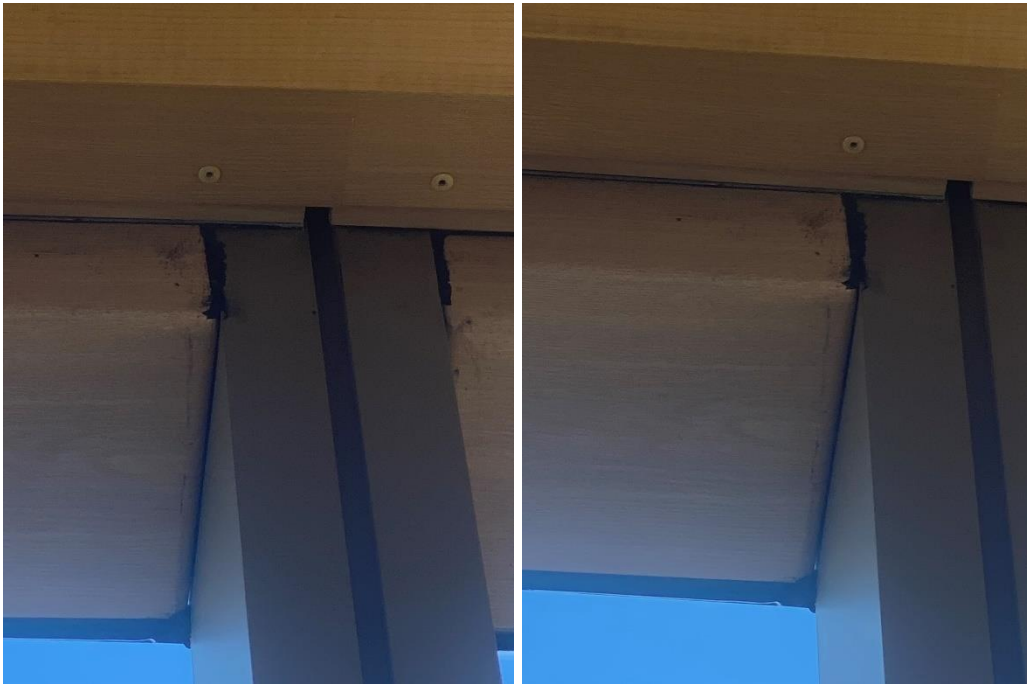
18. Continuing along the window front, there were a number of window blades and horizontal pelmet junctions having the same defect as the prior defect, and should the builder choose to leave the mastic in place it also needs to be cleaned up in order to have minimum mastic and a consistent straight line between each material (window frame and horizontal pelmet).

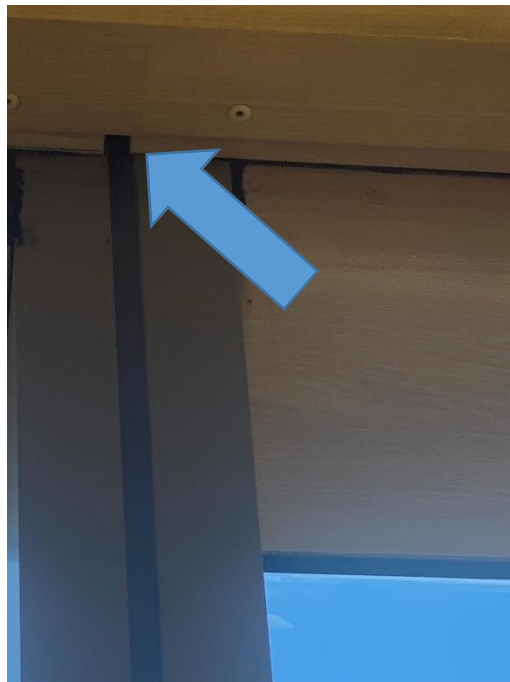
19. The ceiling horizontal panel has a gap which has no mastic nor consistency, this gap needs to be filled or the panel removed with consistent gap between the panels.

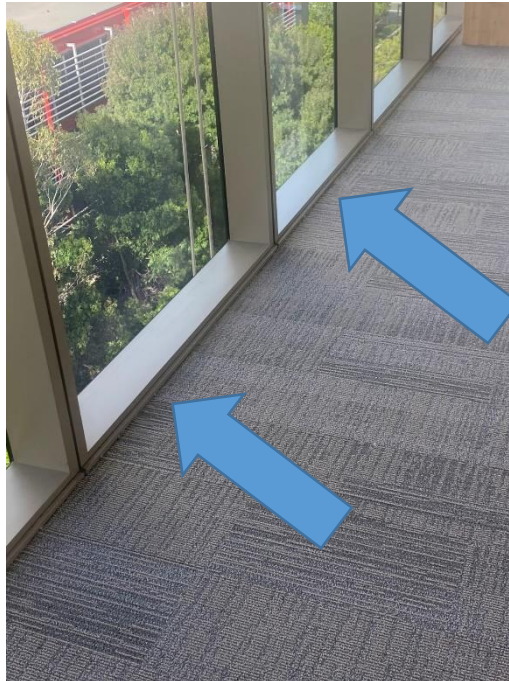
20. Along the windowsill and carpeted floor junction, there is a cleat, the cleat is damaged, scratched and the powder coat removed. A touch up exercise needs to be applied to the entire bottom bead of the windowsill and carpeted floor junction.

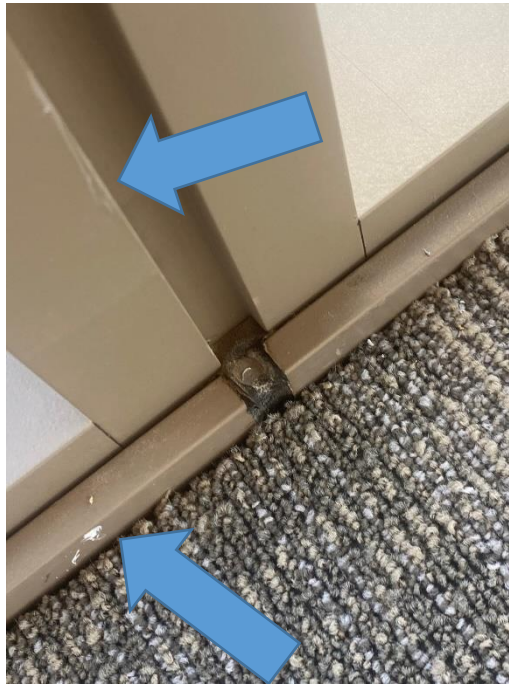
22. Paint marks and scratch marks on the window frame.

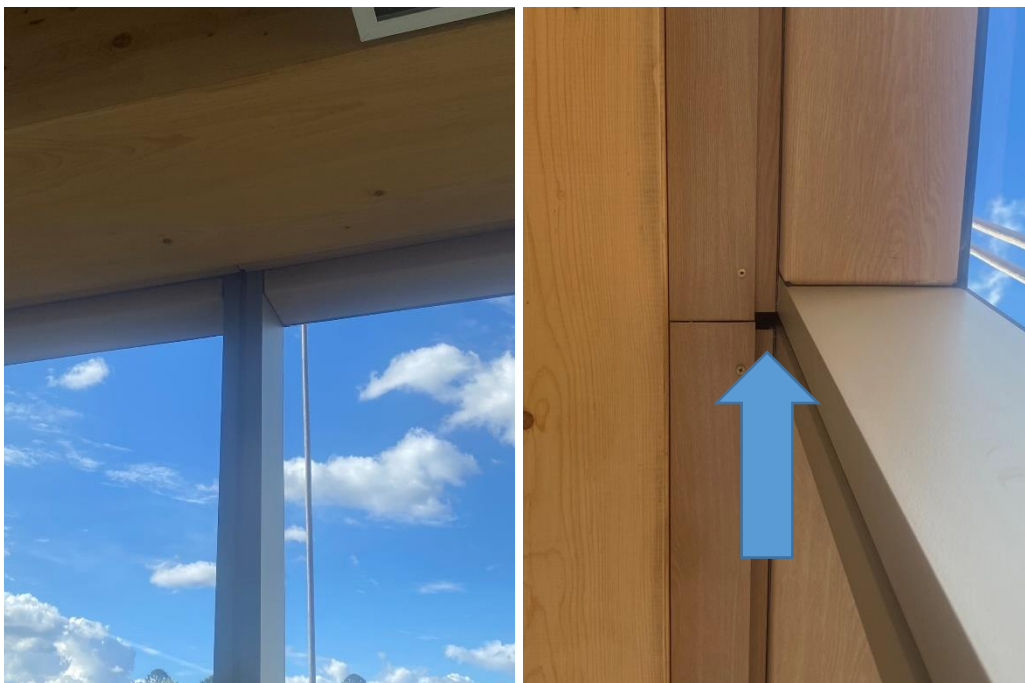
23. The ceiling pelmet has been cut in a way that has created a hole for vermin to live within. This hole should be made good by replacing the short ceiling horizontal panels in order to have no gap or quirk within the infill panel. This issue is found throughout the office suite.

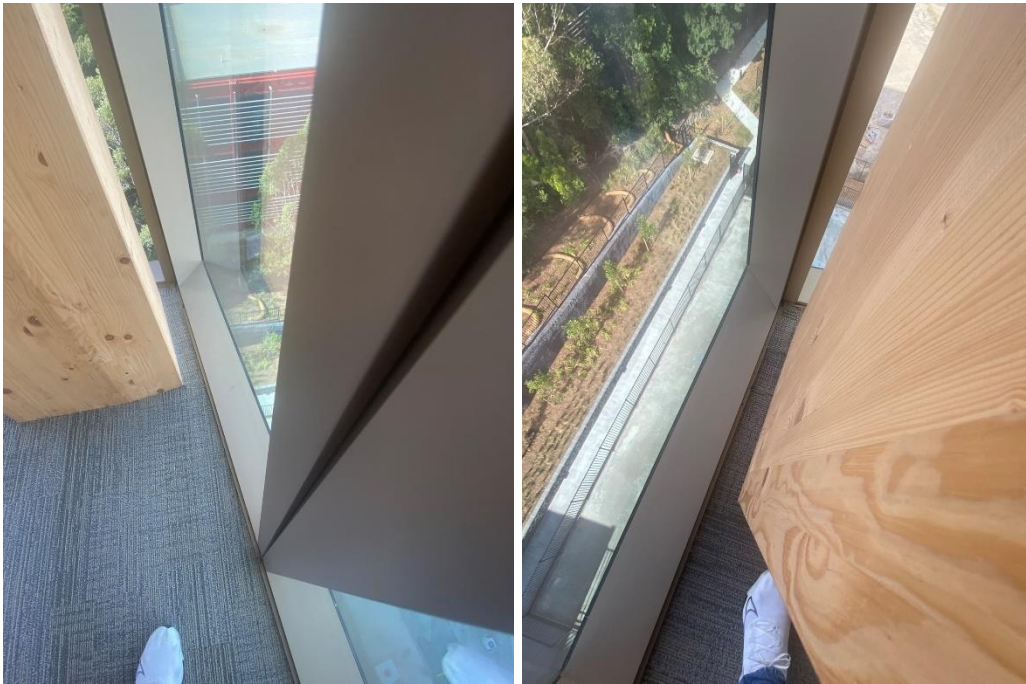
28. Carpet tiles need to be glued down behind the pillar.

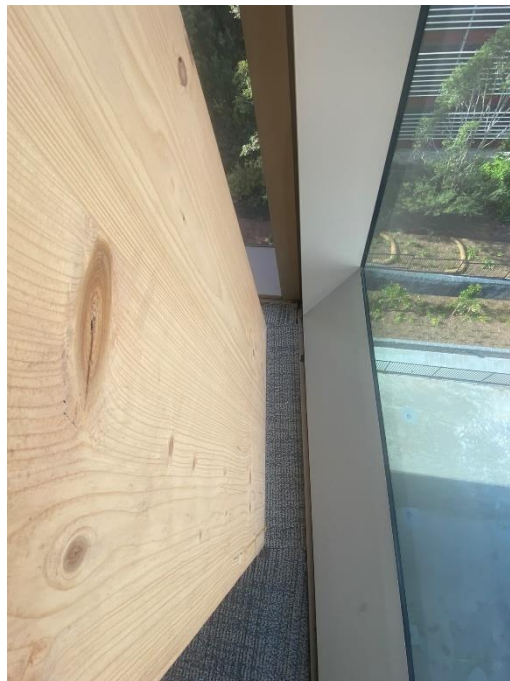
29. The timber column timber finish is rough / coarse, and should a hand be rubbed up against this timber, a person's hand could have a timber splinter inserted within their hand; sand back, fill and re-stain of the timber is required.

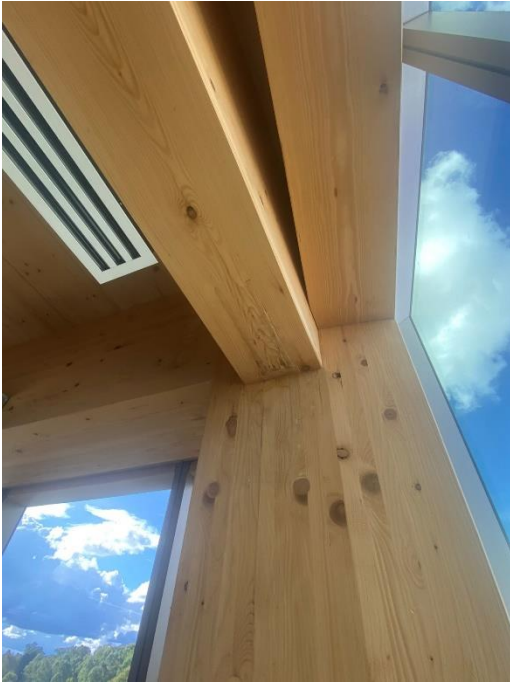
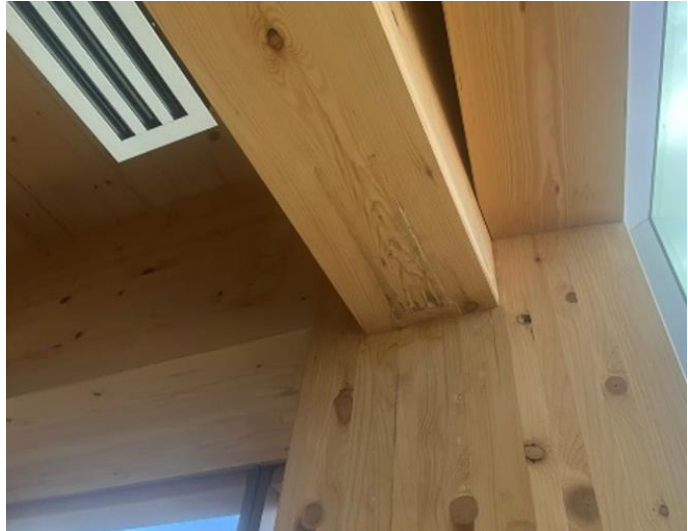
30. The ceiling beam shows signs of poorly selected, patched, filled and bogged timber.

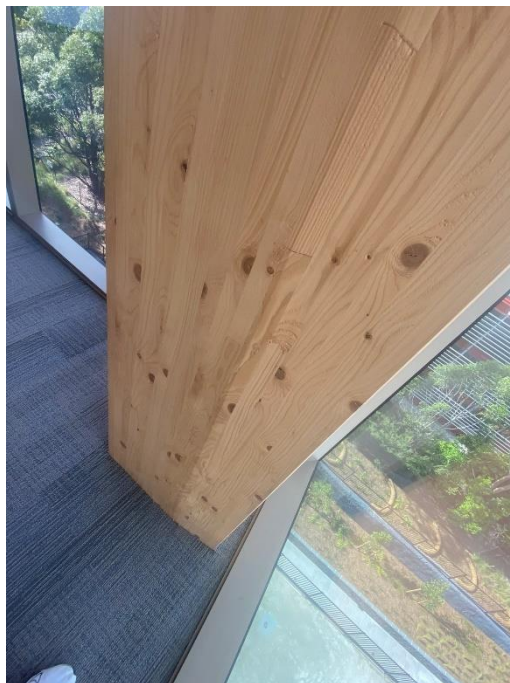
31. Column showcases poorly patched and prepared timber panelling. This needs to be sanded back and re-stained in order to achieve a smooth and consistent finish.

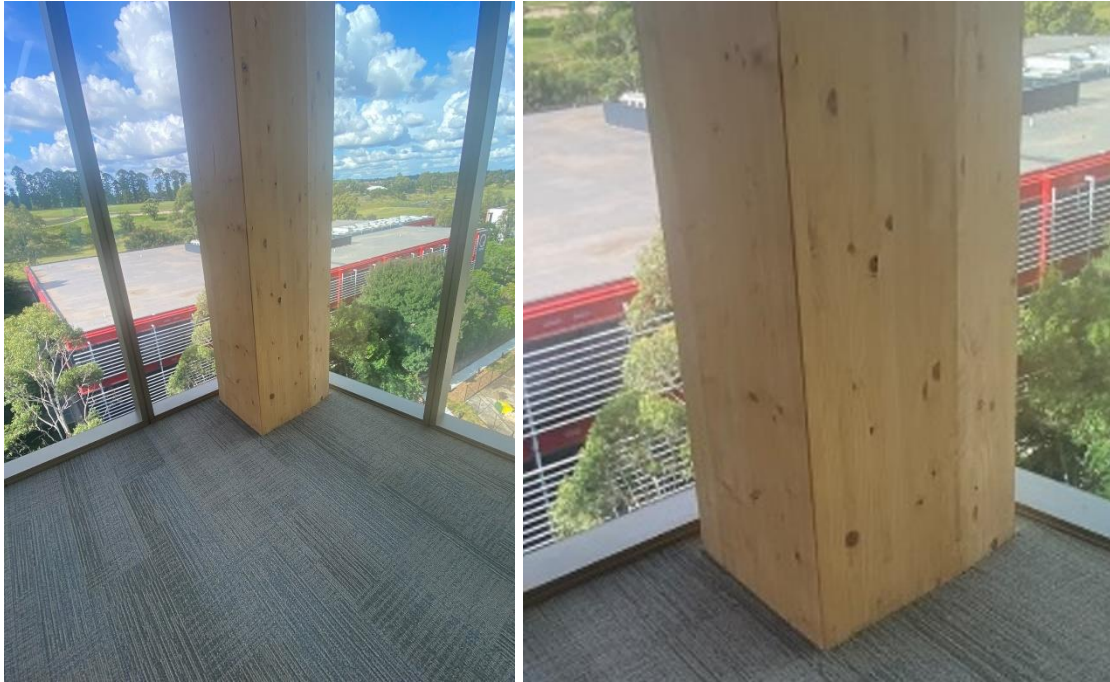
32. The column has been clad with a timber veneer. The column external mitres are expressed and not a sealed external miter junction that would be expected for a new build.

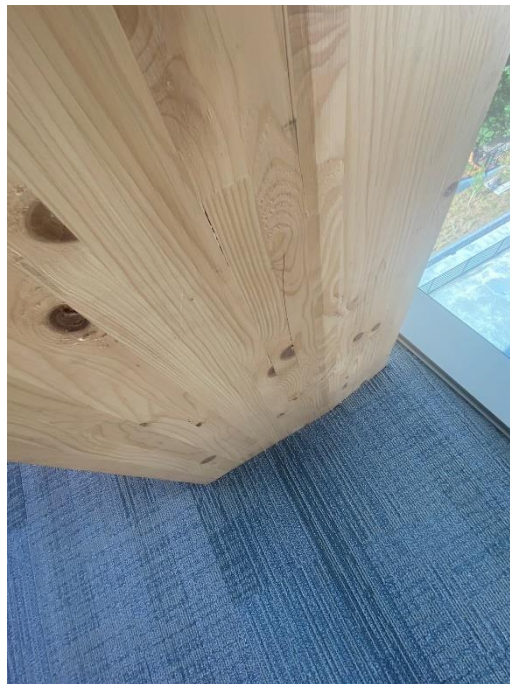
33. This column has cracks within the veneer timber cladding over the column. This timber cladding needs to be sanded back smooth and cracks filled, and another clear coat applied to the timber.

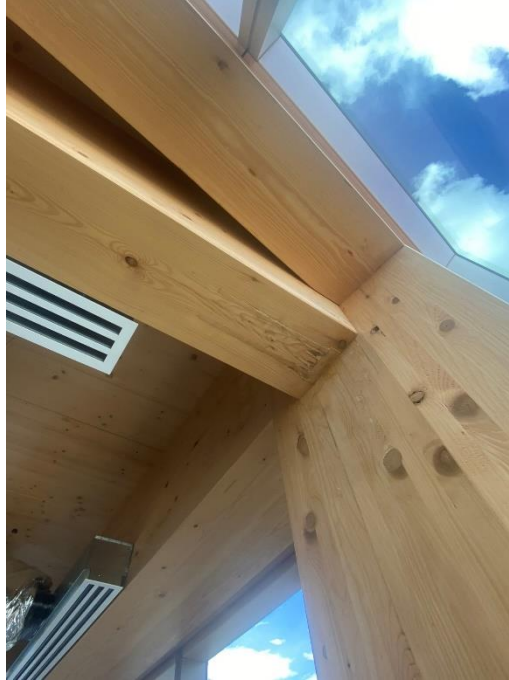
34. The timber appears to have a one-coat clear coat system applied to the timber, with the timber being located hard up against the external windows, I would expect this clear coat to evaporate and the raw timber to commence to discolour due to the ultraviolet rays being magnified that come through the glazing, and the timber will rapidly decline in quality if an adequate paint or stain system is not applied.

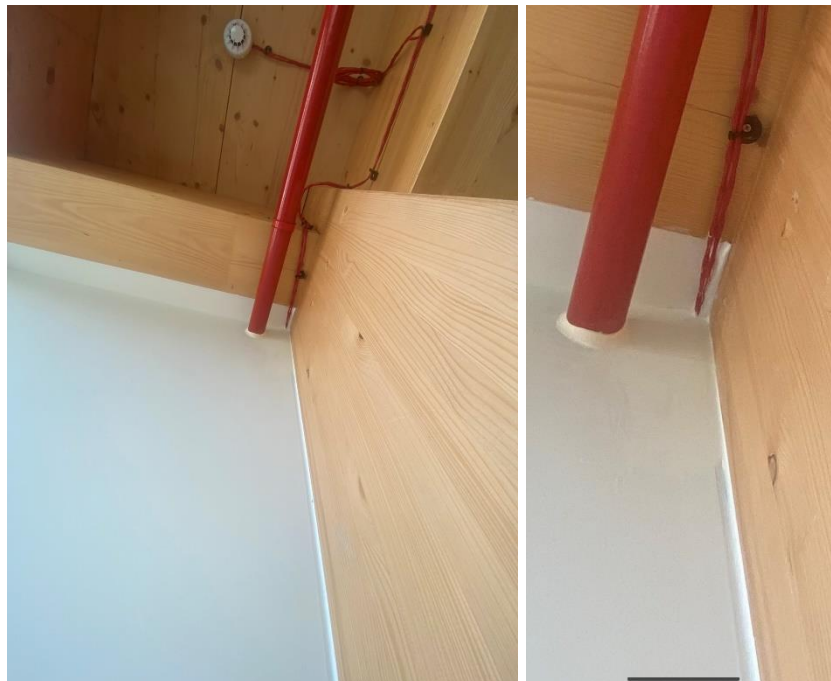
39. Control joint has been filled where the plasterboard wall and timber column junction meets, I am referring to the top 300mm of the wall.

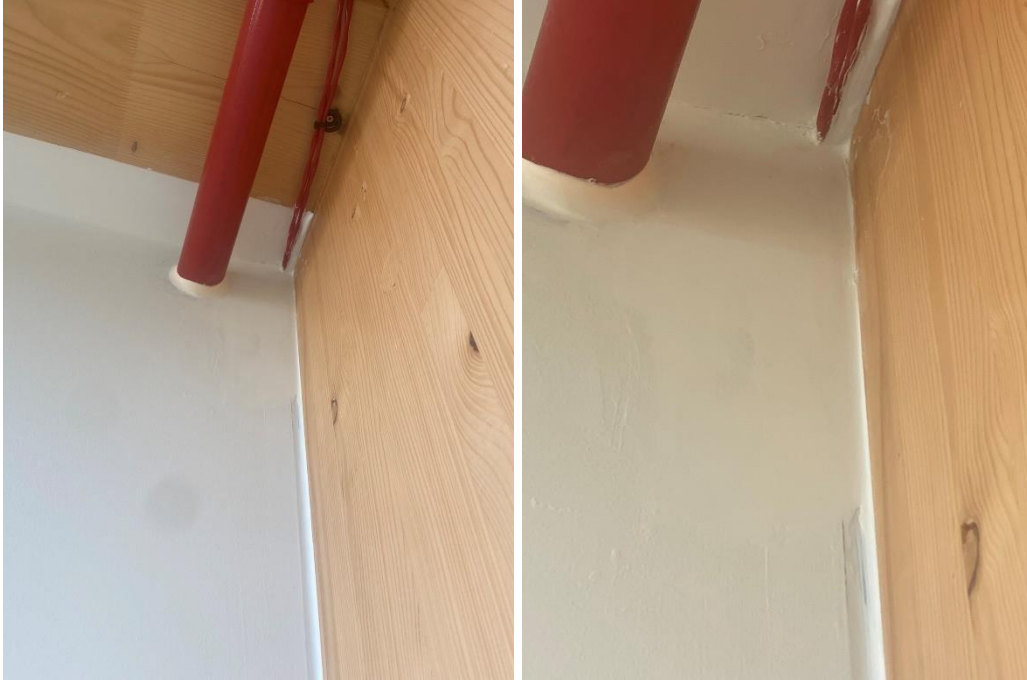
40. Excessive mastic used between the wall and metal pipes and within the internal junctions of the walls. All excessive plaster and mastic need to be removed in order to achieve square junctions, as the existing plaster will crack and fall away the moment there is differential heat within the plaster and metal pipework, which will leave cracks and defects within the excessive grout / plaster.

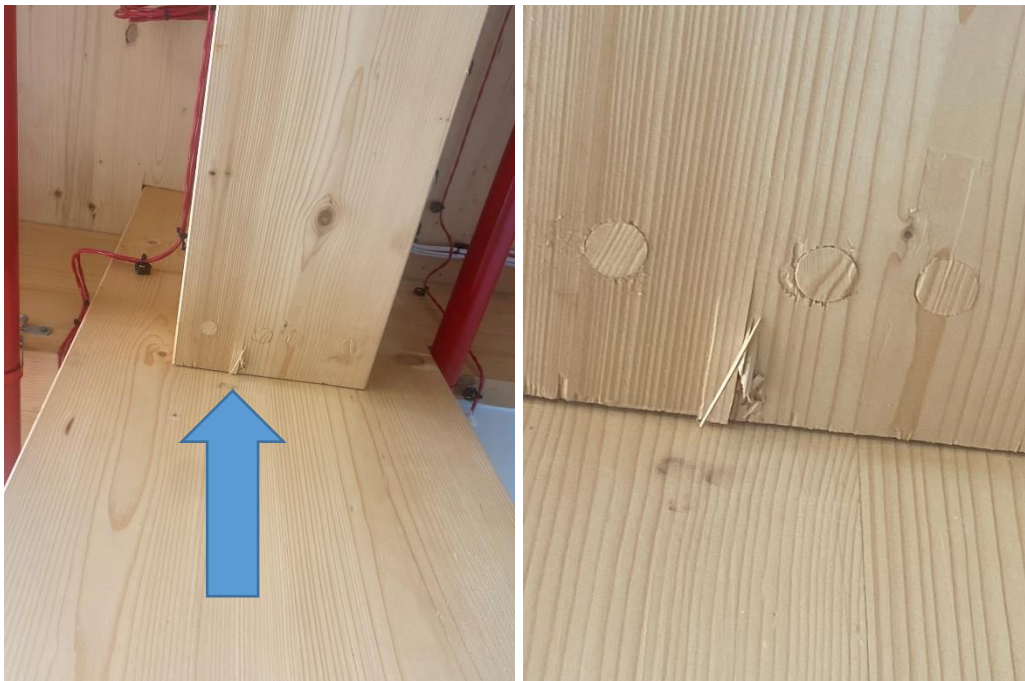
42. There are splits within the timber cladding applied to the underside of the dropdown beams.

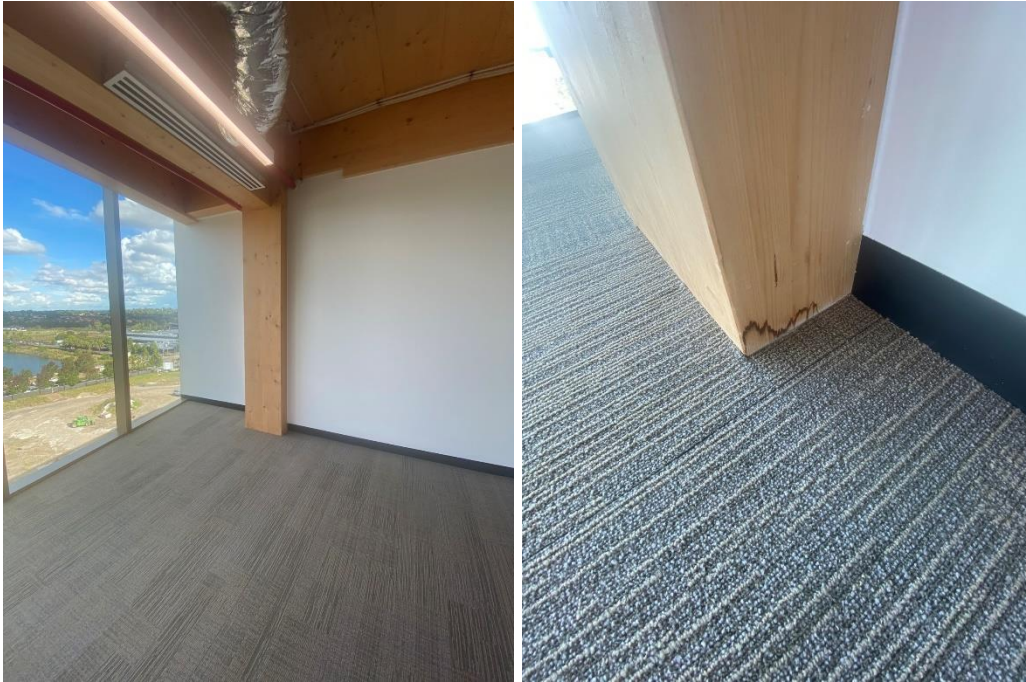
43. Water stains seen at the bottom of the column, this needs to be bleached out and clear coat applied to the entire timber to have a three-coat system.

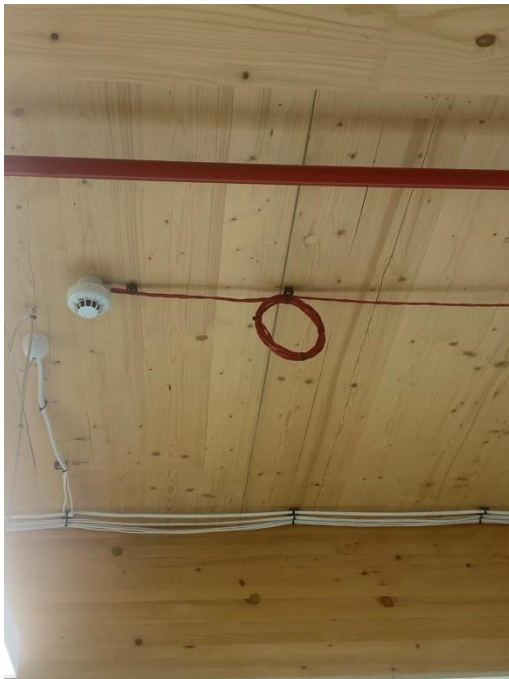
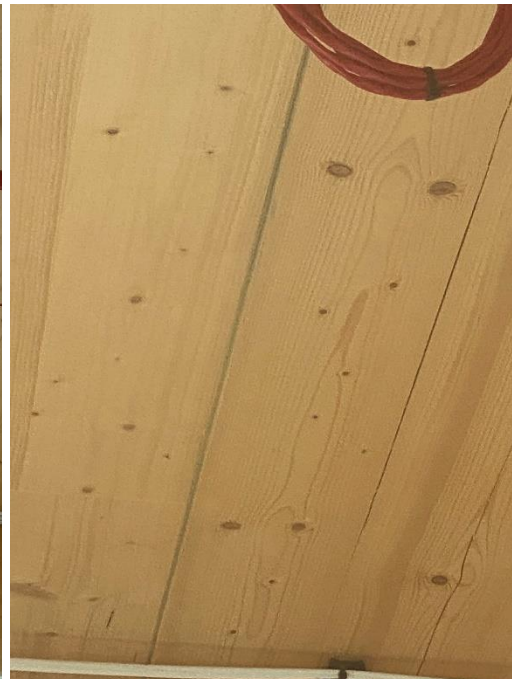
47. Ceiling panels have been installed with butt joints and no glue nor fixings are seen within the joints, however, there are areas within the roof which show excess glue coming through the timber joints.

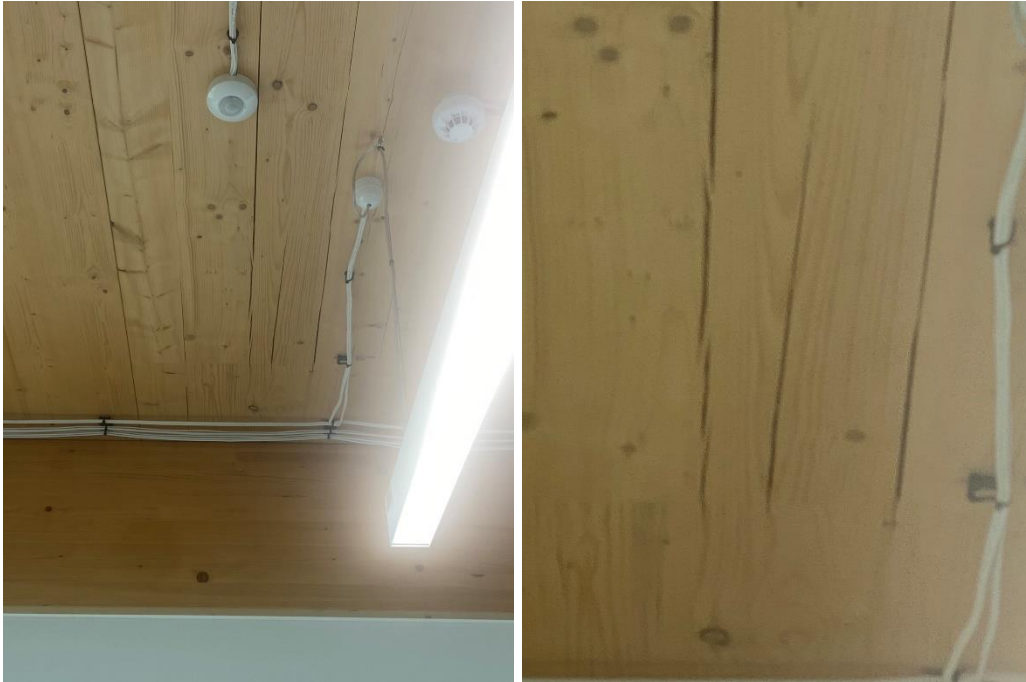
48. Randomly found throughout the office suite are cracks / splintered timber ceiling members which should have been filled prior to any clear coat being applied.

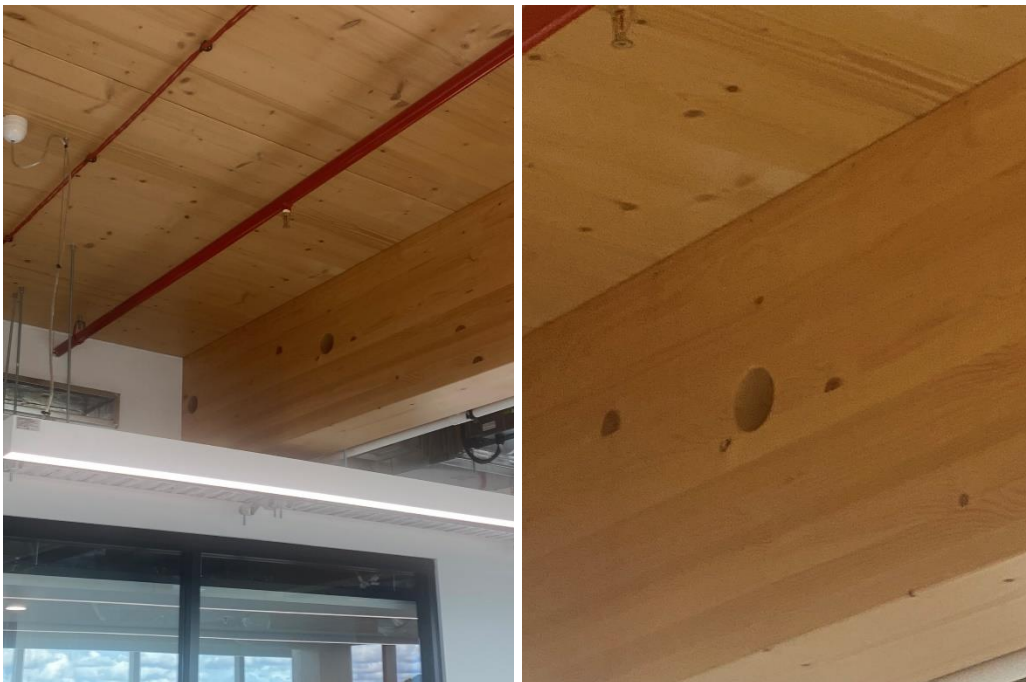
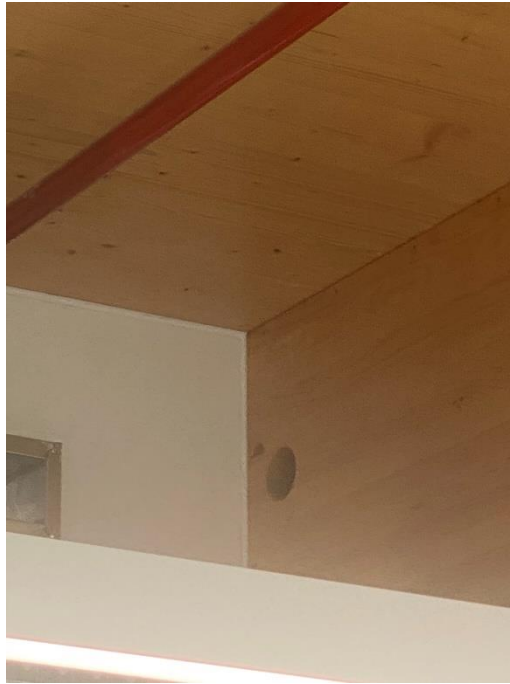
49. There are holes within the timber beams which have not been capped or timber plugged. I was advised by the builder that these holes have been left in place for future access points within the beam, which I can understand, however there are proprietary capping members that should have been installed to eliminate the dust collection and / or moisture entry point into the timber members from the AC, as it currently stands.

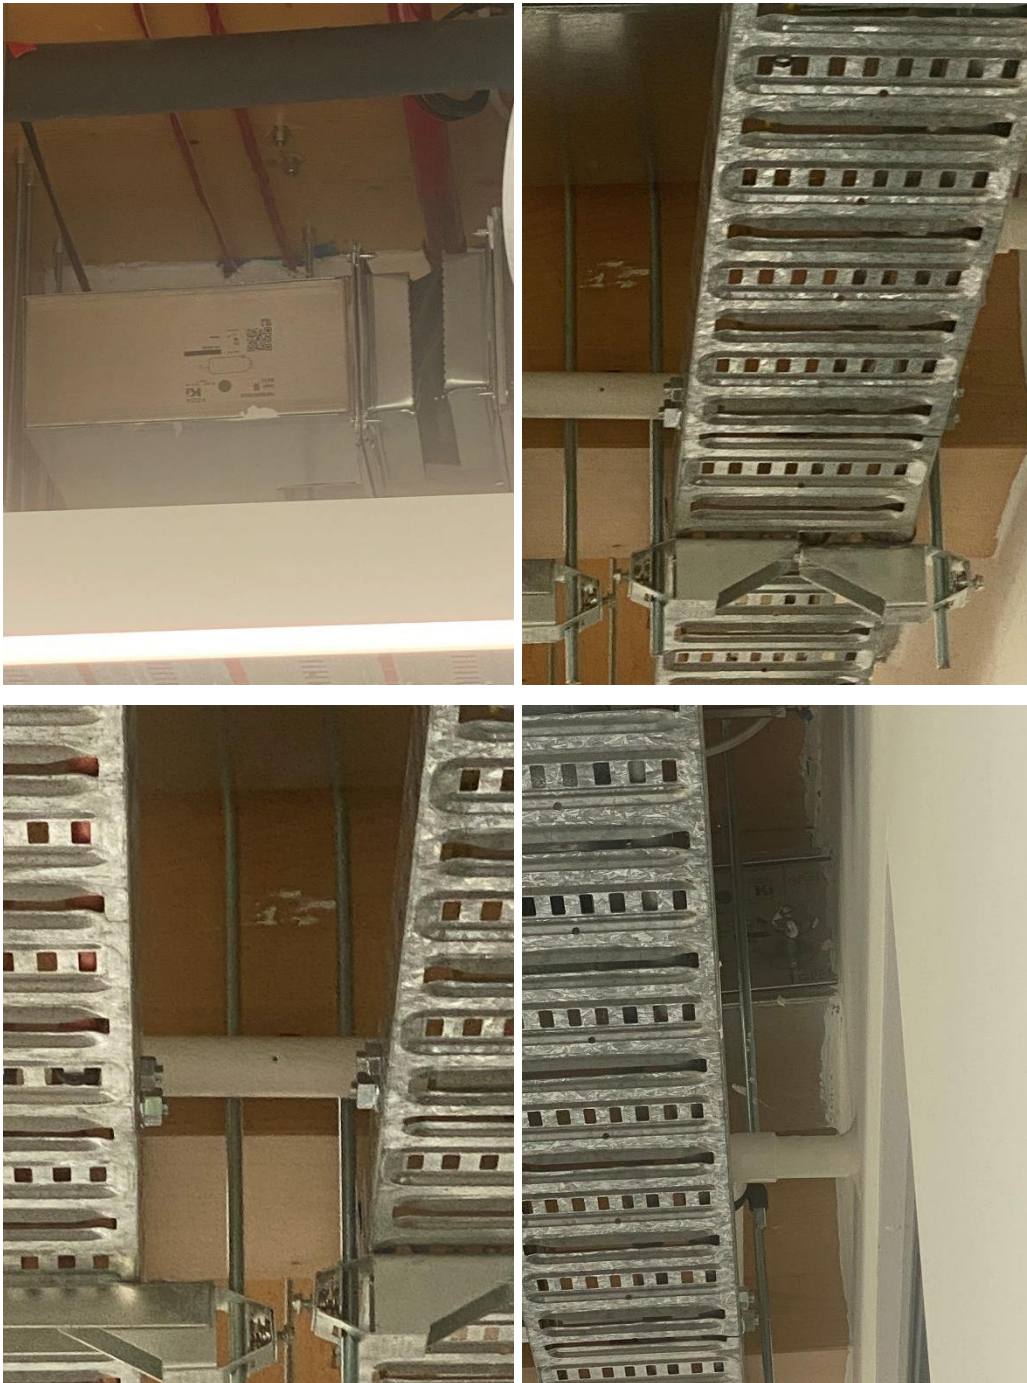
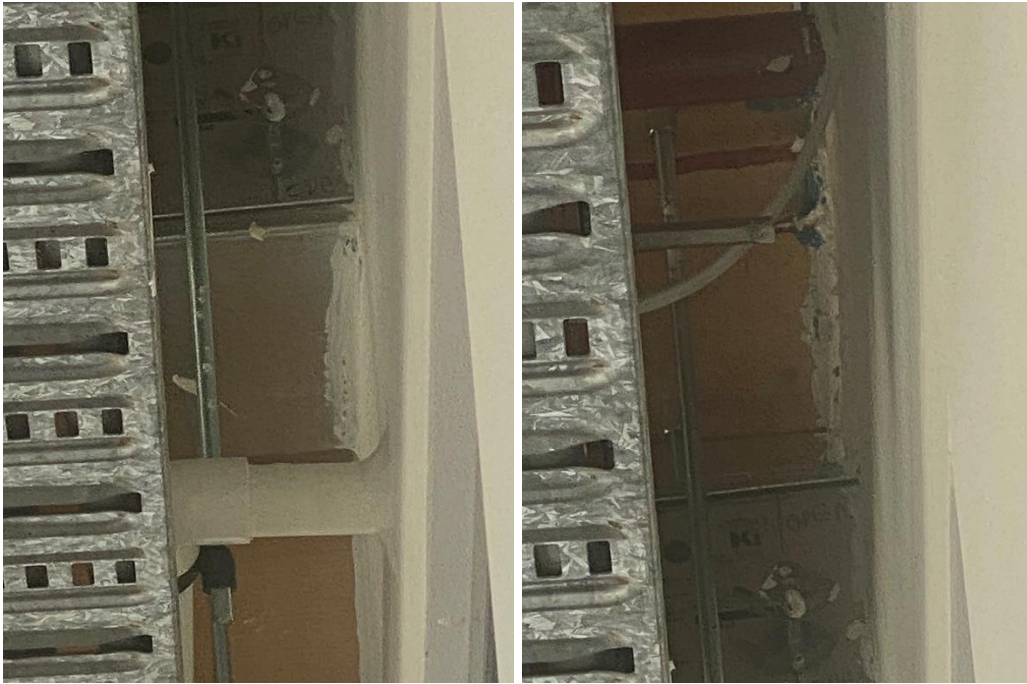
51. In various locations, there is excess paint splash marks on the AC and timber cladding, together with excess mastic / sealant applied to the internal junctions which has created an overall poor quality finish. In order to save on the number of defects, I have grouped this defect covering a number of areas as seen within the photos below.

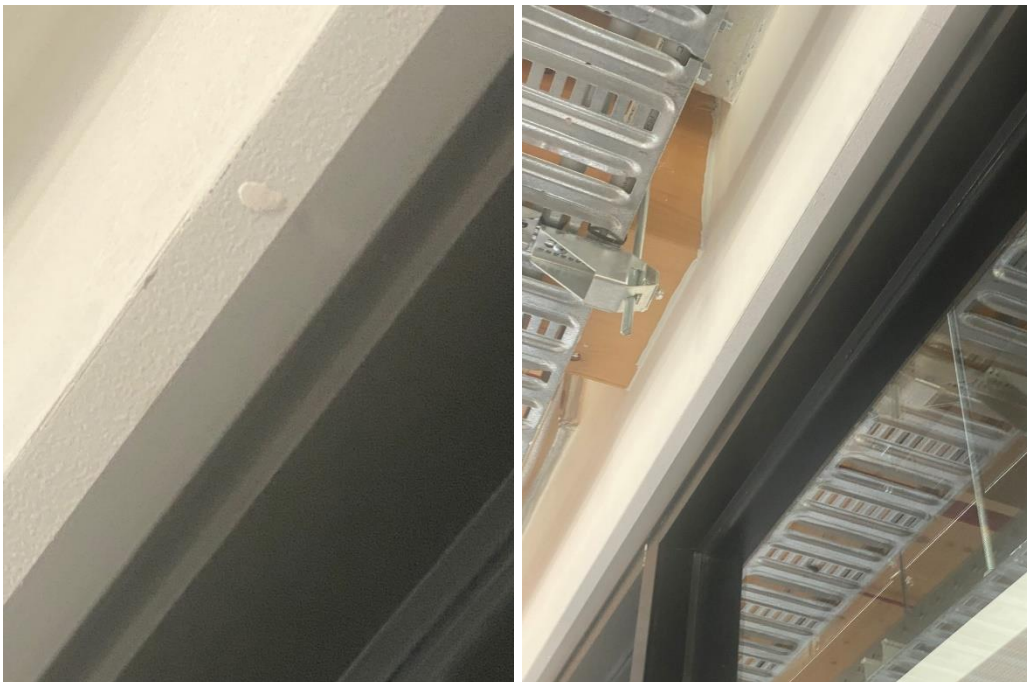
53. When viewing the shopfront / office front, the head reveal needs to be sanded back with the removal of any excess plastering dollops and re-painted in order to achieve an adequate finish to the plastering and painting trades.

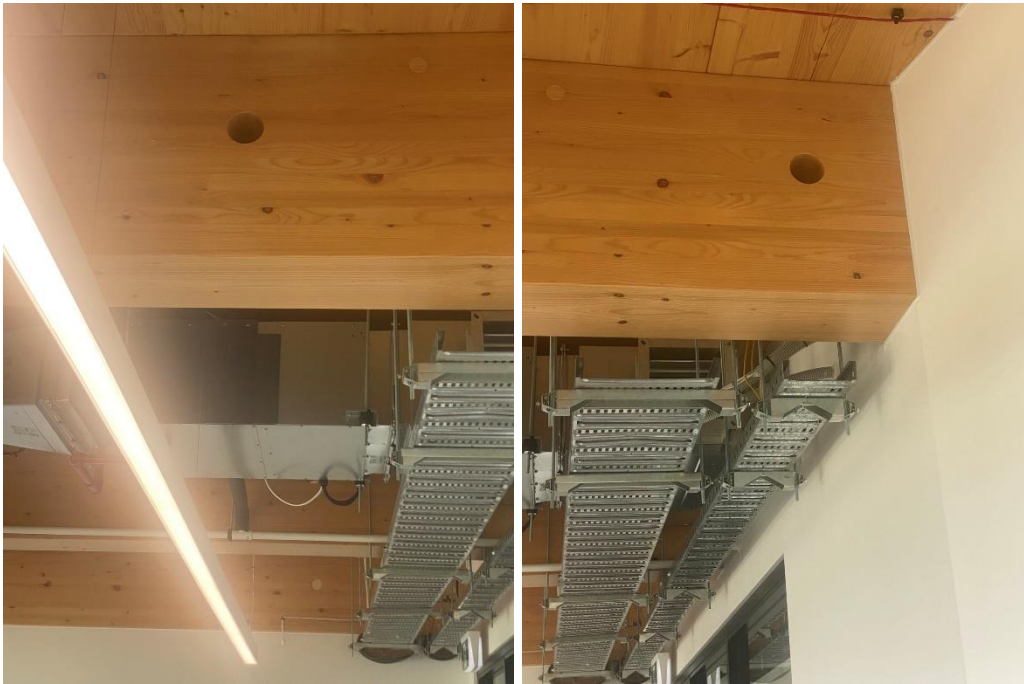
54. A second beam found with holes that have not been capped or plugged up.
