# **Dilapidation Report For The Development At: 14 Fairfax Road Mosman NSW 2088**

Dilapidation Report Carried Out On:

12 Fairfax Road Mosman NSW 2088

17<sup>th</sup> June 2019

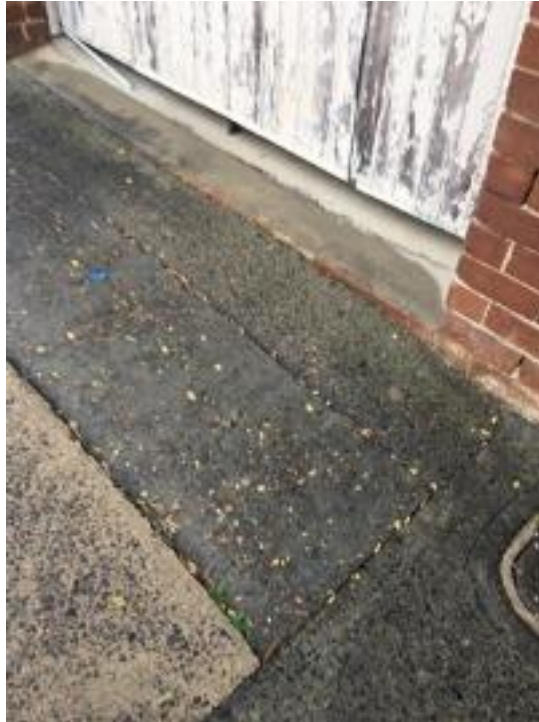
Cracked concrete / footpath

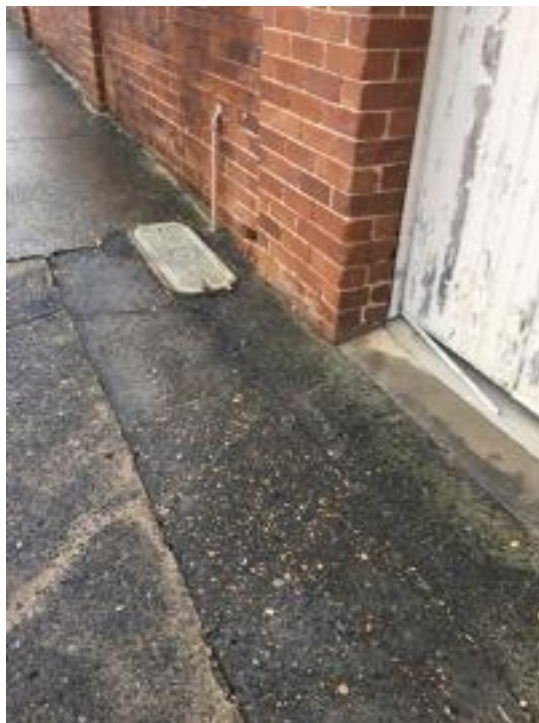
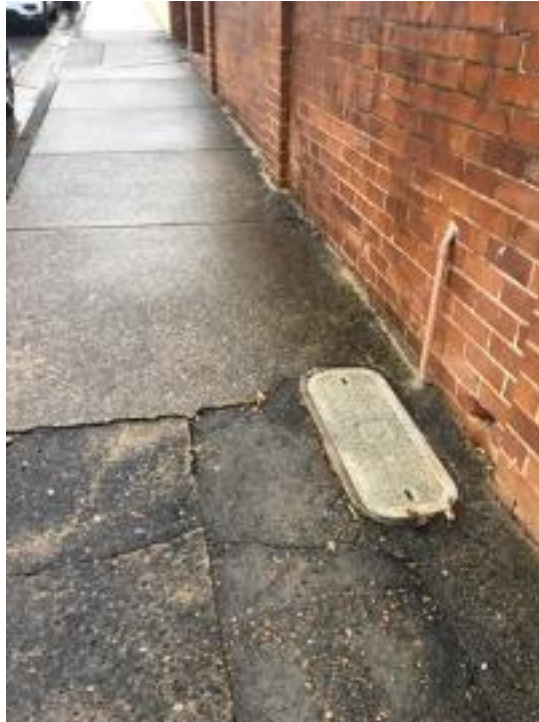
Cracked concrete footpath, driveway and layback

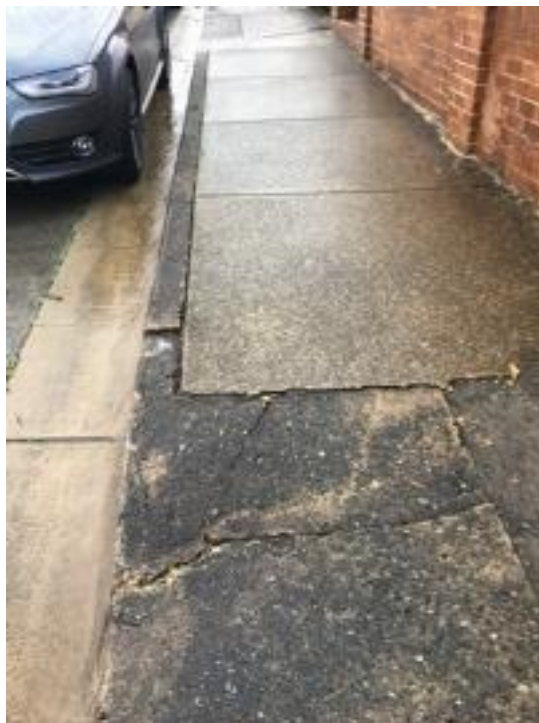
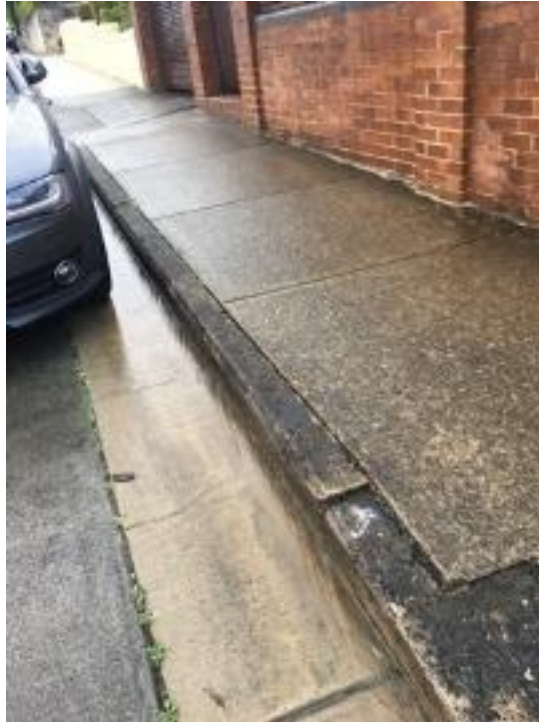
Cracked concrete curb and gutter

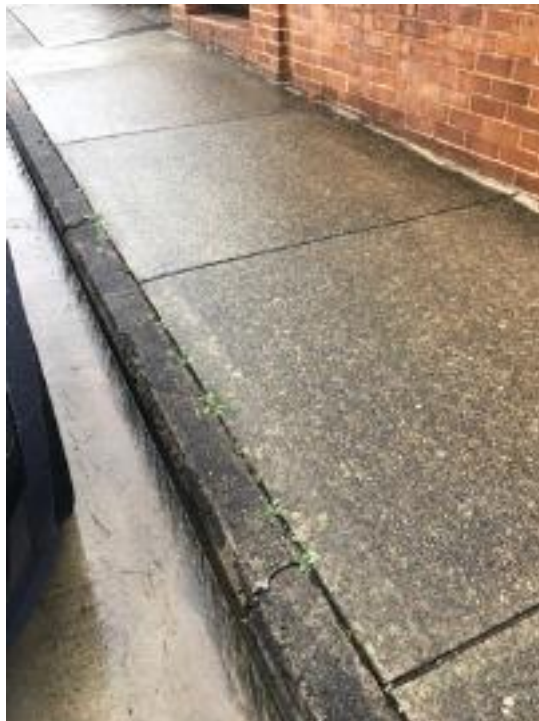
Cracked concrete layback / crossover

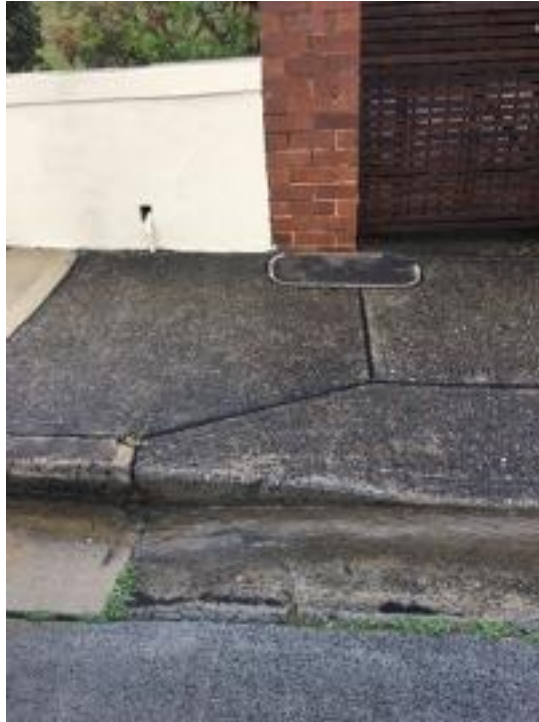
Cracked concrete apron and layback / driveway

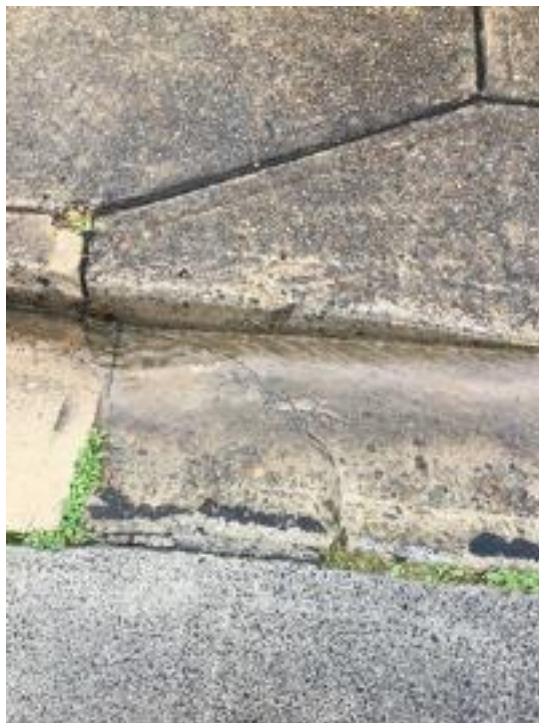
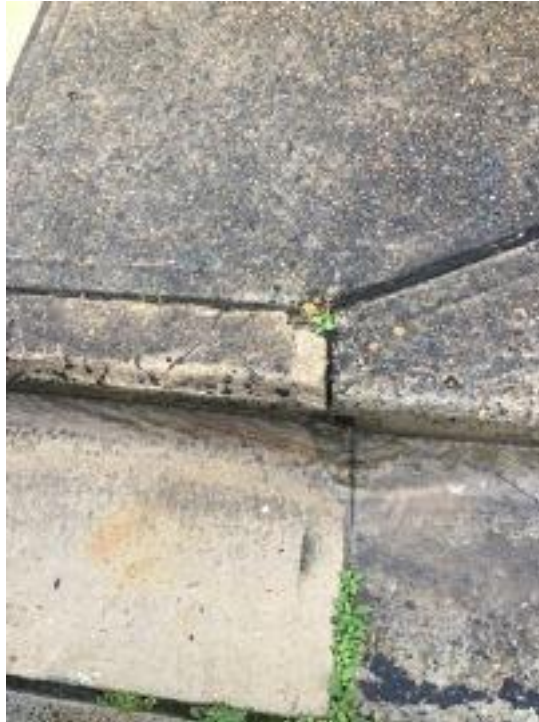
Cracked concrete curb, gutter and layback

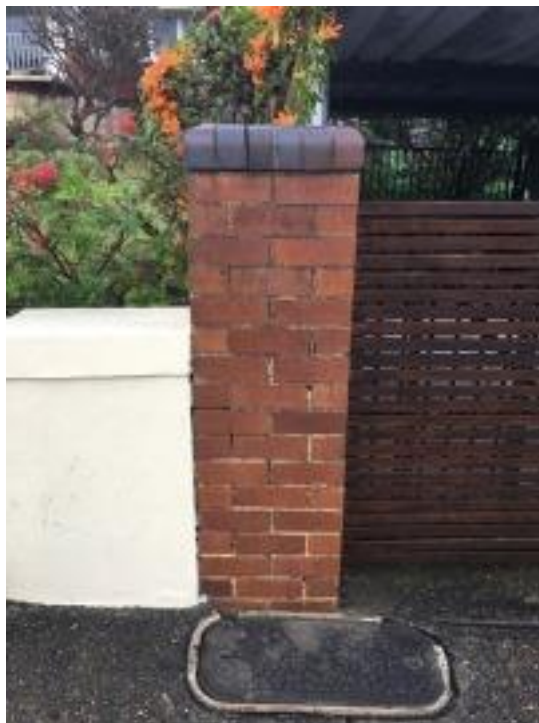
Minor cracks within the face brickwork within the front brick pillar

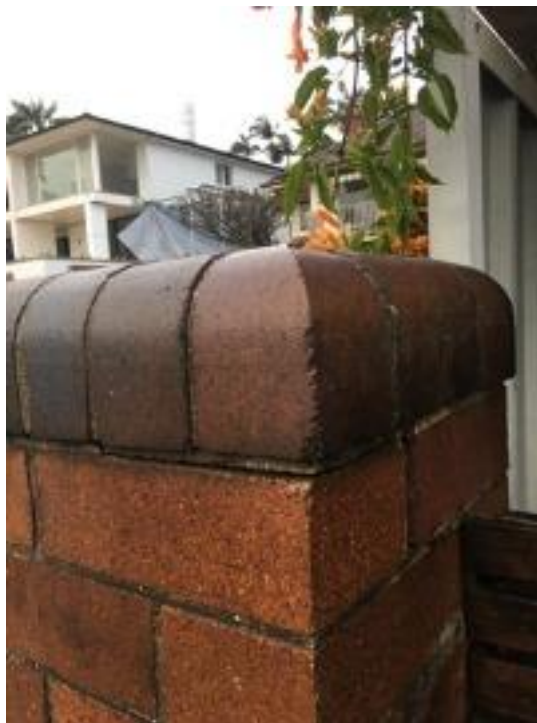
Existing cracks within the brick mortar joints of the brick pillars

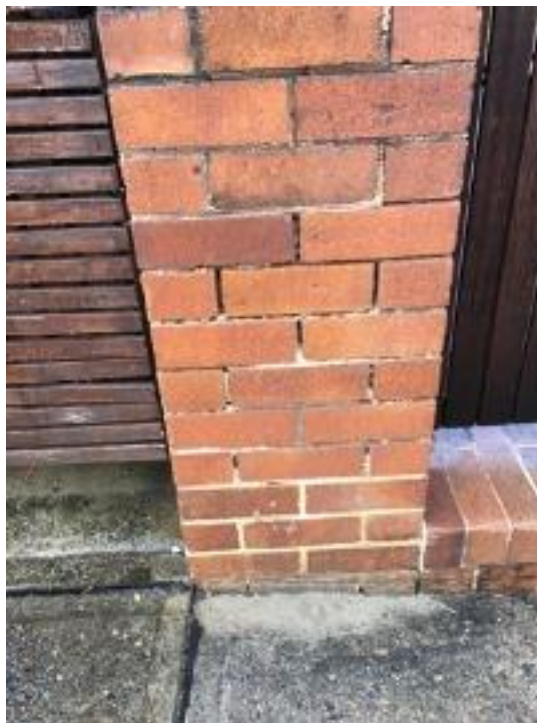
Existing cracks within the brick mortar joints of the brick pillars

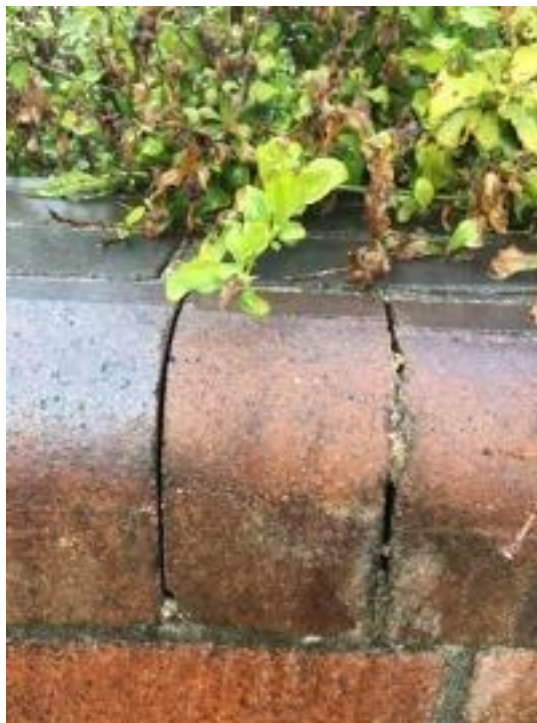
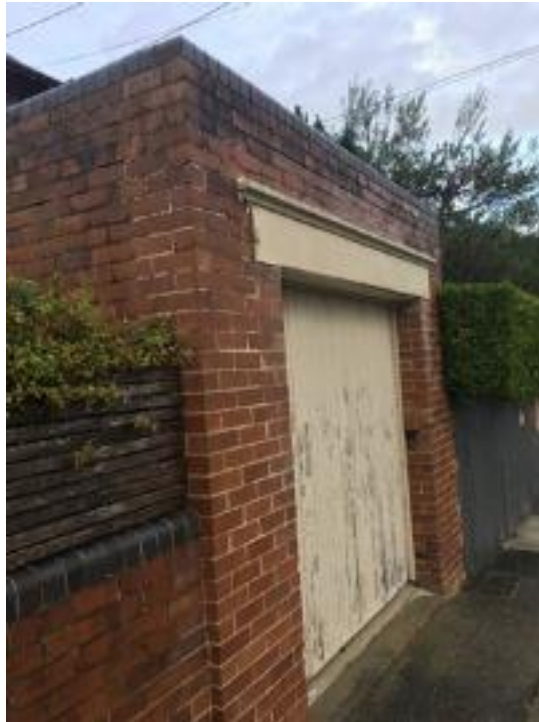
Existing cracks within the brick mortar joints within the street elevation of the garage structure

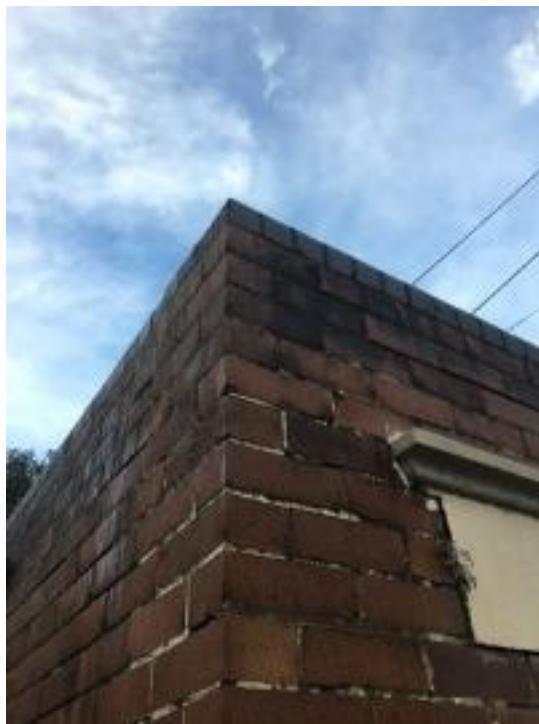
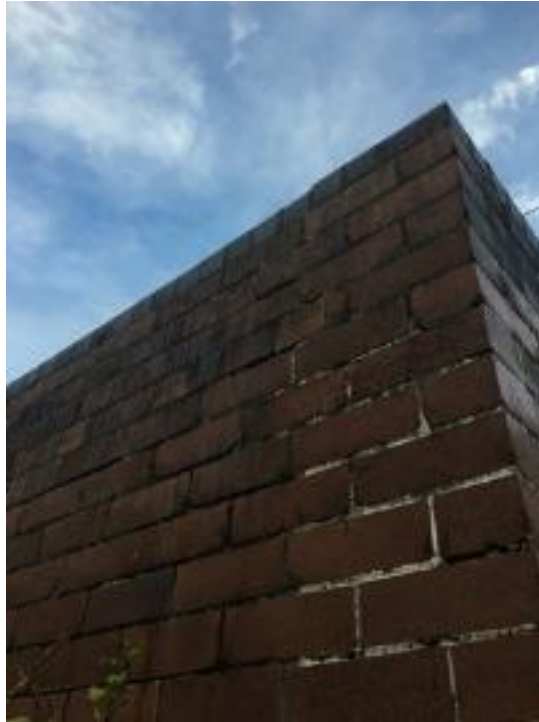
Existing cracks within the brick mortar joints within the street elevation of the garage structure

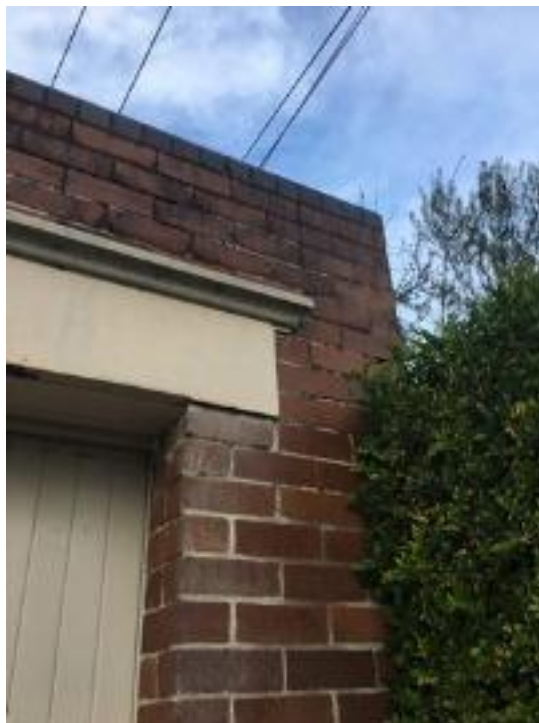
Existing cracks within the brick mortar joints within the street elevation of the garage structure

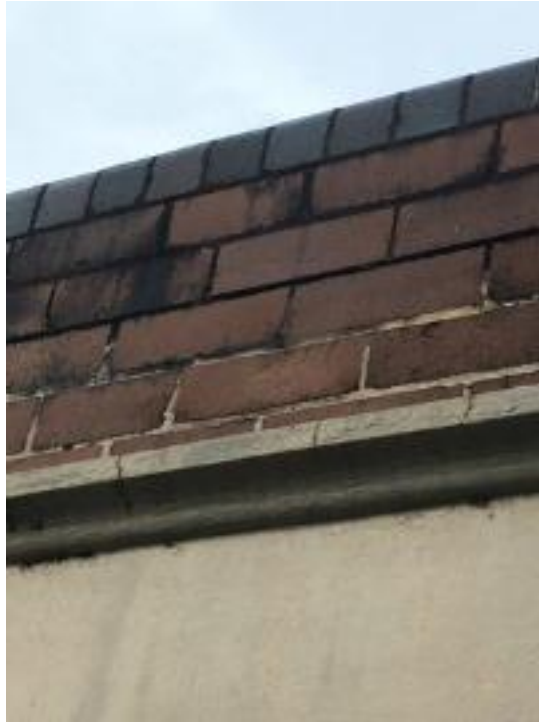
Above the garage lintel, there are existing cracks within the brick mortar joints within the street elevation of the garage structure

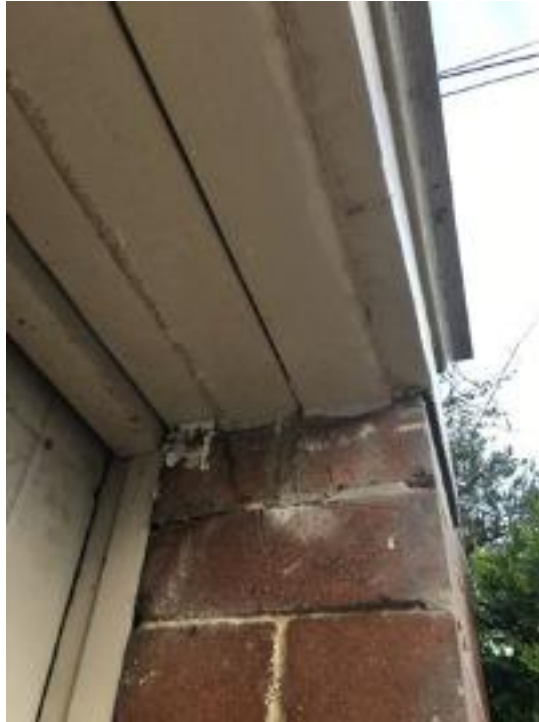
Cracked bricks within the street elevation garage pillar

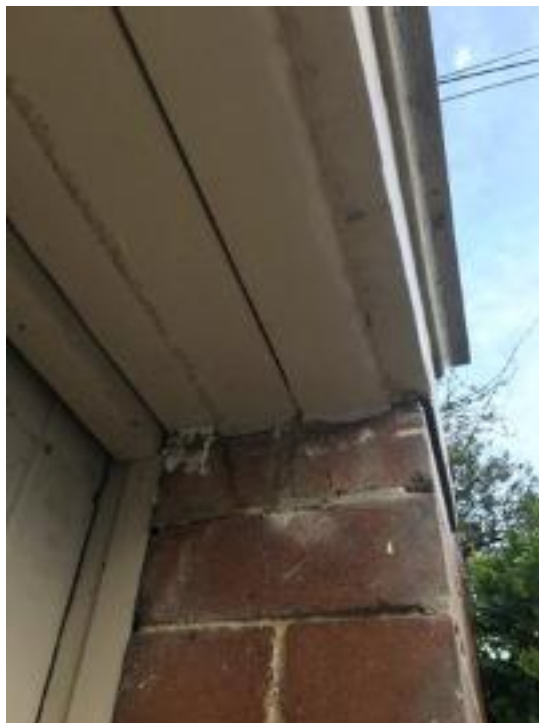
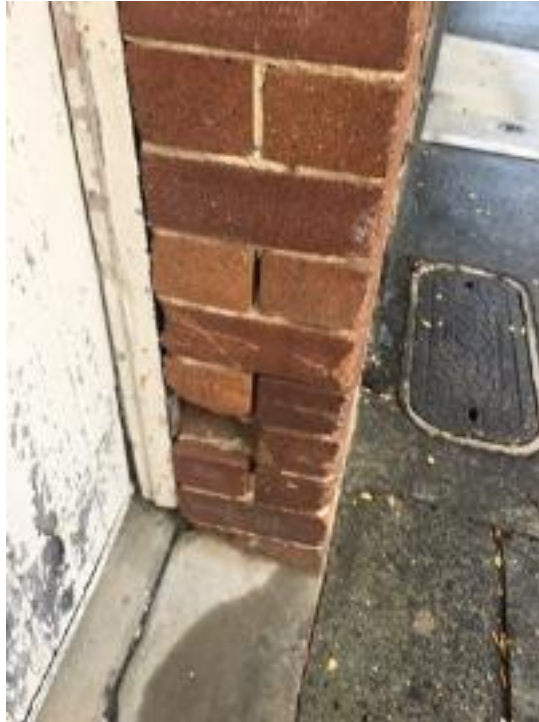
Missing bricks and damaged brick pillar

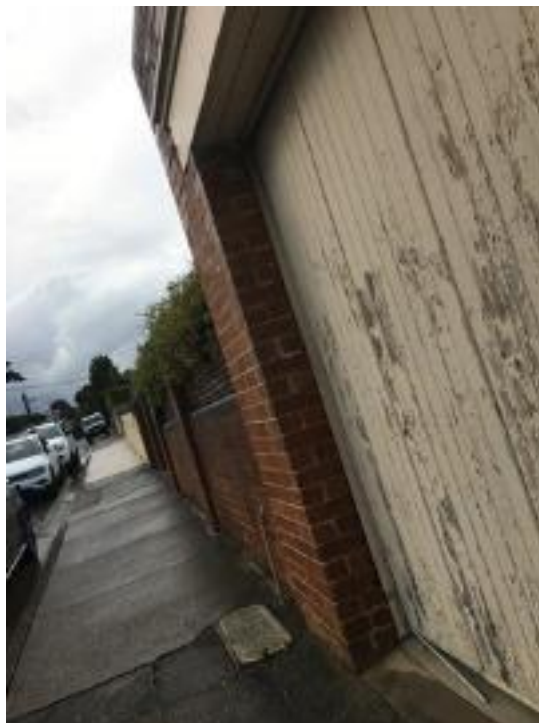
The entire length of the garage walls are structurally unstable, the brick walls are leaning over, there are cracks within the brick mortar joints and through the body of the brickwork

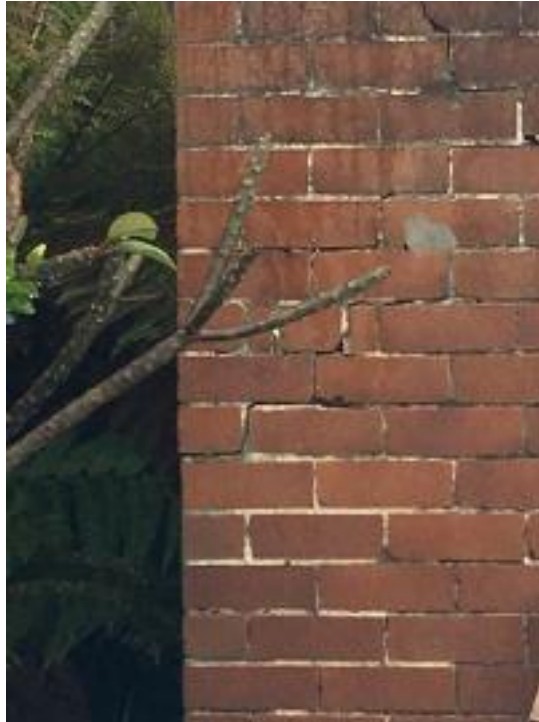
Major structural cracks within the garge structure

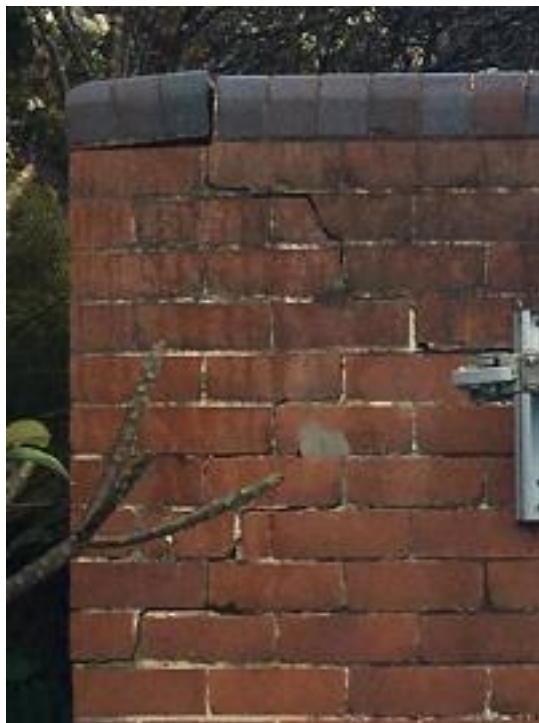
The garage needs to be demolished and re-built, as it is leaning over, and there are cracks in every elevation of the garage

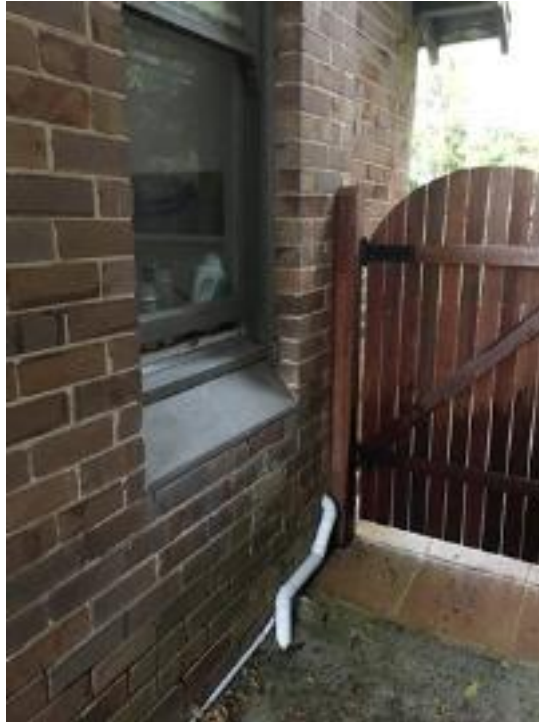
Cracks in the window sills / render, and missing mortar within the face brickwork

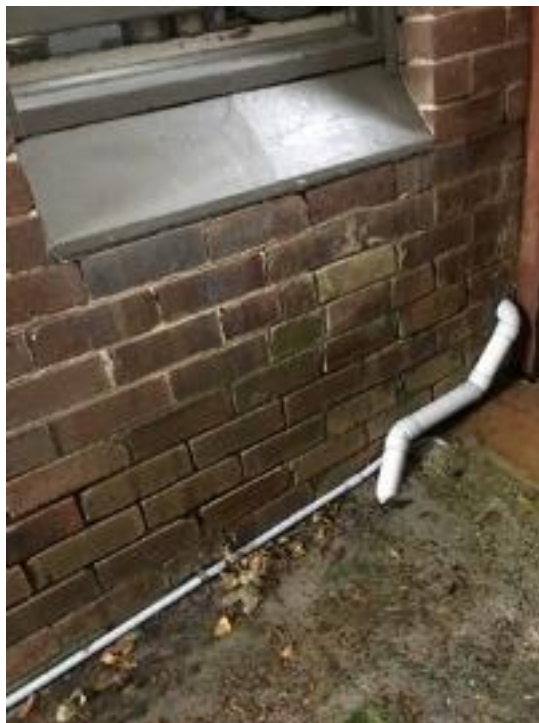
Cracks in the window sills/render, and missing mortar within the face brickwork

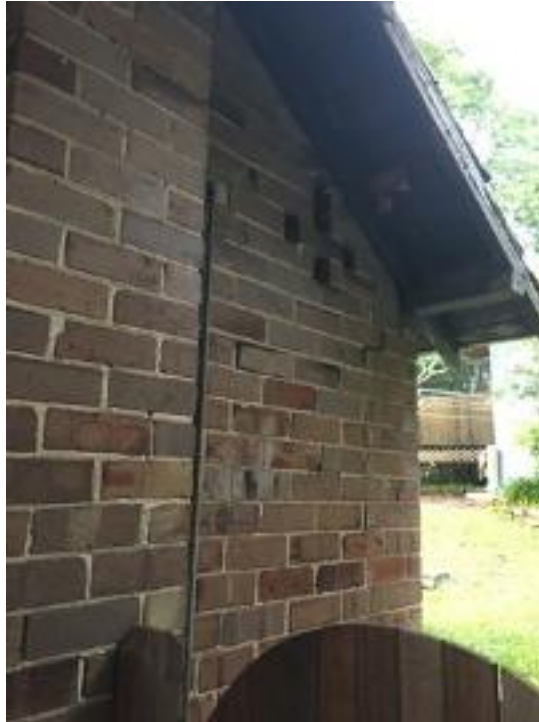
Cracks in the rear elevation / rear right coner of the house

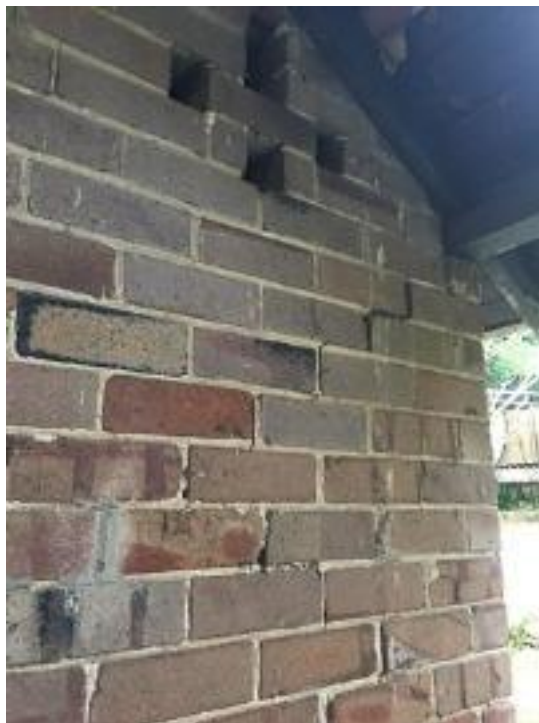
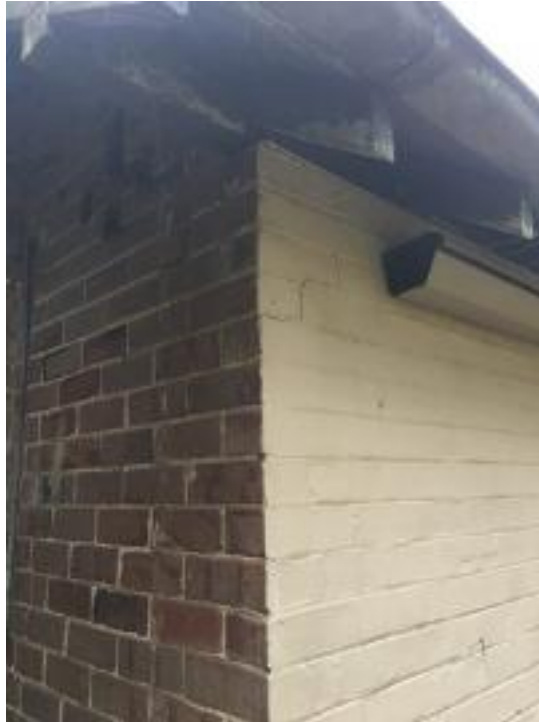
Cracks in the mortar joints within the rear elevation of the house

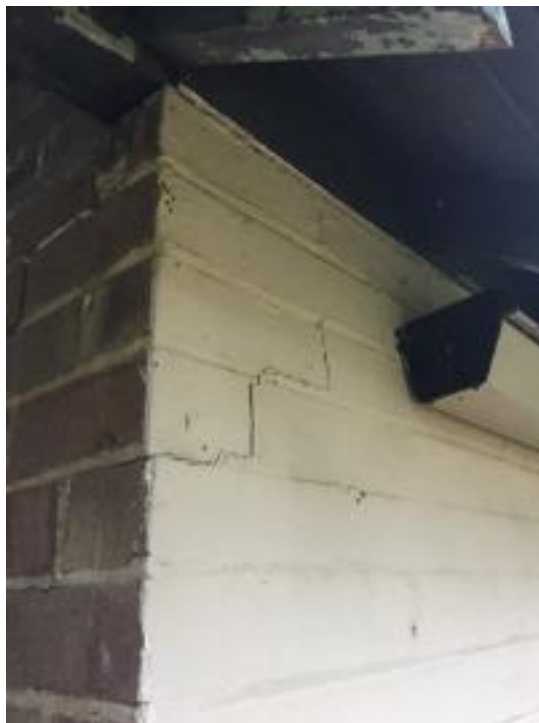
Minor cracks in the brick mortar joints / face brickwork, rear elevation of the house

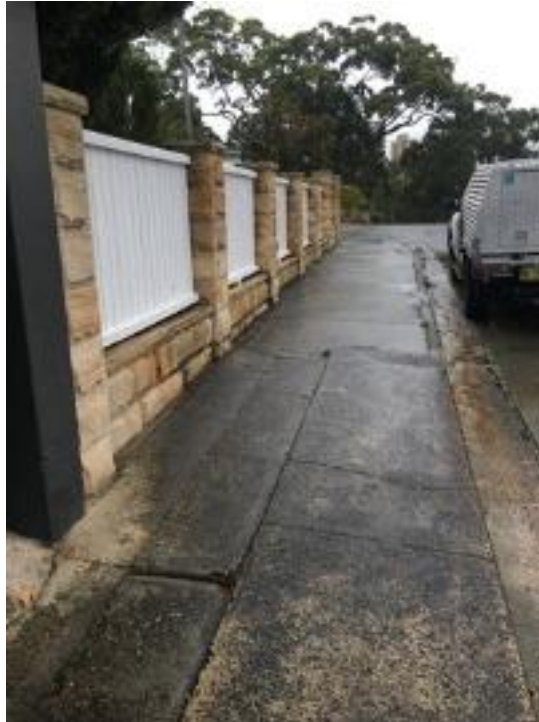
Old / existing cracks / damages in the concrete footpath

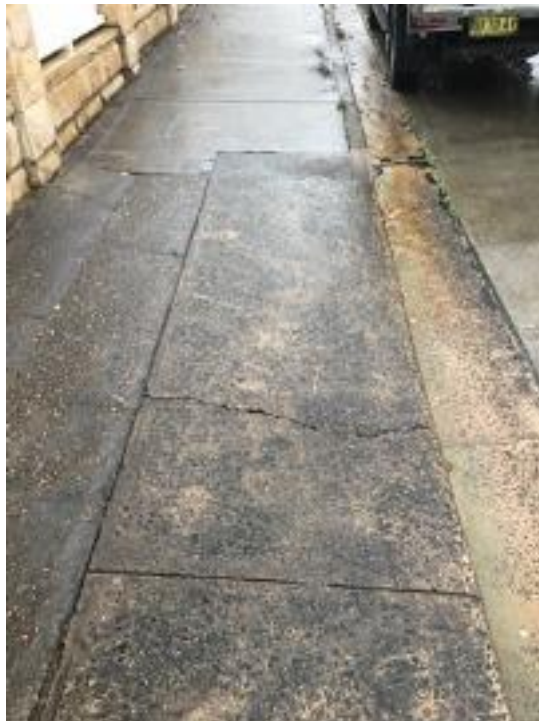
Cracks in the concrete curb, gutter and footpath

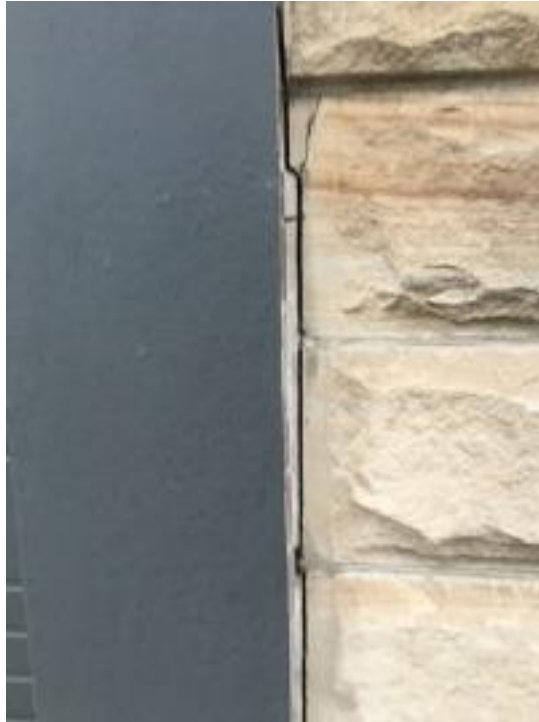
Settlement cracks in between the neighbour's boundary wall / rendered wall, and the existing sandstone pillar

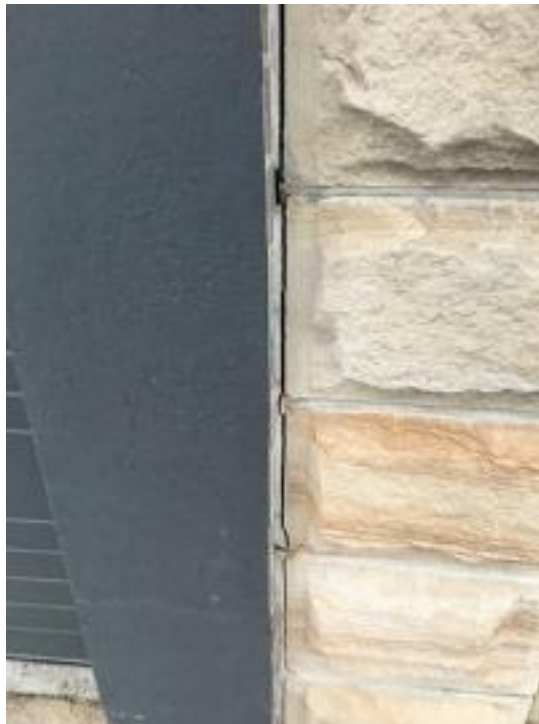
Settlement cracks in between the neighbour's boundary wall / rendered wall, and the existing sandstone pillar

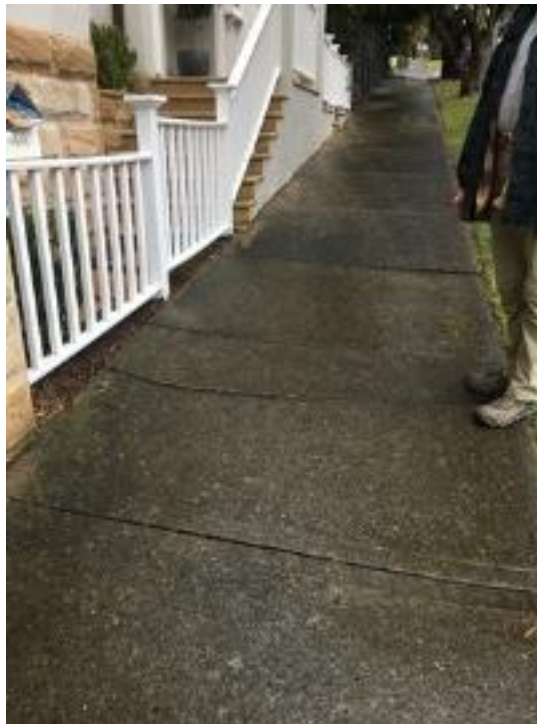
Cracked concrete footpath, out the front door of the property

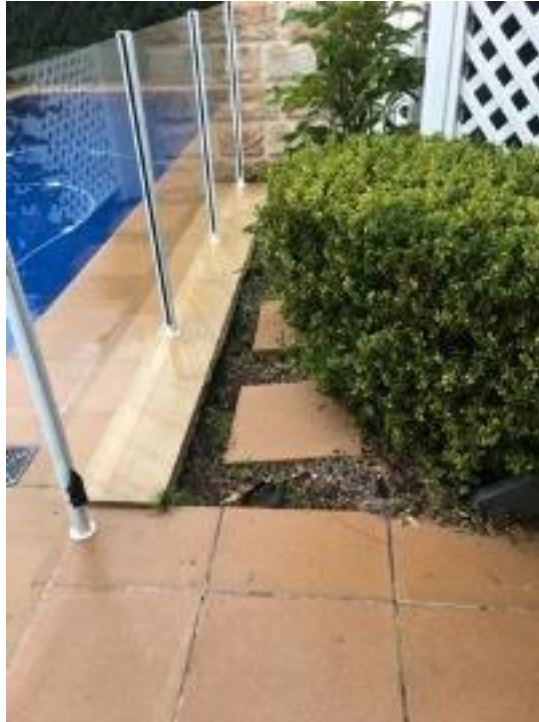
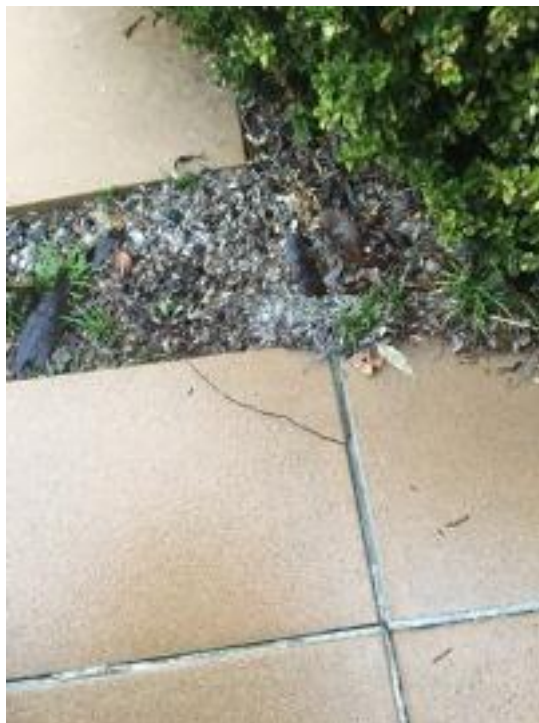
Cracks in the floor tiles, floor tile mortar joints / grout joints, and missing control joints / cracks / tile growth cracks

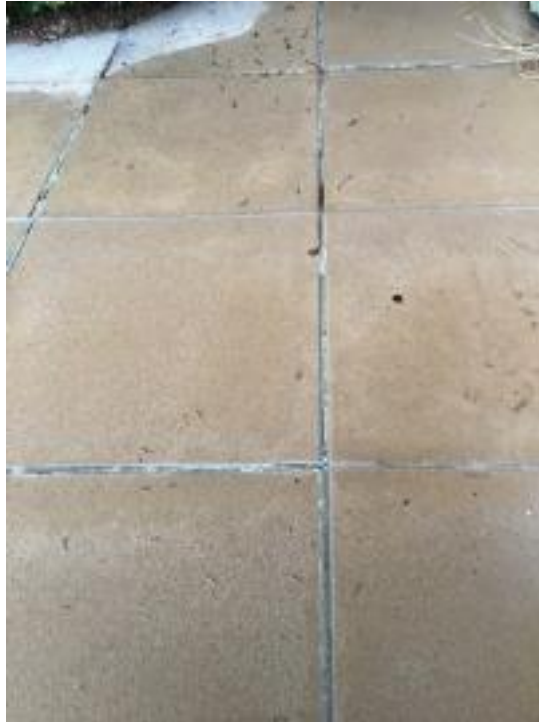
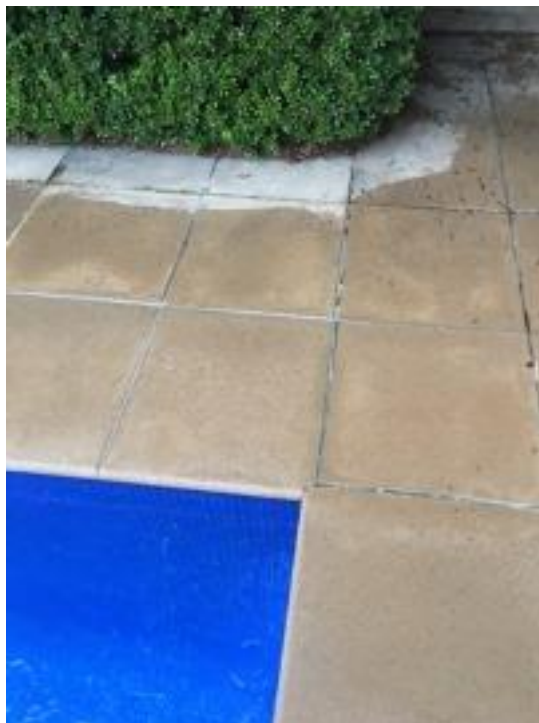
Existing hairline cracks in the floor tiles / pool coping and concourse tiles

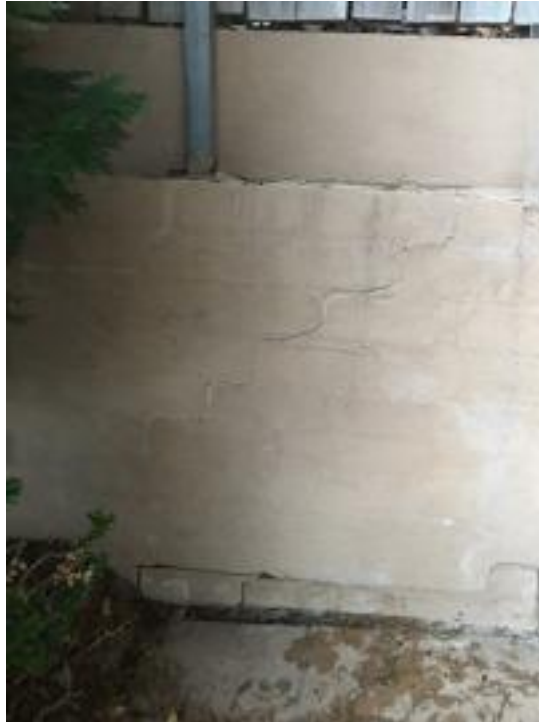
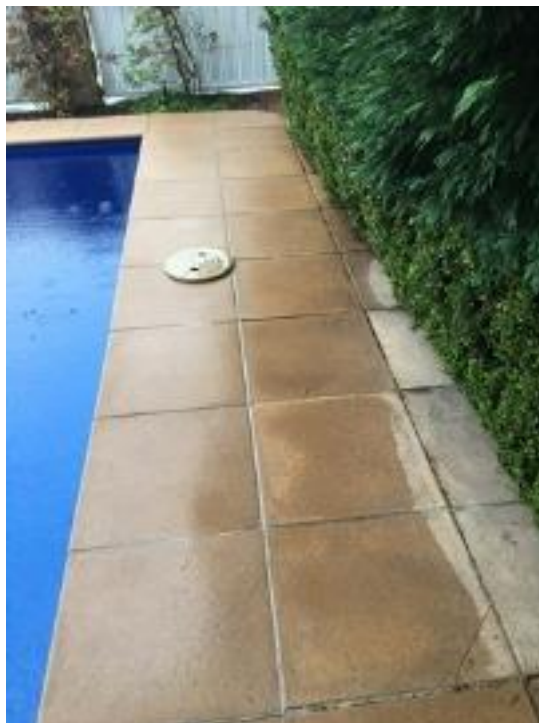
Chipped / cracked pool floor tiles within the pool concourse

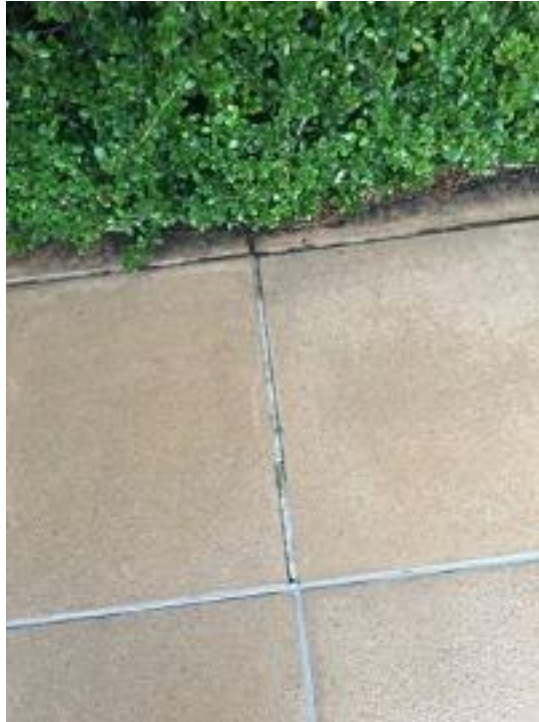
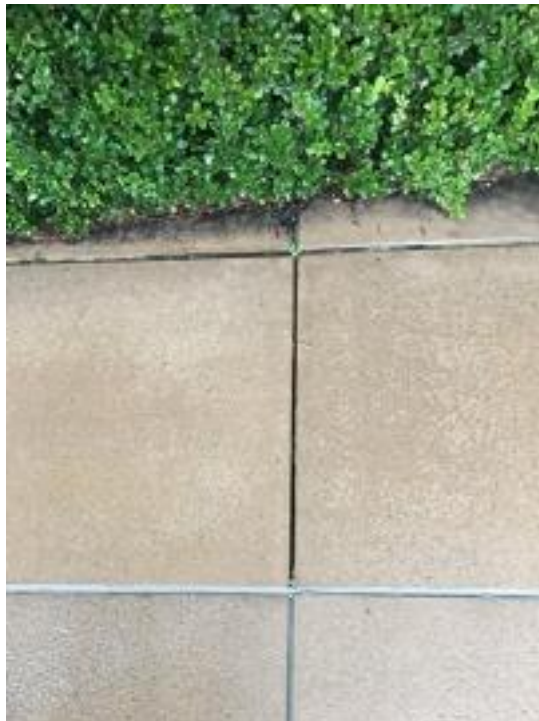
Missing grout within the pool concourse floor tiles

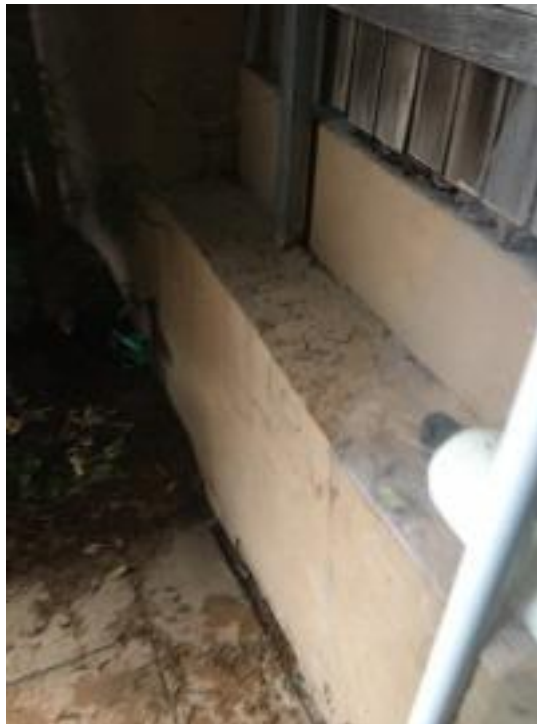
Retaining wall / side boundary wall that is shared between the two properties, is cracked and defective within the brick mortar joints

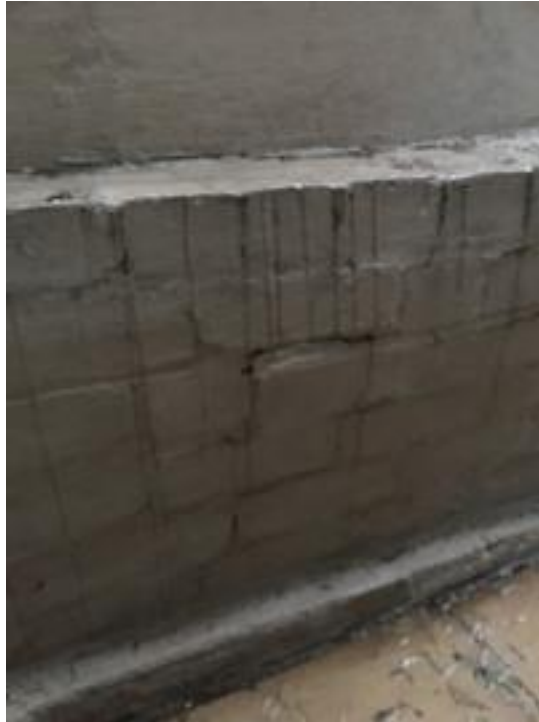
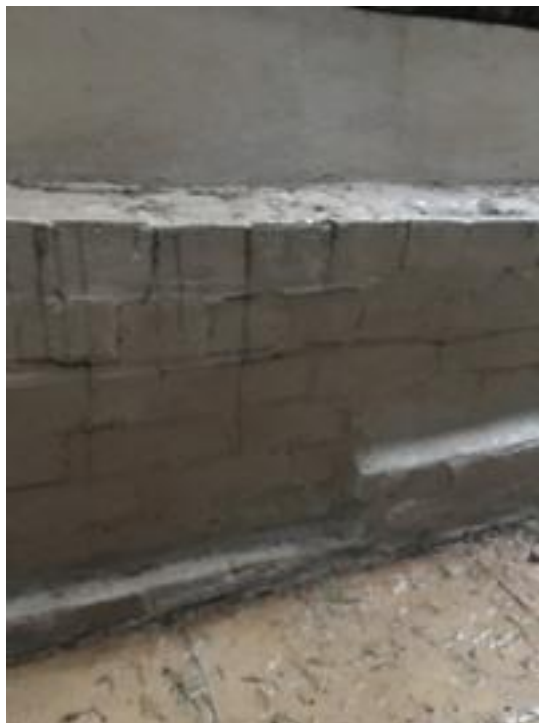
Brick walls and footing along the boundary line working as a retaining wall, has existing minor hairline cracks in the walls, through the body of the bricks and through the brick mortar joints

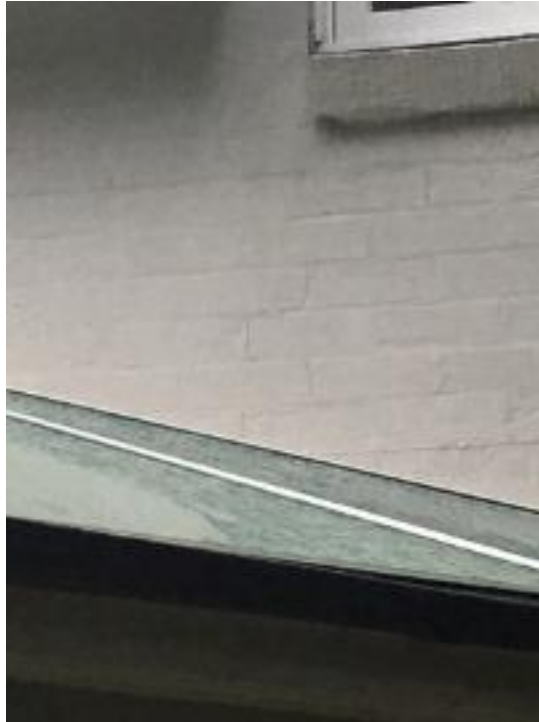
Minor cracks in the rear elevation masonry walls above the roof line

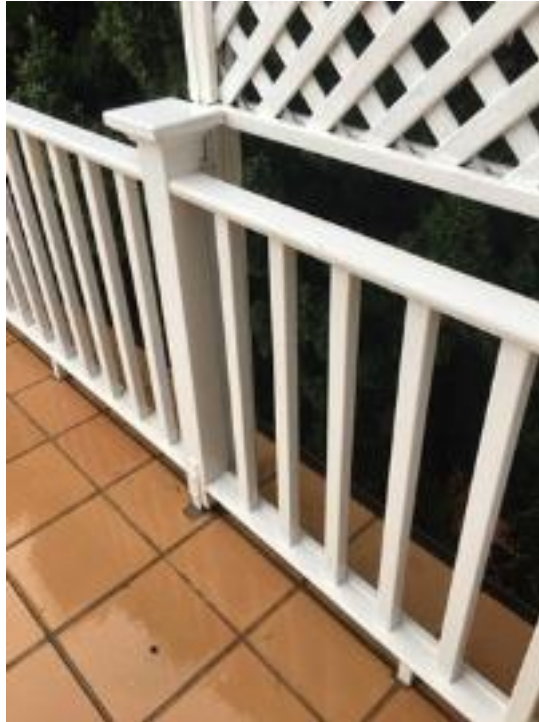
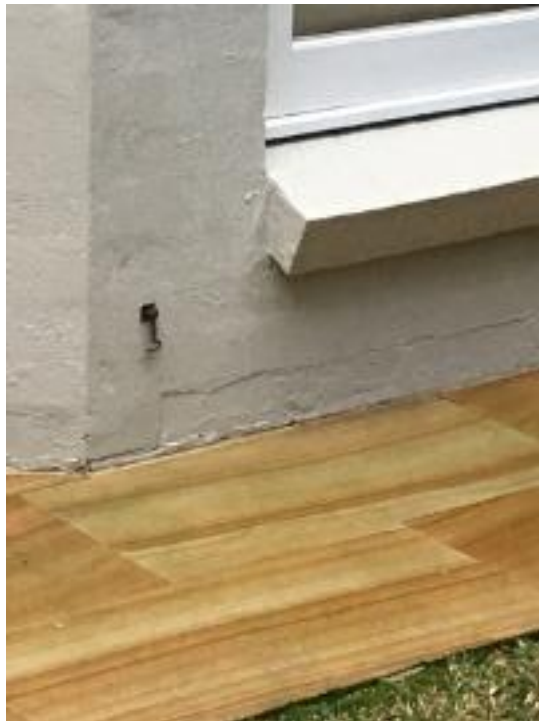
Minor cracks in the base of the external masonry wall

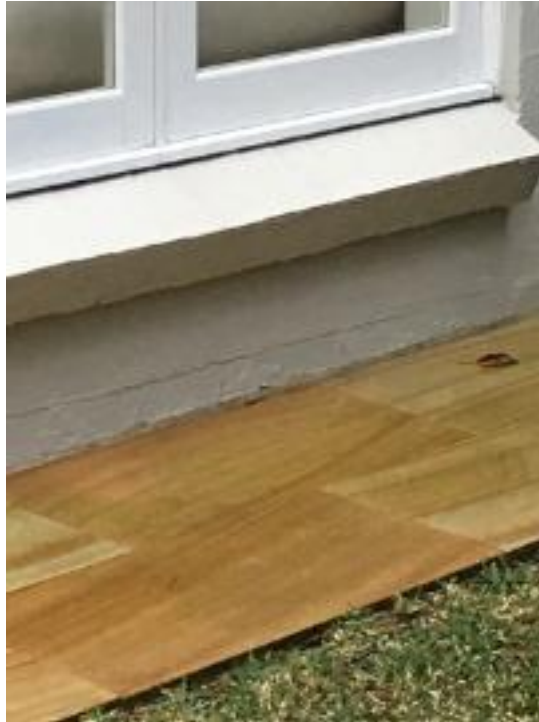
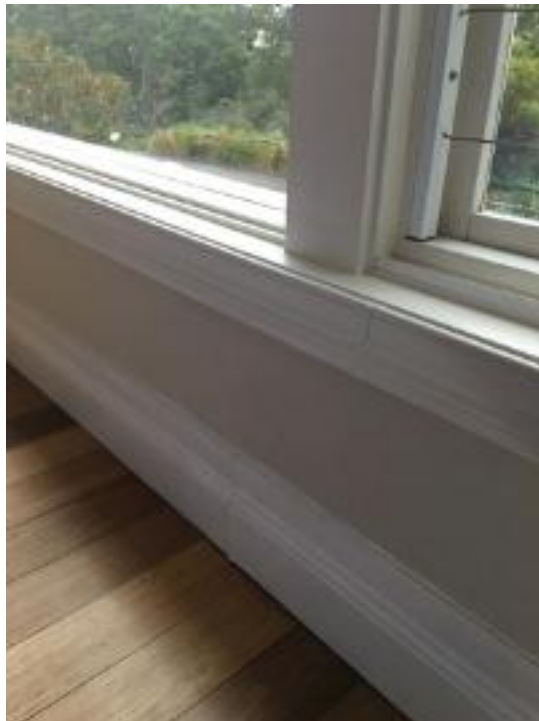
Minor cracks in the render and timber skirting plus the window frames / architraves

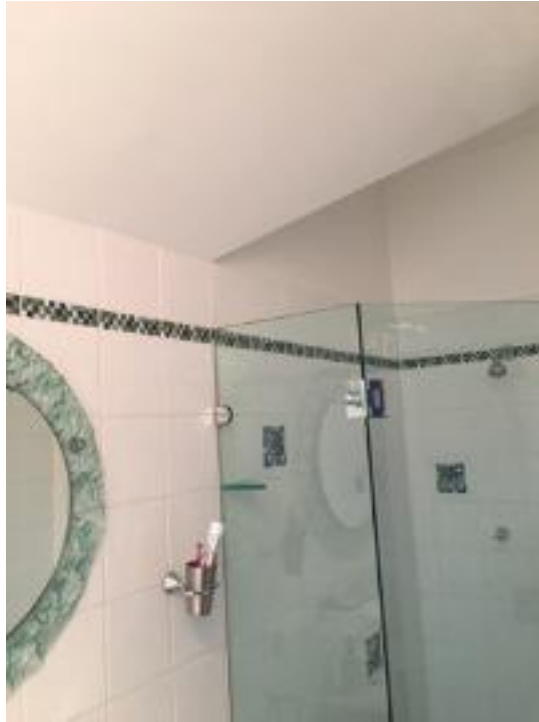
Hairline cracks in the wall tiles above the shower cubicle

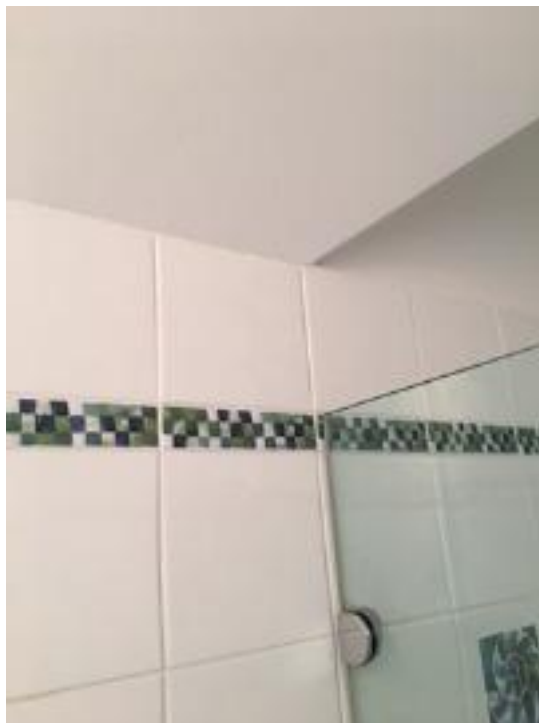
Wall and ceiling junctions within the bathroom have existing hairline cracks within the internal junction

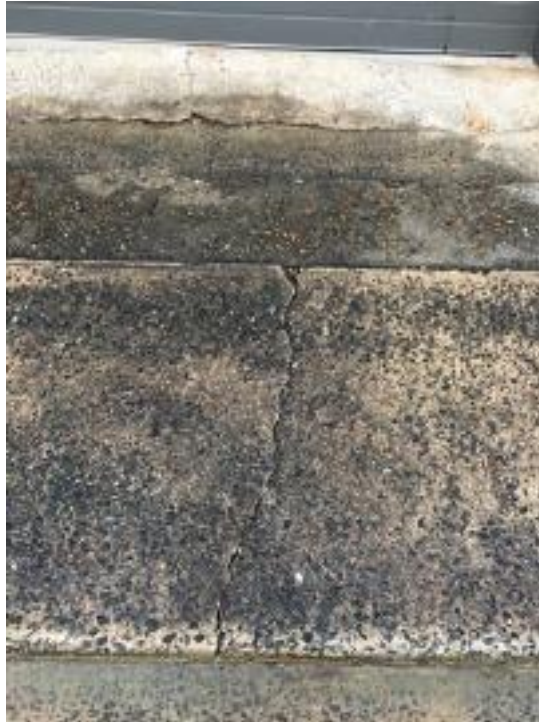
Cracks in the concrete layback and footpath

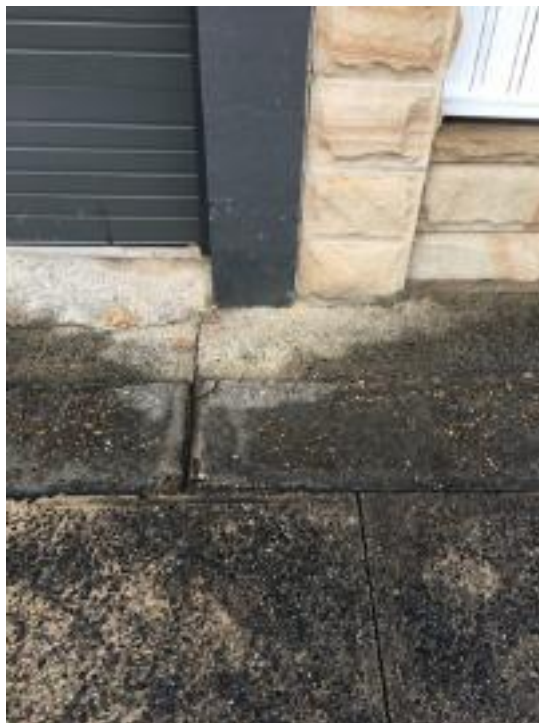
Footpath has excessive cracks within the old and new concrete footpaths

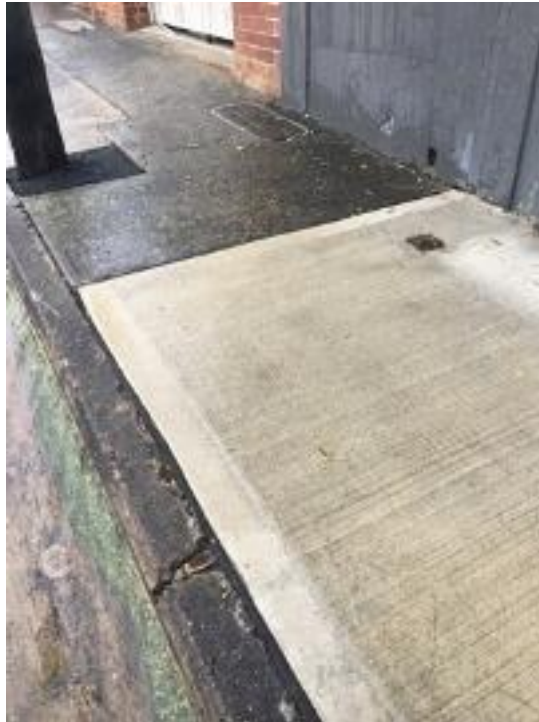
The curb and gutter are defective / cracked
