Dilapidation Report For The Development At: 40 Sunrise Road Palm Beach NSW 2108

Dilapidation Report Carried Out On:

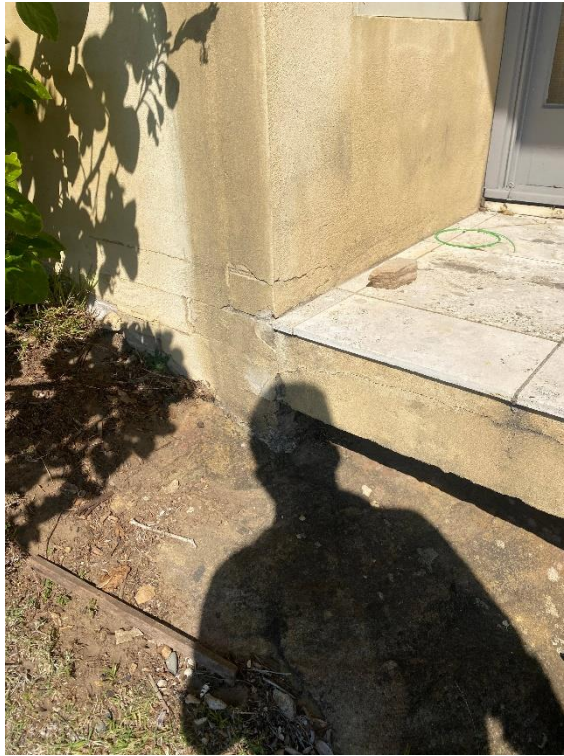
Minor hairline cracks in the external renderd walls.

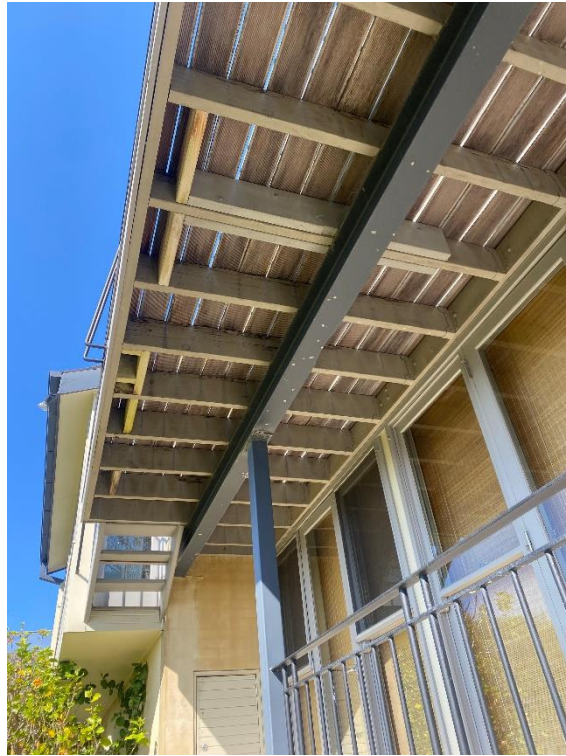
Deterioration within the timber floor joists in the back veranda.

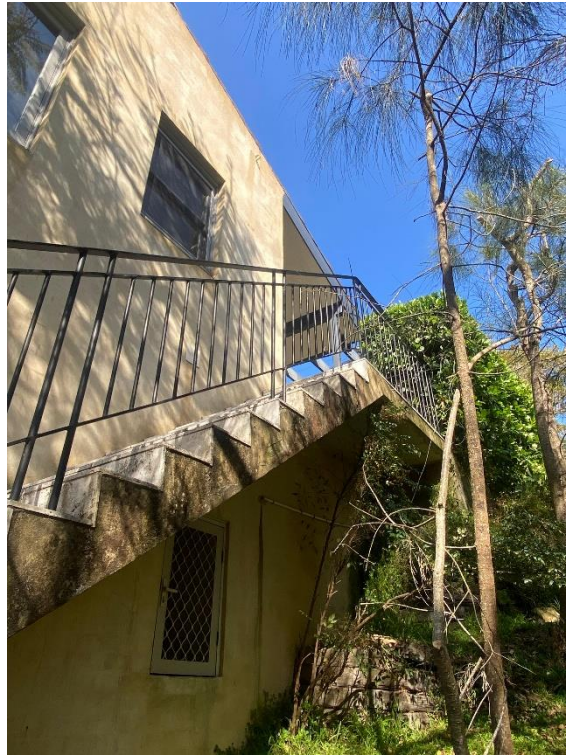
Cracks within the suspended concrete slab staircase / render.

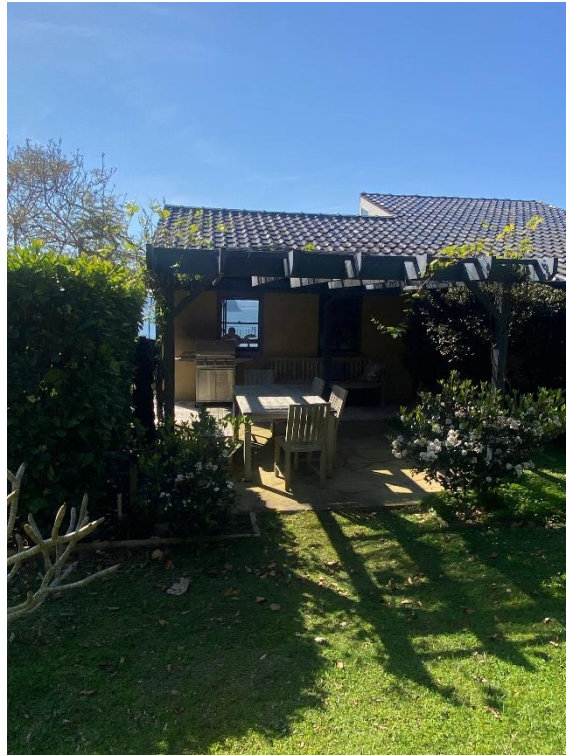
Hailrine cracks within the concrete pathway and external floor tiles.

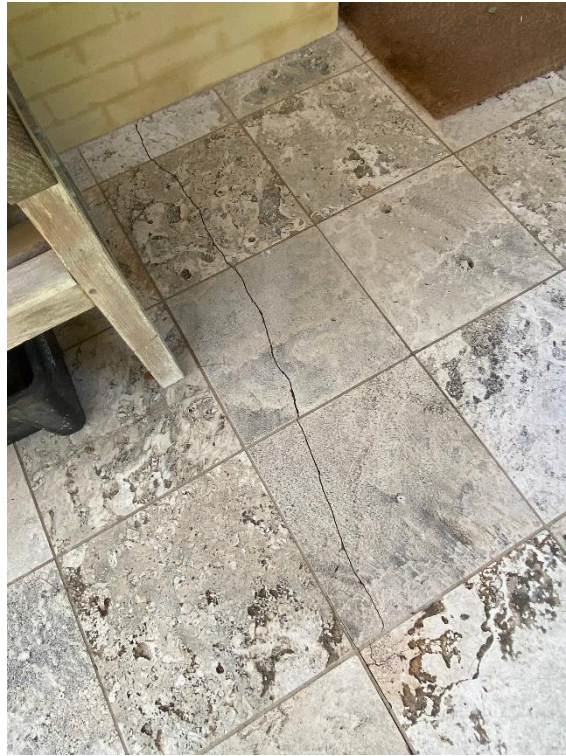
Hailrine cracks within the concrete pathway and external floor tiles.

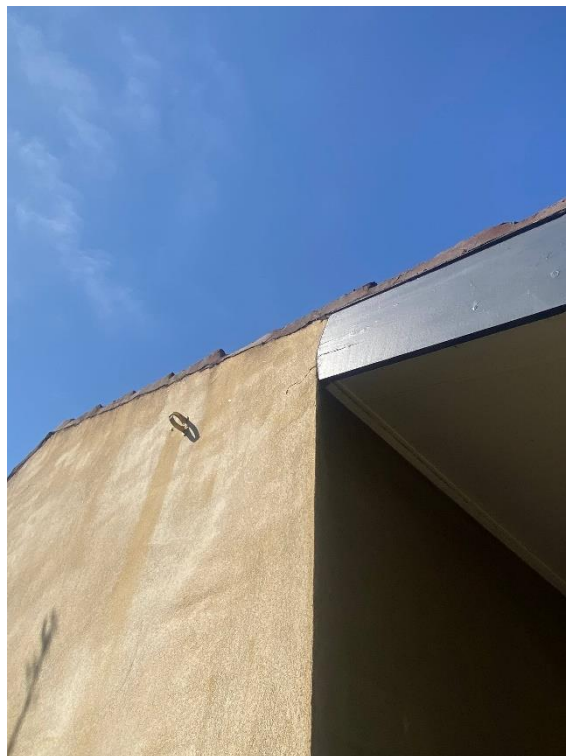
External render shows minor crazed cracking.

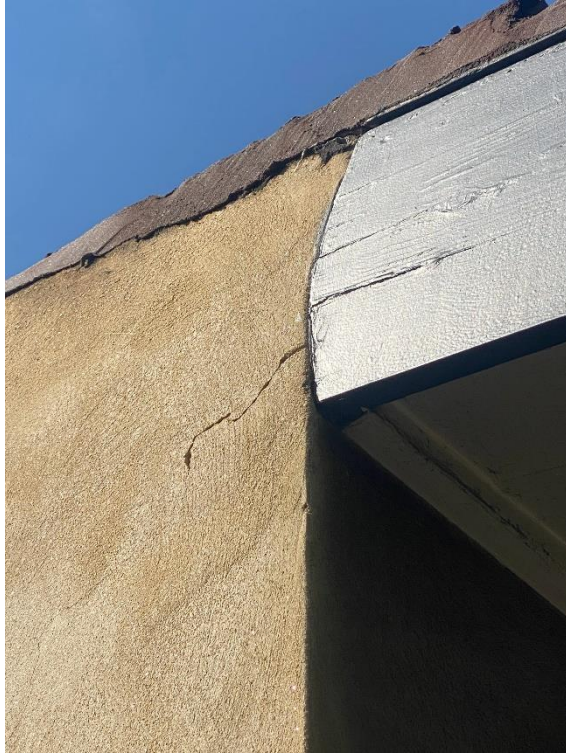
External render shows minor crazed cracking.

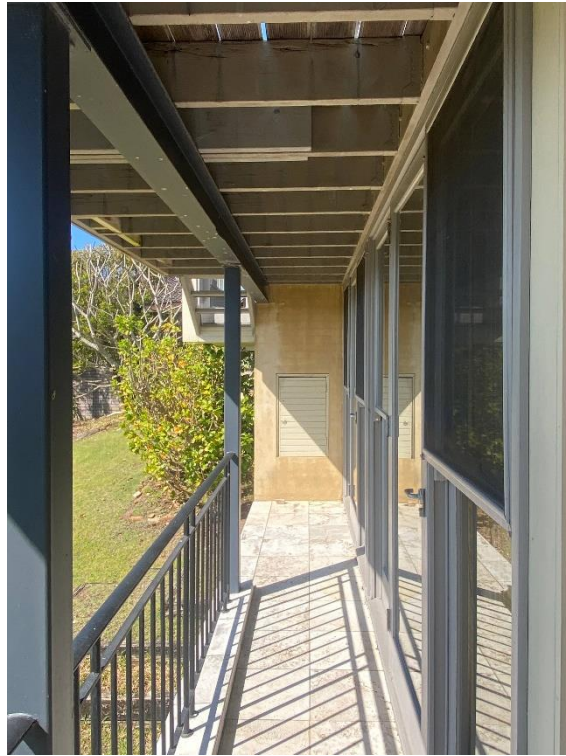
Veranda wall has horizontal cracks within the brickwork / bagging.

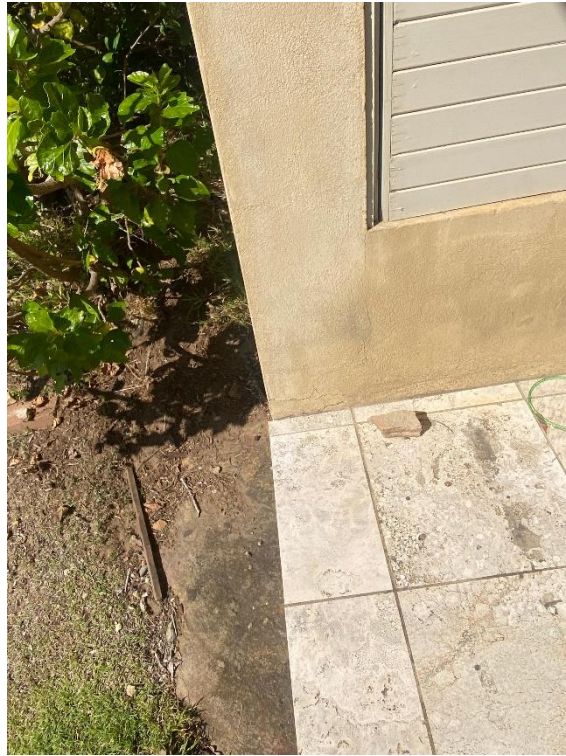
Horizontal cracks at the base of the wall and wall junction together with hairline cracks within the floor tiles.

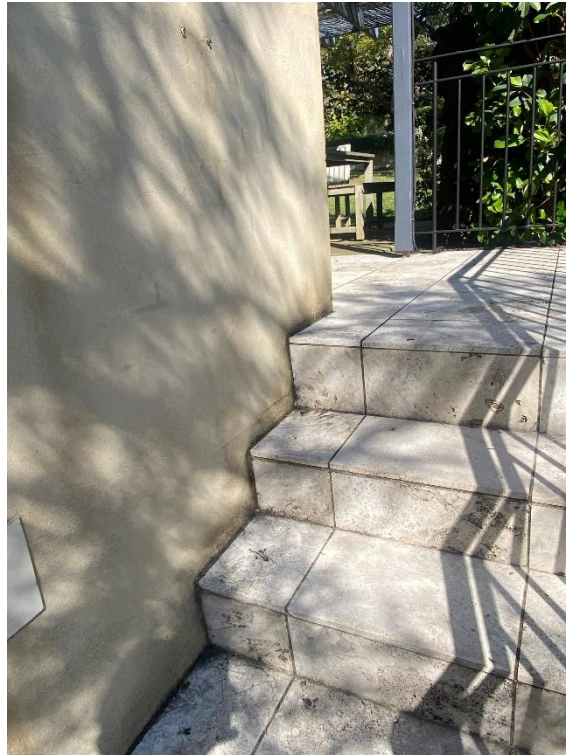
Minor cracks seen within the external rendered walls adjacent to the stairs.

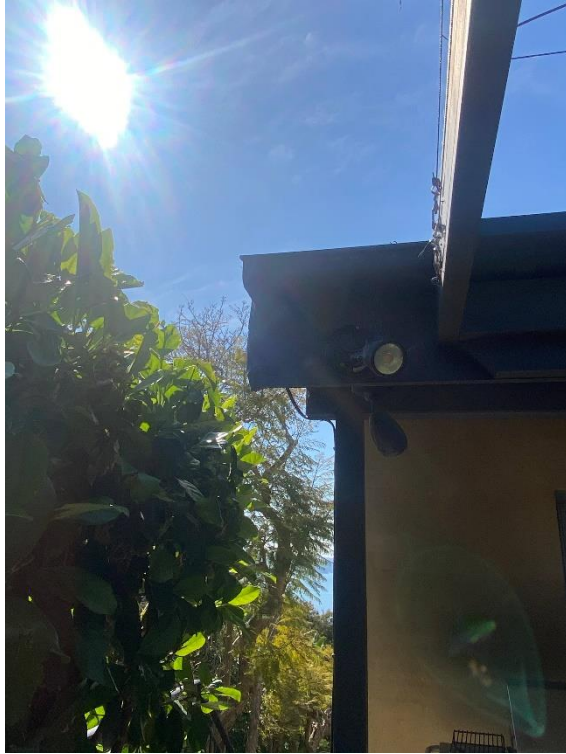
Wood rot and decay within the timber fascia boards.

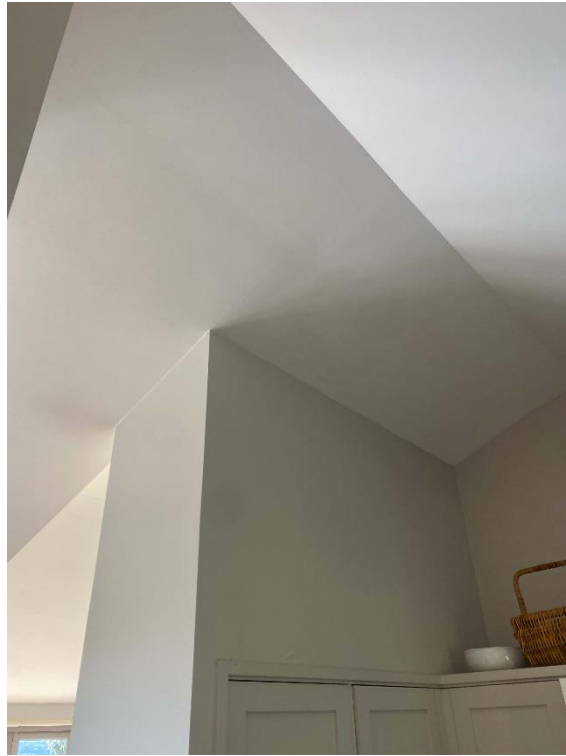
Minor cracks within the internal entry foyer and adjacent to the kitchen.

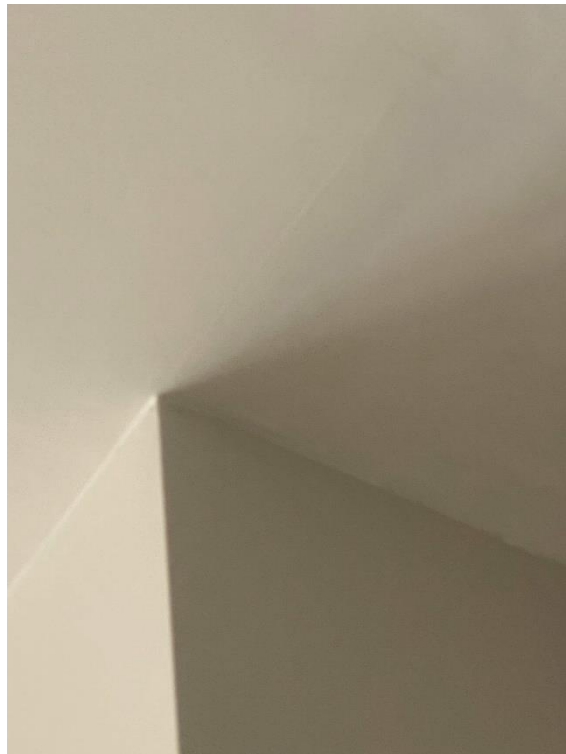
Minor hairline cracks within the plasterboard ceiling within the entry foyer.

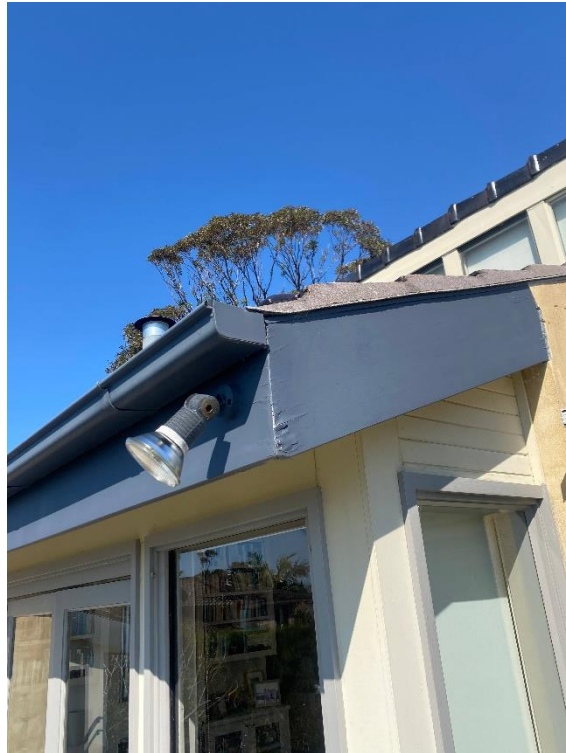
Wood rot within the timber fascia boards and timber bargeboards on the back veranda.

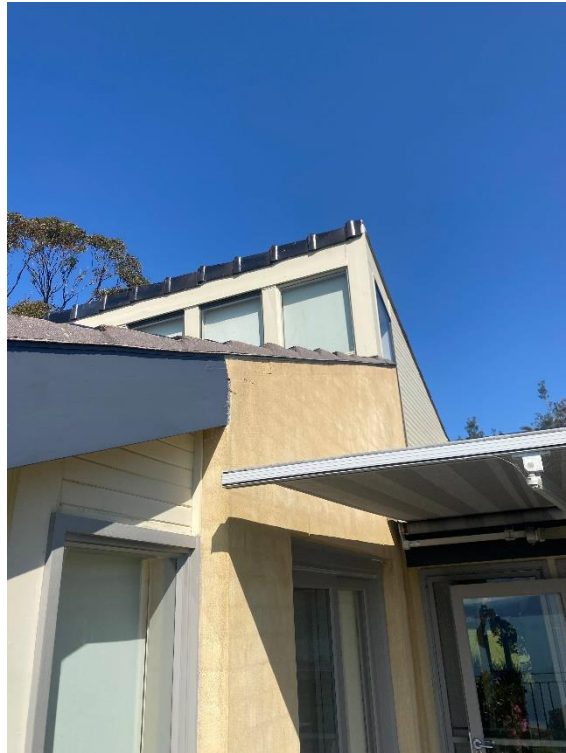
Cracks within the brickwork and render just beneath the cement sparging of the roof tiles.

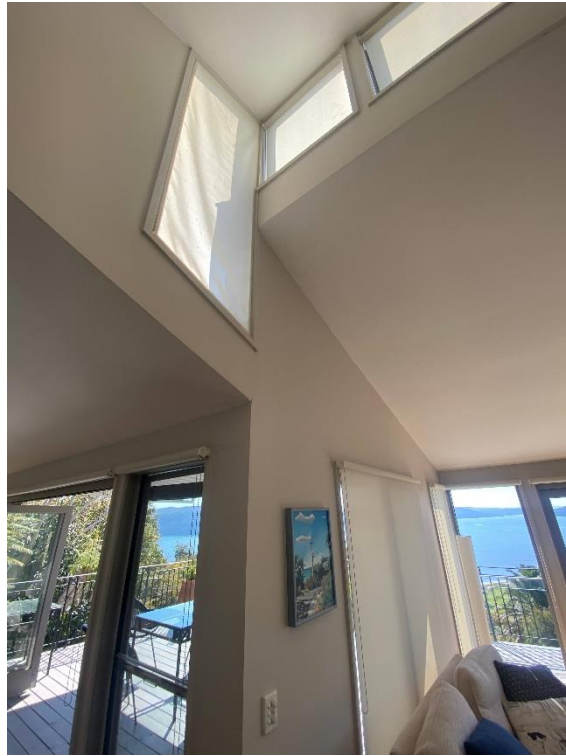
Living room walls have minor horizontal and vertical cracks adjacent to the window.

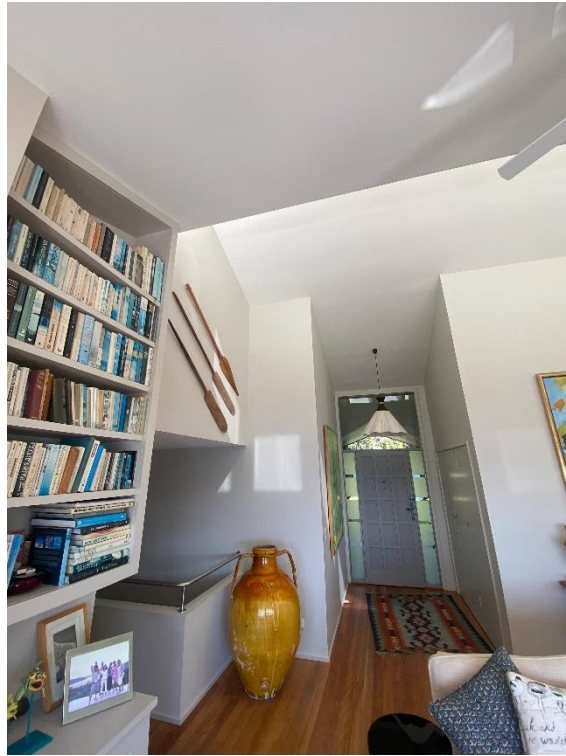
Living room wall and ceiling junction has horizontal cracks within the plasterboard.

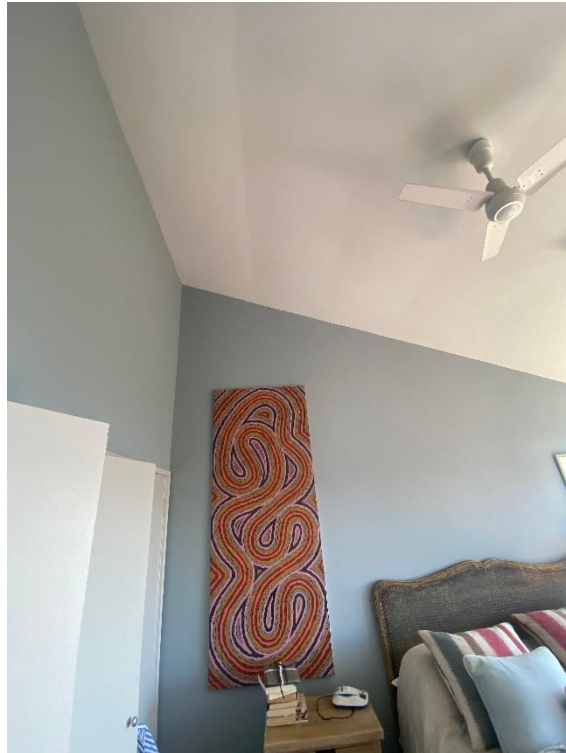
Bedroom ceiling and wall junction has minor horizontal / splayed cracking between the two materials.

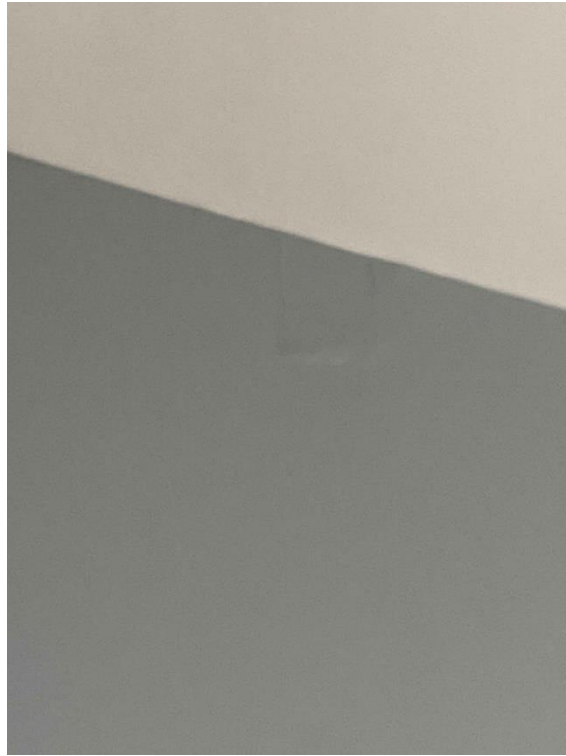
Bedroom ceiling and wall junction has minor horizontal / splayed cracking between the two materials.

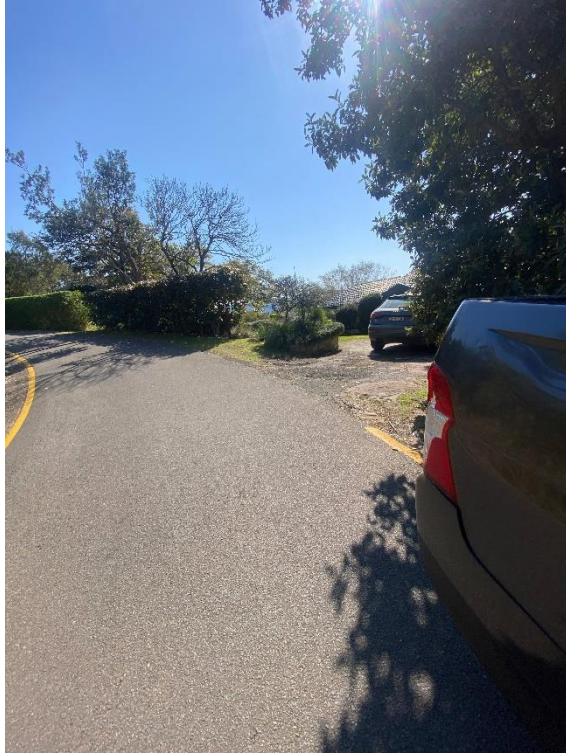
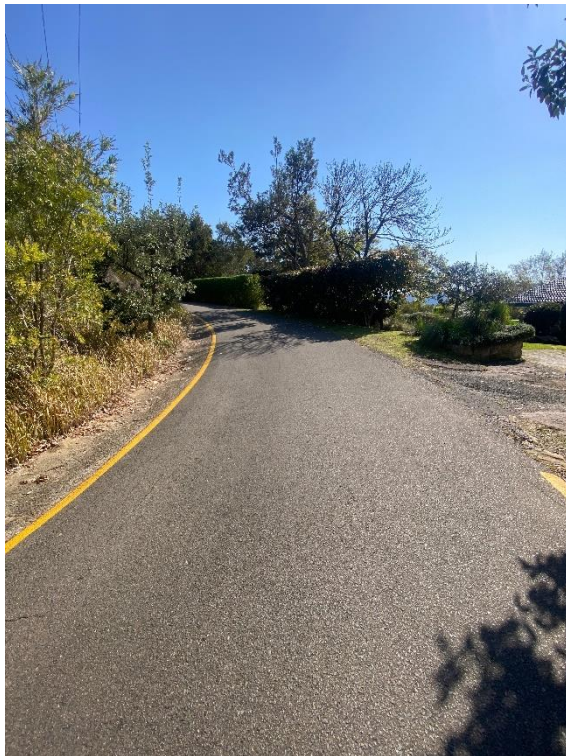
No defects seen within the road, note, no curb & gutter.

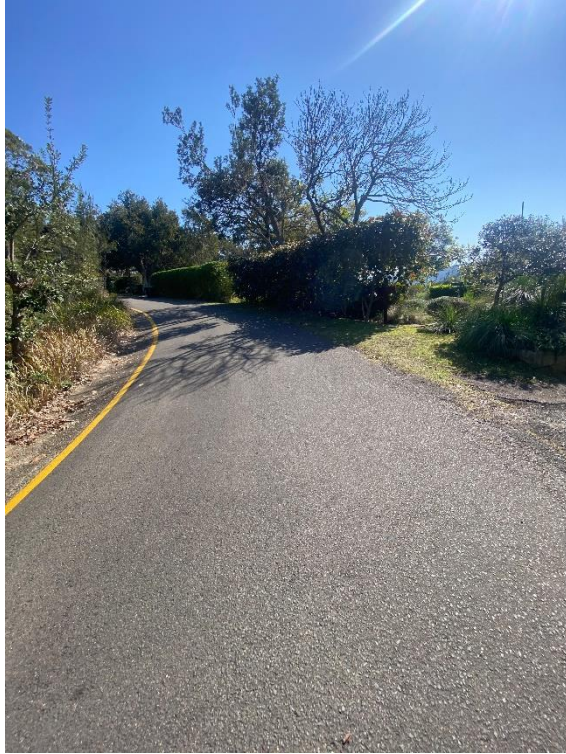
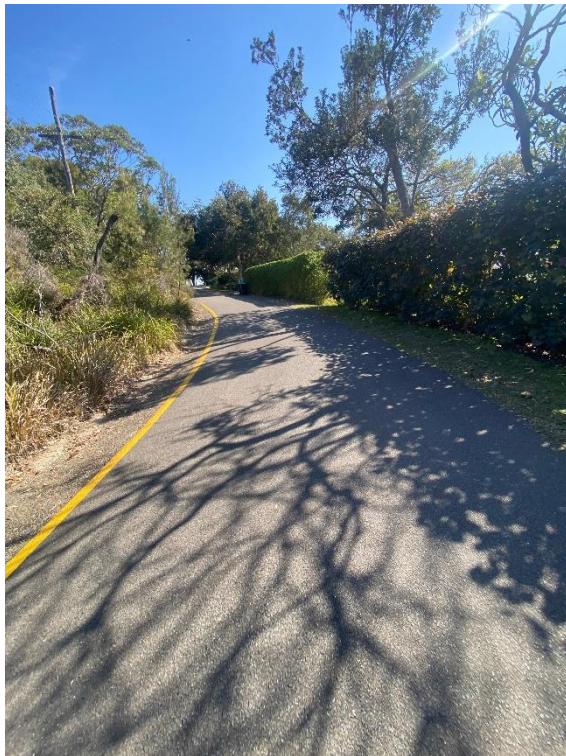
No defects seen within the road, note, no curb & gutter.

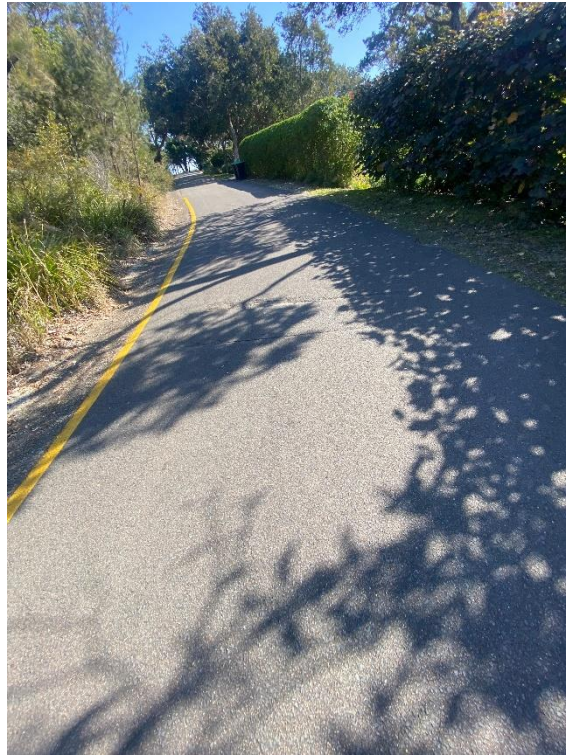
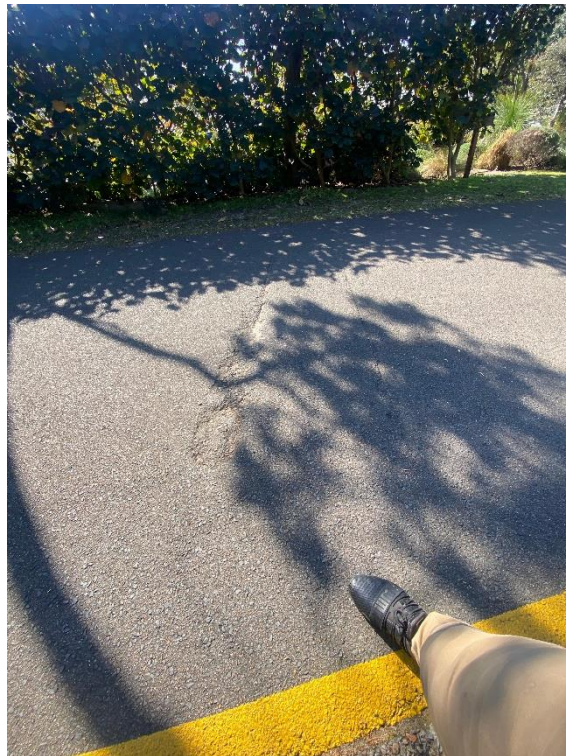
Cracks within the concrete / bitumen road in front of the proposed development site.

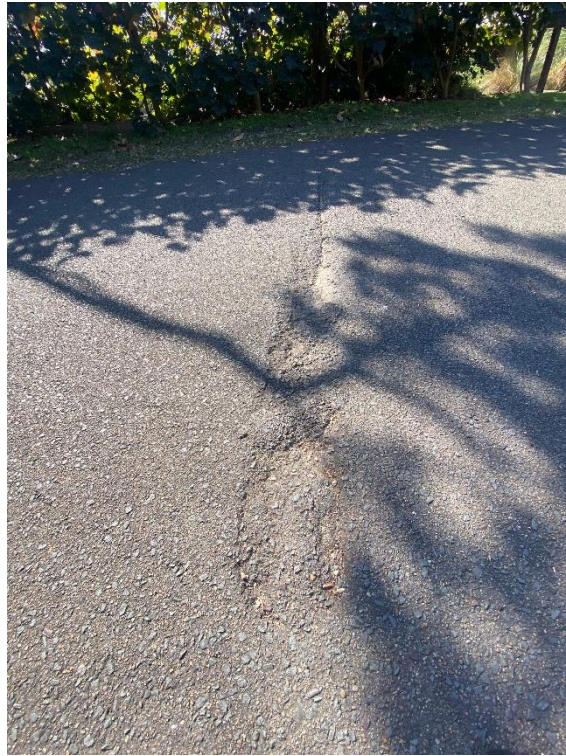
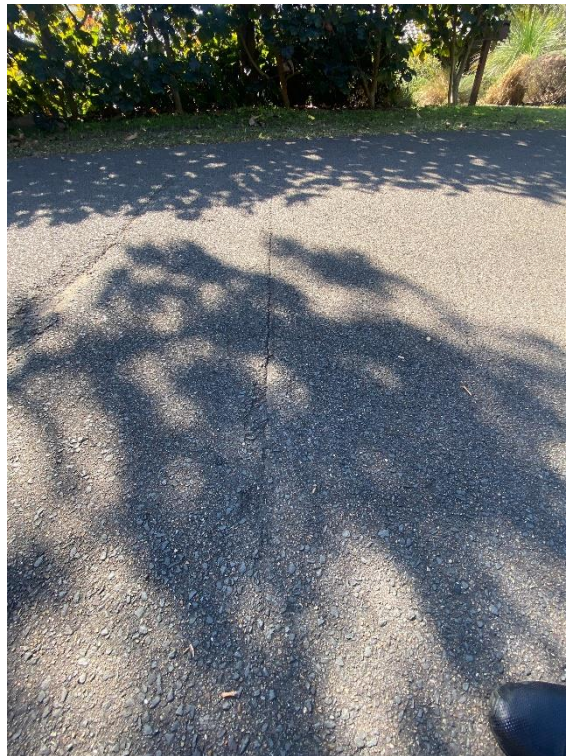
Cracks within the concrete / bitumen road in front of the proposed development site.

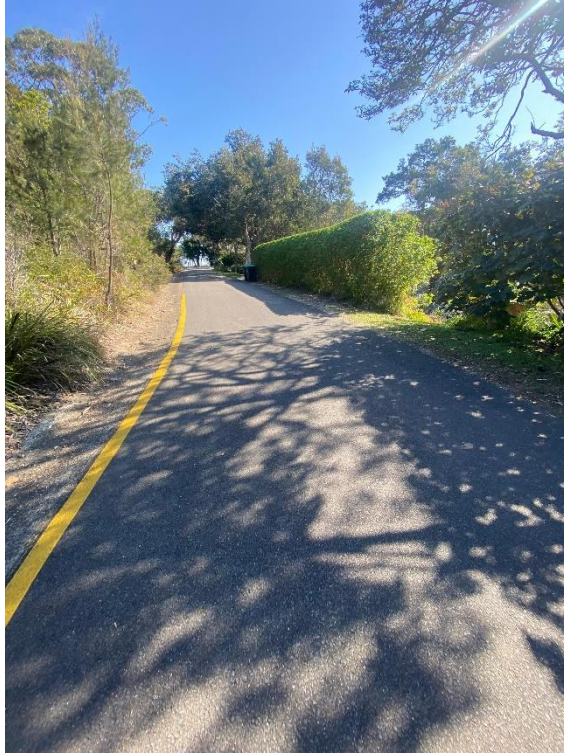
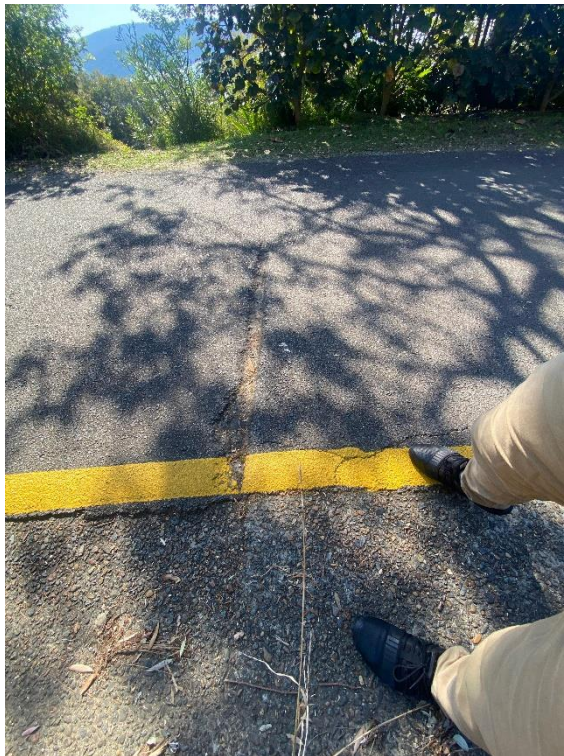
Cracks within the concrete / bitumen road in front of the proposed development site.

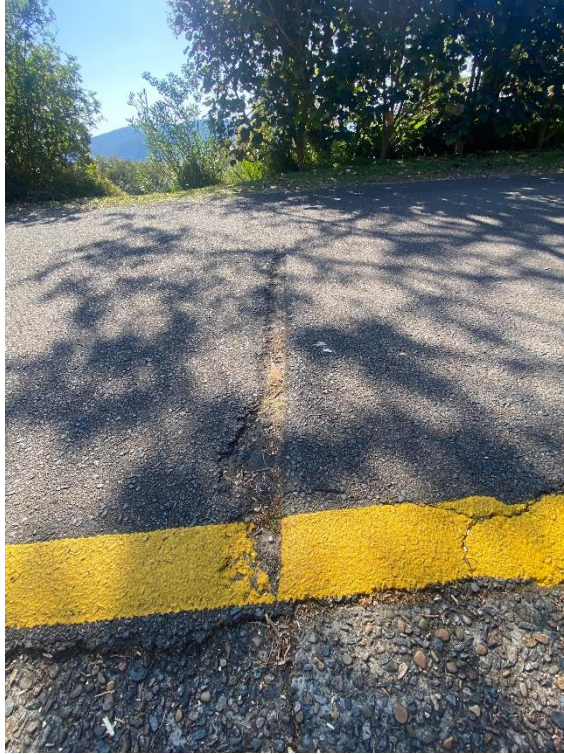
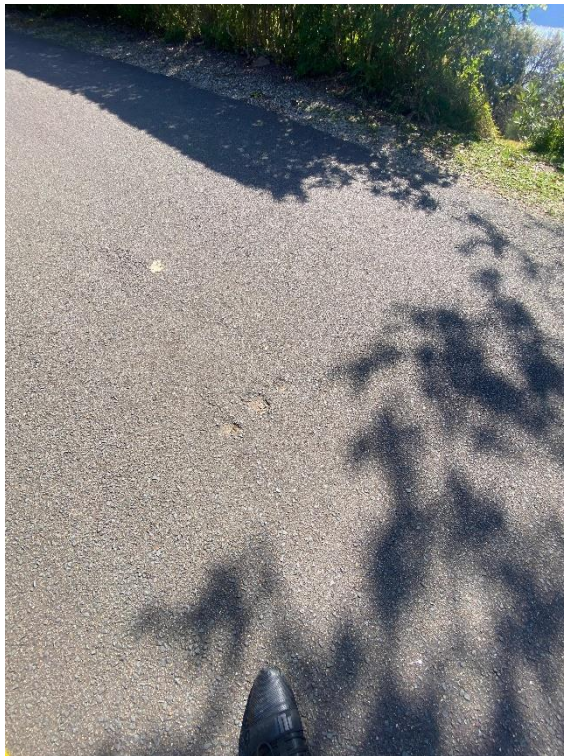
Cracks within the concrete / bitumen road in front of the proposed development site.

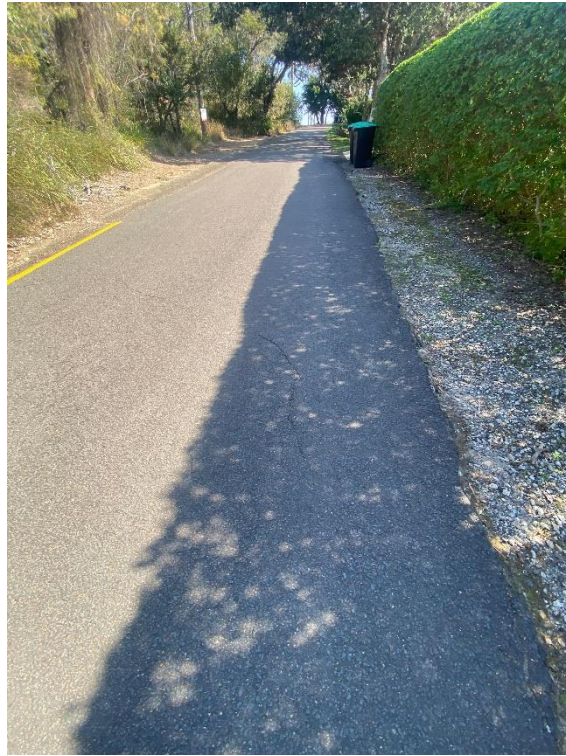
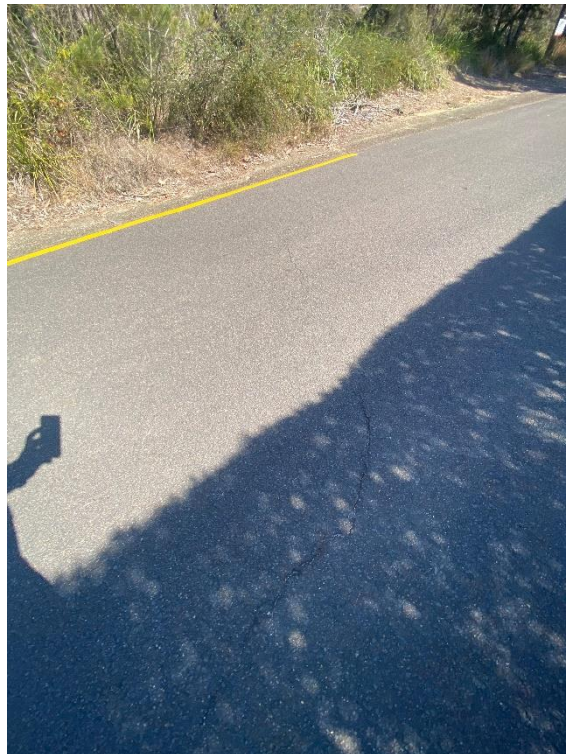
Cracks within the concrete / bitumen road in front of the proposed development site.

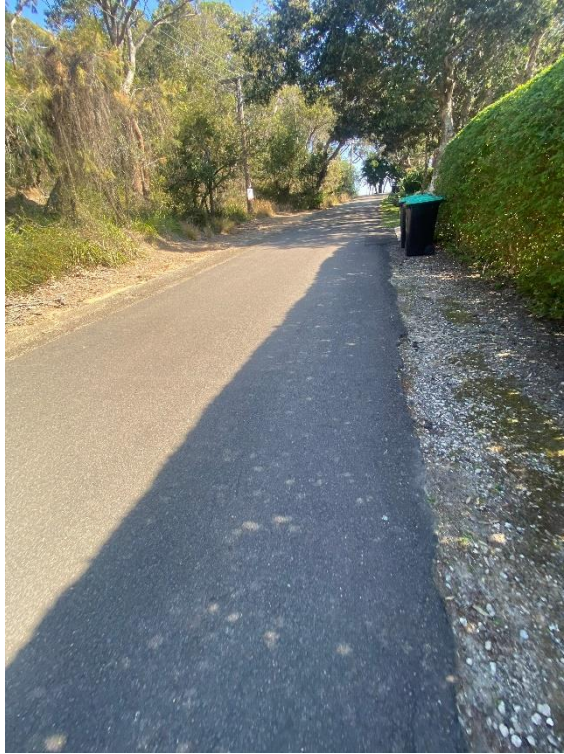
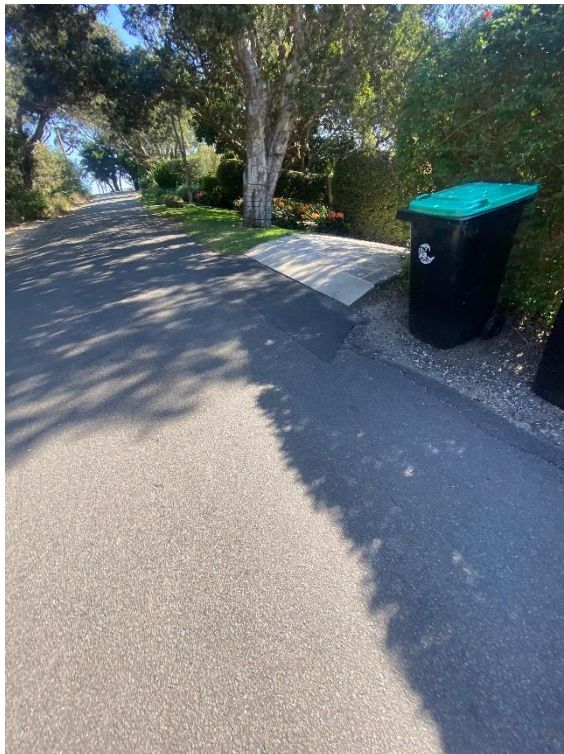
Condition of the road to the left of the building site, adjacent neighbour.

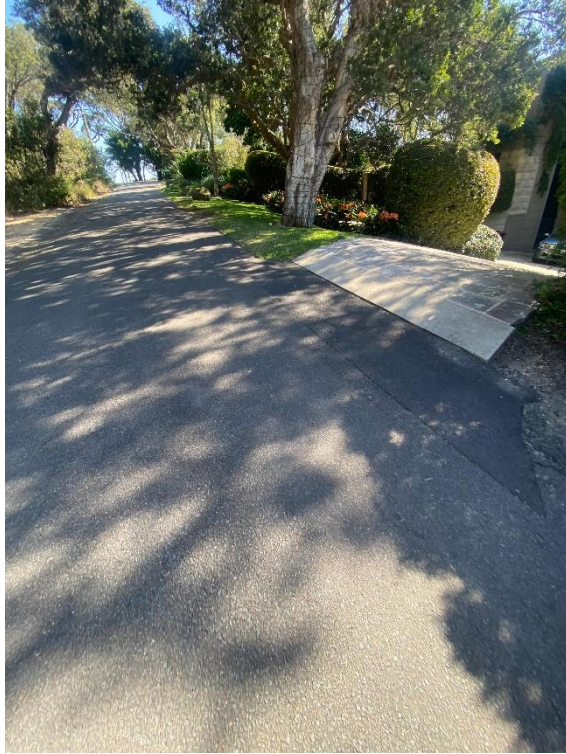
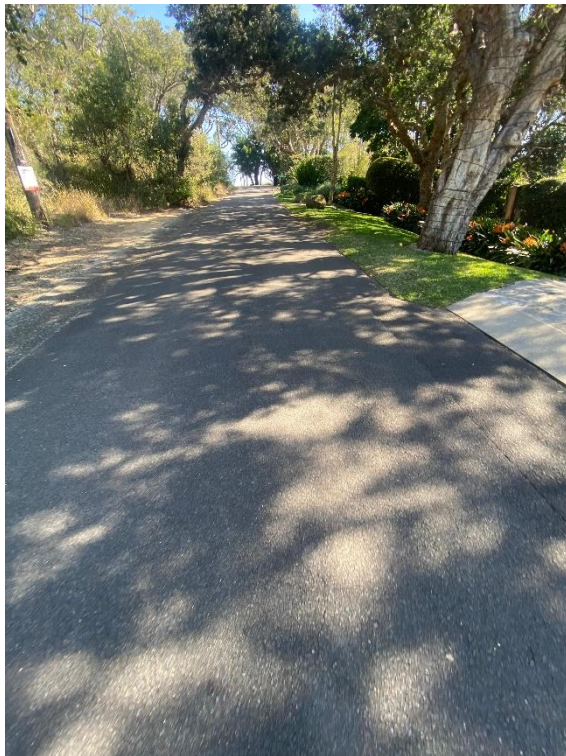
Minor cracking within the road.

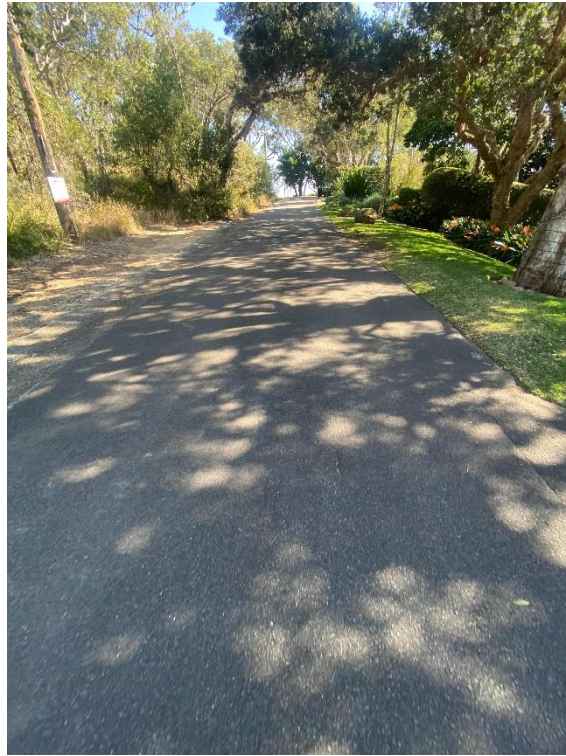
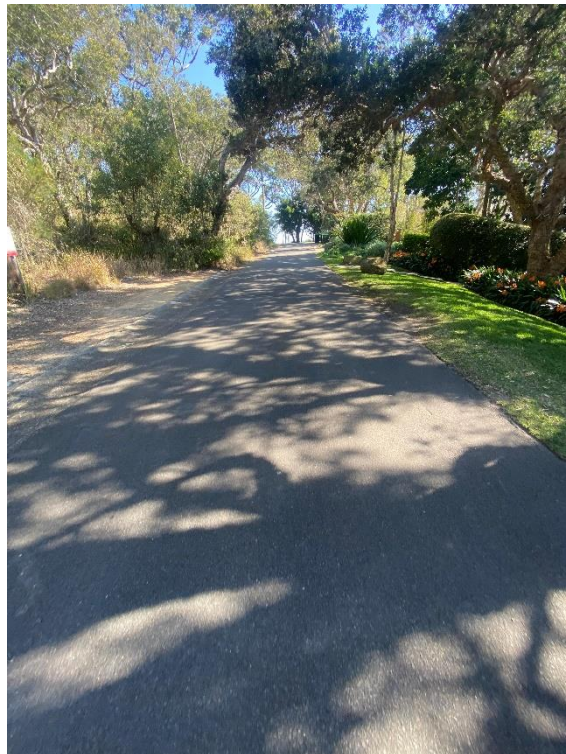
Minor cracks within the concrete / bitumen road.

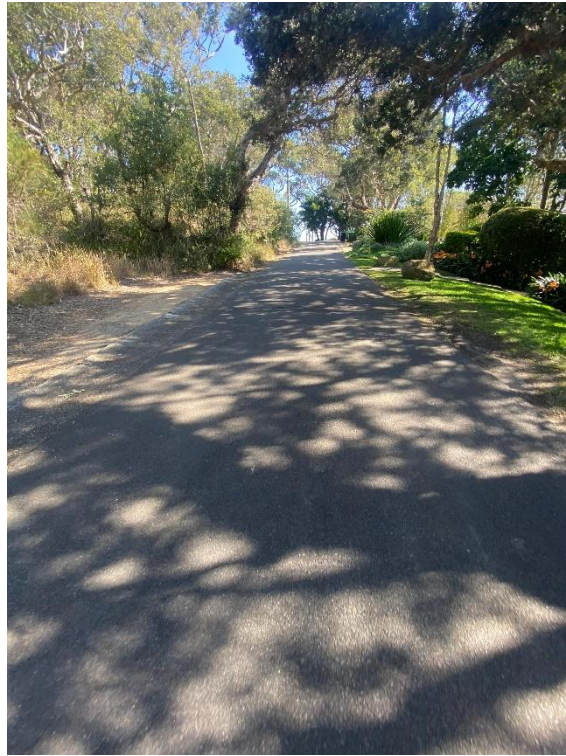
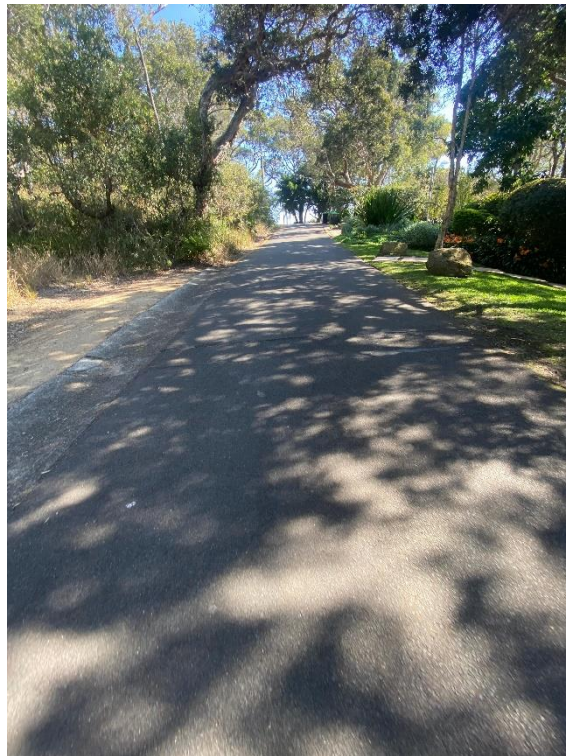
Minor cracks within the concrete / bitumen road.

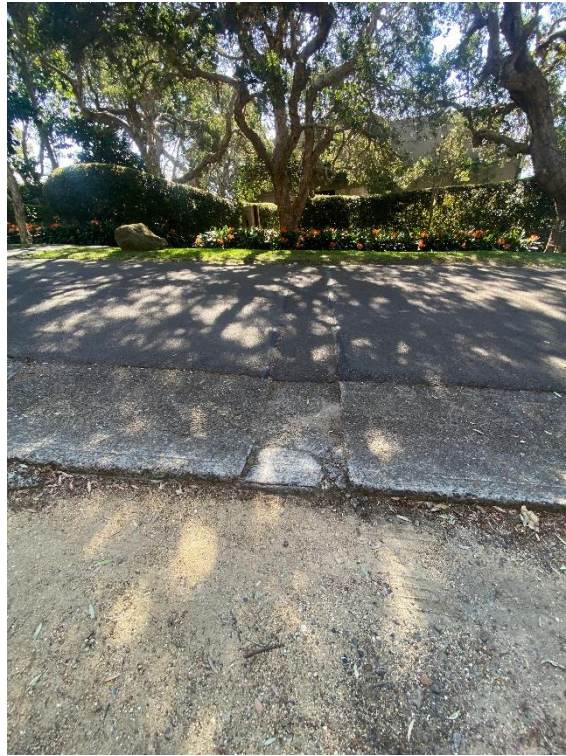
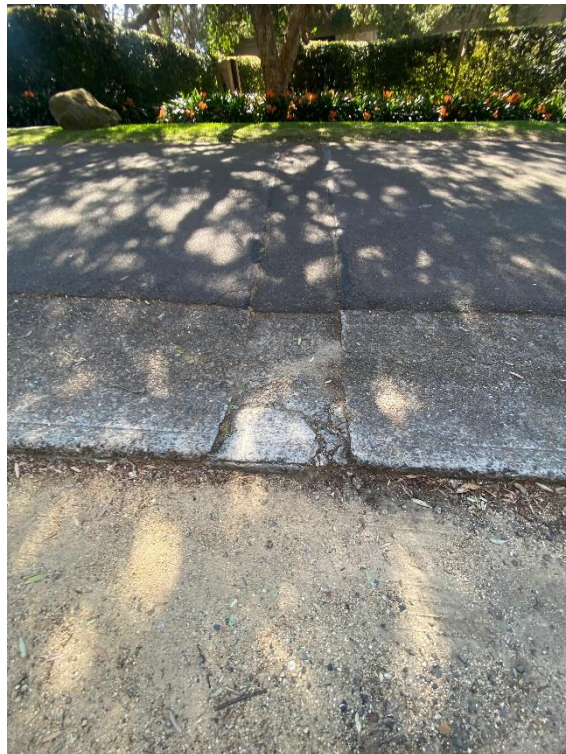
The road has had saw cuts and patchwork carried out in the past still visible in the current road curb & gutter.

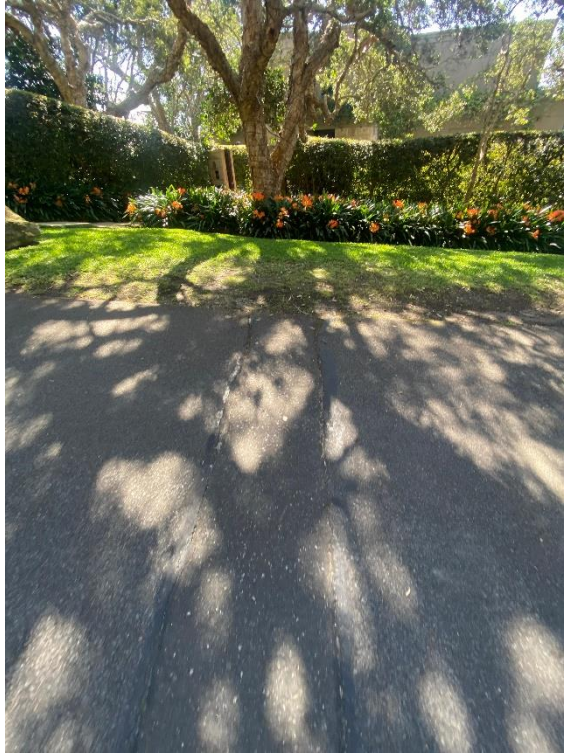
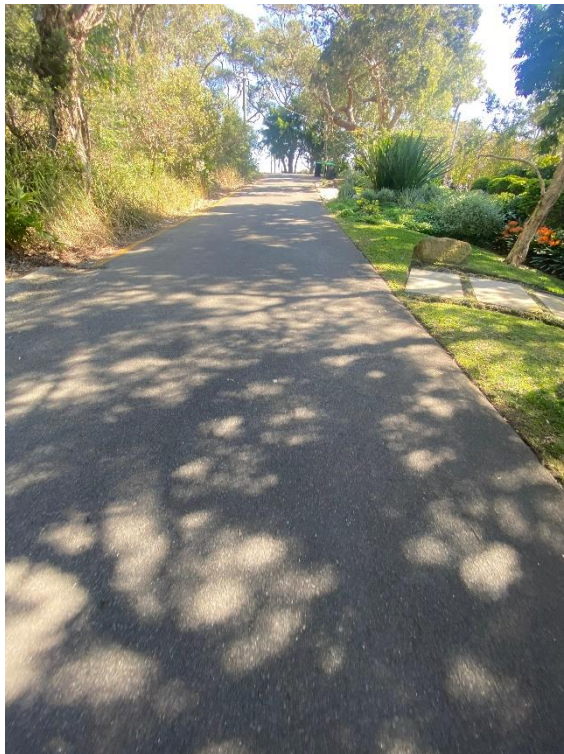
Road in good condition with no major cracks to report on.

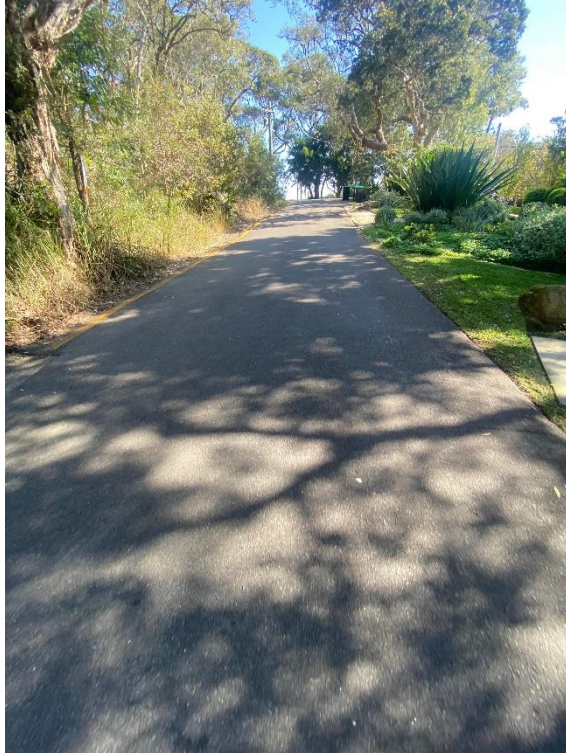
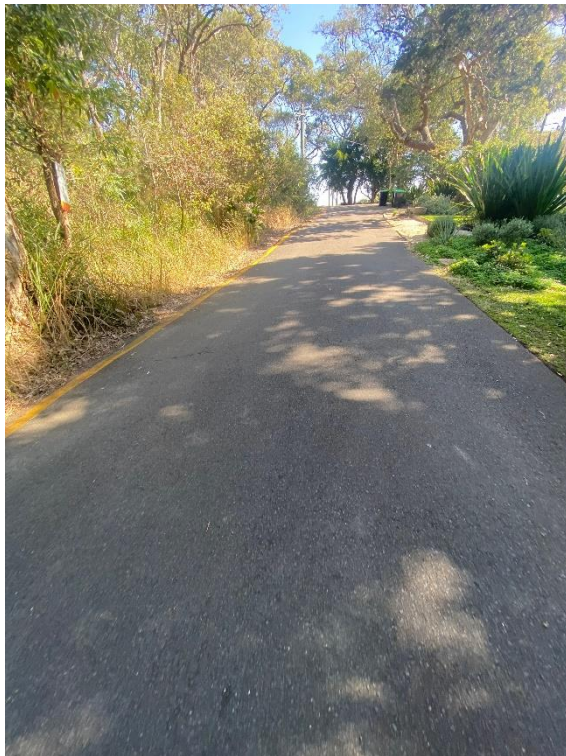
Road in good condition with no major cracks to report on.

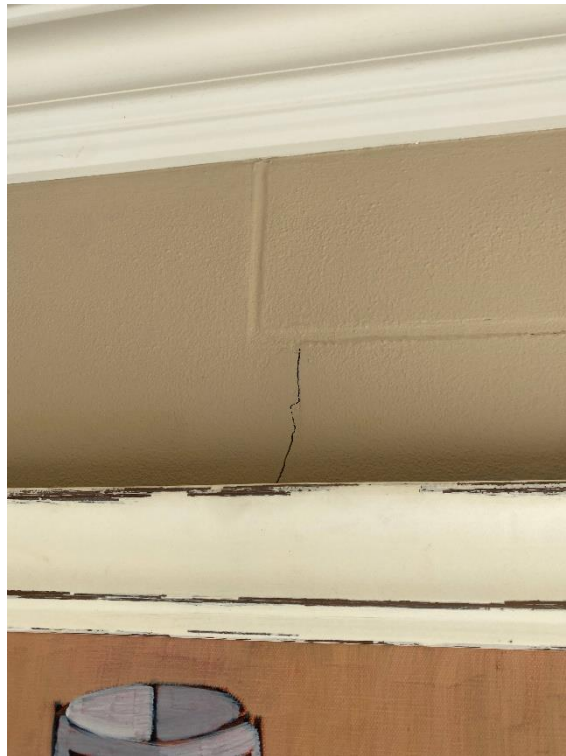
Minor cracks within the internal rendered walls beneath the cornices spanning behind the artwork.

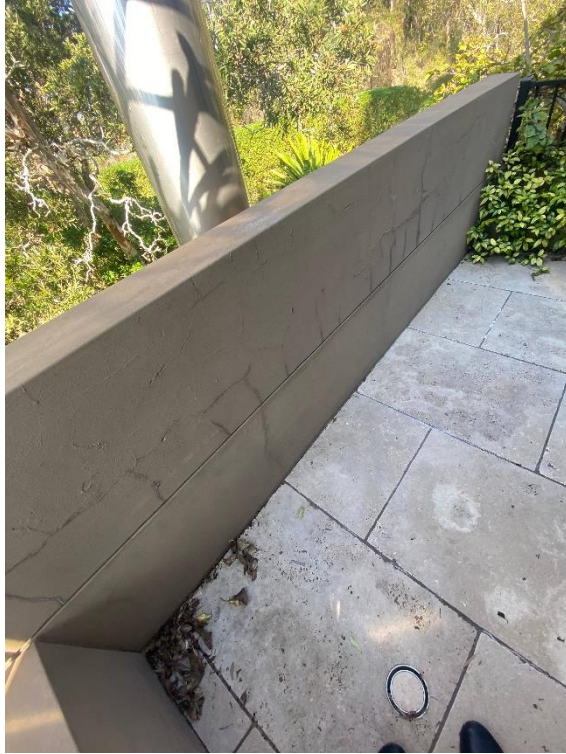
Outside veranda masonry walls have minor crazed cracking.

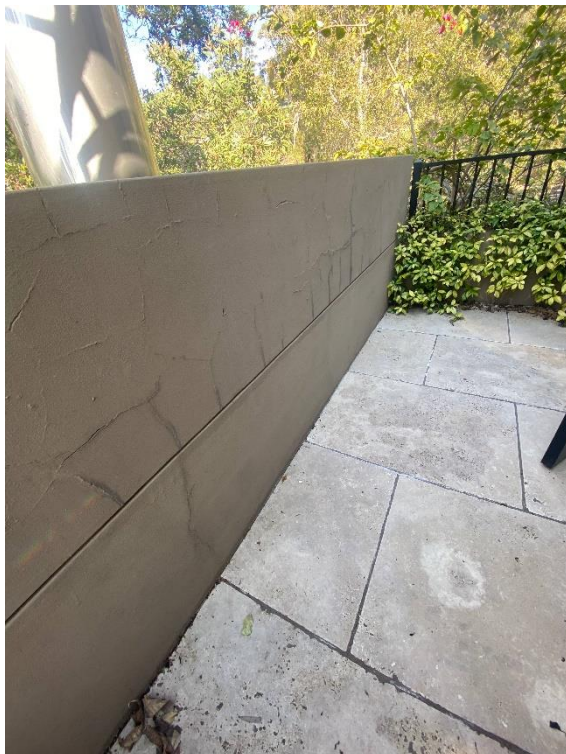
Outside veranda masonry walls have minor crazed cracking.

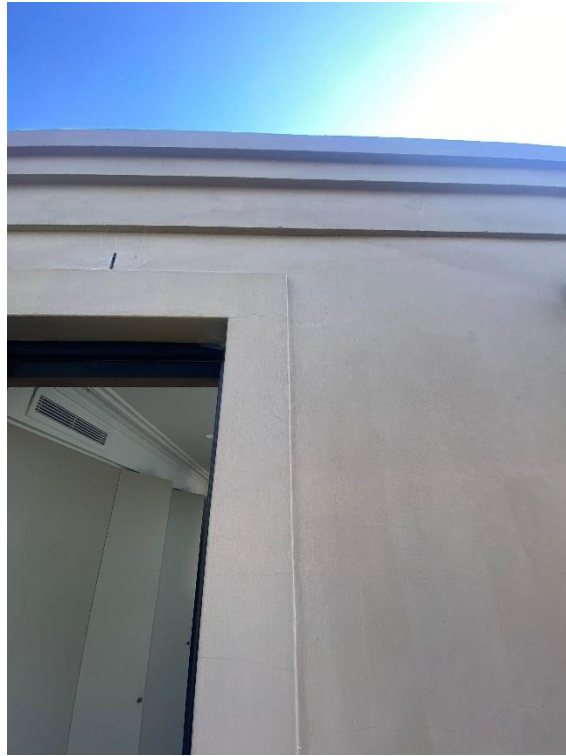
External walls of the home have minor hairline cracks within the right side external veranda.

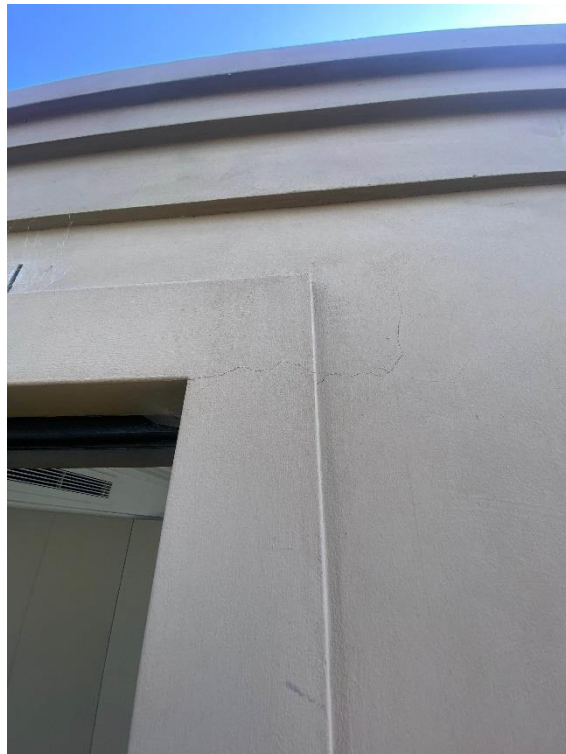
External walls of the home have minor hairline cracks within the right side external veranda.
