Dilapidation Report For The Development At: 40 Sunrise Road Palm Beach NSW 2108

Dilapidation Report Carried Out On:

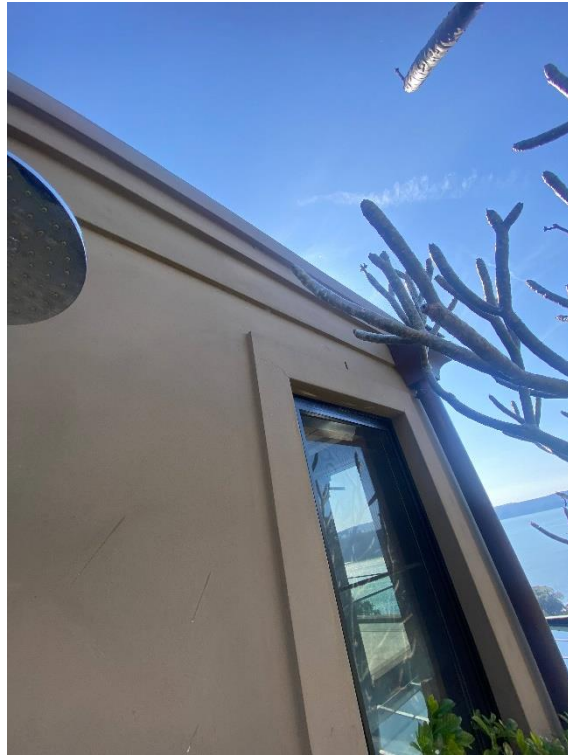
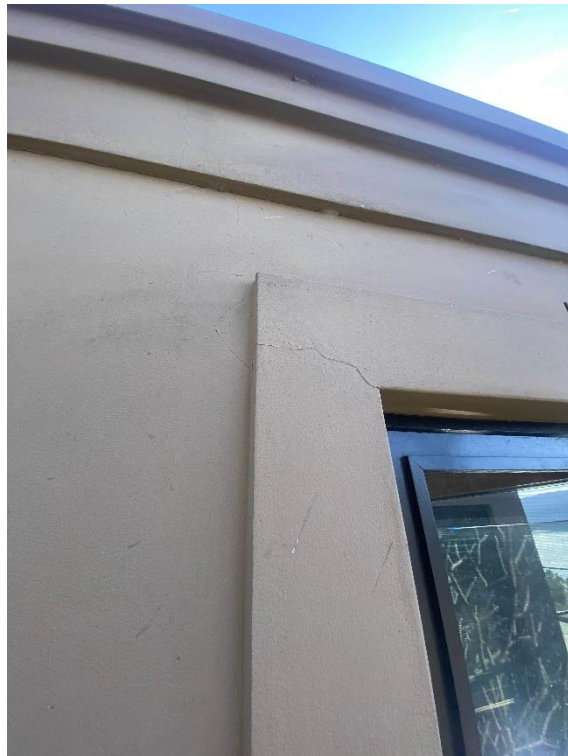
External walls of the home have minor hairline cracks within the right side external veranda.

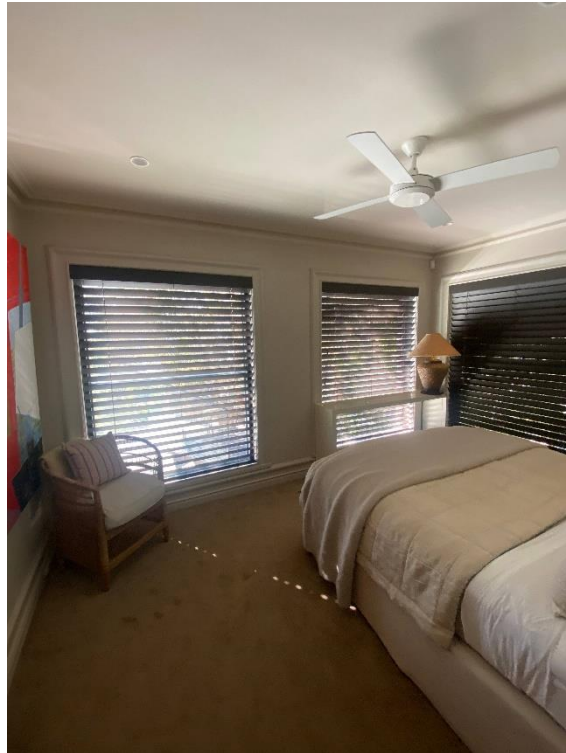
Internal bedroom has minor cracks within the rendered walls, I'm referring to the walls facing the rear of the property due north.

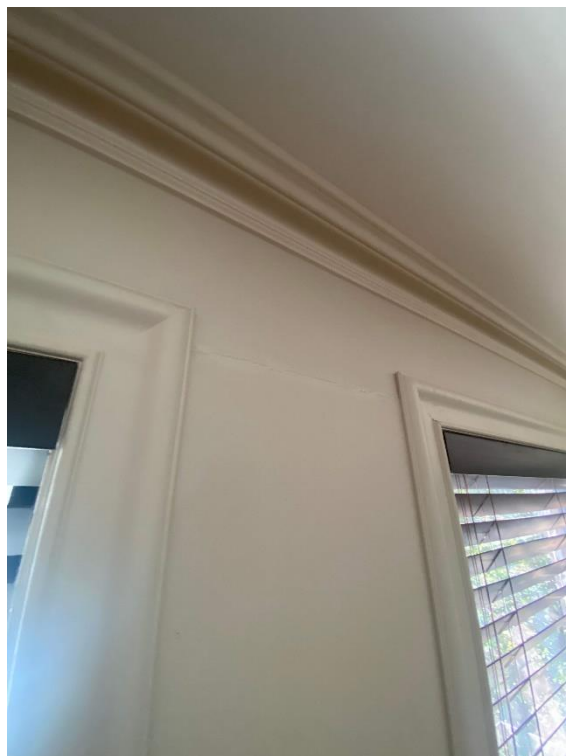
Minor horizontal cracks seen within the rendered walls between the windows.

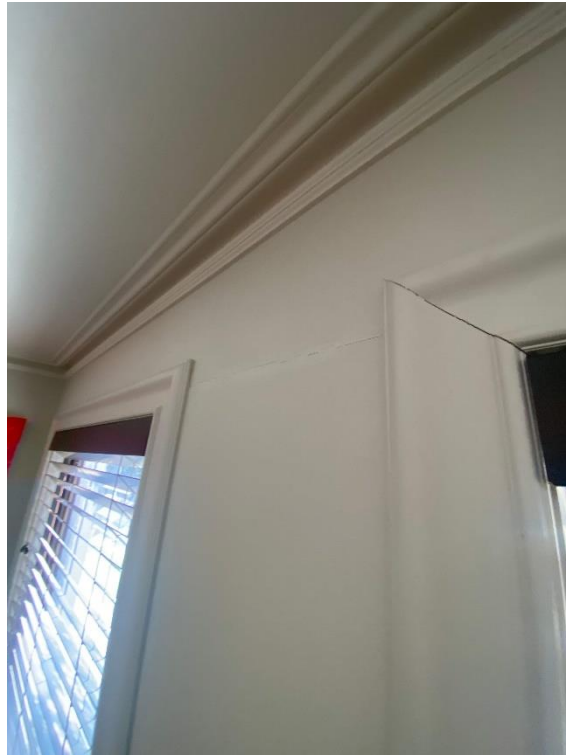
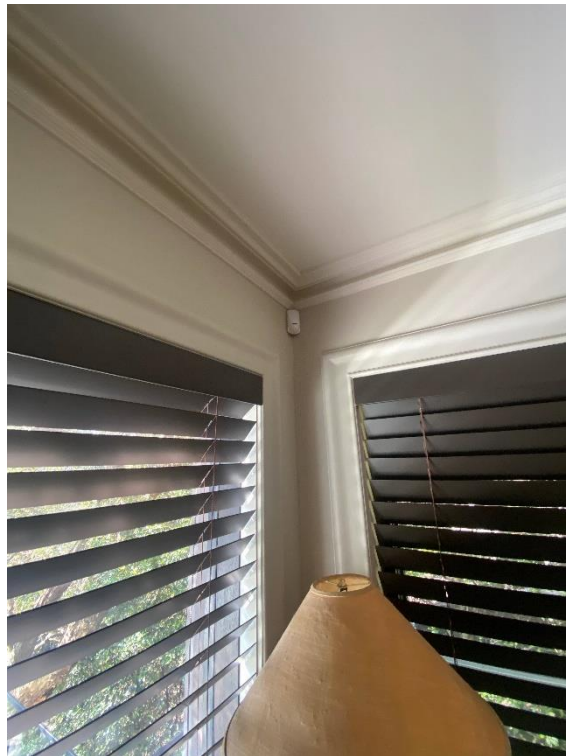
Minor cracks within the bedroom wall internal junction, running down the internal junction from the alarm sensor.

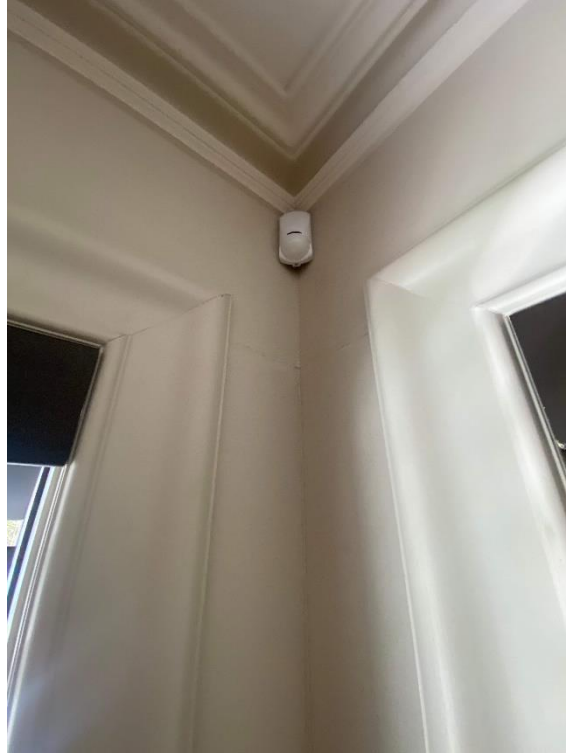
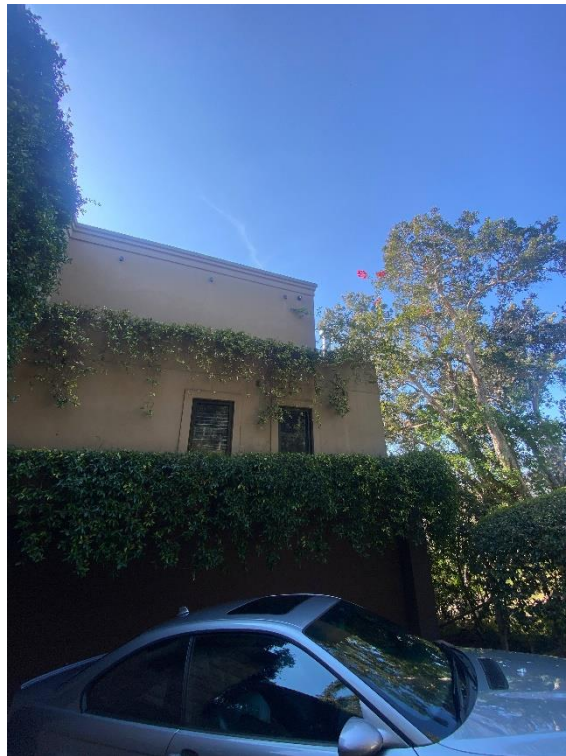
External front right corner masonry / rendered wall has a long splayed crack adjacent to the CCTV camera.

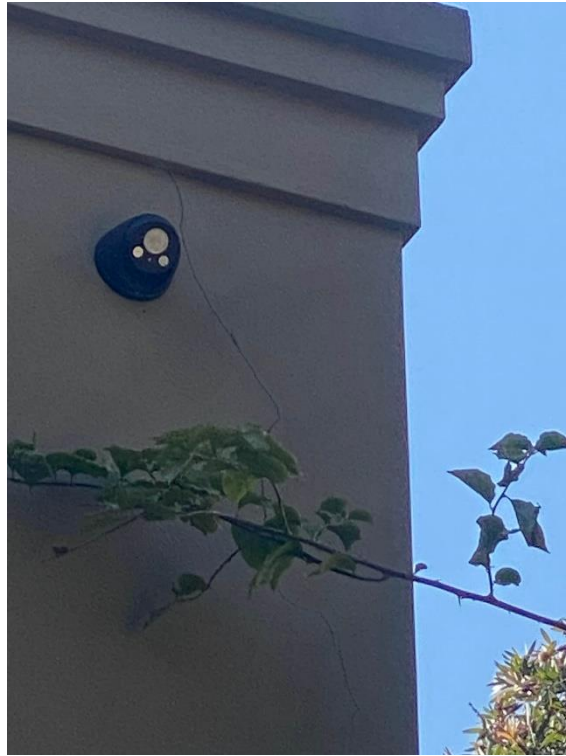
Please feel free to contact me on 0411 880 588 to discuss further.
