The Property Inspectors

Commercial Pre-Purchase Building Inspection Report

Client: Wyndham City Council
Property Address: 15-19 Station Place Werribee
Date of inspection: 02/11/2023

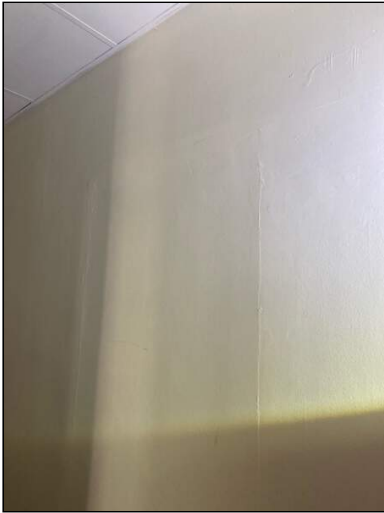
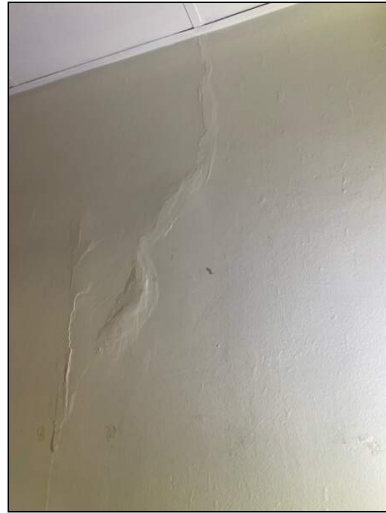
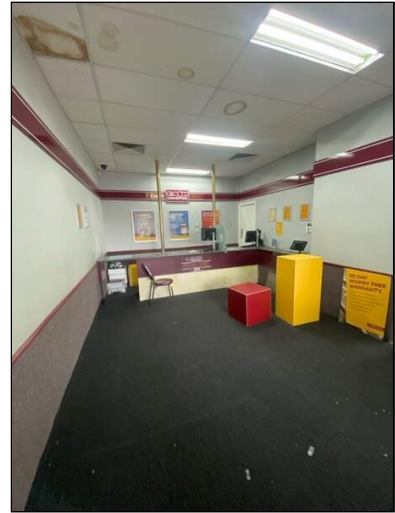
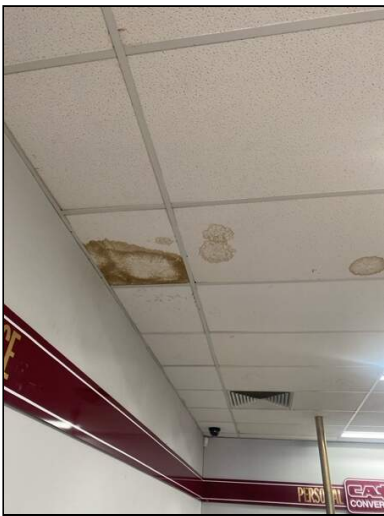
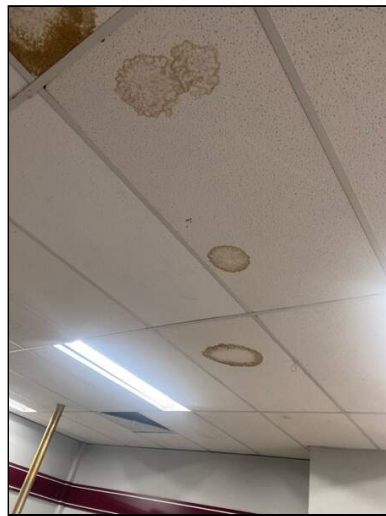
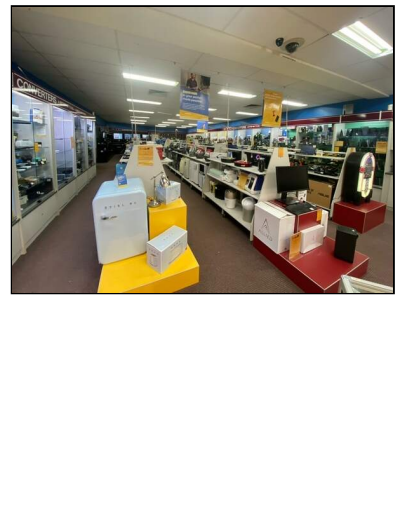
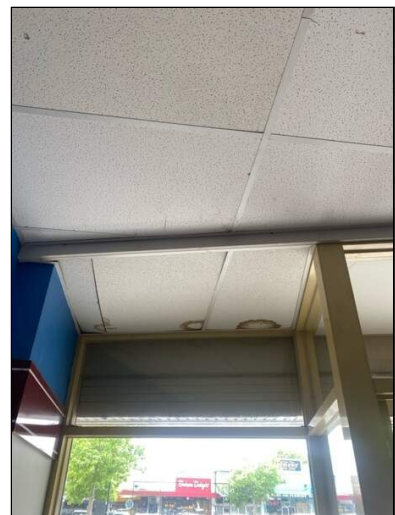
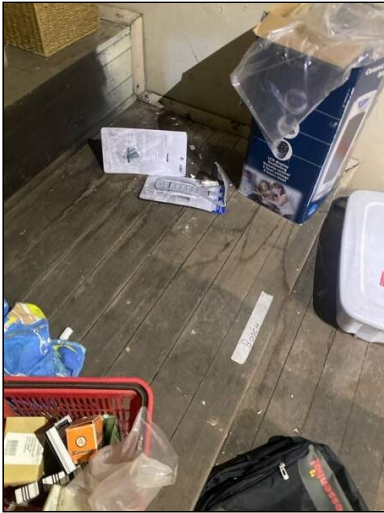
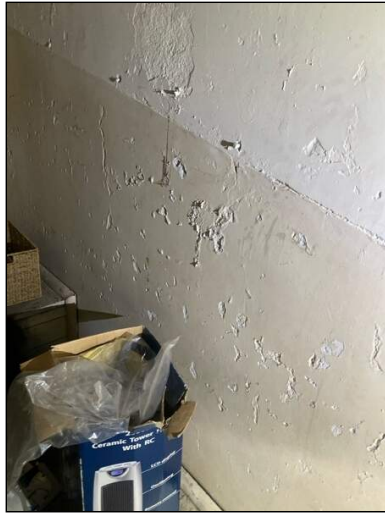
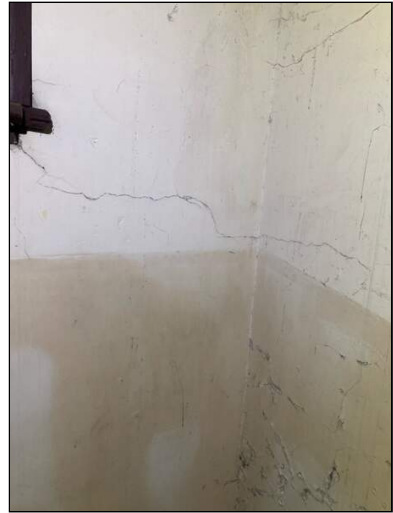
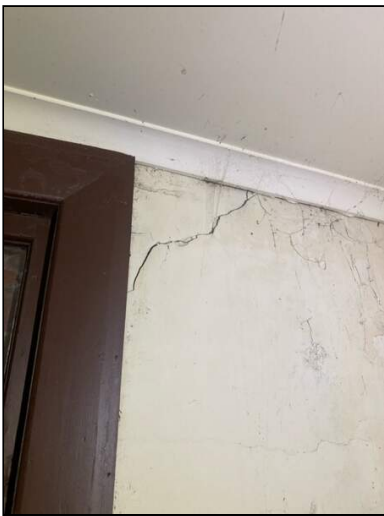
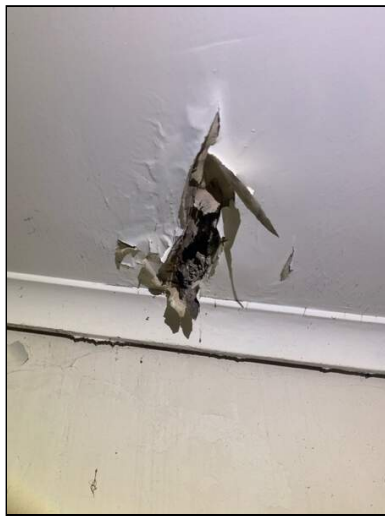
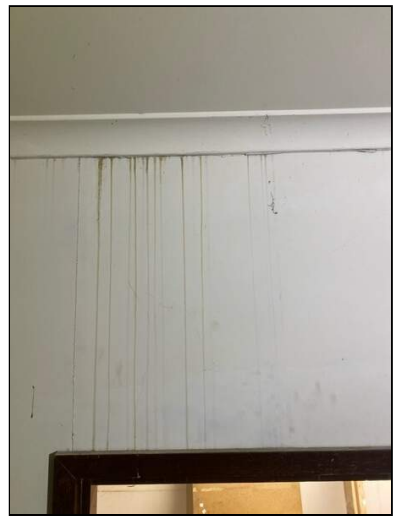
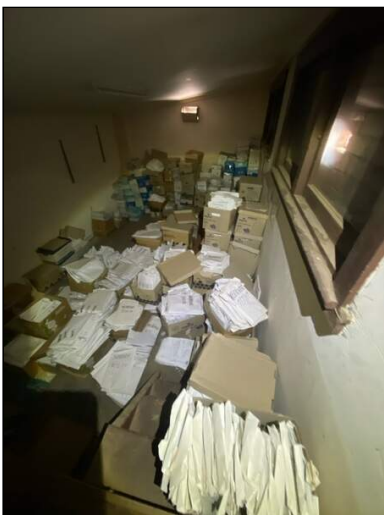
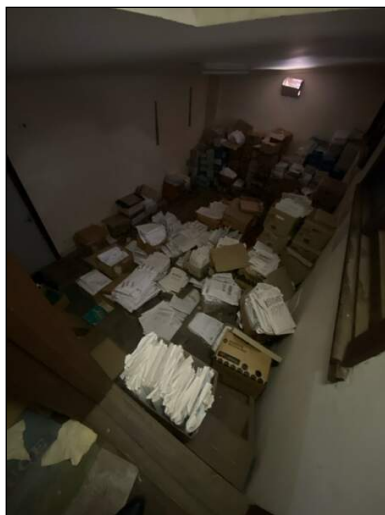
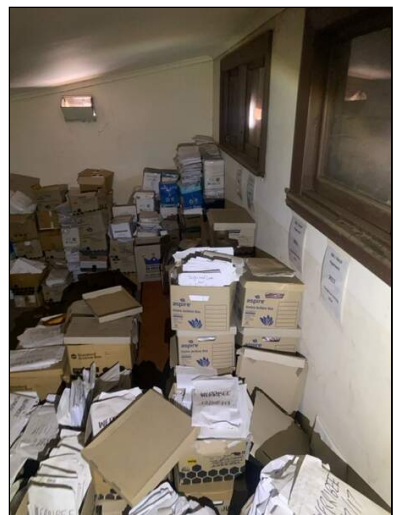
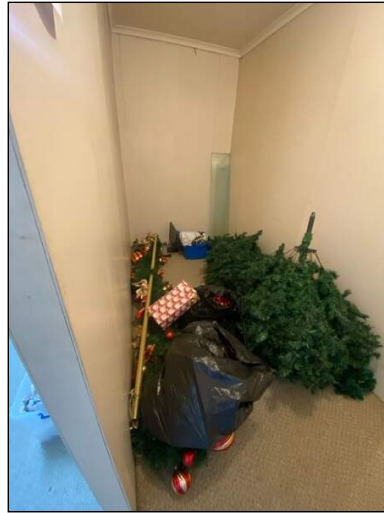
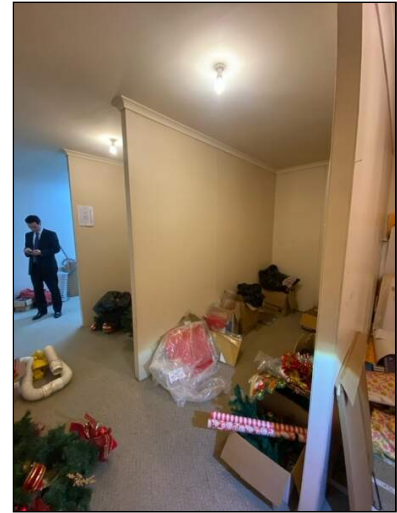
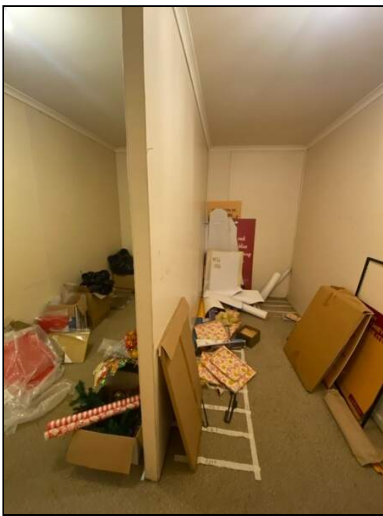
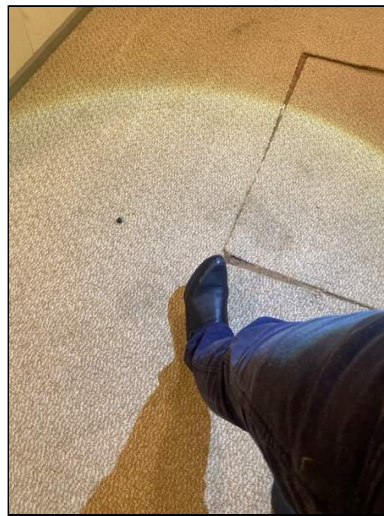
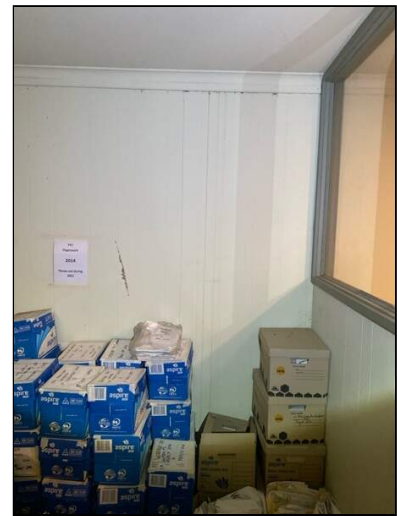
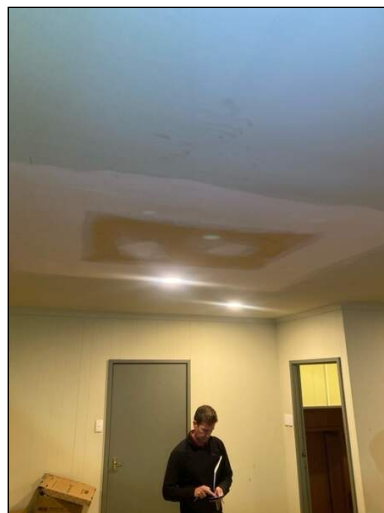
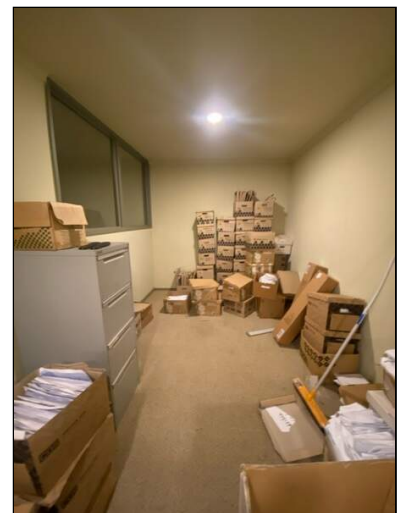
Defect Rating **Major Defects**

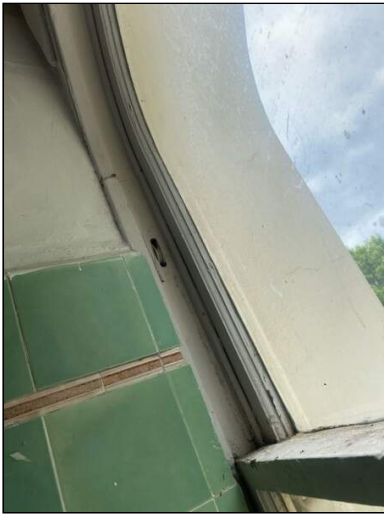
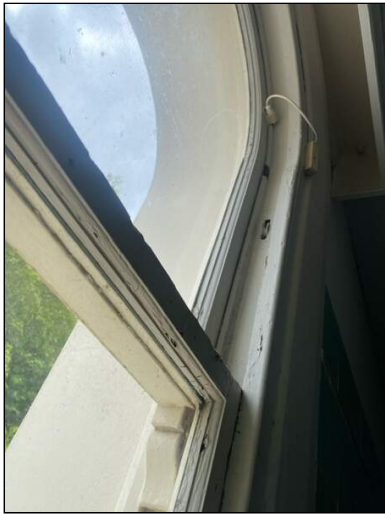
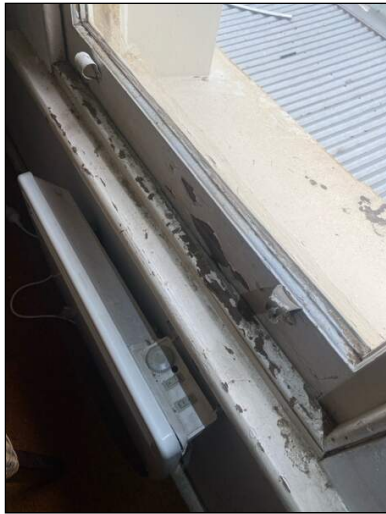
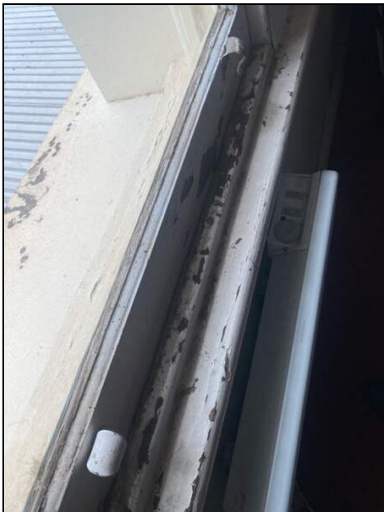
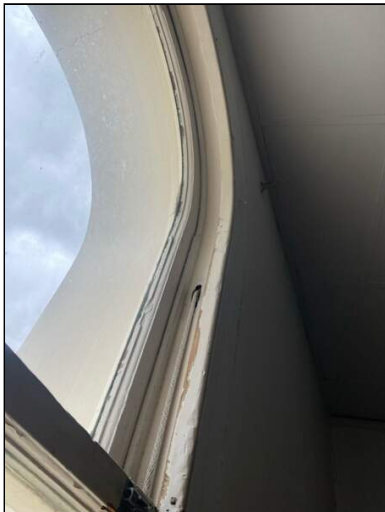
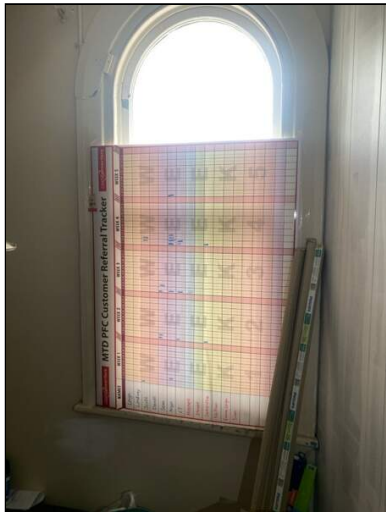
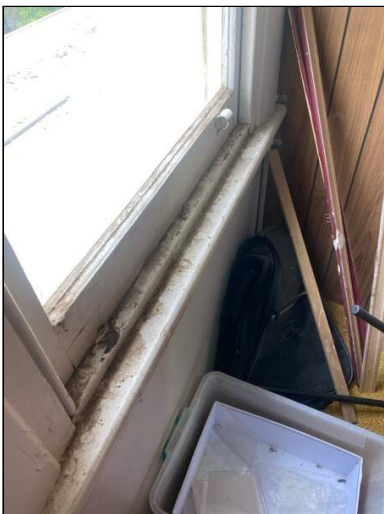
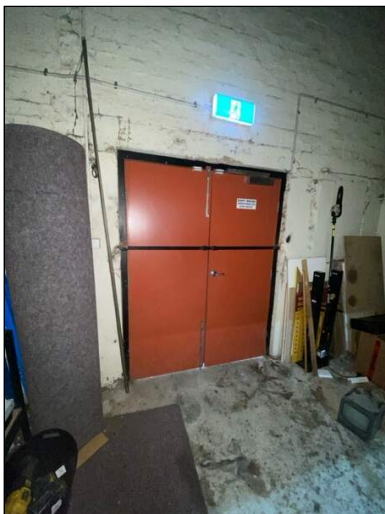
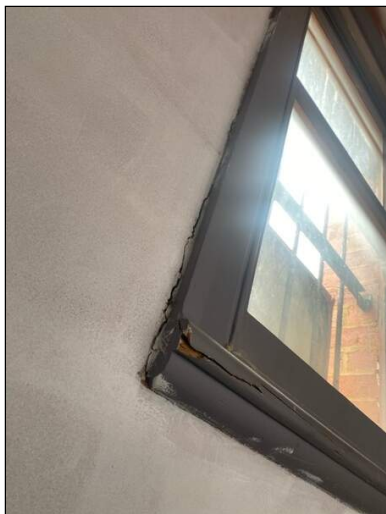
Defect Rating Major Defect

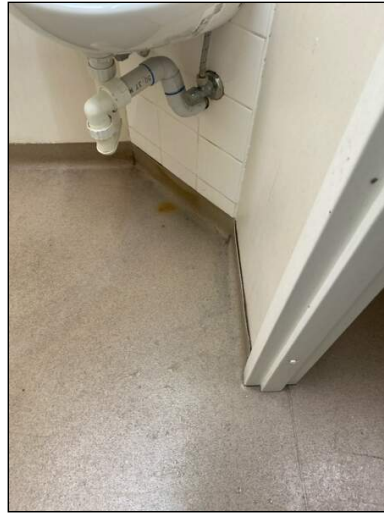
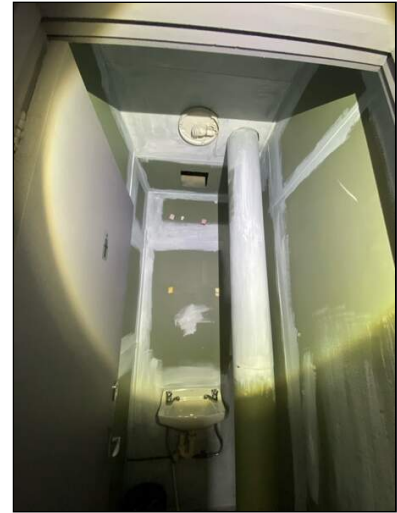
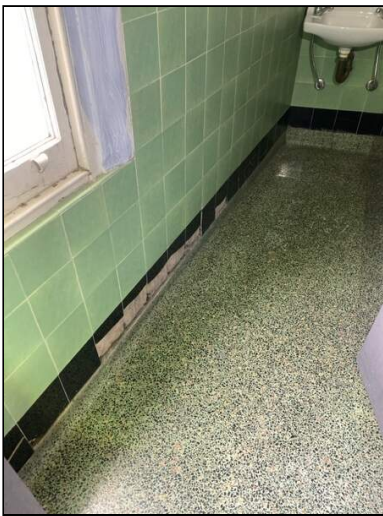
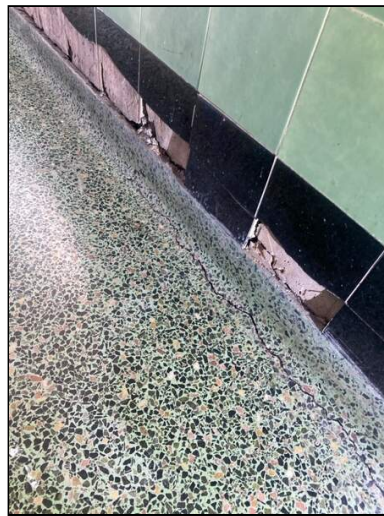
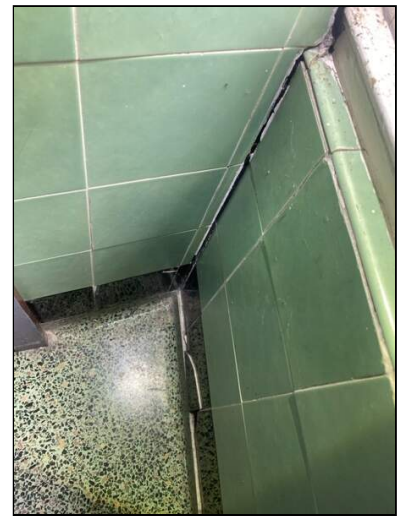
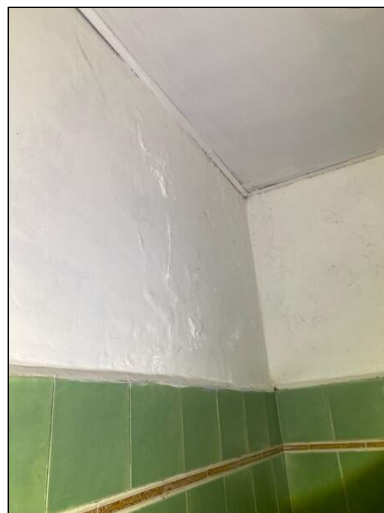
Answer	<p>Within the shower, the tap(s) are dripping and leaking, possible faulty washer</p> <p>Tap(s) can be seen to be dripping due to a faulty washer, this item can be replaced by a plumber</p>
Sub-question	<p>*** CONDENSATION / EXHAUST FAN ANSWERS ***</p>

Answer	<p>Exhaust fan faulty / Not working</p> <p>Condensation damage evident, exhaust fan faulty</p>
Answer	<p>Refer To Supplementary Text / Photos / Defect Rating</p>
Defect rating	<p>Major defect</p>
Photos

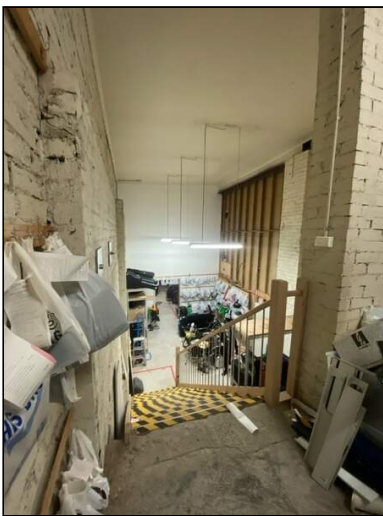
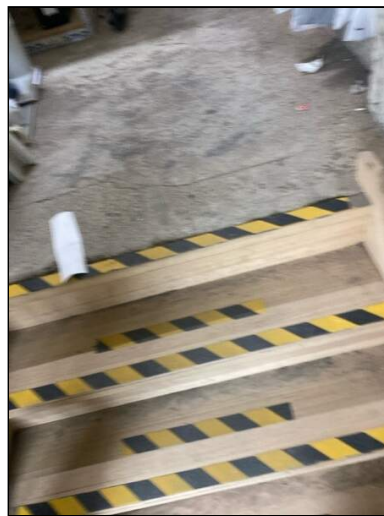
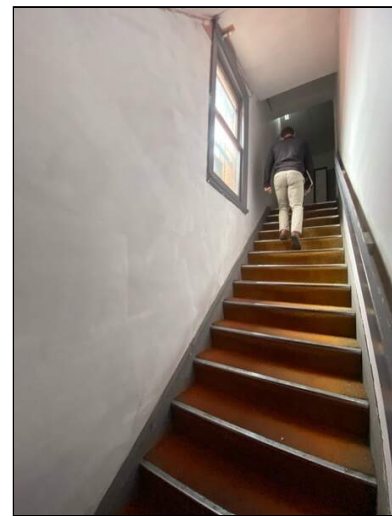
Defect Rating Safety Hazards

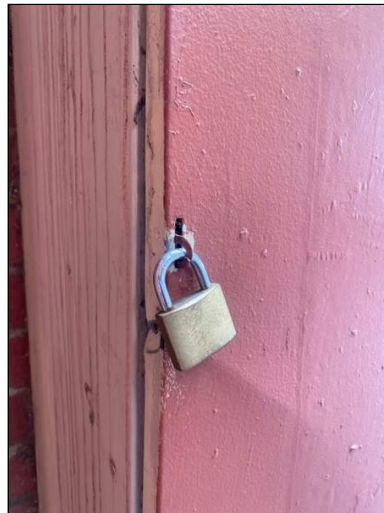
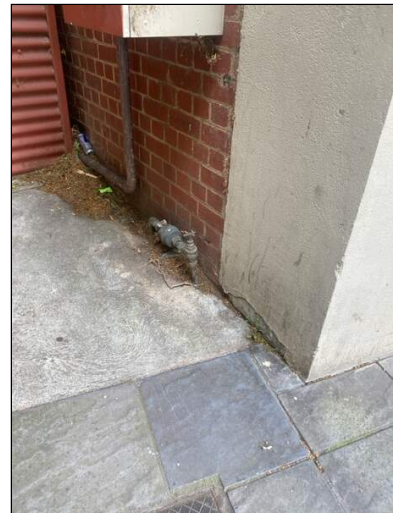
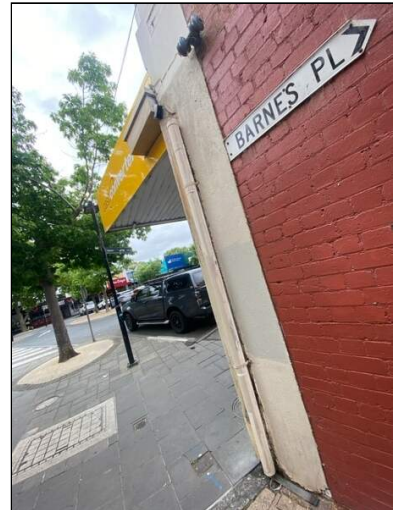
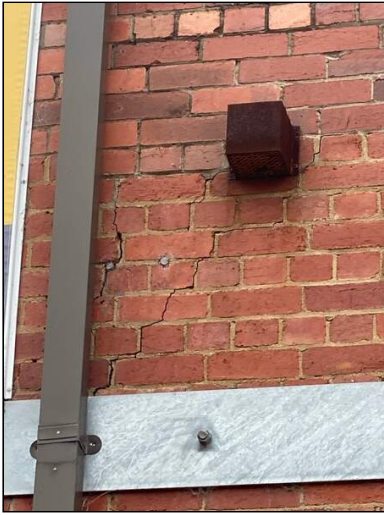
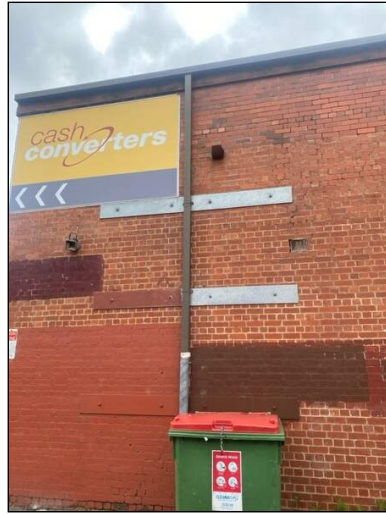
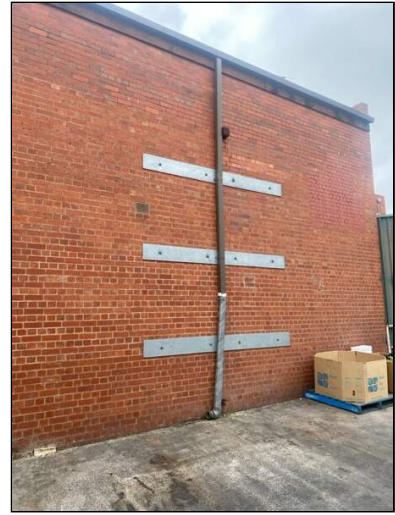
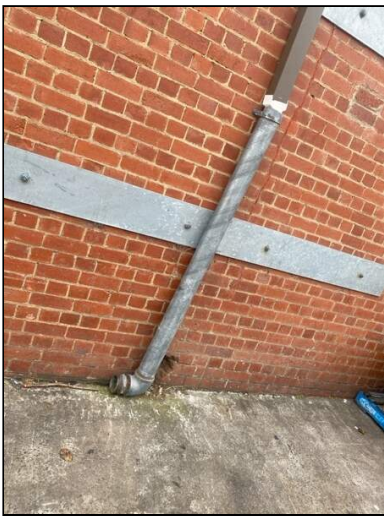
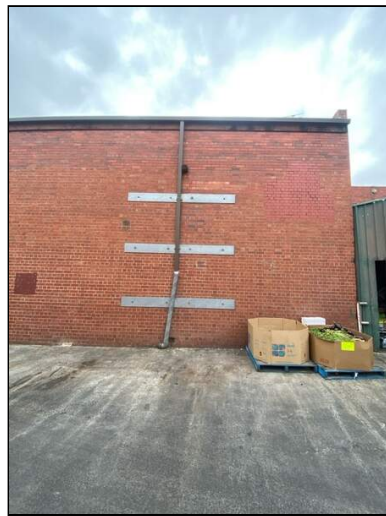
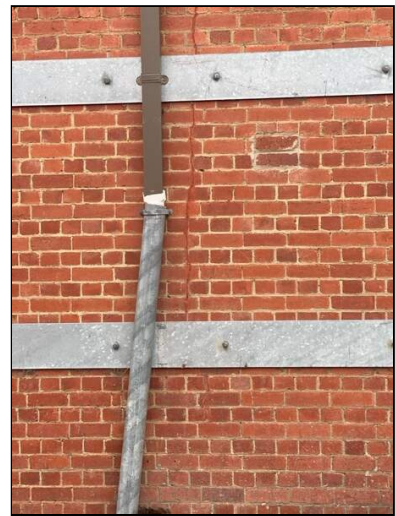
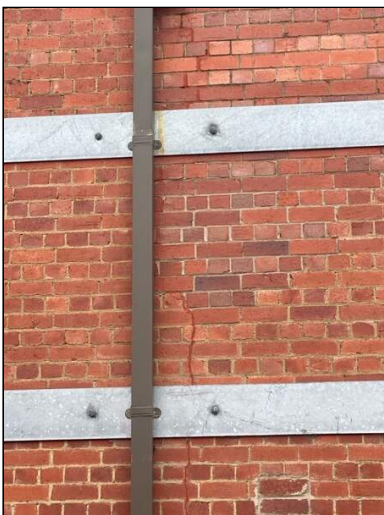
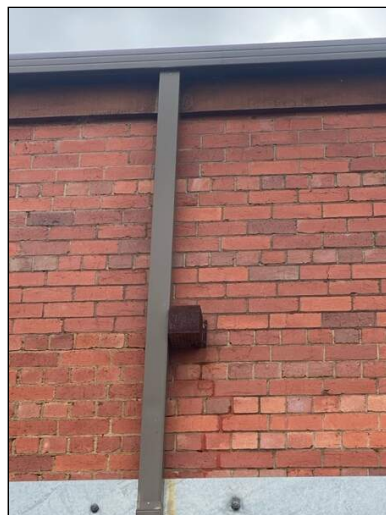
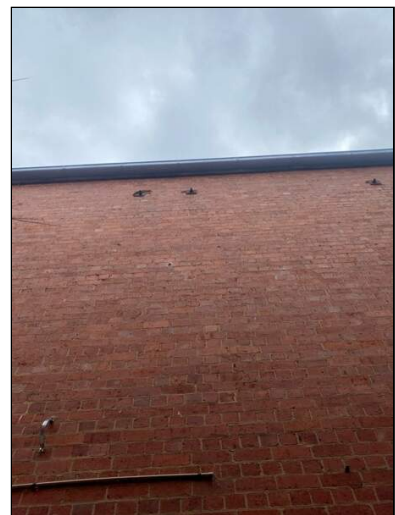
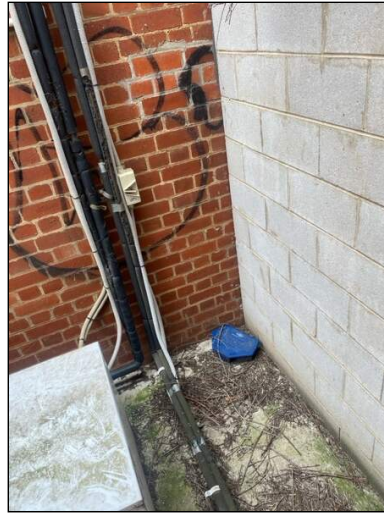
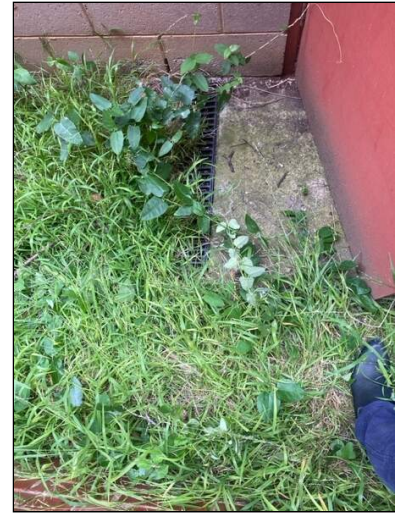
Major Defects

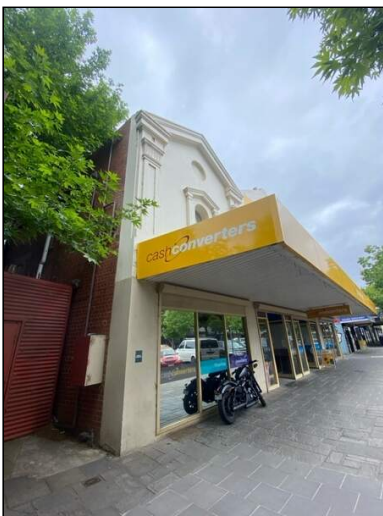
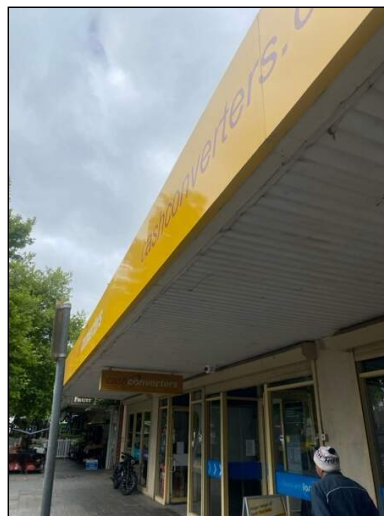
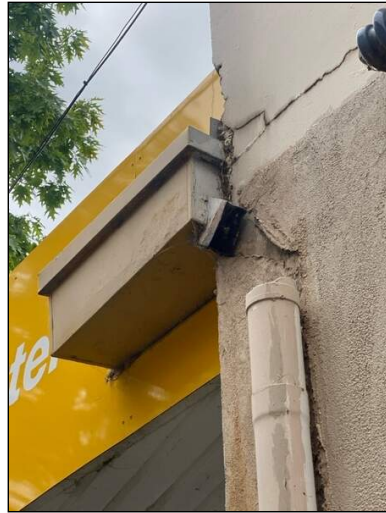
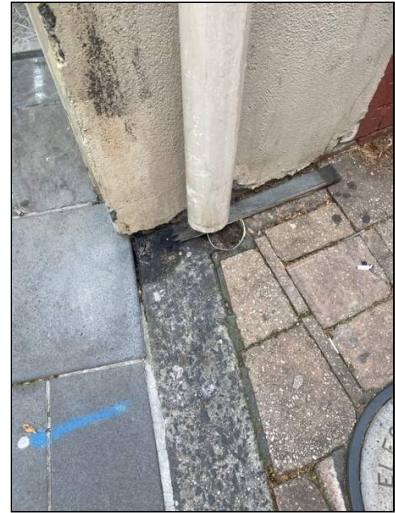
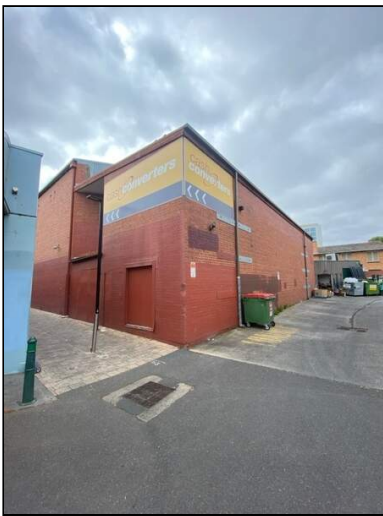
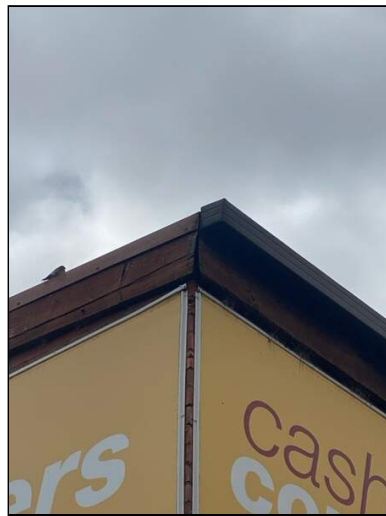
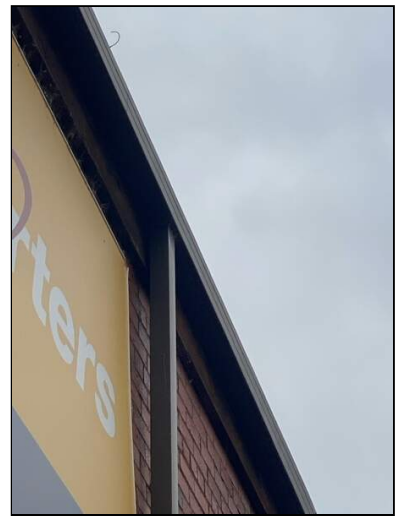
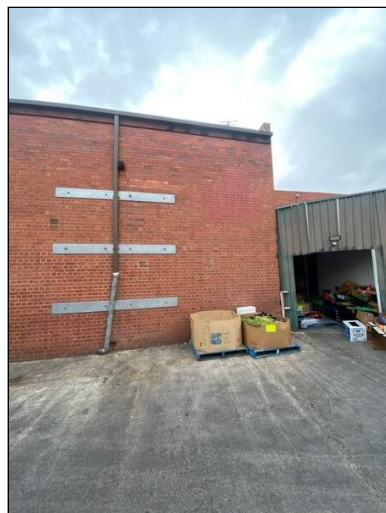
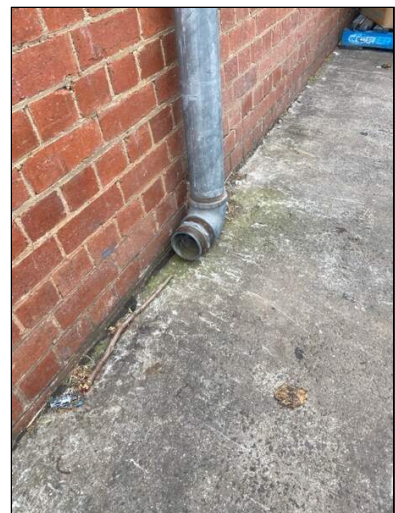
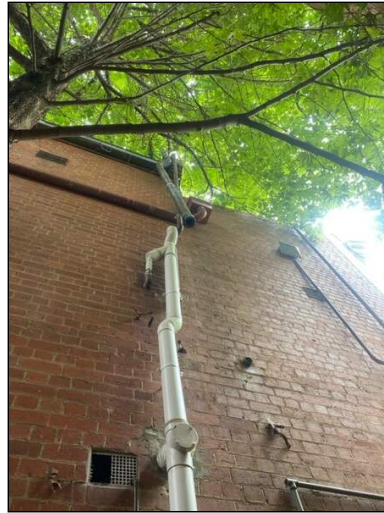
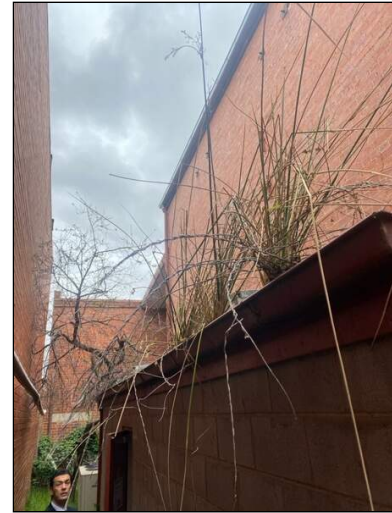
Defect Rating Further investigation as I did not inspect the entire roof elevation
