Pre-Lease Condition Report For The Property At:

229 Brisbane Water Drive Point Clare NSW 2250

4th May 2022

Prepared by:
The Property Inspectors
Emilio Calandra

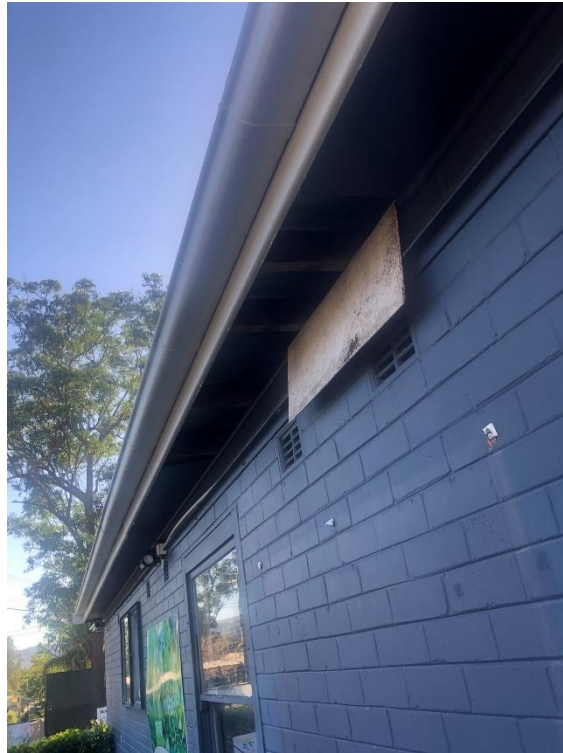
Fallen soffit linings.

Wood rot found within the external doors and windows, together with chipped timber windows.

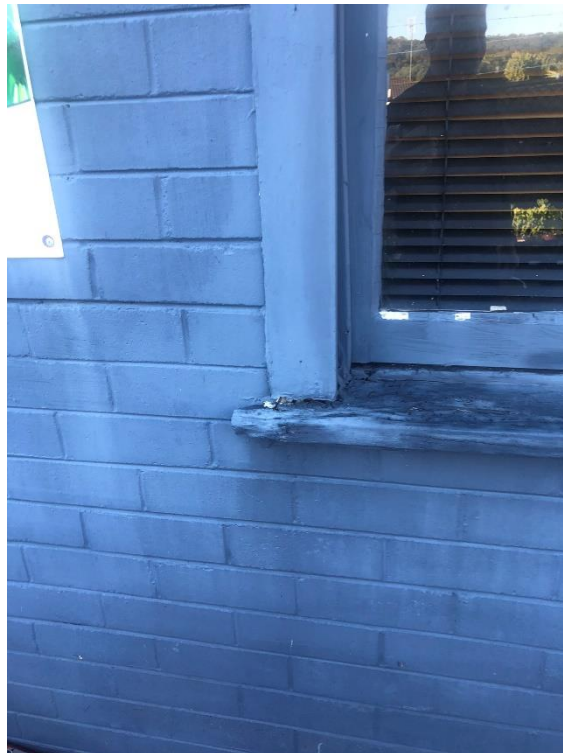
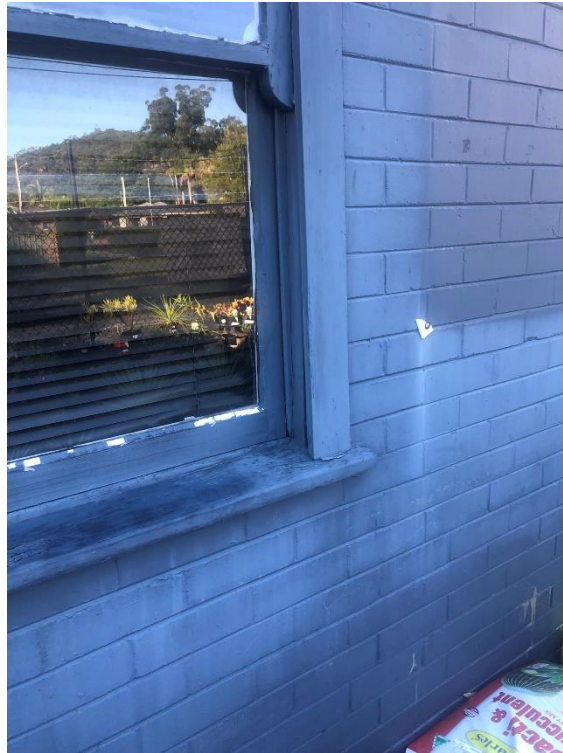
Wood rot within the windowsill, architrave and window unit.
Cracked concrete pathways and leaning metal fence line.

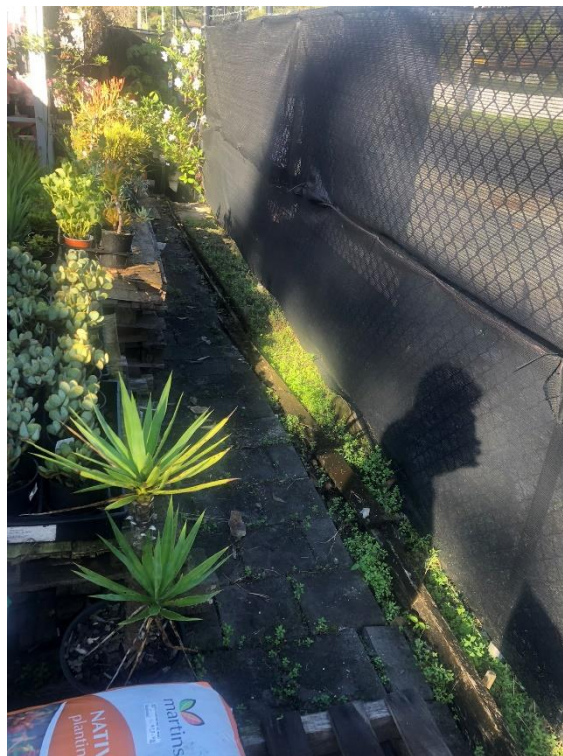
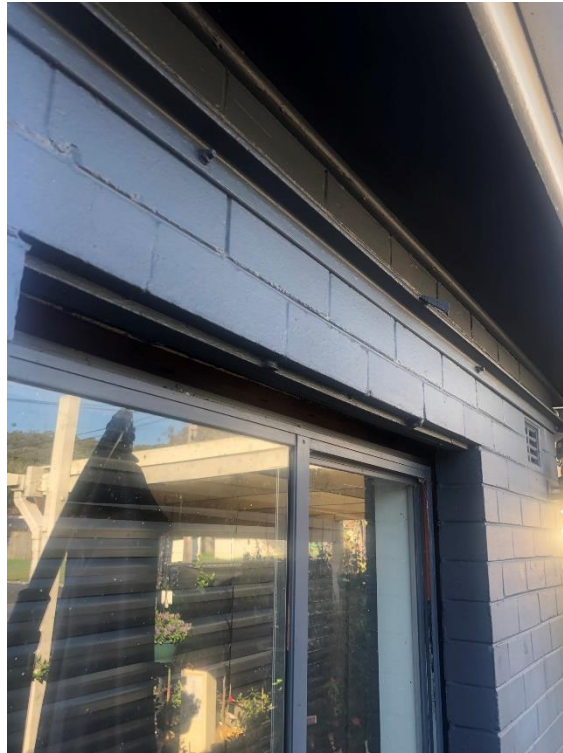
Missing window storm moulds.
Damaged wire fencing.

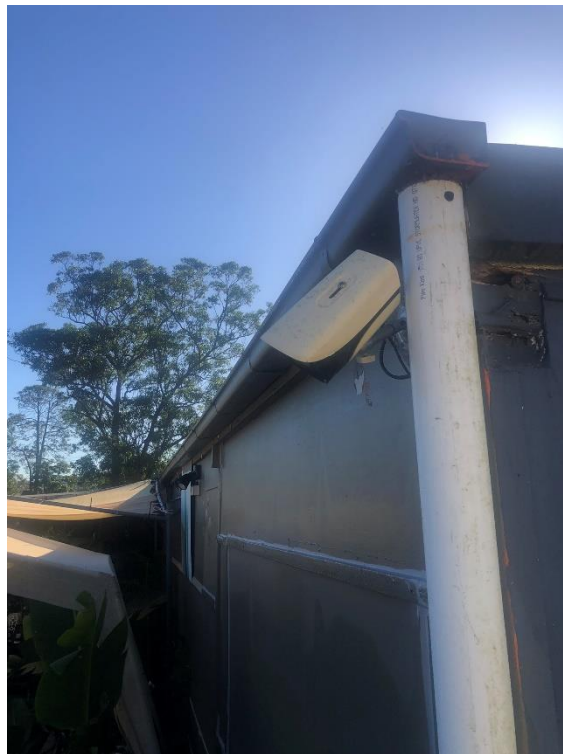
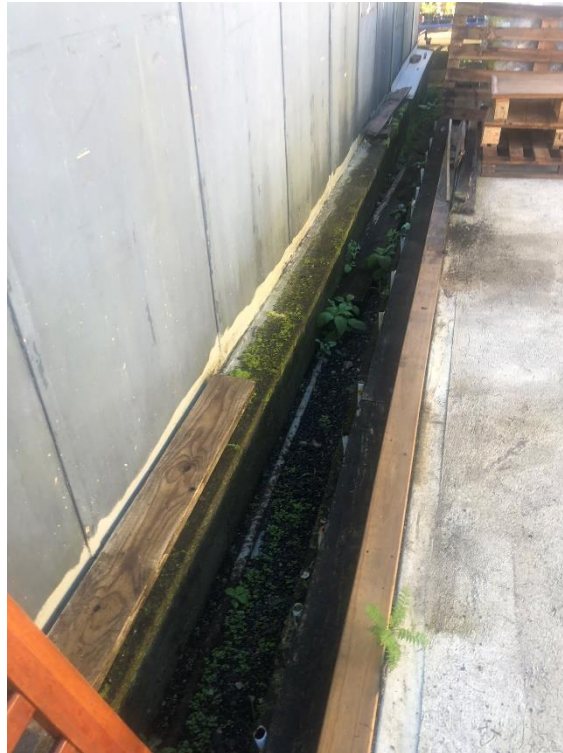
Mould and moisture damage within the concrete slab and external fibro / asbestos wall linings.
Cracked and damaged fibro / possible asbestos wall linings.

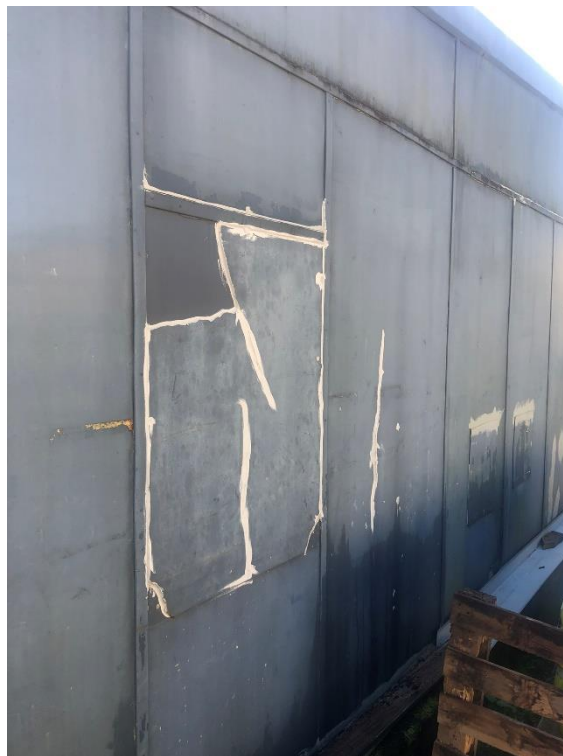
Cracked asbestos / fibro wall linings.

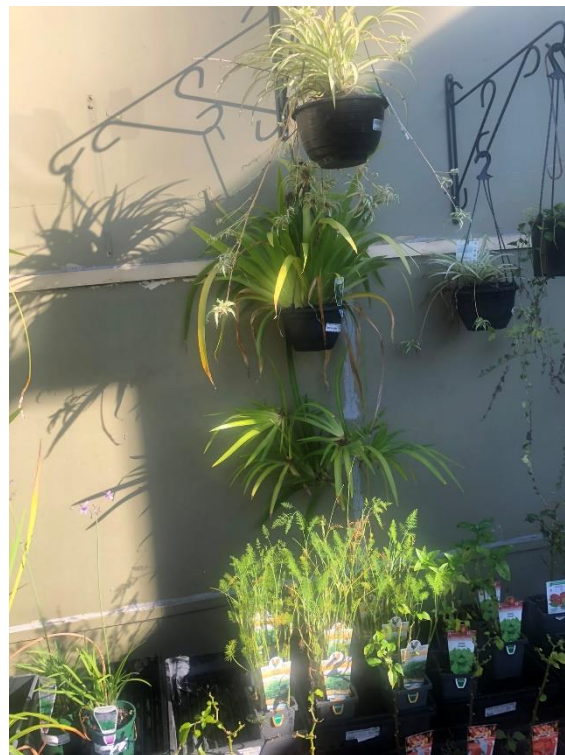
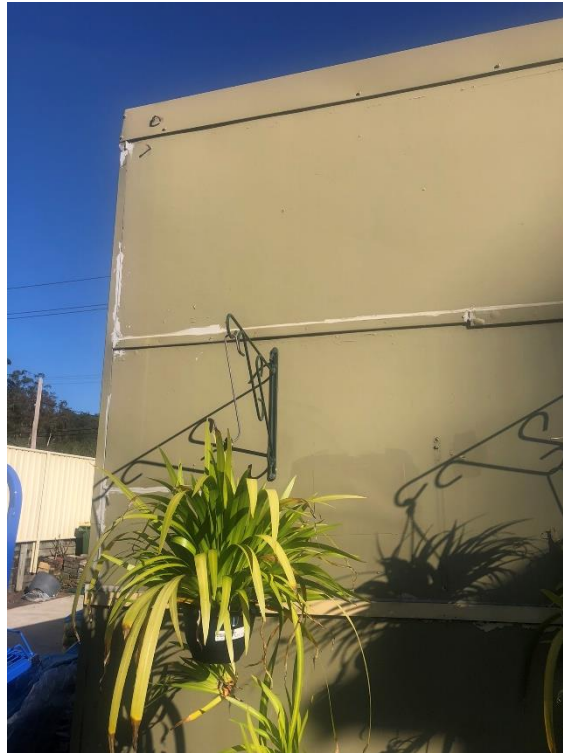
Cracked asbestos / fibro wall linings.

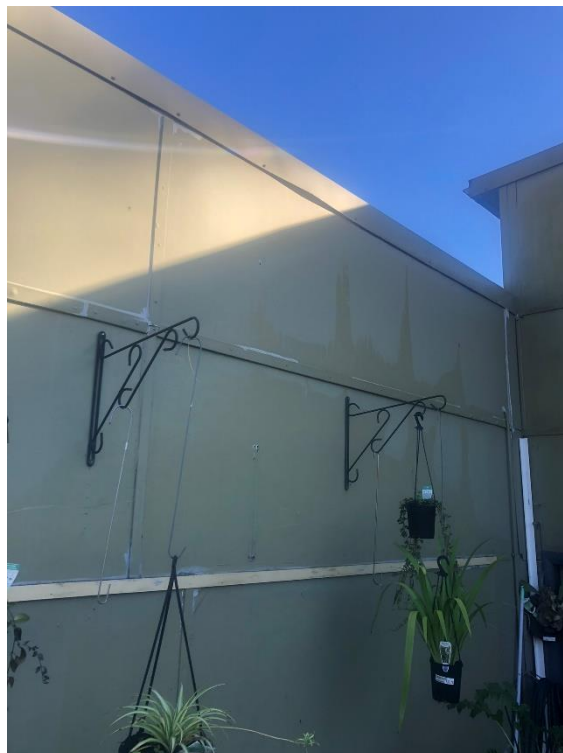
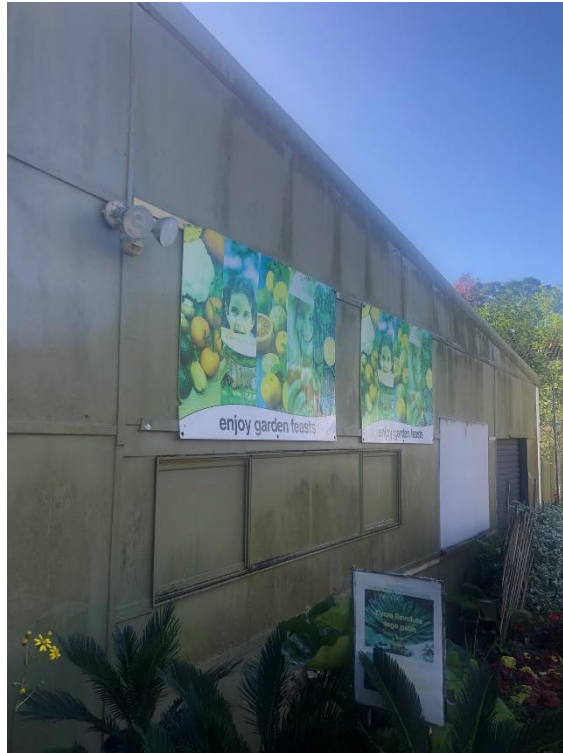
Cracked asbestos / fibro wall linings.
Damaged and leaning steel structure with lightweight canopy.

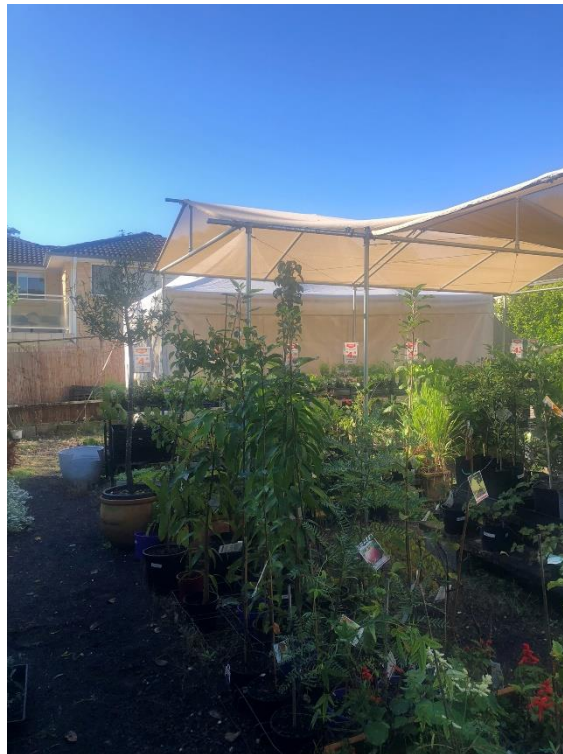
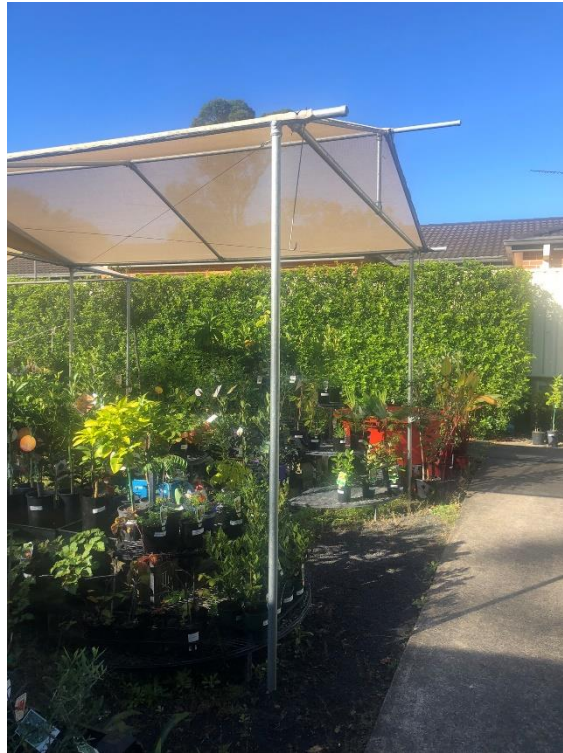
Damaged and leaning steel structure with lightweight canopy.
Cracked and damaged fibro / asbestos wall linings.

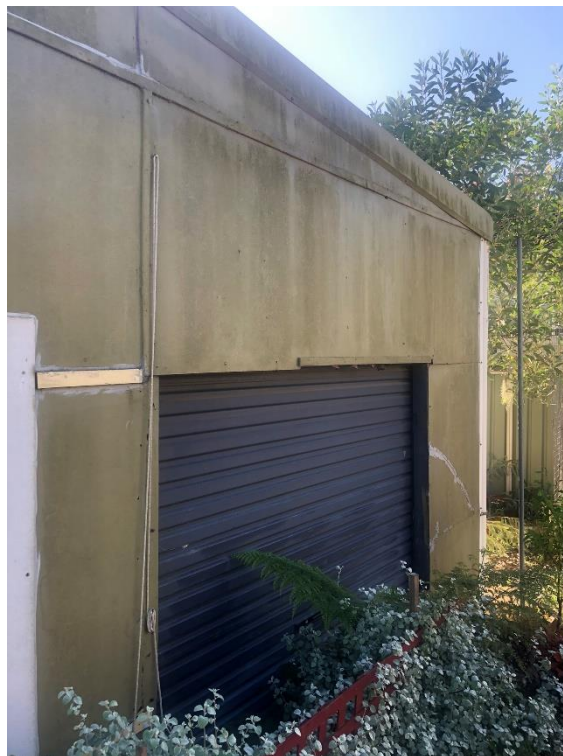
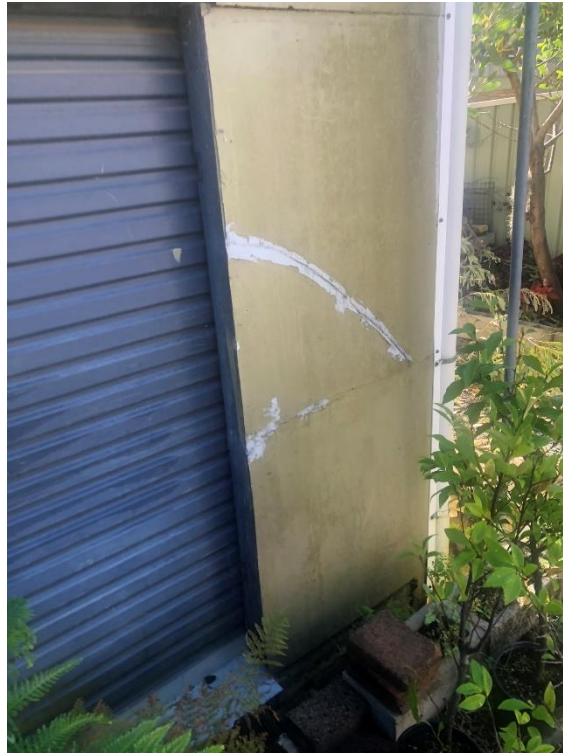
Cracked, damaged wall linings which have been partially repaired in the past.
Water ingress within the building form various locations can be seen.

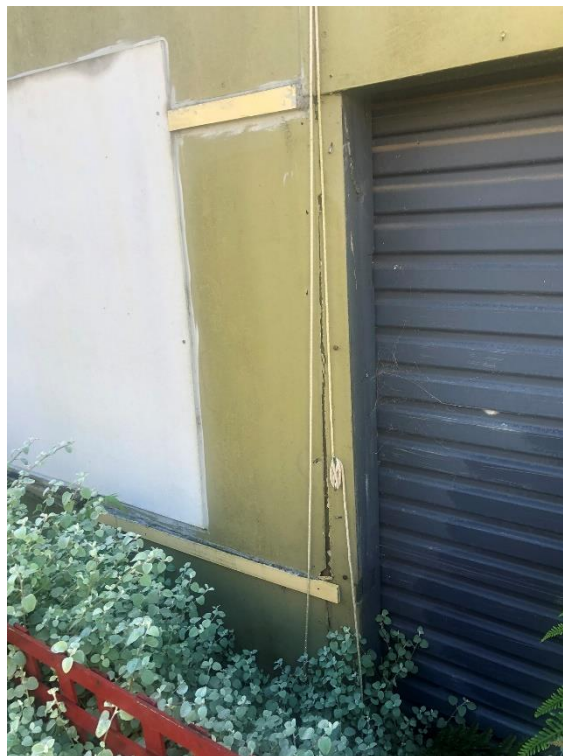
Cracked, damaged and partially repaired fibro / asbestos wall linings.

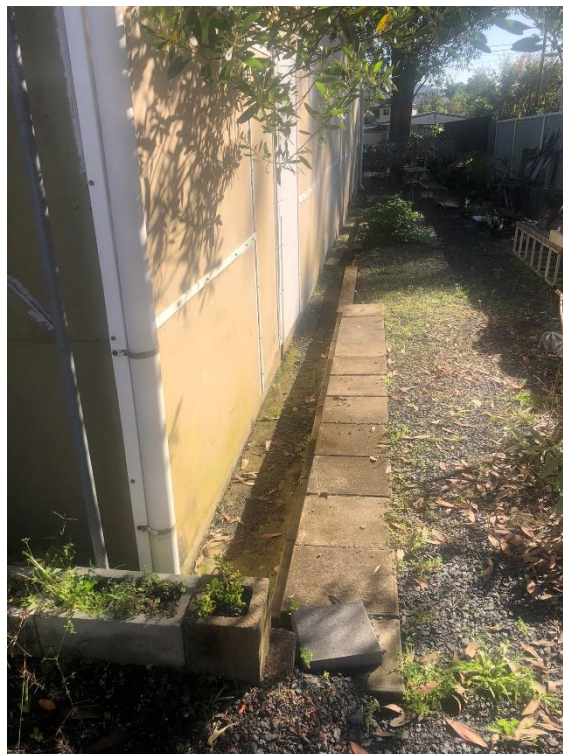
Stormwater system draining onto the floor, water damage and moisture seen within the external walls.

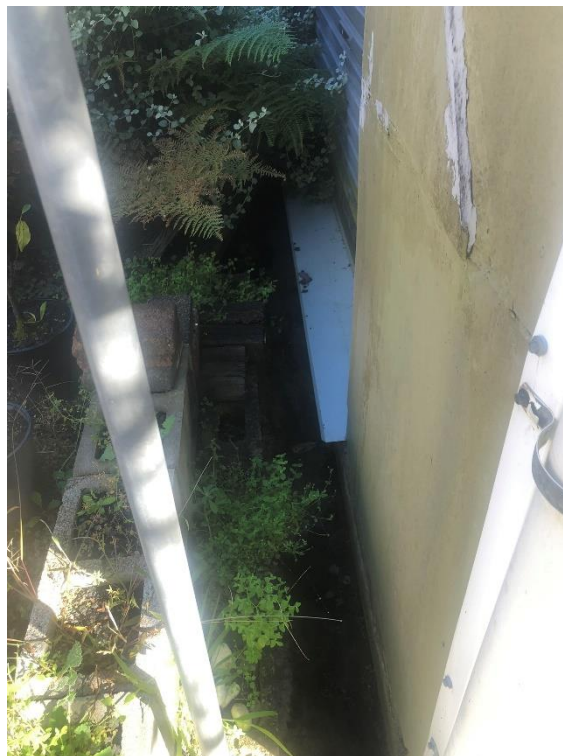
Cracked and damaged wall linings, mould and moisture within the external wall linings.

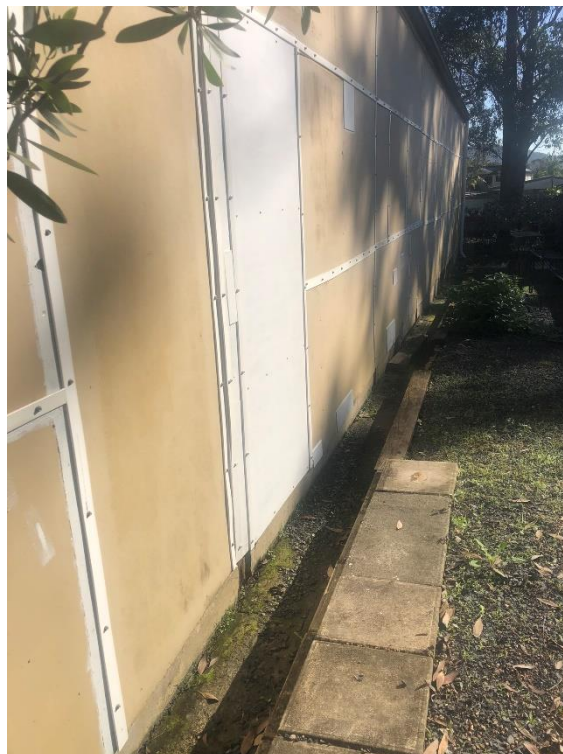
Damaged trimwork and cover panels to the external wall linings.

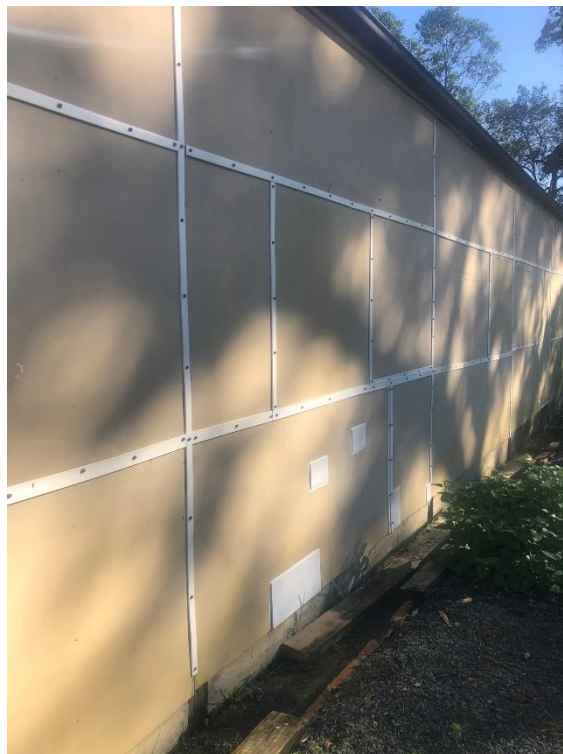
Cracked, damaged and missing fibro / asbestos wall linings and cover panels.

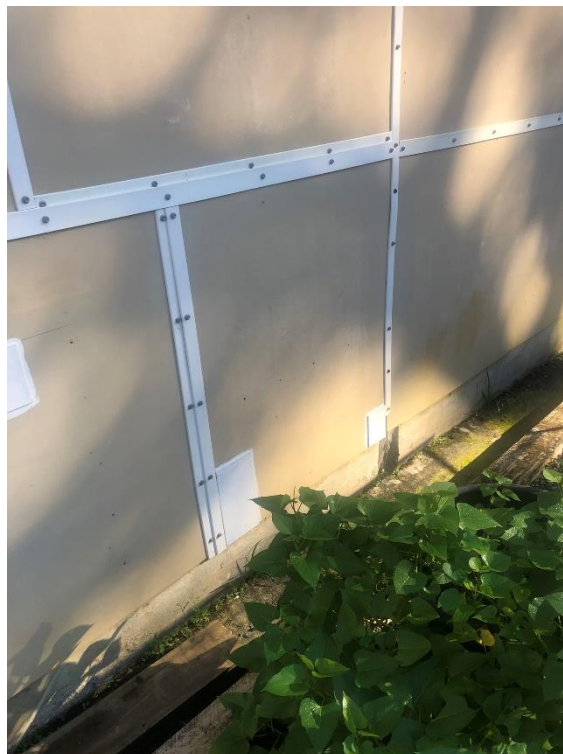
Mould and moisture within the external fibro / asbestos wall linings, together with major wood rot within the timber members that support the structure of the building.

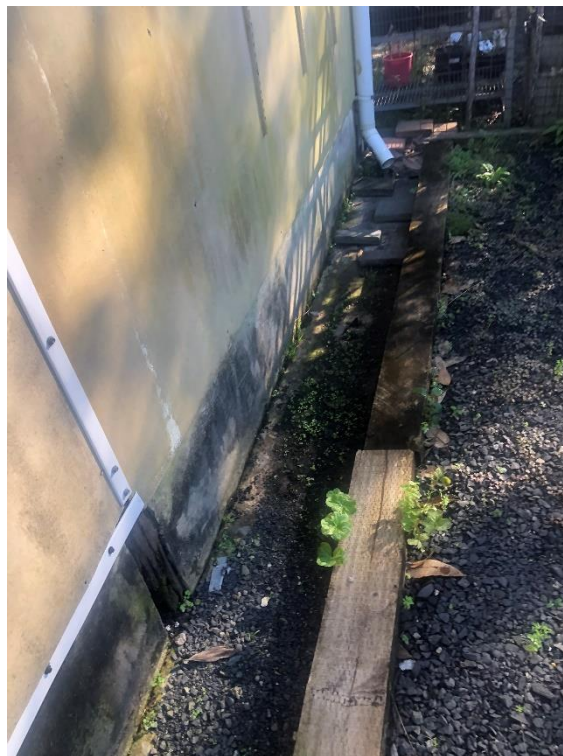
Dilapidated garden beds and pathways and excess mould and moisture seen within the surrounding pathways and wall linings / walls of the main building.

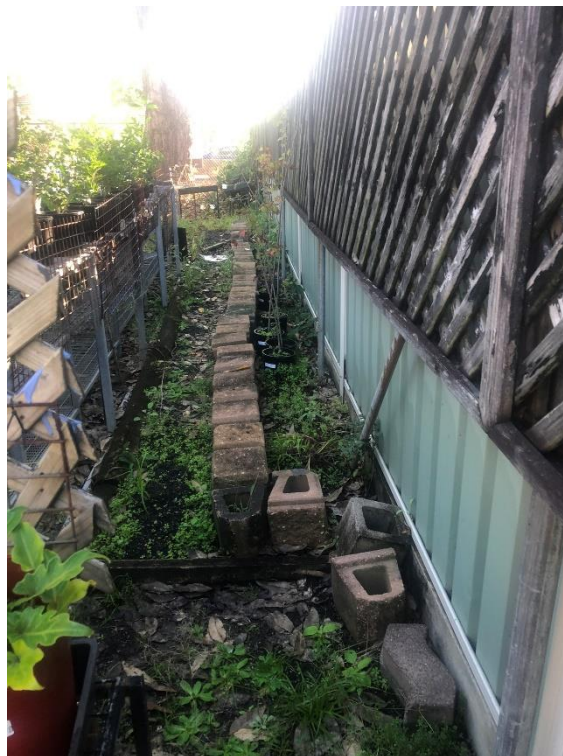
Collapsed lattice, together with damaged fibro wall and fence linings.
Subsided pavers and vegetation within the floor pavers.

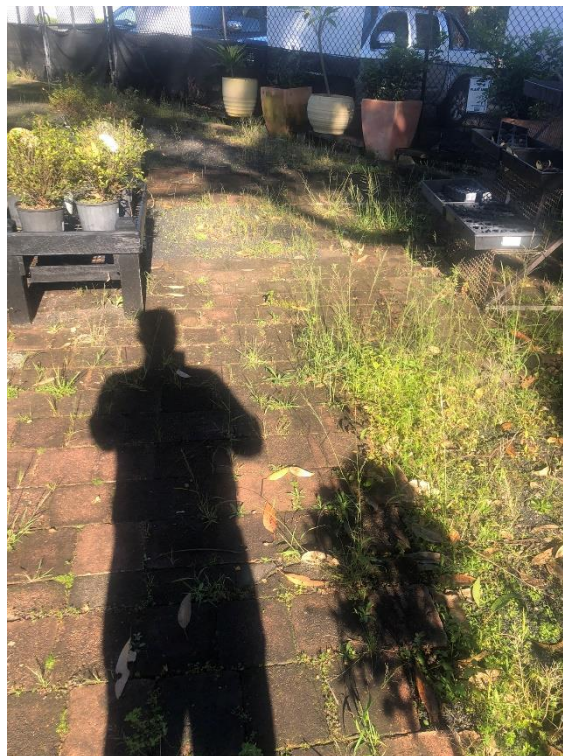
Subsided pavers and vegetation within the floor pavers.

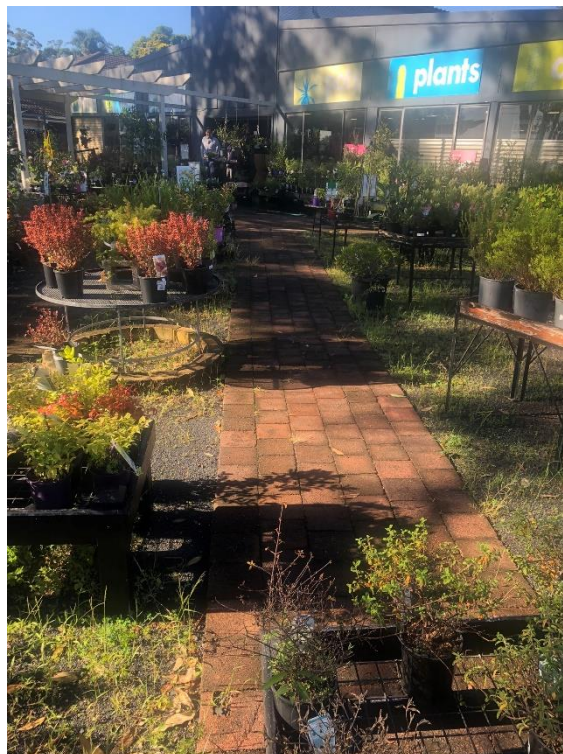
Subsided pavers and vegetation within the floor pavers.
Cracked and damaged wall linings, disengaged timber fascia boards and metal roof cappings.

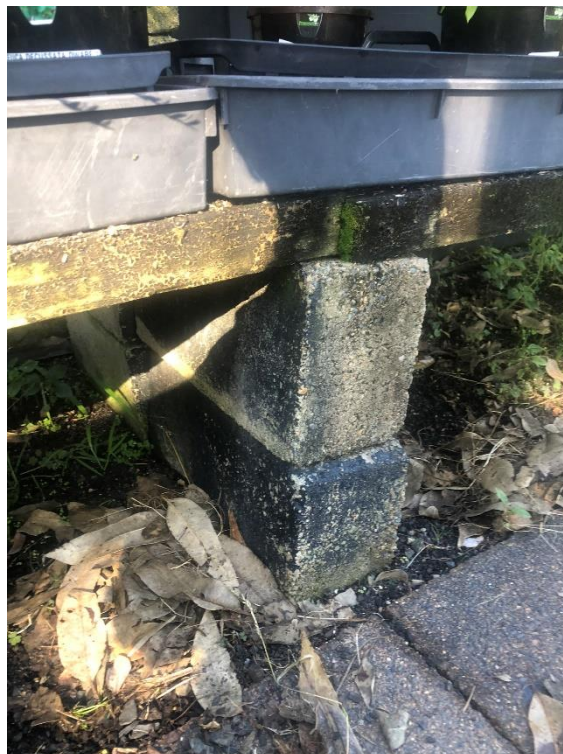
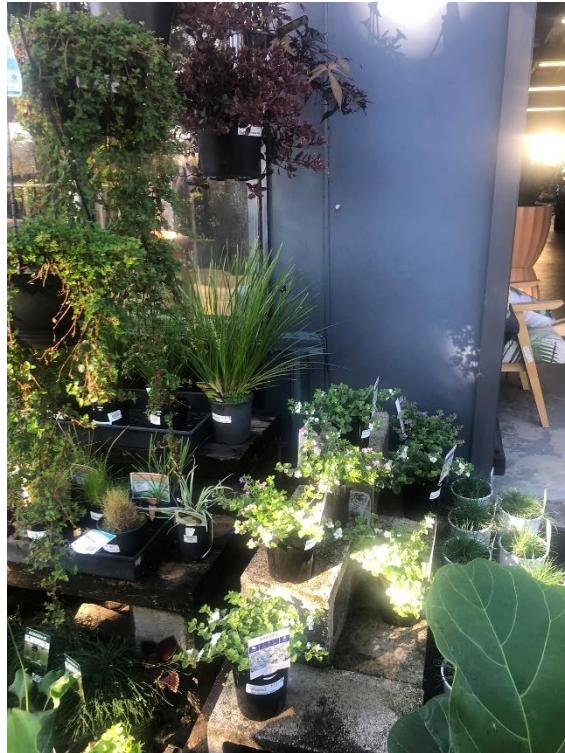
Cracked and damaged fibro / asbestos wall linings.

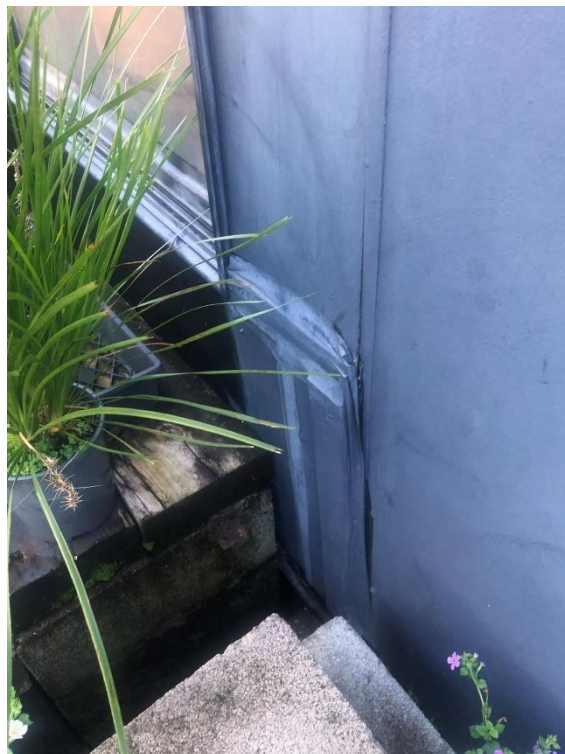
Cracked and damaged fibro / asbestos wall linings above and surrounding the external windows and within the external walls.

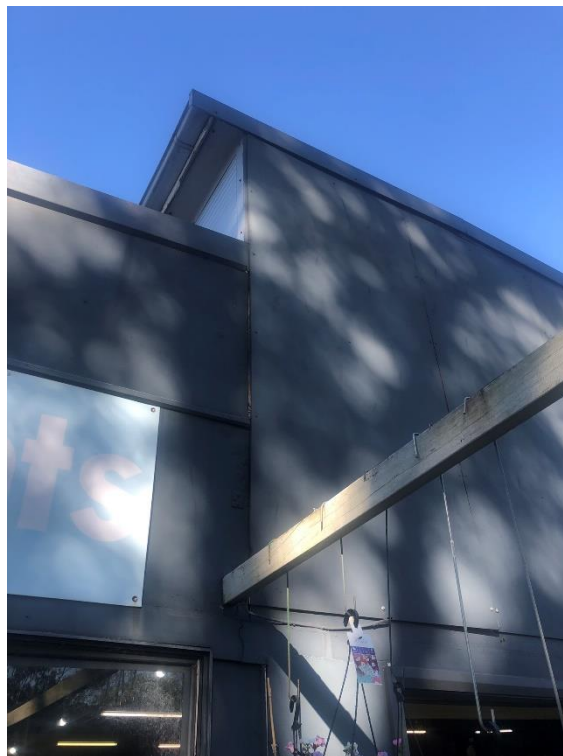
Cracked and damaged fibro / asbestos wall linings above and surrounding the external windows and within the external walls.

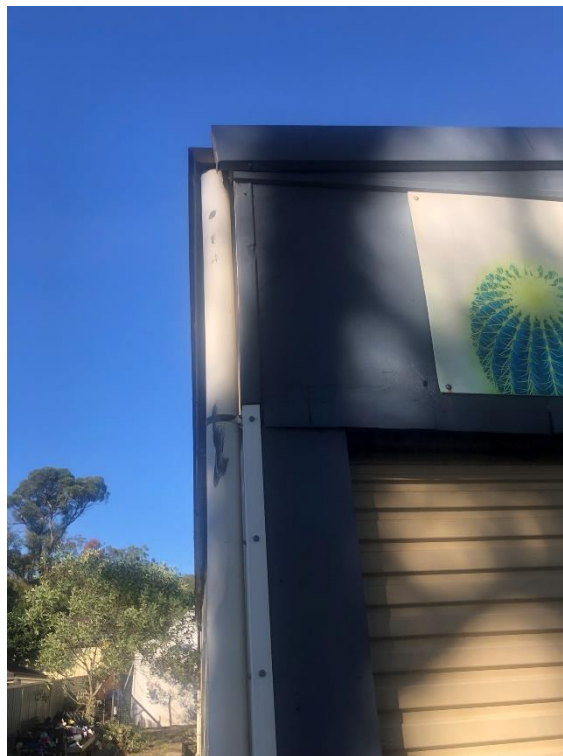
Cracked and damaged fibro / asbestos wall linings above and surrounding the external windows and within the external walls.

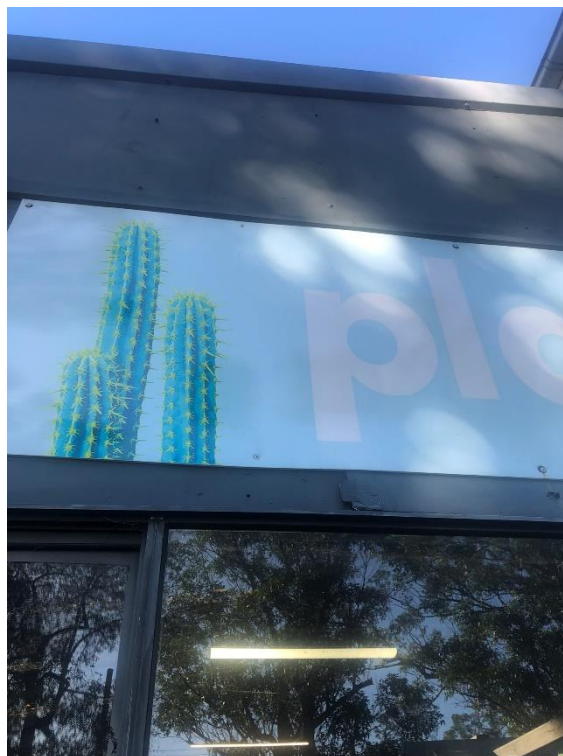
Cracked and damaged fibro / asbestos wall linings above and surrounding the external windows and within the external walls.

There is excessive moisture within the internal walls, doors and windows of the storeroom.

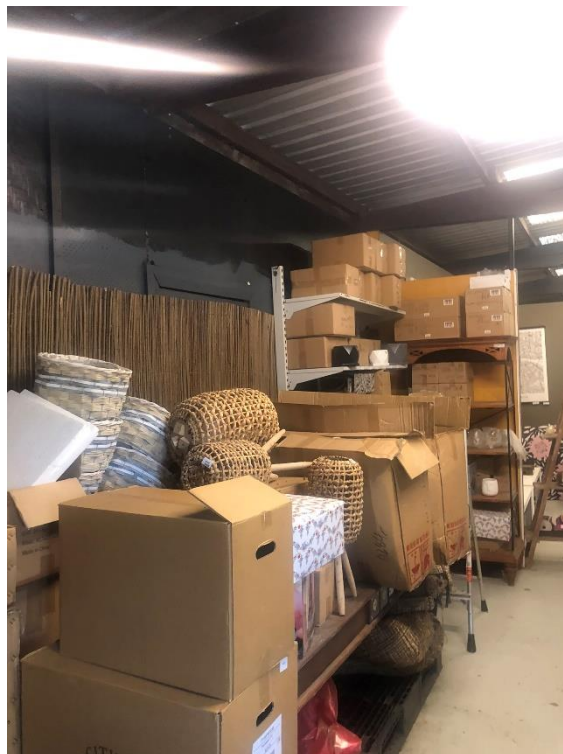
The internal walls and floors within the commercial premises have minor cracks within the concrete floor plus wear and tear within the walls.

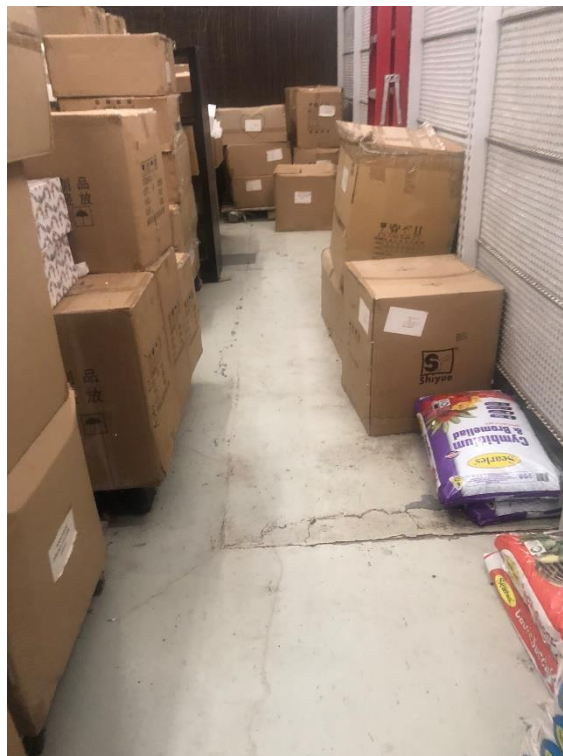
Cracked concrete floor within the storeroom / shop.

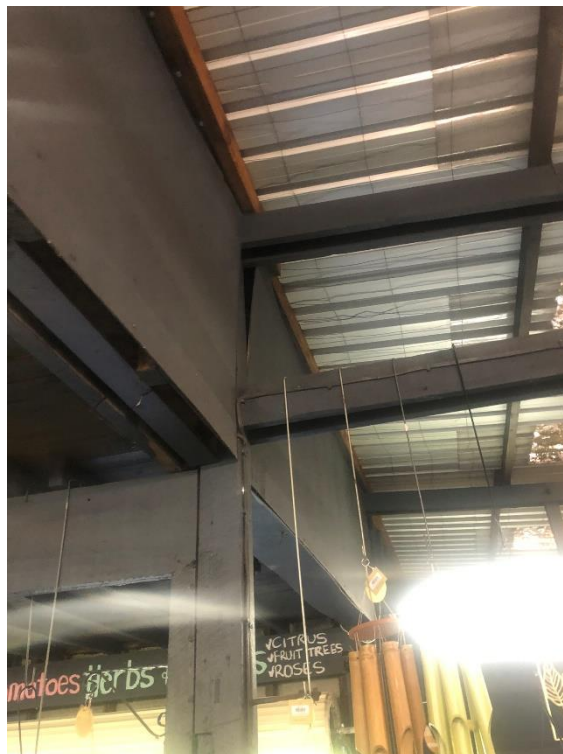
Broken and dmaaged wall linings within the internal elevation of the nursery.

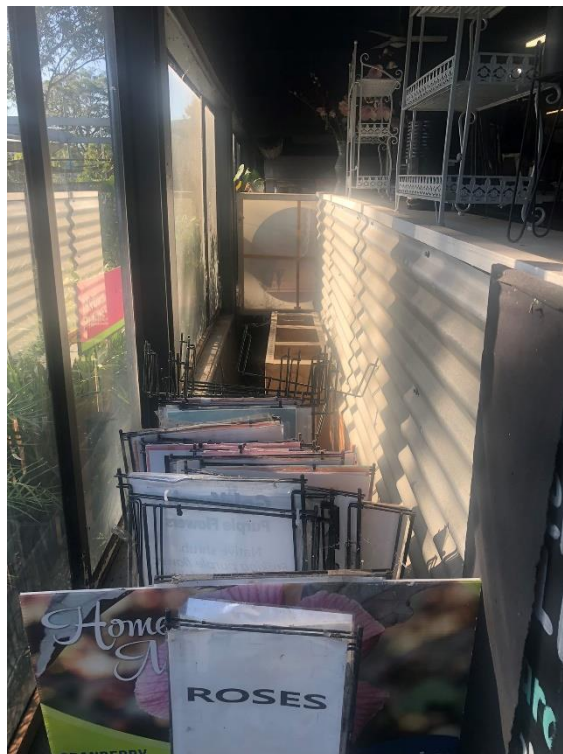
Not all aspects of the storeroom were able to be inspected due to excess personal belongings, but I could see excessive moisture entering the storeroom via the windows and within the internal elevations of the wall.

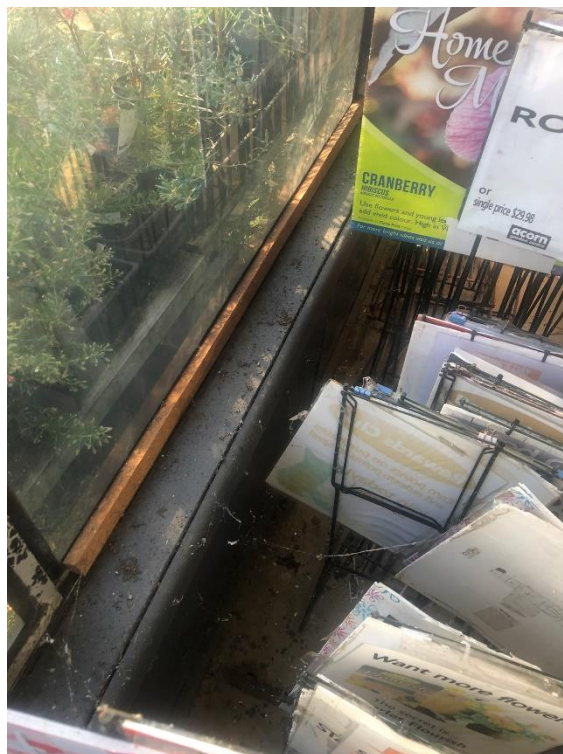
Moisture ingress within the internal walls and storeroom.
Electrical meter box does not comply with current regulations, an overhaul of the entire electrical meter box must be carried out immediately.

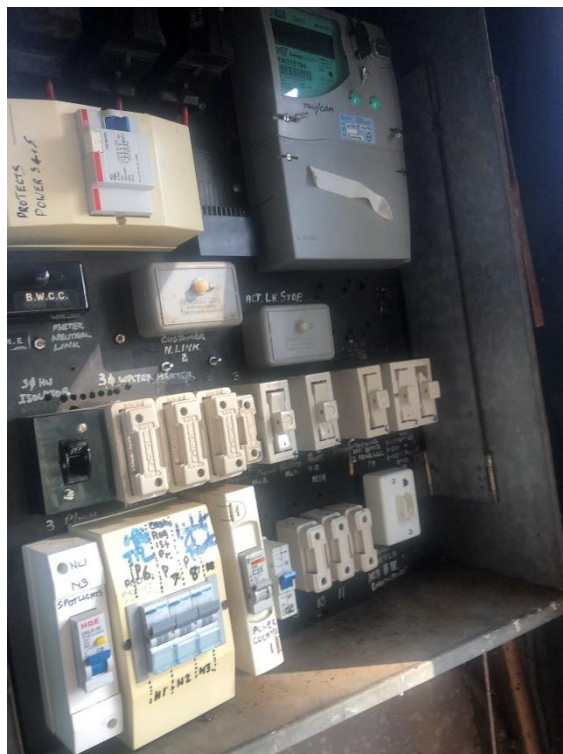
Electrical meter box does not comply with current regulations, an overhaul of the entire electrical meter box must be carried out immediately.

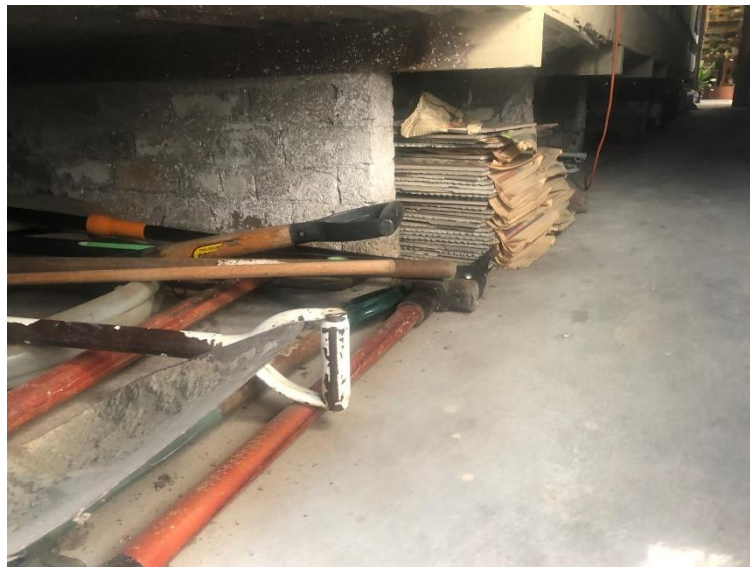
Rust seen within the steel colourbond.
Cracks within the suspended floor and walls and within the concrete floors.

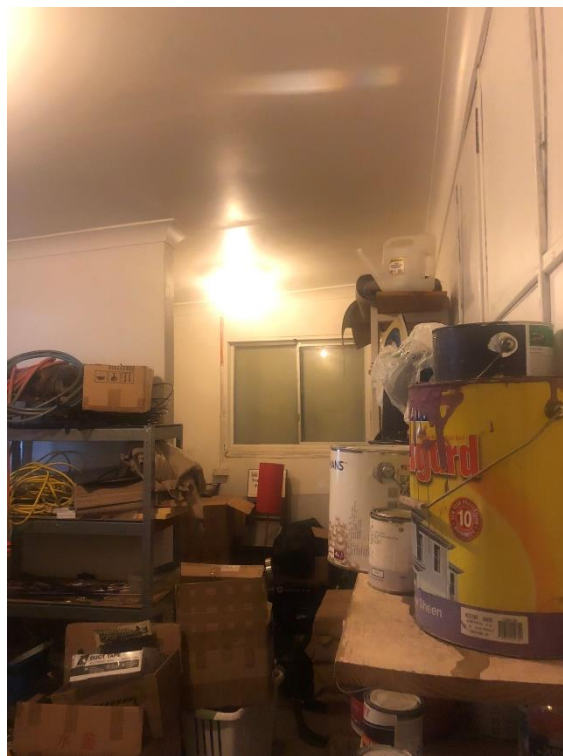
The storeroom was overfilled with personal belongings, no major defects were found, minor hairline cracks were seen within the internal plasterboard ceilings and wall linings.
No access was available to the roof void on the day of my inspection.

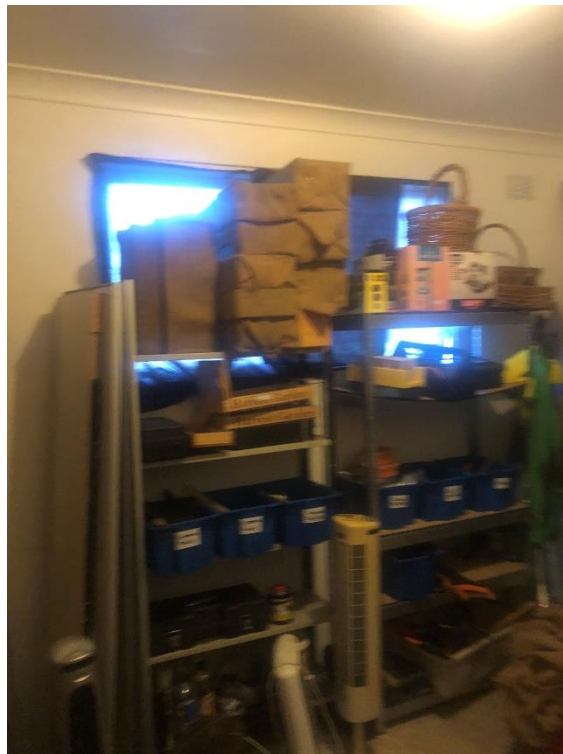
Moisture within the internal walls, all within 1m of photograph taken.

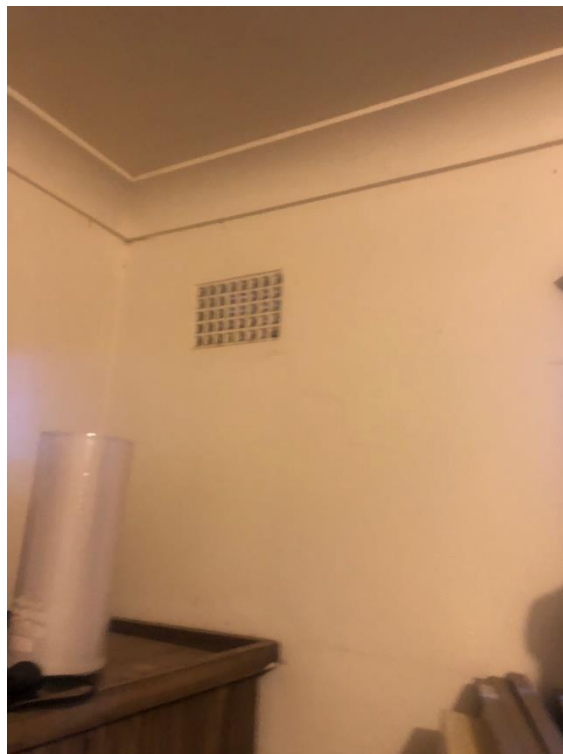
Floors were concealed and covered within the storeroom by the current tenants belongings.
Moisture and dampness seen within the internal masonry walls within the storeroom.

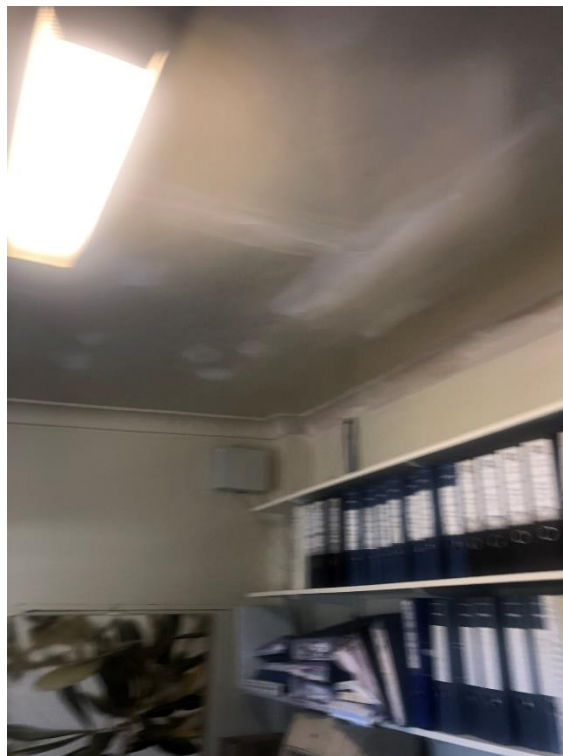
Mould, moisture and dampness within the office walls, cornices and ceiling.

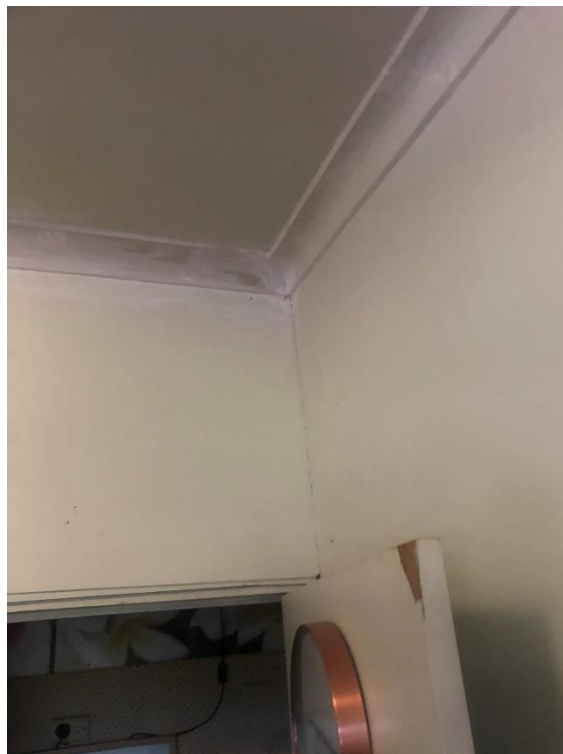
Mould within the internal plasterboard wall linings in various locations within the office.

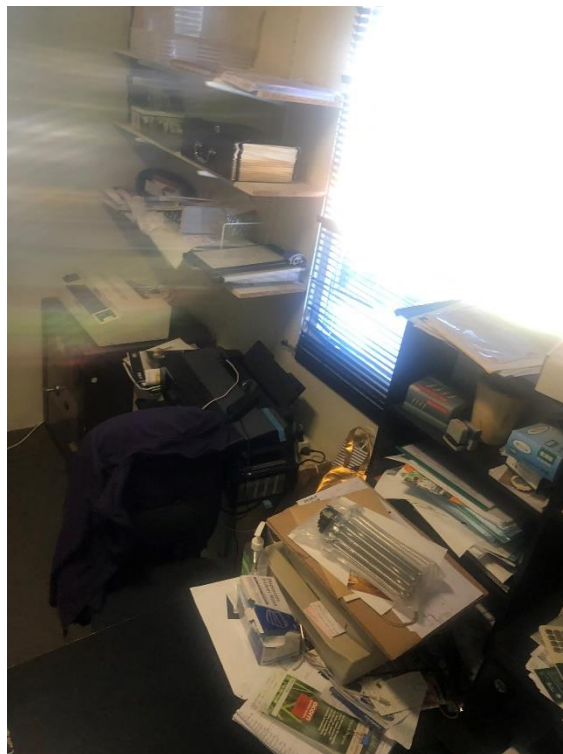
Cracked internal junction of the office wall linings and cornices, together with a significant spring / bounce in the floor beneath the doorway.

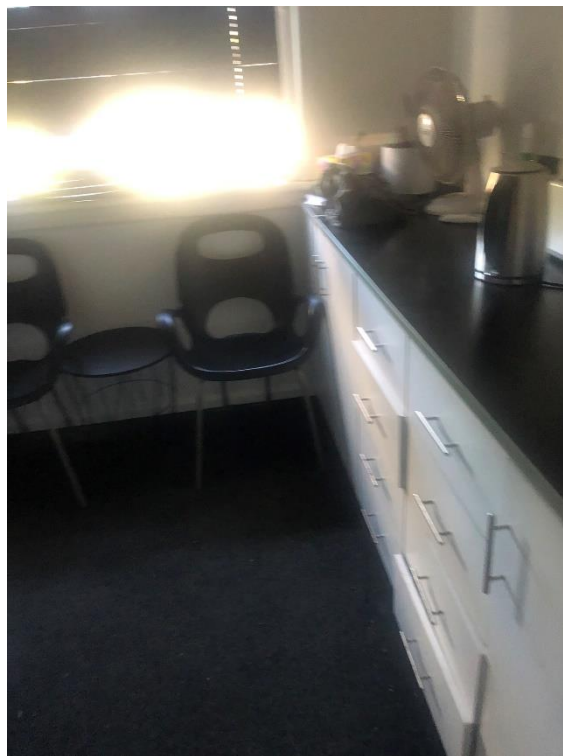
Missing kitchen doors and drawer fronts.

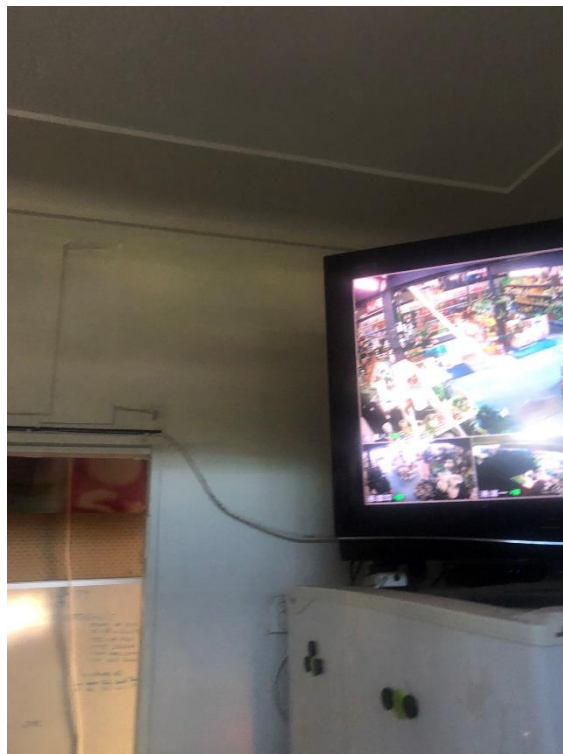
Cracks within the plasterboard wall linings and the door behind the fridge and CCTV camera system and the door was unable to be opened.

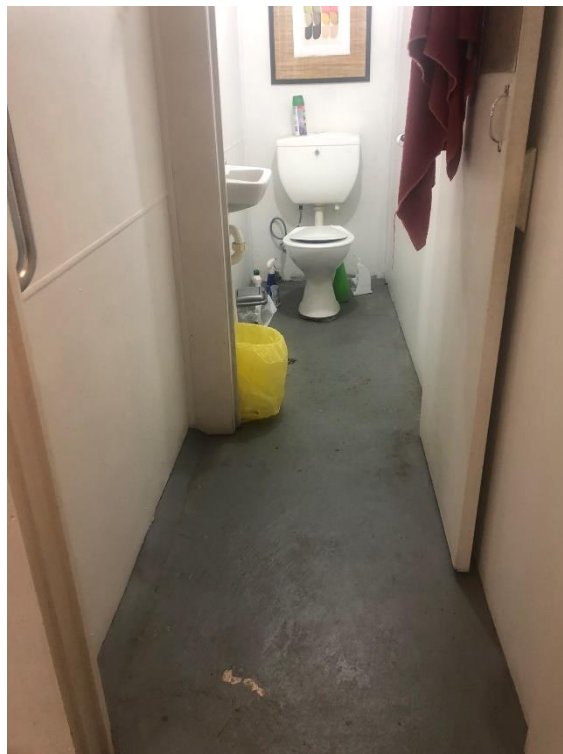
Mould and moisture within the men's bathroom wall linings and timber framing.
It looks like the men's and women's bathroom area was flooded / submersed under a significant quantity of water for a significant period of time.

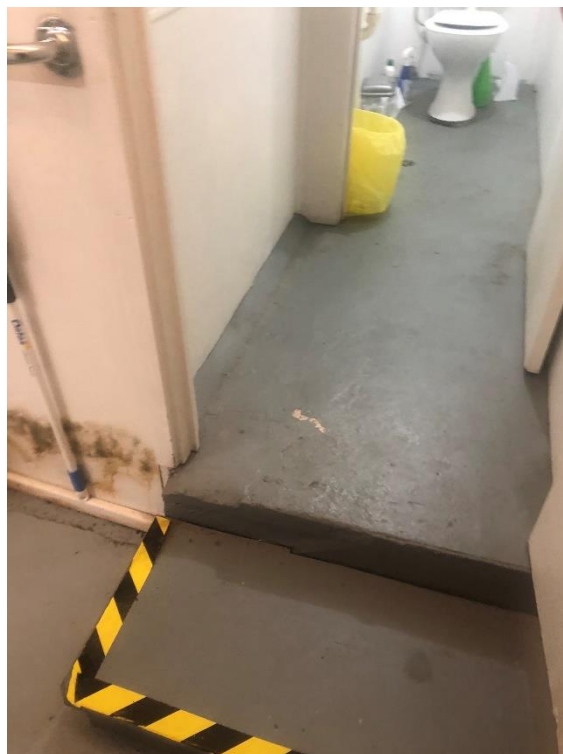
Hallway leading to bathroom has mould and moisture present within the wall linings.

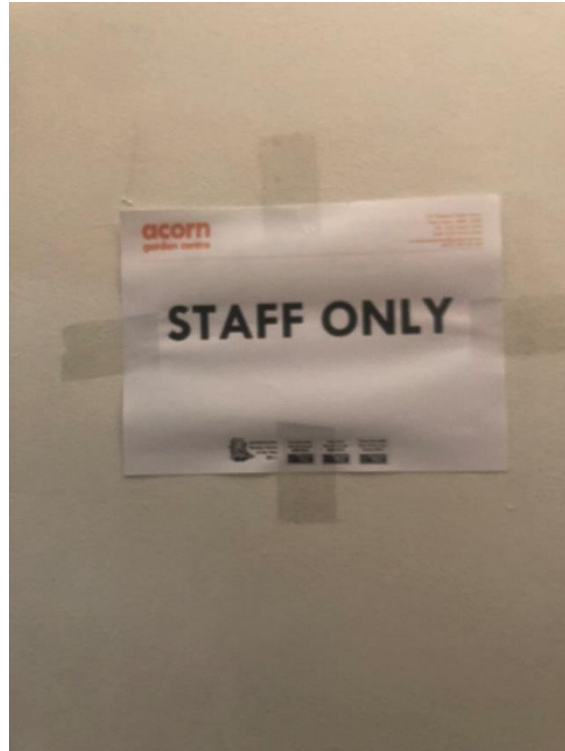
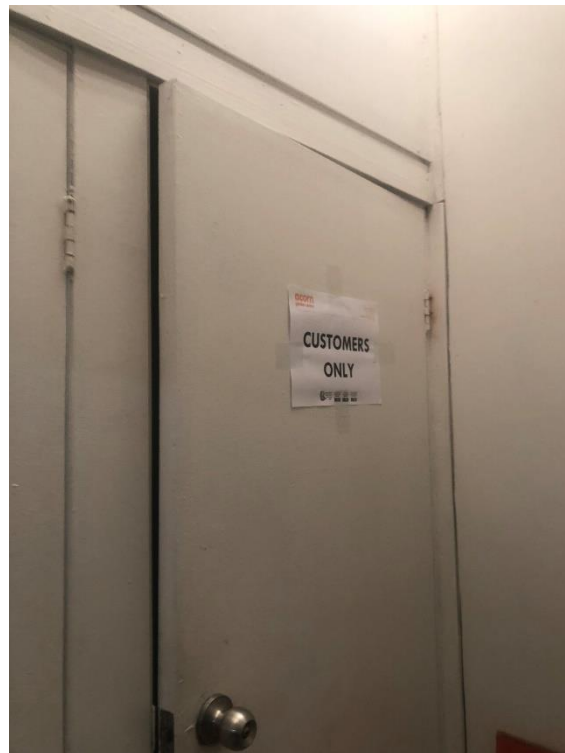
Mould and moisture within the bathroom doors.
