Pre-Lease Condition Report For The Property At:

229 Brisbane Water Drive Point Clare NSW 2250

4th May 2022

Prepared by:
The Property Inspectors
Emilio Calandra

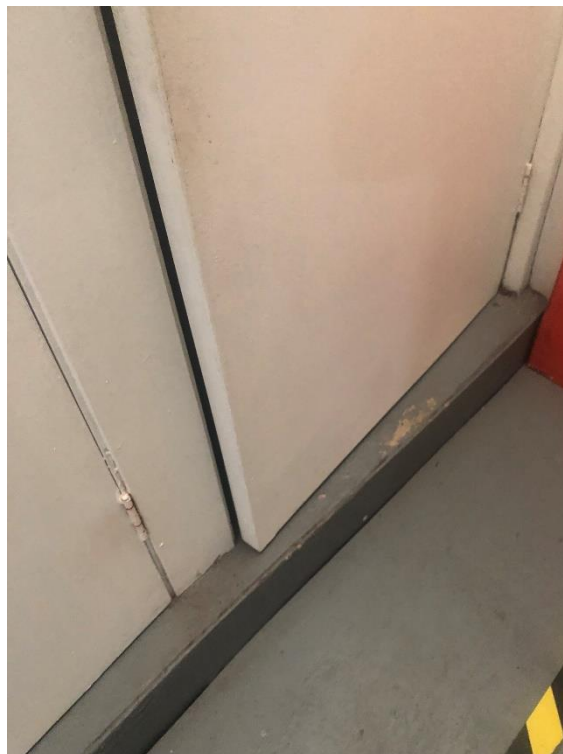
Moisture within the second bathroom.

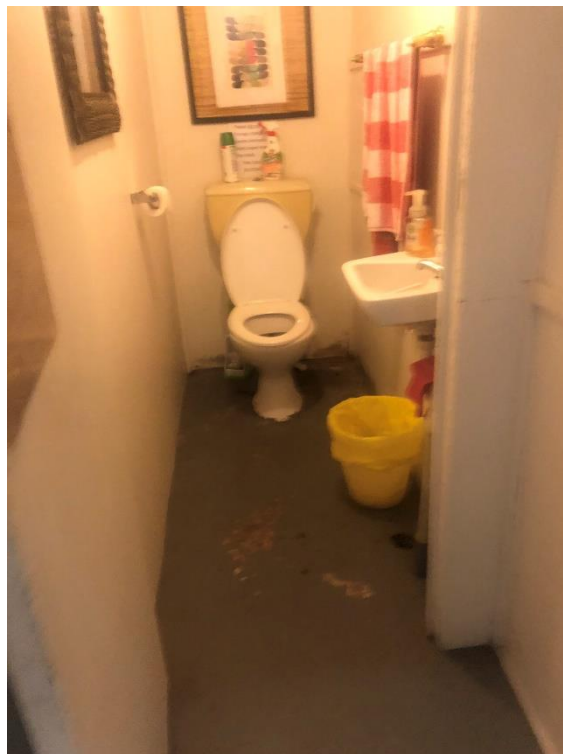
Mould and moisture within the wall linings and floor junctions.
Cracks within the bathroom floor.

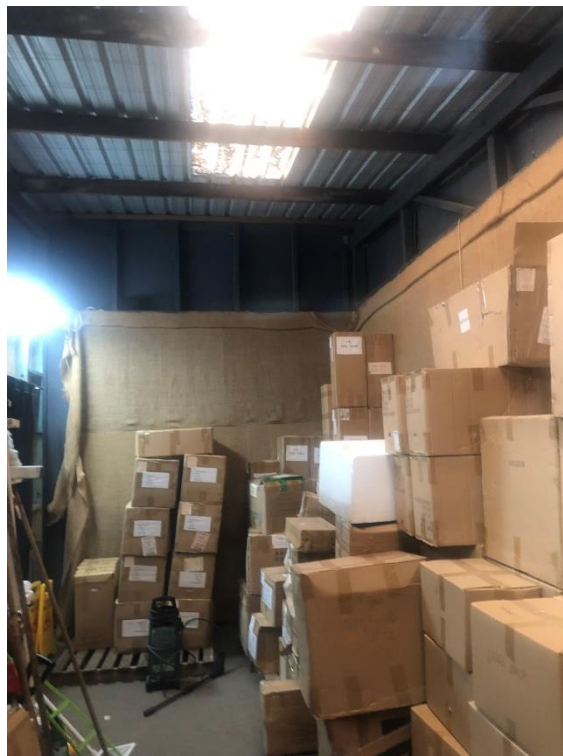
First floor loft / storage area has excess personal belongings which obstructed access and my line of sight, no major defects were seen within these areas, however minimal access was available on the day of my inspection.

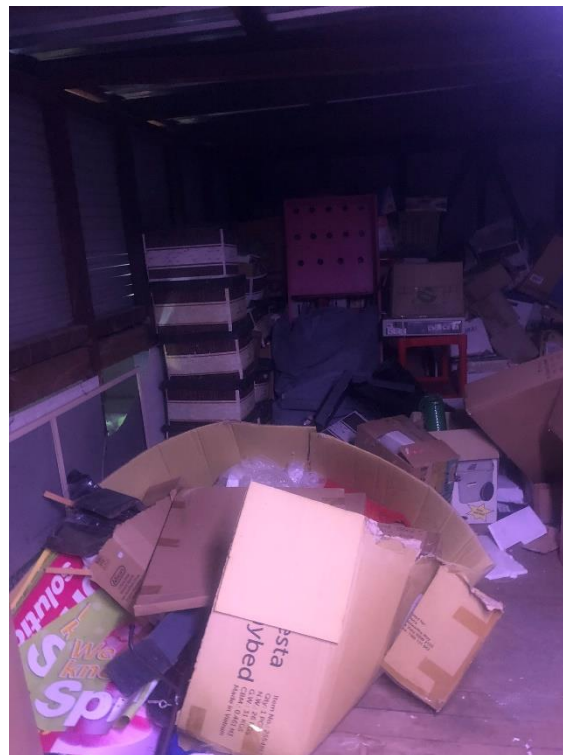
First floor loft wall linings are cracked, I assume these linings are made out of asbestos or fibrous based products.
