# **Dilapidation Report For The Development At: 26 Edwards Bay Rd, Mosman**

## Dilapidation Report Carried Out On:

24 Edwards Bay Road

30<sup>th</sup> April 2026

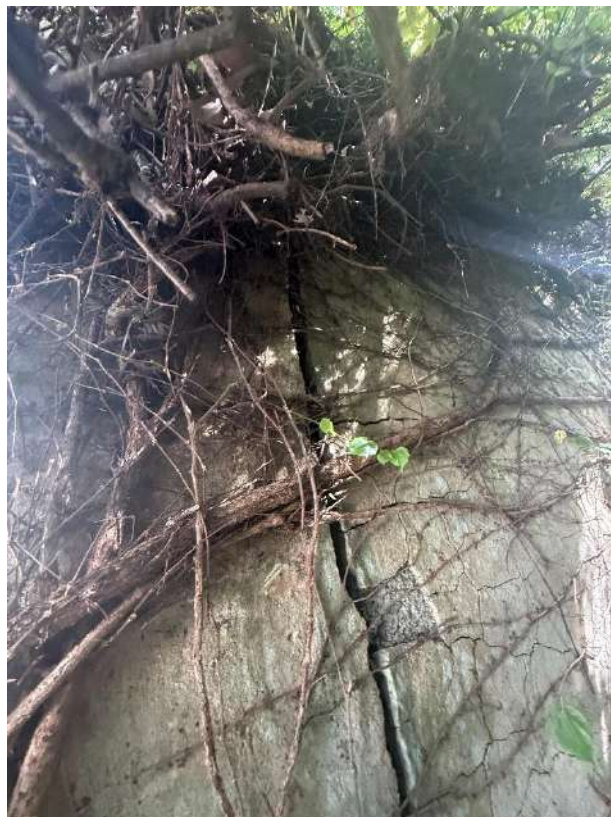
Left and right masonry walls on either side of entry stairs are structurally cracked horizontally and vertically within the masonry walls

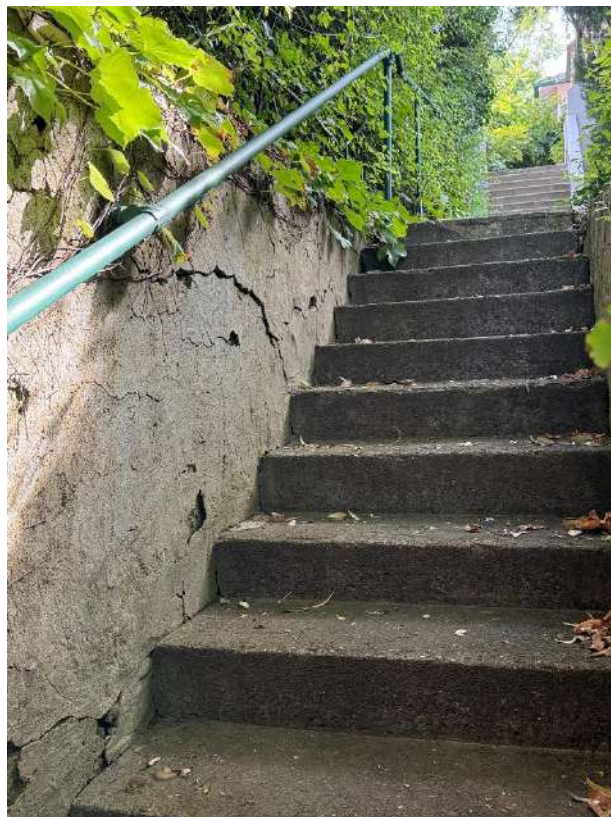
Left and right masonry walls on either side of entry stairs are structurally cracked horizontally and vertically within the masonry walls

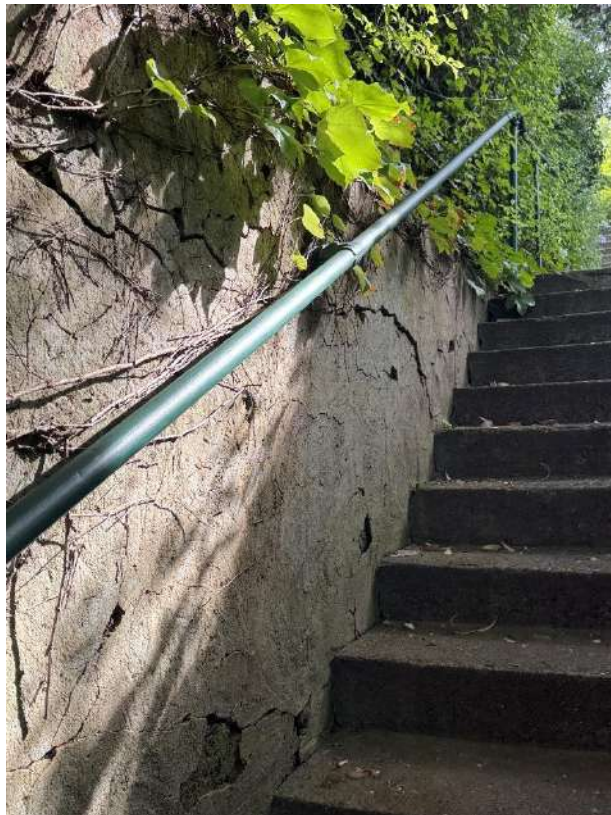
Left and right masonry walls on either side of entry stairs are structurally cracked horizontally and vertically within the masonry walls

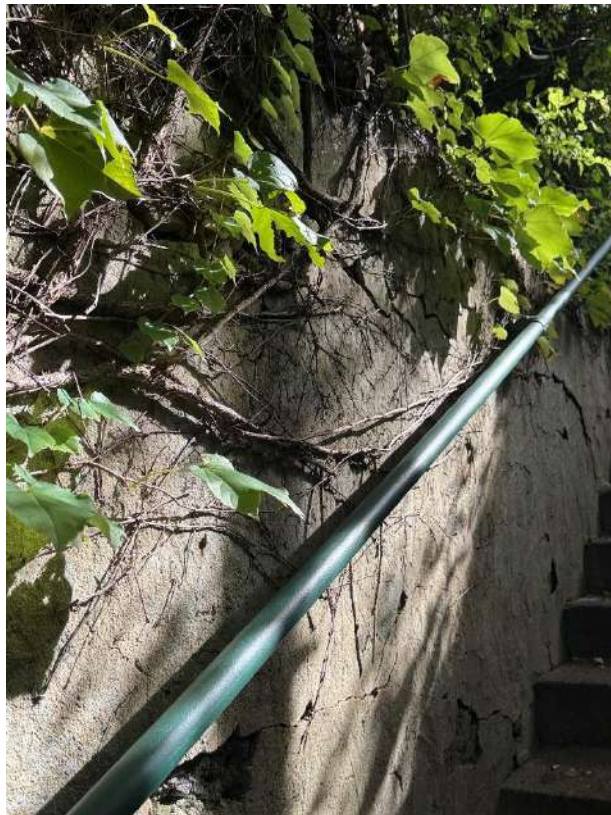
Left and right masonry walls on either side of entry stairs are structurally cracked horizontally and vertically within the masonry walls

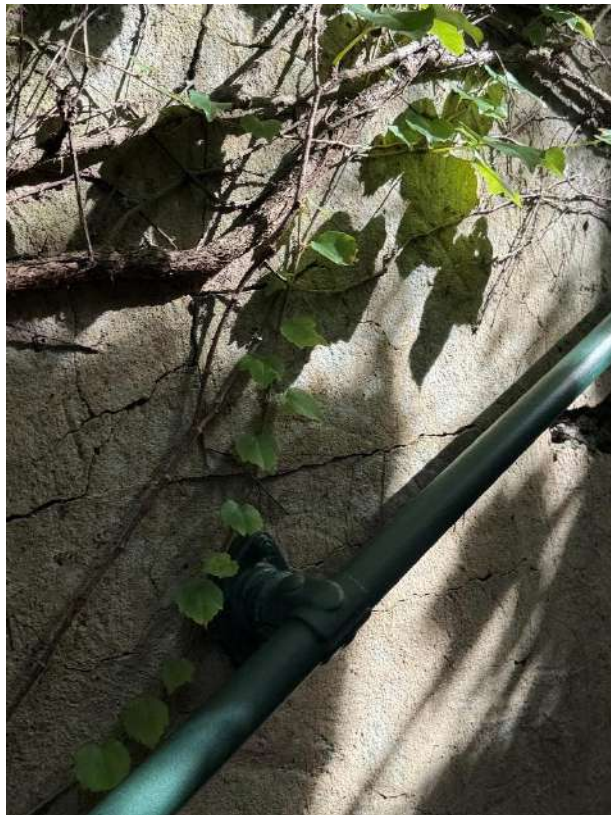
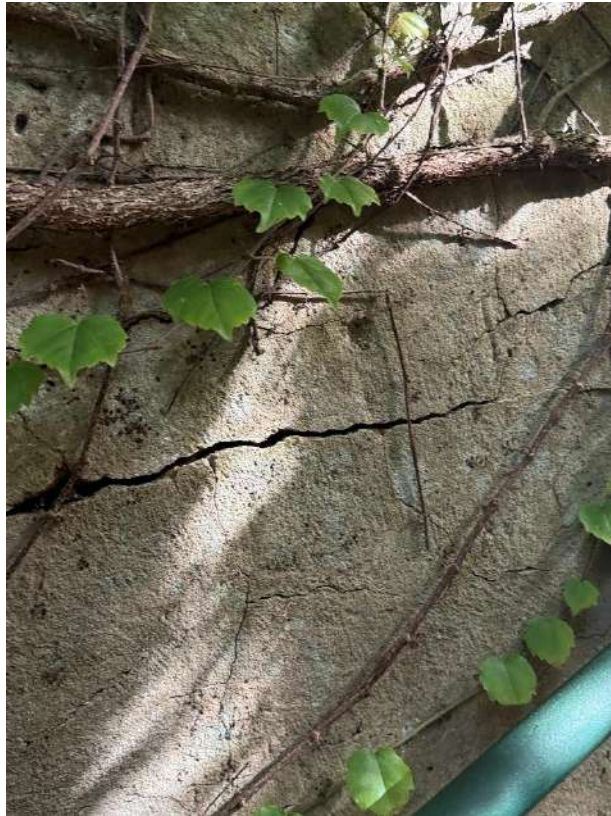
Left and right masonry walls on either side of entry stairs are structurally cracked horizontally and vertically within the masonry walls

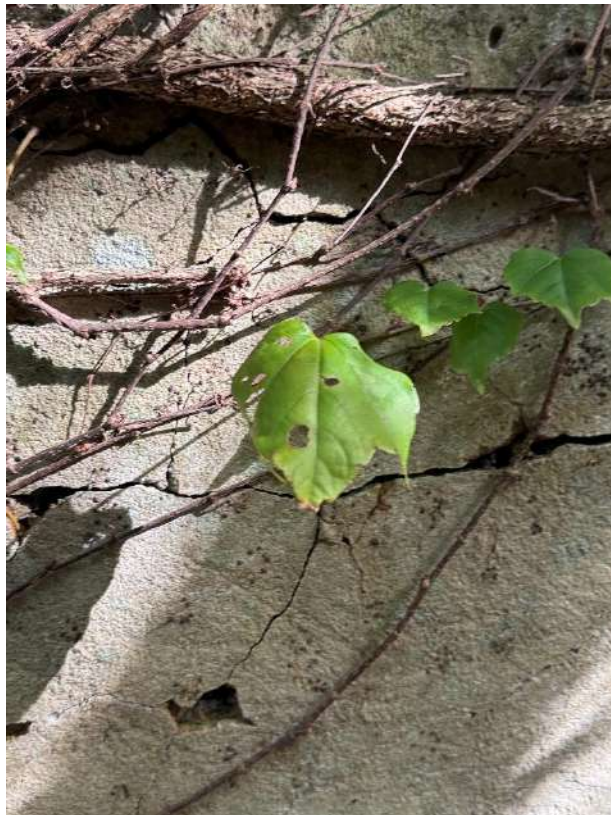
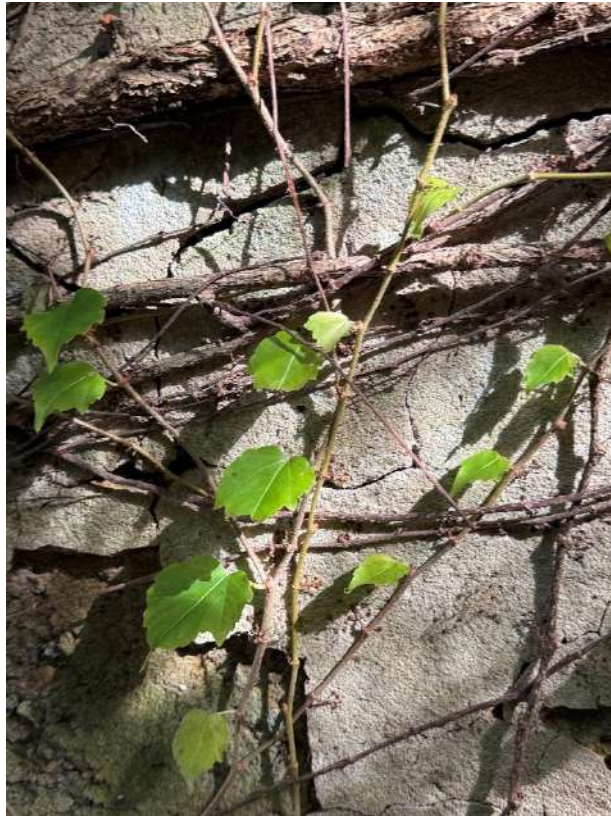
Left and right masonry walls on either side of entry stairs are structurally cracked horizontally and vertically within the masonry walls

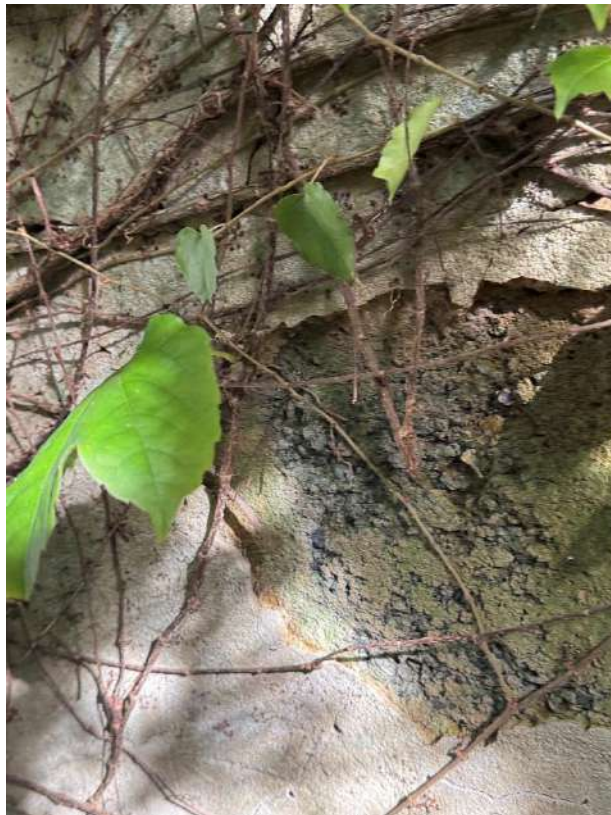
Left and right masonry walls on either side of entry stairs are structurally cracked horizontally and vertically within the masonry walls

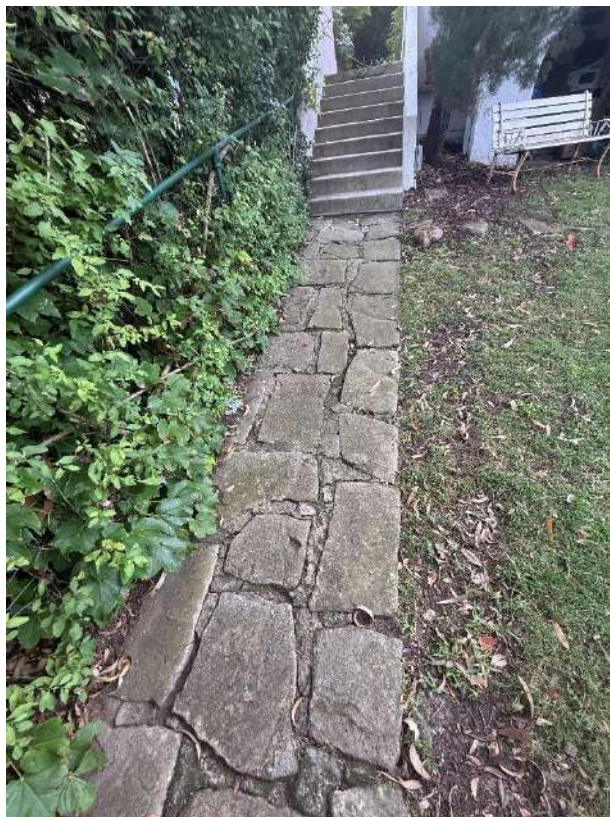
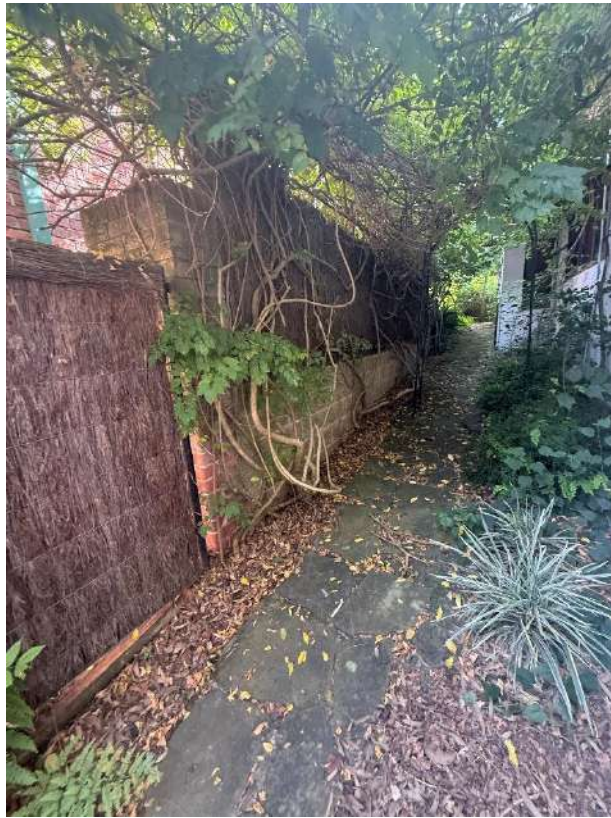
Minor hairline cracks in sandstone flagging floor finish

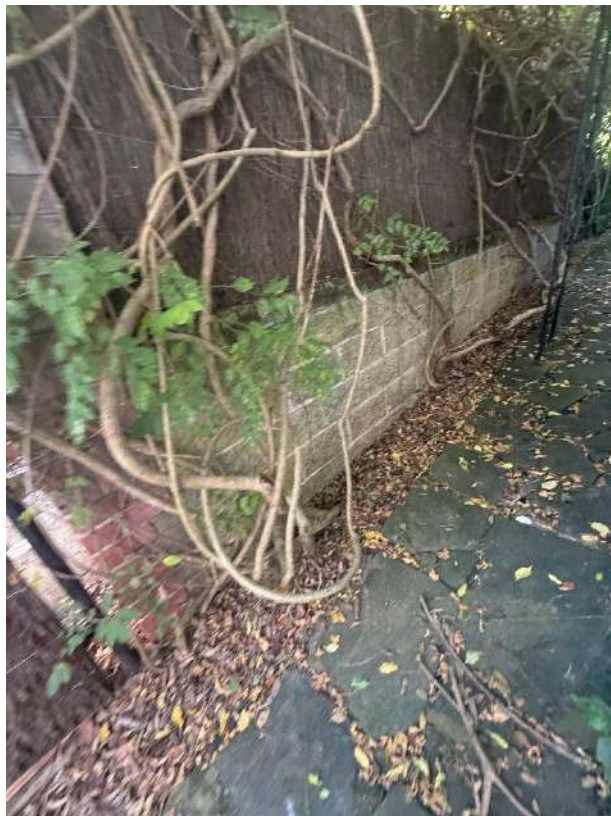
Boundary masonry wall shows signs of minor horizontal cracks within the block work

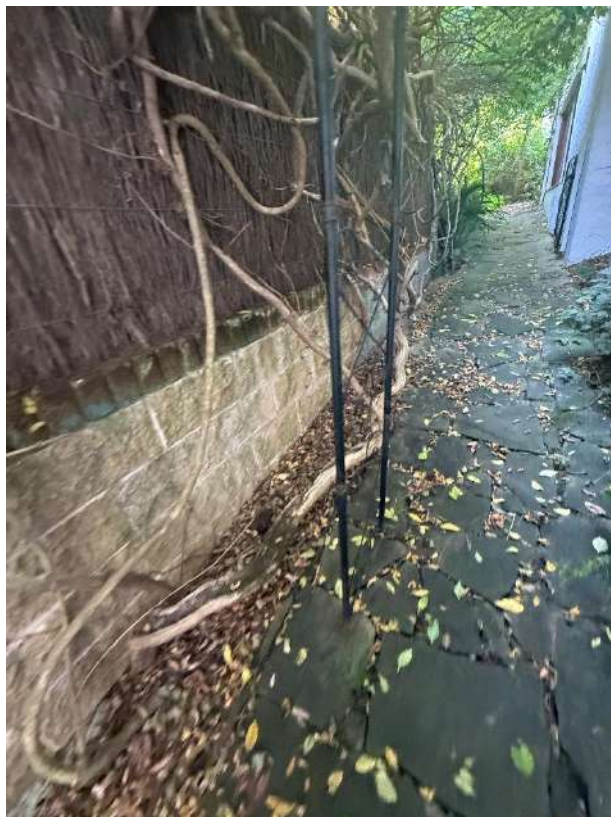
Cracks within the sandstones flagging floor finish

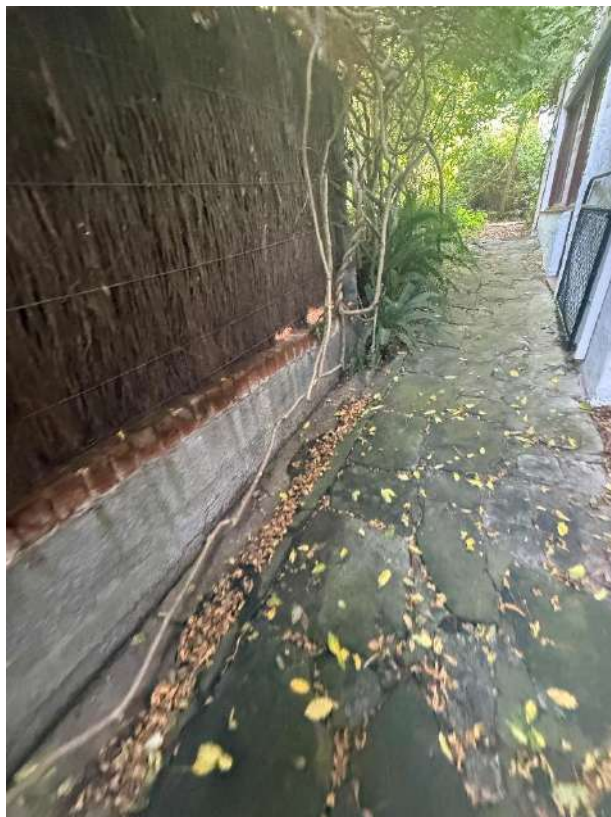
Hairline cracks within the blockwork along the boundary line

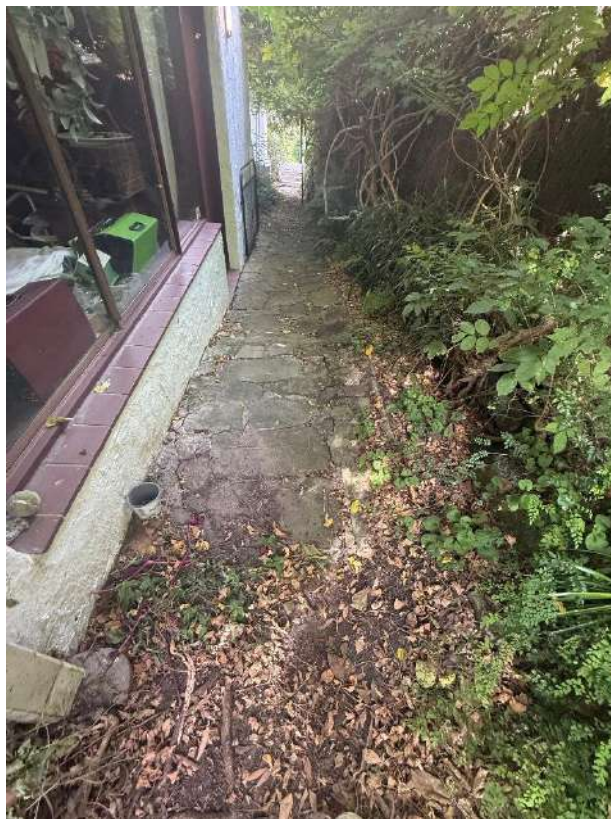
Cracks within the sandstone flagging floor finish

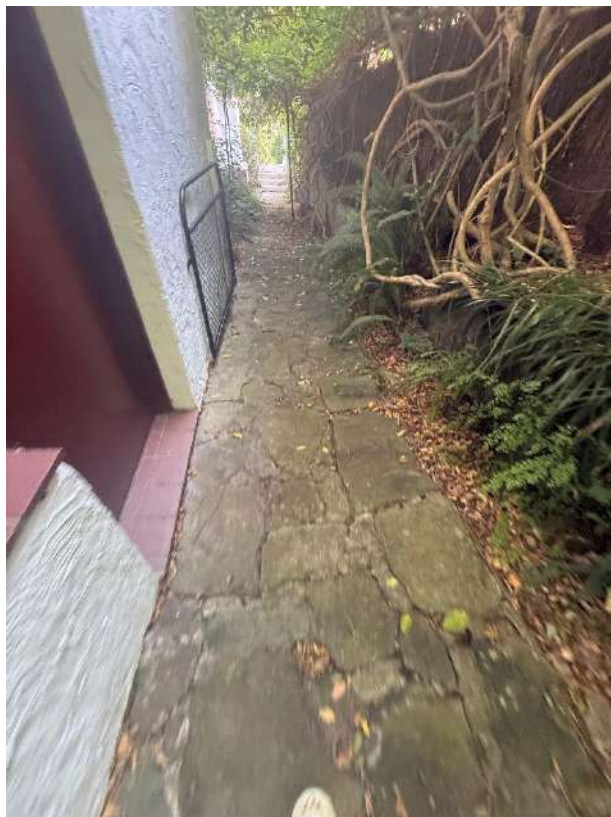
Cracks within the sandstone mortar joints

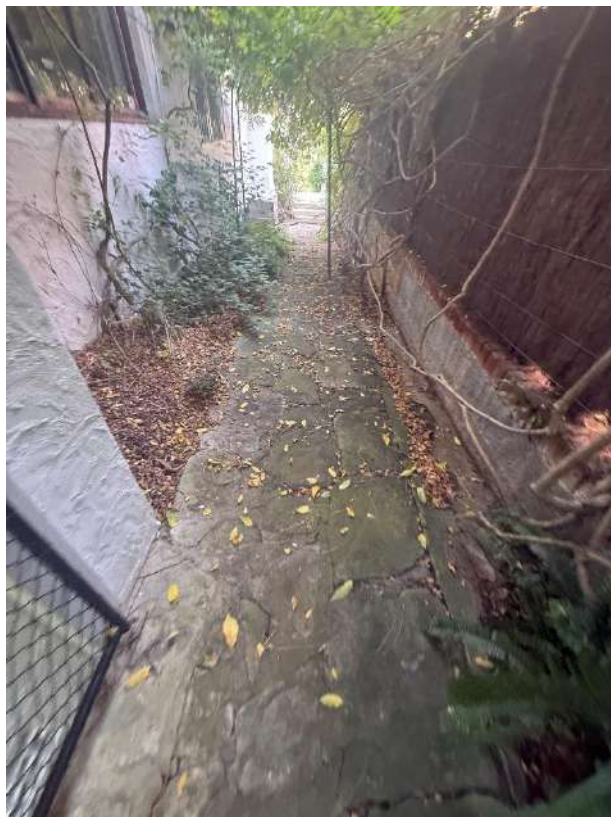
Cracks within the sandstone mortar joints

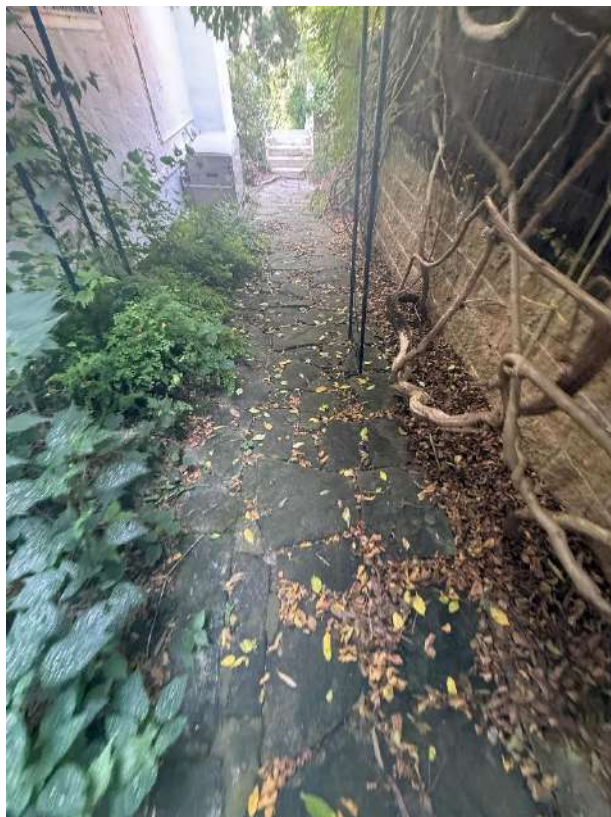
Cracks within the sandstone mortar joints

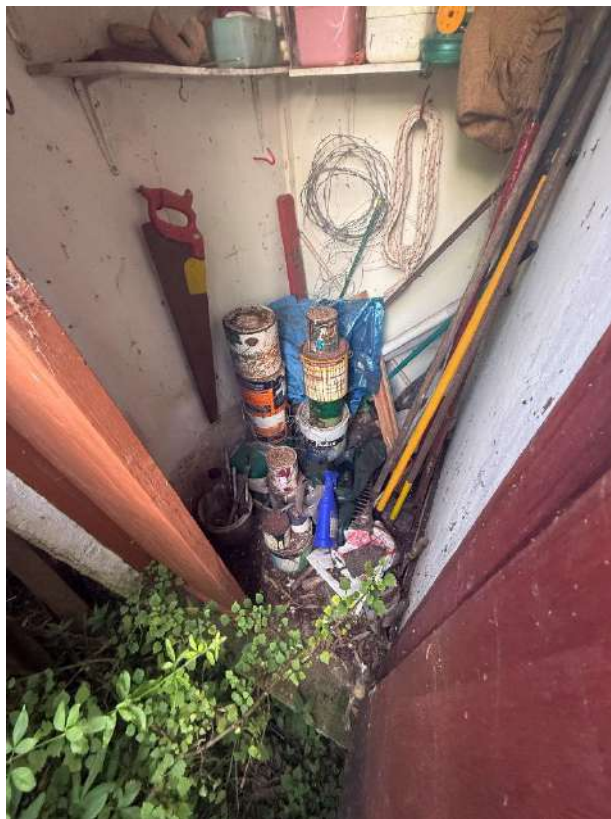
Minor hairline cracks within the outside WC and laundry

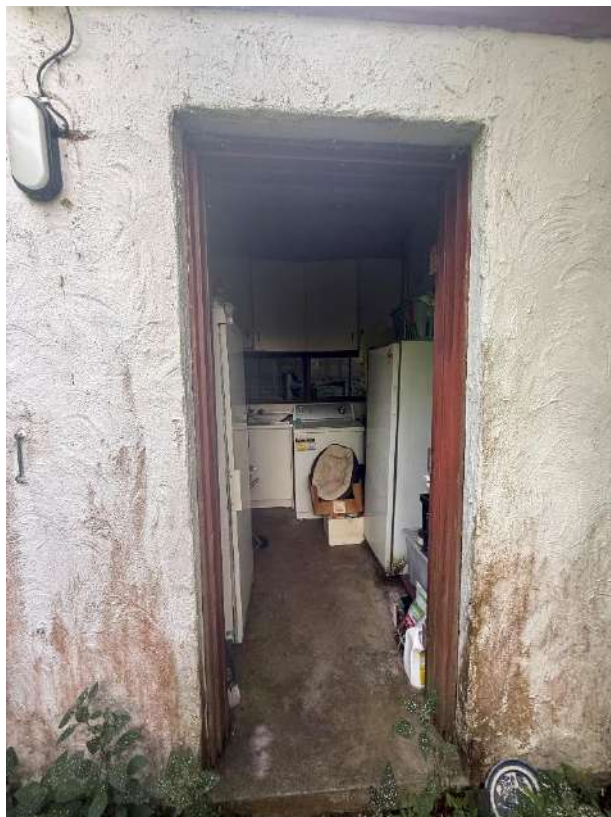
Minor hairline cracks within the outside WC and laundry

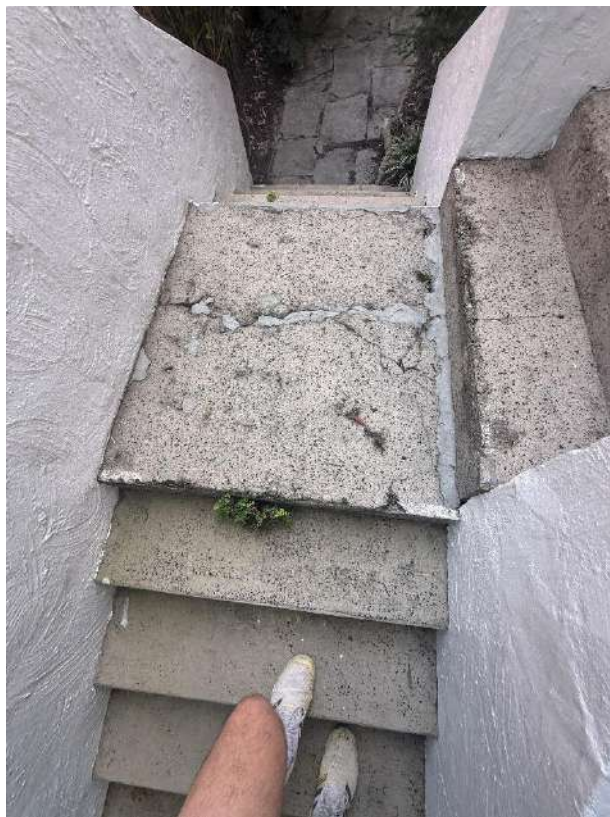
Considerable cracks within the entry stairs and landing leading to the front door

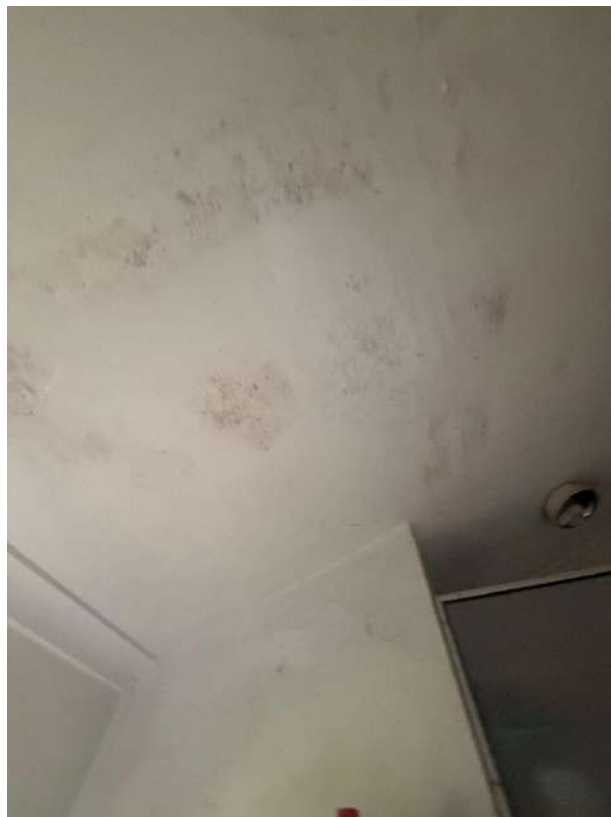
Moisture damage within the ceilings outside bathroom

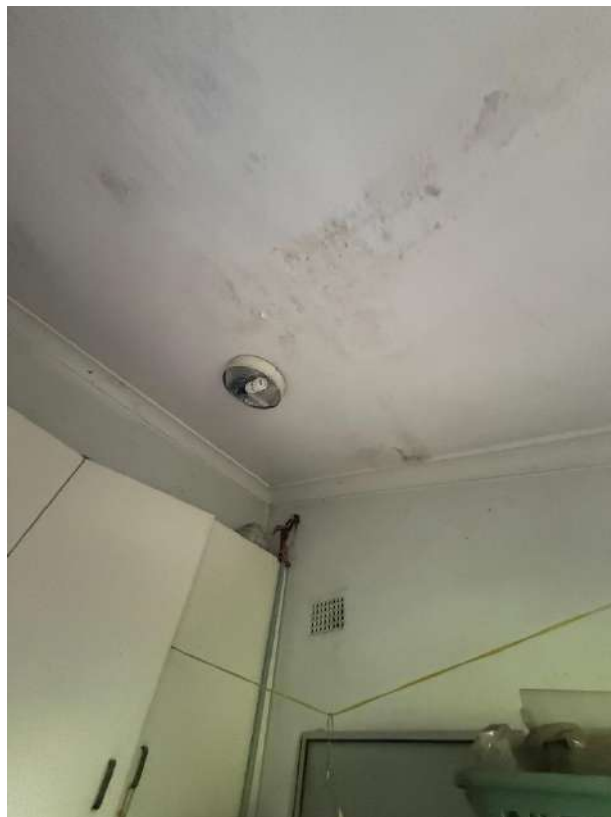
Moisture damage within the ceilings outside bathroom laundry

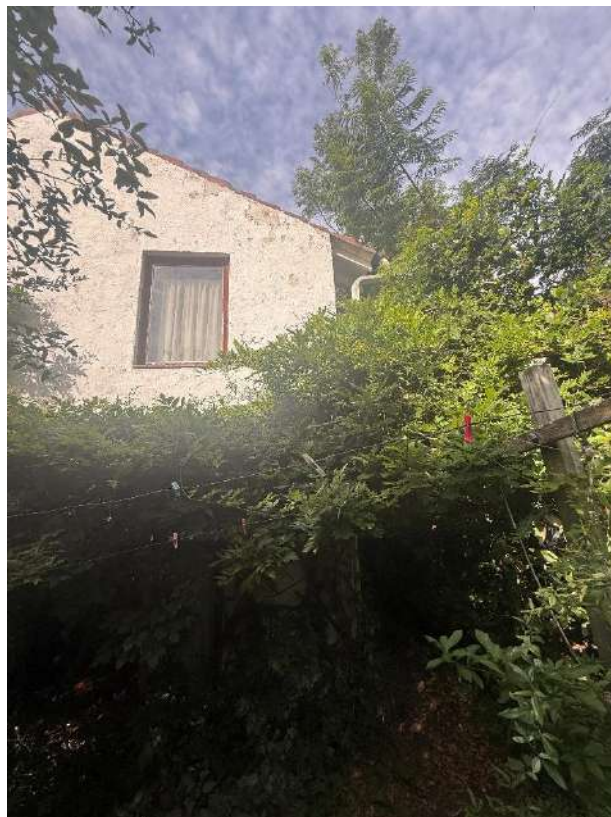
Rising damp in the outside bathroom

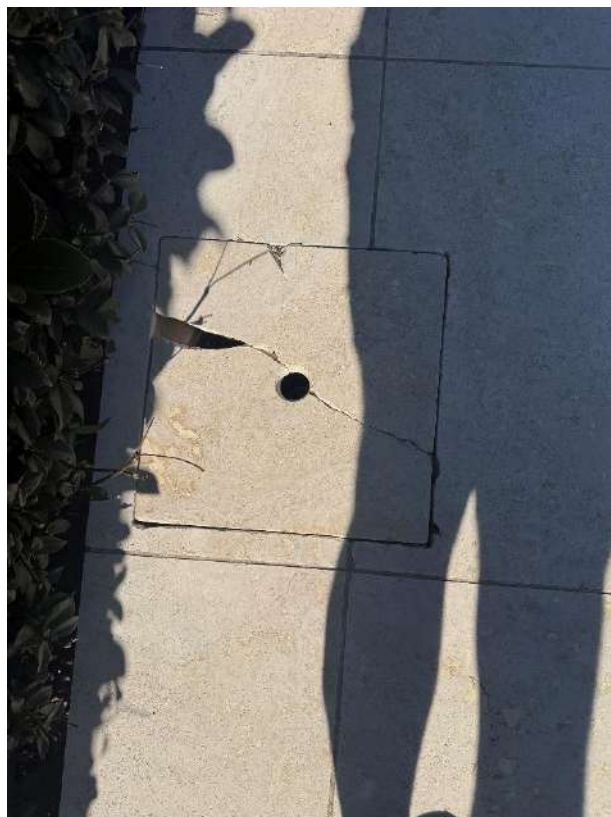
Cracks within the pool skimmer box cover

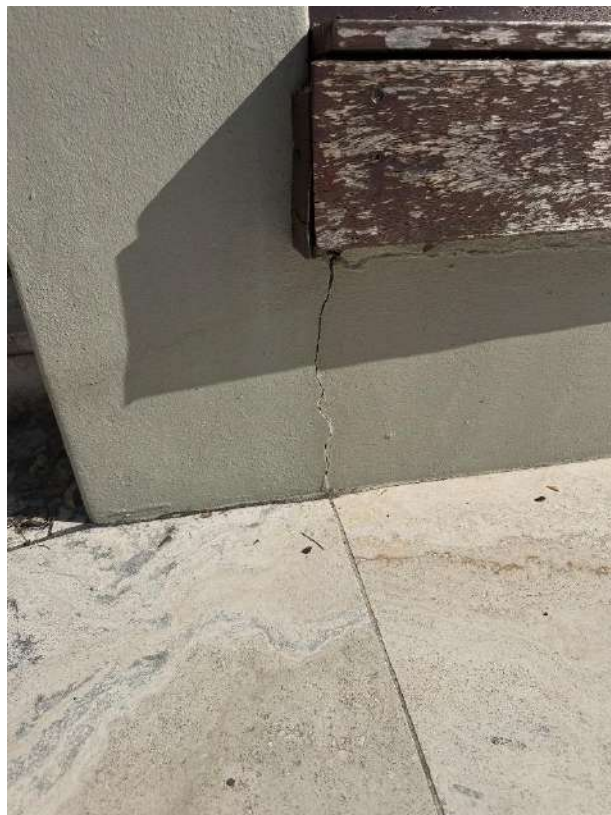
Retaining wall minor horizontal and vertical cracks within the render

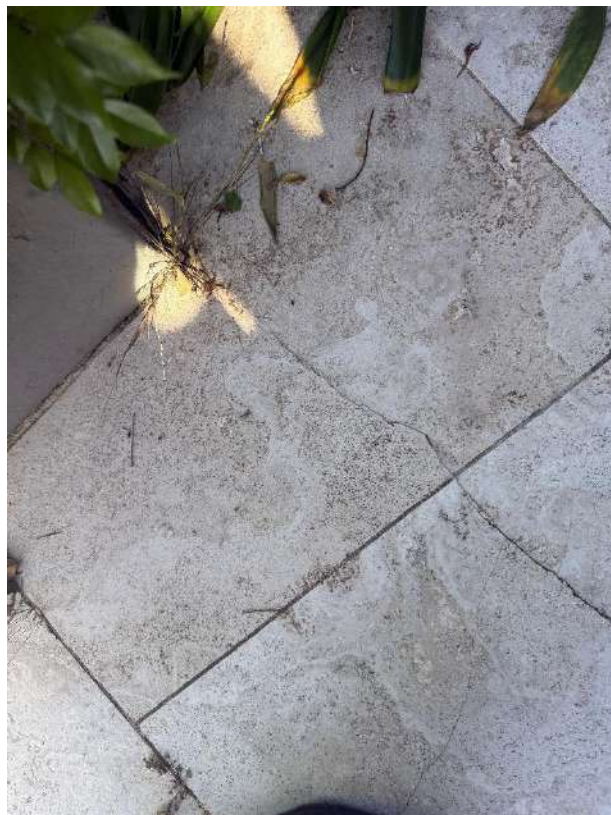
Elevated lifted drummy and cracked floor tiles and pathway

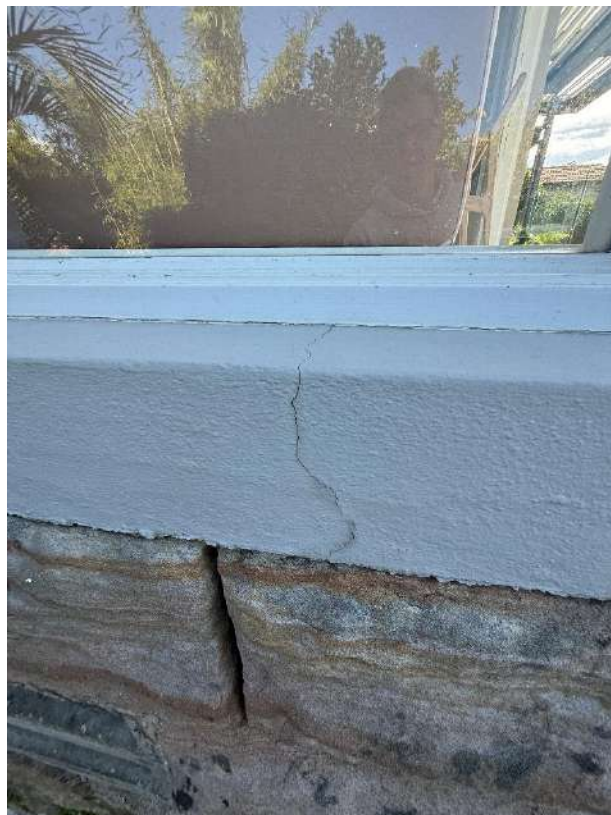
Crack within the external rendered wall below the window

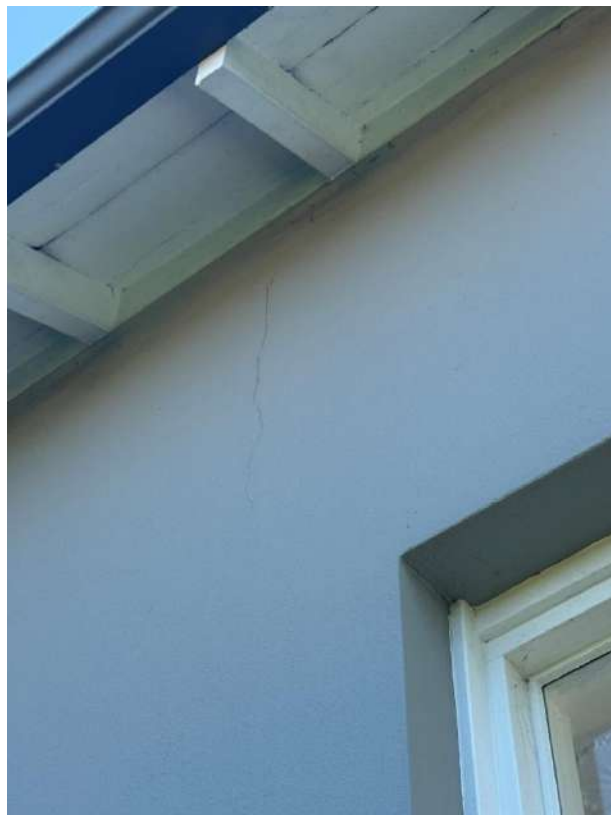
Top-left corner of the window has a vertical and horizontal crack within the external rendered wall

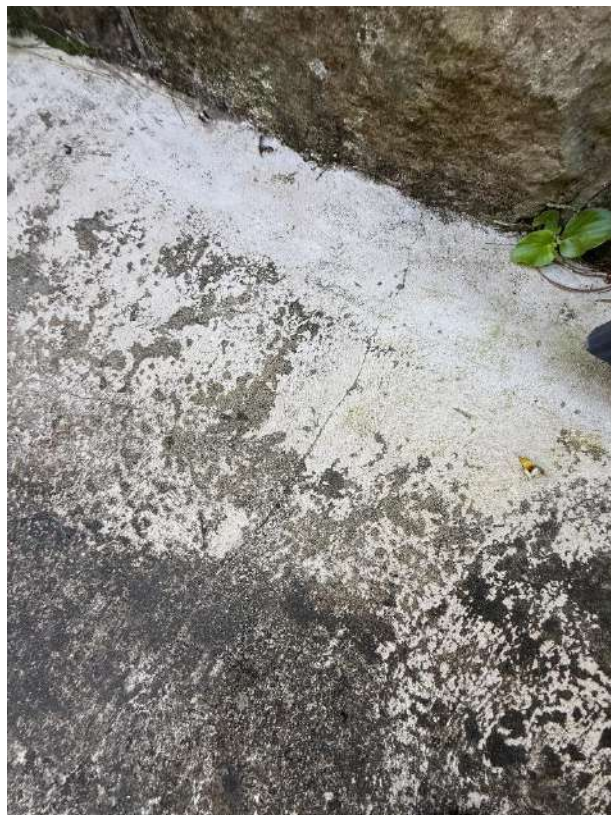
Cracks within the concrete left pathway

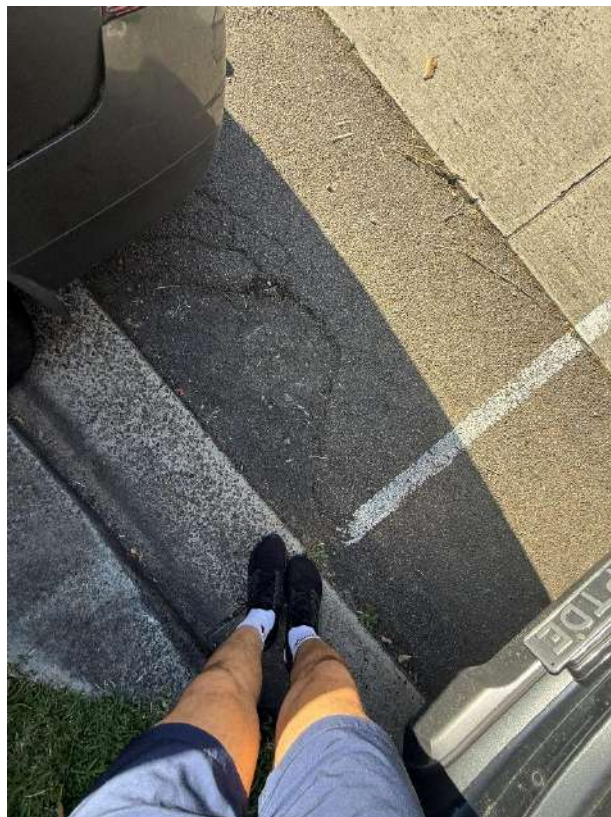
Minor cracks within the concrete curb and gutter

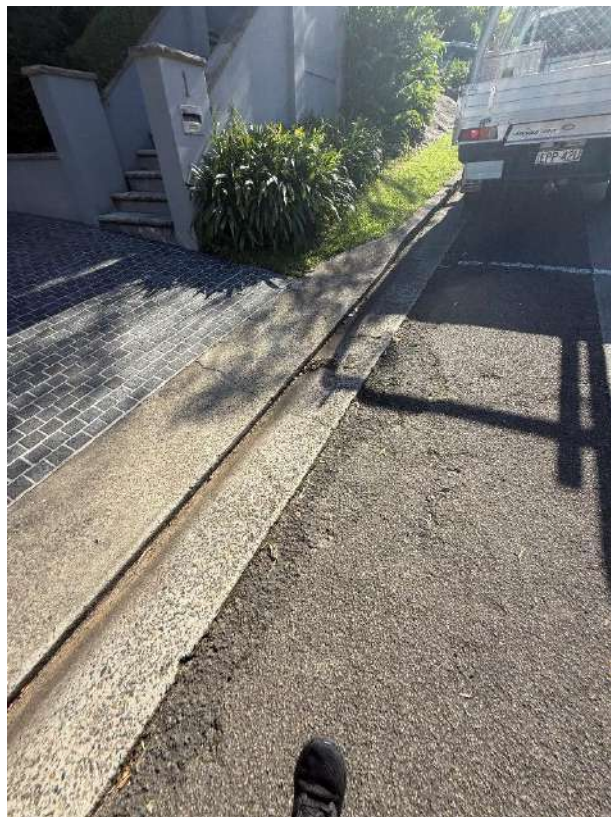
Conditions of bitumen in front of number 1

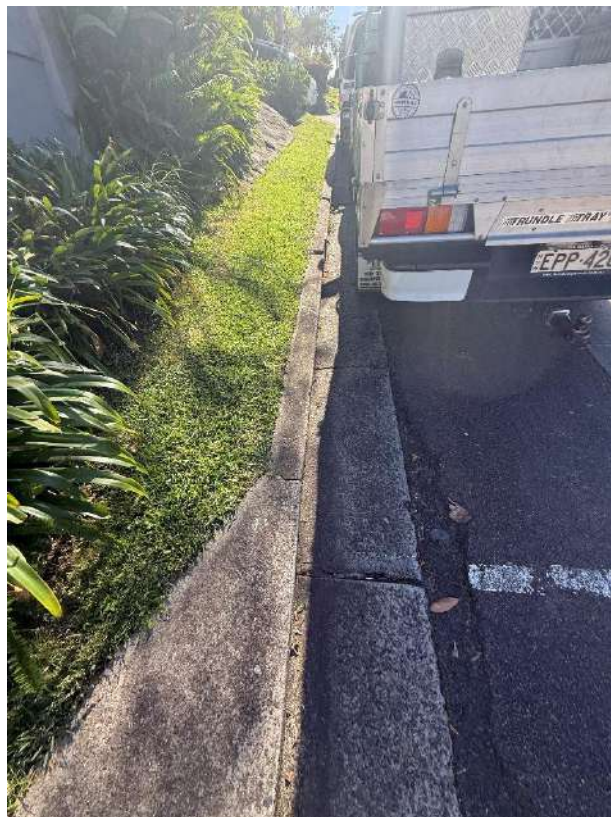
Cracks in curb and gutter

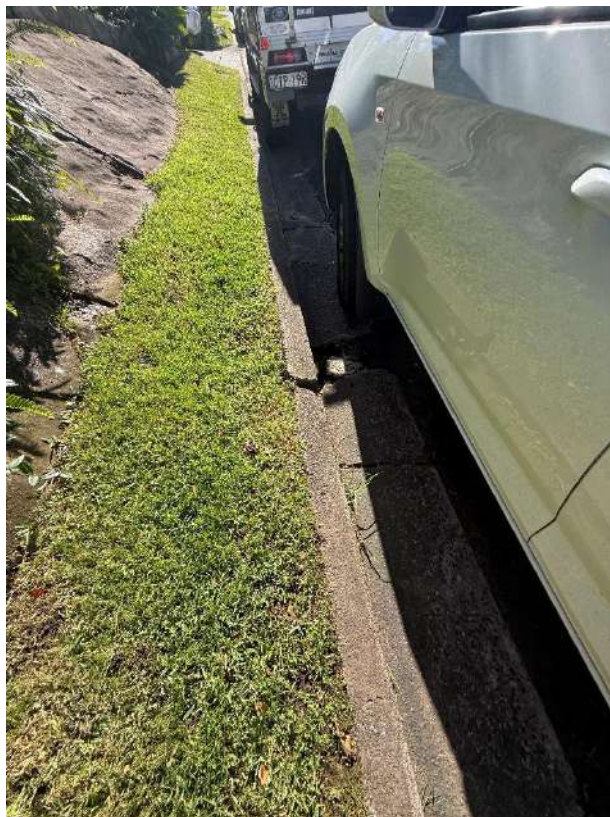
Cracks in curb and gutter

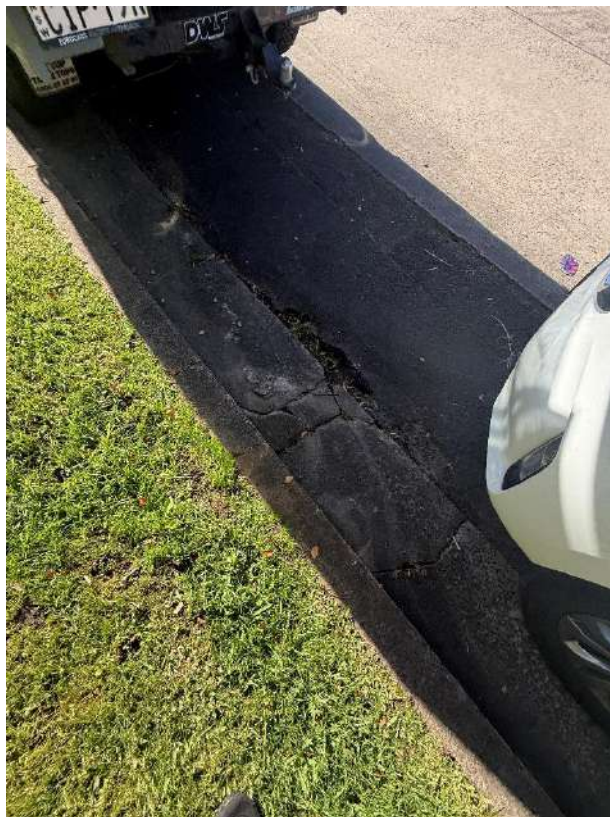
Considerable cracks and damage within the curb and gutter

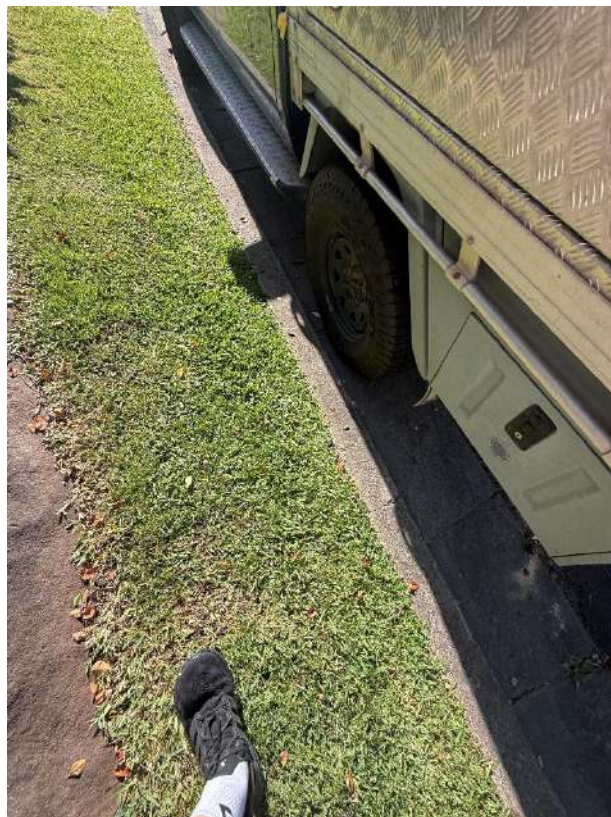
Considerable cracks and damage within the curb and gutter

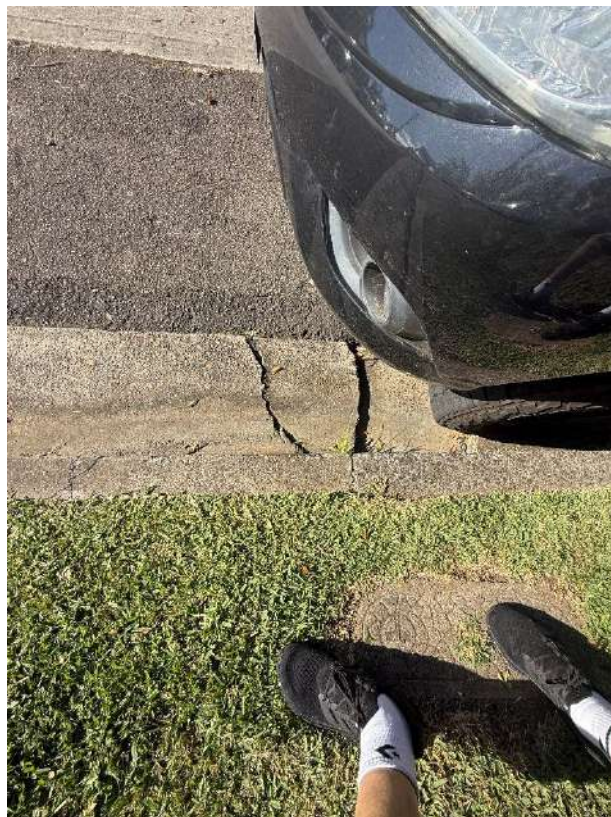
Cracks and damage within the curb and gutter

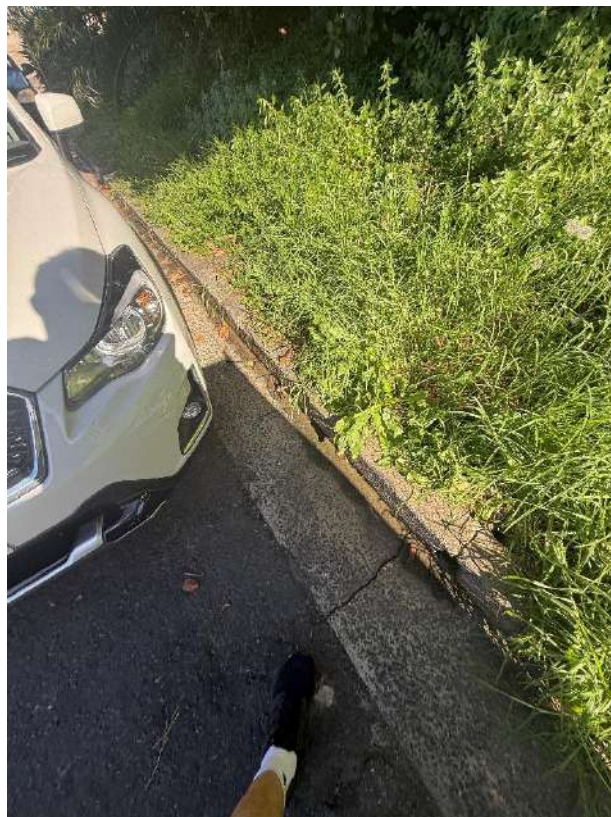
Cracks in the concrete curb and gutter

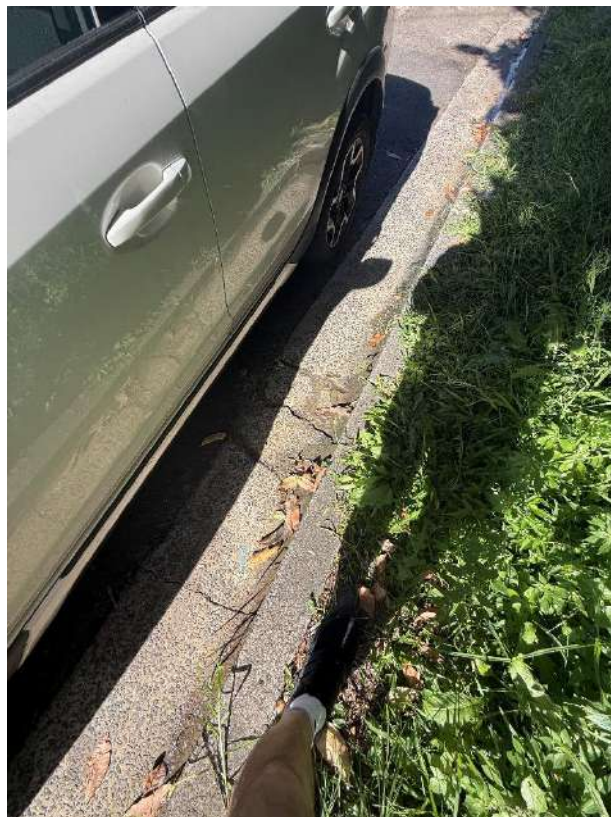
Considerable cracks and damage within the curb and gutter

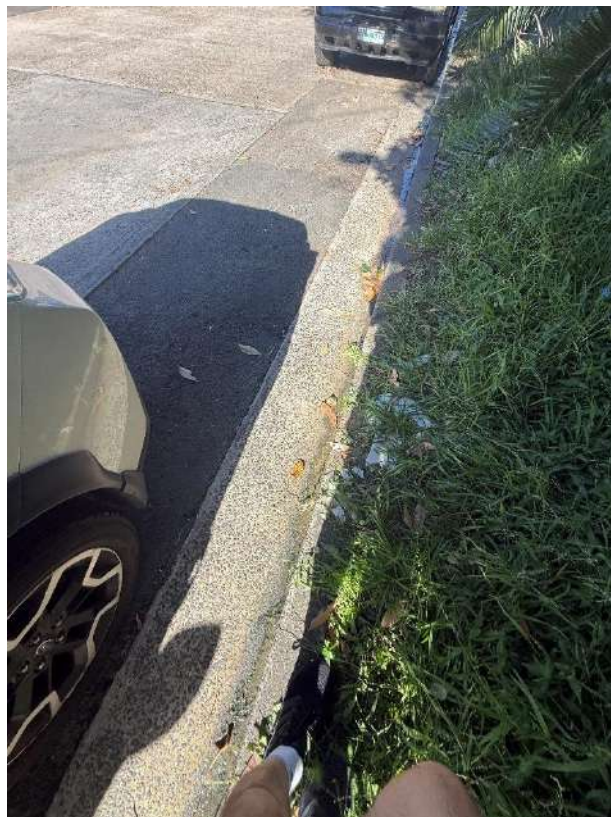
Considerable cracks and damage within the curb and gutter

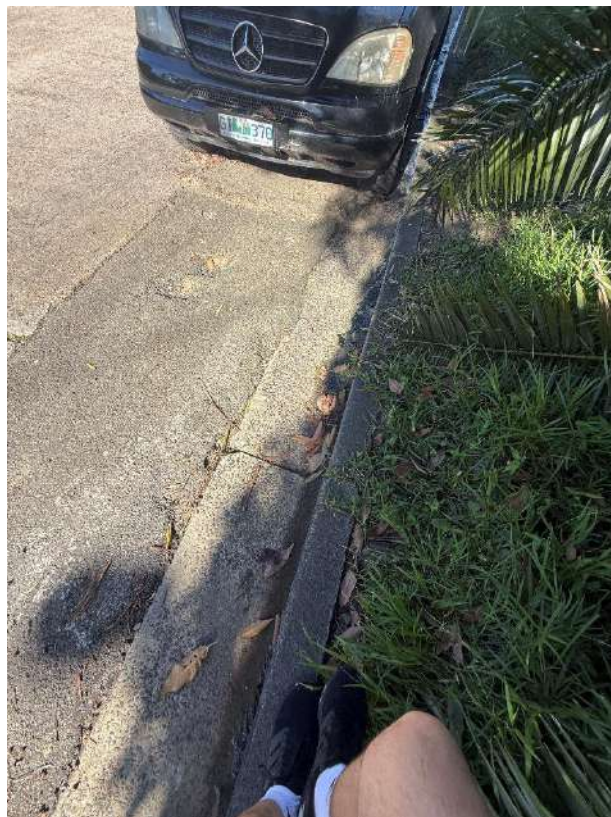
Minor cracks within the concrete curb and gutter

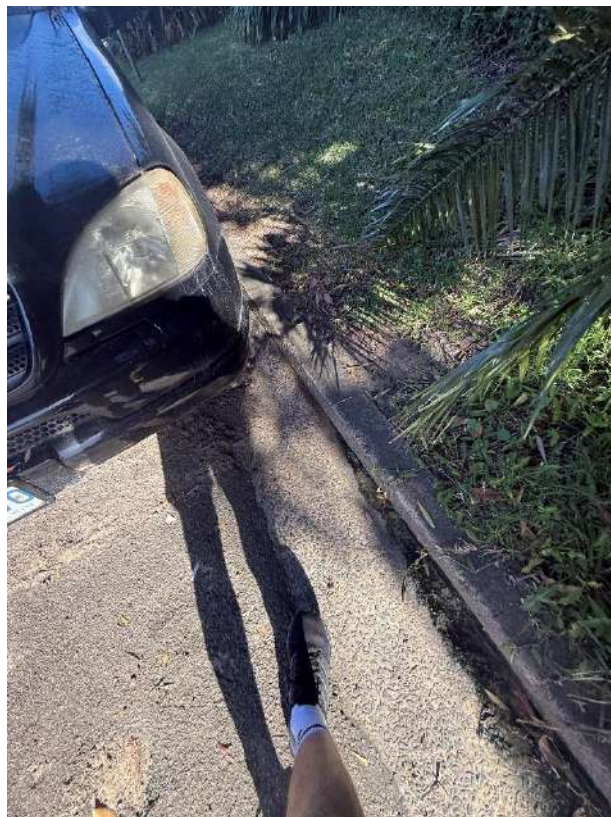
Minor cracks within the concrete curb and gutter

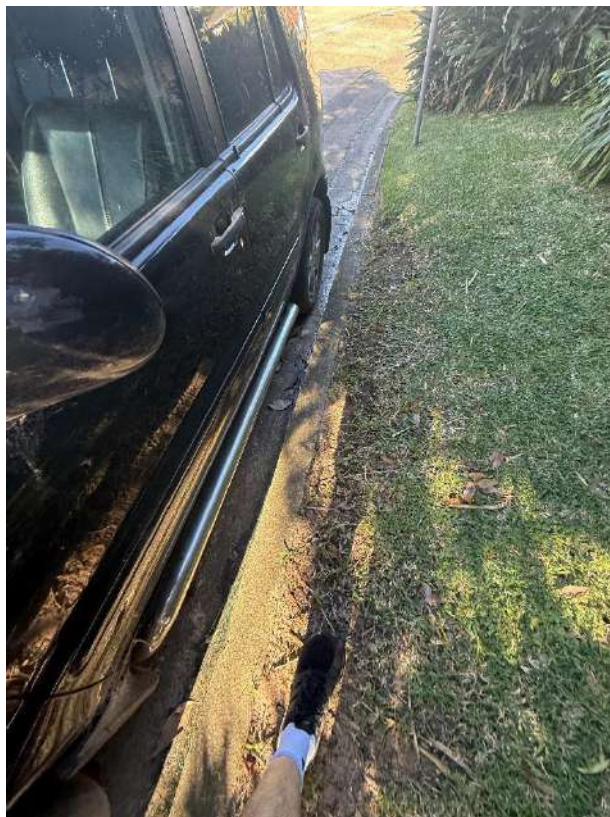
Minor cracks within the concrete curb and gutter

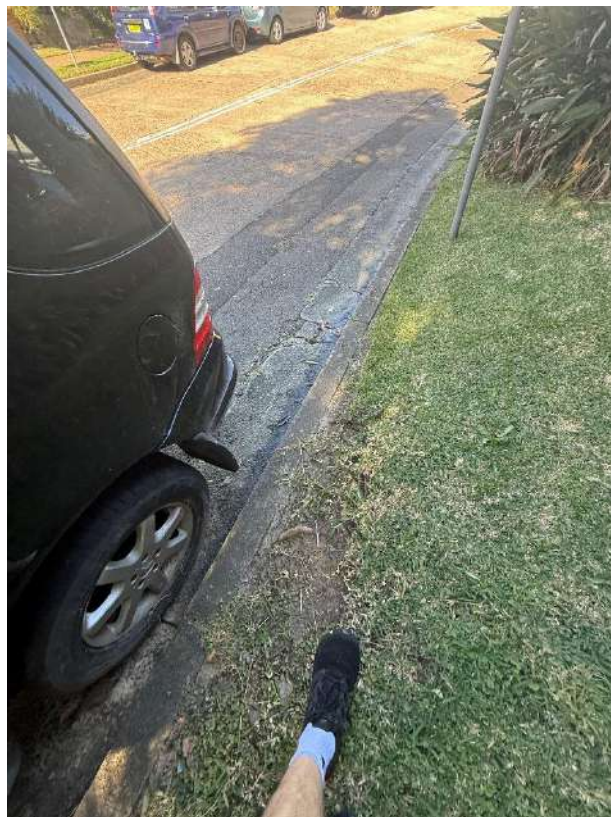
Minor cracks within the concrete curb and gutter

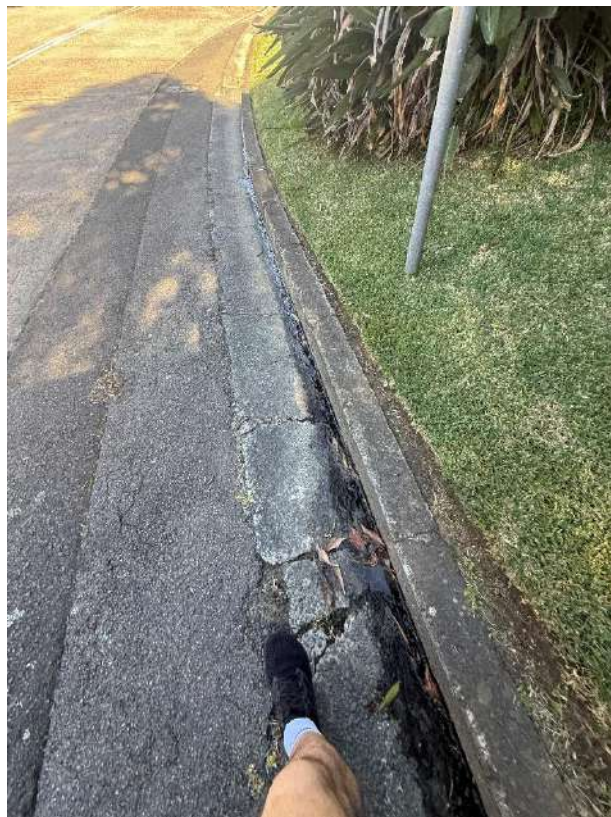
Considerable cracks within the concrete curb and gutter
