# **Dilapidation Report For The Development At: 26 Edwards Bay Rd, Mosman**

## Dilapidation Report Carried Out On:

24 Edwards Bay Road

30<sup>th</sup> April 2026

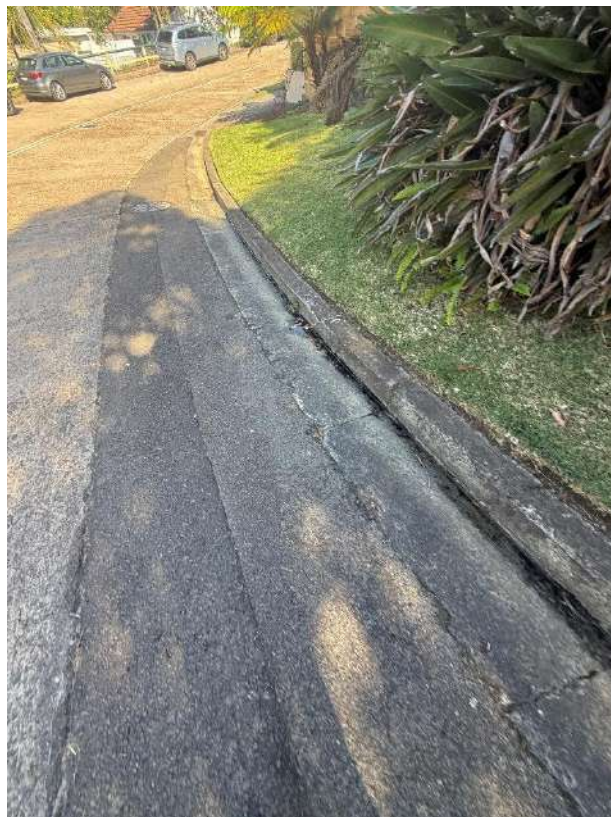
Wear and tear within the concrete curb and gutter

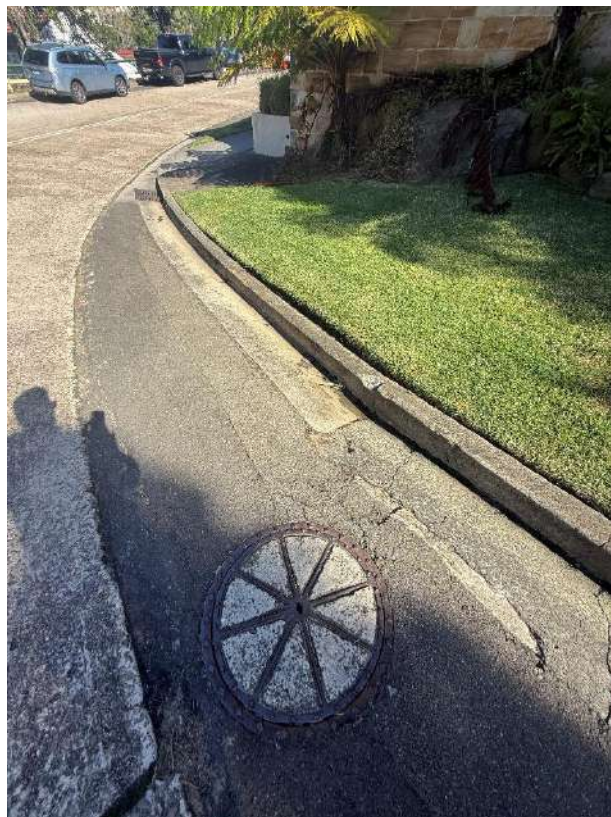
Wear and tear within the concrete curb and gutter

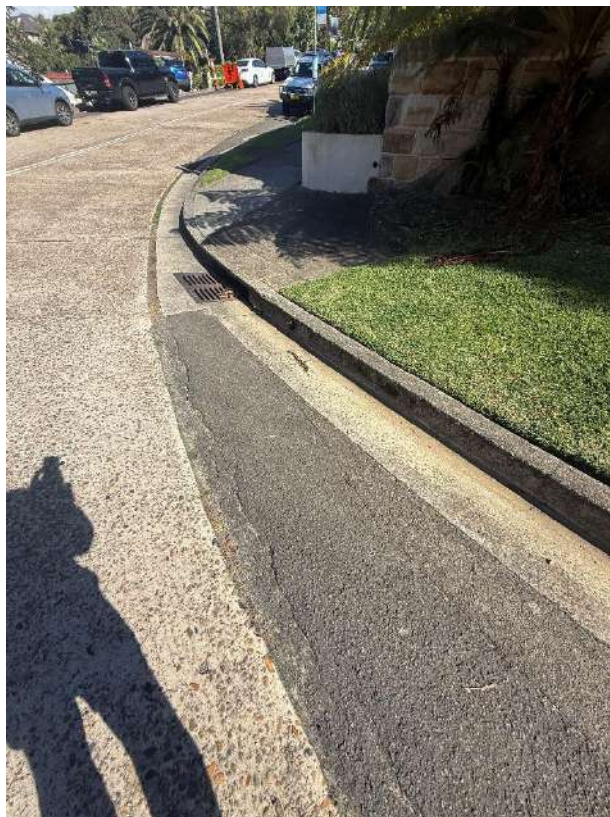
Bitumen cracked

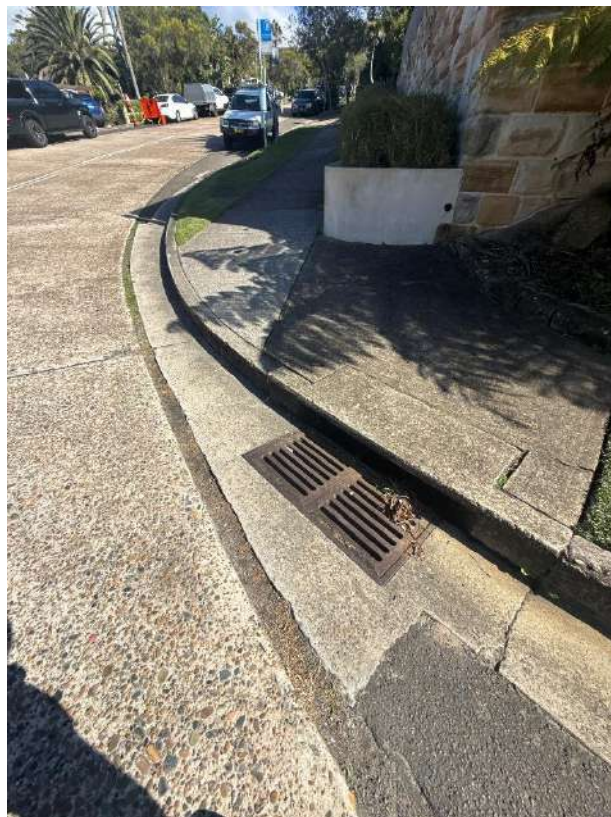
Bitumen cracked

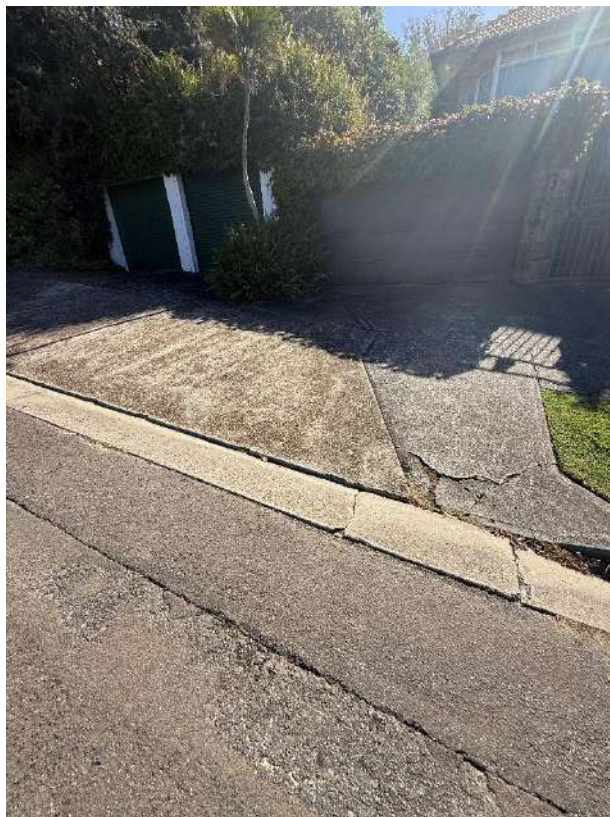
Road in poor condition and cracks within the concrete driveway and curb and gutter

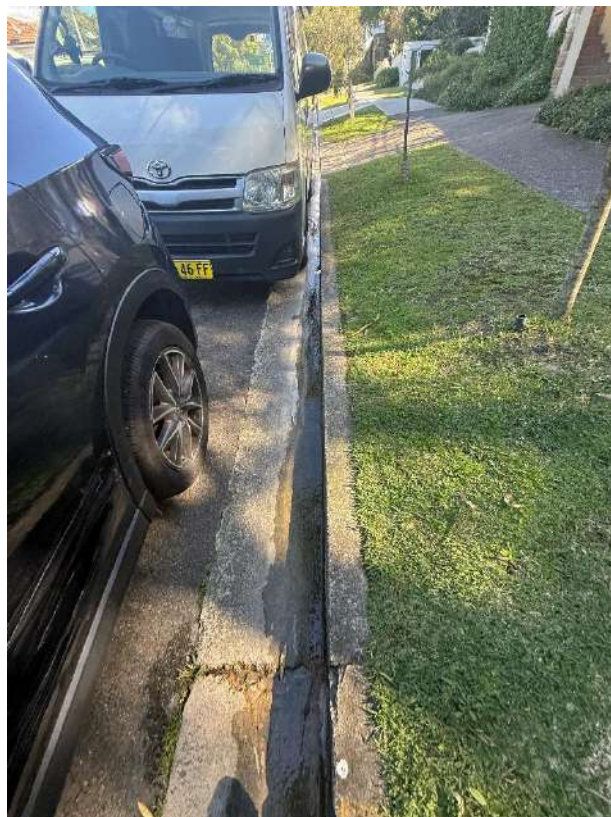
Considerable cracks within the concrete curb and gutter

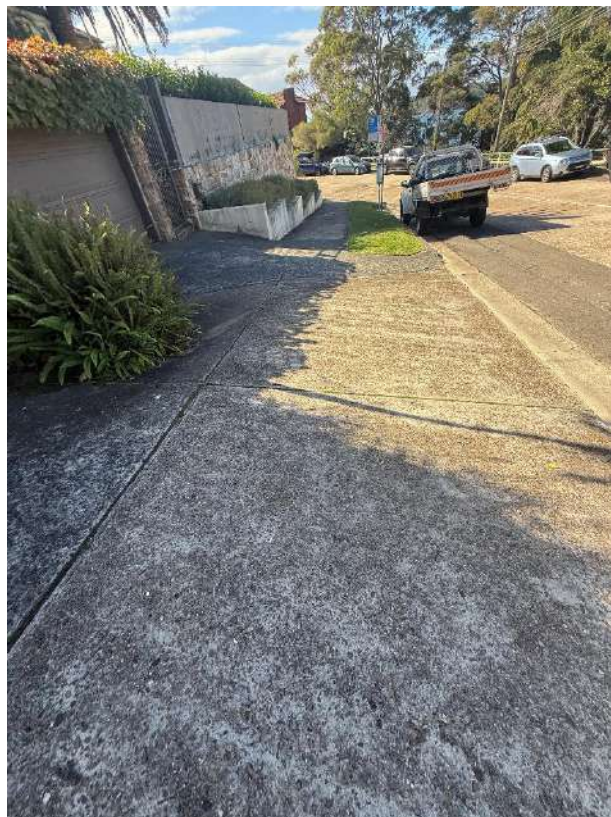
Crack within the concrete driveway and layback

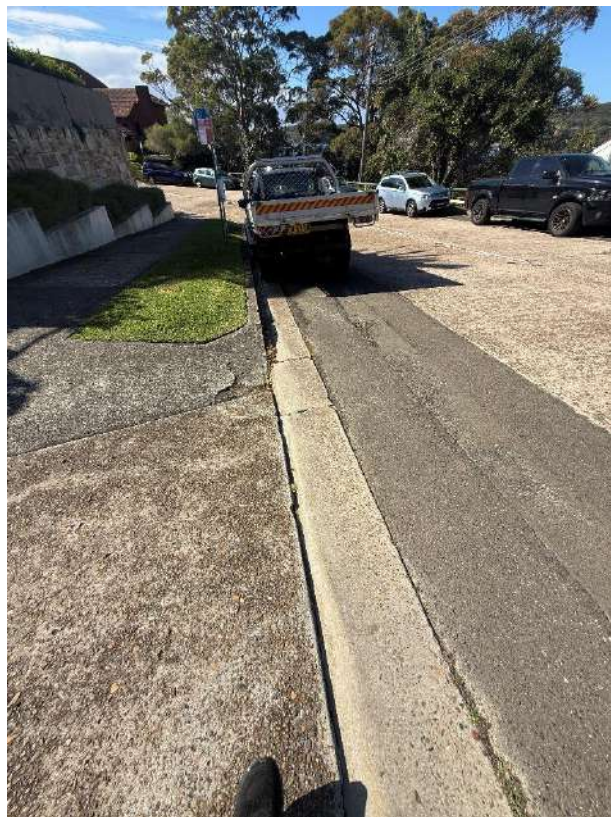
Cracks in the concrete driveway

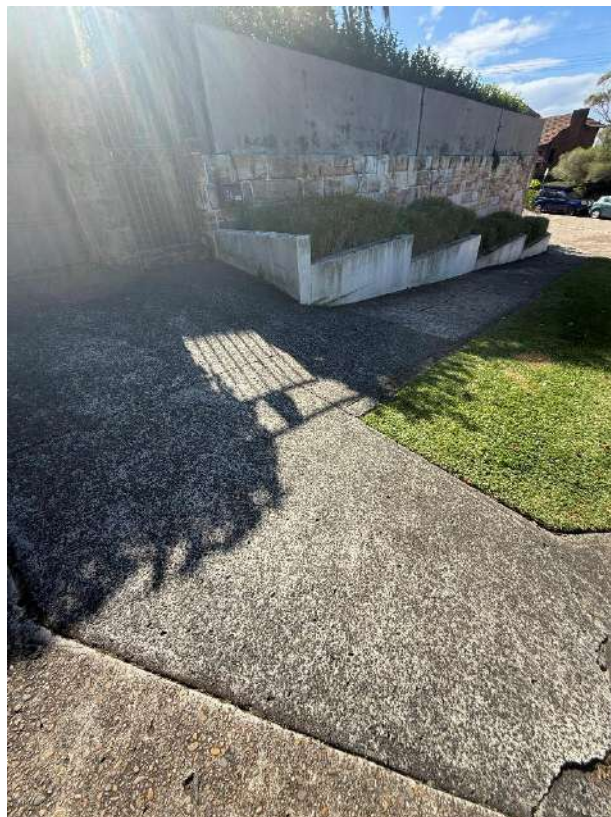
Cracks in the concrete driveway

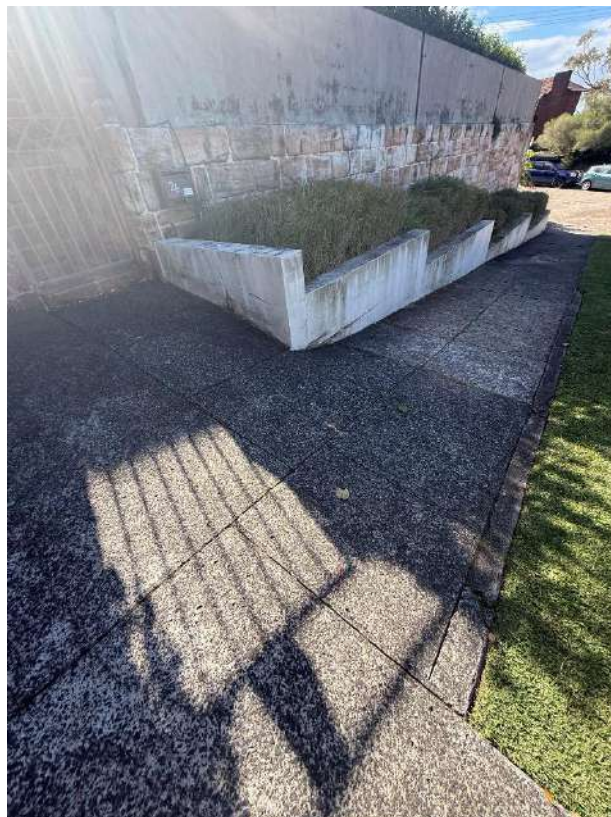
Cracks in the concrete driveway and foot path

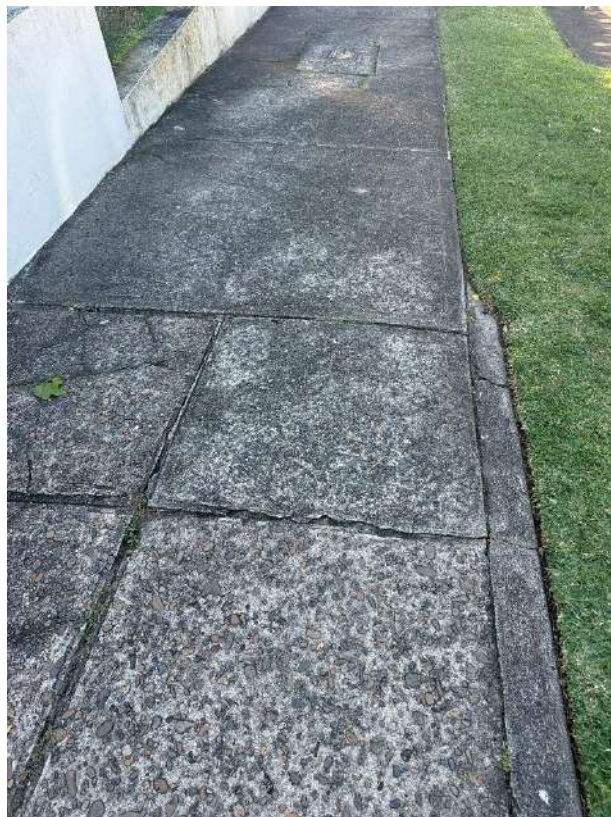
Cracks in the concrete foot path

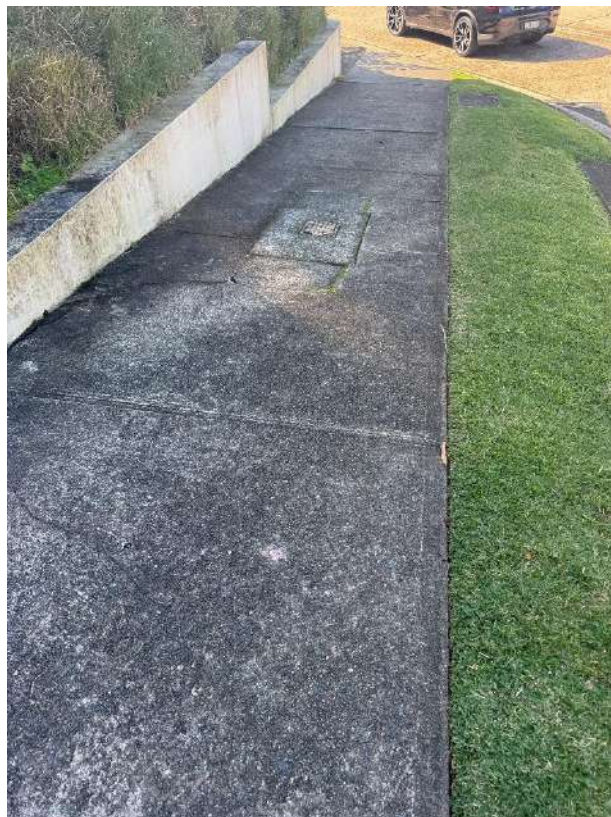
Cracks in the concrete foot path
