The Property Inspectors

Residential Pre-Purchase Building Inspection Report

Property Address: 7/20 Herbert Street Dulwich Hill

Date of inspection: 14/06/2016

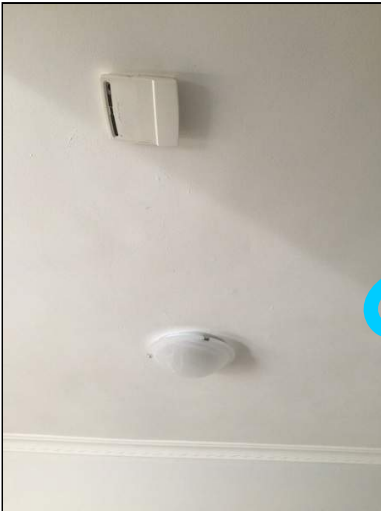
Location: Living room

Minor sagging in places

Some sagging of the plasterboard ceiling is evident in places.

Details: Crazed cracks in ceiling lining

Defect Rating: Minor Defect

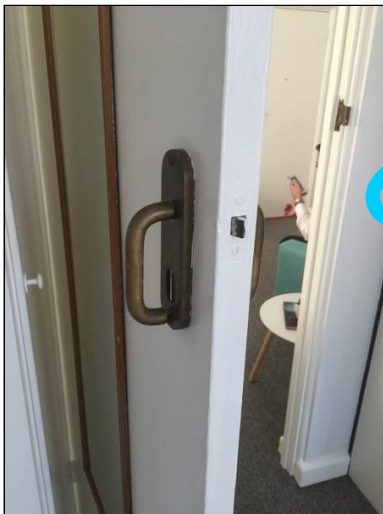
Location: Bedroom door handle needs attention

Doors/Frames; Do all doors and hardware operate freely and do not bind on frames, and are they free of decay/corrosion and other damage? **Minor maintenance required**

Defect Rating: Minor Defect

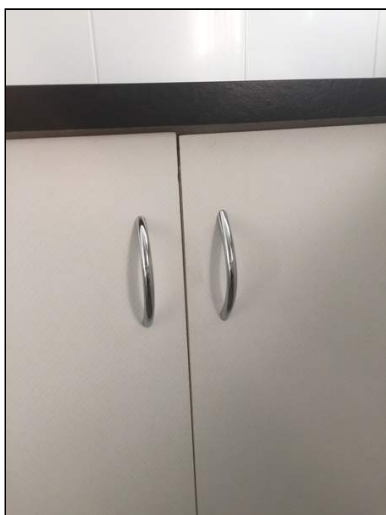
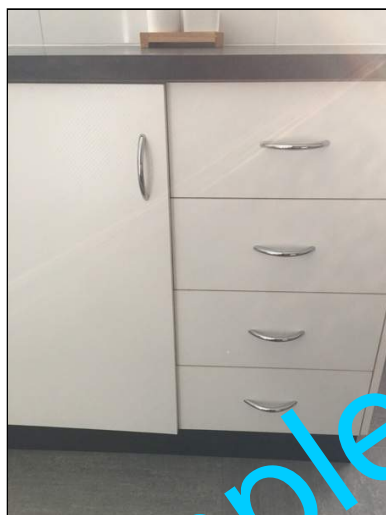
Location: A number of doors bind and require adjustment

Kitchen; Do the cupboard doors and drawers operate freely? **Drawers swollen and binding**

Defect Rating: Minor Defect

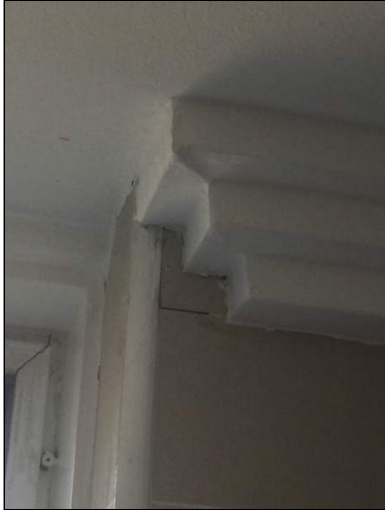
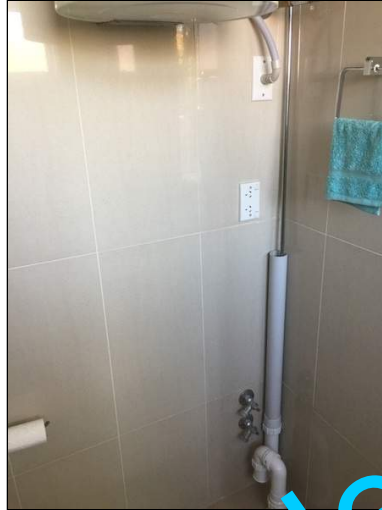
Cracked tiles

Location: Cracked wall tiles
Missing grout
Excess sealant

Defect Rating: Minor Defect

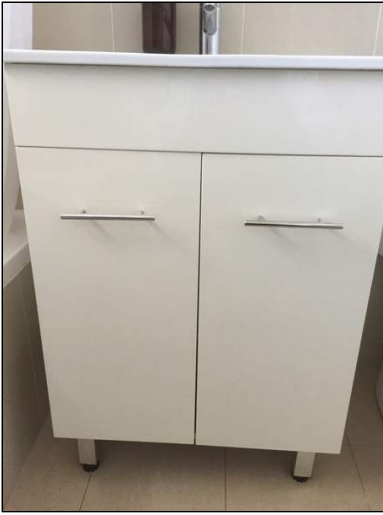
Bathrooms/WC; Is the vanity basin, cabinet and mirrors free of damage, and do the doors/drawers operate correctly? **Doors/drawers bind on cabinet frame**

Defect Rating: Minor Defect

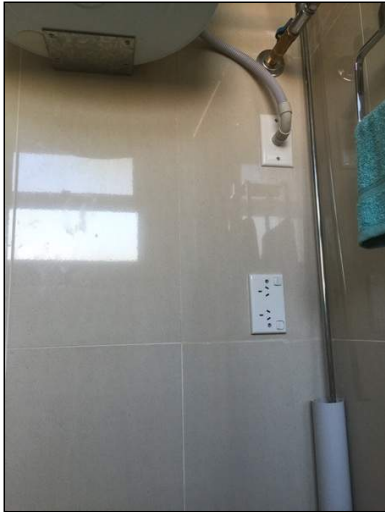
Location: Inconsistent grout colour used in wall tiles

Defect Rating: Minor Defect
