Visual Asbestos Inspection

SITE ADDRESS: 32 Charles Street Killara NSW 2071

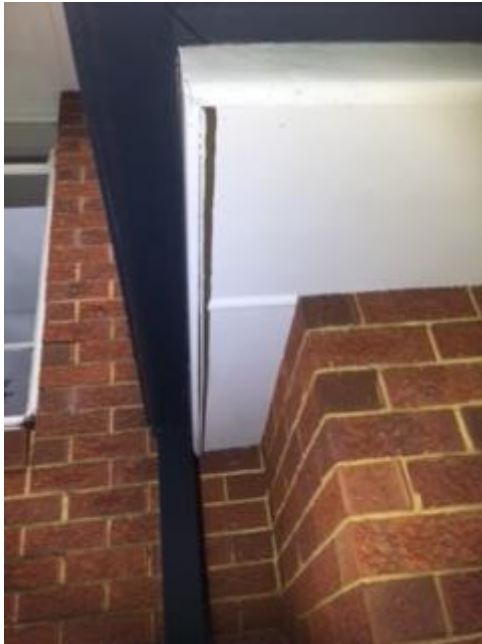
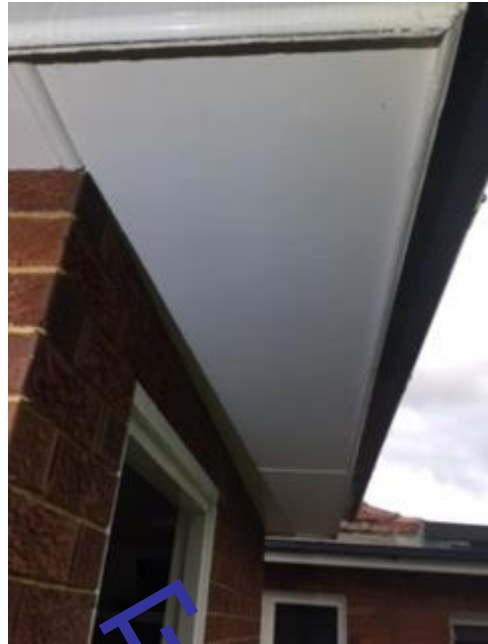
- The areas of concern identified for testing are the entire eave lining, the five individual gables to the roof, and the garage ceiling.

These two photos are taken from opposite ends of the garage ceiling, which will need to be tested for asbestos.
