Residential Pre-Purchase Building Inspection Report

Property Address: 120 Womerah Avenue Darlinghurst

Date of inspection: 27/10/2016

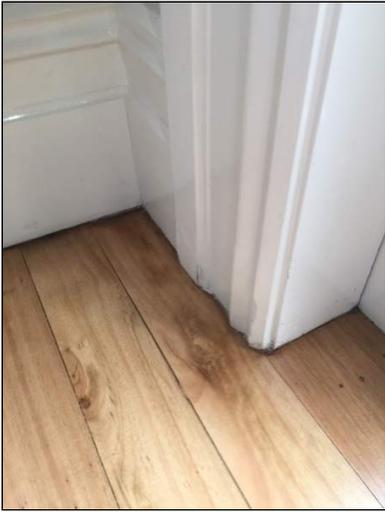
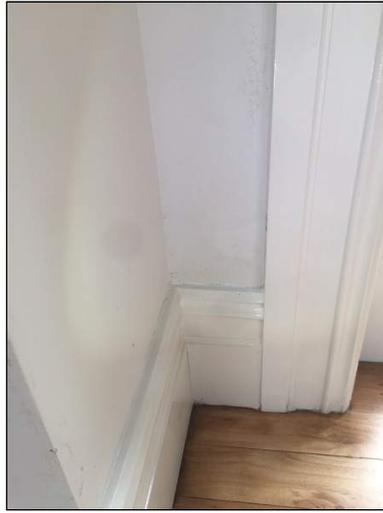
Floors; Are floors free of movement such as spring and bounce, and cracking, and are they free of dampness/staining and other damage?

Minor spring & bounce, There are no expansion joints installed to the floor finishes, .

Expansion joints should be installed to all timber, concrete or tiled floor finishes which have a length of 5.5 metres or an area greater than 5.5 metres squared

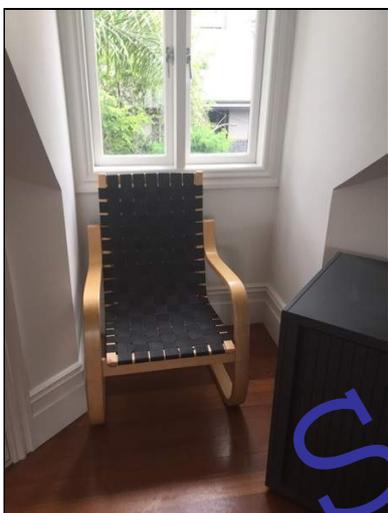
Location : First floor windows over the front elevation

Defect rating : Safety Issue

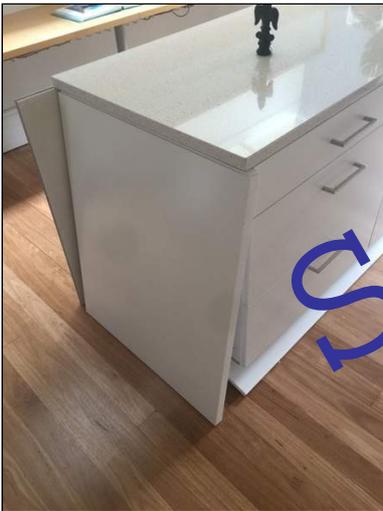
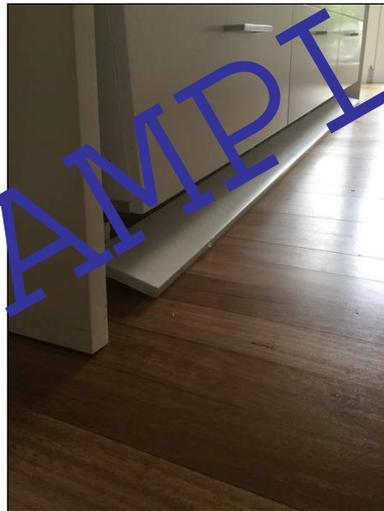
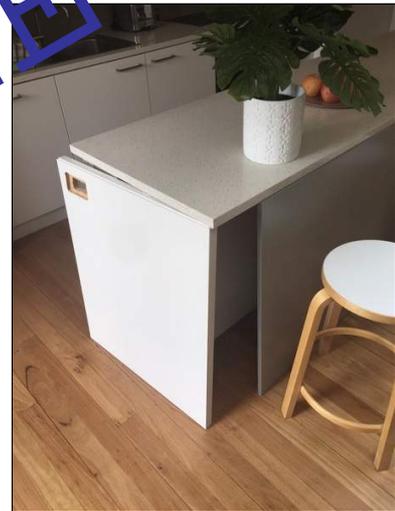
Doors/Frames; Do all doors and hardware operate freely and not bind on frames, and are they free of decay/corrosion and other damage?

Minor maintenance required, Weather damage evident to external door(s), .

It appears new joinery is being installed at the time of the inspection

Defect Rating: Minor Defect

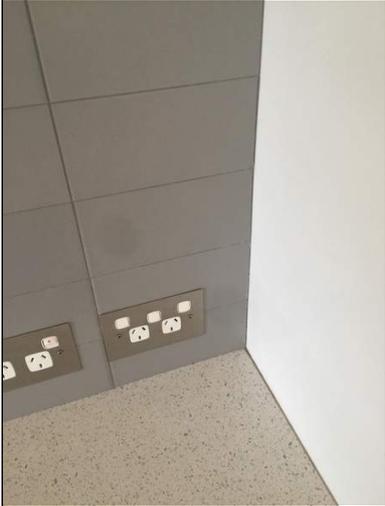
Kitchen; Is the splashback free of cracking, drumminess, or loose/missing grout/sealant? **Gaps in sealant, .**

The sealant can be seen to be incomplete, requiring sealant to be re-applied to the affected area., .

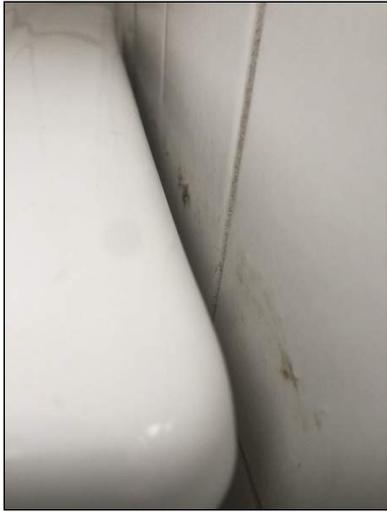
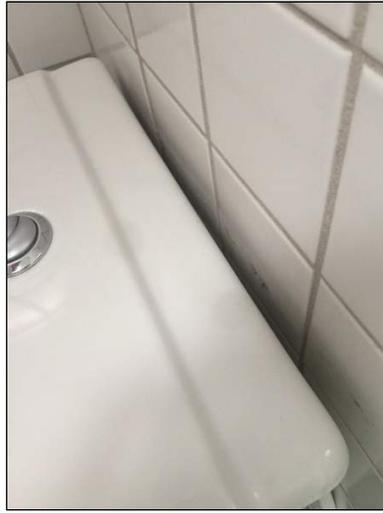
Bathrooms/WC; Are cisterns/pans/bidets correctly installed and are they stable/rigid? **Cistern partially detached from wall, .**

Defect Rating: Minor Defect

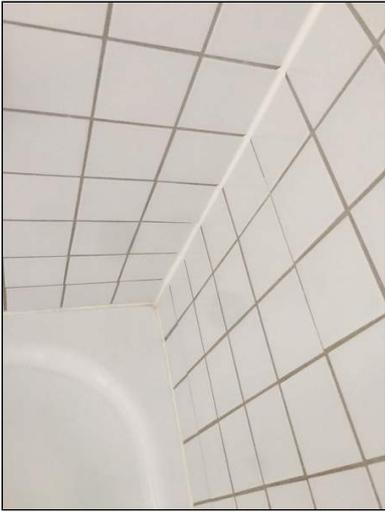
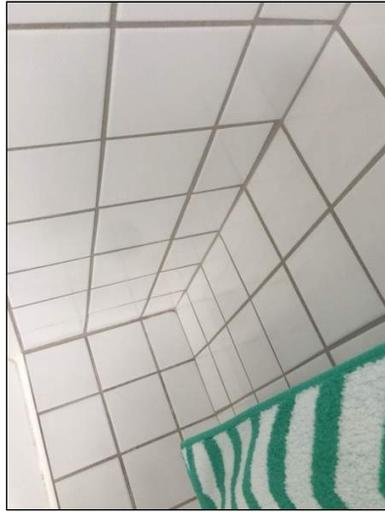
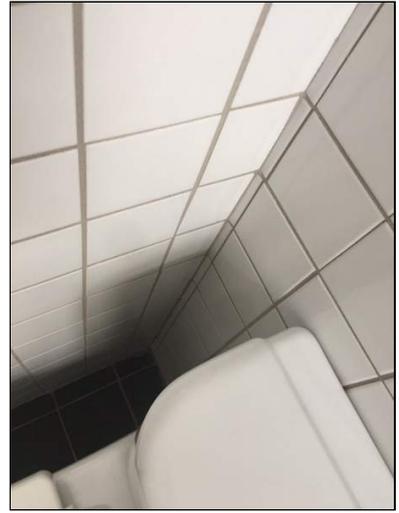
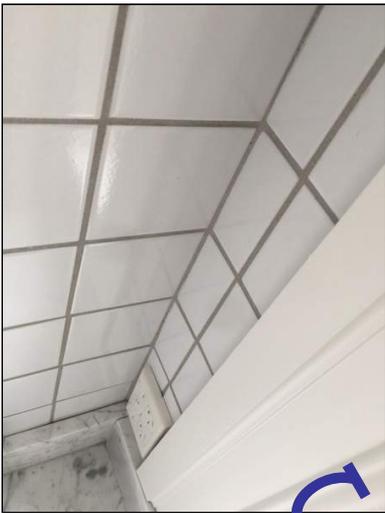
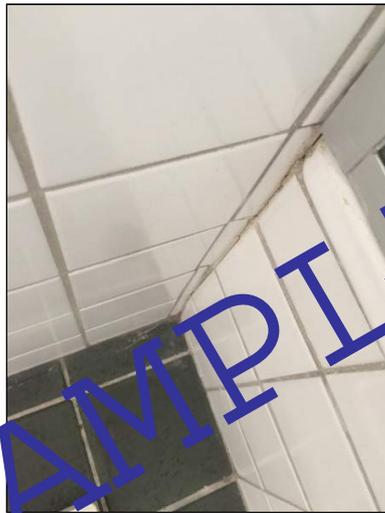
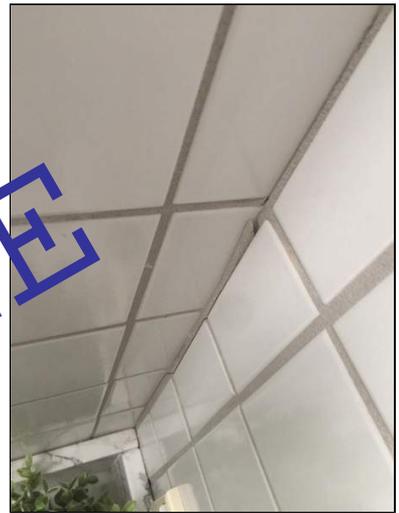
Bathrooms/WC; Are the shower wall and floor tiles free of cracks, drumminess, or loose/missing grout/ sealant?

No silicone sealant applied within the bathrooms, Loose/missing grout, .

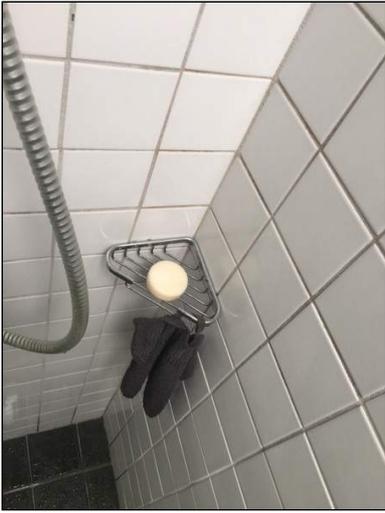
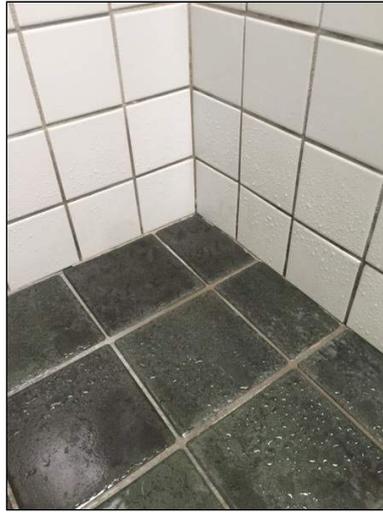
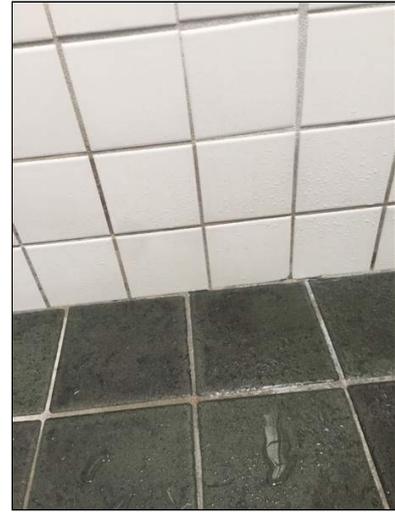
Bathrooms/WC; Are the bathroom wall & floor tiles free of cracks, drumminess, or loose/missing grout/sealant?

No silicone sealant applied within the bathrooms, Gaps in sealant, Loose/missing grout, Drummy tiles, .

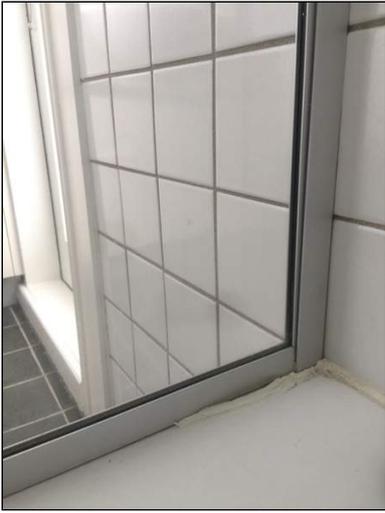
Bathrooms/WC; Is the shower screen free of cracks, and is it adequately sealed at the floor/wall junctions?

Minor gaps in sealant, .

Defect Rating: Minor Defect

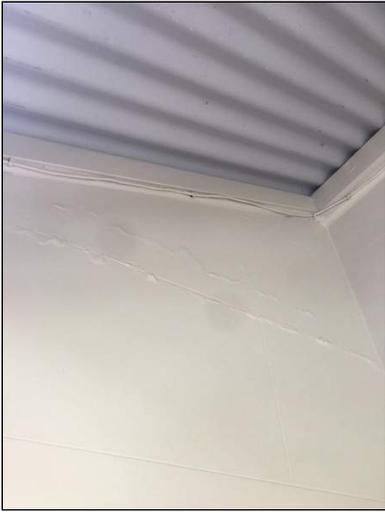
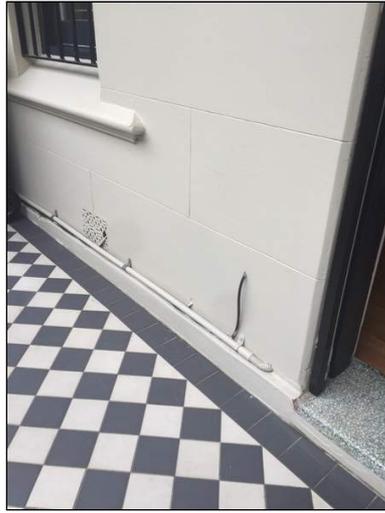
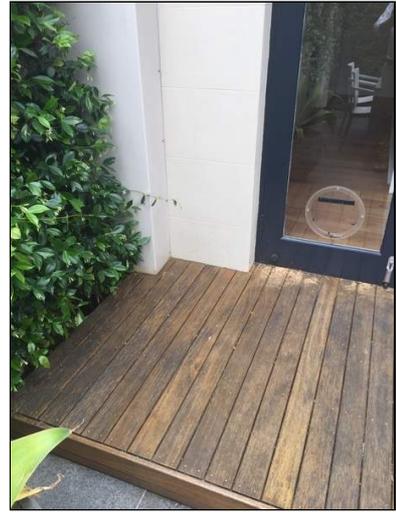
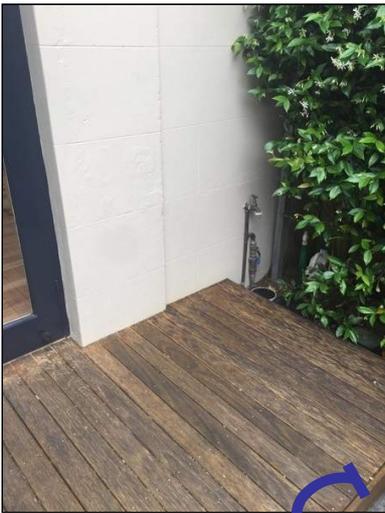
External Walls; Are all walls/wall cladding free of defect/damage, and is the paint/coating maintained? **Weep holes covered, No damp proof course seen through the render walls, Rising damp/salt residue on lower walls, .**

The water within the cavity walls cannot be expelled from the building/walls and some tiles, you will see moisture within the internal walls, skirting and floor coverings due to concealed or missing weep holes

Location: Street front, first floor external common walls have minor defects/moisture within the masonry wall that can be easily repaired or made good by a painter in a few hours work

The missing weep holes and damp proof course is common in these older style terraces, as legislation did not require the builder to implement these measures into the property in the early 1900's

These issues are minor as long as the house is painted regularly so that water/moisture cannot enter the house cavity walls

Defect Rating: Minor Defect

It is imperative that specialist advice be sought to ascertain cause and extent of rising damp problem.

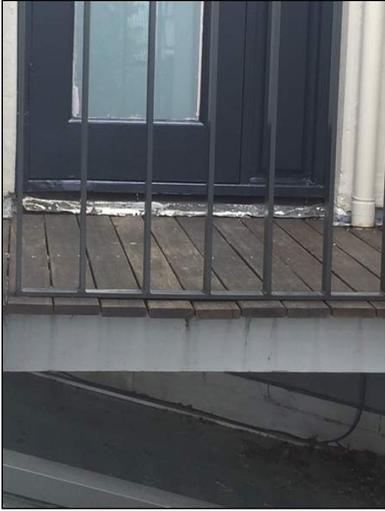
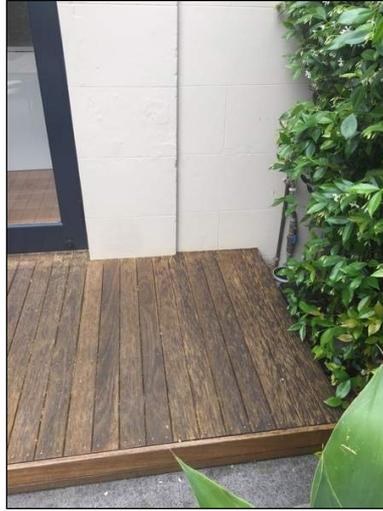
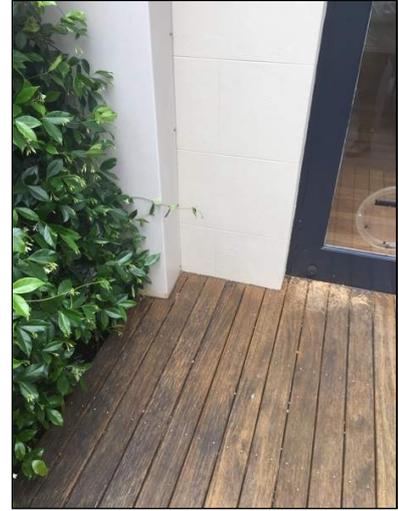
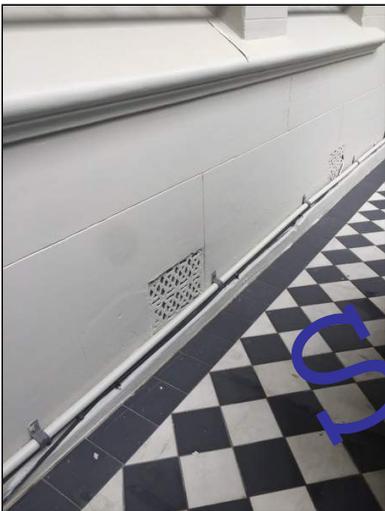
Wall Cladding Flashing & DPCs: Does the wall cladding have suitable flashings and damp proof course, and is it free of dampness damage?

No dampcourse evident, Flashings faulty/defective,

I did not see any moisture in the bottom course of the external ground floor walls nor internal walls, so I assume there is damp proof course, but it's covered up by the render which is a minor issue which does not need to be addressed

Defect Rating: Minor Defect

Infill a timber trim should be installed under the first floor rear doors and a possible water entry point can be resolved (a one hour job for a carpenter)

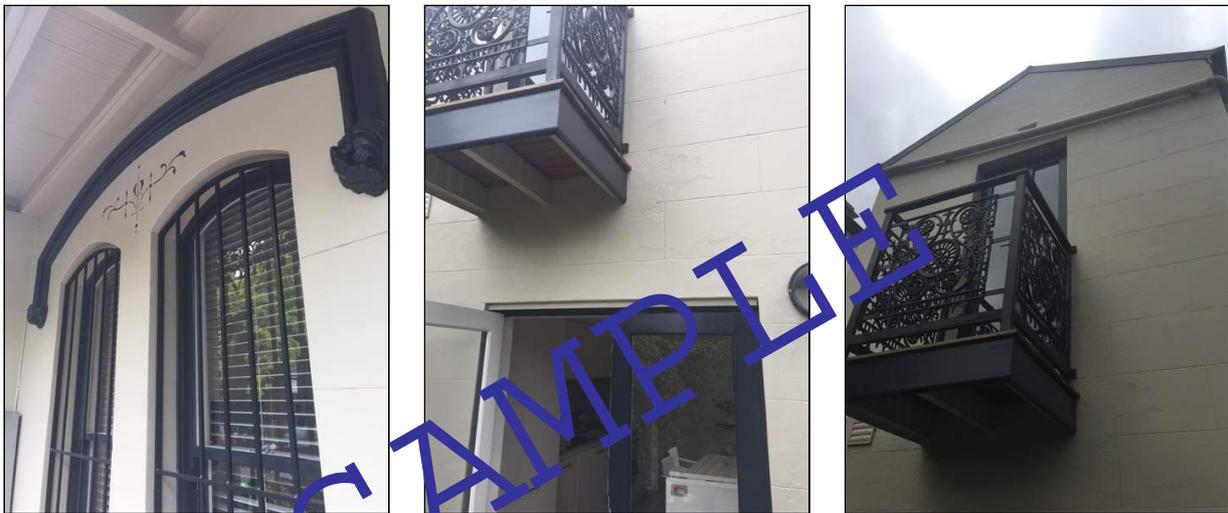
Walls & doors & window junctions, do suitable flashings, mouldings, and sills exist and are they free of defect/damage?

No weep holes were found above or below the windows or doors

Lack of weep holes will create dampness within the cavity and within the internal wall linings and it will contribute towards the render cracking and render crazing, this will eventually become drummy and fall off the wall, any timber attached to the walls in question will rot and deteriorate before its natural time

Location: All external windows and doors do not have weep holes located above or below the door and window suites

Defect Rating: Minor Defect

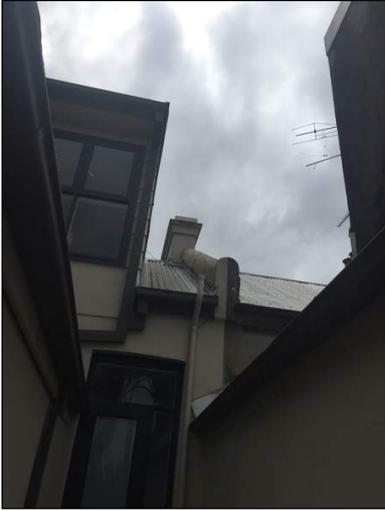
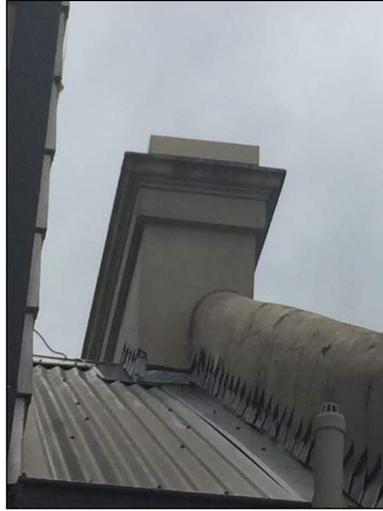
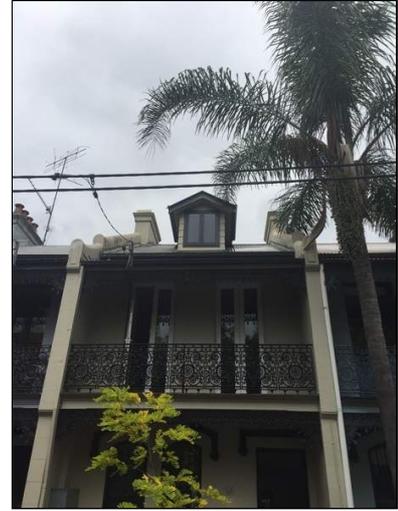
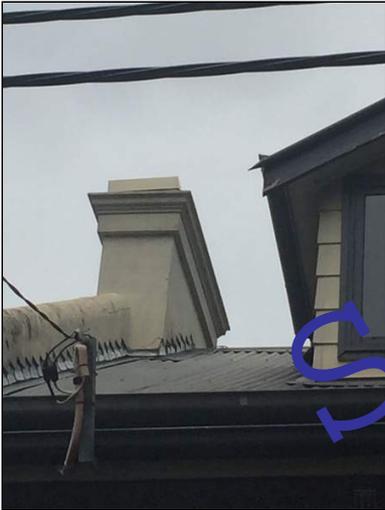
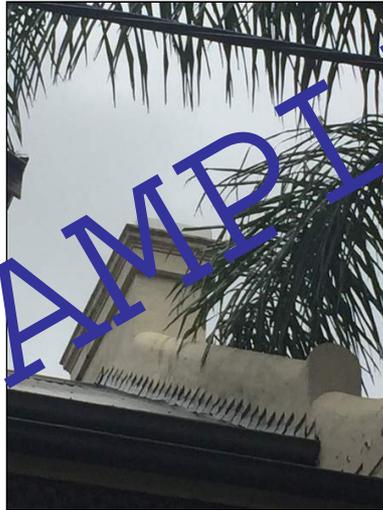
Chimneys; Do chimneys appear plumb and structurally sound, with adequate flashings? .

in good condition with no work required to this part of the property

Defect Rating: Further Investigation

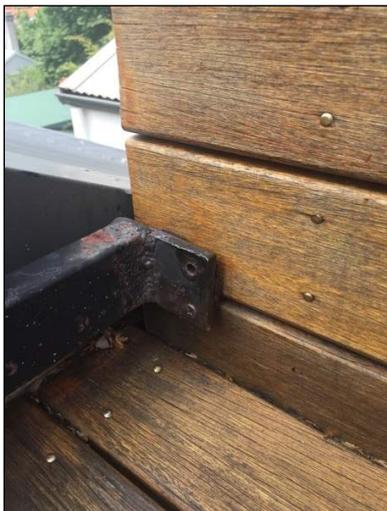
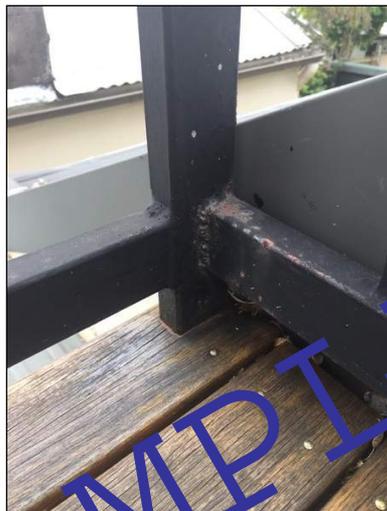
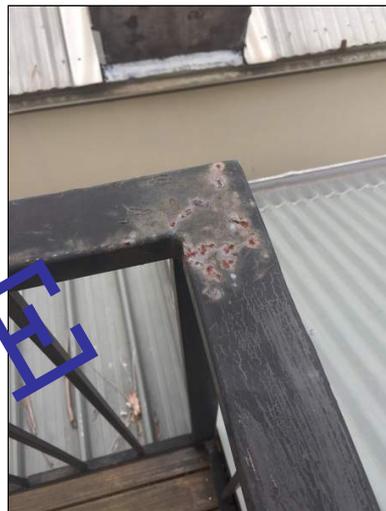
Balconies/verandas/patios/decks/suspended floors/balustrades; Do they appear structurally sound, free of defects?

Location: Minor rusting of the metal posts and rails within all three decks

Second floor handrail fixings are loose and missing (a carpenter can repair and make good this issue within an hours work)

Defect Rating: Minor Defect

Details: A good painter can prepare and preserve the steel from deterioration within one or two days work

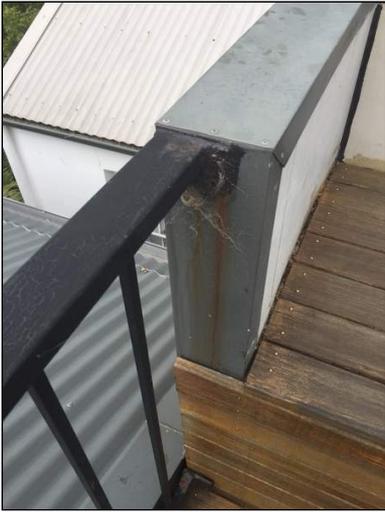
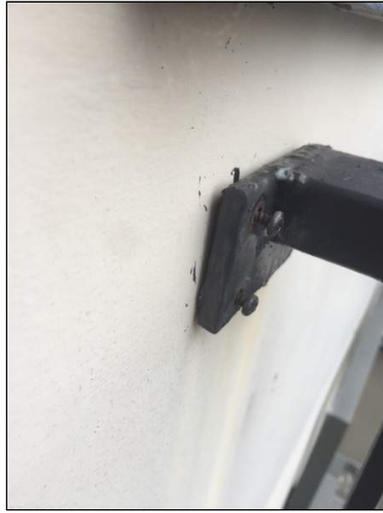
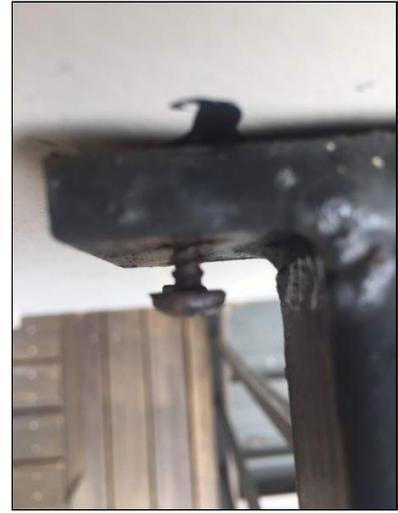
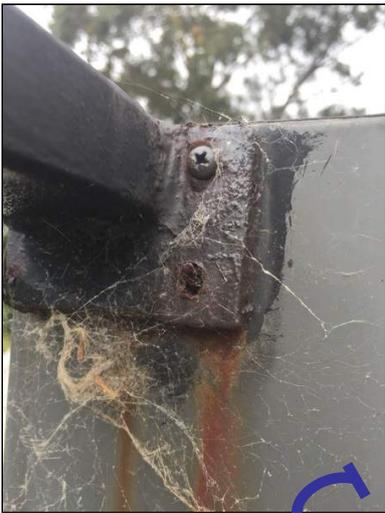
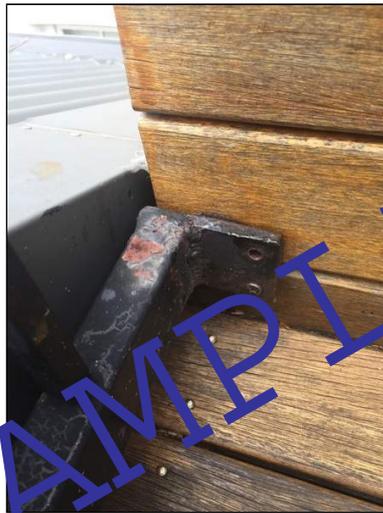
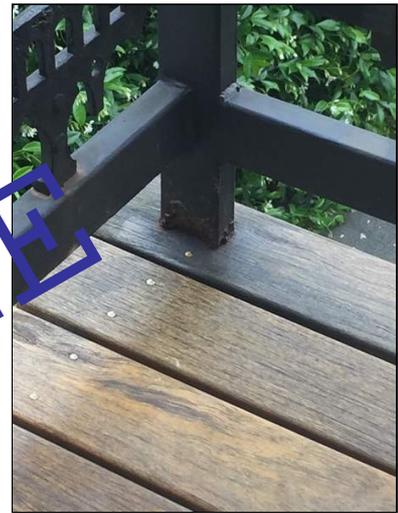
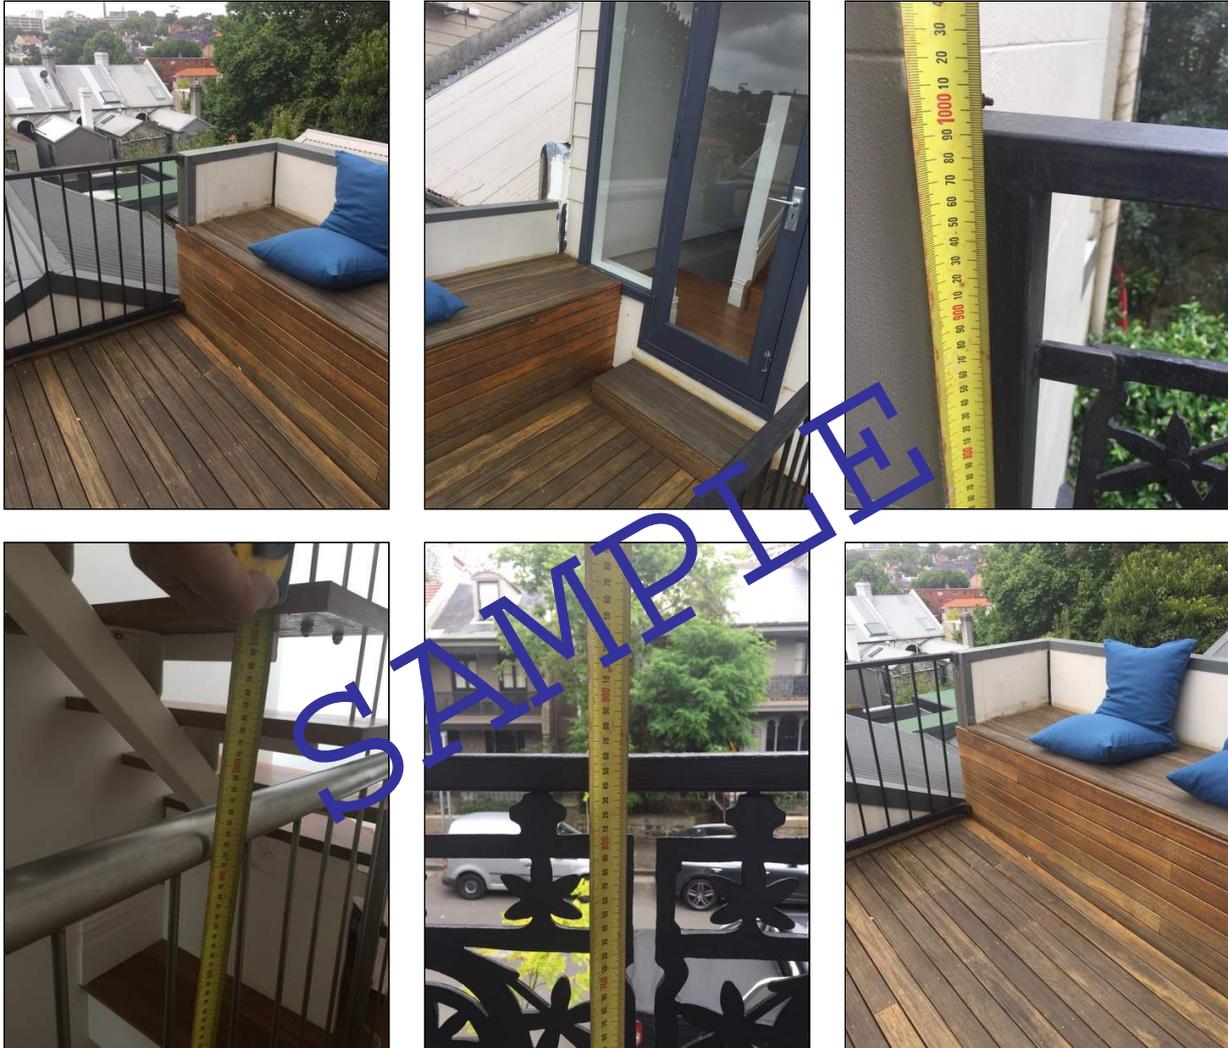
Balconies/verandas/patios/decks/suspended floors/retaining walls/stairs/balustrades; Are handrails installed and are they at the correct height to comply with the Building Code? NOTE : 1 metre high handrails are required around any areas with falls greater than 900 millimetres

Defect Rating: Safety Hazard

A 1 metre balustrading and handrail detail is required to make this deck compliant and limit the liability of the owners

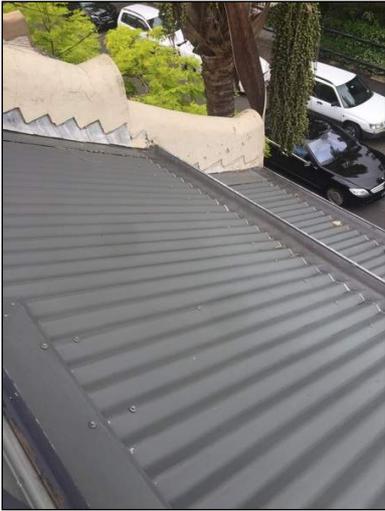
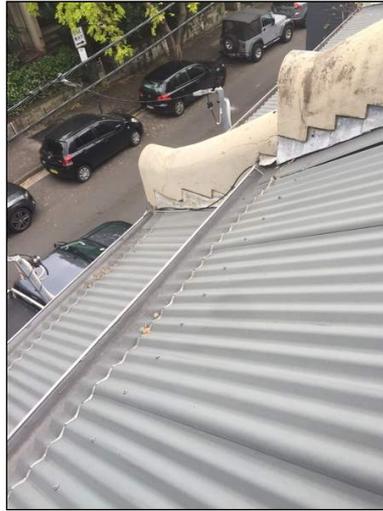
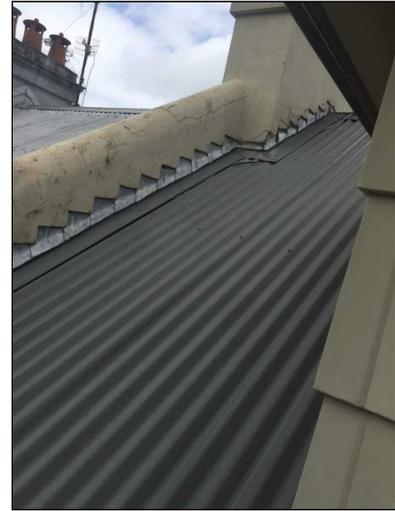
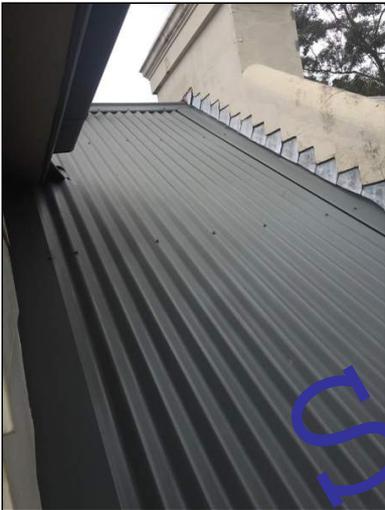
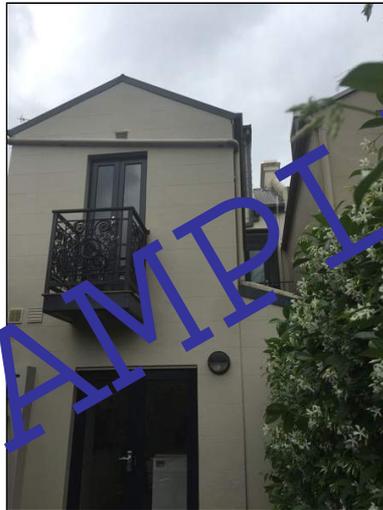
The roof overall appears to be in very good condition

Defect Rating: Further Investigation

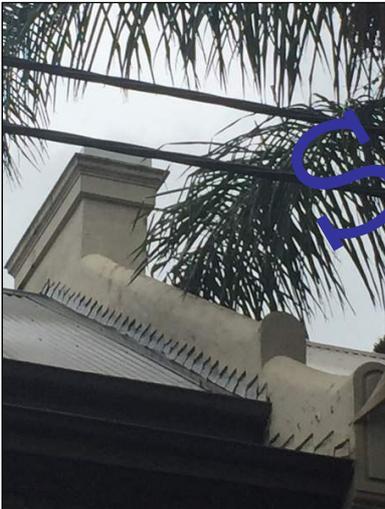
I did not access the roof sheeting & roof plumbing as its was above 3.6 metres in height, There is lead flashing & colourbond metal in direct contact with each other, .

This must be rectified, otherwise the colourbond metal will deteriorate and an aperture will be created, then water entry will take place and it will be difficult to find

Defect Rating: Minor Defect

The replacement of the flashing(s) or additional silicone is to be applied to have the two metals not be in contact with each other

Have a chat with a roof plumber or builder/carpenter for the best solution to be offered.

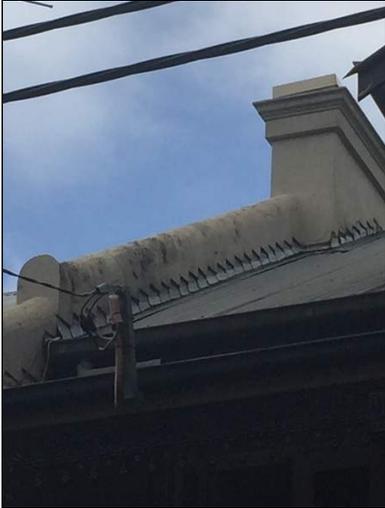
Roof Flashings; Is the flashing free of uplift, corrosion or other defect/damage?

Metal flashing and lead flashing in contact with each other, .

Defect Rating: Minor Defect

Have a roof plumber assess and confirm that there is no direct contact between the lead and colourbond flashing, as they react with each other if in direct contact and the colourbond material corrodes and generally this is concealed and unnoticeable until you have a water leak within the property, .

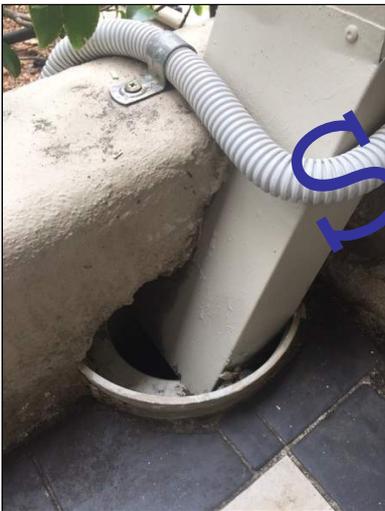
Valleys/Gutters/Downpipes; Are they free of rust, and do they appear to drain effectively?

This has potential to cause differential settlement to the footings, cause rising damp and is also conducive to termite infestation.

This is a major defect because of the potential problems relating to excess water within the sub floor.,I did not access the roof & roof plumbing as it was above 3.6 metres in height

Defect Rating: Minor Defect

Cement sparg is required to seal and cap off this entry point into the stormwater system (fifteen minute job for a handyman/home owner)

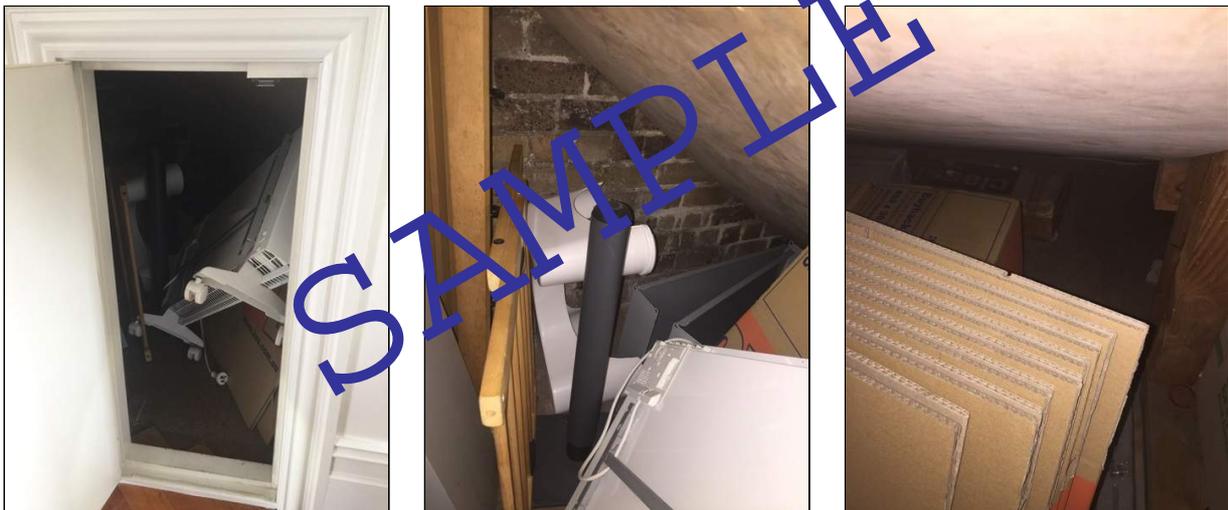
Roof Voids; Is the underside of the roof free of water staining or observed daylight?

Location: Excess belongings within the roof space, so a full assessment could not be carried out, but what I could see shows no water entry or water staining

Defect Rating: Further Investigation

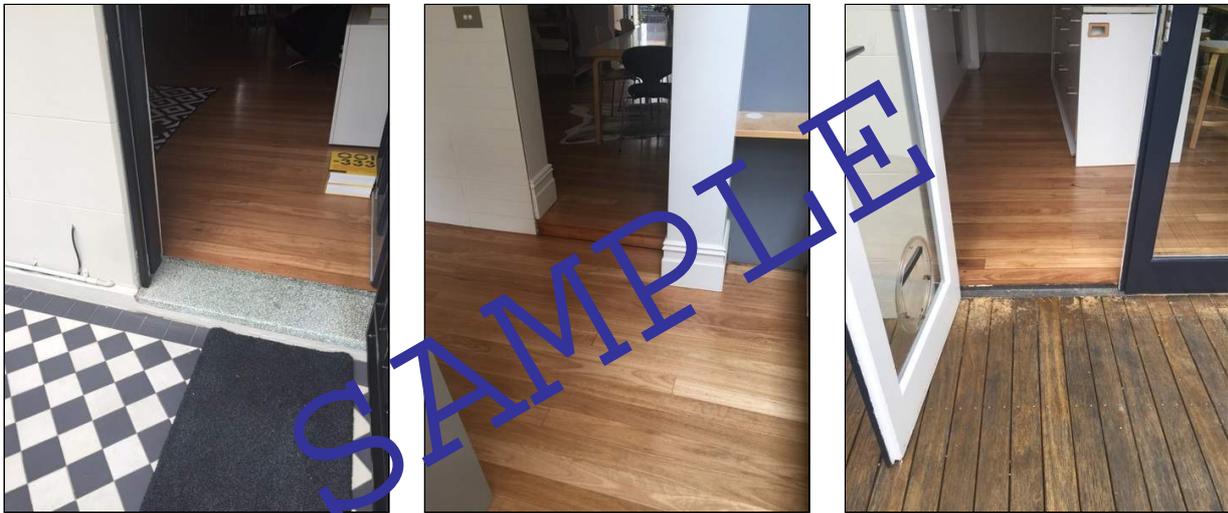
Timber floor; Does the sub floor area appear to be adequately ventilated, and free of dampness?

Inadequate ventilation within the sub floor areas inspected, .

Inadequate crossflow ventilation within the sub floor areas.

As with most older dwellings, sub floor ventilation is inadequate when compared with today's requirements.

Defect Rating: Minor Defect

Details: We recommend a sub floor ventilation system be implemented servicing the sub floor area

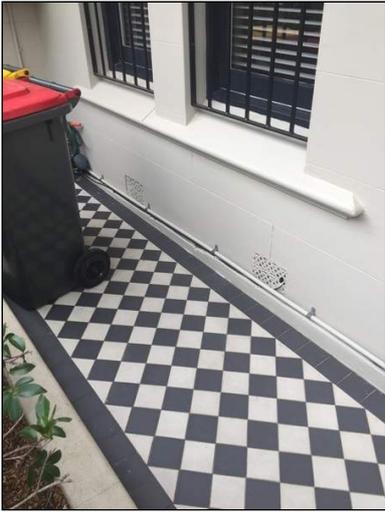
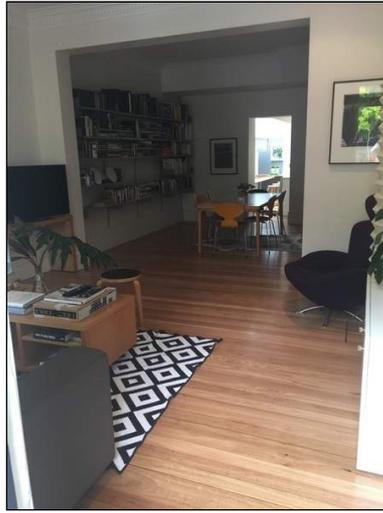
Concrete Pathways, Driveways, Verandas & Decks; Are all areas free of subsidence, undamaged and safe to walk upon?

Minor tripping hazards - settlement - monitor, .

Some settlement and unevenness was observed. Although not an immediate concern these should be monitored for future movement.

Defect Rating: Further Investigation

A landscaper or concreter should be engaged to repair/rectify. Major defects due to safety/injury concerns.

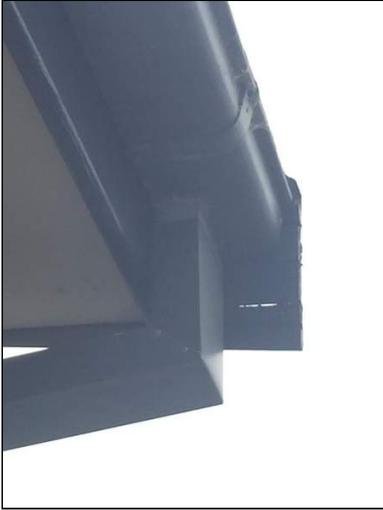
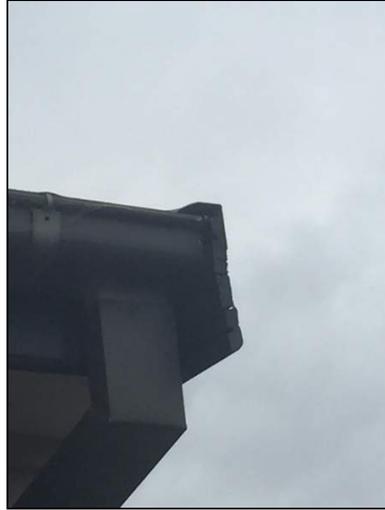
Severity: Minor

The timber pouts are open which allows moisture to enter the timber and it allows the timber to deteriorate over time, a good painter can repair and make good the Eastern timber member without having to replace it

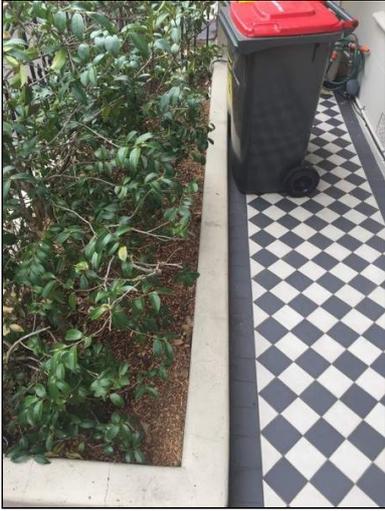
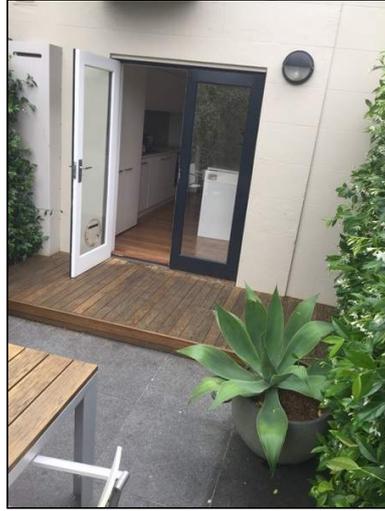
Was the finished ground or paving level above the adjacent internal floor level or damp proof course, or obstructing any weep hole/vent face on the external walls?

Concealed weep holes, where weep holes are partly or fully covered by such things as paths, patios, pavers, lawn, soil, gardens, etc, they may allow concealed termite entry into the structure. Weep holes are installed in external brickwork to allow water penetrating the wall to leak back outside the structure.
