# Dilapidation Report

## 14/9 Goomerah Crescent Darling Point

18<sup>th</sup> May 2017

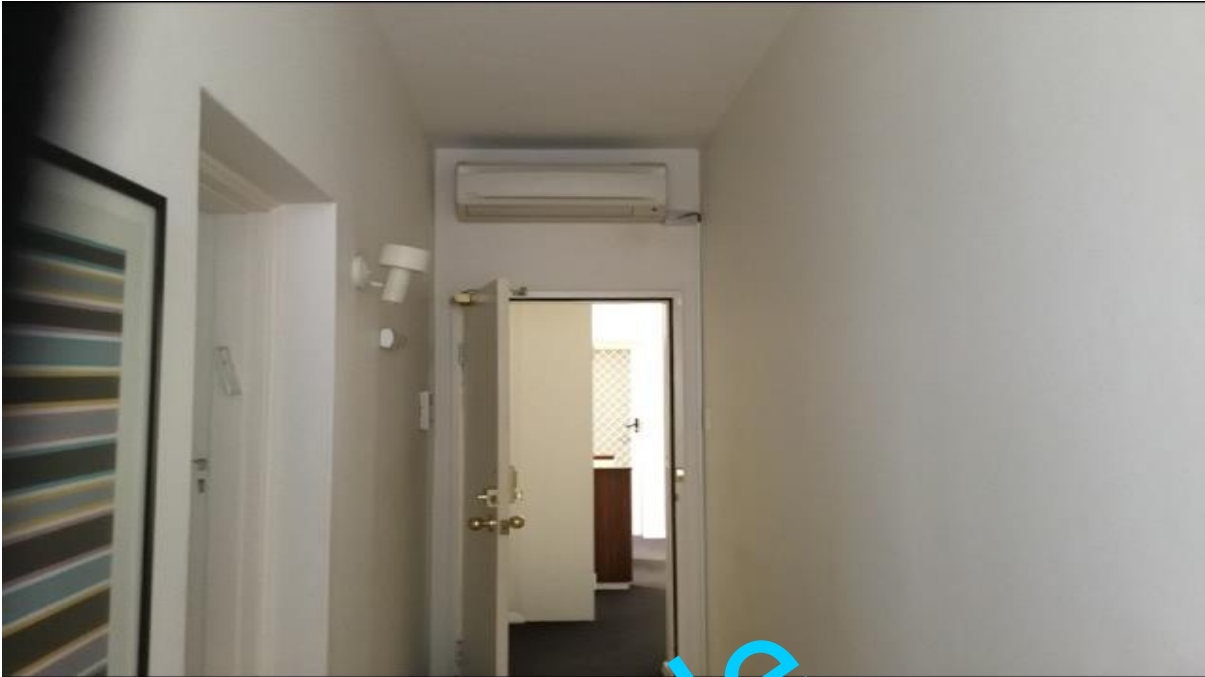
Sample

No Structural or superficial damages found within this area at the time of this inspection.

I inspected the walls, Floor, ceilings and all surrounding surfaces.
