Residential Pre-Purchase Building Inspection Report

Complies with Australian Standard AS 4349.1-2007

Property Address: 22 Redan Lane Mosman

Date of inspection: 05/03/2021

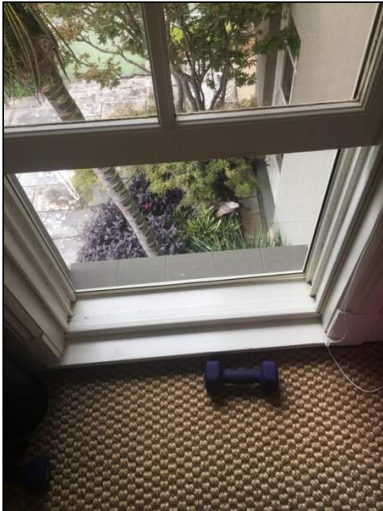
D. 11. Bedroom Windows sills must be no lower than 1.7m from the bedroom floor when there is a fall greater than 2 metres from that window when the window can not open greater than 125mm (2 meters is measured from the internal floor to the outside finish floor level.) Do The Bedroom Windows Comply with CURRENT building regulations ?

Defect rating Minor Safety Issue / defect, as the property in my opinion was built prior to June 2013 and legislation did not deem window restriction locks as necessary at that point in time

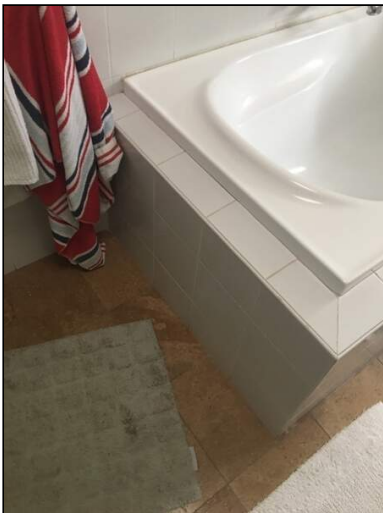
Question D. 27. Bathrooms / WC; Are the BATHTUB " TILES " defective

Answer No, There is loose / missing grout

Grout can be seen to be missing or dislodged requiring the area to be re-grouted

Defect Rating Minor defect

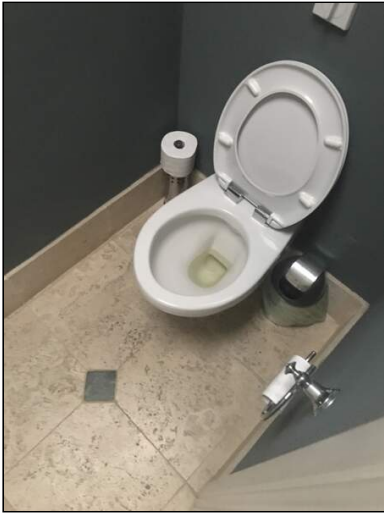
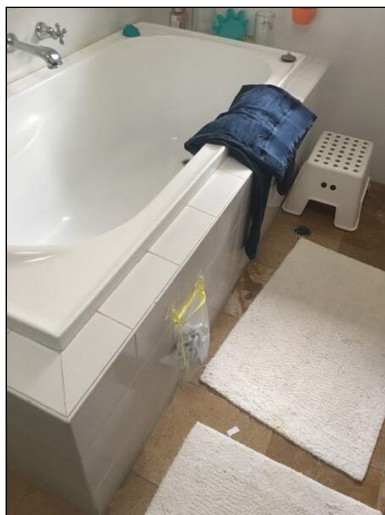
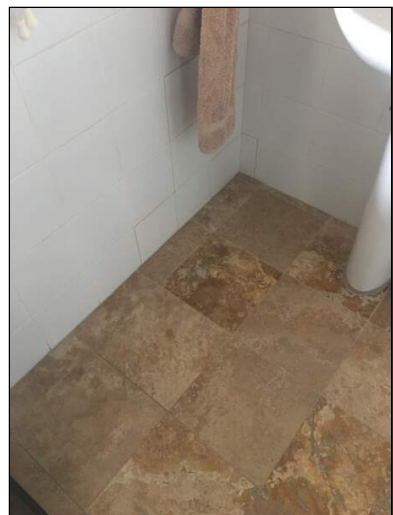
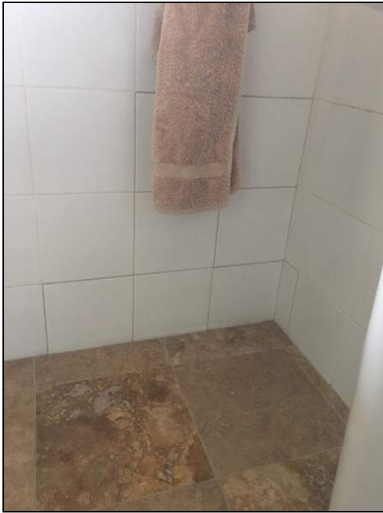
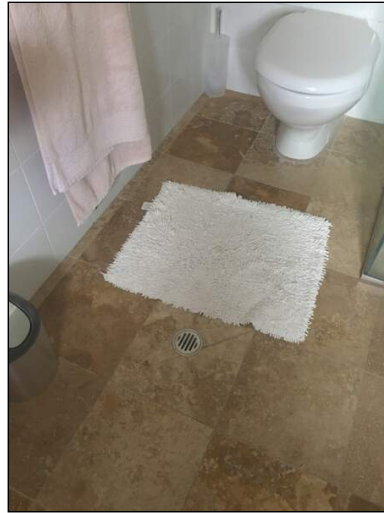
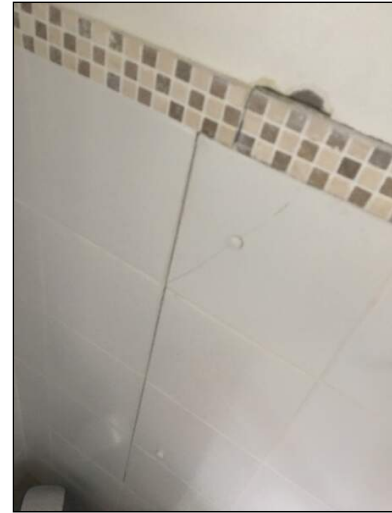
Question D. 31. Bathrooms / WC; Are the BATHROOM WALL & FLOOR TILES free of cracks, drumminess, or loose / missing grout / sealant?

Answer Drummy tiles

Tiles found to be drummy due to failed or inadequate adhesive

Answer Loose / missing grout

Areas of grout can be seen to be missing which require re-grouting

Answer Gaps / defective sealant

Areas of sealant can be seen to be incomplete or defective requiring attention

Answer Minor cracks in the FLOOR & WALL wall tiles junctions

Typically, these cracks are minor and common issues found in most homes / bathrooms due to various reasons

Answer **Minor cracks in the VERTICAL WALL TILE junctions**

These cracks are minor and commonly seen in most properties

These cracks are typical settlement cracks seen within masonry and timber framed walls within wet rooms and bathrooms

Answer **Minor cracks were seen in the WALL TILES & CORNICES / CEILING junctions**

Typical settlement of the wall and ceiling junctions makes these cracks appear
These cracks are very common in masonry walls and timber-framed ceiling / floor structure junctions within bathrooms

Answer **Hairline cracks within the body of the WALL TILE MORTAR JOINTS**

I saw cracks in the grout of a wall tile

The wall tiles can be loose and drummy, further investigation is required as it's not normal to see a tile with cracks within the tile or within the mortar joints around wall or floor tiles, as this could mean the glue has disengaged from the tile or the substrate or that there is an issue within the substrate that is forcing the tile loose / off its original position

Answer **Cracked tiles**

Cracked tiles found at the time of the inspection; these items should be replaced

Defect Rating Minor Defect

These tiles could be left as is, though they have the possibility of cracks developing or dislodging from the substrate therefore could be replaced by a tiling contractor

All cracks should be monitored and sealed with bathroom silicone if they are seen to be stable / stagnant over a period of twenty four months

All cracks should be monitored and sealed with bathroom silicone if they are seen to be stable / stagnant over a period of twenty four months.

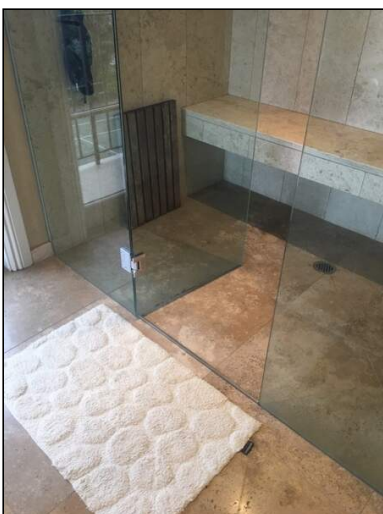
Question D. 32. Bathrooms / WC; Is the SHOWER SCREEN free of defects or damage?

Answer Inadequately sealed at floor / wall junctions

Inadequately sealed at floor / wall junctions:

Defect Rating Minor Defect

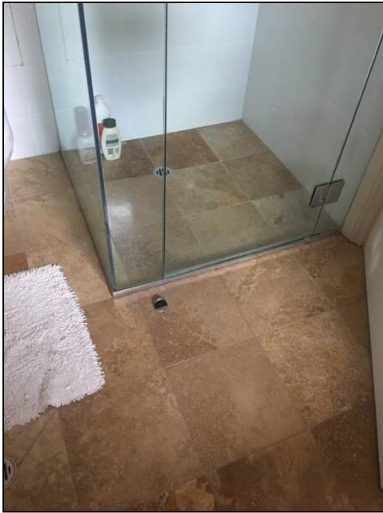
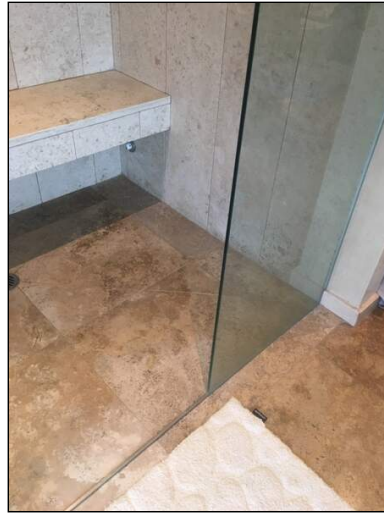
Question **D. 34. Bathrooms / WC; Are the SHOWER WALL & FLOOR TILES free of cracks, drumminess or loose / missing grout / sealant?**

Answer **Loose / missing grout**

Grout can be seen to be missing or dislodged requiring the area to be re-grouted

This is a minor defect and commonly found in older style homes or not so recently built or renovated properties

Defect Rating Minor Defect

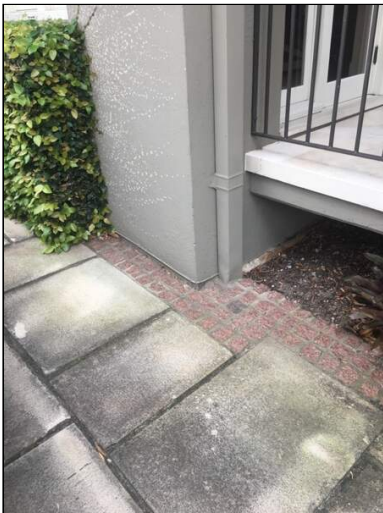
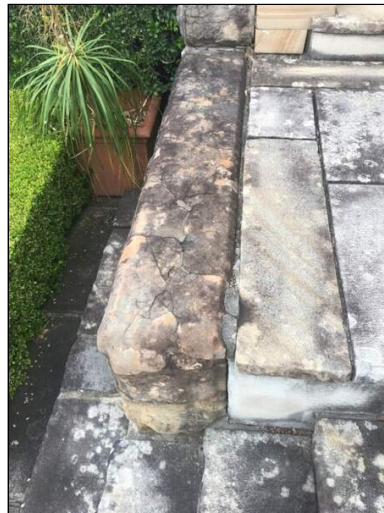
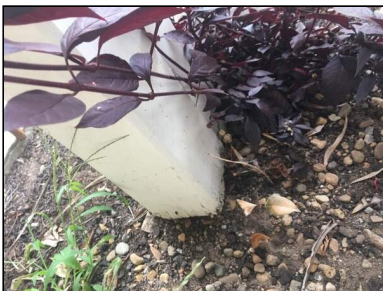
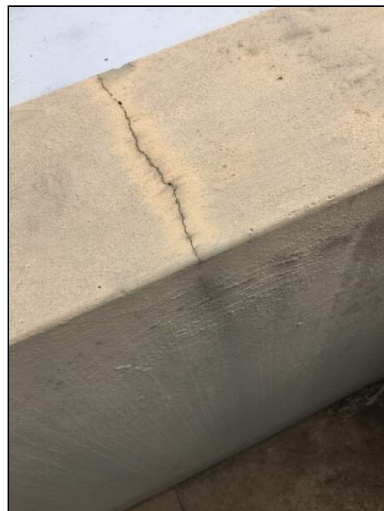
Question S. 56. *** SUMMARY OF THE DEFECTS WITHIN THE EXTERNAL ELEVATIONS

Defect Rating Minor Defect

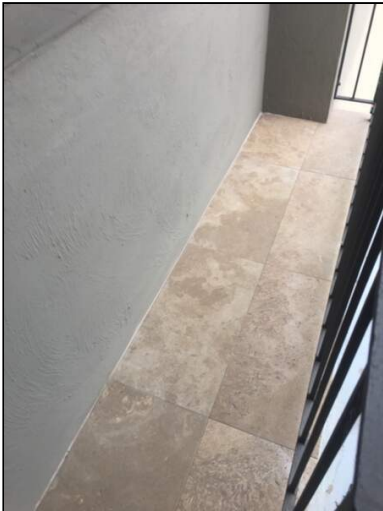
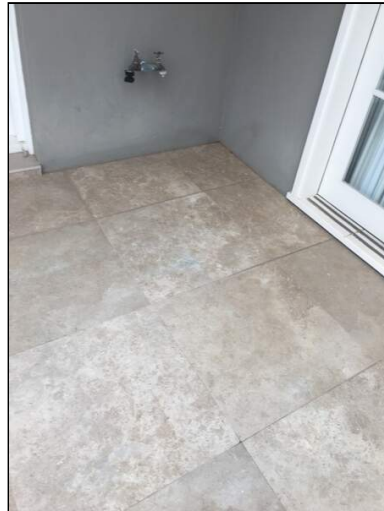
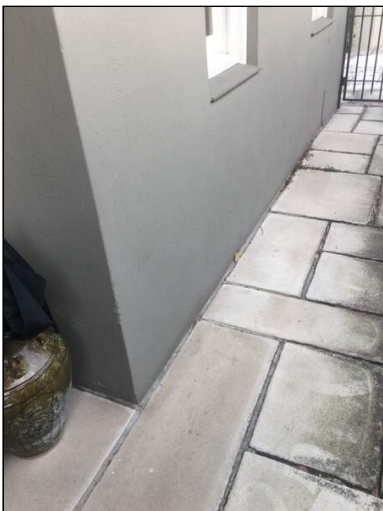
Question **D. 59. External walls (Non-Structural elements assessment) Are all walls, wall cladding and soffit linings free of defect / damage, and are the paint / coatings maintained?**

Answer **Weep holes covered**

Defect Rating Minor Defect

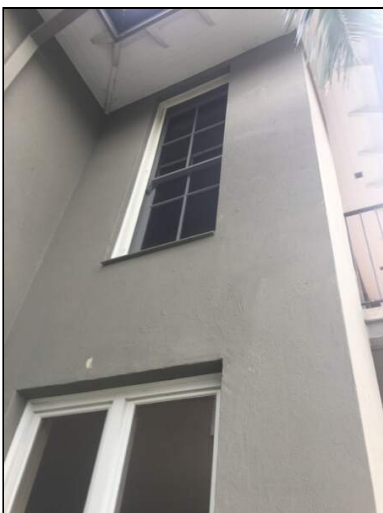
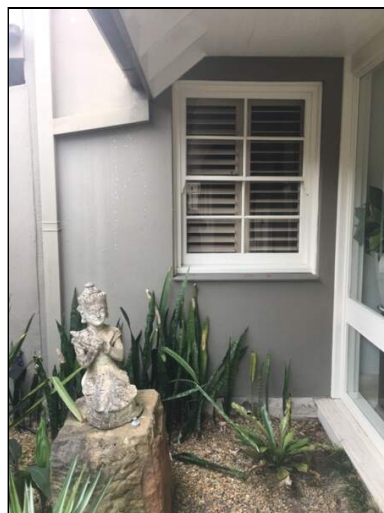
Question **D. 60. External "Walls & Doors/Windows"**

Answer **Missing weep holes above/below the windows or doors**

Defect Rating Minor Defect

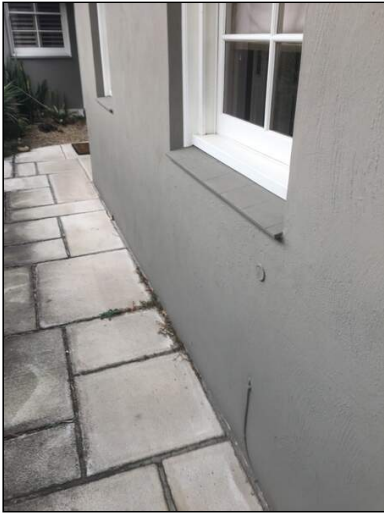
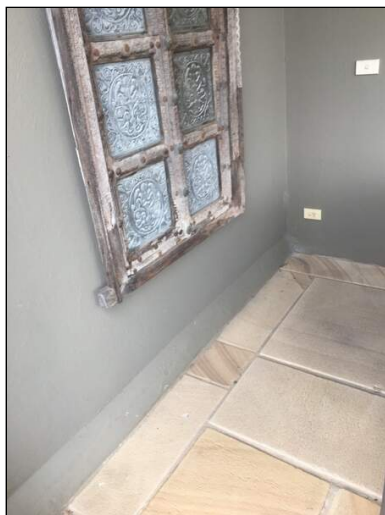
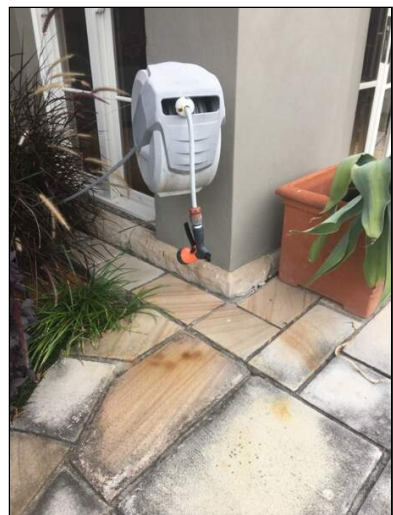
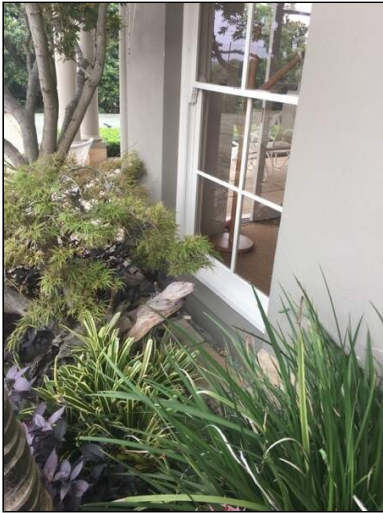
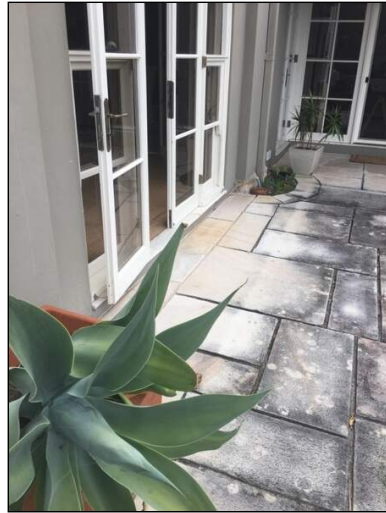
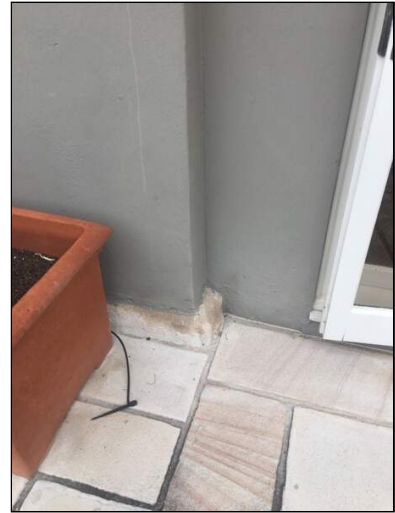
Question D. 61. Wall Cladding "Flashing & DPCs"

Answer I cannot see a damp proof course / flashing evident at the BASE of the external walls within this property

Defect Rating Minor Defect

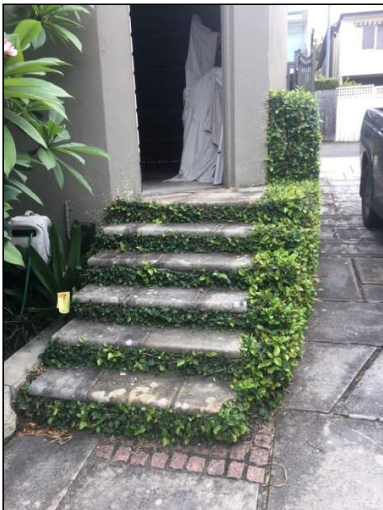
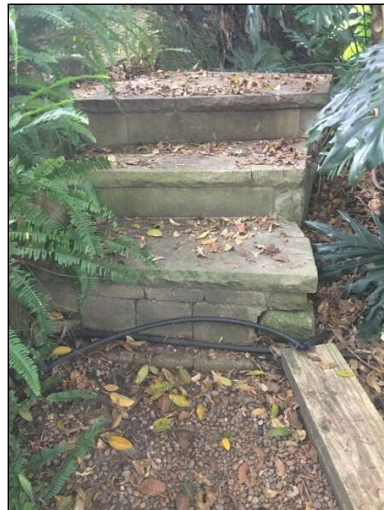
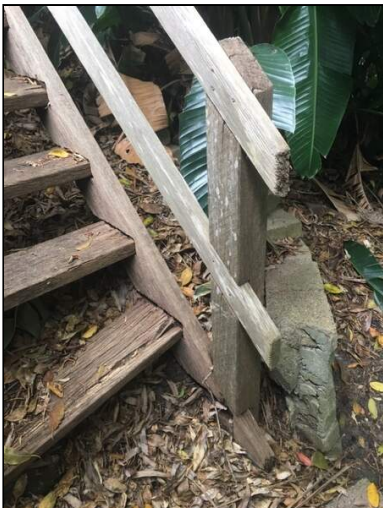
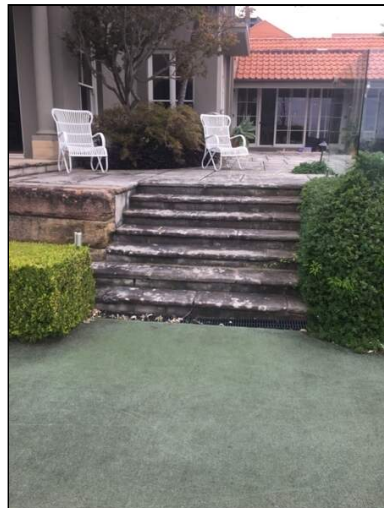
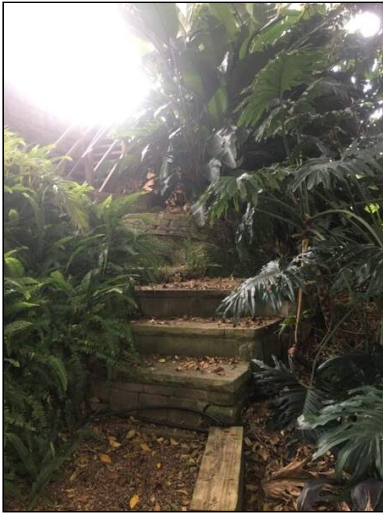
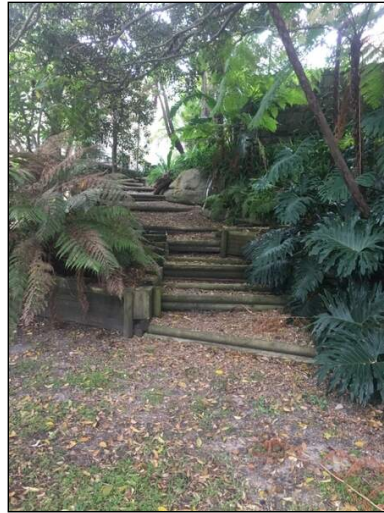
Photos

The stairs are a safety hazard in their current condition, they do not meet current regulations

Answer **Missing grab rail**

Answer **Timber finish to the staircase is defective**

Timber finish to the staircase can be seen to be defective and in need of replacement, these works should be undertaken by a carpenter to limit further deterioration of the staircase

Answer **Water damage / rot to staircase**

The timber stairs need to be repaired, as they are not in good condition

There is the possibility that a person can fall due to the current conditions of the stairs, as they could be slippery when wet and when mould and mildew are found to be present on these stairs

Goings don't have slip prevention measures installed on the nosings, this area is a safety hazard and should be rectified as soon as possible

Defect Rating Safety Hazard

A carpenter must be engaged to repair and make good the staircase treads and goings / stringer and substructure

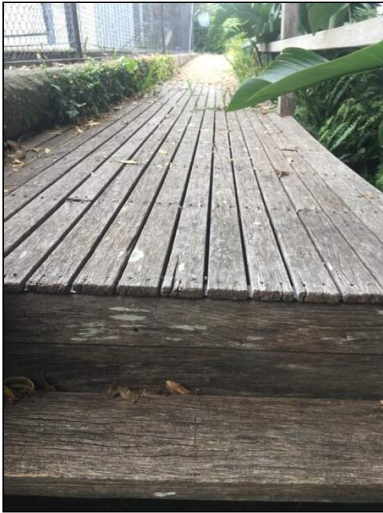
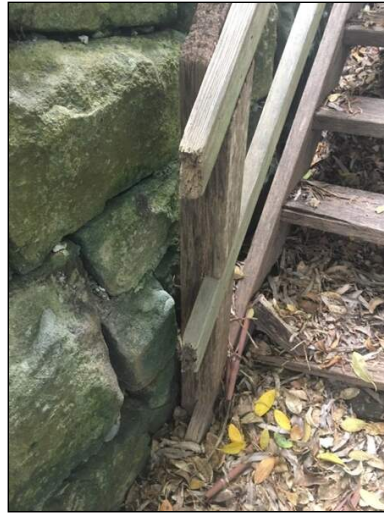
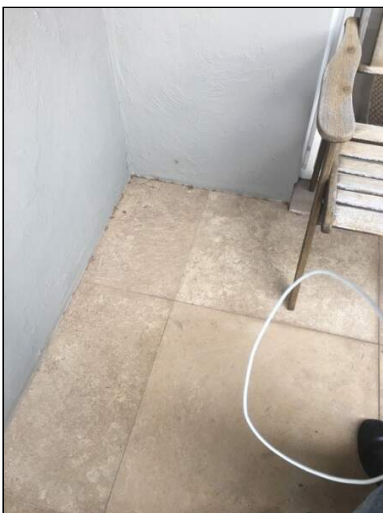
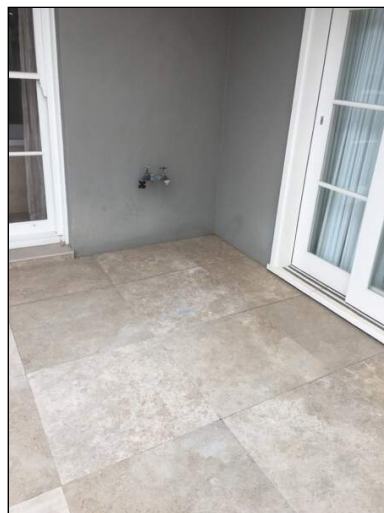
Photos

Answer **Timber decay, major**

Immediate repairs required as it unsafe to leave it as it is

Answer **Timber flooring, defective**

Timber flooring could be seen to be defective requiring attention

Answer **Missing expansion / control joints with the floor**

Minor defect if left as is, but could be implemented easily and quite quickly and inexpensively, this will allow you to control were the cracks and future movement will show up should the property re-settle between periods

Answer **Missing grout in the floor tiles**

Answer **Loose timber decking boards**

Defect Rating Minor Defect

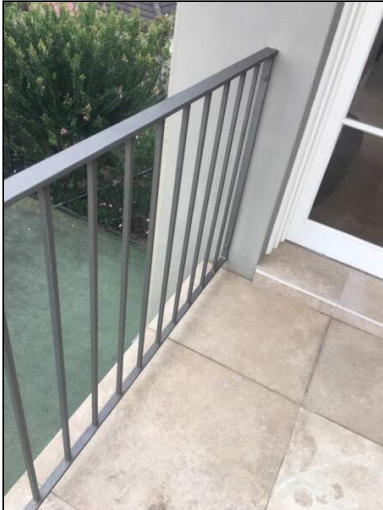
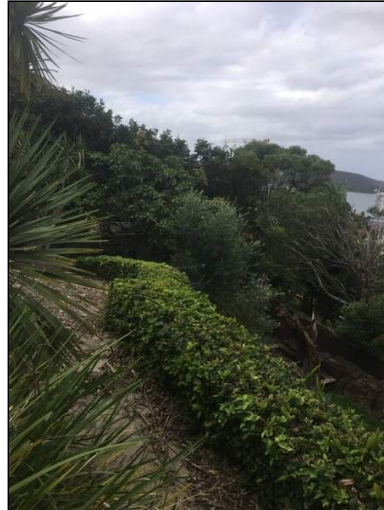
Photos

Missing handrails and balustrading

Randomly found throughout the house, there are handrails & balustrades not installed in areas that require restraint measures installed

Defect Rating Safety Hazard

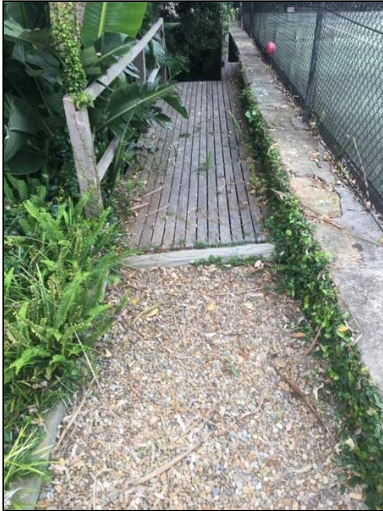
Photos

Answer **Decking is loosely fixed**

Decking boards were seen to be loosely fixed, these areas could be seen as a trip hazard and should be attended to by a carpenter

Answer **Dry / wet rot within the timber structure**

Dry/wet rot can be seen within the timber structure, these areas should be attended to by a carpenter to ensure the integrity of the structure is maintained.

Answer **The hardwood decking boards are in direct contact with the adjacent finished surfaces, wet rot can and will develop over time in the non-accessible areas of the hardwood decking boards**

This is a minor issue, but it should be looked at once you move in as it's cheaper to maintain your property than to repair / replace or re-build a defect / issue

Answer **No / defective ant capping installed**

Ant capping was defective or not evident at the time of inspection.

Answer **Non-structural / loose handrail & balustrade detail installed on site**

Defect Rating Minor Defect

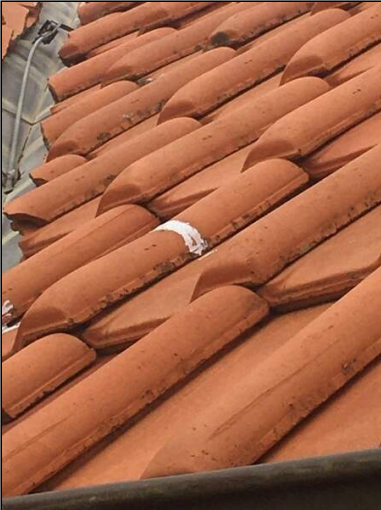
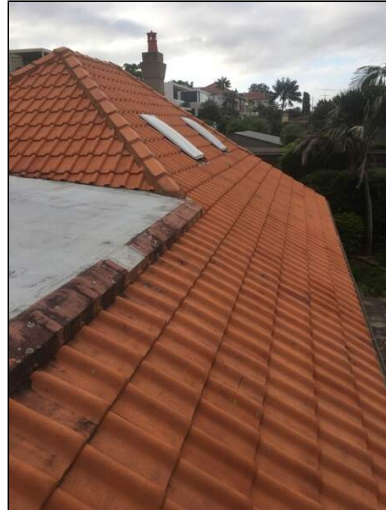
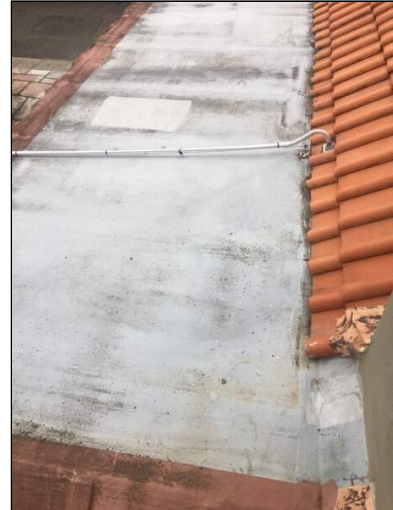
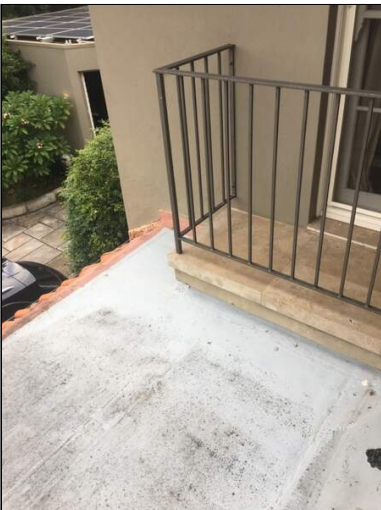
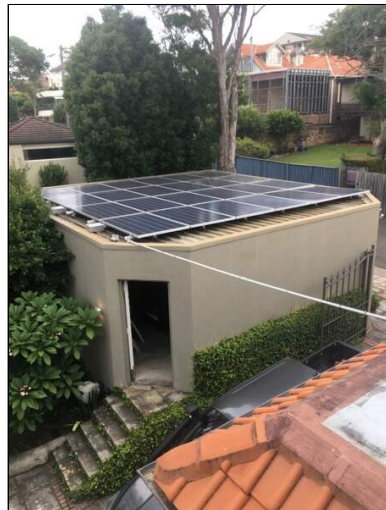
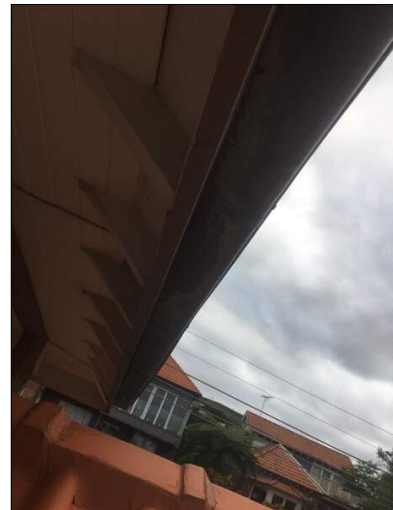
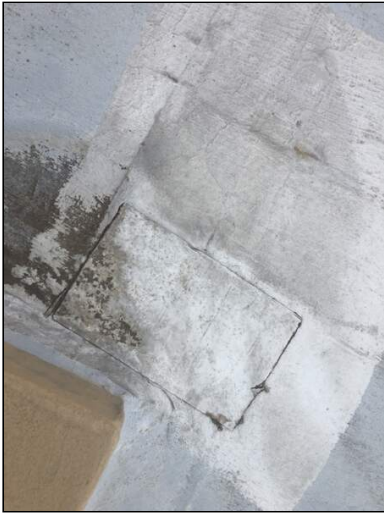
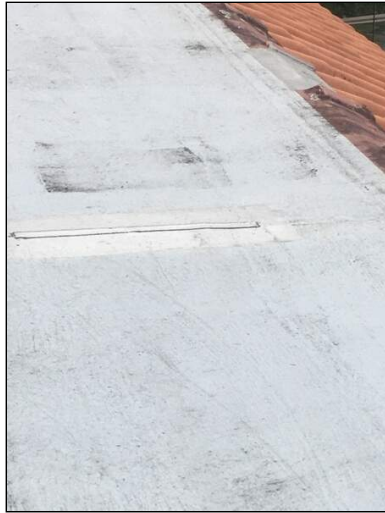
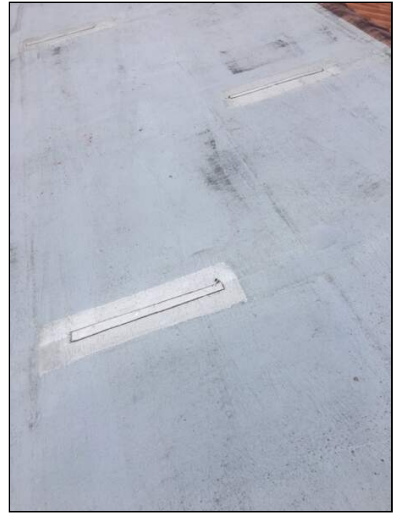
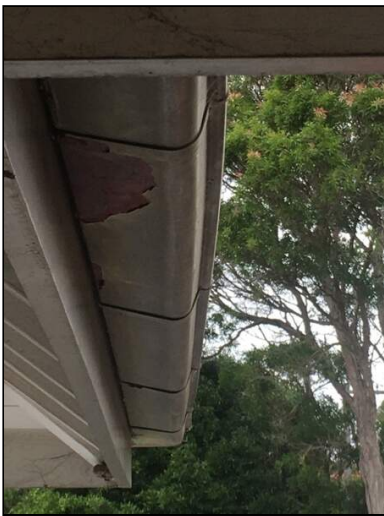
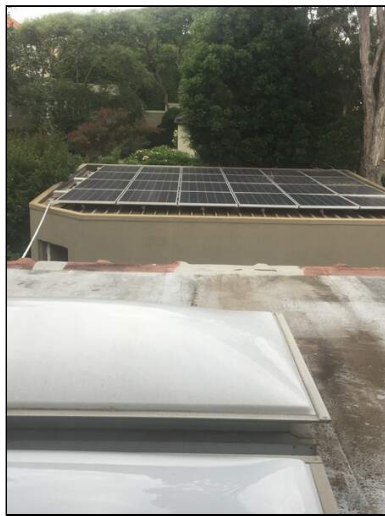
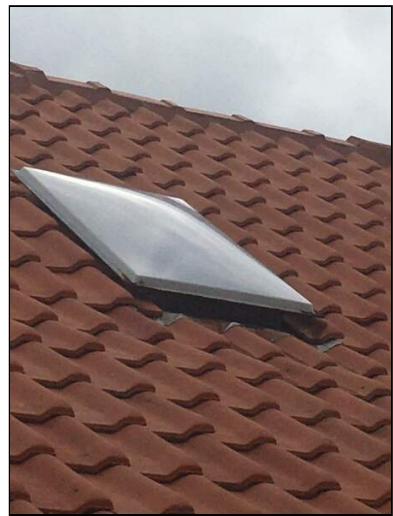
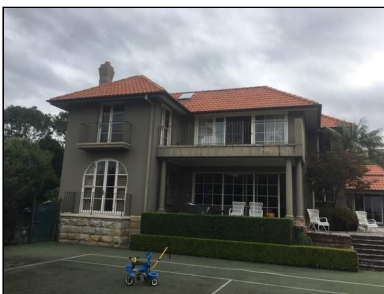
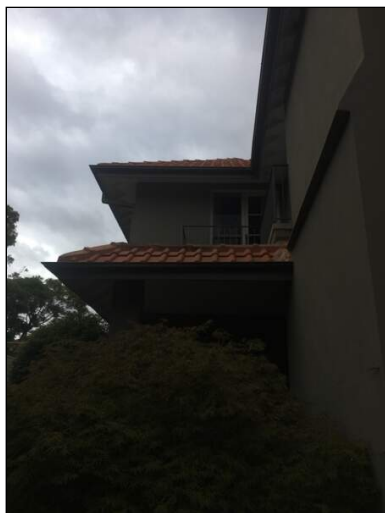
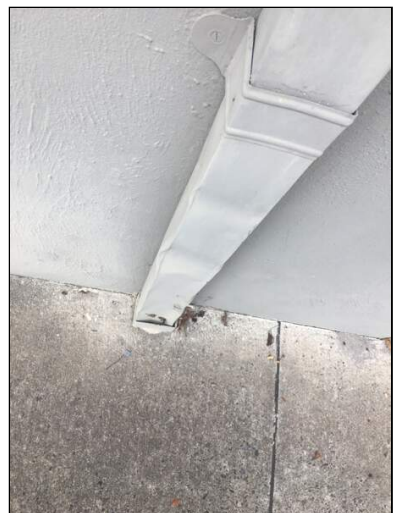
Photos

You cannot rely upon this report for the condition of the roof tiles / roof sheeting / roof plumbing or any other elements found on the roof over the entire property

Defect Rating Further investigation as I did not inspect the entire roof elevation

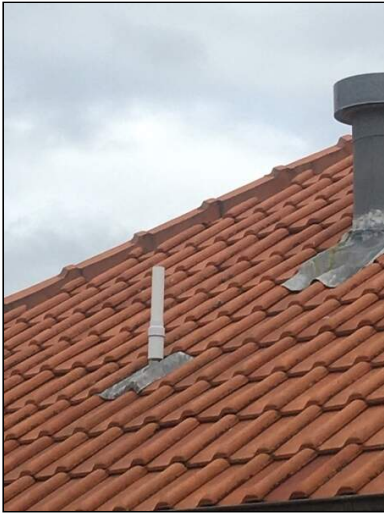
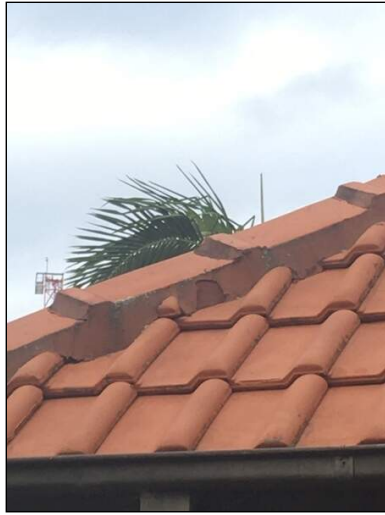
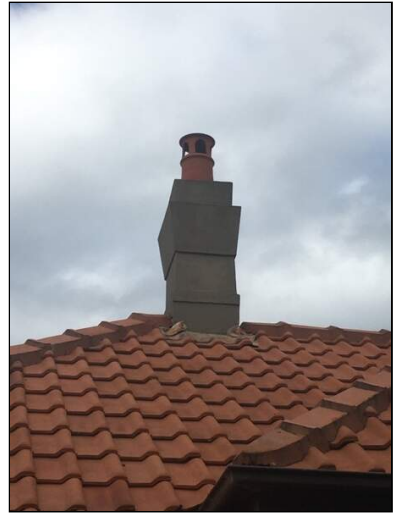
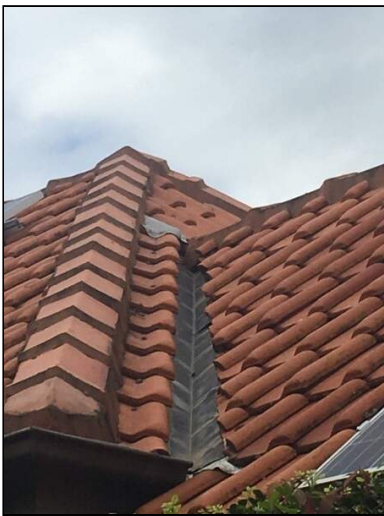
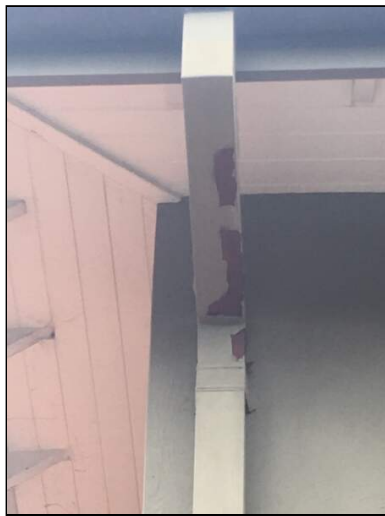
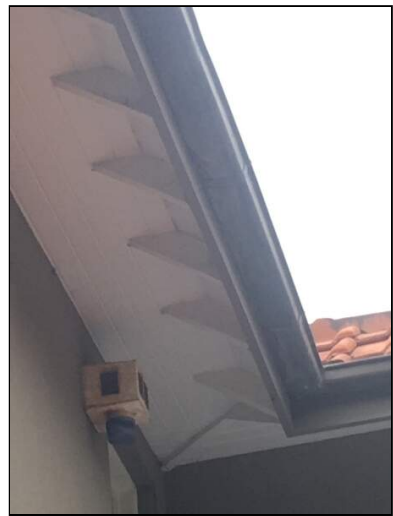
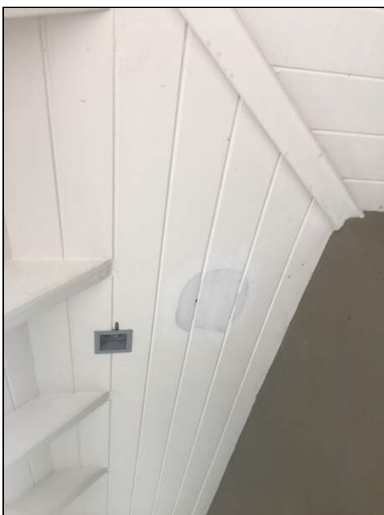
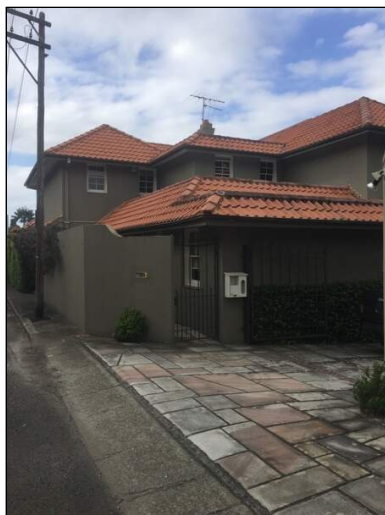
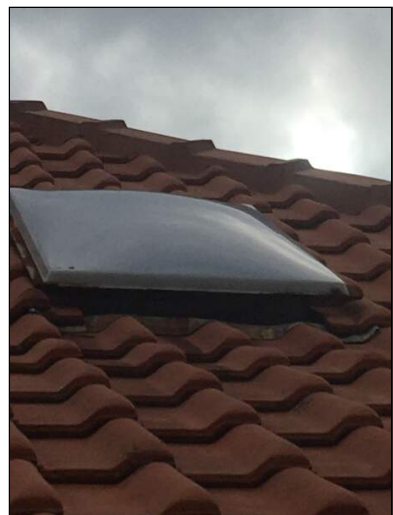
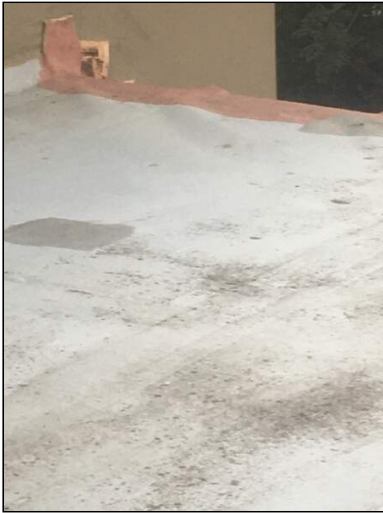
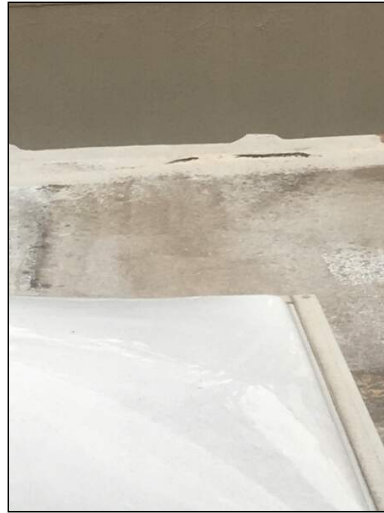
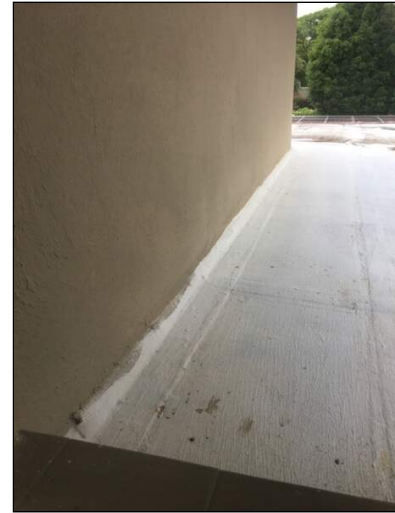
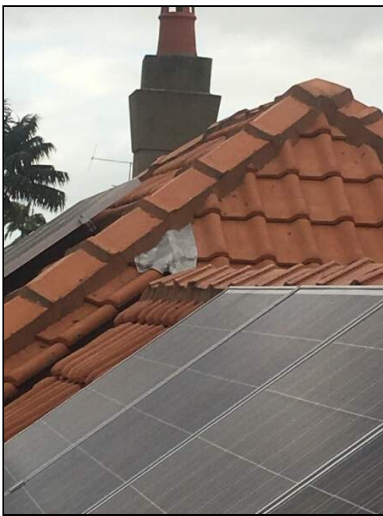
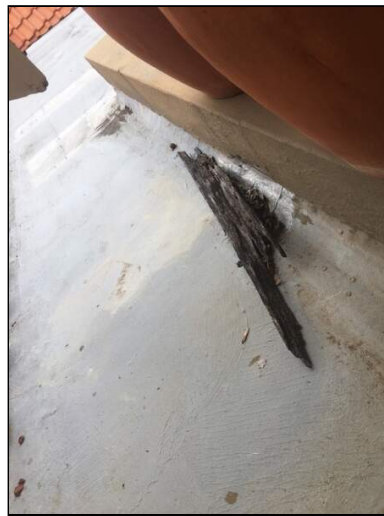
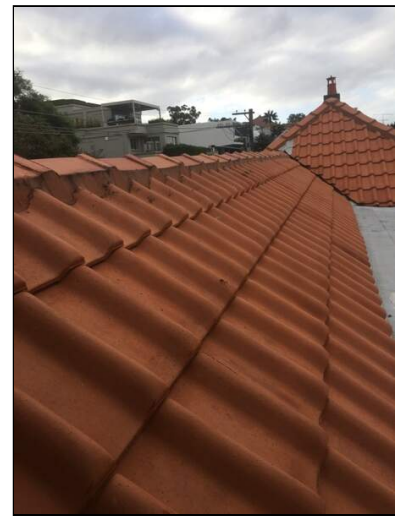
Dislodged tiles in a few areas
Minor cracks were seen within the roof tiles
Minor gaps were seen in the roof tiles and valley iron junctions
I encourage you to engage a roof tiler to rectify this issue

Answer **Minor repairs are required to the roof elevation to make the roof linings / roof void watertight**

Defect Rating Minor Defect

Answer **Extensive rust found within the roof sheeting**

Extensive rust was found on the roof sheeting

Answer **Considerable rust seen within the roof sheets / roof plumbing**

The rusted roof sheet/s should be replaced as they could allow water entry now or in the near future if not addressed

Location The garage roof sheeting and roof plumbing needs to be repaired due to rust and damage within the roof sheeting

Answer **Corroded flashings**

The flashings are corroded and in need of repair or replacement

Answer **Impact damaged flashings**

The flashings installed needs to be worked on as they are defective

Answer **Damaged and defective roof capping's**

Location Garage roof sheets & roof plumbing need to be repaired

Answer **Skylight cover defective**

Answer **Damaged / Dented downpipes**

There are downpipes that need to be repaired within this property

Answer **Downpipe joins leaking**

Answer **Eave and soffit lining, detached / defective**

Eave and soffit lining detached, damaged and loose.

Replacement is required ASAP

A roof plumber would be the best contractor to call to have this repaired

A roof plumber should be engaged to repair and make good this issue

Repairs are required to the roof capping, to make the property and roof framing / void watertight

Minor works are required by a roofing contractor to have the skylight PVC / GLASS cover replaced due to it being defective, which could allow water to enter the property if left as is

Downpipe joins leaking, have a roofing plumber repair / seal this issue while it's a minor defect

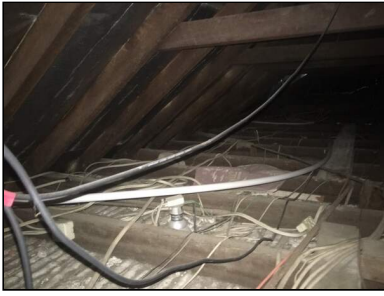
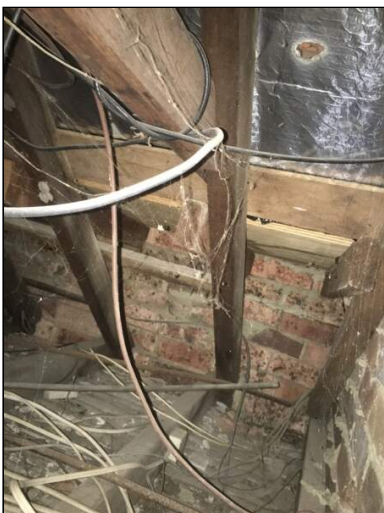
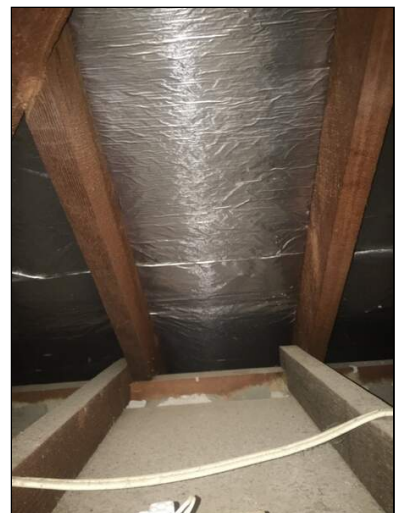
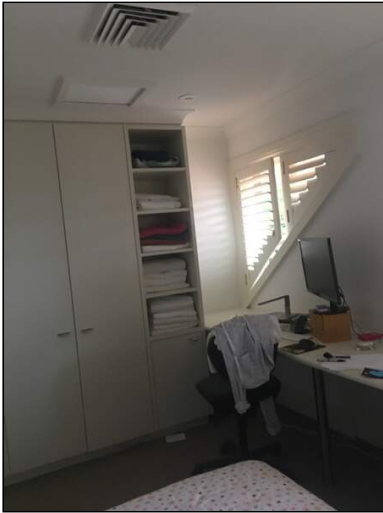
Answer **Water staining evident to underside of roof**

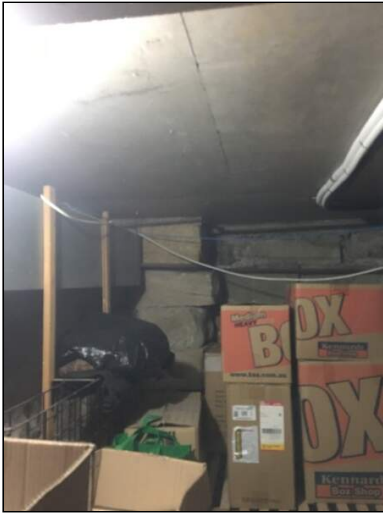
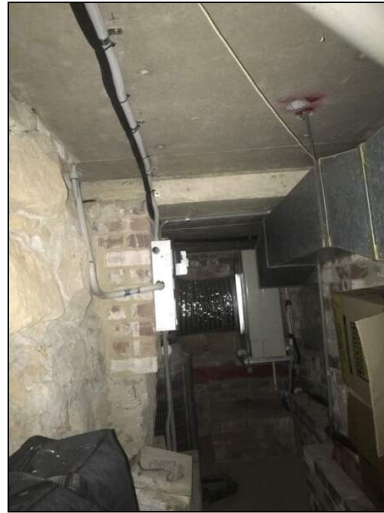
Defect Rating A second inspection is recommended once access is provided (Subfloor access is very important for any property with a timber floor structure)

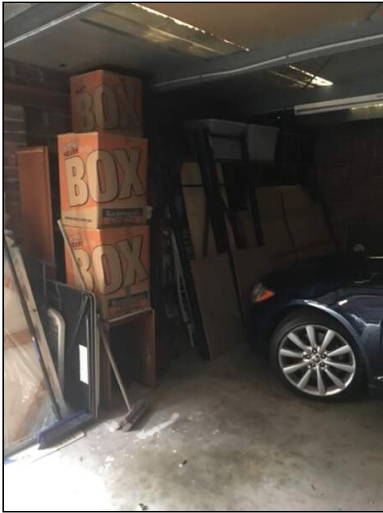
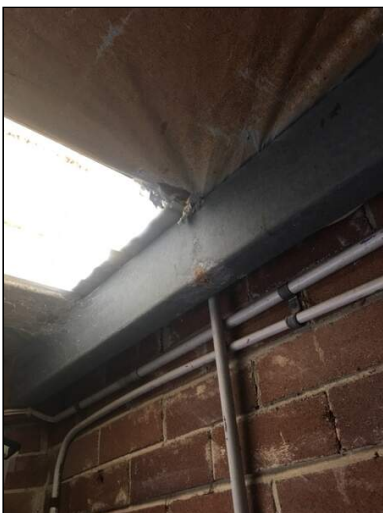
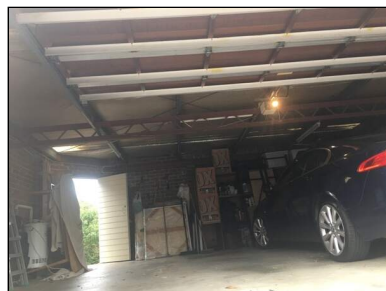
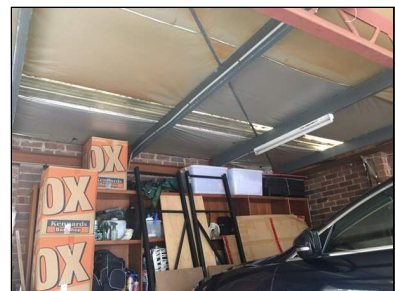
Defect Rating General Comment / minor defects

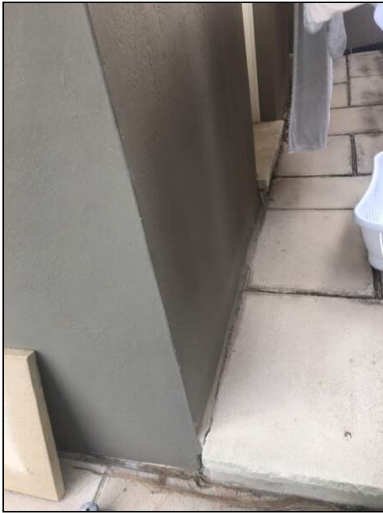
Bricks grow in time, concrete shrinks over time: we should allow for this settlement to take place over time within our building, hence why expansion and control joints are recommended by manufacturers and projects engineers and noted within the Australian Standards

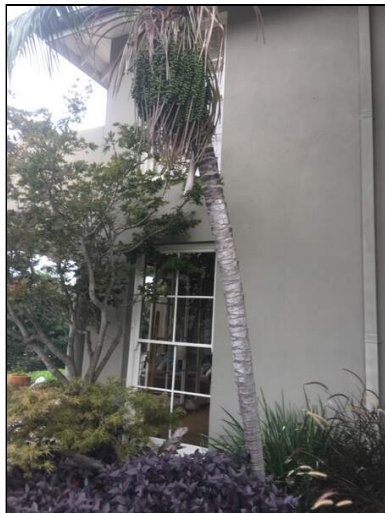
Defect Rating Minor Defect

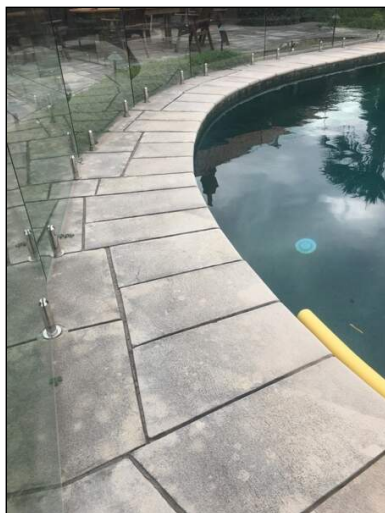
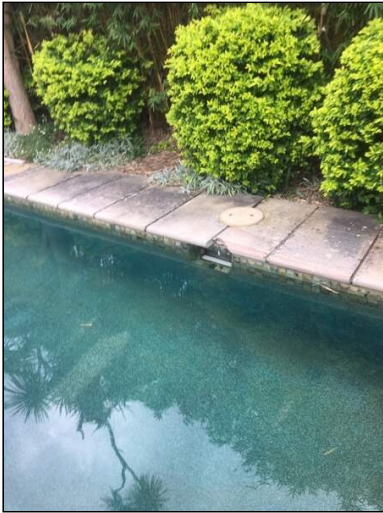
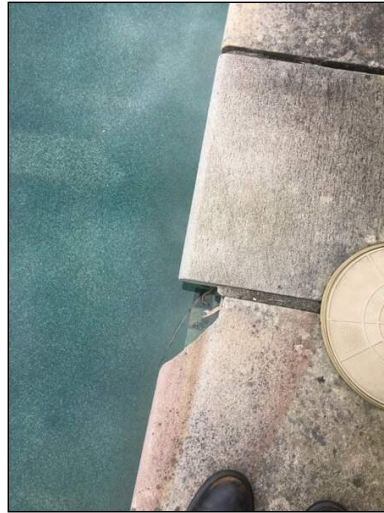
Answer **Summary Of Defects / Issues within the pool area**

Defect Rating Compliance Report should be reviewed and considered by the prospective buyer
