SITE ASSESSMENT & ADVICE

Site Address: 6.08 & 6.09 of 8 Elizabeth MacArthur Drive Bella Vista NSW 2153

Report Type: General-Purpose Building Defect Report

Date of Inspection (s): 13/04/2023

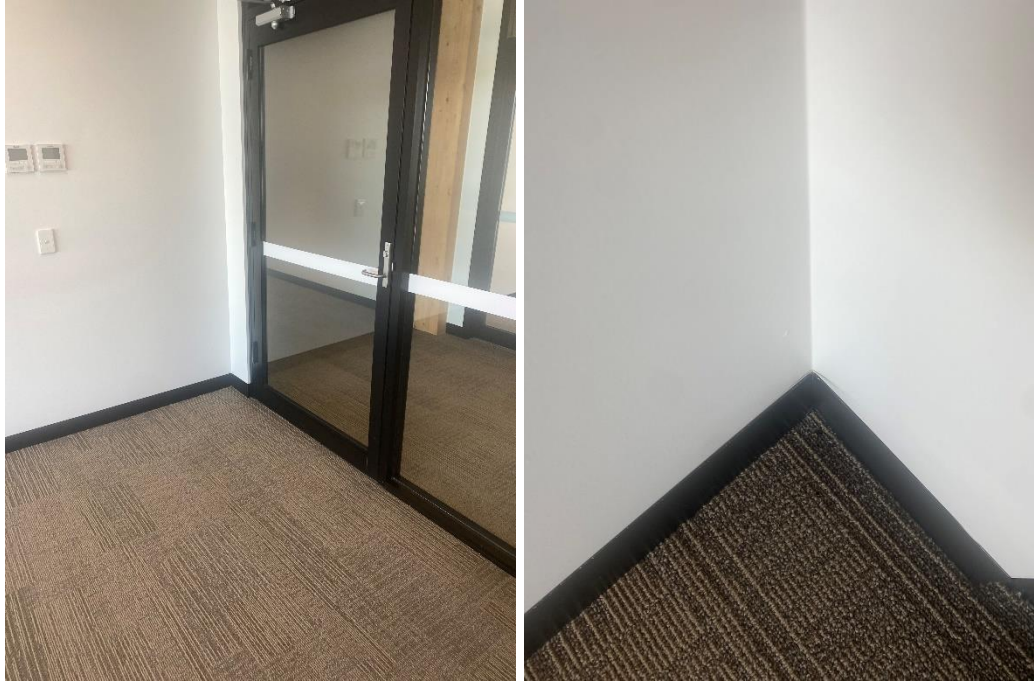
1. As you enter the room to the right, there are scuff marks on the paintwork above the skirting board.

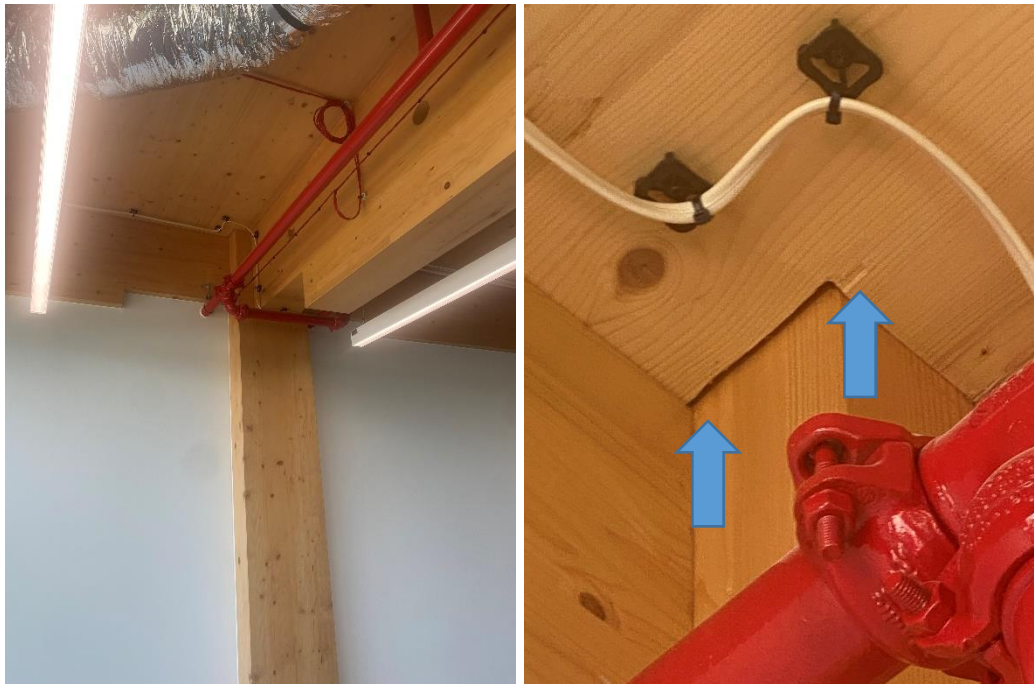
2. The ceiling panel has been poorly cut where it meets the column, together with the ceiling panel being chipped.

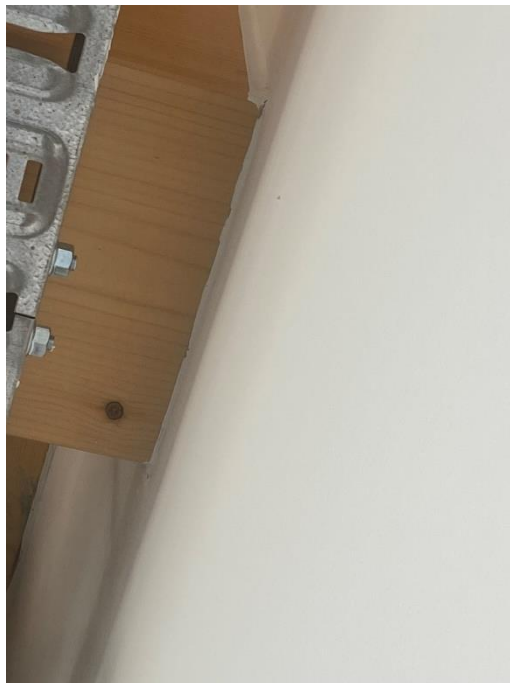
5. Within the ceiling and dropdown beam junction, there is excess silicone and mastic smeared over the timber dropdown beam.

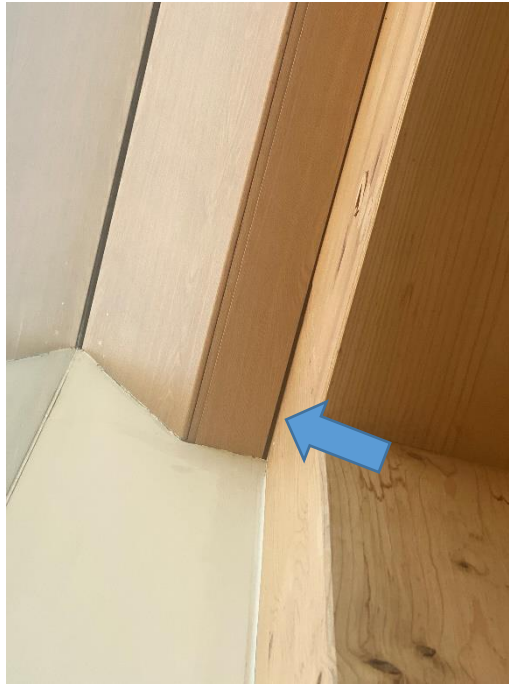
6. Carpenter has poorly cut and installed the pelmet, as you can see there is excess gaps between the pelmet and beam junction within the bottom 300mm of the pelmet.

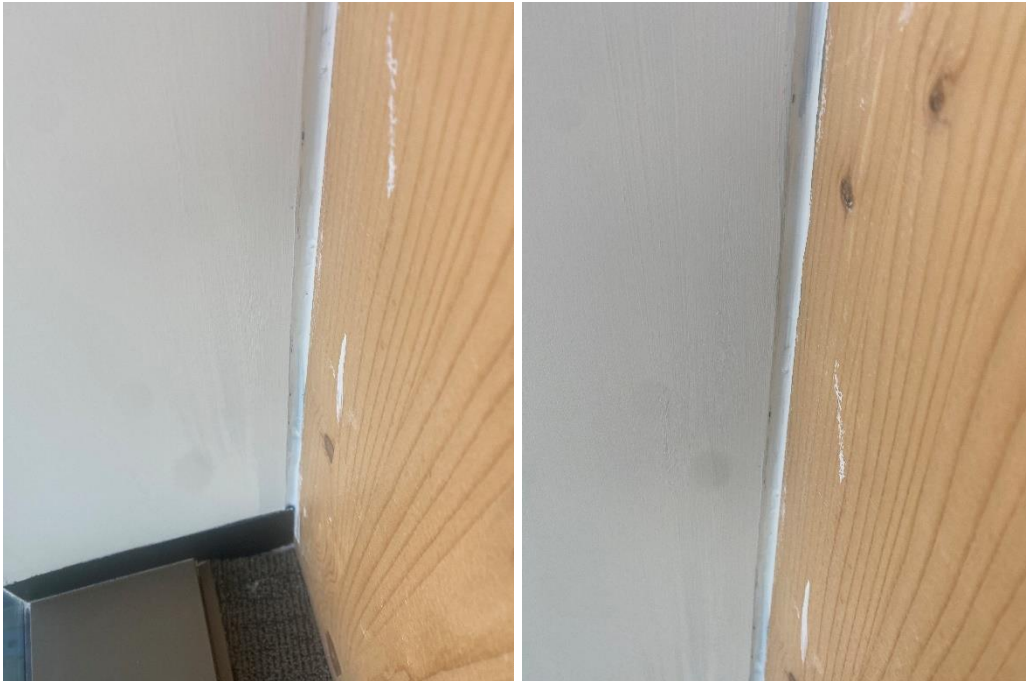
9. The wall has not had a three-coat paint system applied, as you can see a slight smear through the paintwork on the plasterboard wall perpendicular to the column, together with the removal of paintwork from the timber columns are required.

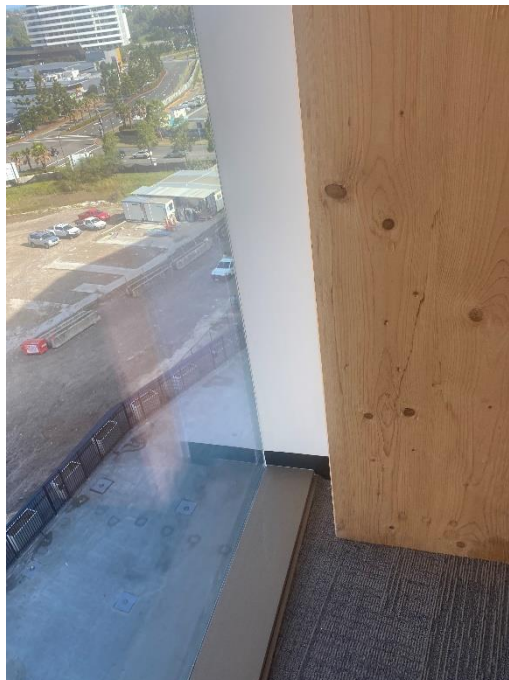
10. Remove paintwork from the skirting board and windowsill.

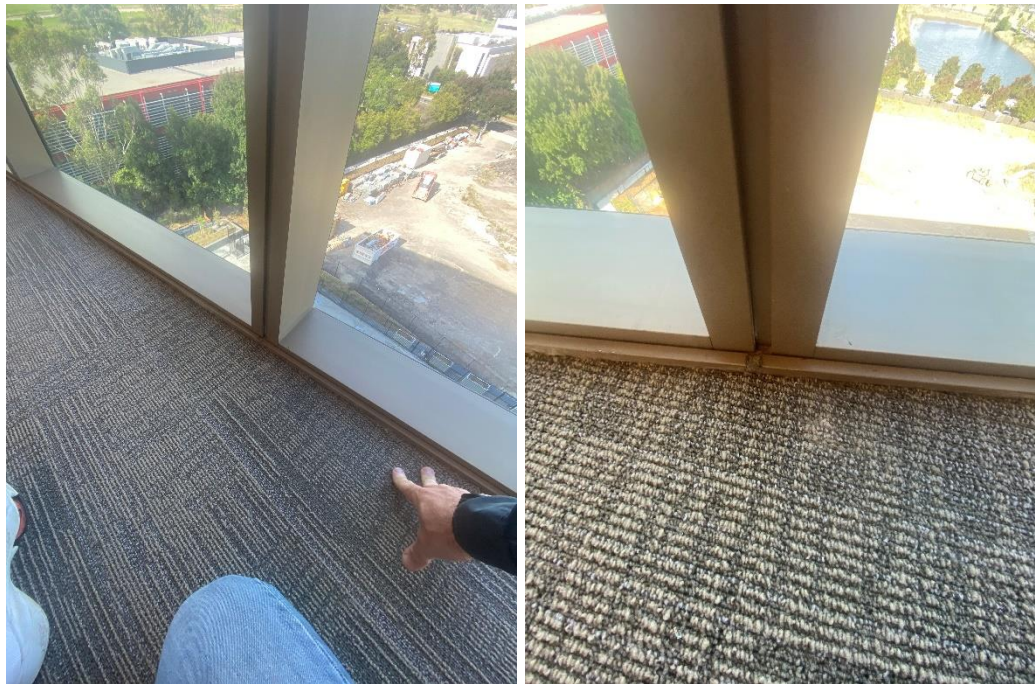
15. Window beading has been inconsistently treated with a painted construction sealant and non-painted construction sealant applied in various locations. A consistent finish should be achieved by having the sealant in a natural colour or having it painted one consistent colour.

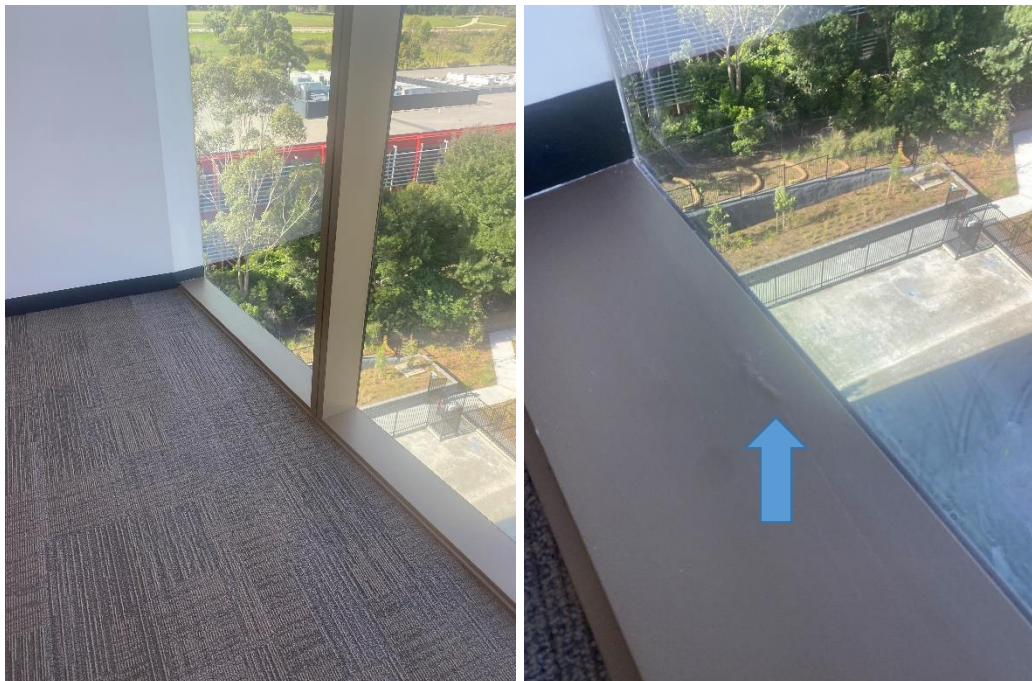
20. The back left corner of the office windowsill has been poorly prepared, it needs to be sanded down / prepared to remove the excess paint or substrate build up.

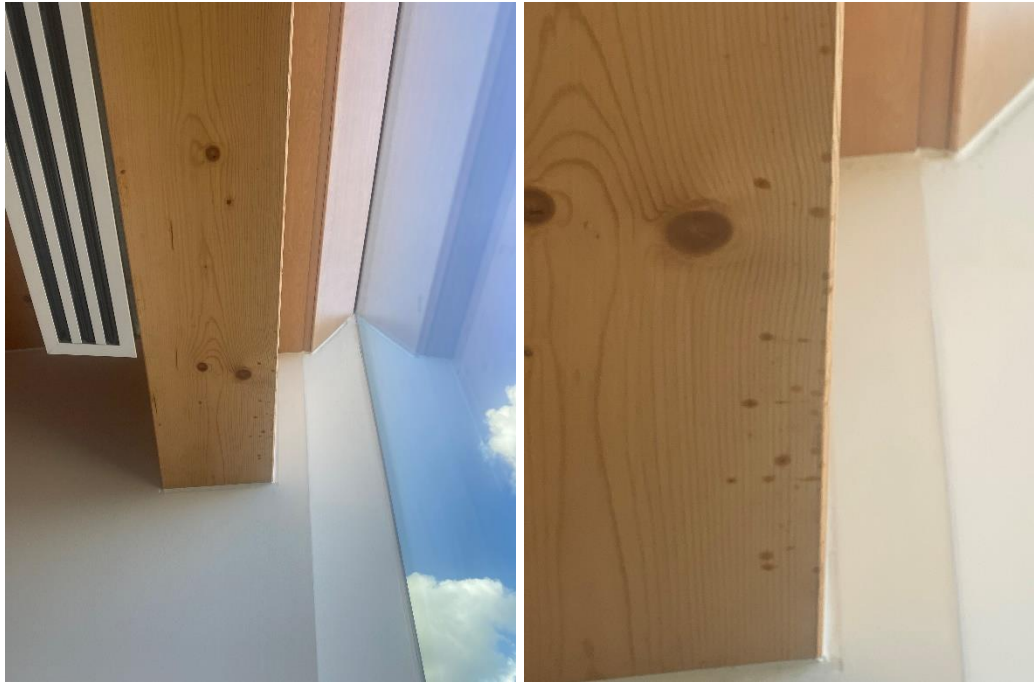
21. Back left corner of the office, there is sap leaching out of the timber dropdown beam timber cladding.

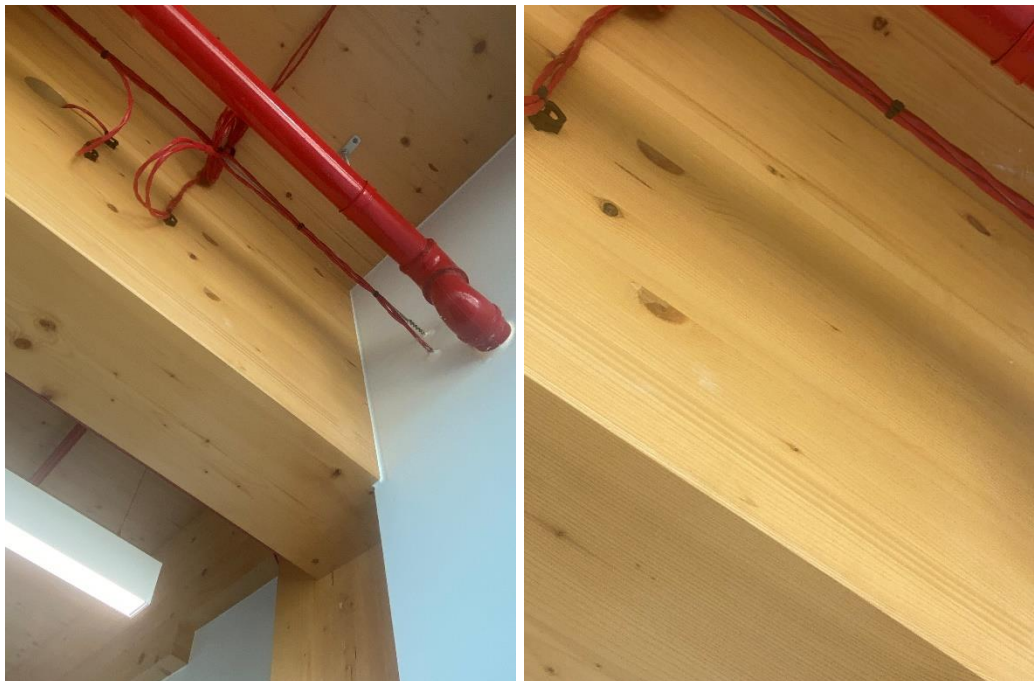
22. There are paint smear marks on the dropdown timber beam.

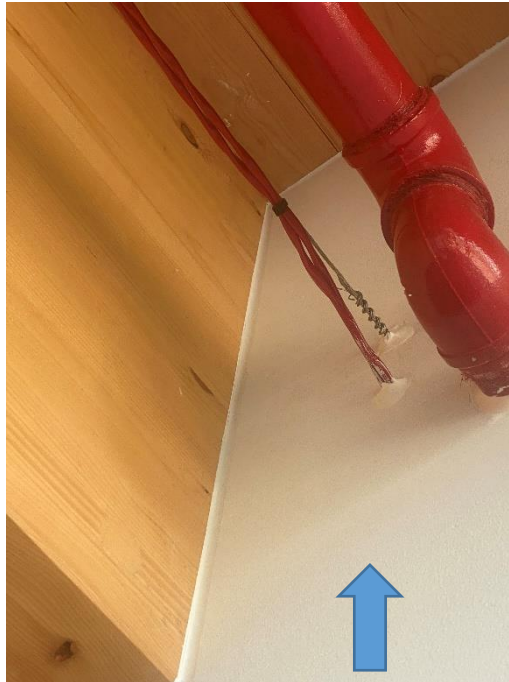
23. Poorly prepared and painted plasterboard adjacent to the metal pipe protruding through the plasterboard wall. Painter to prepare and paint the wall as required.

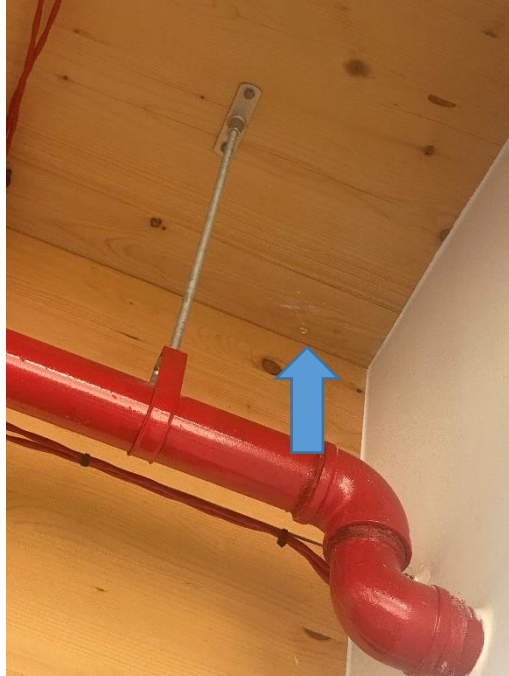
24. Paint smear marks need to be removed off the timber ceiling panels.

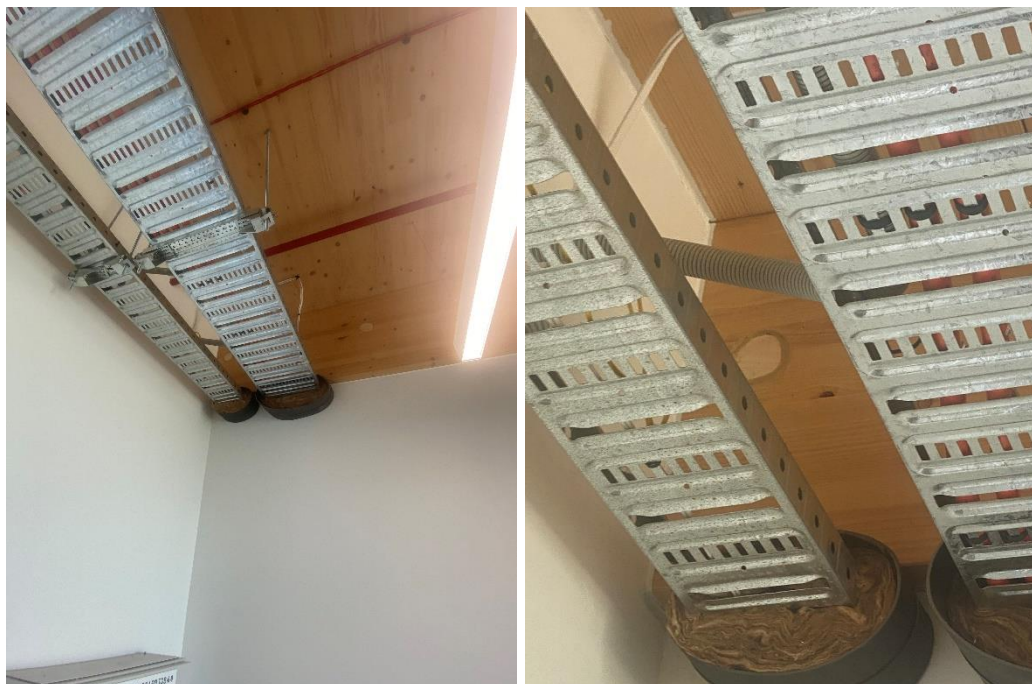
33. The timber beams have been plugged with the incorrect timber, as seen within the image below. There are approx. six locations which need new timber plugs installed.

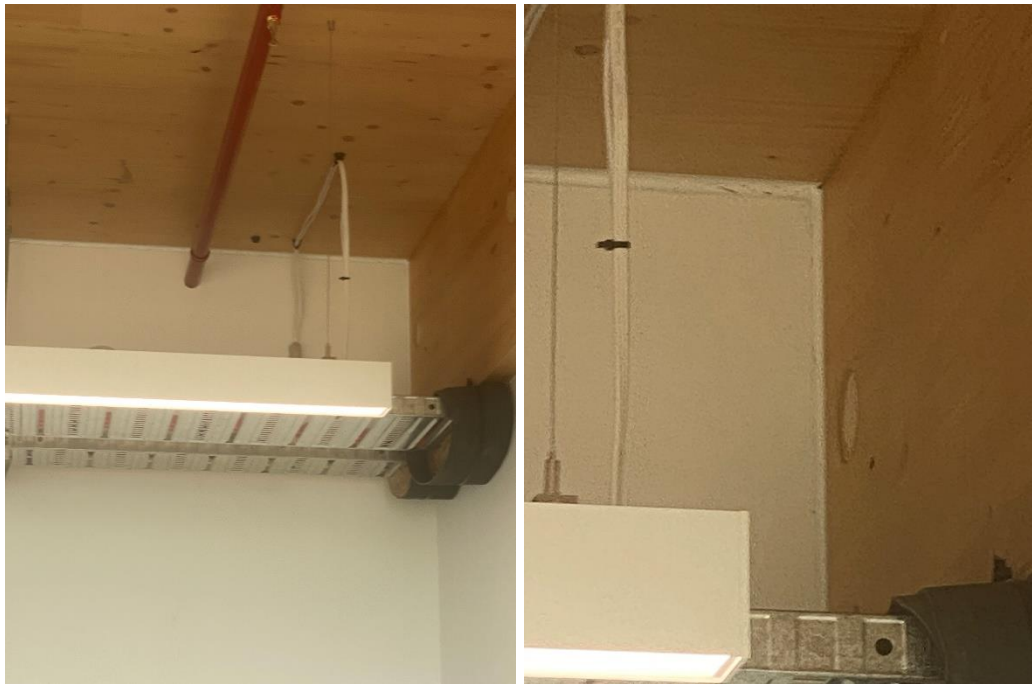
34. There is inconsistent and excessive mastic used between the plaster walls and timber ceiling and it has been poorly addressed with mastic and / or filling compound, which is only highlighted by poorly patched and painted sealant.

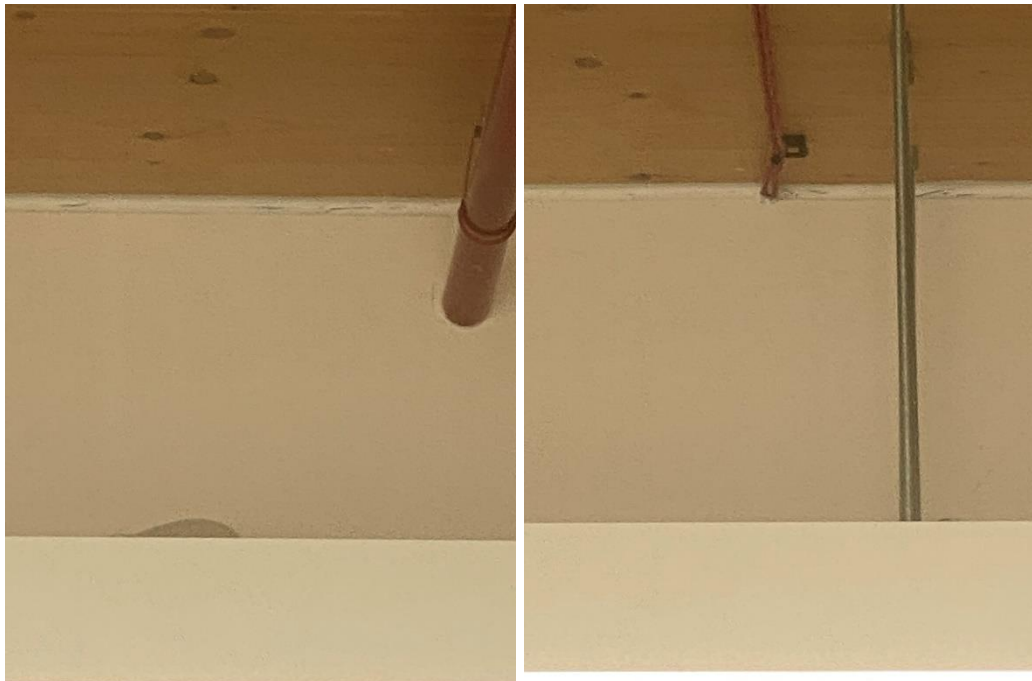
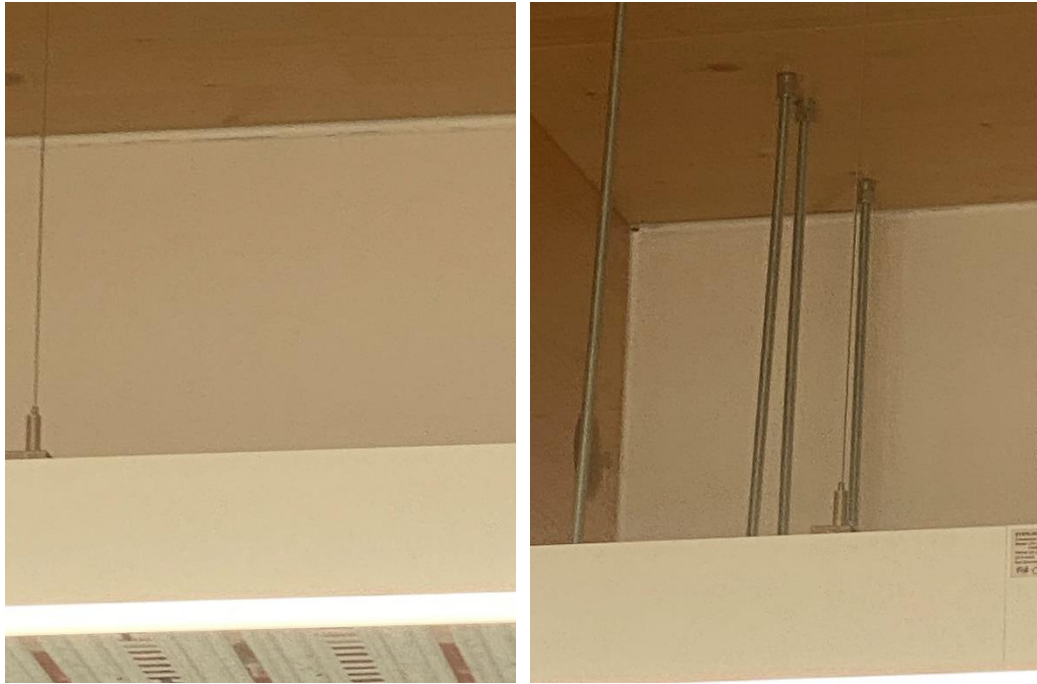
35. There is inconsistent and excessive mastic used between the plaster walls and timber ceiling and it has been poorly addressed with mastic and / or filling compound, which is only highlighted by poorly patched and painted sealant.

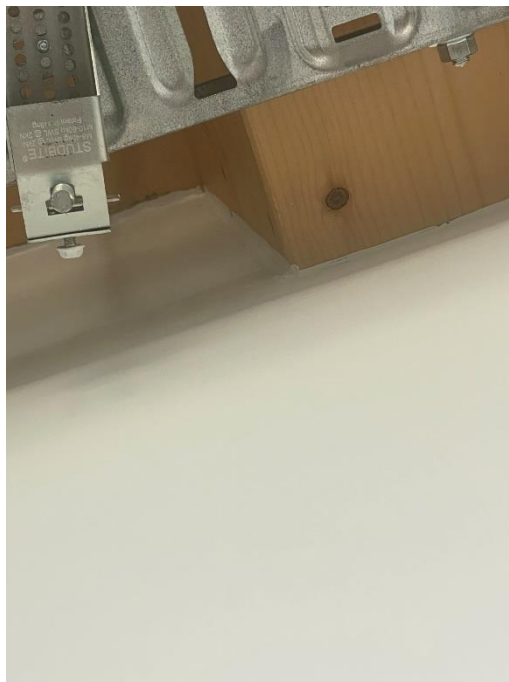
36. Along the secondary beam on the ceiling, the cable tray strapping needs to be re-secured parallel and perpendicular to the tray.

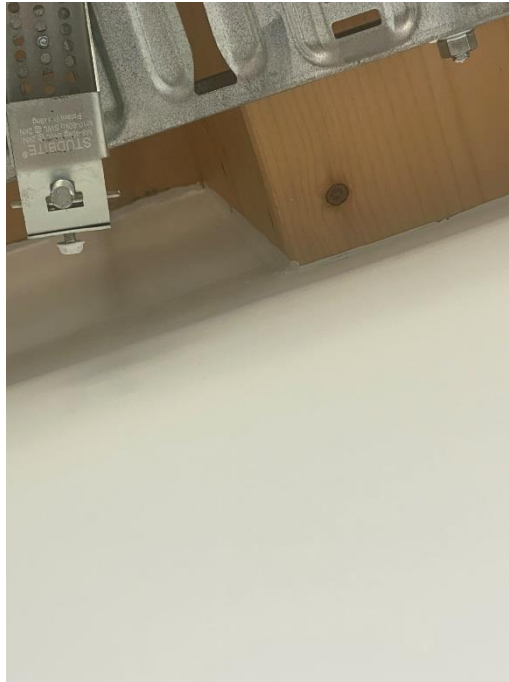
37. Secondary dropdown beam on the ceiling and wall junction has excess mastic and paint smearing on the plasterboard wall and clear coat timber beam and ceiling junction.

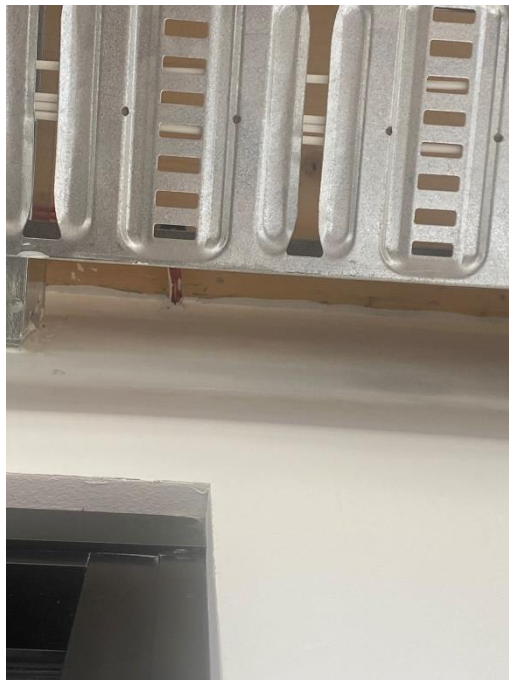
38. Along the wall and ceiling junction, there is excess mastic and paint on the timber ceiling and electrical cables.

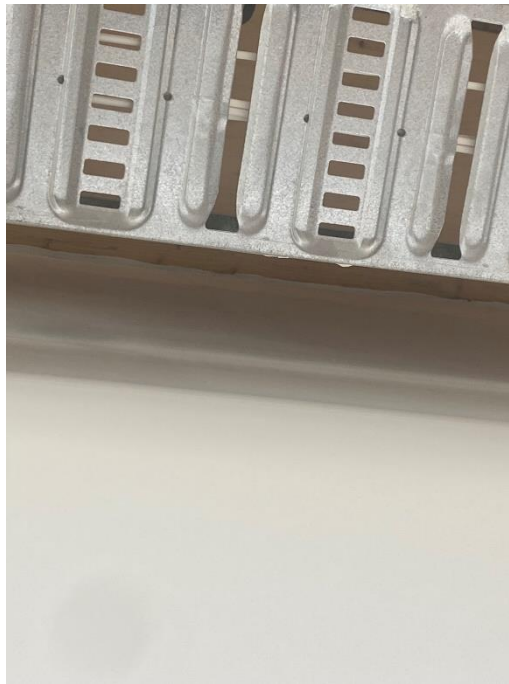
39. In the office, the paint applied to the plasterboard wall on the top 100mm of the wall only has one coat of paint, additional coat of paint in order to achieve a one-coat sealer and two-colour coat paint system.

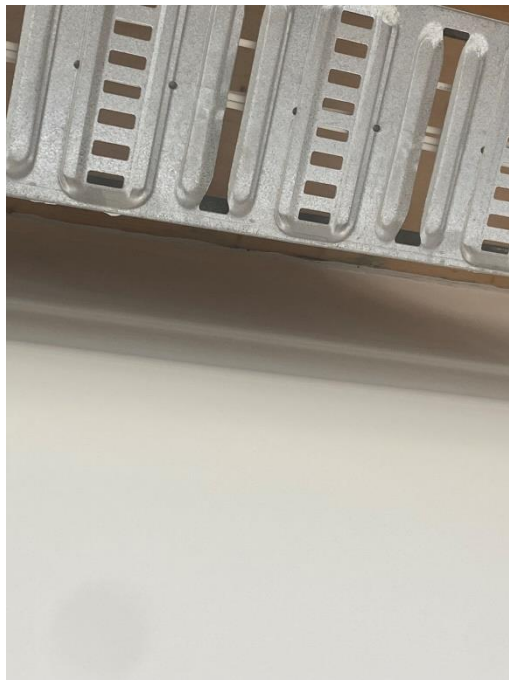
40. Along the wall dividing the office suite and the hallway, the painter has poorly cut in the paintwork which has smeared on the timber ceiling linings.

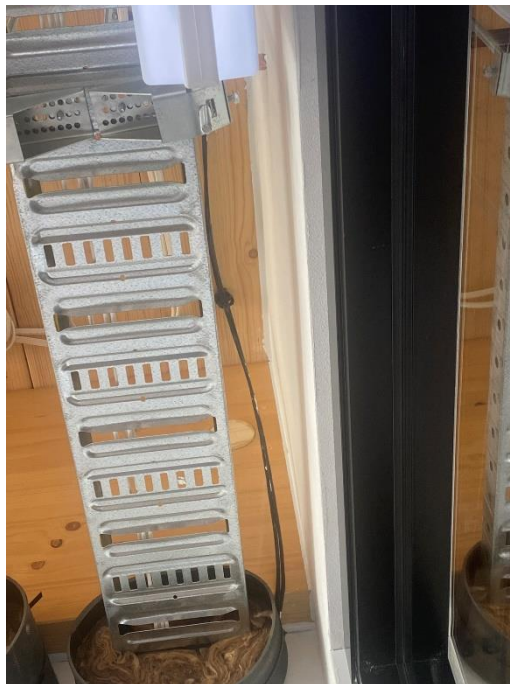
43. Timber dropdown beams have been plugged with the incorrect timber, white plugs were installed within the yellow timber, new plugs with matching timber colour and grain are required.

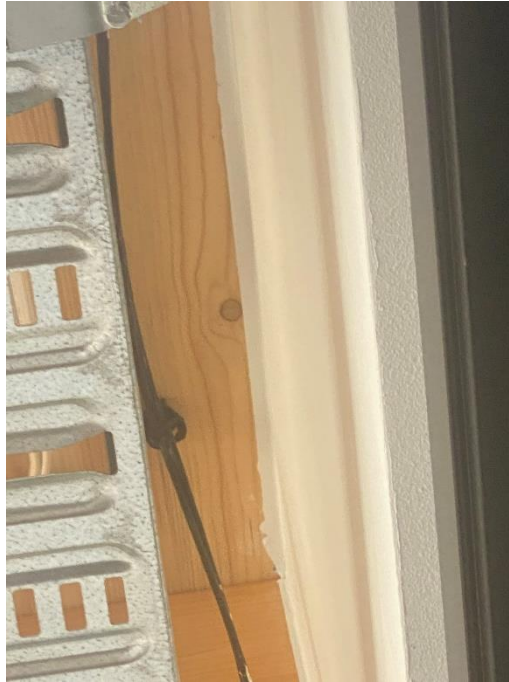
44. Running along the common dividing wall between this office and the adjacent office, there is excess mastic on the wall and ceiling junction.

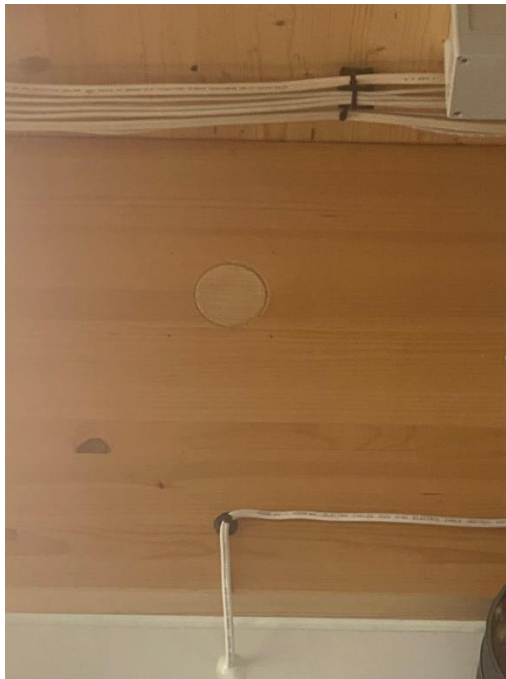
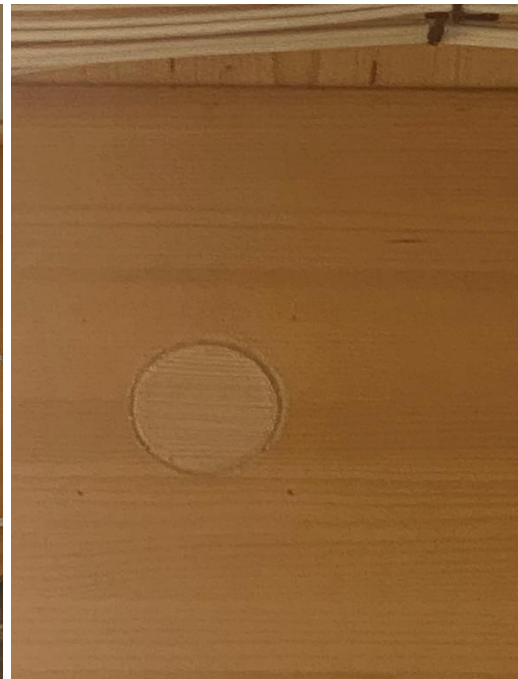
45. Along the middle of the beam adjacent to the common wall, there are holes within the beam which have been plugged using the incorrect timber colour and grain.

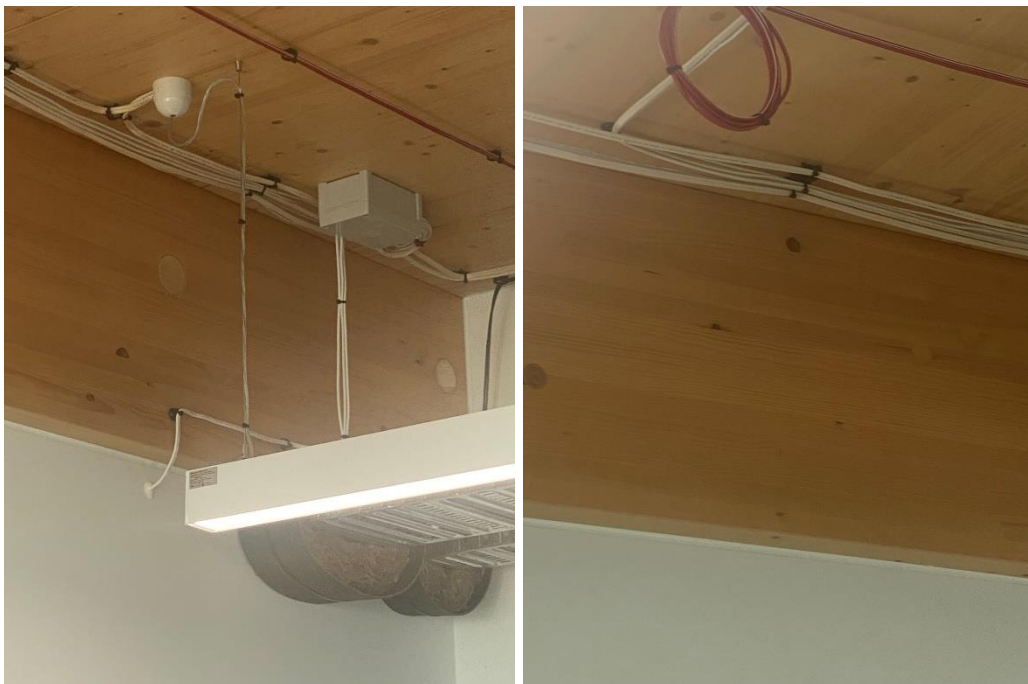
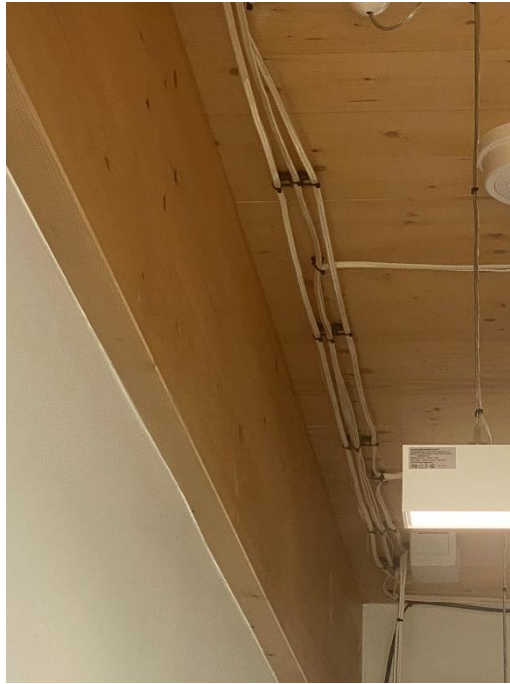
46. Throughout the entire office suite, there are electrical cables servicing lights and power, not concealed within conduit. Should a ceiling be installed, the electrical cables exposed and not concealed within conduit is adequate, however, it does not appear that there is a ceiling being installed, therefore, the electrical cables should be housed within flexible or fixed conduit or on a tray.

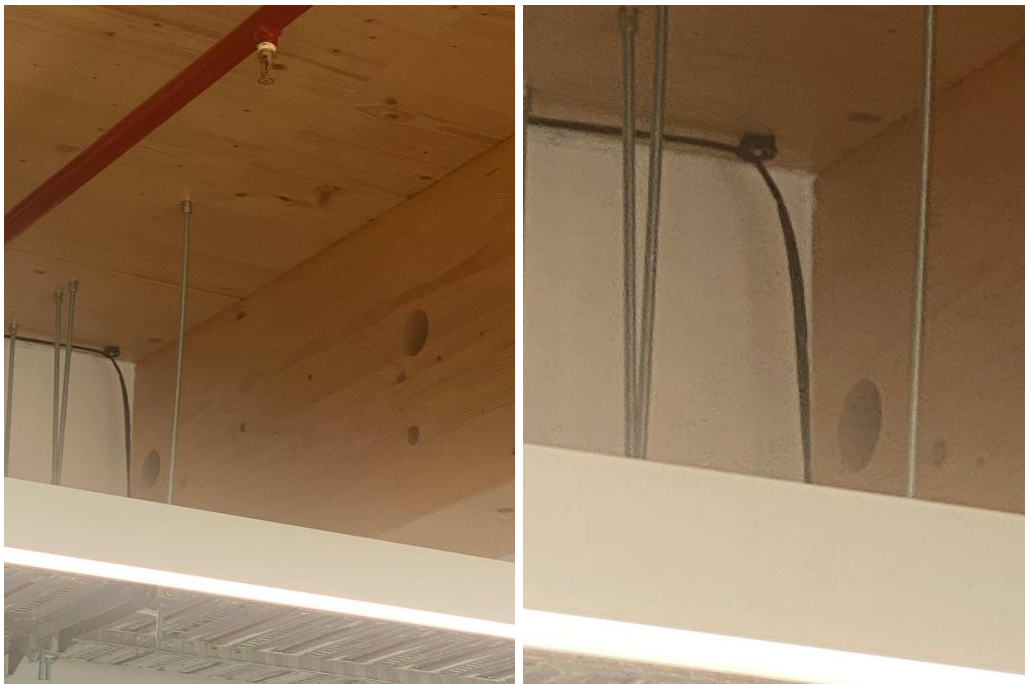
47. The dropdown beams have had holes drilled through them which have compromised the structural integrity of the beams and they have not been plugged matching the remaining holes that were plugged within the other beams.

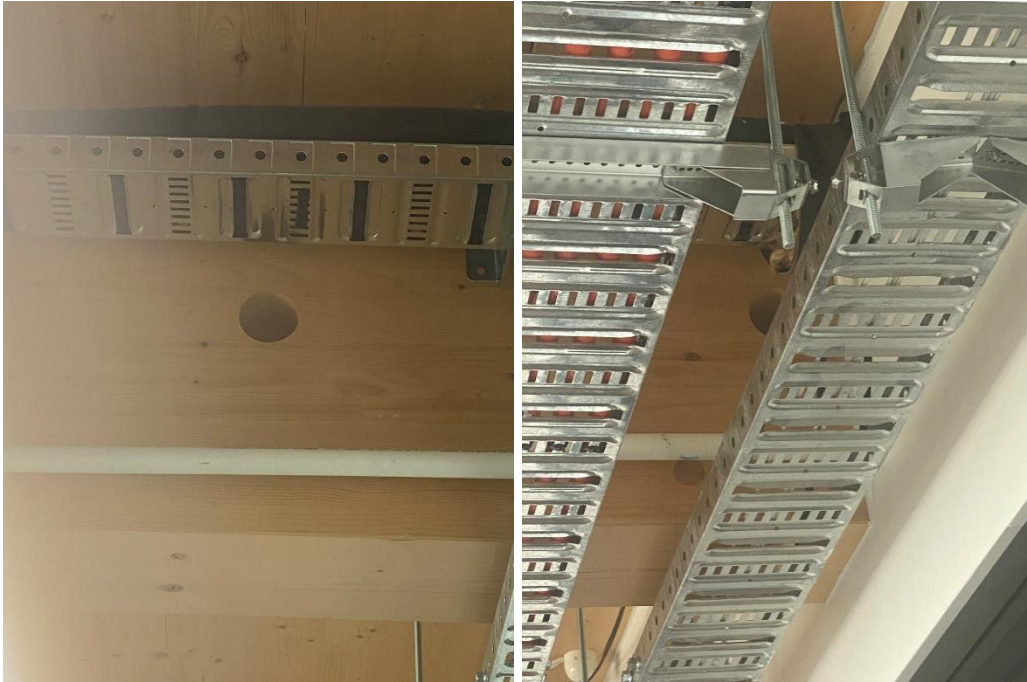
48. Second dropdown beam on the ceiling has holes created within the face of the beam, which have compromised the structural integrity and the have not been plugged nor finished off.

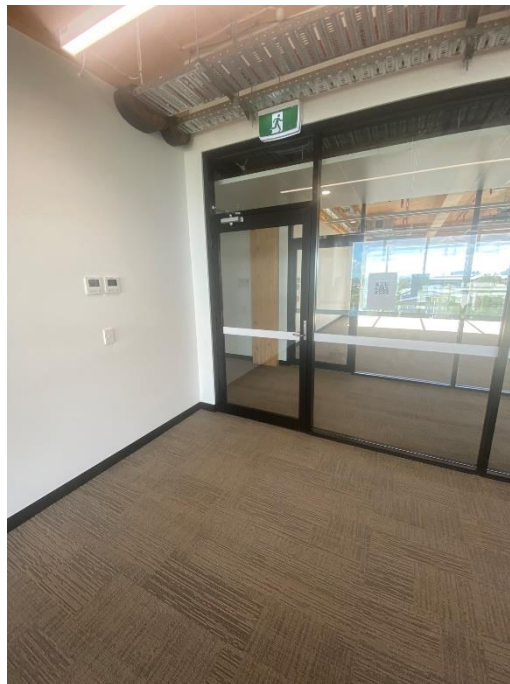
49. Entry door hinge style has a 4mm gap, the door head style has a 2mm gap and the door lock style has a 3mm gap between the jamb and the single leaf door. Carpenter to adjust in order to have equal gaps and quirks between the aluminium door and the aluminium door frame.

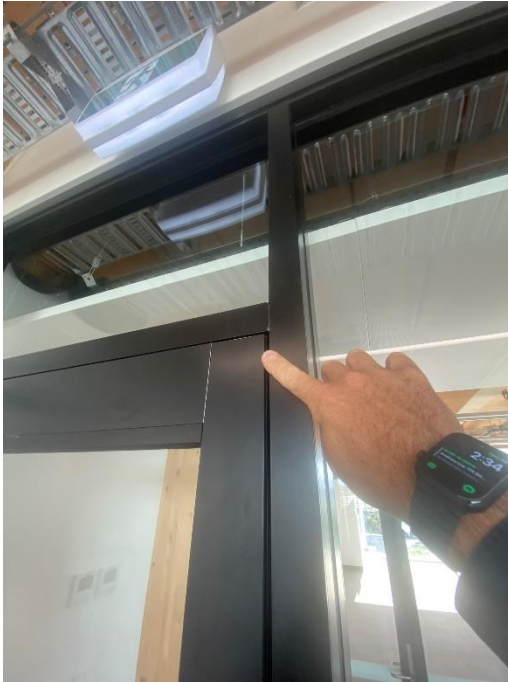
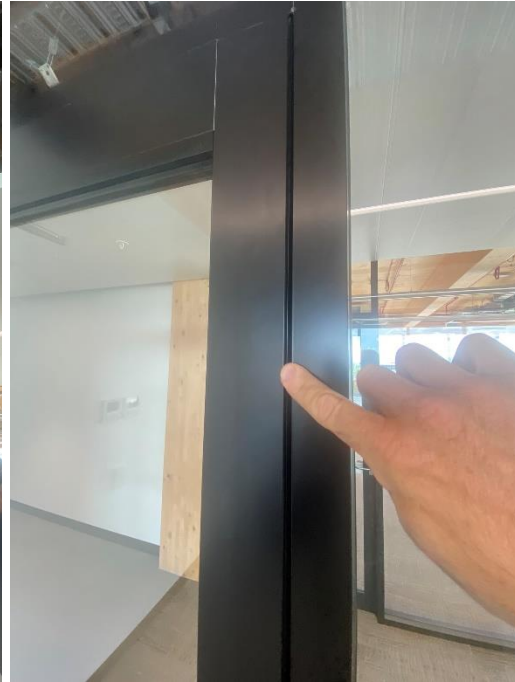
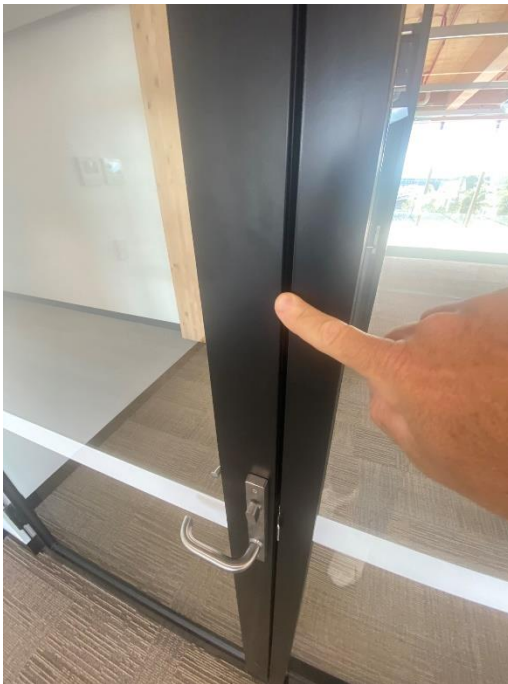
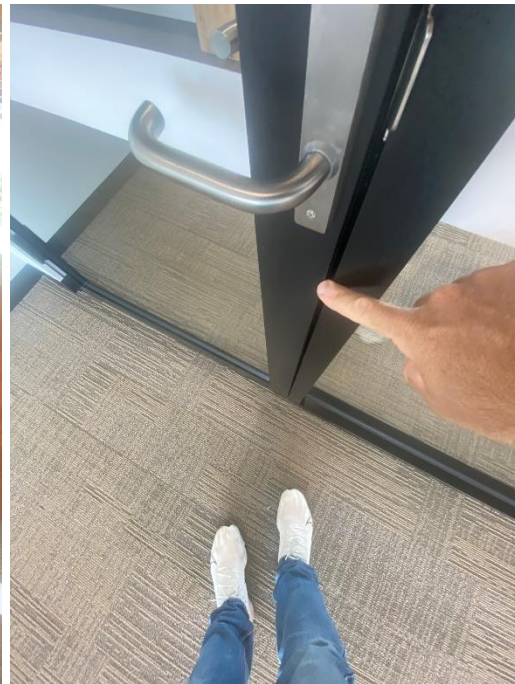
50. The aluminium door is out of wind on the lock side at the top of the door by 5mm.

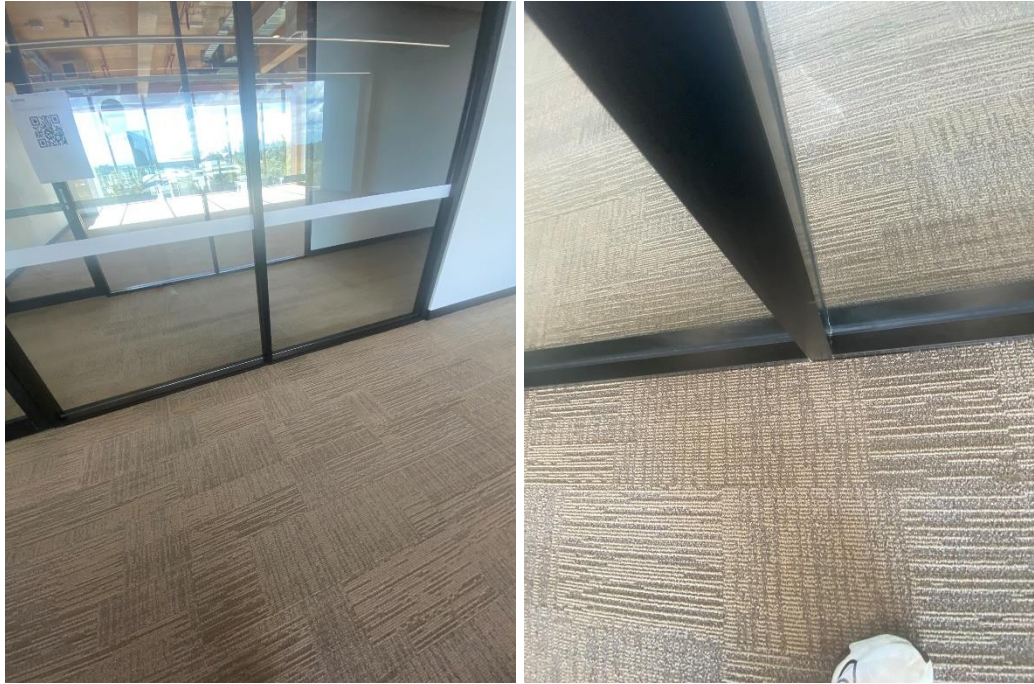
51. White paint smear marks seen within the black aluminium powder coated window frames.

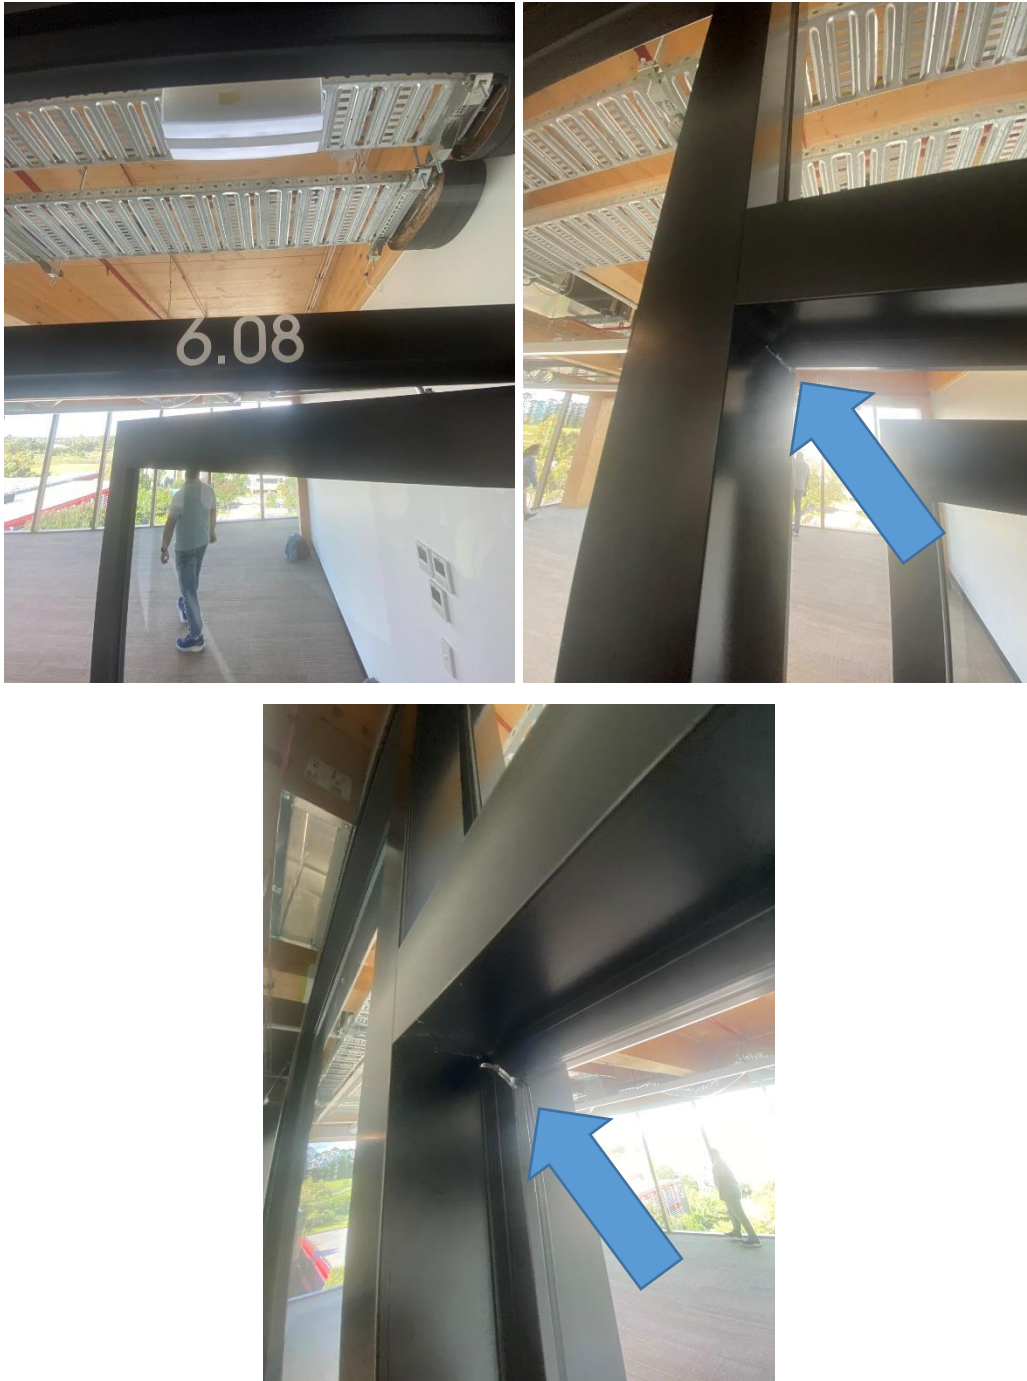
1. Top left doorjamb rebate has an expressed joint within the mitre.

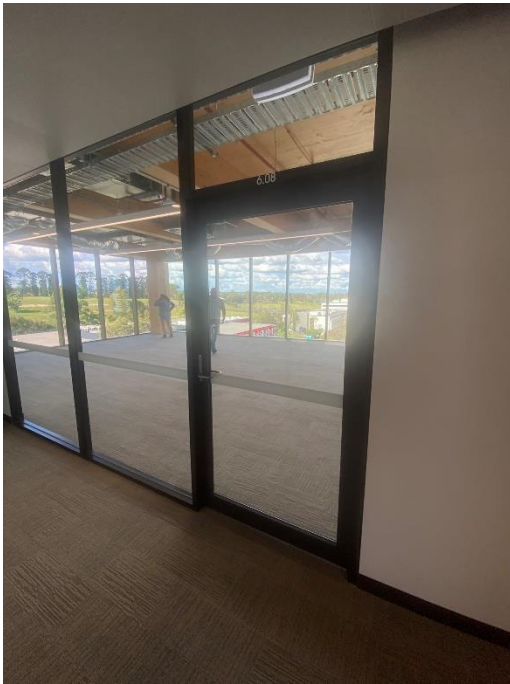
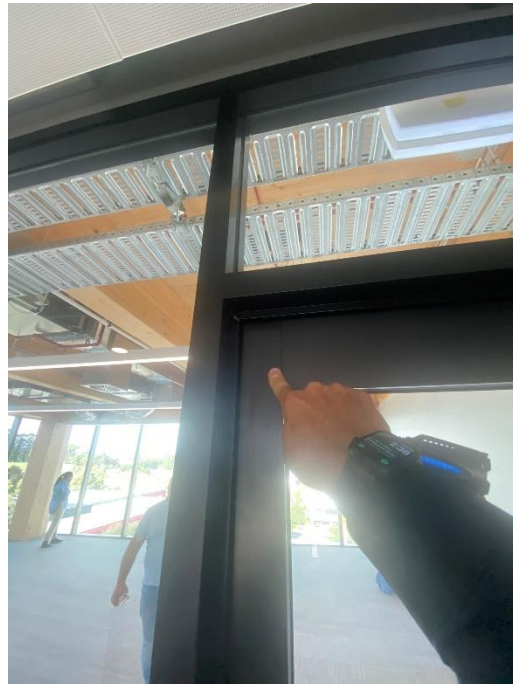
2. Entry door is out of wind in the top left corner by 8mm.

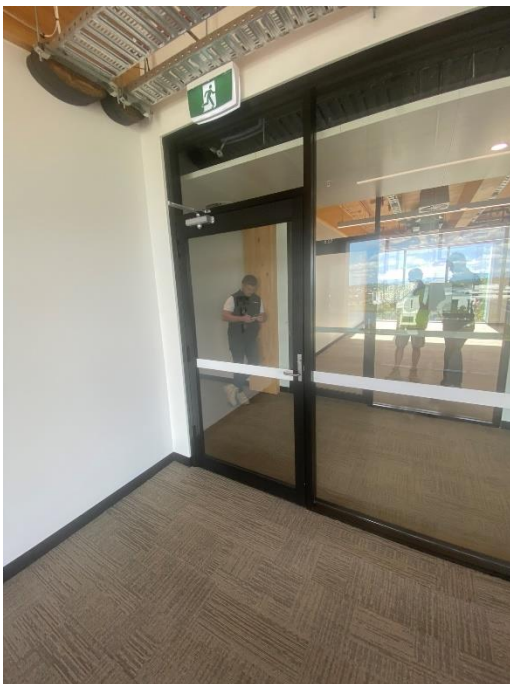
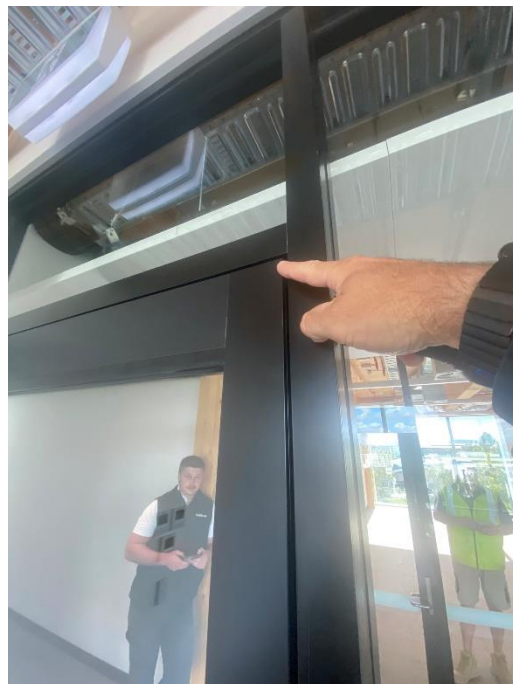
3. Inconsistent gap between the entry door and doorjamb, lock side. Typically, doors should have a 3mm quirk on the left, right and top side of the door.

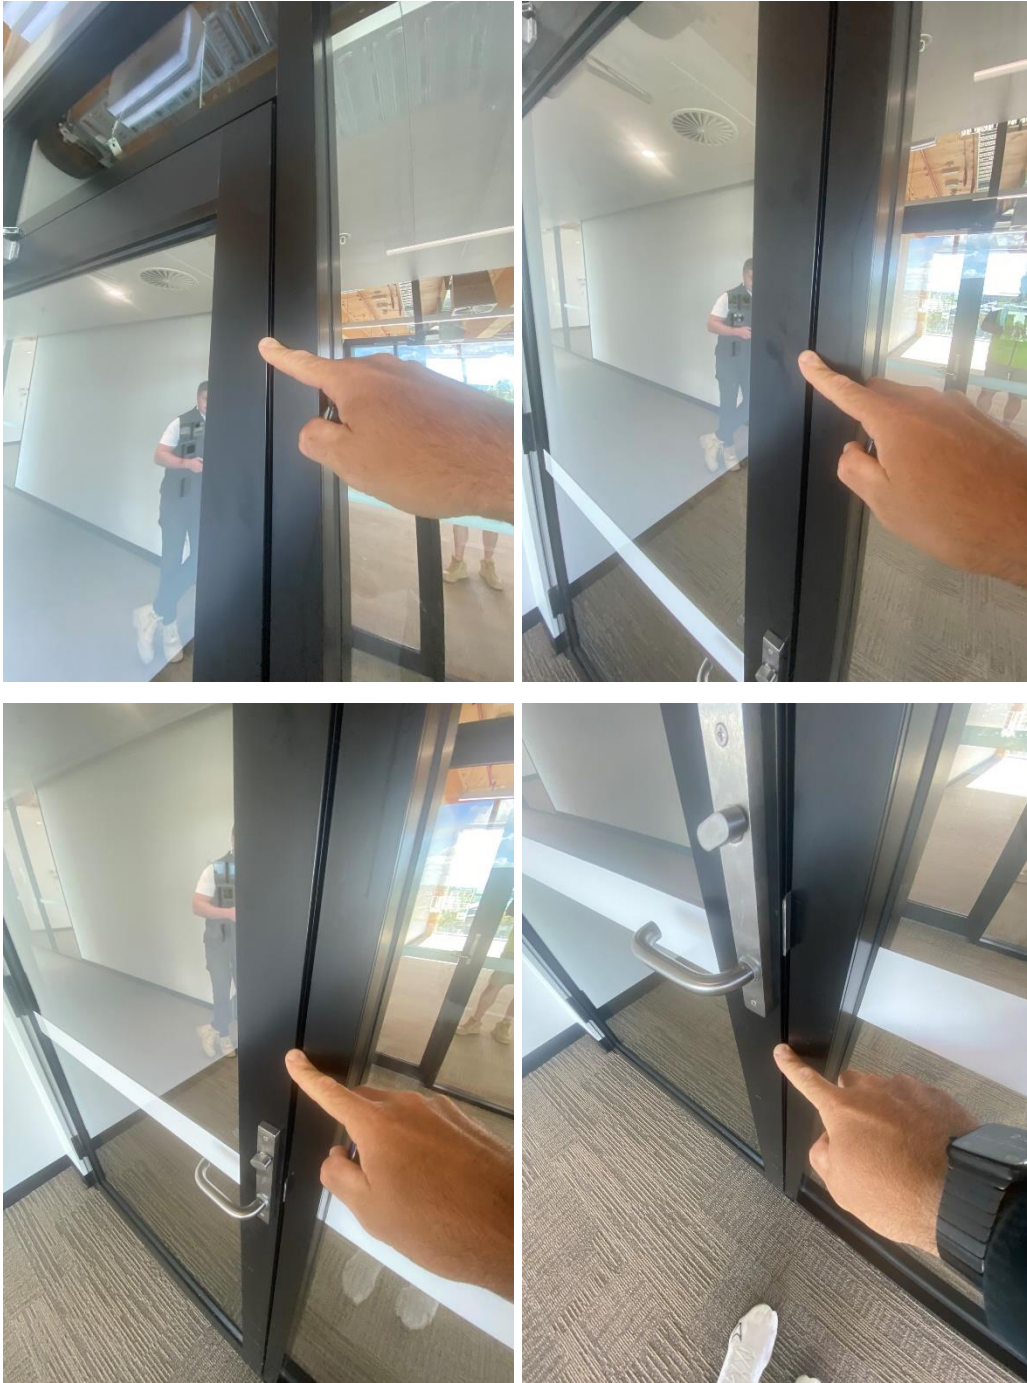
4. Door out of wind / aluminium door twisted by 4mm over the length of the door.
