SITE ASSESSMENT & ADVICE

Site Address: 6.08 & 6.09 of 8 Elizabeth MacArthur Drive Bella Vista NSW 2153

Report Type: General-Purpose Building Defect Report

Date of Inspection (s): 13/04/2023

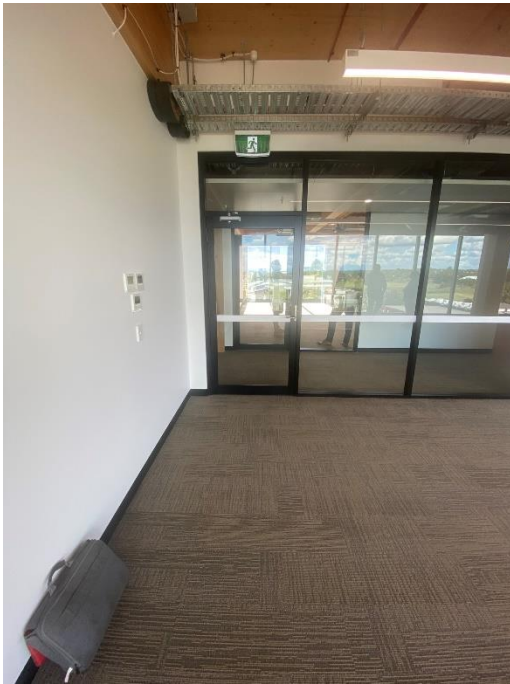
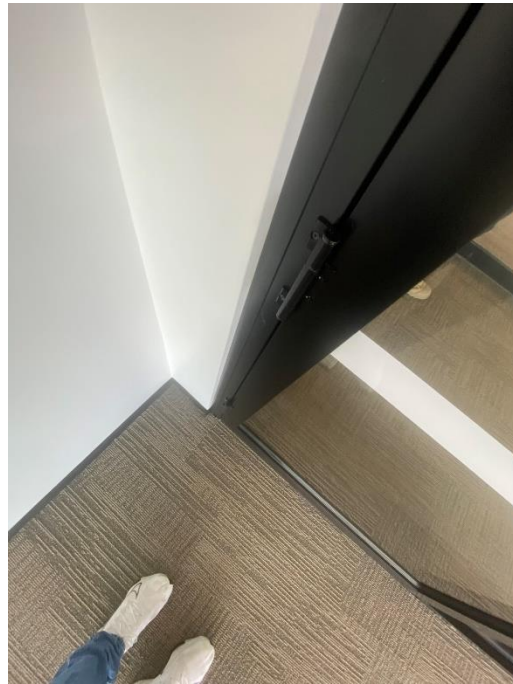
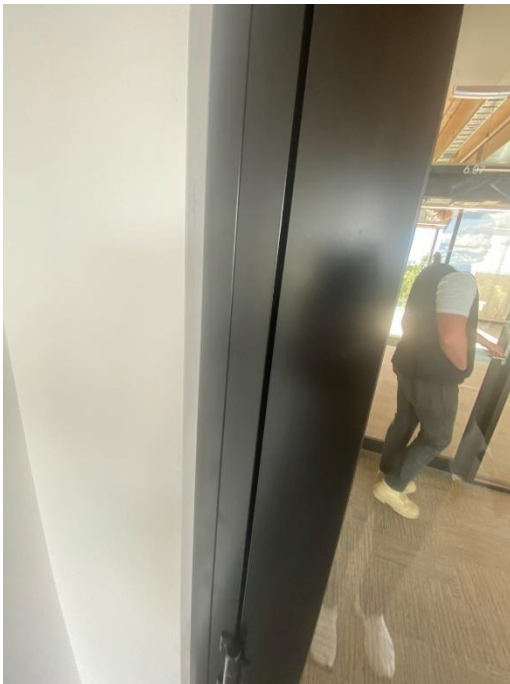
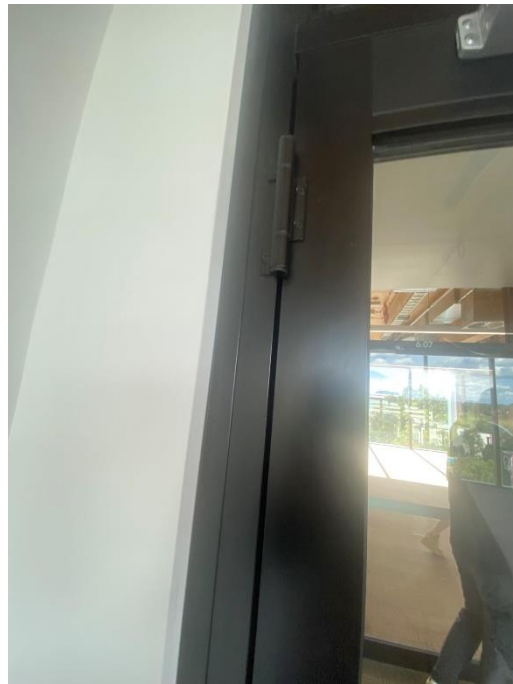
5. Entry doorjamb, hinge side has an inconsistent quirk when read against head and lock style.

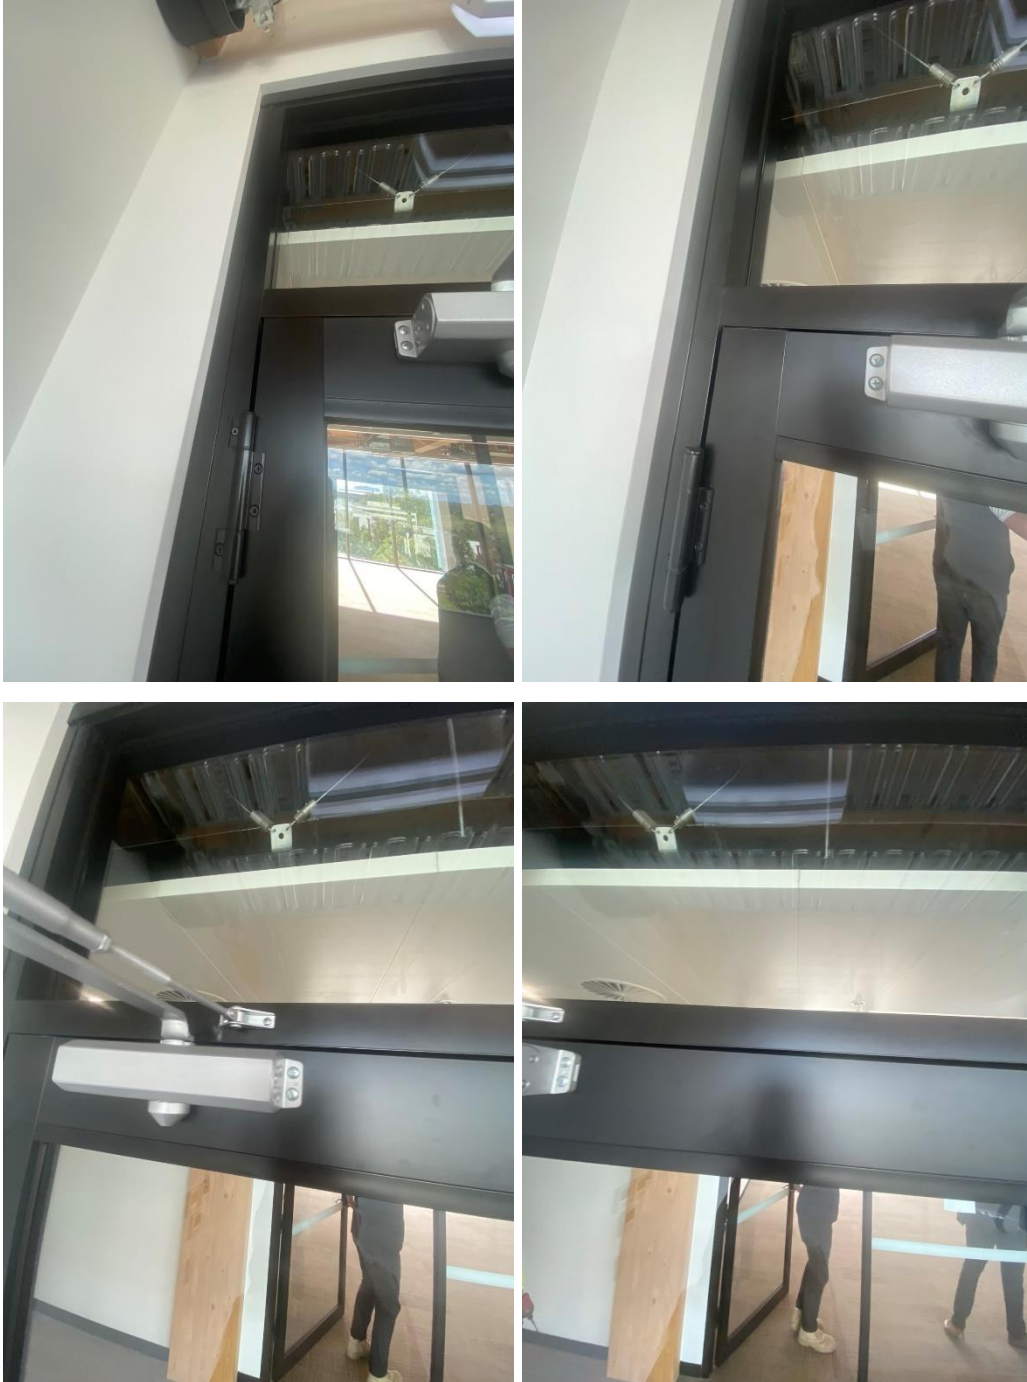
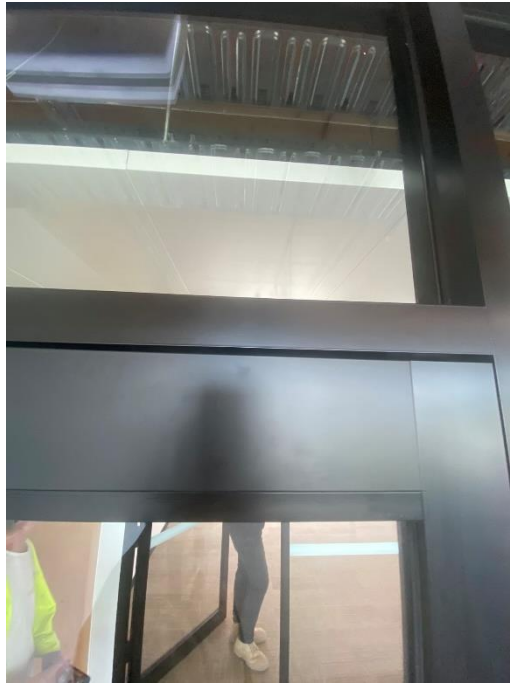
6. Entry door head and transom bar has an inconsistent gap and quirk when read against the left and right styles. Lowering of the door or cutting down of the aluminium door is required in order to have a consistent gap on the top, left and right side of the door.

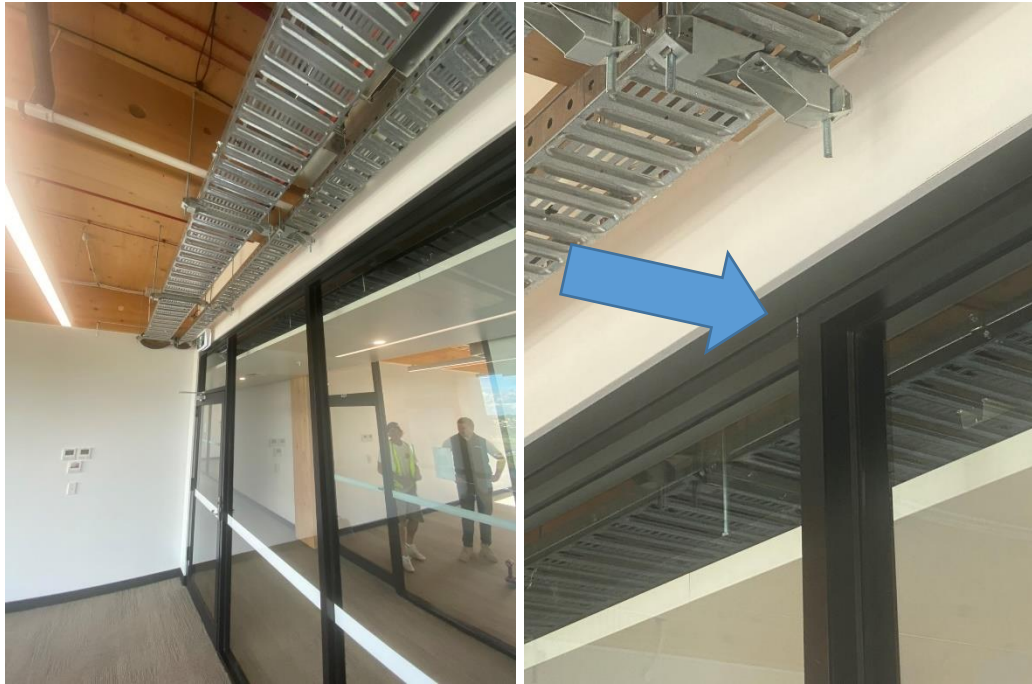
9. Aluminium frame junctions are proud and the frame has white marks on the edge / cut aluminium which needs to be coloured matching the black main frame.

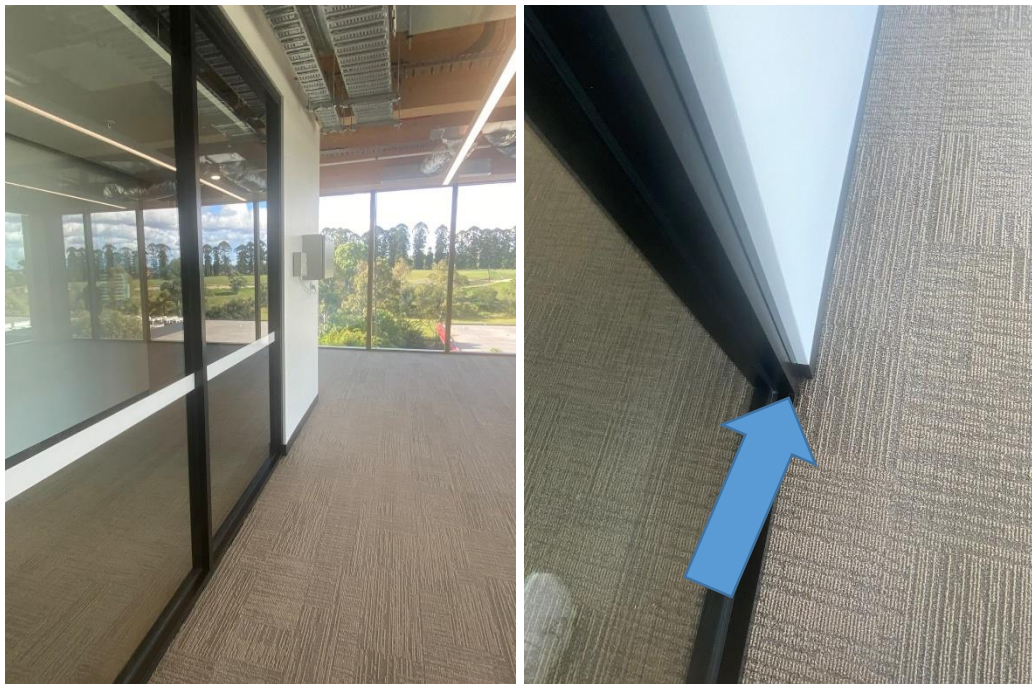
10. Aluminium frame and plasterboard wall junction, at the base of the wall, needs the plasterwork sanded back and re-painted.

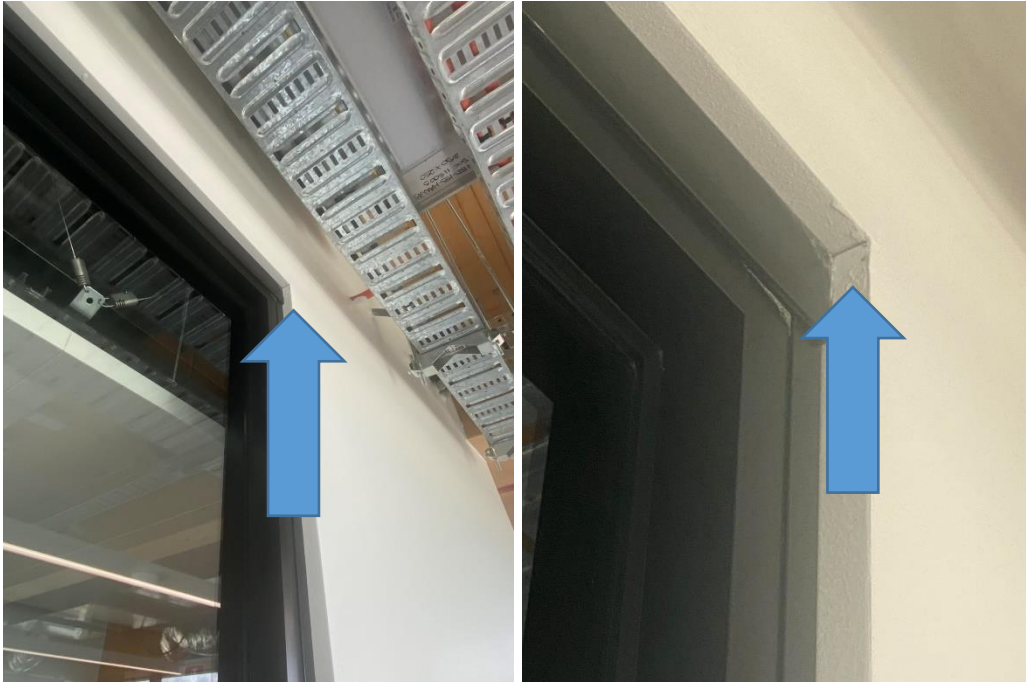
11. Window frame and plasterboard reveal junction, in the top right corner, needs to be sanded back, patched and re-painted.

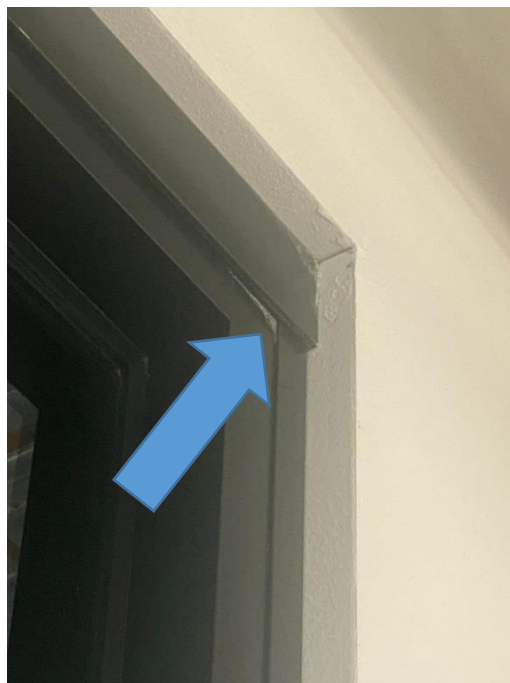
12. White discolouration seen on the black window frame between the window head and cover panel.

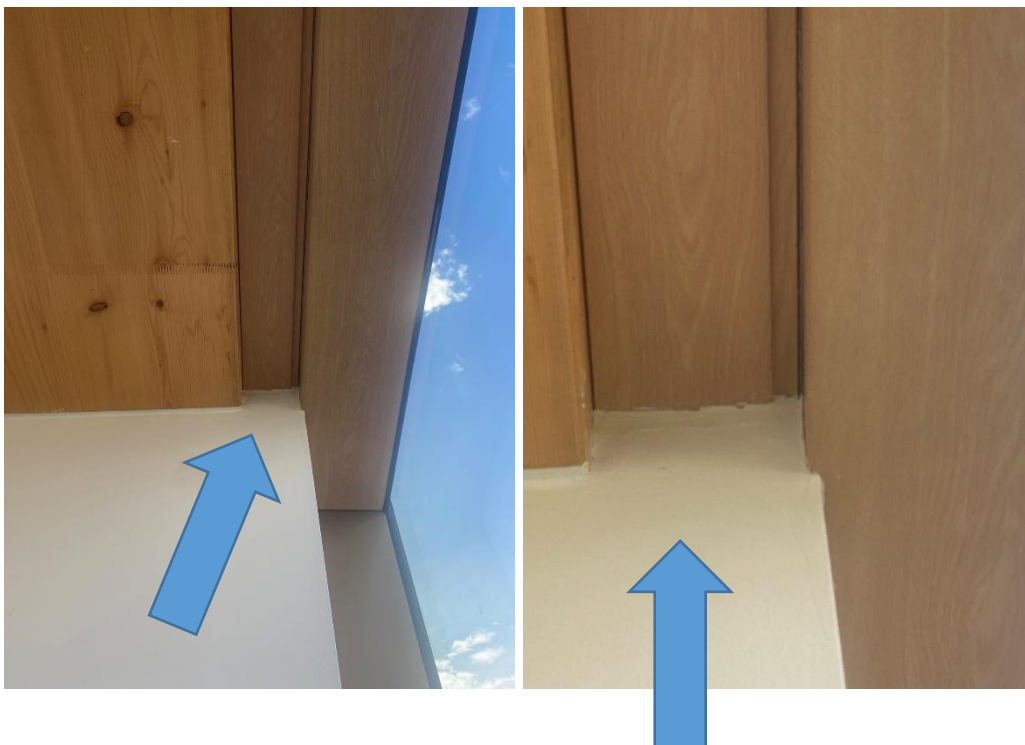
15. Plastering has not been sanded back smoothly prior to painting, texture can be seen through the paintwork. Sanding back and re-painting of this area is required.

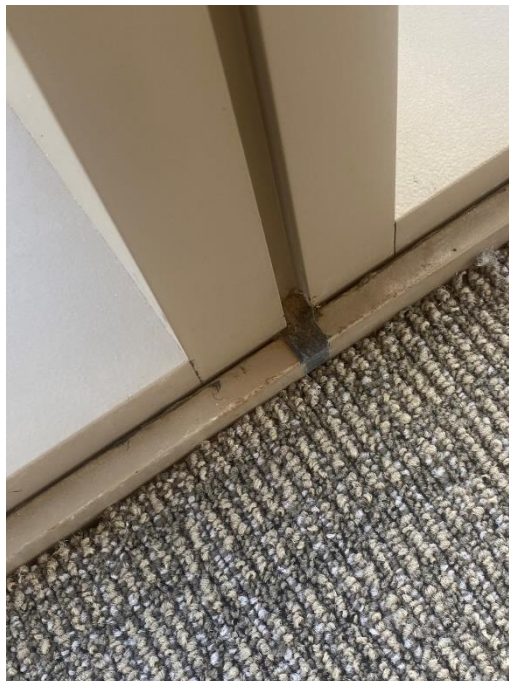
21. There is mastic that connects the aluminium bead installed at the bottom of the windowsill and carpet junction. The bead has various colours used within the mastic of the material, which needs to be consistent in colour as currently there is a cream colour mastic and a black colour mastic used in various locations, and a consistent colour, ideally cream or bone should be used for this application.

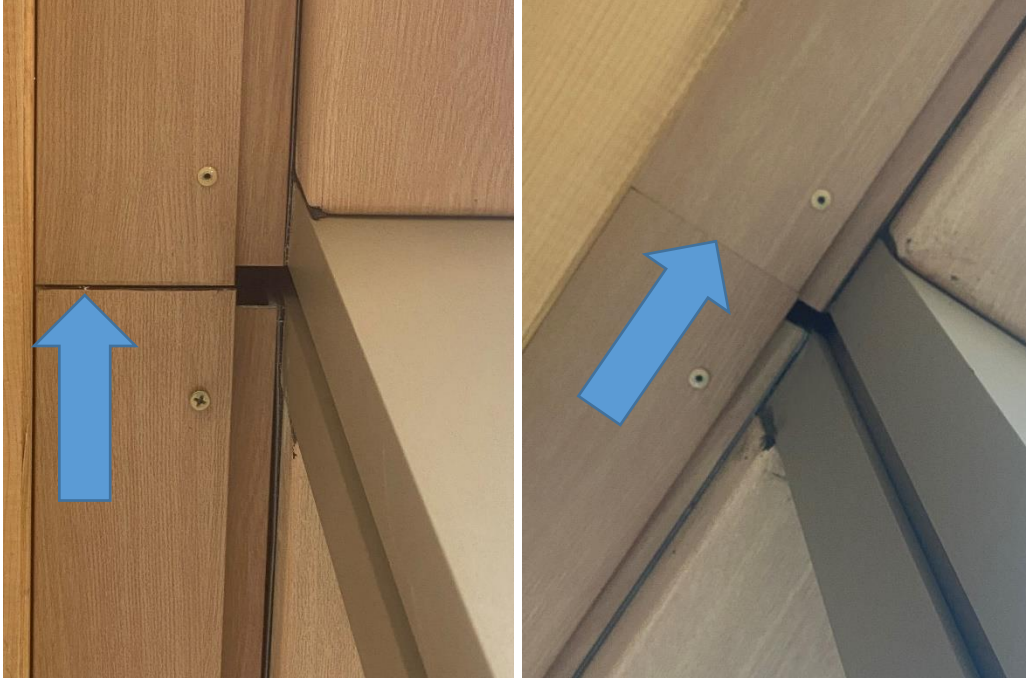
24. The ceiling panel has inconsistent and poorly applied material, as you can see within the two images below, they showcase one which has an excessive gap between the panels, which now looks like a shadow line, and the other has no gaps which resembles one long piece of material. Consistency is key and I suggest all openings be closed up with longer materials being used in order to achieve the details seen within the right image below.

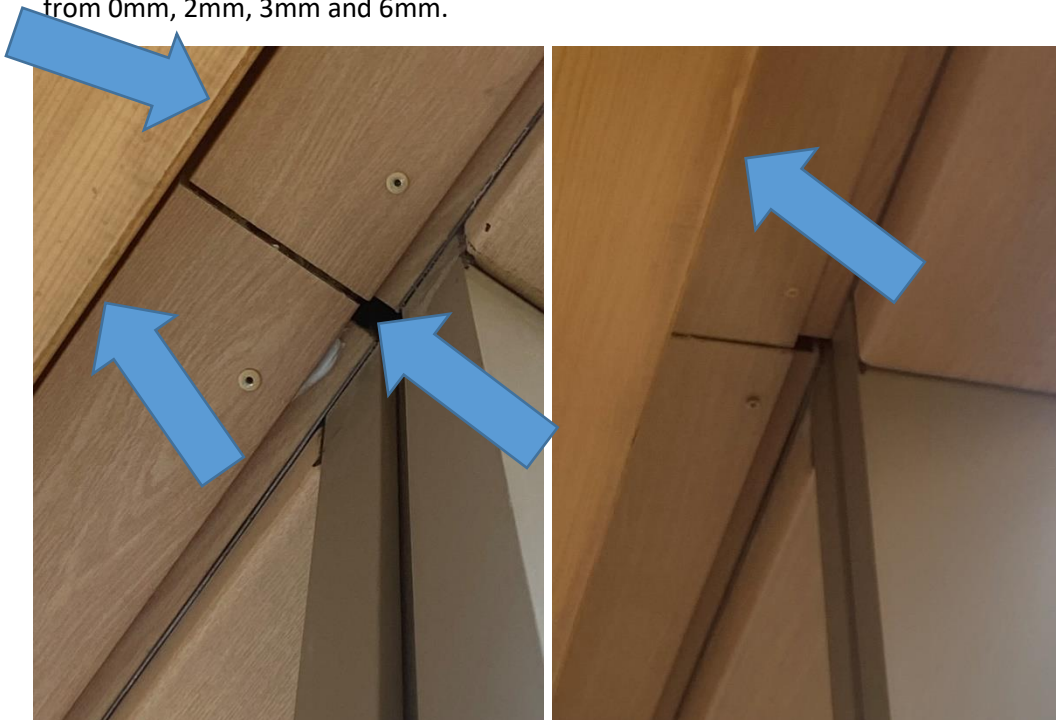
25. Within the images below, it highlights inconsistent gaps and quirks throughout the ceiling panels. Some have a gap of 2mm, and some have a gap up to 5mm. New ceiling panels are required in order to achieve a consistent and professional finish, as currently the gaps range from 0mm, 2mm, 3mm and 6mm.

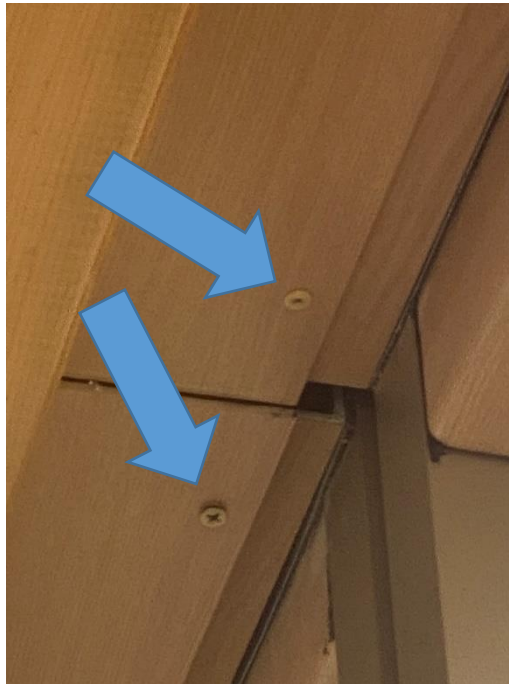
26. The ceiling panels are fixed in place with screws, there are screws that have been countersunk / semi flush with the material and there are screws which are still proud and not recessed in a professional manner. All fixings should be countersunk with a PVC snap cap applied over the screw head.

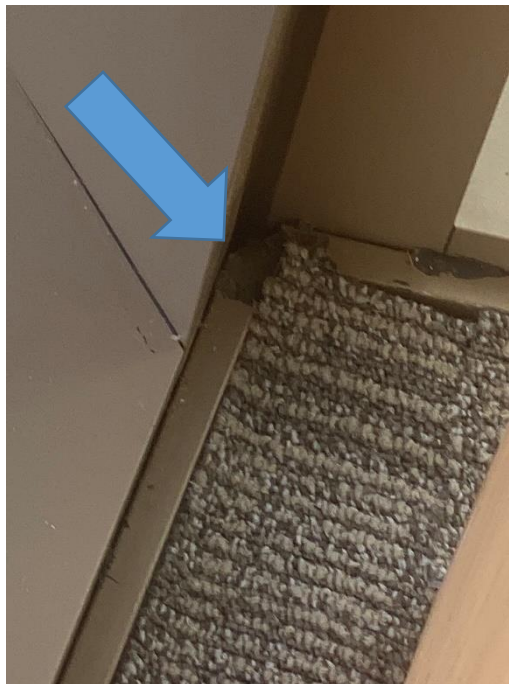
27. Floor trimwork is short within the junction within the wall and window frame.

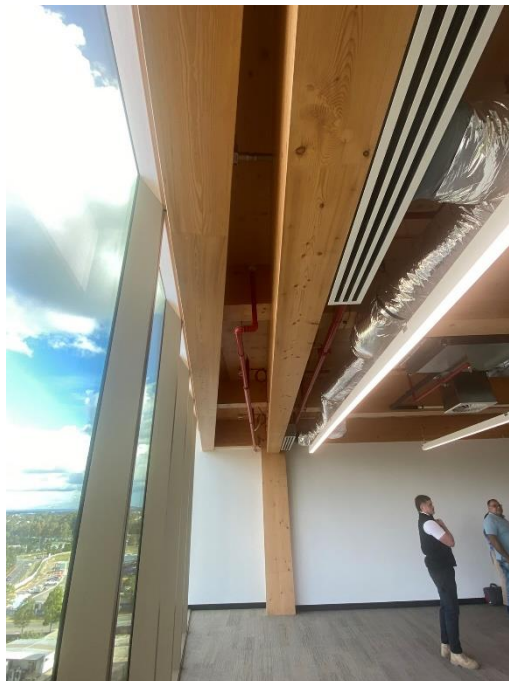
35. Clear coat runs can be seen to be dripping off the underside of the dropdown beams, seen within the image below. A light rub down to remove the lacquer that has bubbled, possibly due to excess lacquer being applied in the one application.

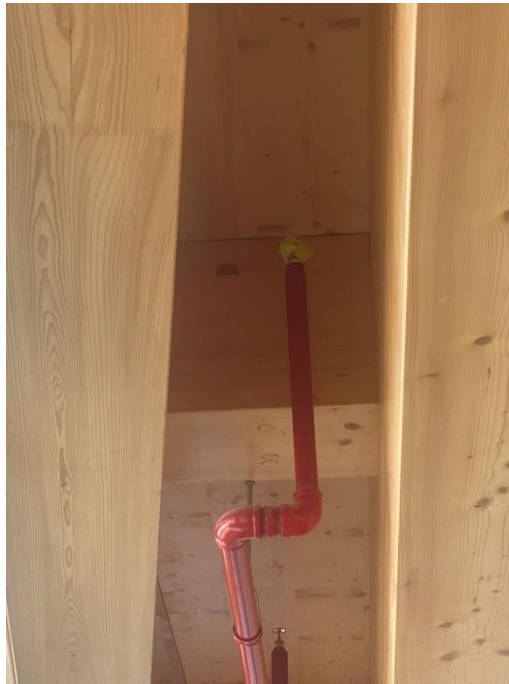
36. Smoke sprinkler system is not in working order, the sprinkler head is covered with a yellow plastic / masking tape material which needs to be removed and the fire consultant needs to return to make sure the fire compliance certificate is correct and that the building is built meeting BCA / NCC requirements in relation to fire compliance.

I understand the property was presented to you as complete and ready to occupy, it is difficult to understand how a fire compliance report has been issued with the sprinkler heads being covered, making the sprinklers non active / working as designed to obtain compliance. We recommend that you review the fire compliance certificate once the repairs have been done to the sprinkler system in order for you to understand if in fact this office and office building meets current fire compliance regulations, as, in our opinion, it currently does not with the yellow tape covering the existing sprinkler head.

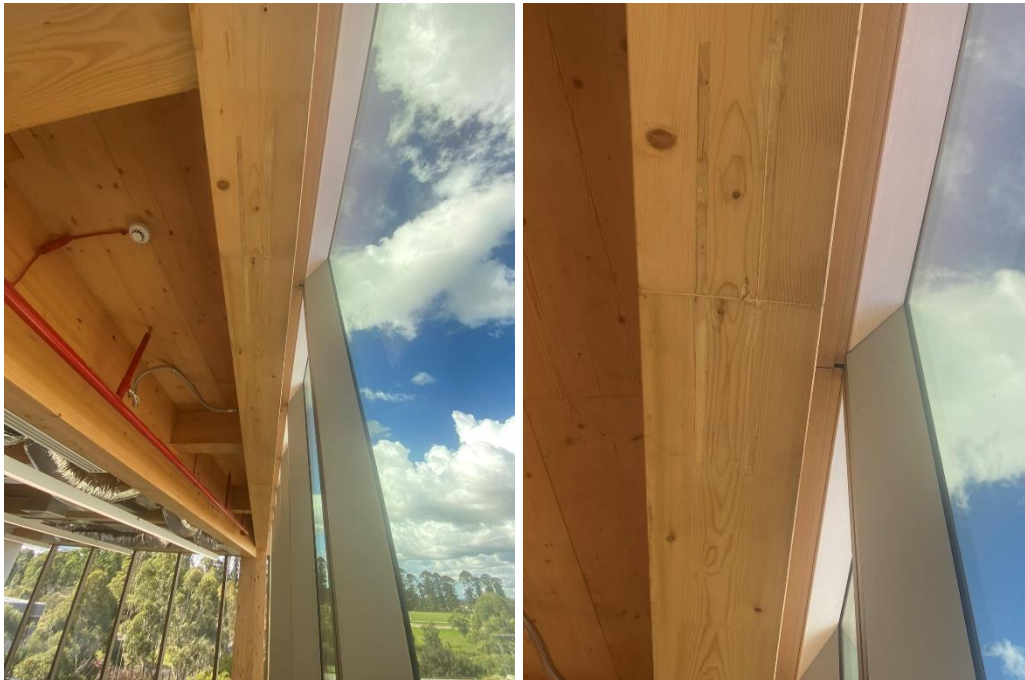
37. Poorly patched and selected materials used to the underside of the ceiling beams, as highlighted within the two images below.

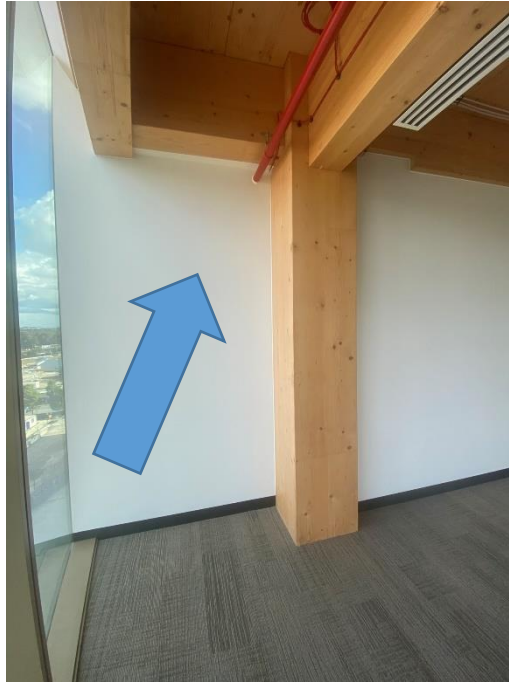
38. Inconsistent paint application applied to this wall; final coat of paint is required on order to achieve a consistent finish.

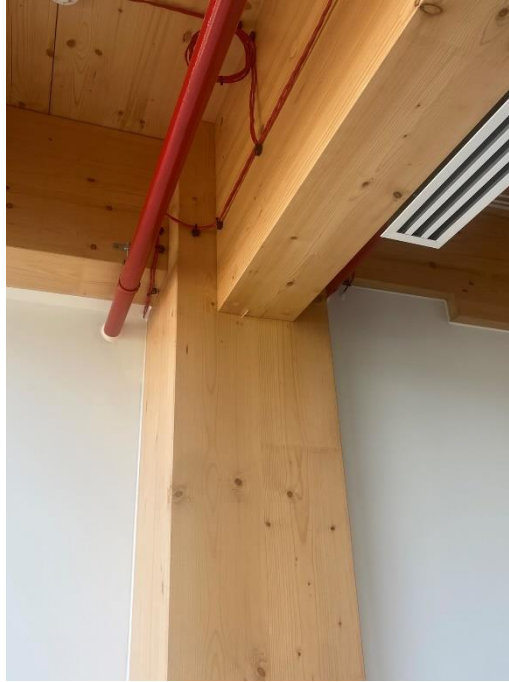
41. There are open / excessive gaps between the timber column and timber beam junctions and ceiling and beam junctions. There are tight junctions between timber members and there are gaps between the timbers which represents as an inconsistent finish / detail within this dressed feature within the commercial suites.

These gaps will only consistently grow to be larger as time passes and it is my opinion that it would be best for all junctions to be expressed and corked in order to achieve a consistent finish or the opposite; expressed and left open in order for a consistent detail / finish.

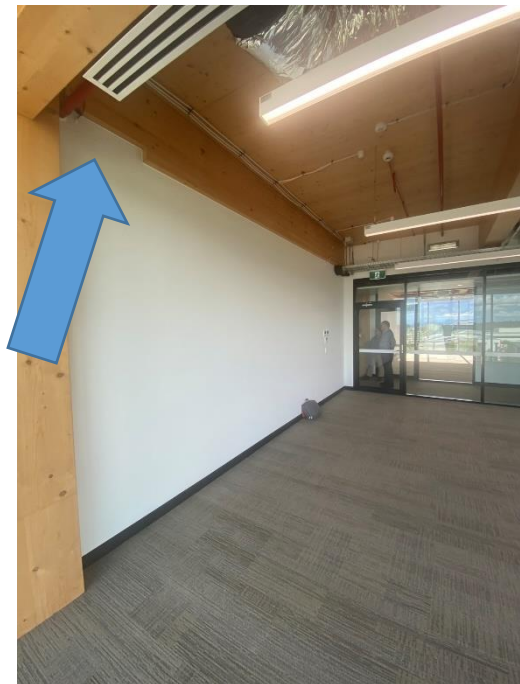
44. The wall beam detail has been checked out and no in fill timber panel has been installed, an in fill panel should be installed in order to achieve a symmetrical line to the underside of the beam to achieve a complete and sympathetic detail as one would expect for a new build.

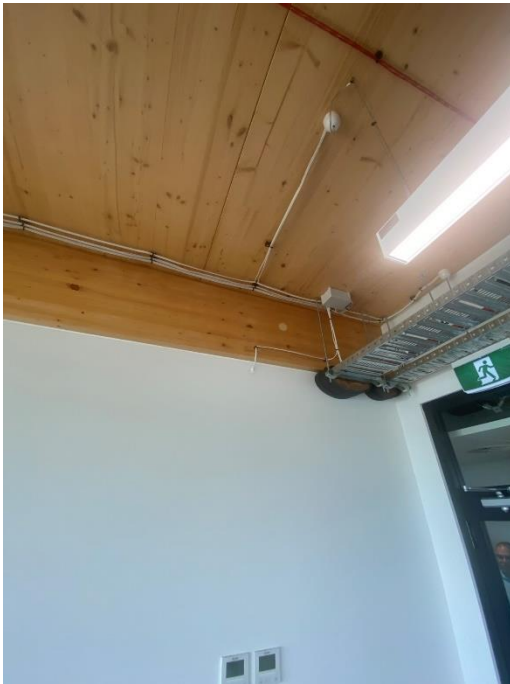
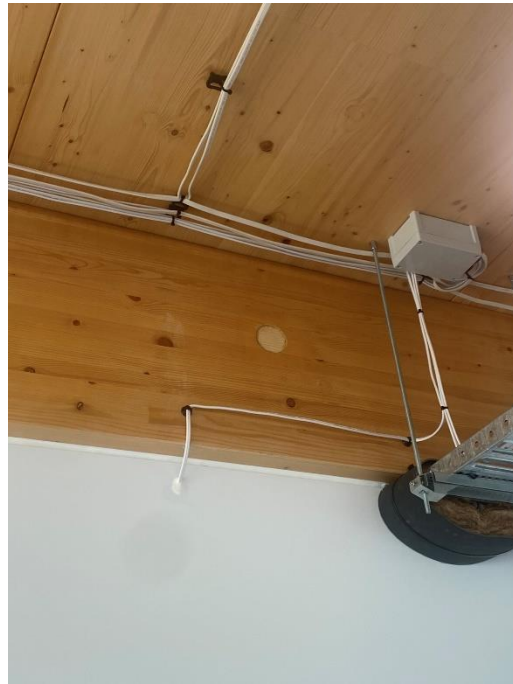
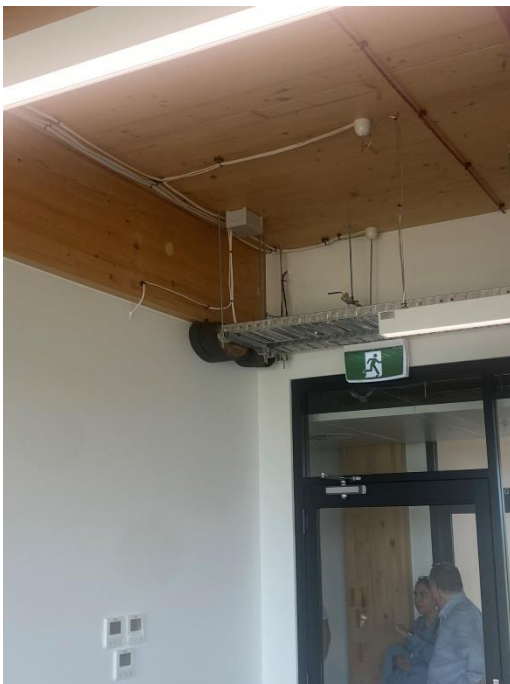
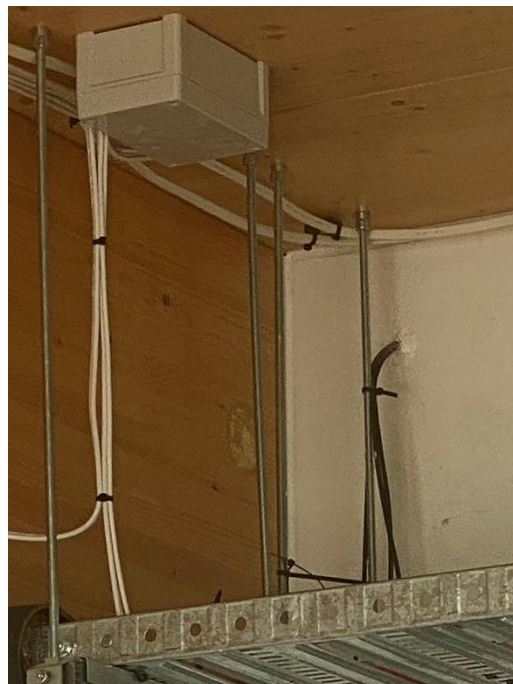
45. Incorrect timber grain and colour was used to plug up the holes within the beam. There are examples elsewhere of the holes being plugged up correctly and difficult to see when the correct timber was used, this is not the case here and there are a number of holes which need to be plugged with the correct matching timber.

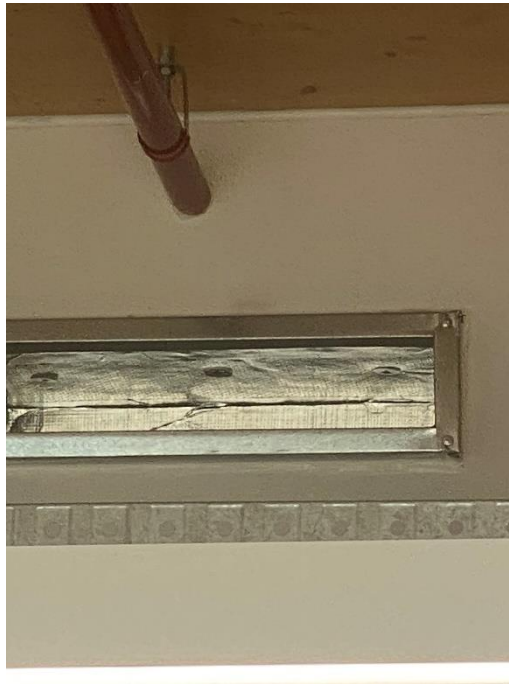
46. I asked the builders whilst on site what this penetration was, and they claim that it's a penetration for future services into the office space. It is difficult to understand how this penetration would comply with the fire regulations to compartmentalize this suite to the other suites and / or common area / hallway.

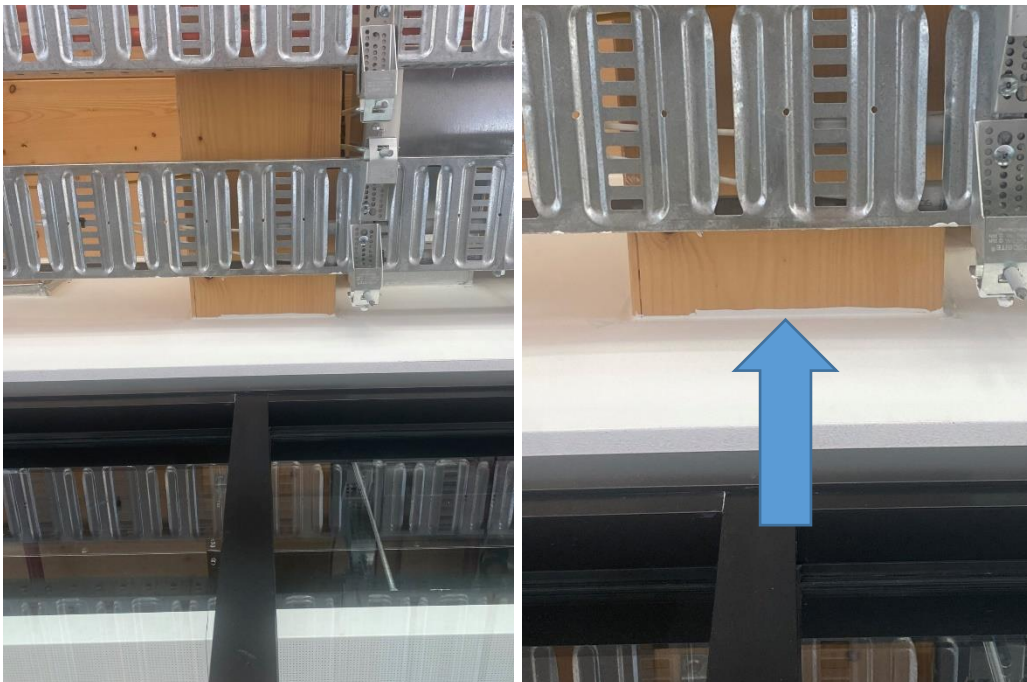
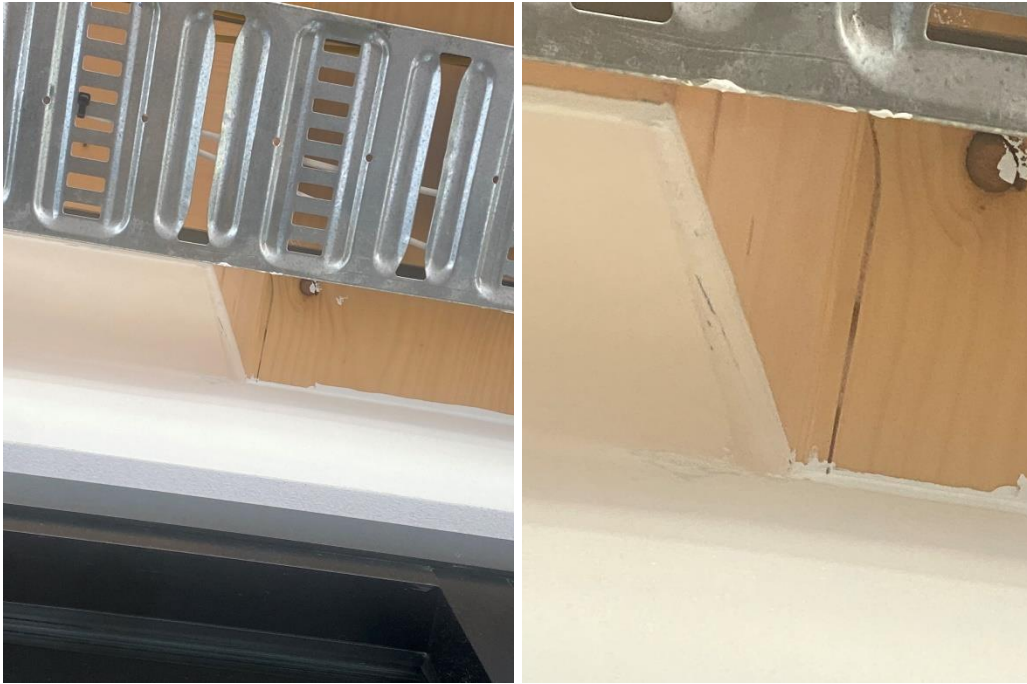
52. Above the shopfront / office front, the wall and timber beam junctions showcase excess mastic between the wall and underside of the beam, and it also shows poor painting skills as the lines are not straight nor crisp as expected within a new build.
