# **Dilapidation Report For The Development At: 14 Fairfax Road Mosman NSW 2088**

Dilapidation Report Carried Out On:

12 Fairfax Road Mosman NSW 2088

17<sup>th</sup> June 2019

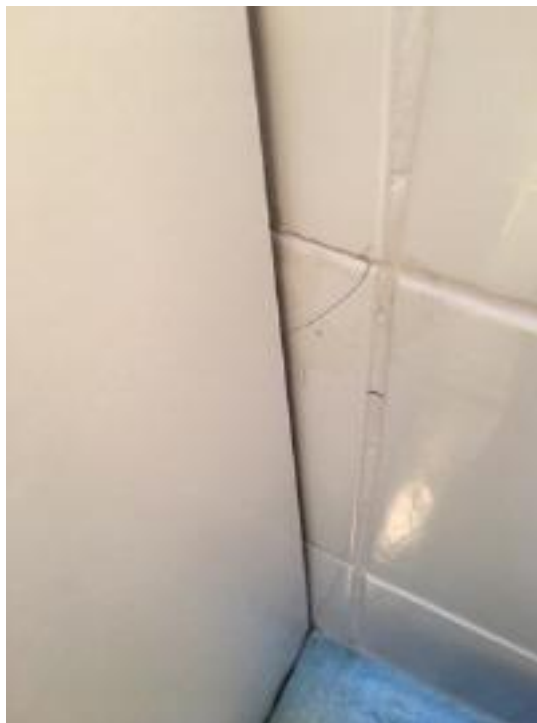
Bathroom wall tiles are chipped and cracked

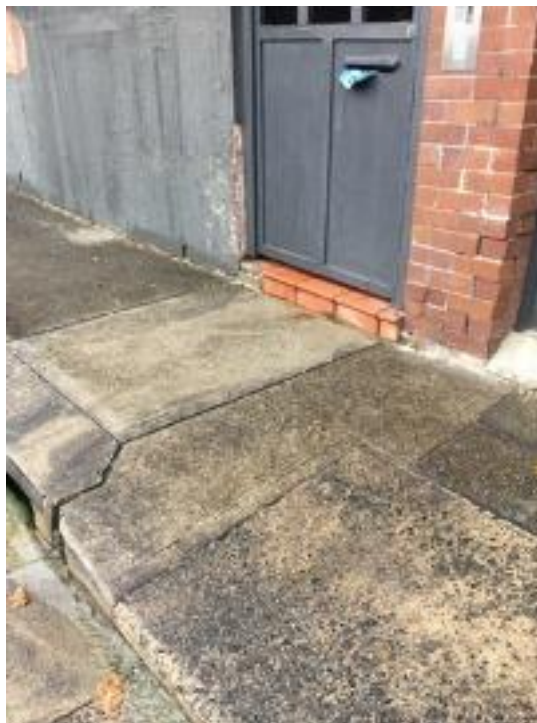
Footpath has excessive cracks within the old and new concrete footpaths
