The Property Inspectors

Commercial Pre-Purchase Building Inspection Report

Client: Wyndham City Council
Property Address: 15-19 Station Place Werribee
Date of inspection: 02/11/2023

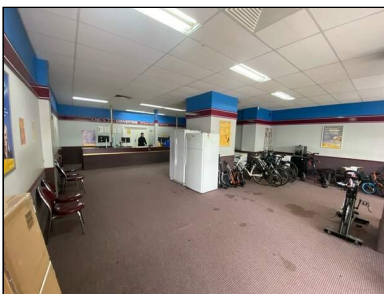
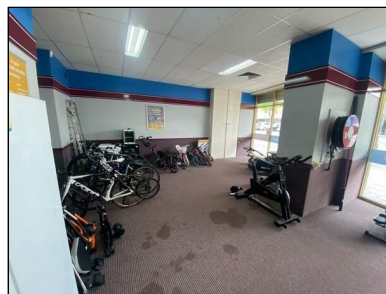
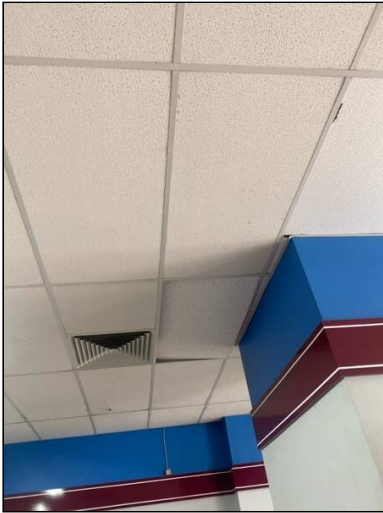
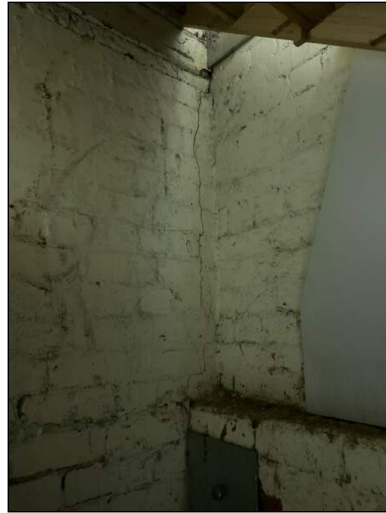
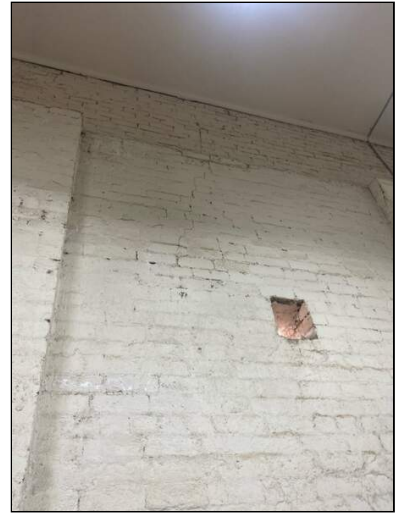
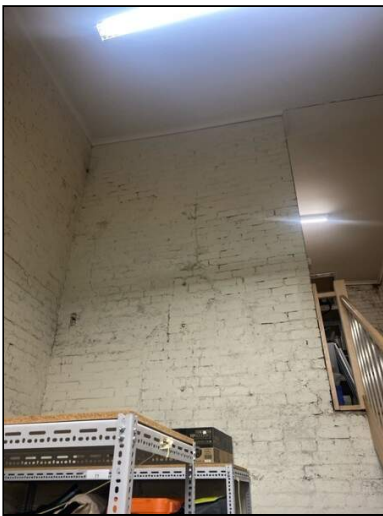
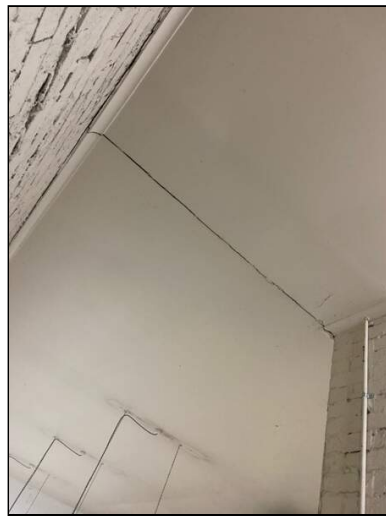
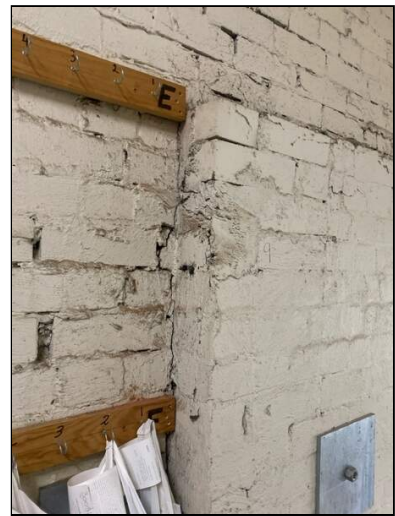
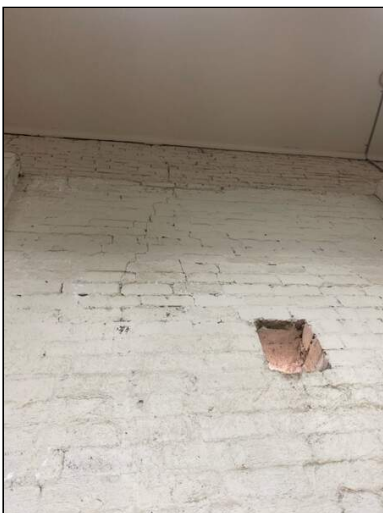
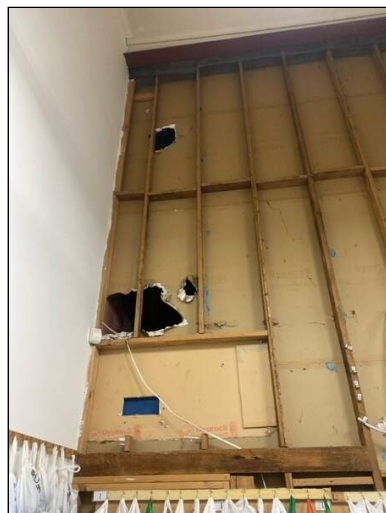
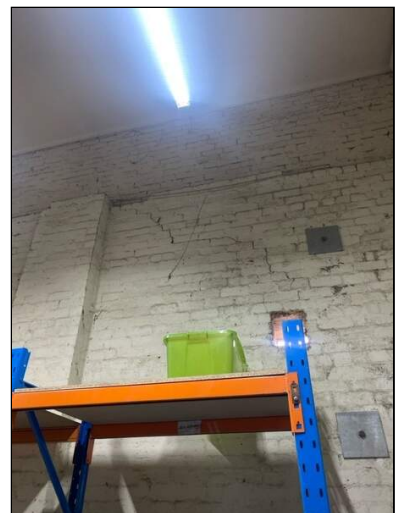
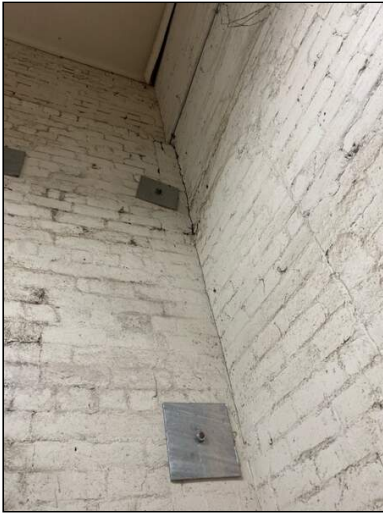
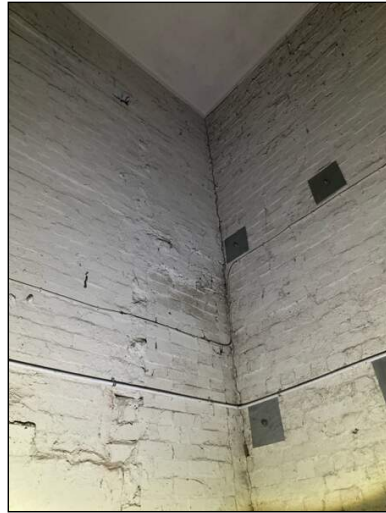
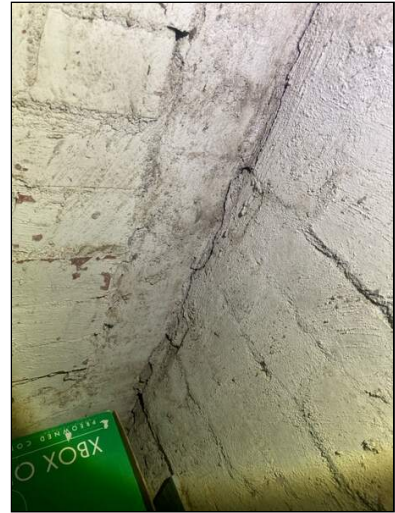
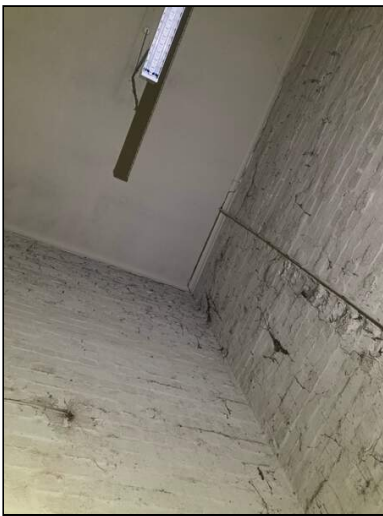
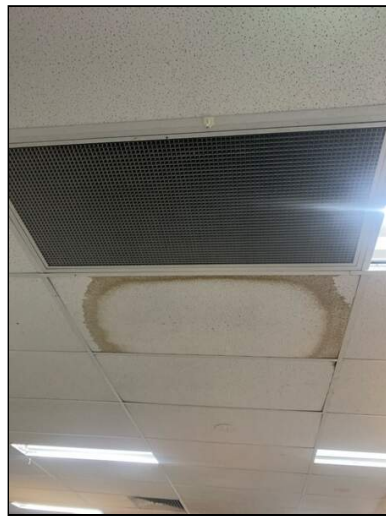
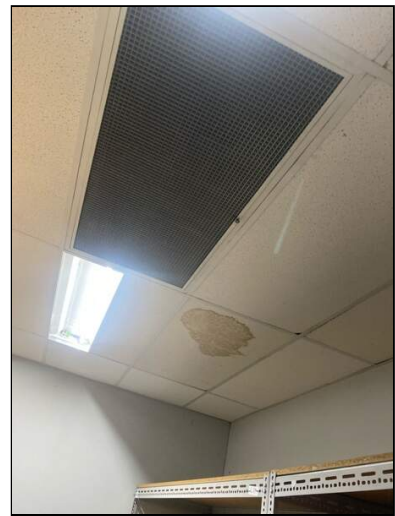
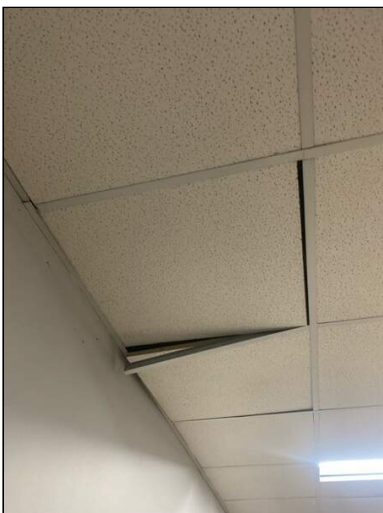
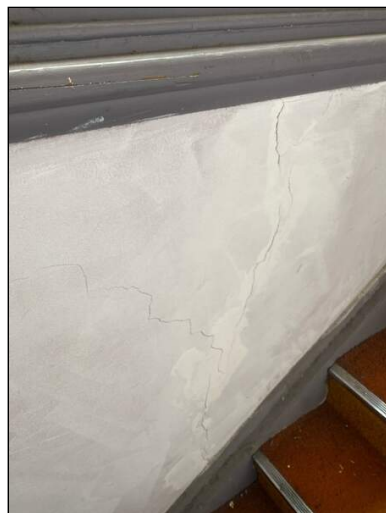
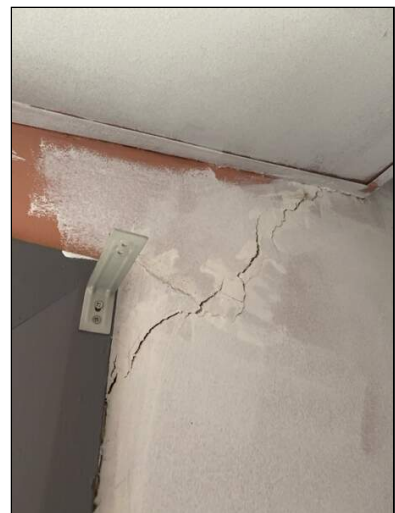
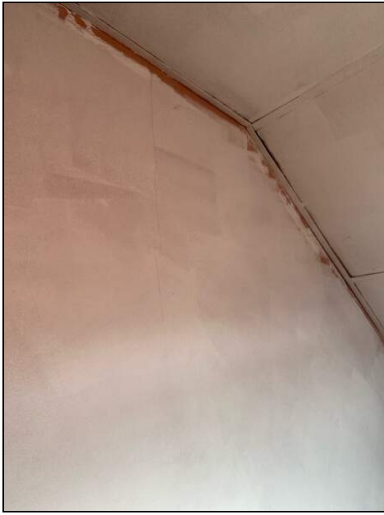
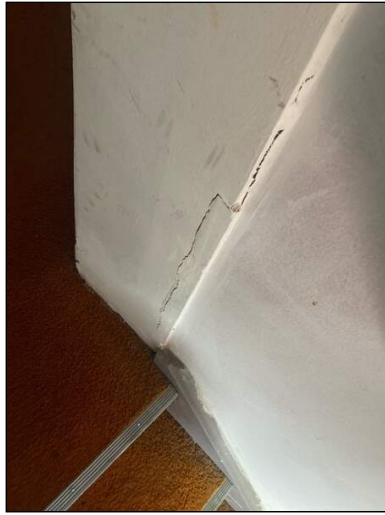
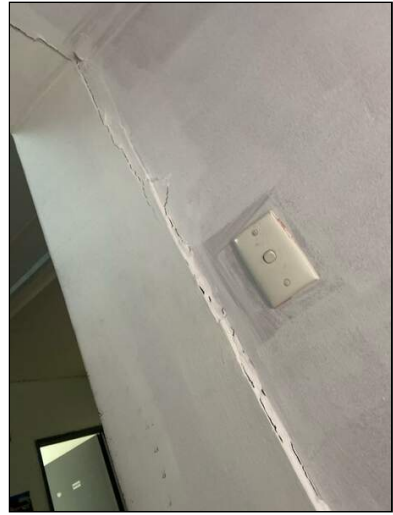
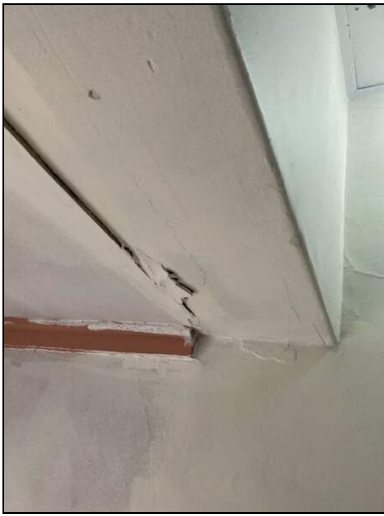
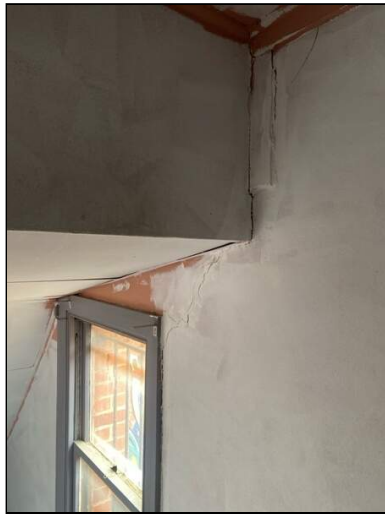
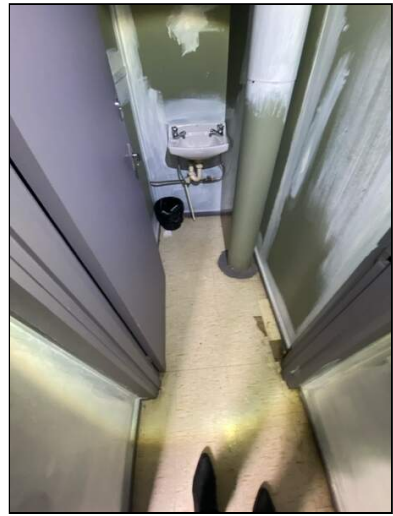
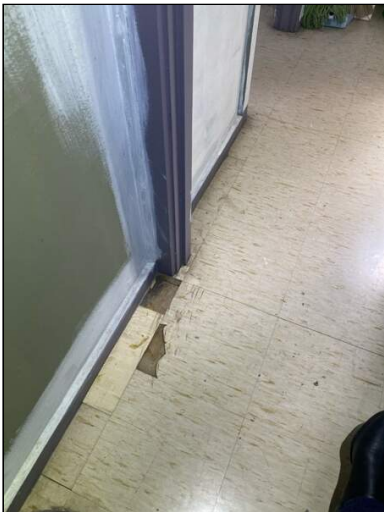
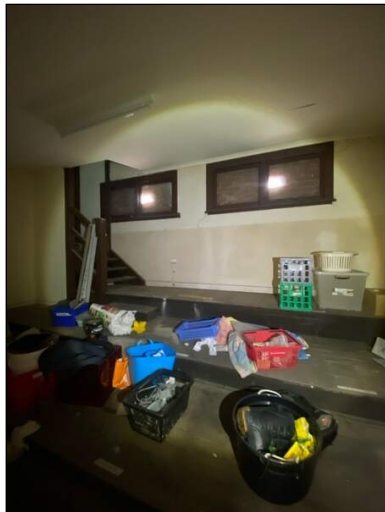
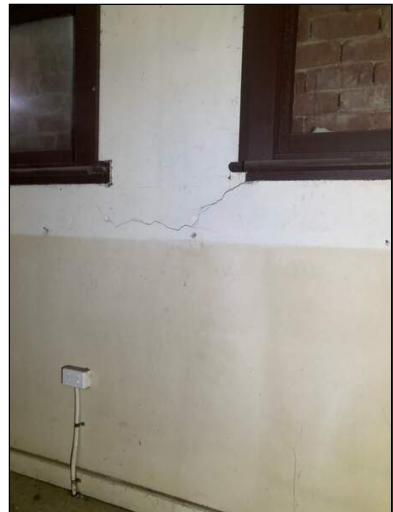
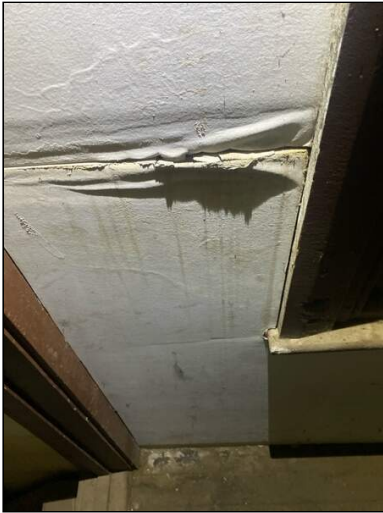
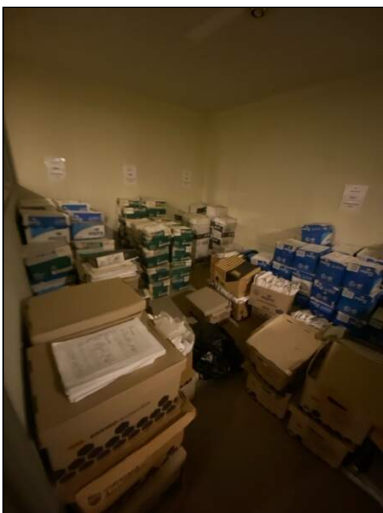
Defect Rating **Major Defects**

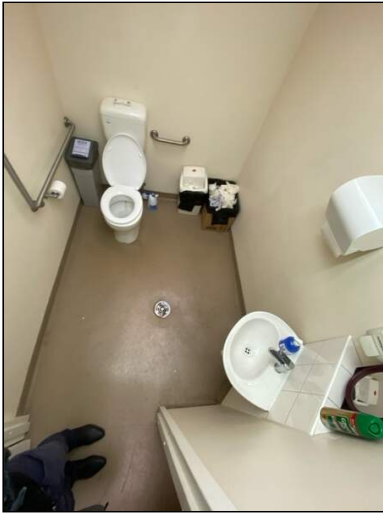
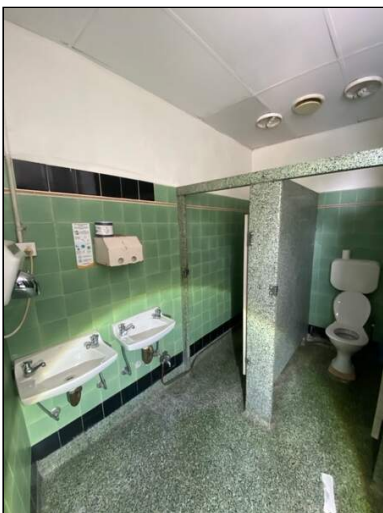
Answer	<p>Within the shower, the tap(s) are dripping and leaking, possible faulty washer</p> <p>Tap(s) can be seen to be dripping due to a faulty washer, this item can be replaced by a plumber</p>
Sub-question	<p>*** CONDENSATION / EXHAUST FAN ANSWERS ***</p>

Answer	<p>Exhaust fan faulty / Not working</p> <p>Condensation damage evident, exhaust fan faulty</p>
Answer	<p>Refer To Supplementary Text / Photos / Defect Rating</p>
Defect rating	<p>Major defect</p>
Photos

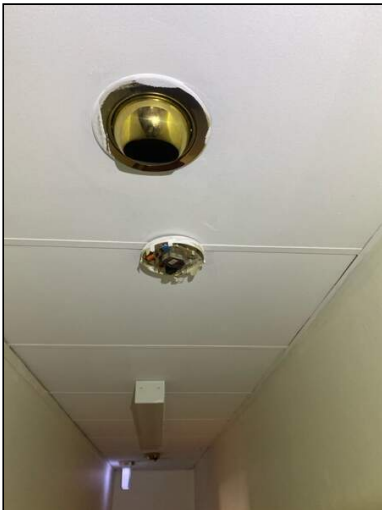
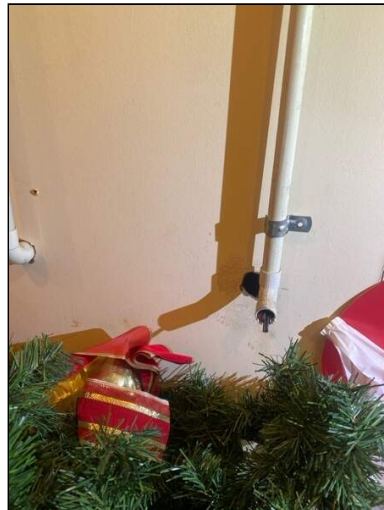
THIS IS A MAJOR DEFECT

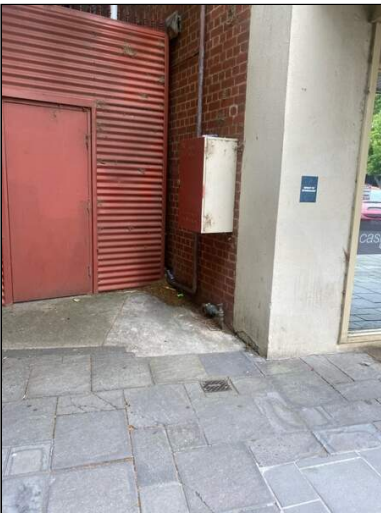
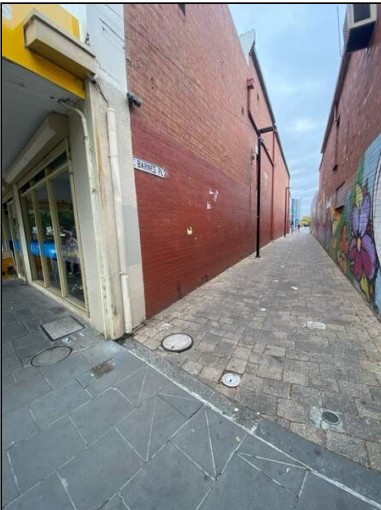
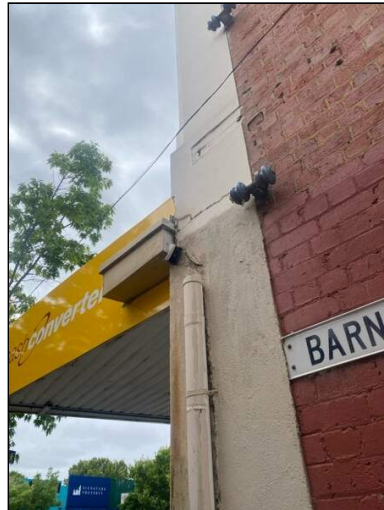
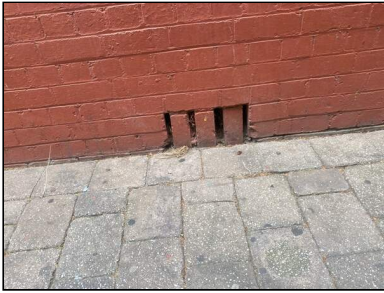
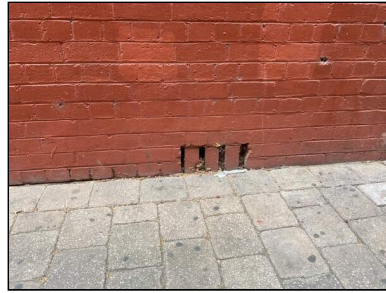
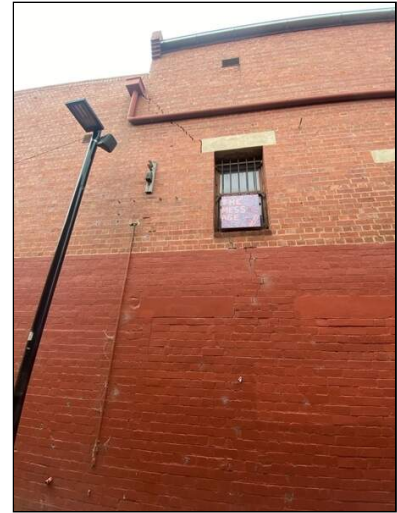
Photos

The air vents installed to the external walls are covered / obstructed which will allow pests and moisture to enter the subfloor area if left as is

I see that there is inadequate vents / grills within the external walls making the subfloor area non-compliant due to poor / reduced volume of air for ventilation and poor crossflow ventilation to the subfloor area

I see that there are missing vents / grills from the external walls, therefore making the subfloor area non-compliant due to poor ventilation and poor crossflow ventilation to the subfloor area

Lack of weep holes will create dampness within the cavity and within the internal wall linings and it will contribute towards the render cracking and render crazing, this will eventually become drummy and fall off the wall, any timber attached to the walls in question will rot and deteriorate before its natural time

Answer	<p>Damp proof course is faulty / defective (Moisture above DPC)</p> <p>There is dampness seen on the external walls above the damp proof course</p> <p>You should engage a builder or hydraulic engineer to assess and make good this issue to mitigate any further impact to the area in question</p>

Answer	<p>Missing window storm moulds</p> <p>There are missing window storm moulds / excess gaps which may allow pests / vermin / moisture to enter the cavity</p>

Door storm moulds are missing, gaps may allow pests / vermin / moisture to enter the cavity

This is not ideal as wood rot can develop and wet and damp materials could draw termites to the property

Major Defects

Finding the reason / source of the water entry to the eaves / soffit lining boards is required and once repaired, the eaves also need to be repaired and re-painted

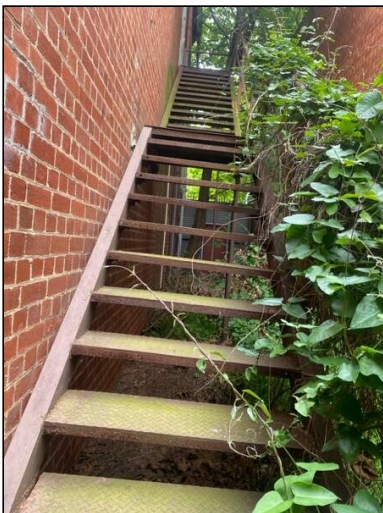
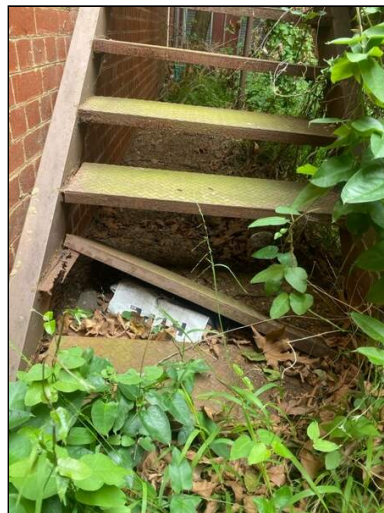
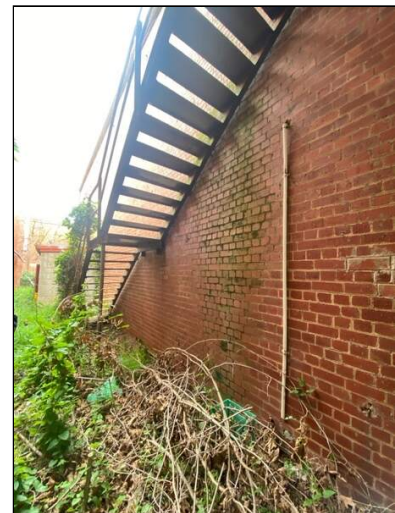
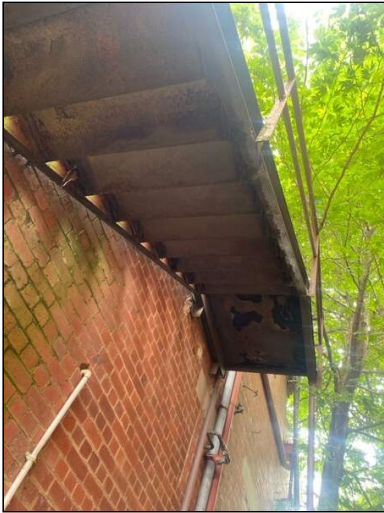
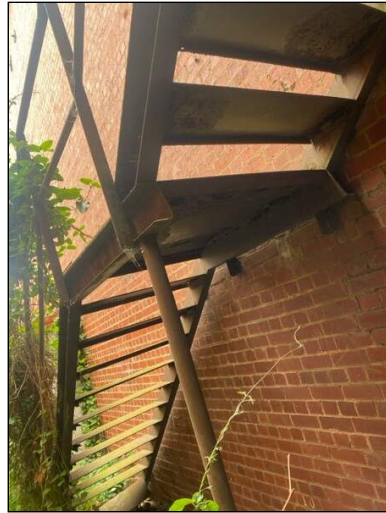
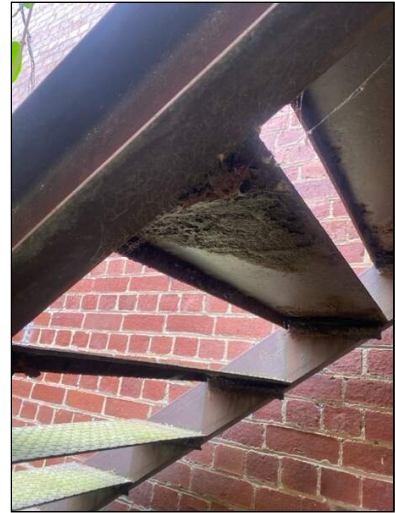
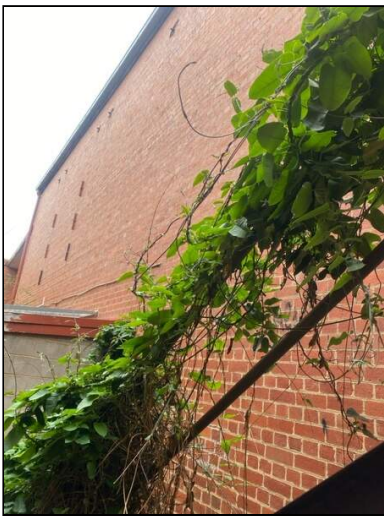
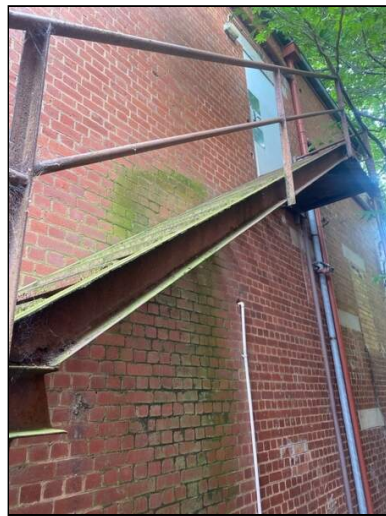
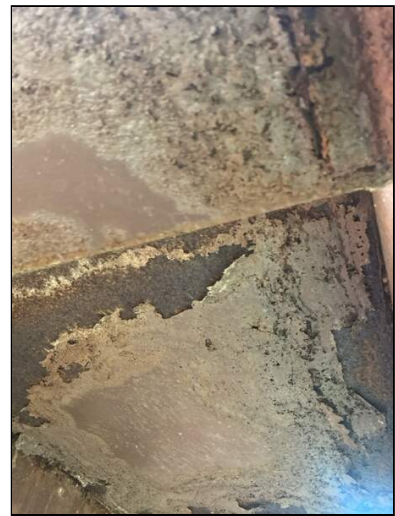
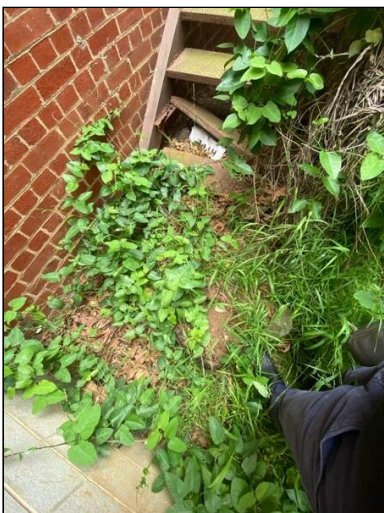
Stairs and handrails are in order at the time of this inspection

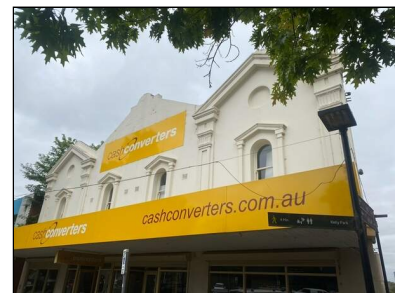
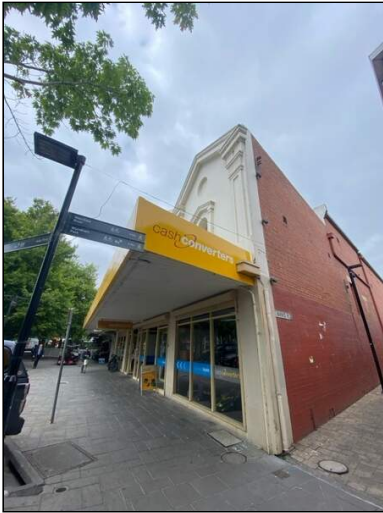
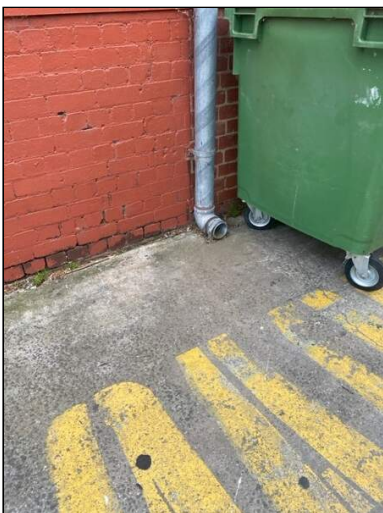
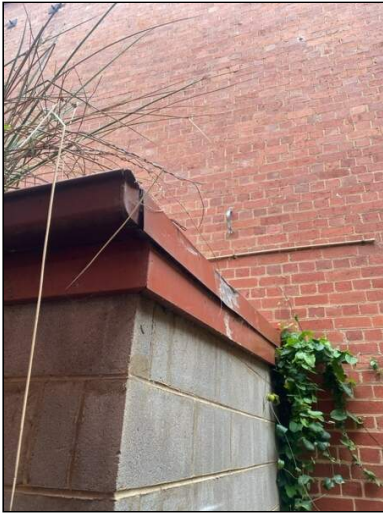
Defect Rating Further investigation as I did not inspect the entire roof elevation

A second inspection is recommended with a drone or a two-man team meeting WH&S guidelines
