# **Dilapidation Report For The Development At: 26 Edwards Bay Rd, Mosman**

## Dilapidation Report Carried Out On:

24 Edwards Bay Road

30<sup>th</sup> April 2026

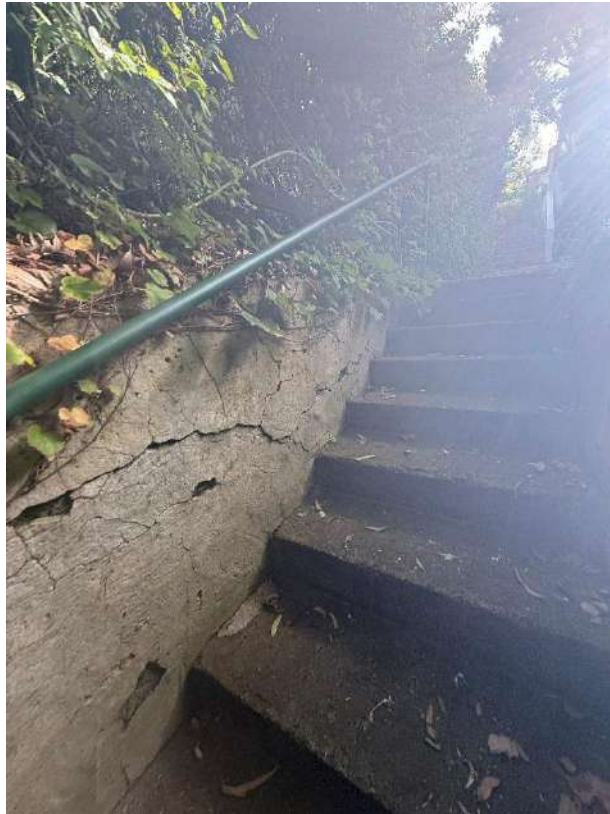
Left and right masonry walls on either side of entry stairs are structurally cracked horizontally and vertically within the masonry walls

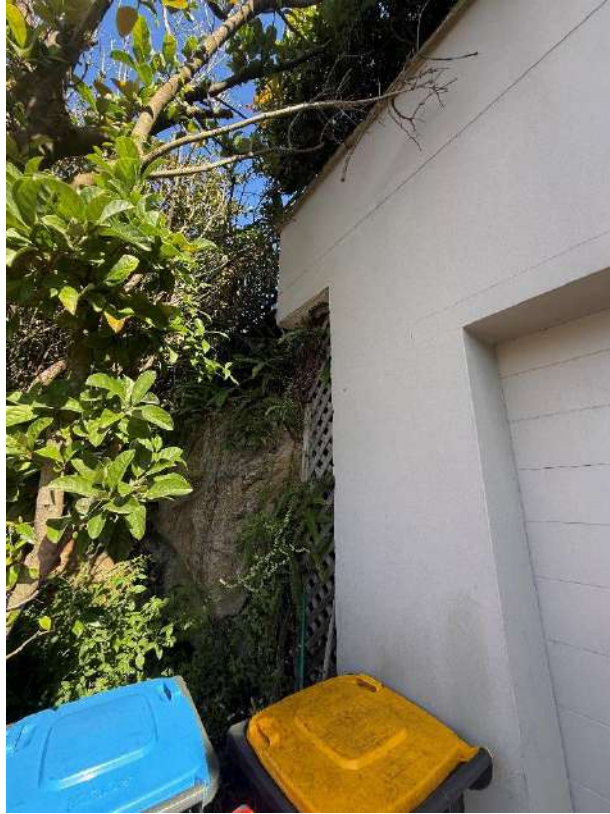
Top-left corner, minor hairline cracks within the masonry wall abutting the sandstone boulder

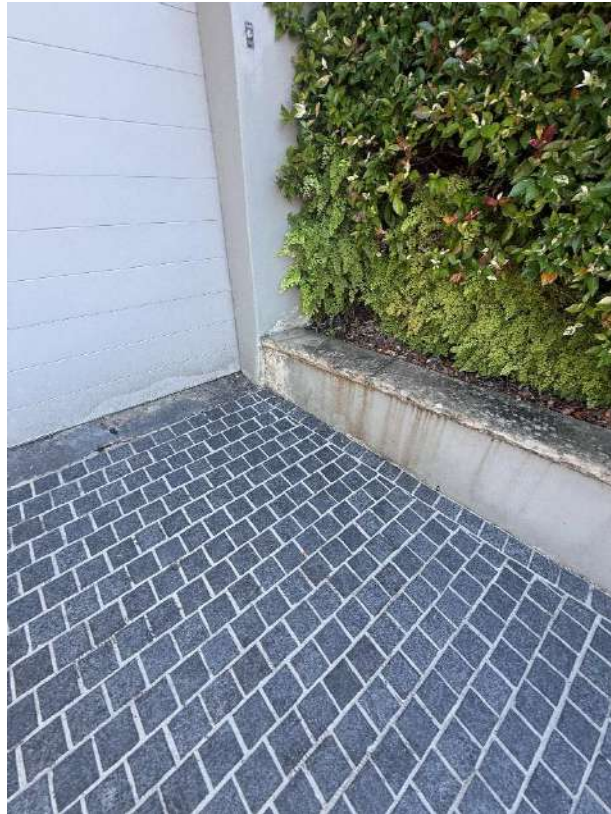
Minor cracks seen within the masonry boundary wall abutting the garage wall

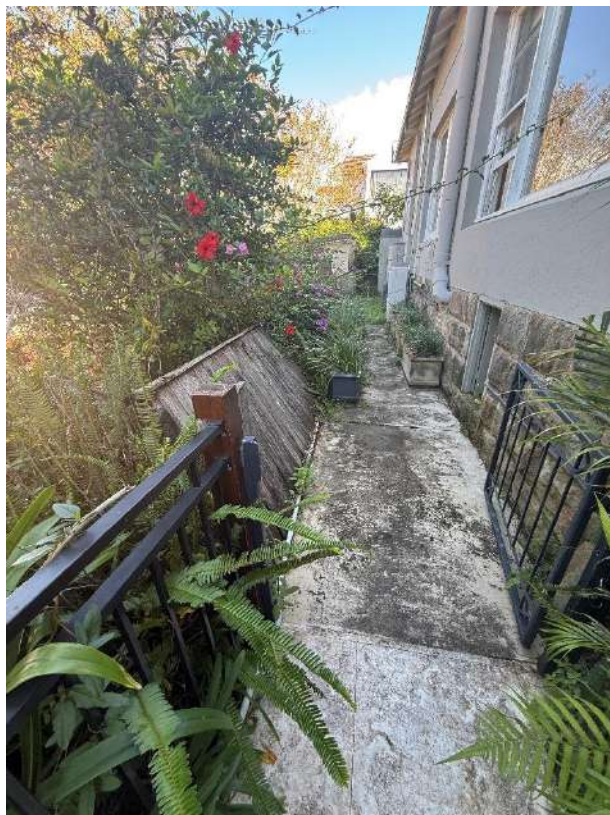
Boundary fence collapsed

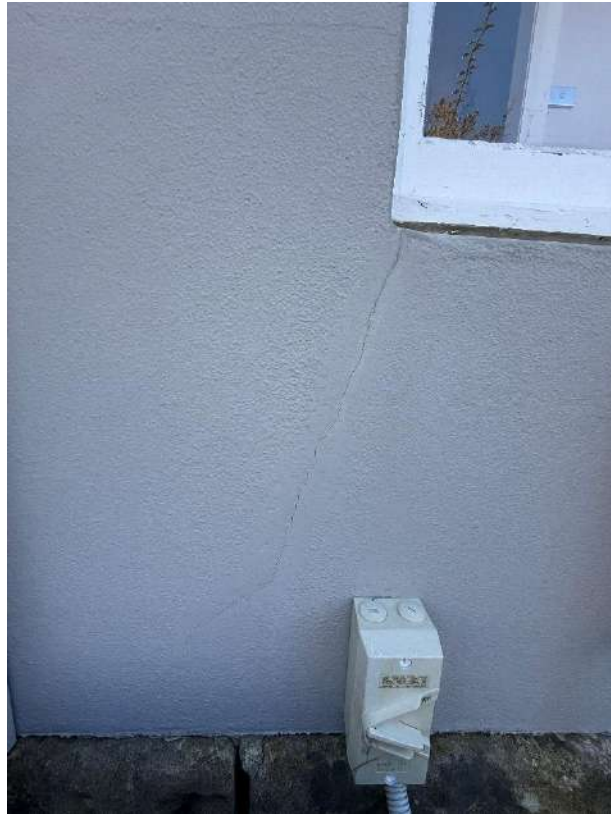
Horizontal and vertical cracks in the masonry wall to the bottom-left of the window

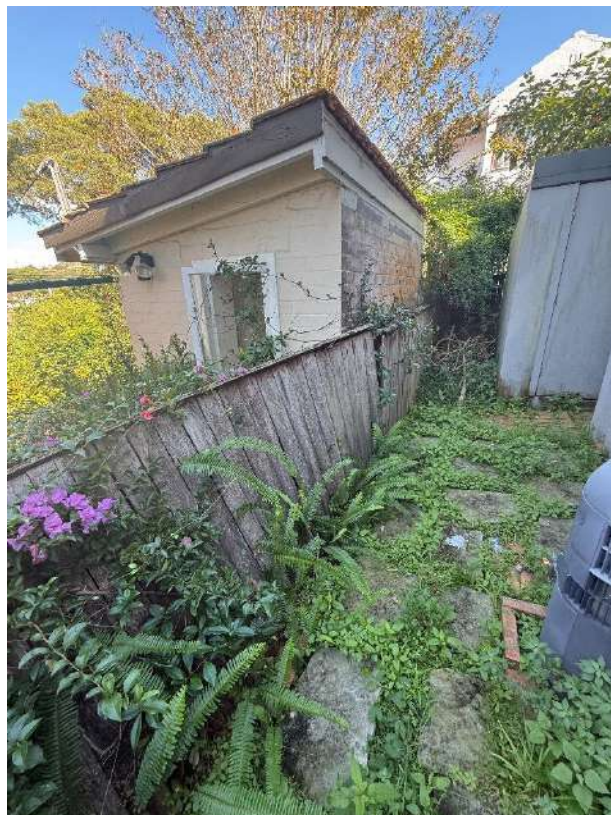
Collapsed boundary fence

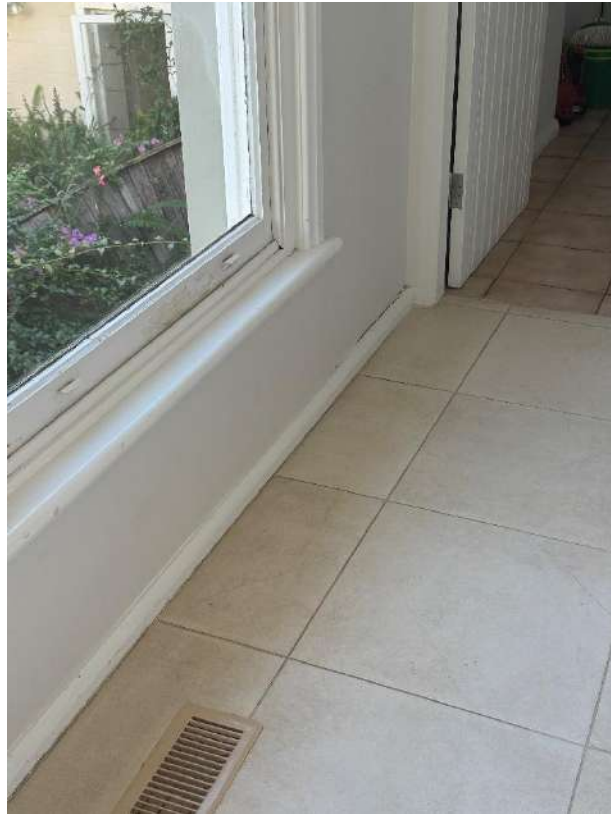
Vertical crack beneath the window within the wall below the double hung window

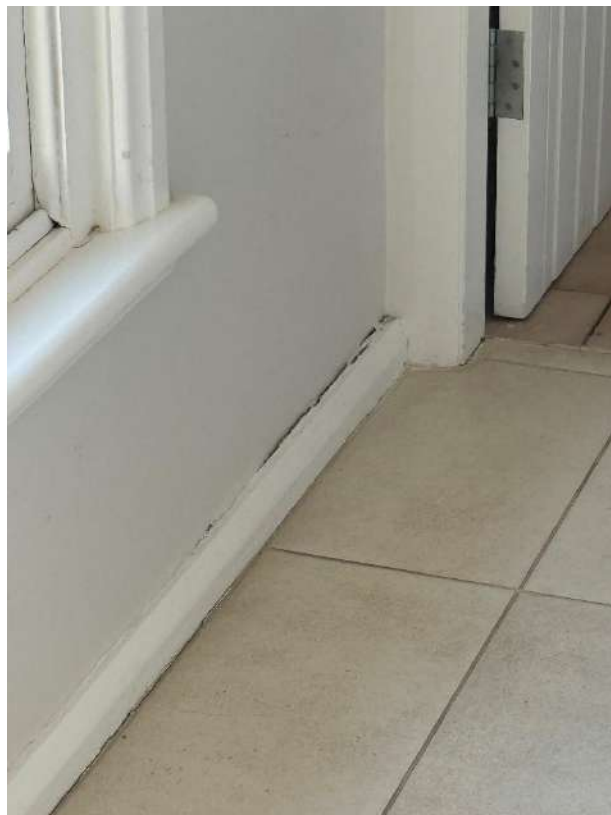
Crack within the timber skirting board within the junction in the hallway
