The Property Inspectors

Commercial Pre-Purchase Building Inspection Report

Property Address: 2/268A Captain Cook Drive Kurnell

Date of inspection: 04/12/2018

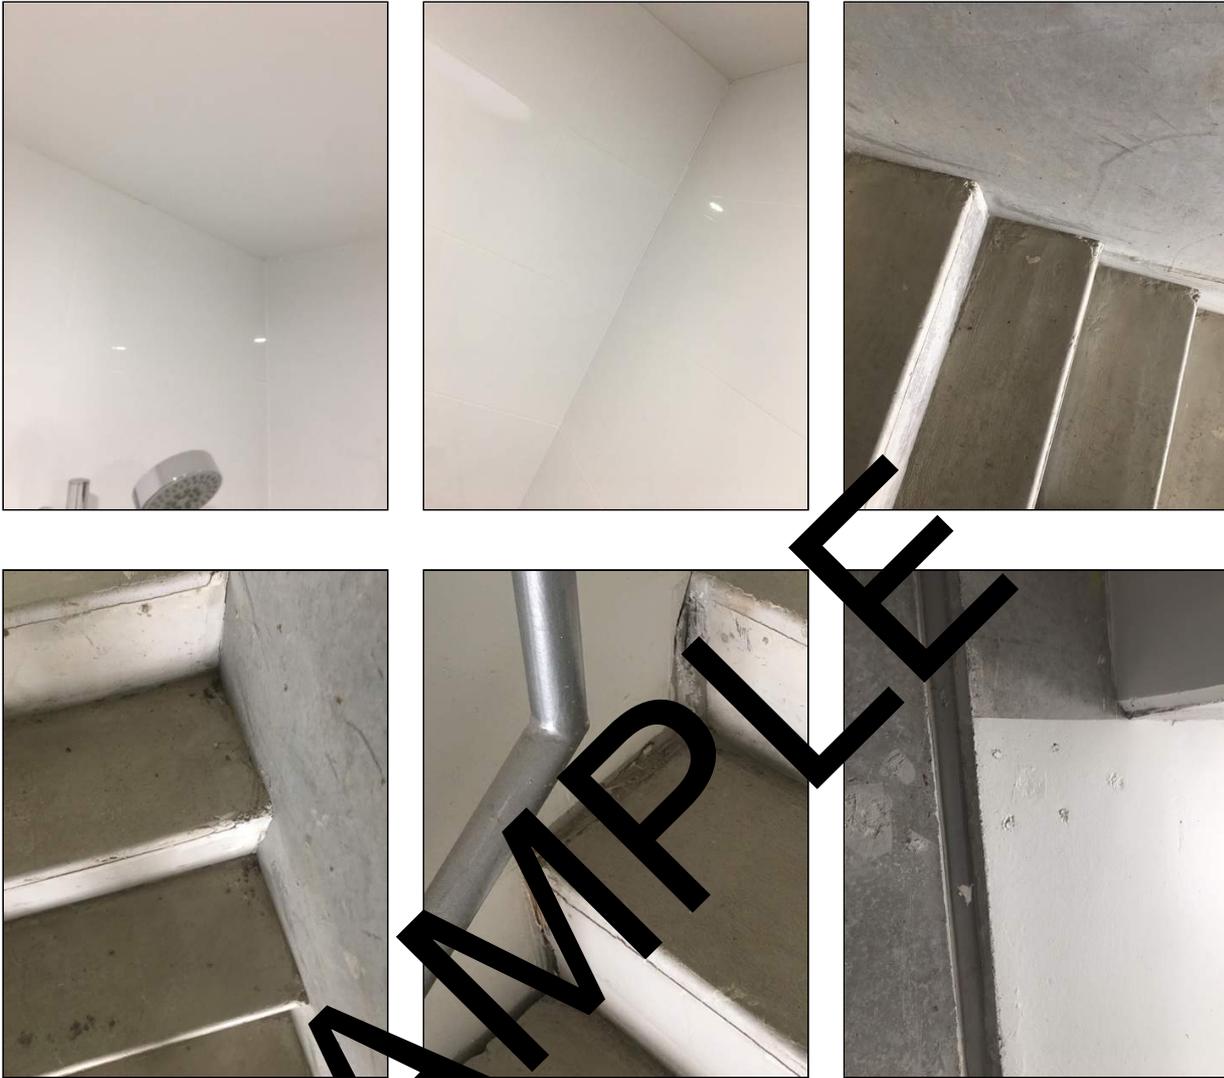
Question Ceiling and ceilings free of sagging, nail popping, cracking, staining or other damage?

Answer Minor cornice cracking

Minor cornice cracks are seen between the cornices and ceilings and cornices and walls, this is possibly due to normal movement within a property and is considered an acceptable and non-structural issue

1. Cracks were found within the cornices where each length of cornices meet and are set together
2. A good plasterer and painter can repair and make good these issues quite easily and cost effectively.

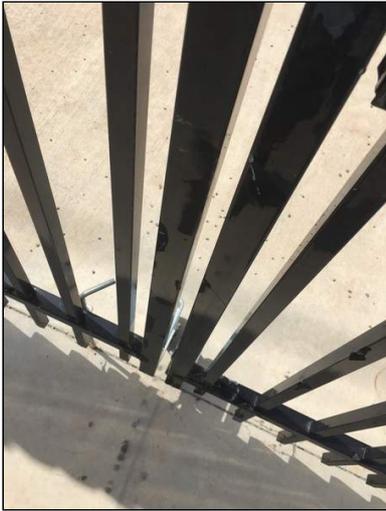
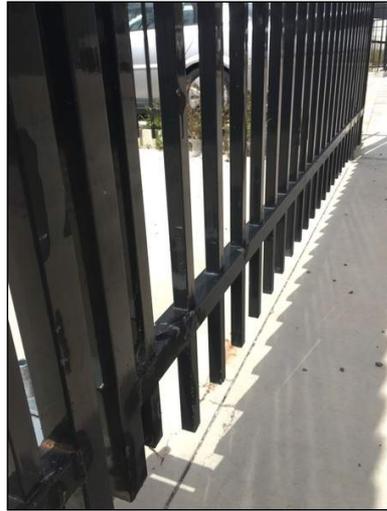
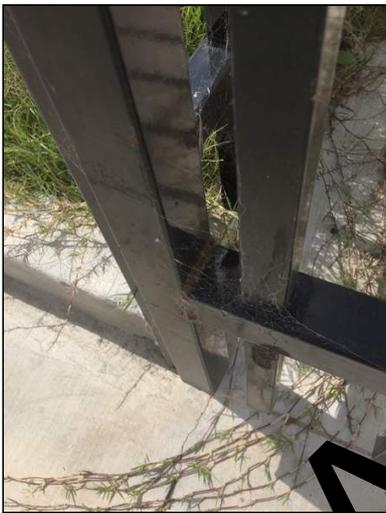
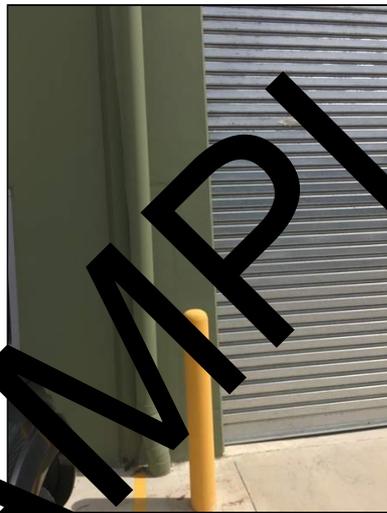
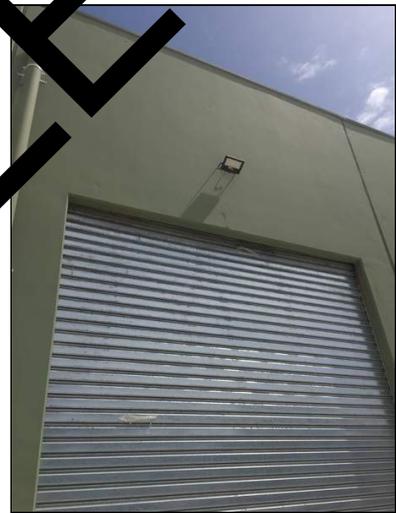
Photos

Defect Rating Safety Hazards & Major Defects
