Residential Pre-Purchase Building Inspection Report

Complies with Australian Standard AS 4349.1-2007
Inspection of Buildings Part 1: Pre-Purchase
Inspections Residential Buildings - Appendix C

Property Address: 12 Loombah Road Dover Heights

Date of inspection: 17/06/2017

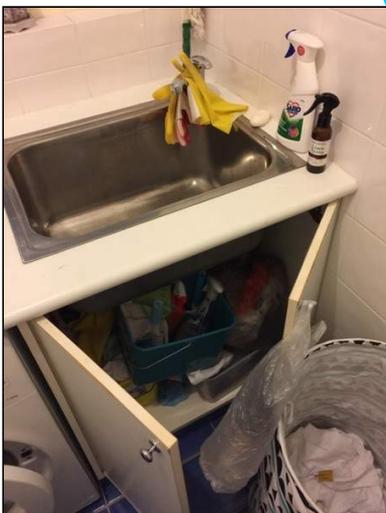
Defect Rating Minor Defect

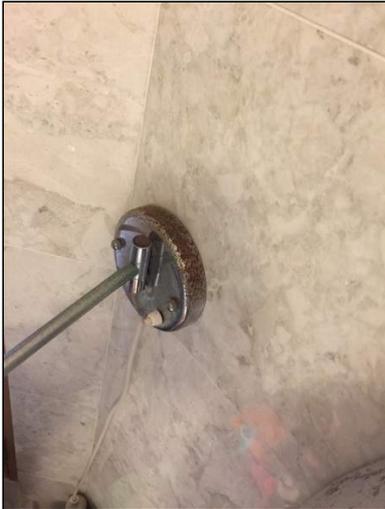
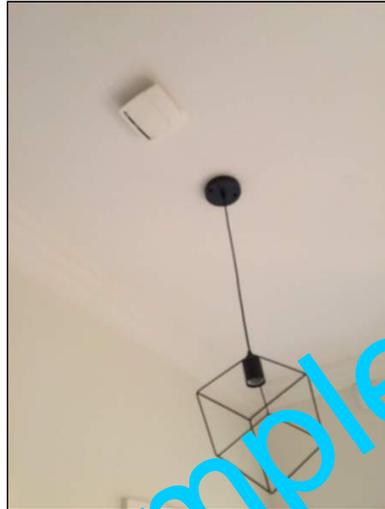
Defect Rating Minor

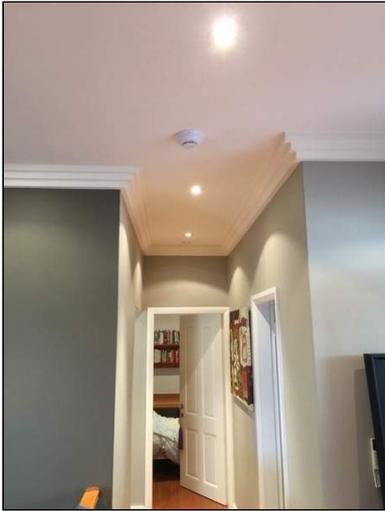
Answer Yes, but in the wrong location

Defect Rating Safety Hazard

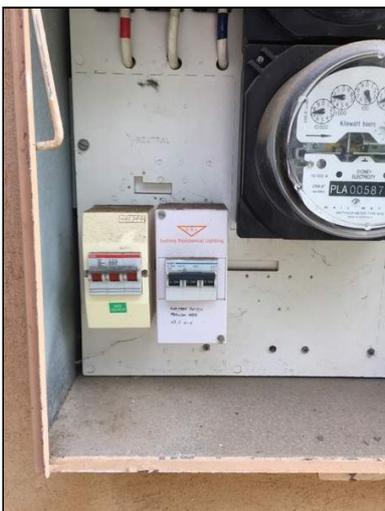
Description The sub board within the garage has the outer case missing and cables/wires loose and exposed

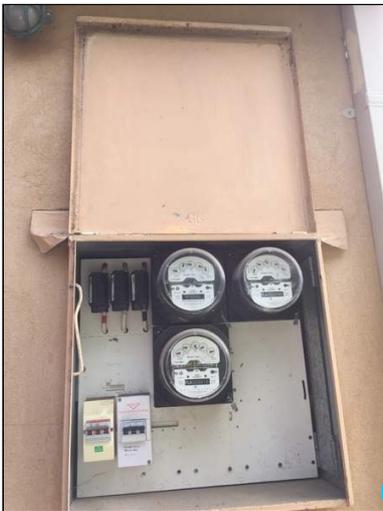
Defect Rating Minor Defect

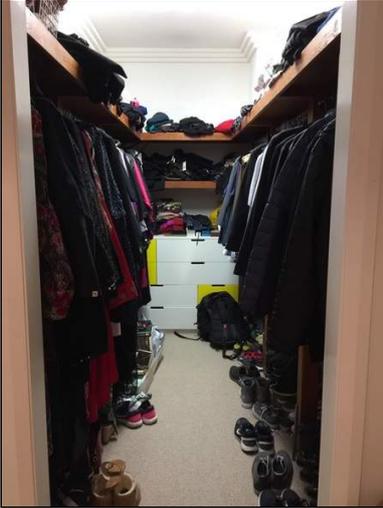
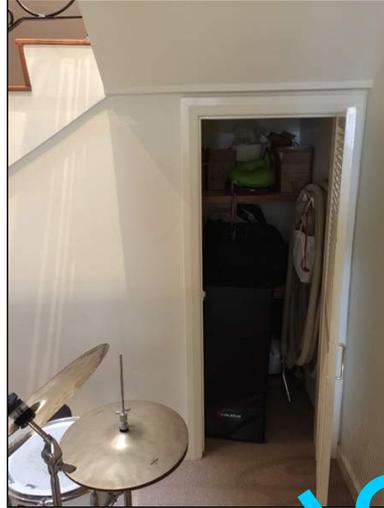
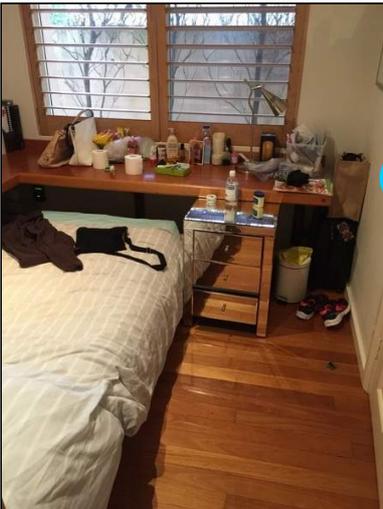
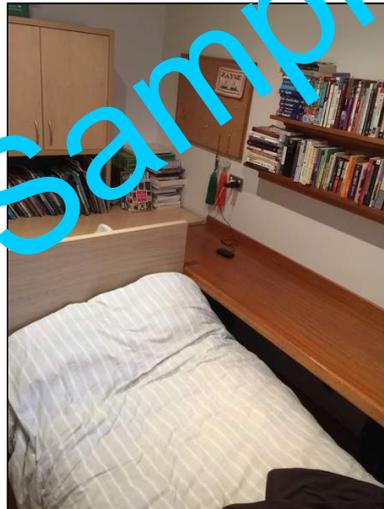
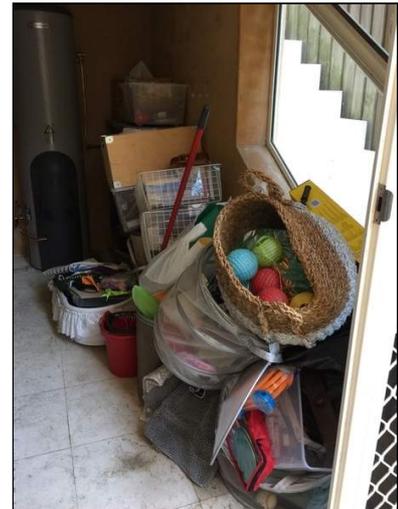
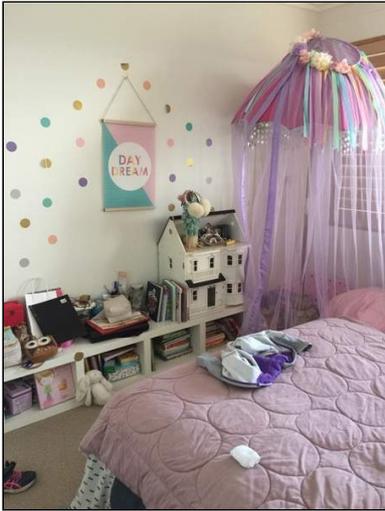
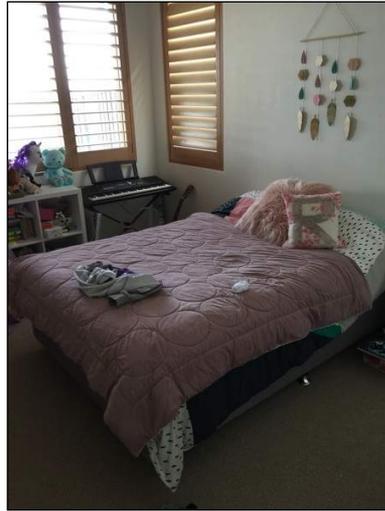
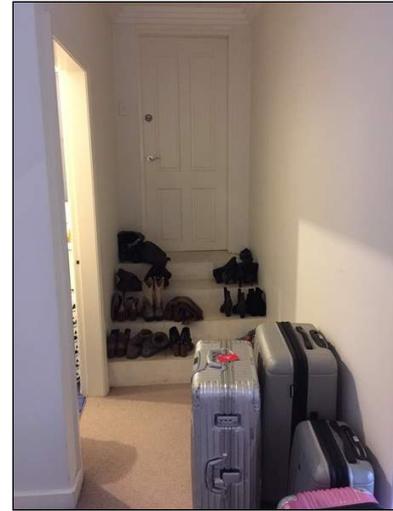
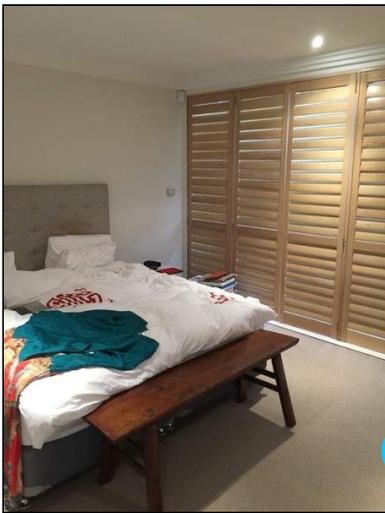
Defect Rating Note: Not all areas were able to be inspected due to excess belongings - Some Photos attached

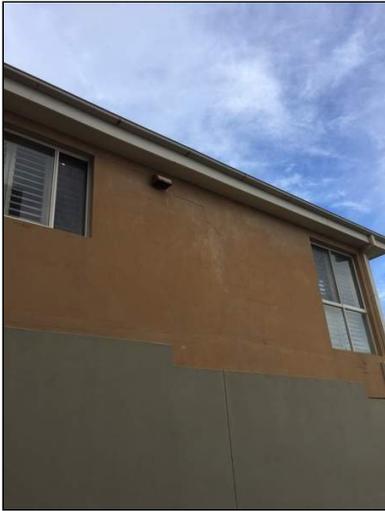
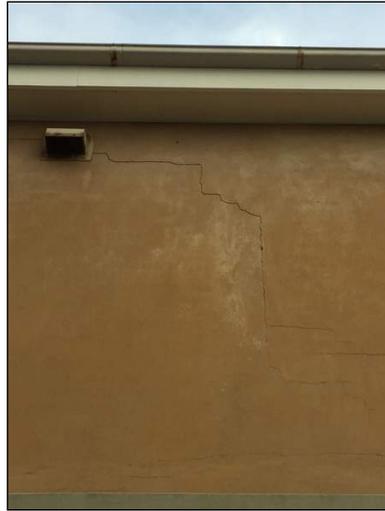
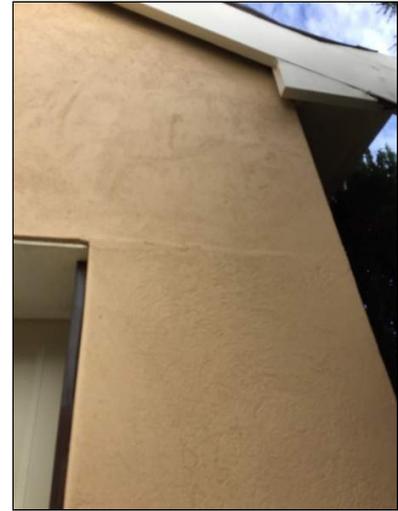
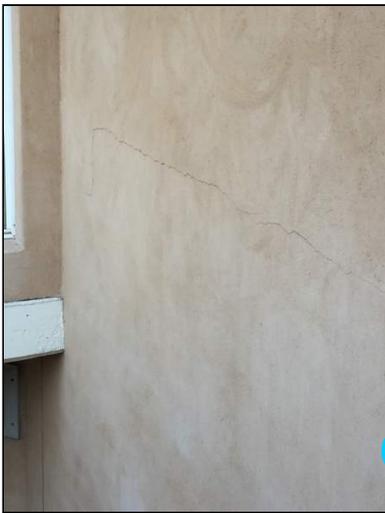
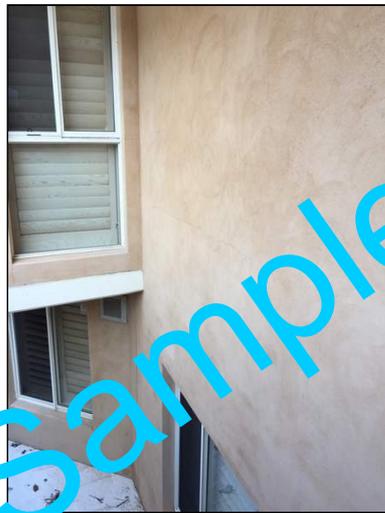
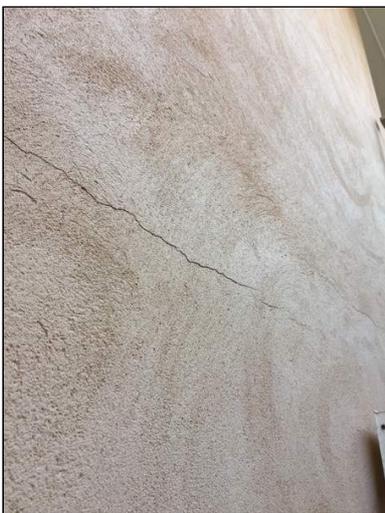
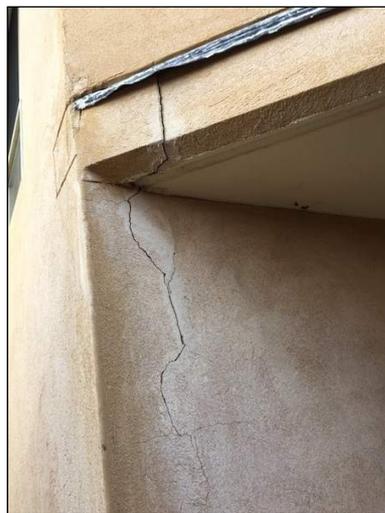
Answer **Small to Medium cracks were found within the external brickwork**

The house has minor to moderate cracks seen within the external elevations of the property

There was evidence of Category 2 cracking in sections of the mortar lines/bricks.

Defect Rating Minor defects

These issues are non-structural issues but they should be monitored and if they continue to open up or develop over time a structural engineer should be engaged " This is a minor defect In the current condition of the property "

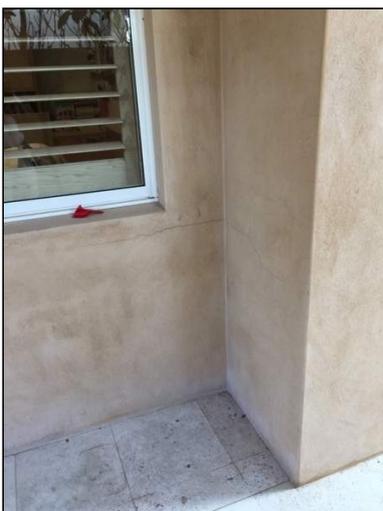
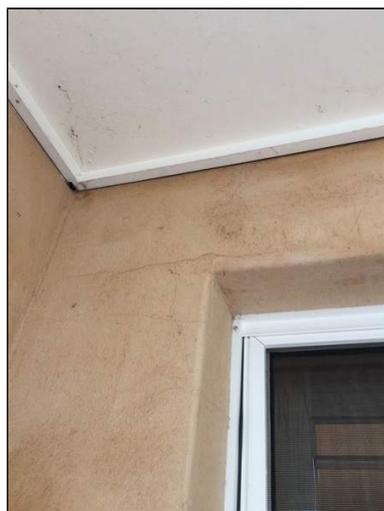
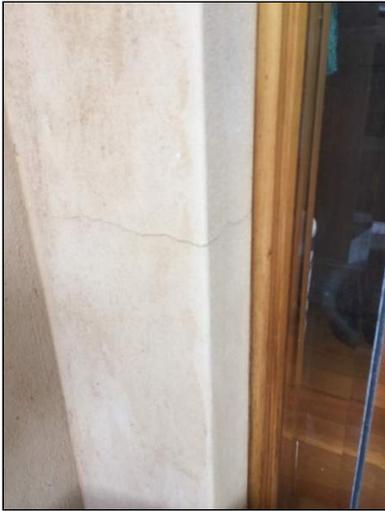
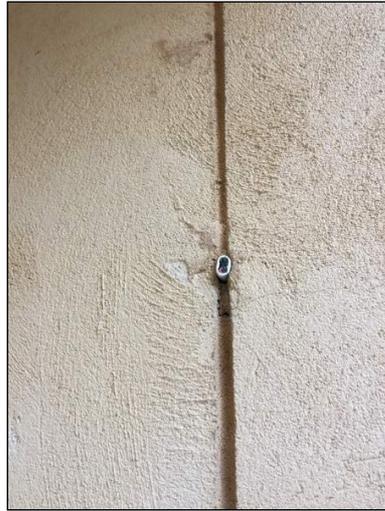
Answer **Crazed cracking in rendered finish**

Cracks found are assess to be existent the external lining and not in the masonry wall/substrate

Defect Rating Minor Defect

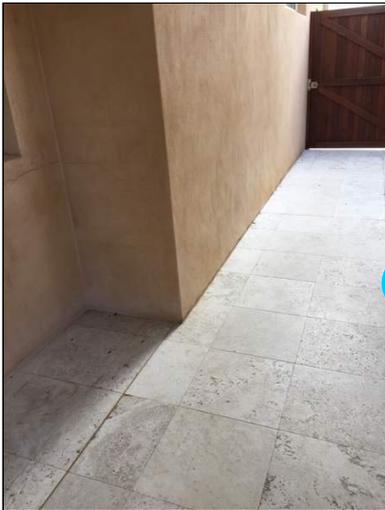
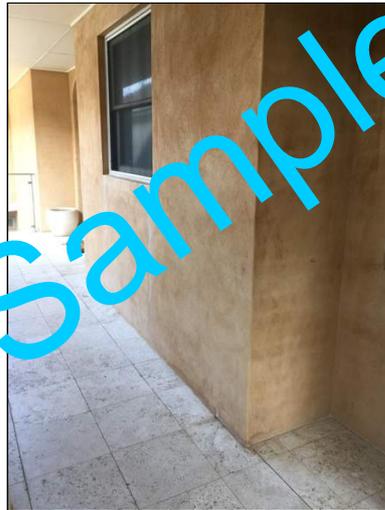
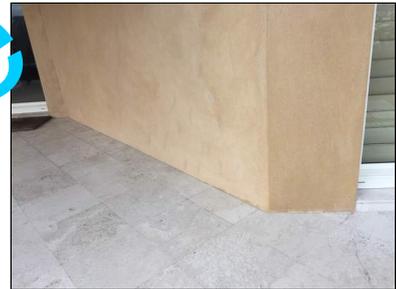
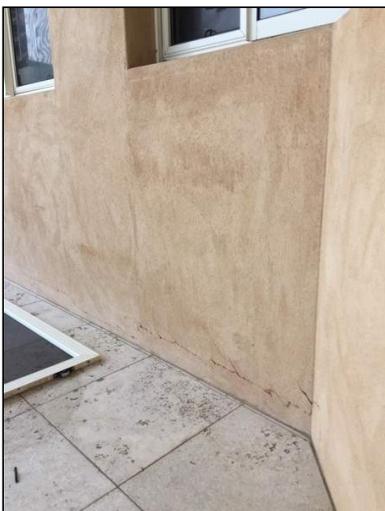
Weep holes should be installed to allow moisture to seep out of the wall cavities, when no weep holes are installed or seen in a property such as this one it raises the possibility of moisture being trapped within the internal skin of the house

This is a common problem found in homes that are rendered after the original build. Builder and bricklayers often install flashings and weep holes when they build a new building, but when new owners move into a house they often render the external wall linings and the weep holes get covered over by the renderer and painter as they don't always expose the weep holes

Defect Rating Minor Defect

It is best practice to have all surrounding surfaces around the building clear of any materials that may retain moisture with minimal garden beds up against the building, all hard surfaces around the building should direct the surface water and any stormwater away from the building keeping the walls, foundations and footings of the house as dry as possible limiting the possibility of rising damp.

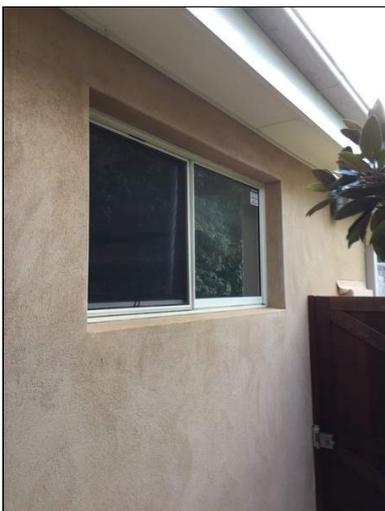
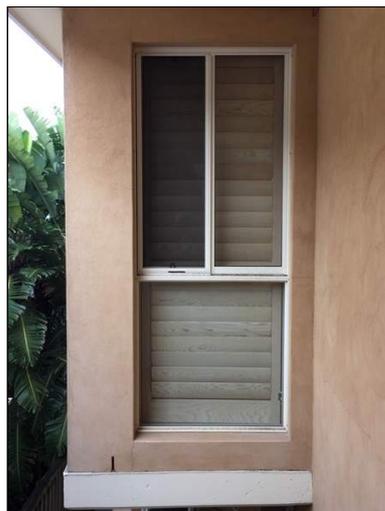
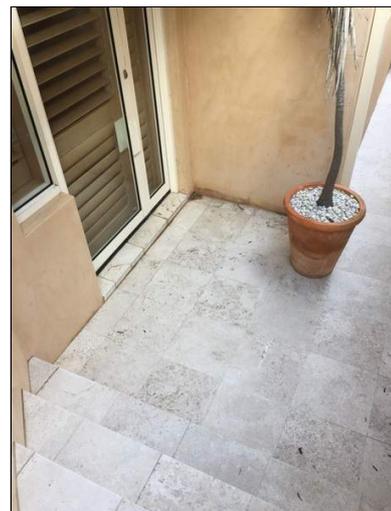
Answer **Missing weep holes above or below windows or doors**

Lack of weep holes will create dampness within the cavity and within the internal wall linings and it will contribute towards the render cracking and render crazing, this will eventually become drummy and fall off the wall, any timber attached to the walls in question will rot and deteriorate before its natural time

Defect Rating Minor Defect

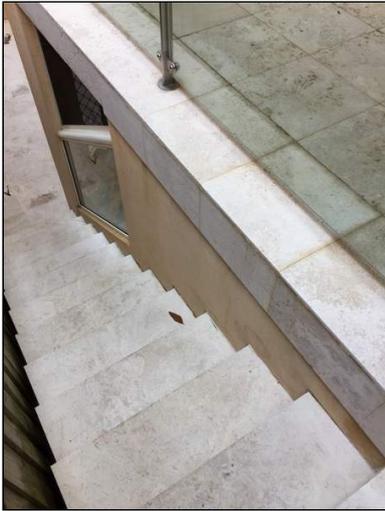
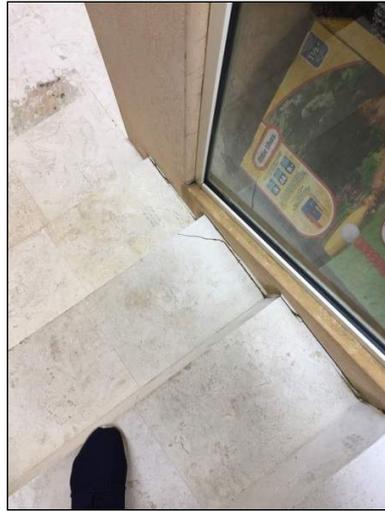
Goings don't have slip prevention measures installed on the nosings, this area is a safety hazard and should be rectified as soon as possible.

Answer Defective stair balusters & handrail

Answer Cracked Tiles

Tiles to staircase can be seen to be cracked and of need of repair.

Tiles to staircase were found to drummy and if left as is could pose a safety risk.

Answer Render/applied finish defective

Poorly finished, cracked or damaged finished to the staircase.

Defect Rating Safety Hazard

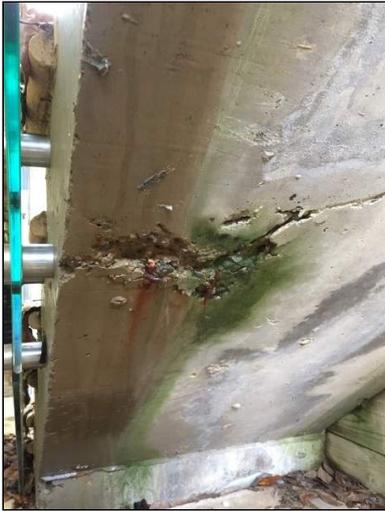
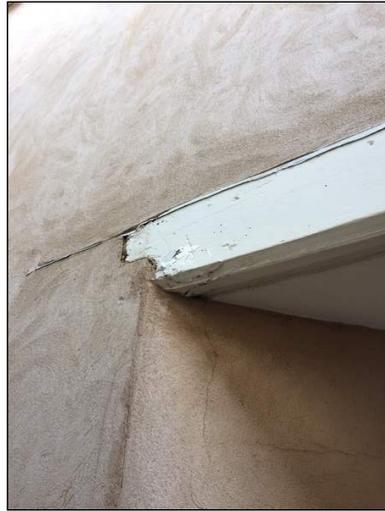
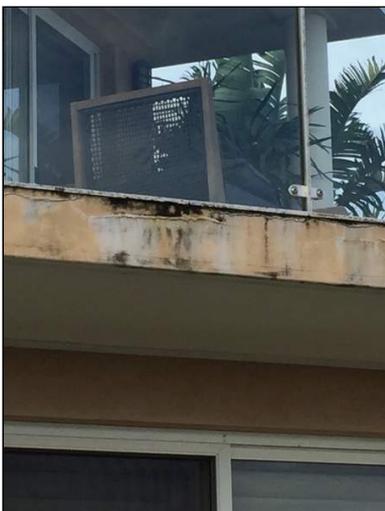
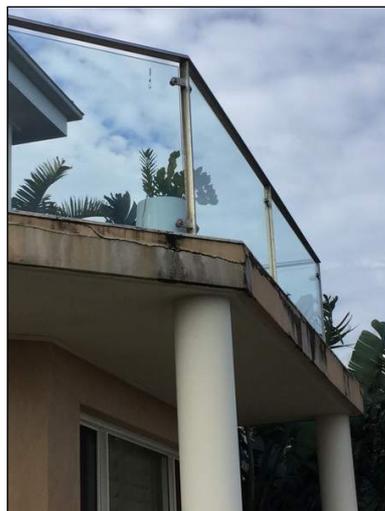
Answer **Cracked floor tiles**

The tiled deck/veranda can be seen to be cracked, this could be through the structure and floor finish, further investigation is required.

Answer **Soffit lining - Defective**

Location Rear veranda slab edges are cracked and defective

Defect Rating Major Defect

This should be assessed by a builder or tiles to prevent the structure / tiles from further delamination and deterioration

Soffit lining can be seen to be defective requiring repair which could be undertaken by a carpenter and painter.

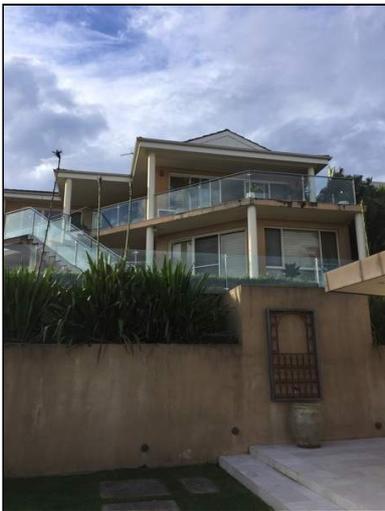
Answer Missing handrails and balustrading

Randomly found throughout the house there is handrails & balustrades not installed in areas that require restraint measures installed

Defect Rating Safety Hazard

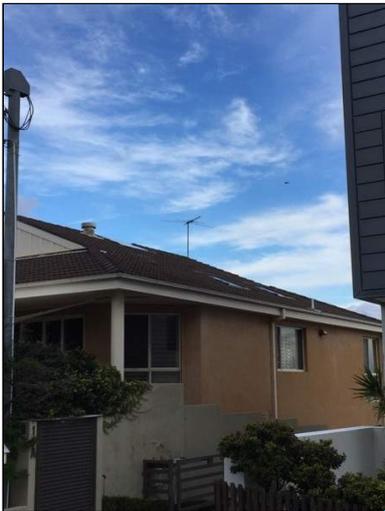
Question Roof tiles, shingles, slates: Is the roof free of cracked and broken/decayed tiles? **SPECIAL NOTE: The Inspector takes minimal photos whilst on the roof so the inspectors hands are free during the inspection for safety reasons and photos are generally taken from afar if any**

Answer **I did not access the roof tiles nor roof plumbing as the gutter line was above 2.7metres in height**

Location I inspected the roof tiles over the garage, as it is a single storey building, there were no defects found within the roof nor the roof plumbing

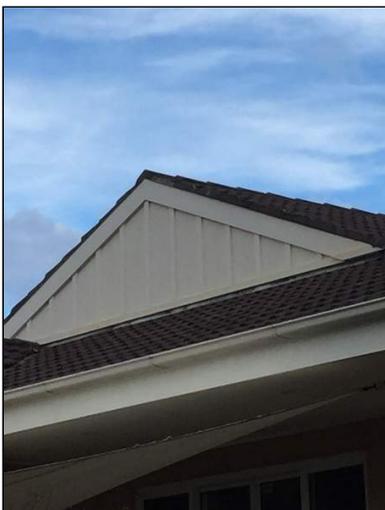
Answer Paint/coating in poor condition

There is deteriorated gable cladding (Dry / Wet Rot)

Location The deterioration within the gable, fascia, soffit lining, and bargeboards are common in properties in this location due to being in a high location with an element of risk to access these exposed materials and due to their location being so high and remote

Defect Rating Minor Defect

A carpenter and painter needs to be engaged to have this repaired or replaced

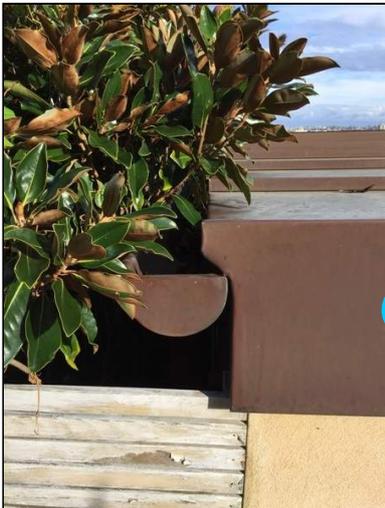
Question [Valleys/Gutters/Downpipes; Are they free of rust, and do they appear to drain effectively?](#)

Defect Rating Further investigation

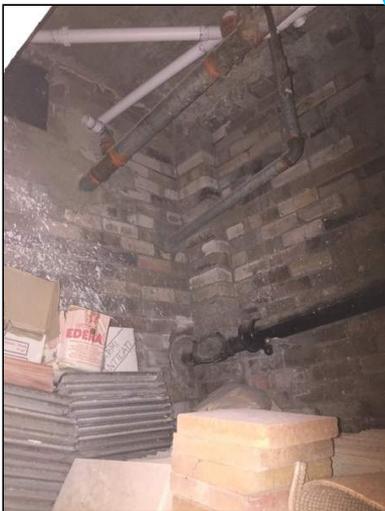
Question Timber floor; Does the sub floor area appear to be adequately ventilated, and free of dampness?

Answer **Inadequate ventilation within the sub floor areas inspected**

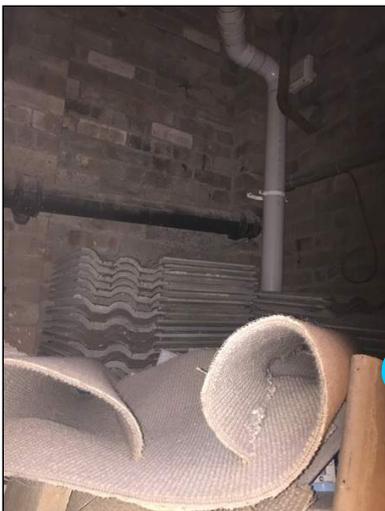
Answer The masonry walls have dampness within the supporting walls, under the floor structure. This needs to be regularly inspected as this is not desirable, this means there is constant moisture within the sub floor area and this could lead to pest/termite infestation

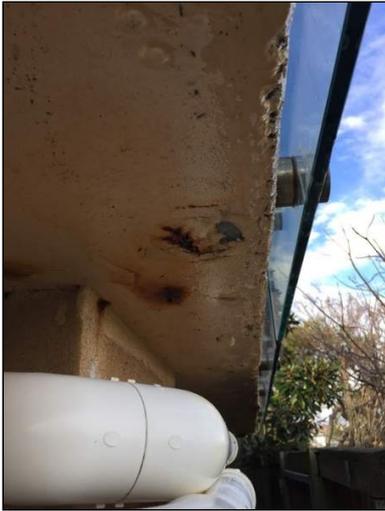
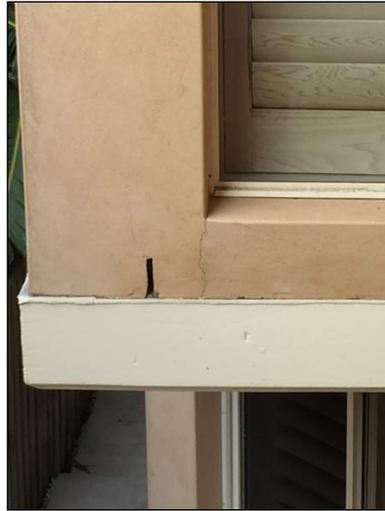
Answer Concrete slab edge dampness evident

Defect Rating Major Defect

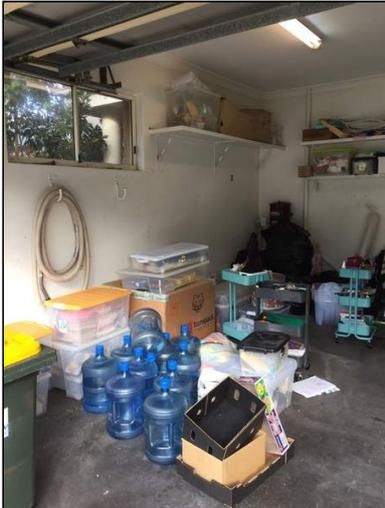
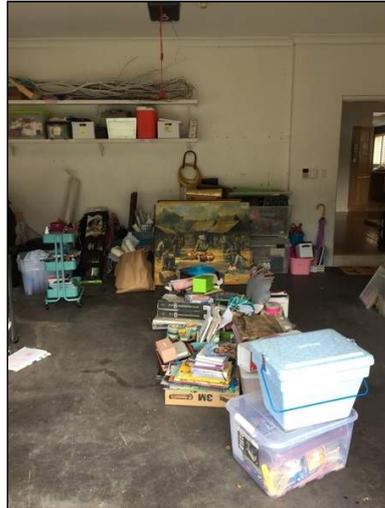
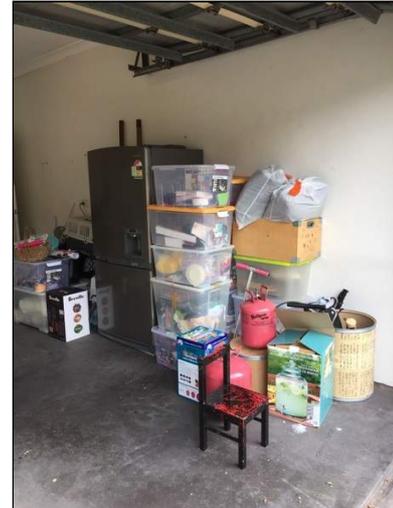
Answer I was unable to access the entire subfloor area

Defect Rating Minor Defect

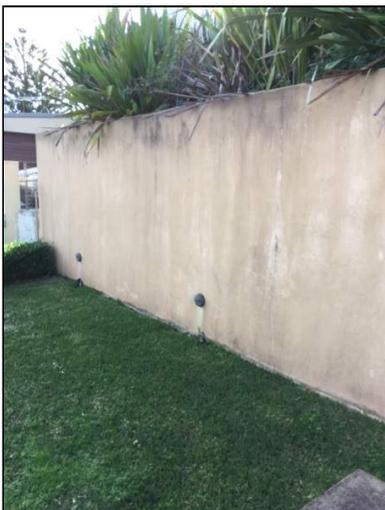
Answer Minor cracking evident

Defect Rating Minor Defect

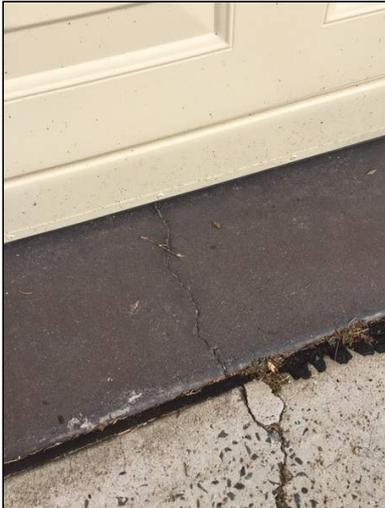
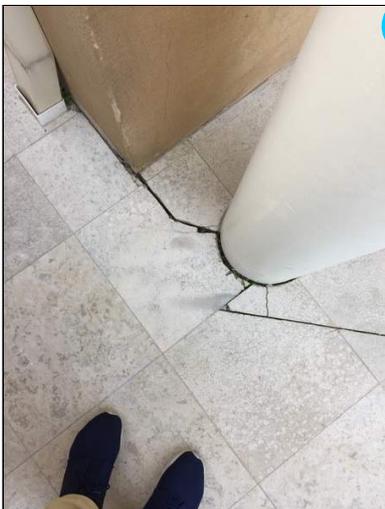
Answer Minor cracks - Minor tripping hazards - settlement to be monitored

Defect Rating Minor Defect

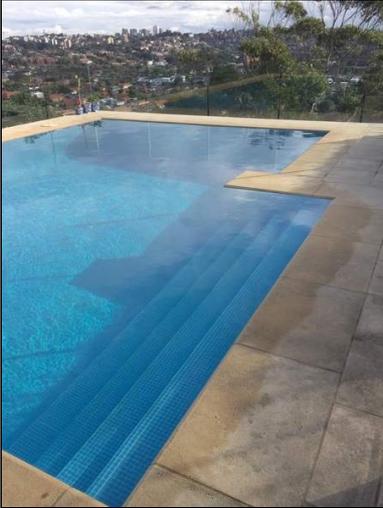
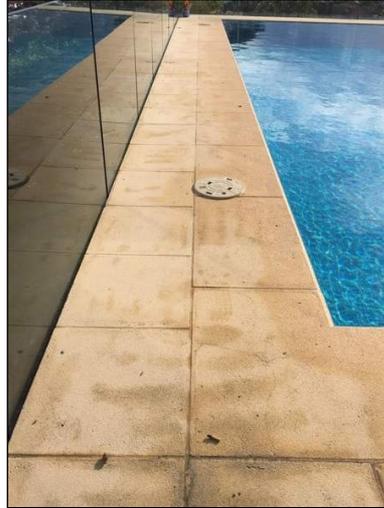
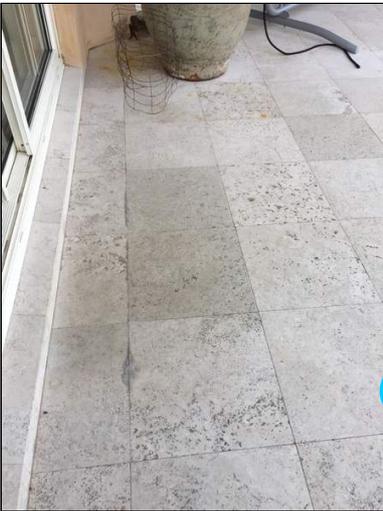
Question Are there expansion joints present in the external floor finishes

Defect Rating Minor Defect

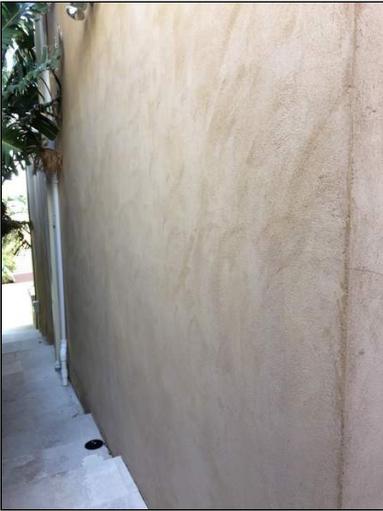
Question Are there expansion joints present in the external walls ? (Every 5.5m a expansion joint or control joint should be installed)

Defect Rating Minor Defect

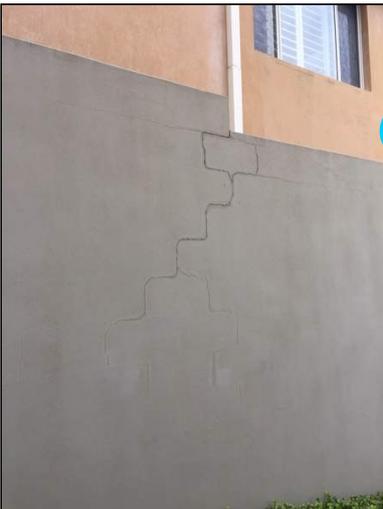
Answer Cracks seen within brick boundary walls/fences

Defect Rating Minor Defect
