Residential Pre-Purchase Building Inspection Report

Property Address: 16 Second Avenue Willoughby

Date of inspection: 17/05/2017

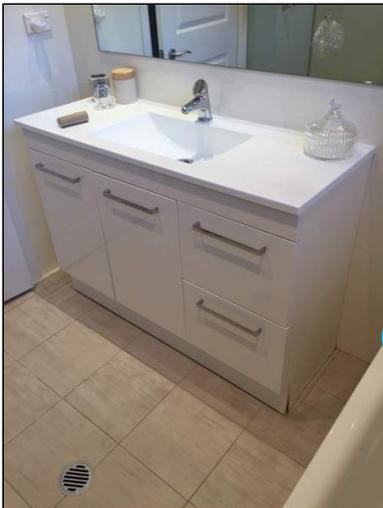
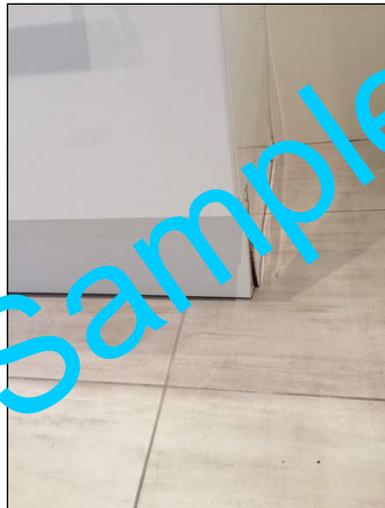
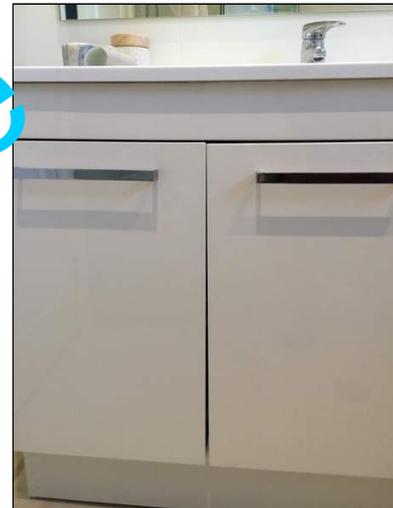
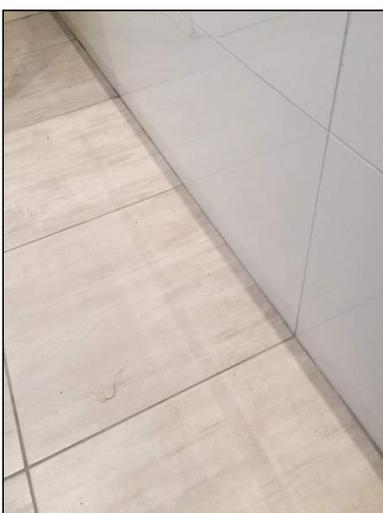
Defect Rating Minor Defect

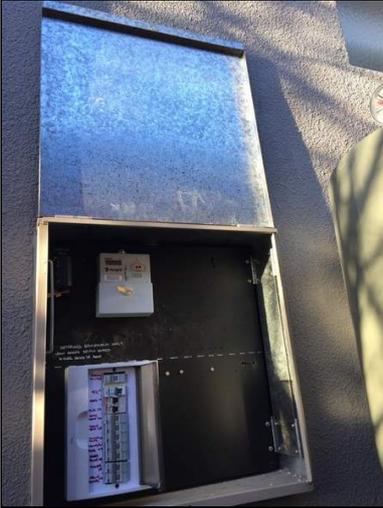
Defect Rating Minor Defect

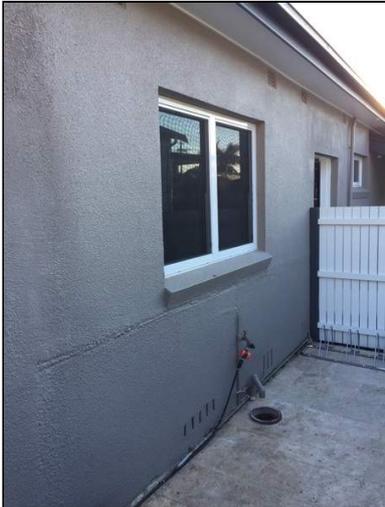
Defect Rating Minor Defect

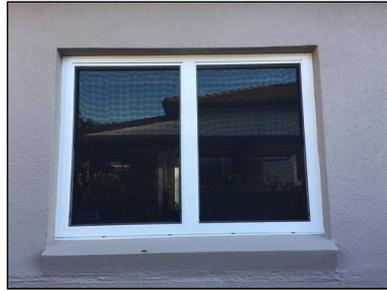
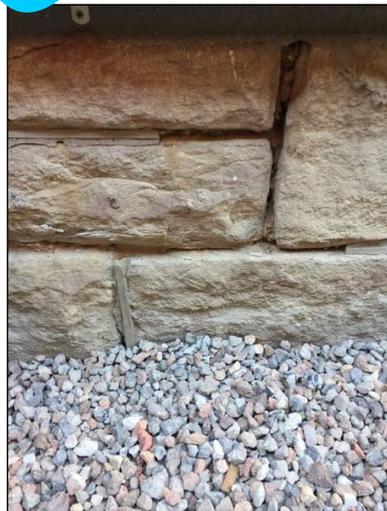
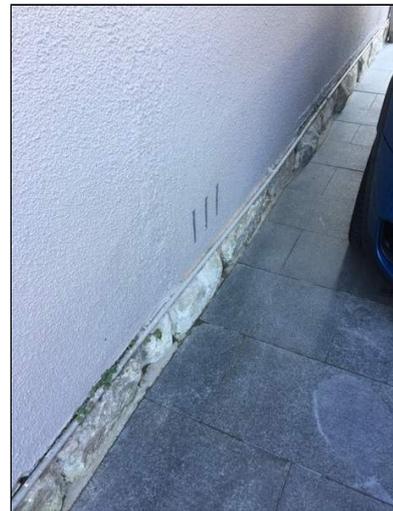
Defect Rating Minor Defect

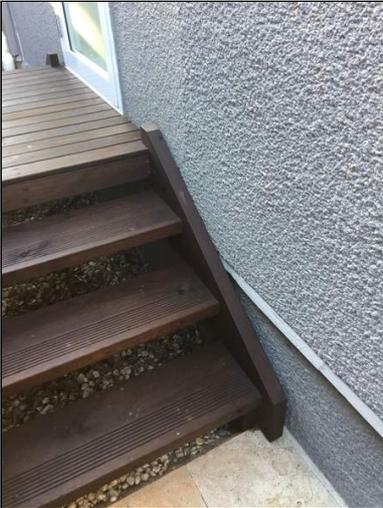
Defect Rating Minor Defect

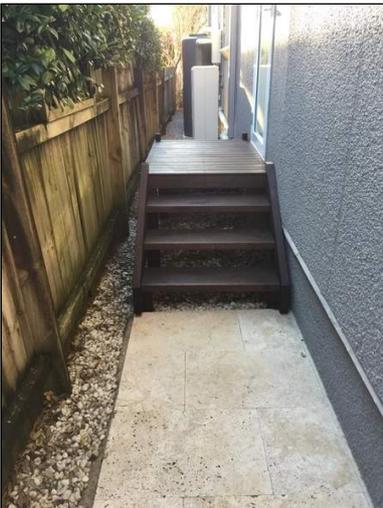
Defect Rating Minor Defect

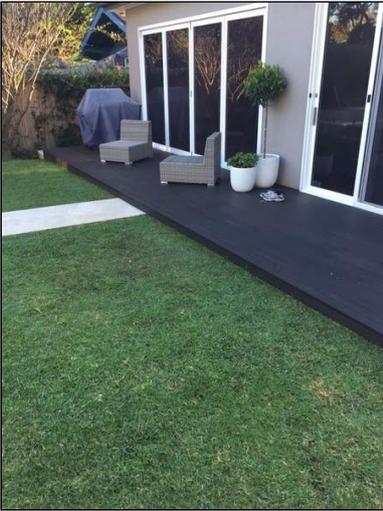
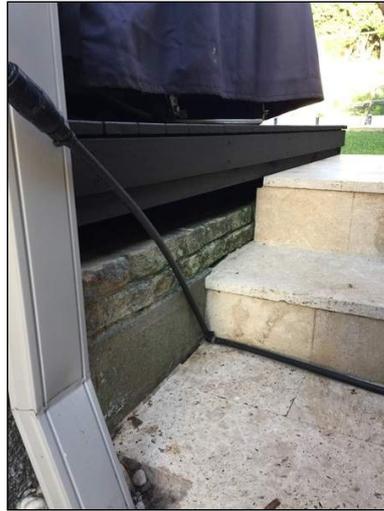
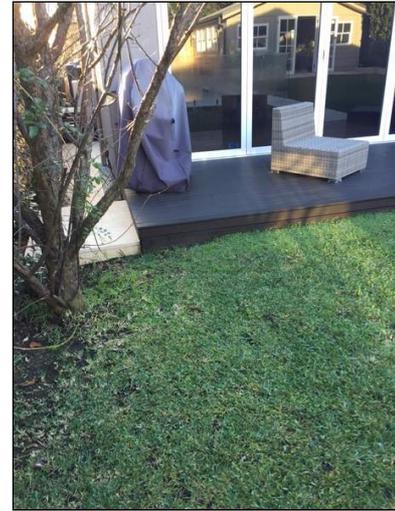
Defect Rating Minor Defect

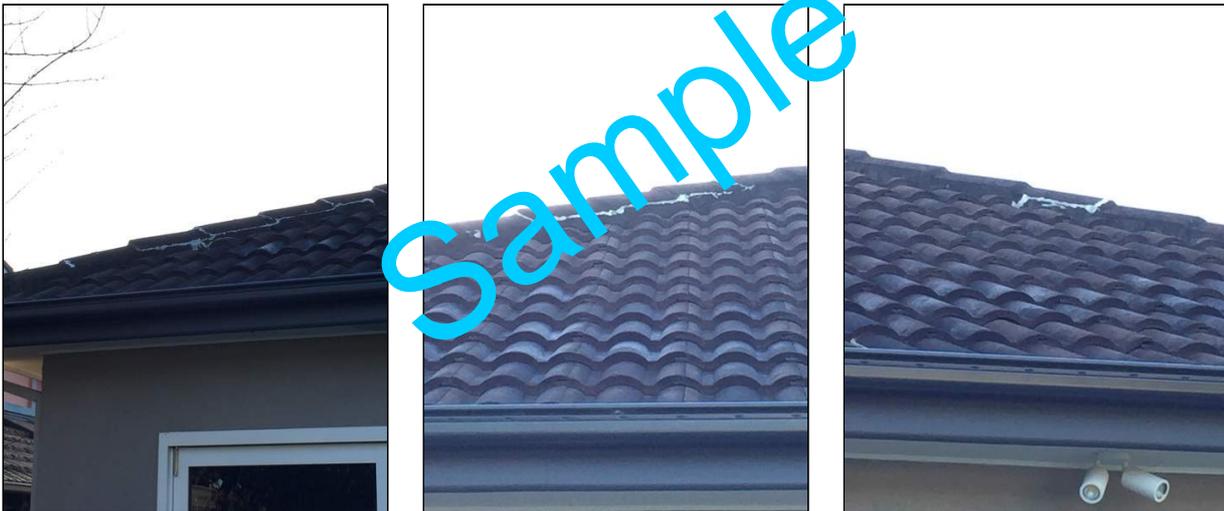
Defect Rating Minor Defect

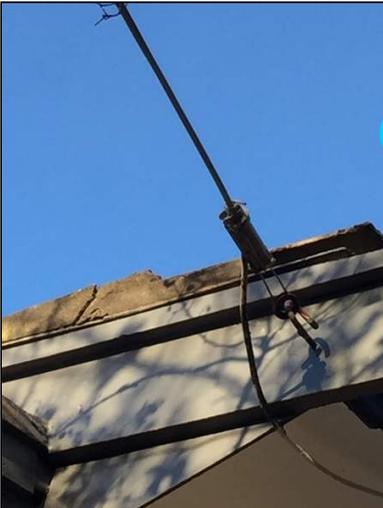
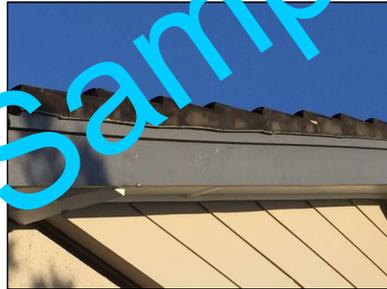
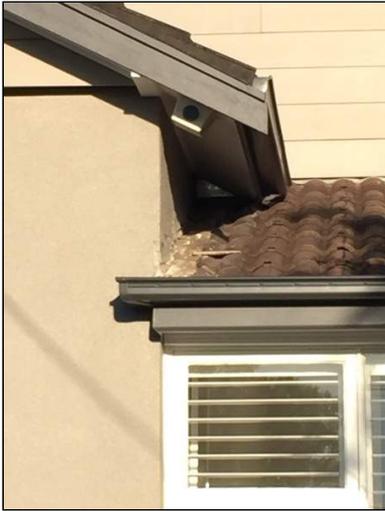
Defect Rating Minor Defect

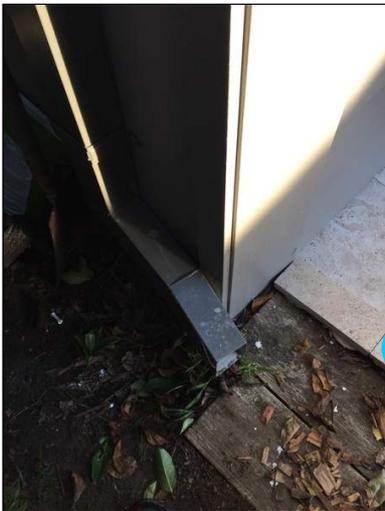
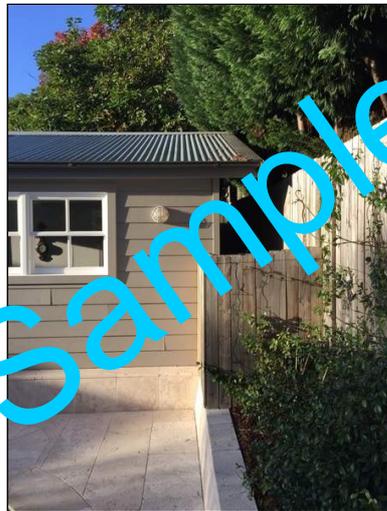
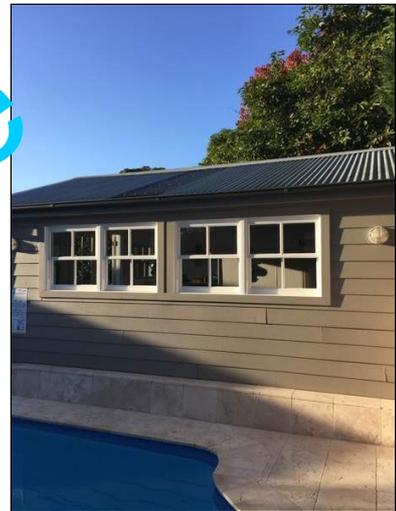
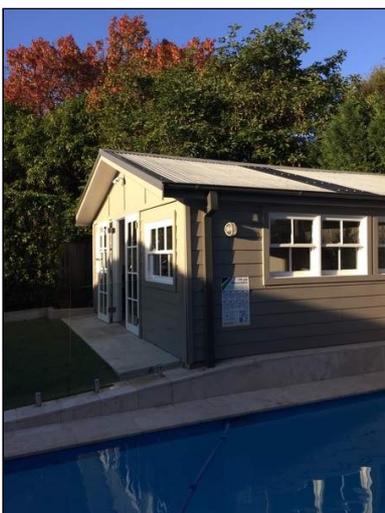
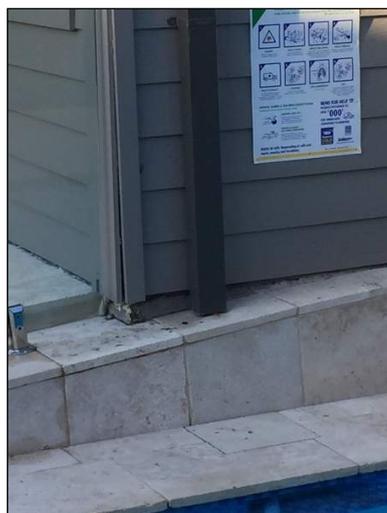
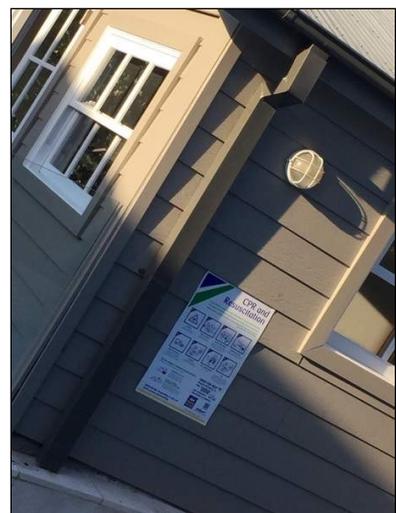
Defect Rating Minor Defect

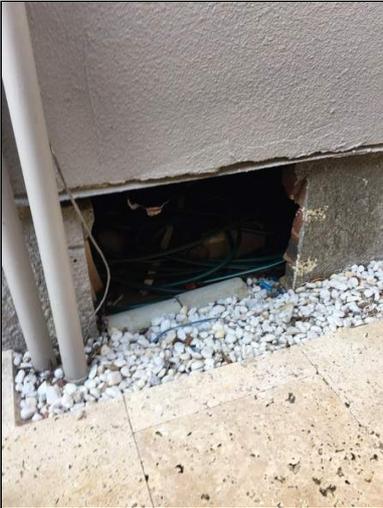
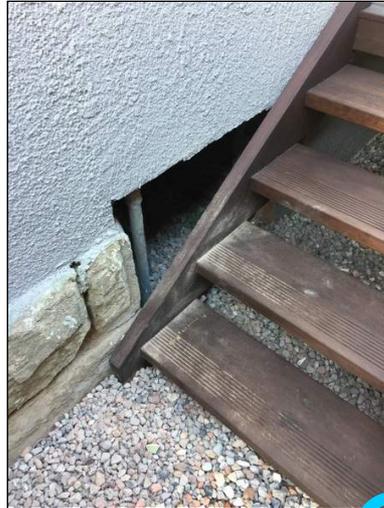
Defect Rating Further investigation

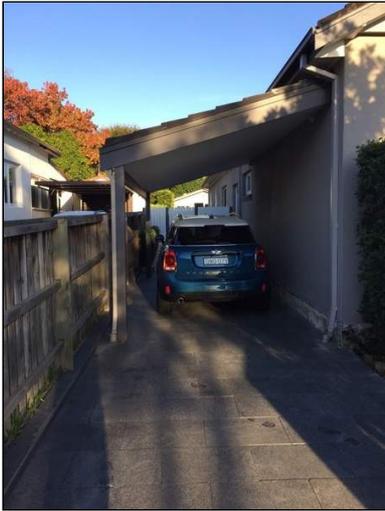
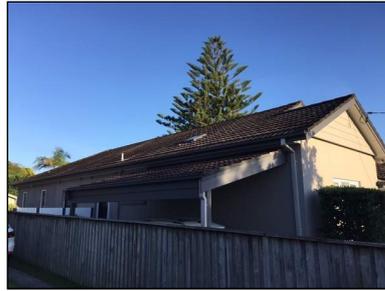
Detached Buildings; Car Accommodation, does the building appear structurally sound and free of defects/damage?

Buildings appear in reasonable condition for their age.

Minor improvements to the painting of the fascia could be done to preserve the timber members

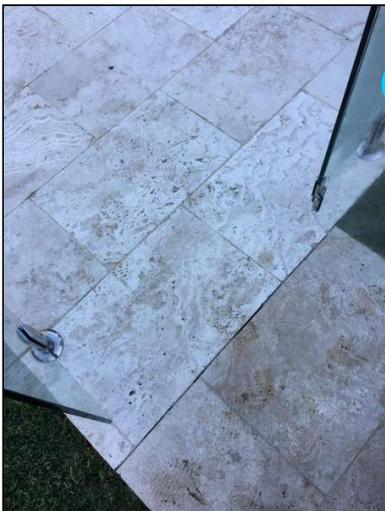
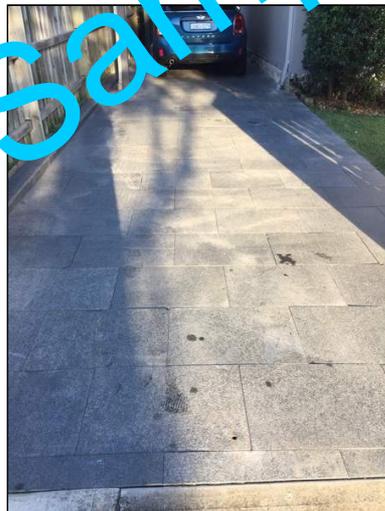
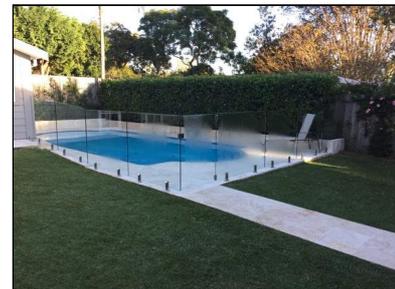
Question Are there expansion joints present in the external floor finishes

Answer No

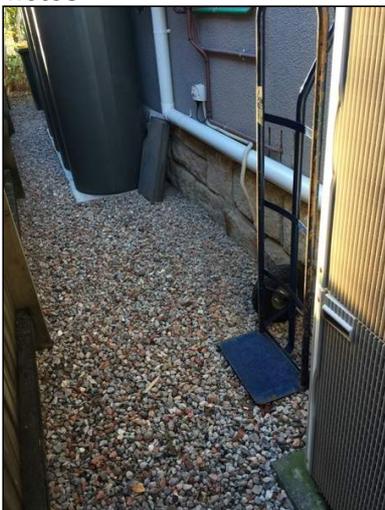
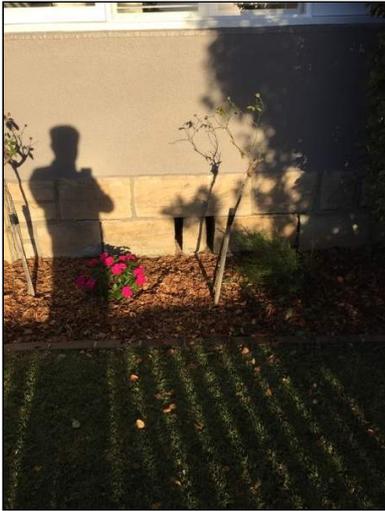
Question Are there expansion joints present in the external walls ? (Every 5.5m a expansion joint or control joint should be installed)

Answer No

Details Minor defect

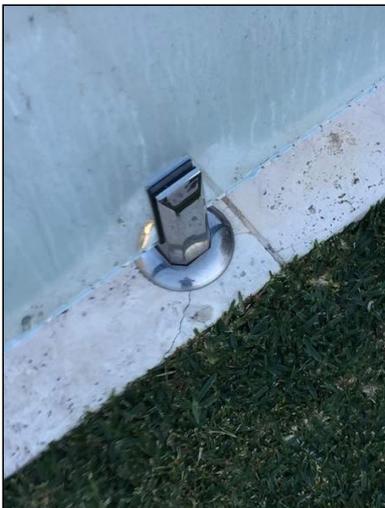
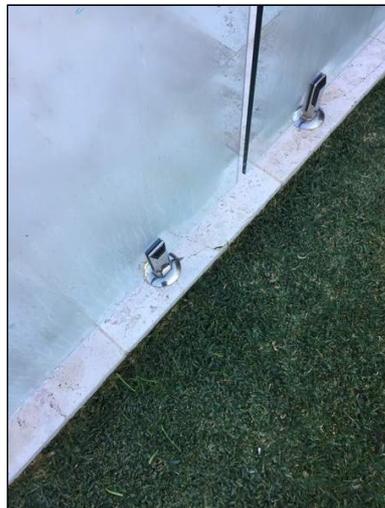
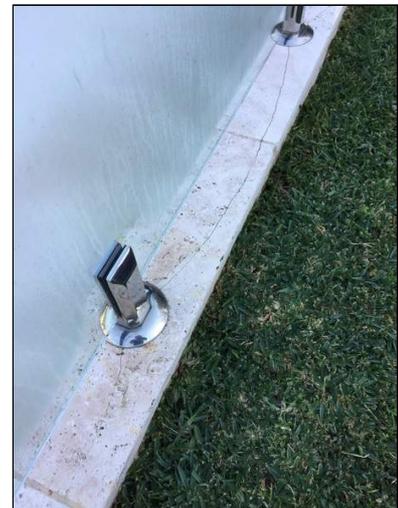
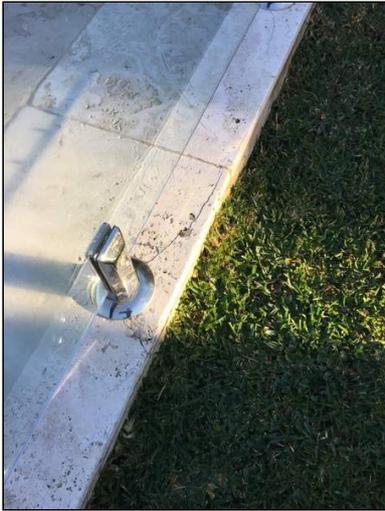
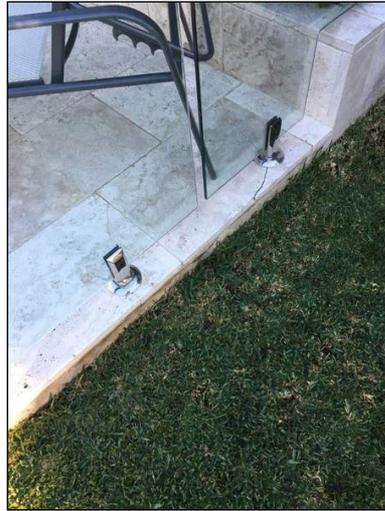
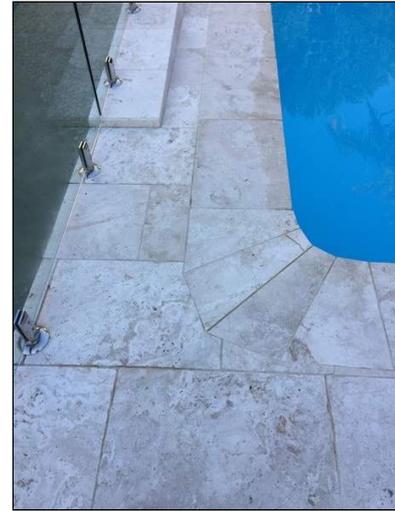
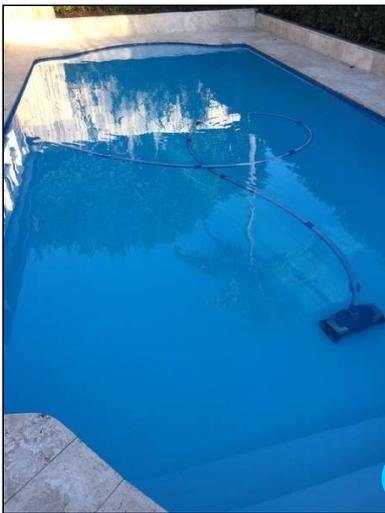
Question Swimming Pool; Do the pool coping tiles appear to be in good condition? Is there an expansion joint between the pool coping tiles and pool concourse floor finish?

Location The pool has cracked tiles around the pool concourse and at the end of the long tile runs
