# **Dilapidation Report For The Development At: 14 Fairfax Road Mosman NSW 2088**

Dilapidation Report Carried Out On:

12 Fairfax Road Mosman NSW 2088

17<sup>th</sup> June 2019

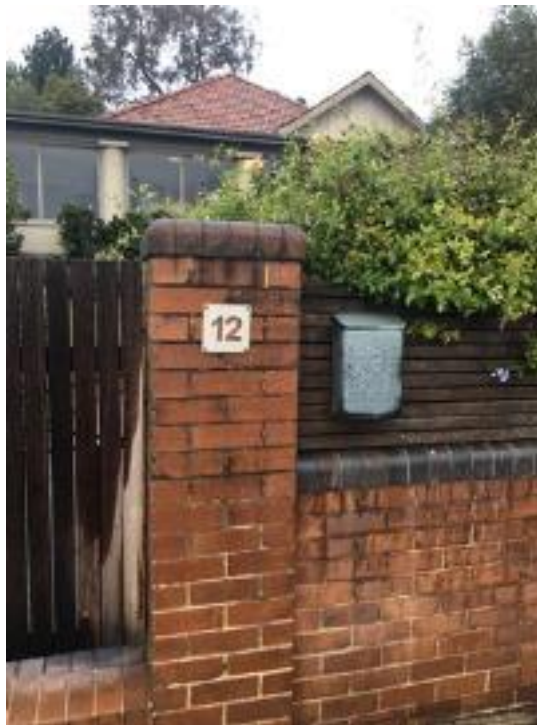
Minor cracks in the street elevation brick fence / mortar joints

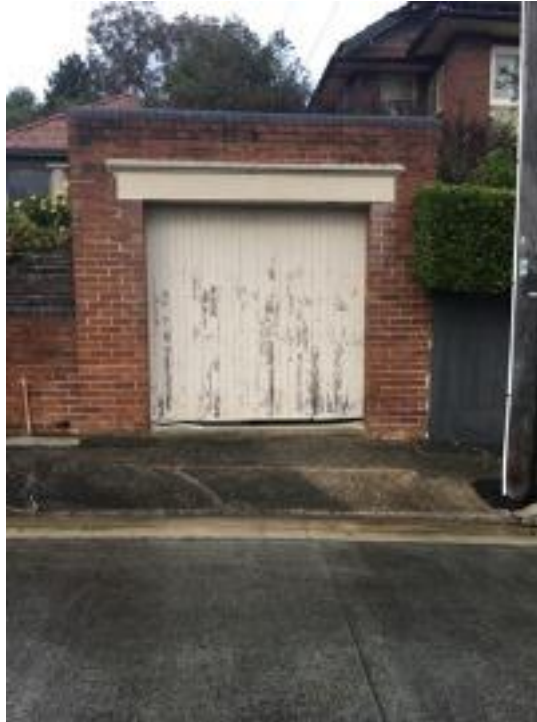
This standalone garage structure is not structurally stable in its current conditions, due to the excessive amounts of cracks found within all external elevations of the detached garage

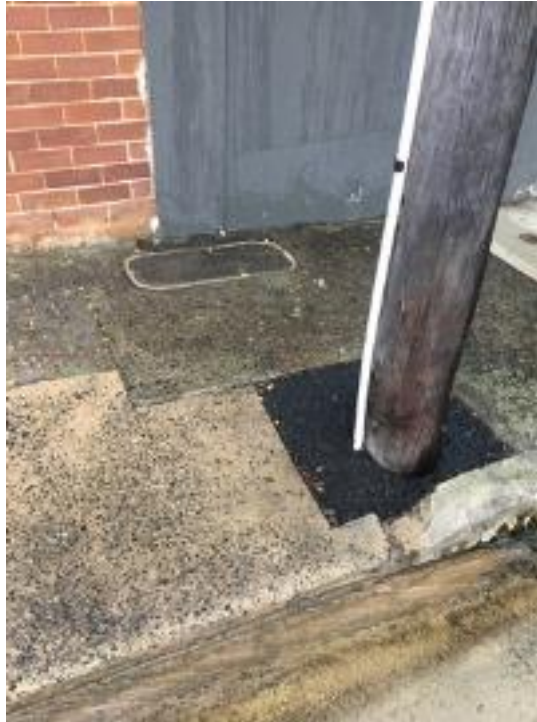
Cracked concrete footpath to the right corner of the footpath, and around the curb and gutter in front of the power pole

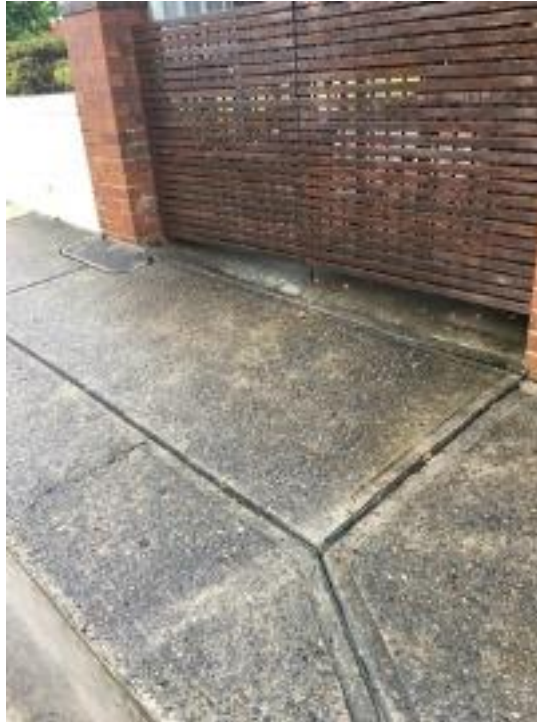
Cracked concrete layback / crossover

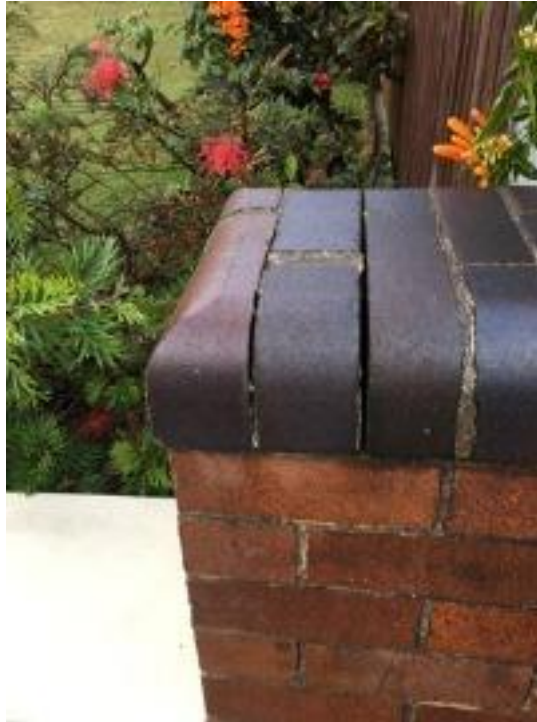
Existing cracks within the brick mortar joints of the brick pillars

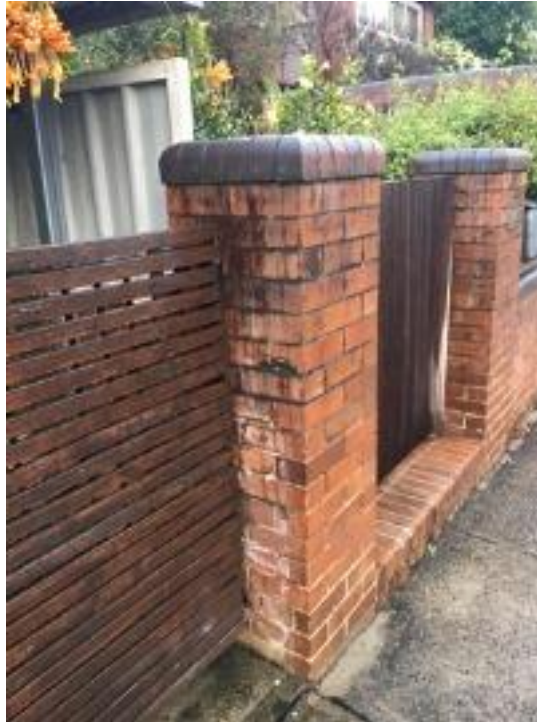
Existing cracks within the brick mortar joints of the brick pillars

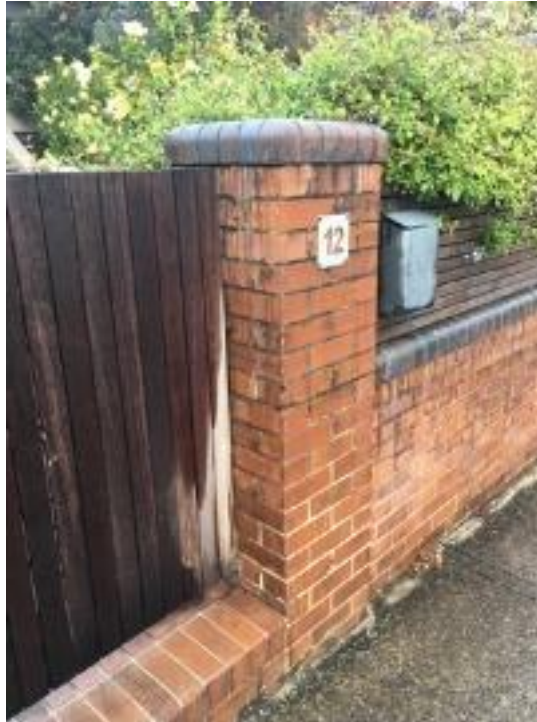
Existing cracks within the brick mortar joints of the brick pillars

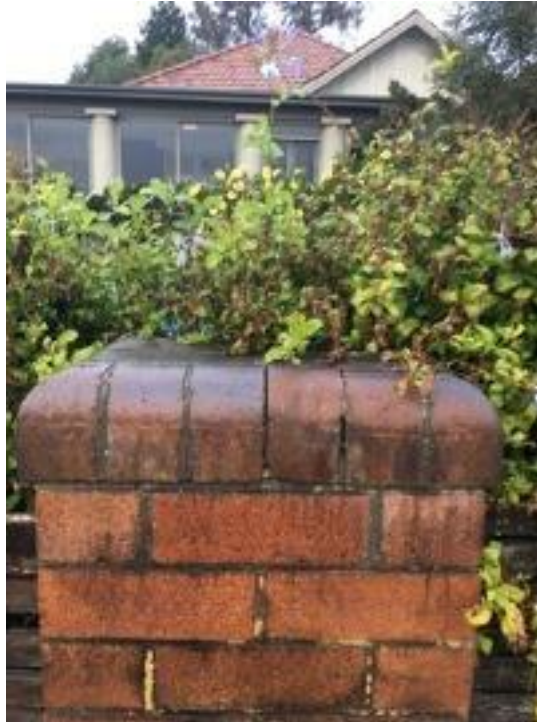
Existing cracks within the brick mortar joints of the brick pillars

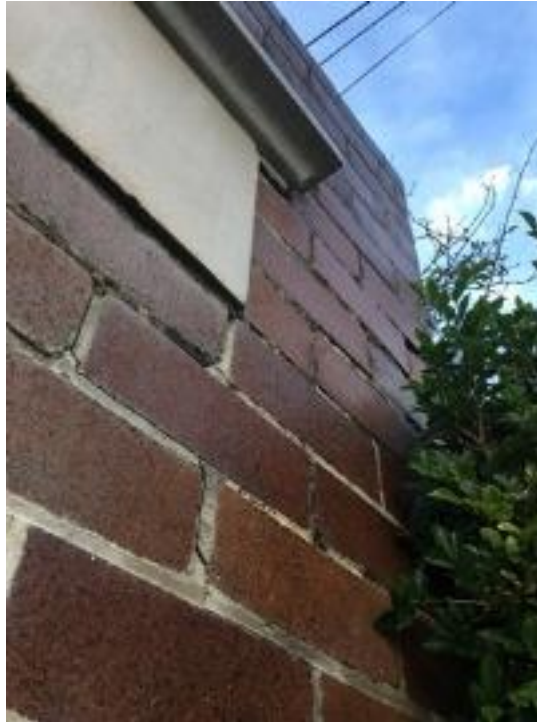
Existing cracks within the brick mortar joints within the street elevation of the garage structure

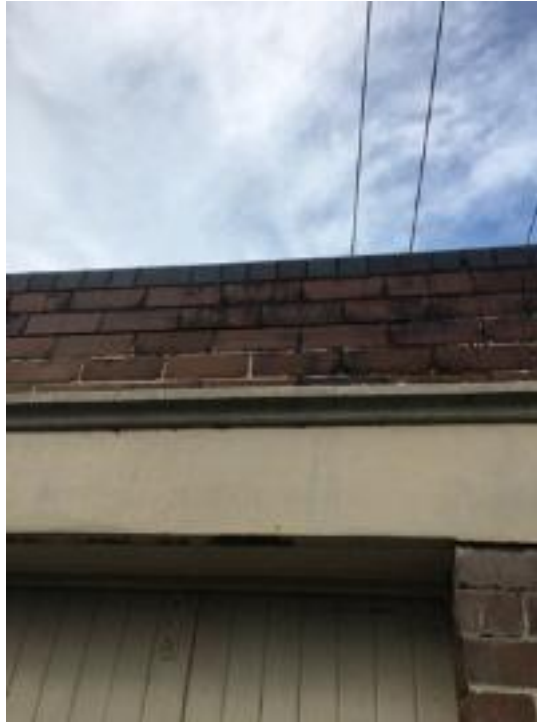
Above the garage lintel, there are existing cracks within the brick mortar joints within the street elevation of the garage structure

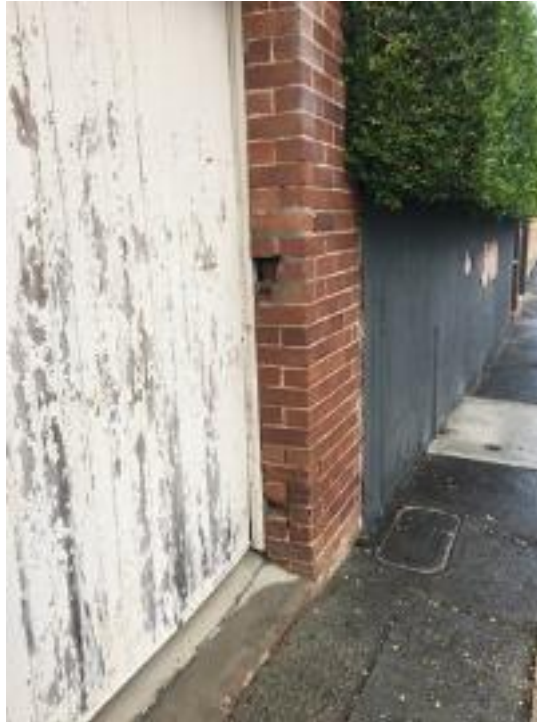
Missing bricks and damaged brick pillar

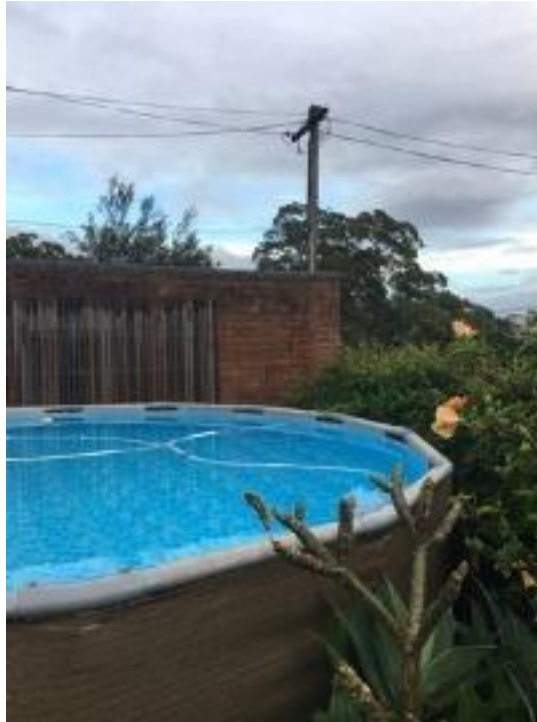
The entire length of the garage walls are structurally unstable, the brick walls are leaning over, there are cracks within the brick mortar joints and through the body of the brickwork

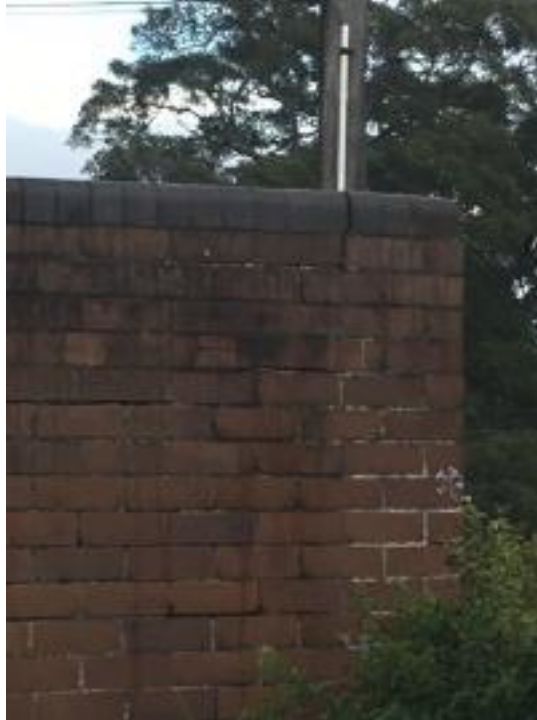
The garage wall is structurally unstable / loose and out of alignment, the brick walls are leaning over and there are cracks within the brick mortar joints and through the body of the brickwork

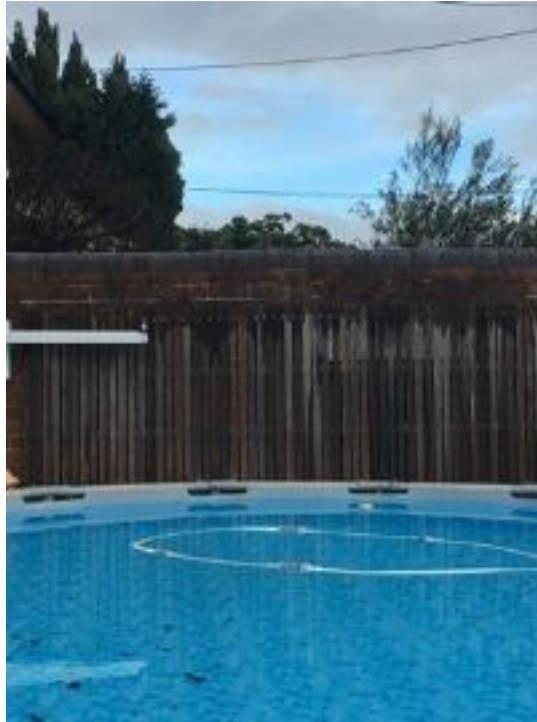
The garage walls are structurally unstable, the brick walls are leaning over and there are cracks within the brick mortar joints and through the body of the brickwork

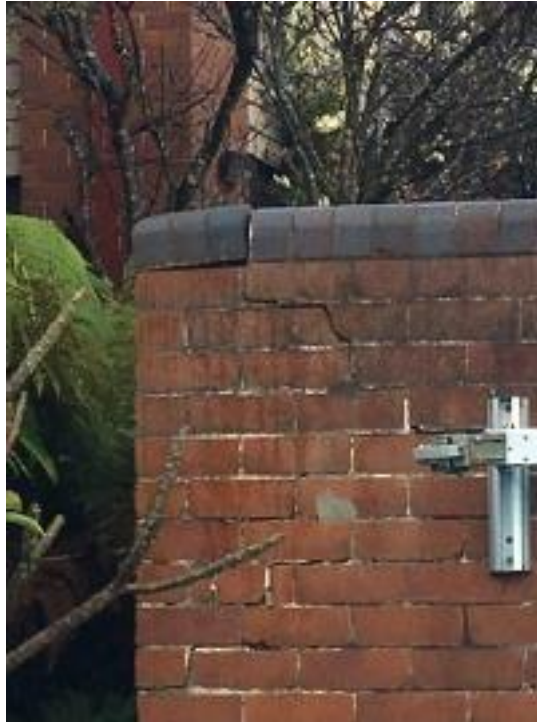
The rear section of the garage wall is structurally unstable

Randomly seen through the garage structure, are cracks within the brick mortar joints and through the body of the brickwork

The brick walls need to be re-supported / strutted / re-built

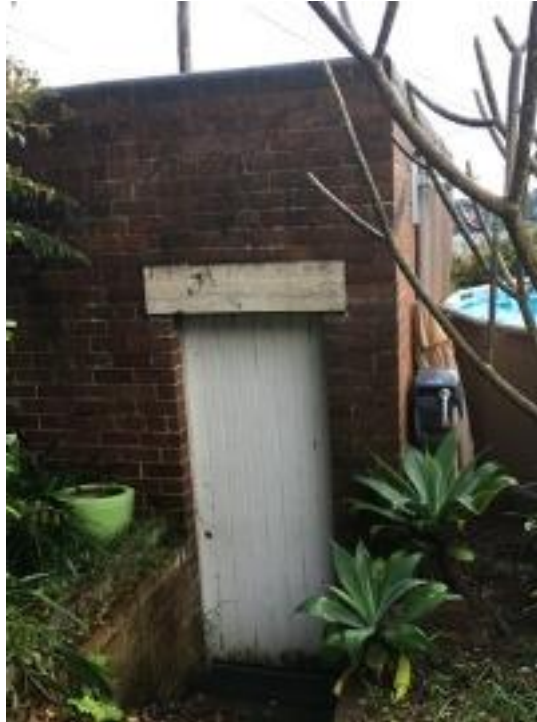
The garage needs to be demolished and re-built, as it is leaning over, and there are cracks in every elevation of the garage

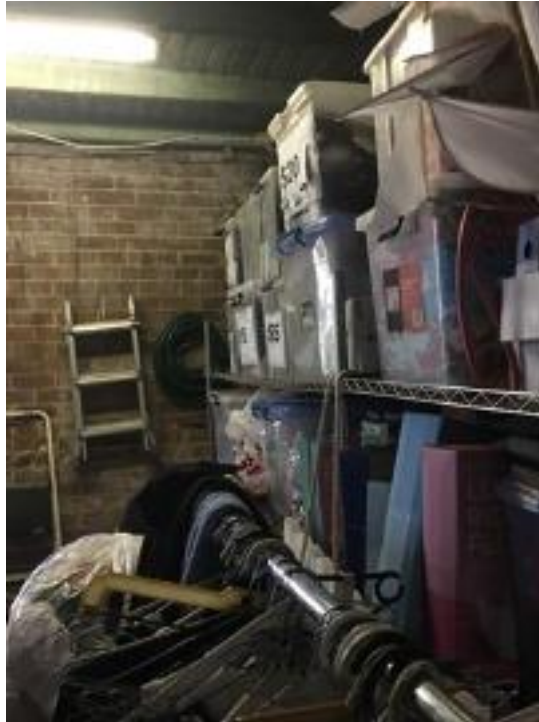
Water ingress within the garage floors, walls and roof structure

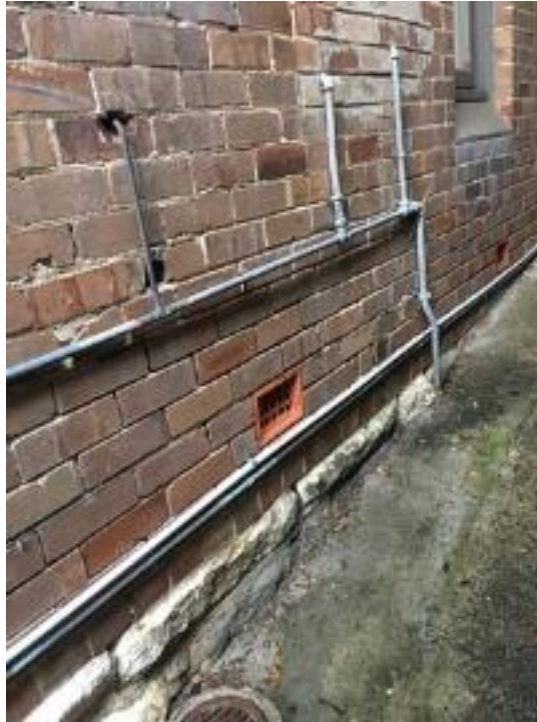
Missing mortar within the face brickwork, right elevation of the house

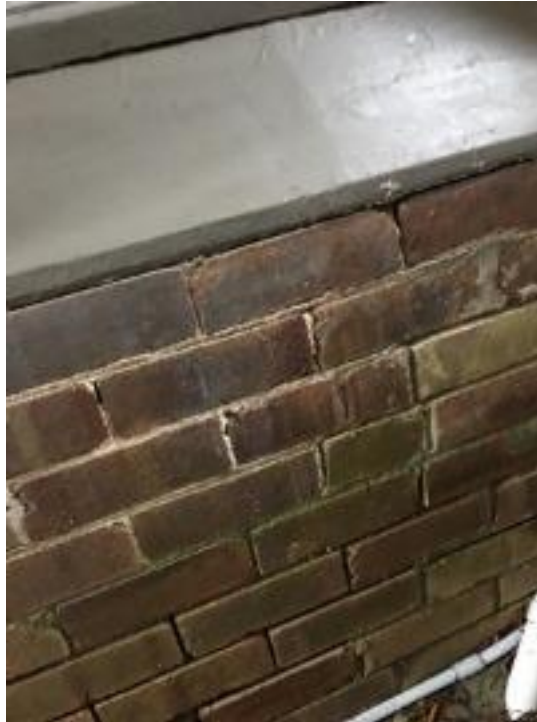
Cracks in the window sills/render, and missing mortar within the face brickwork

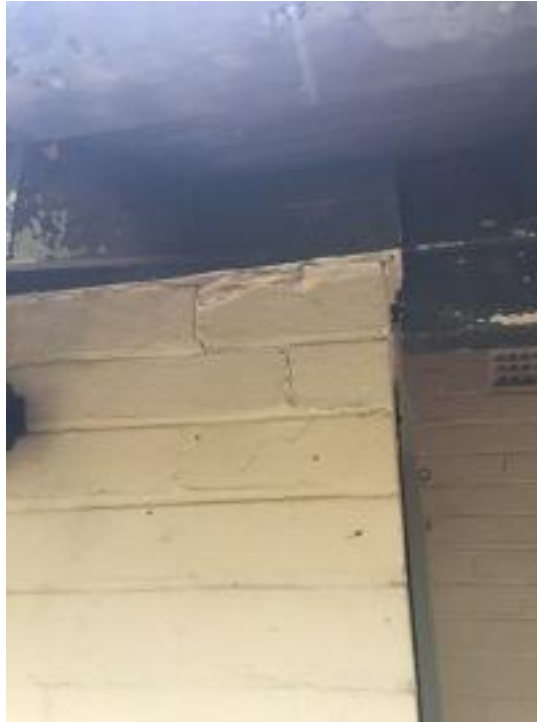
Minor cracks in the brick mortar joints / face brickwork, rear elevation of the house

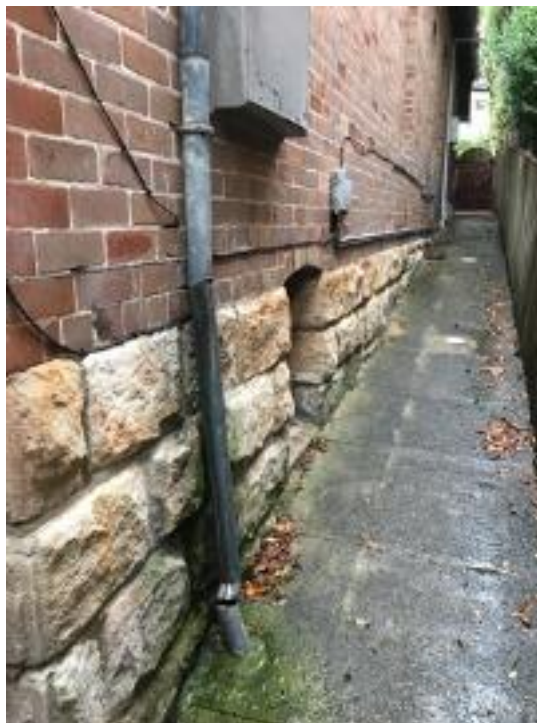
Damaged downpipes

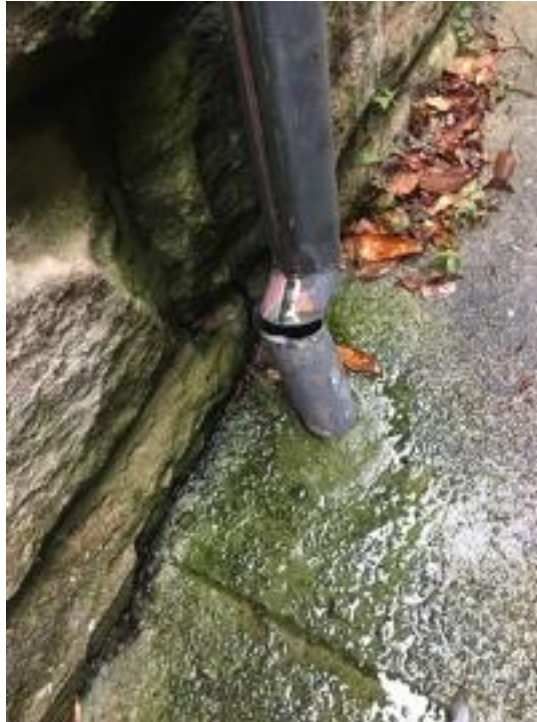
Damaged downpipes

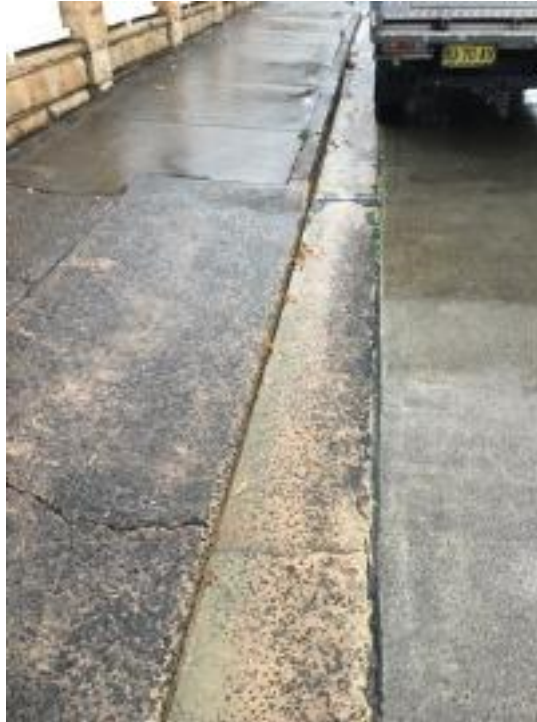
Cracks in the concrete curb, gutter and footpath

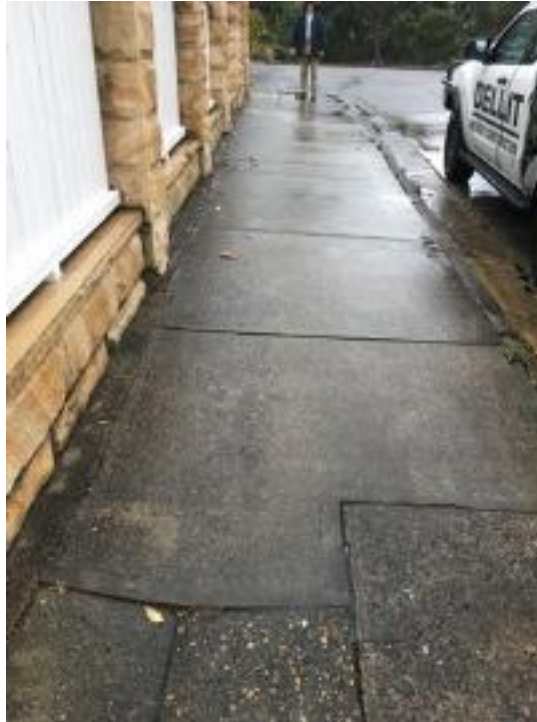
Sunken / subsided concrete footpath

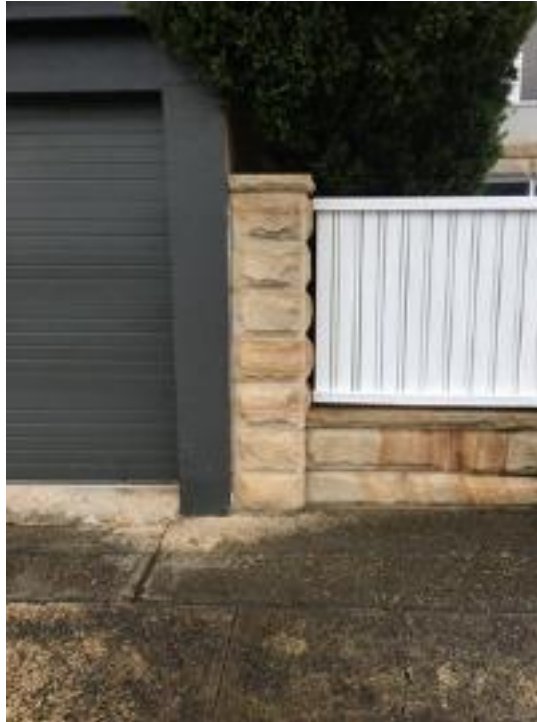
Settlement cracks in between the neighbour's boundary wall / rendered wall, and the existing sandstone pillar

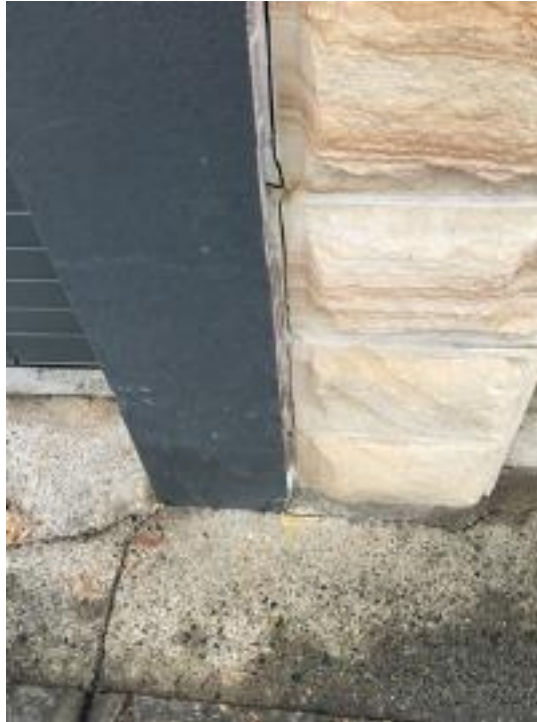
Settlement cracks in between the neighbour's boundary wall / rendered wall, and the existing sandstone pillar

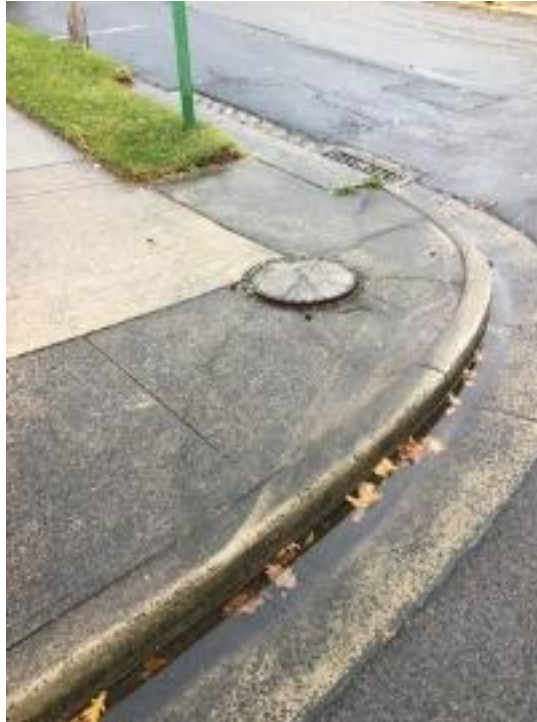
Existing footpath condition in the junction of Fairfax Road and Tivoli Street Mosman (Minor cracks)

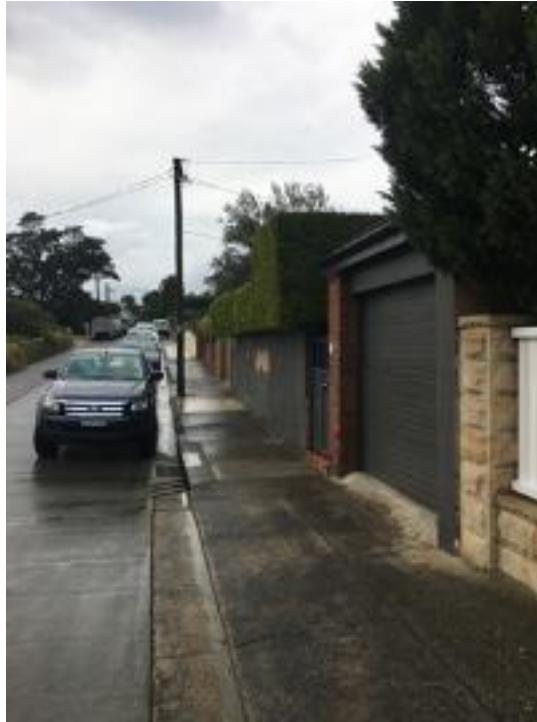
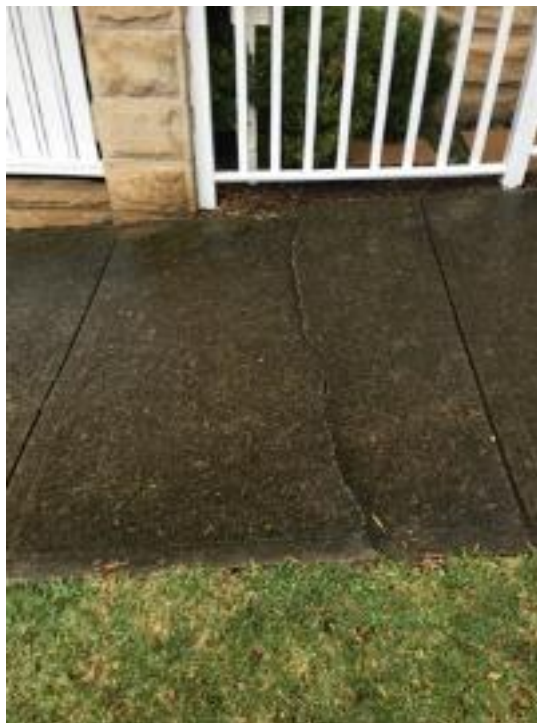
Cracked concrete footpath, out the front door of the property

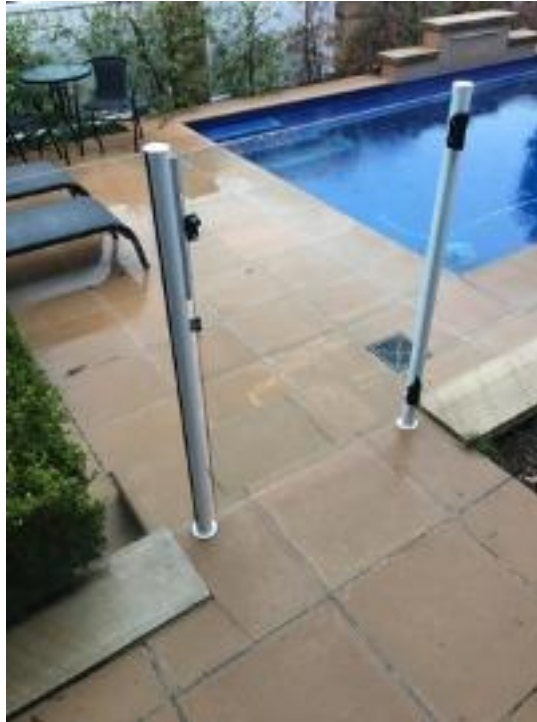
Cracks through the body of the floor tiles (pool concourse floor tiles)

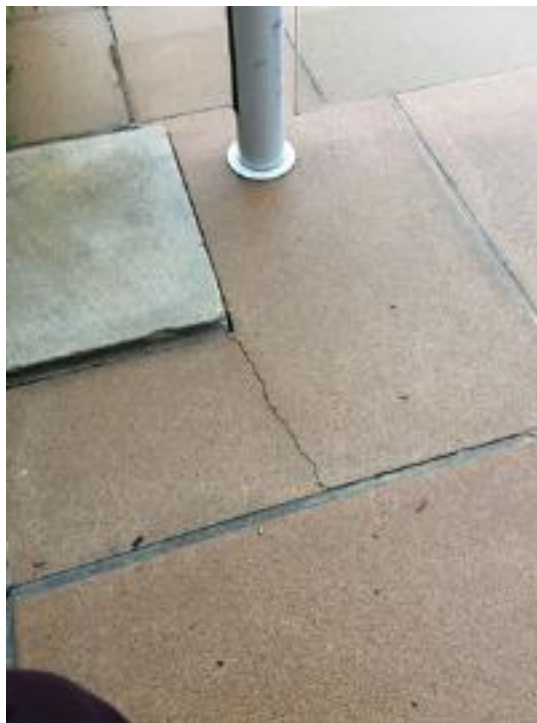
Minor cracks in the pool coping and pool concourse tiles

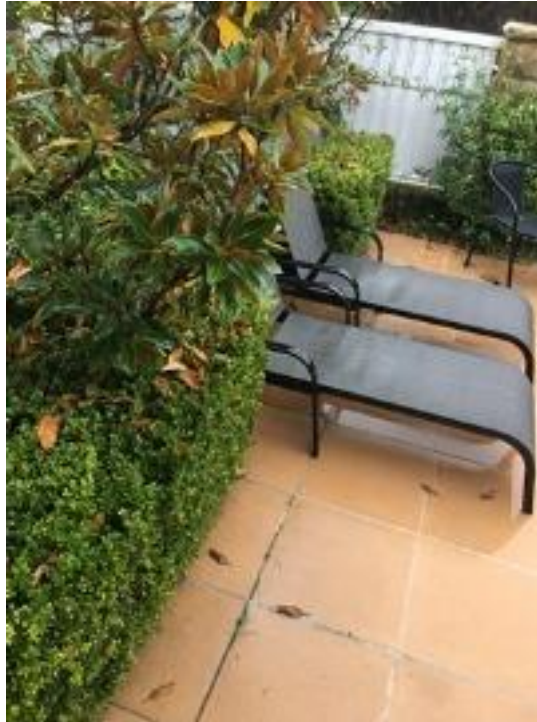
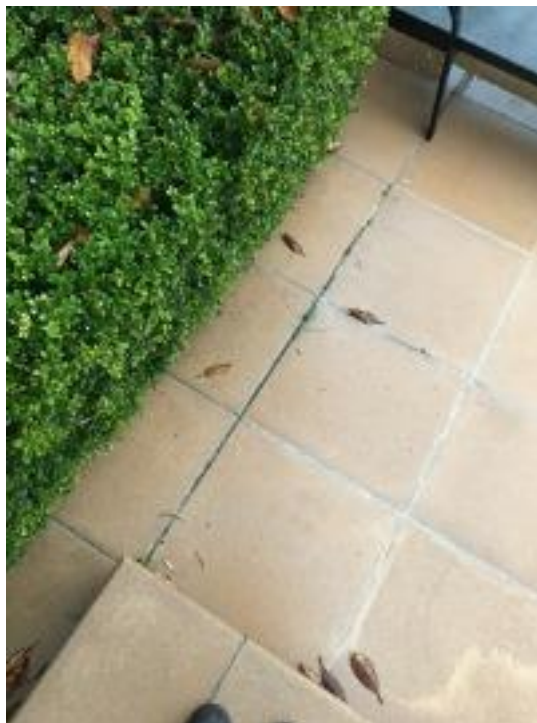
Cracks in the floor tiles and floor tile mortar joints

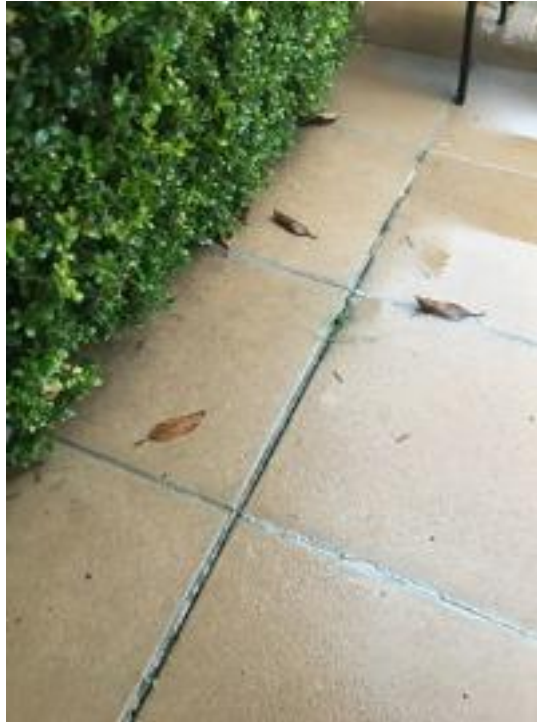
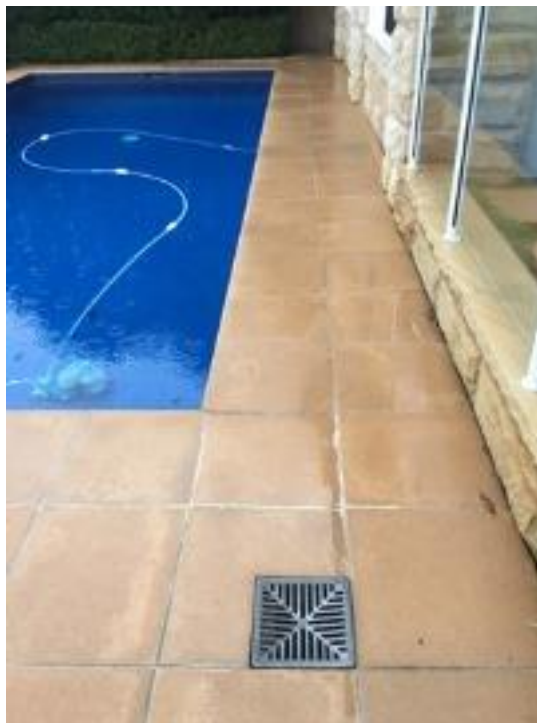
Efflorescence leaching out of the floor tiles and mortar joints within the pool concourse

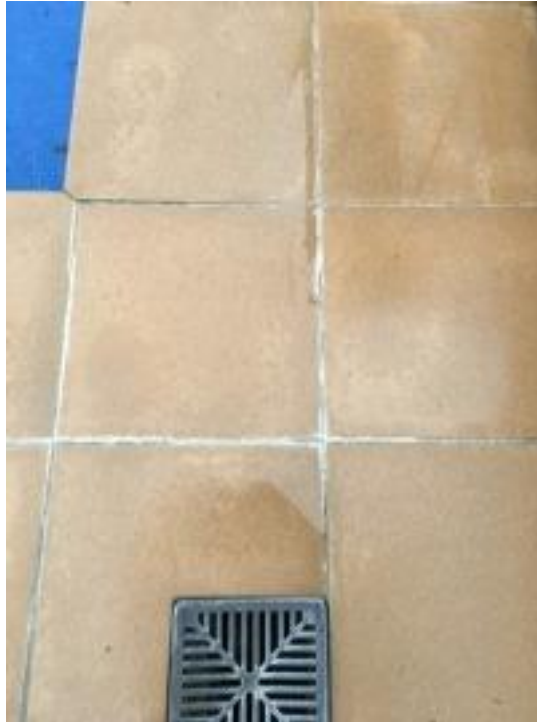
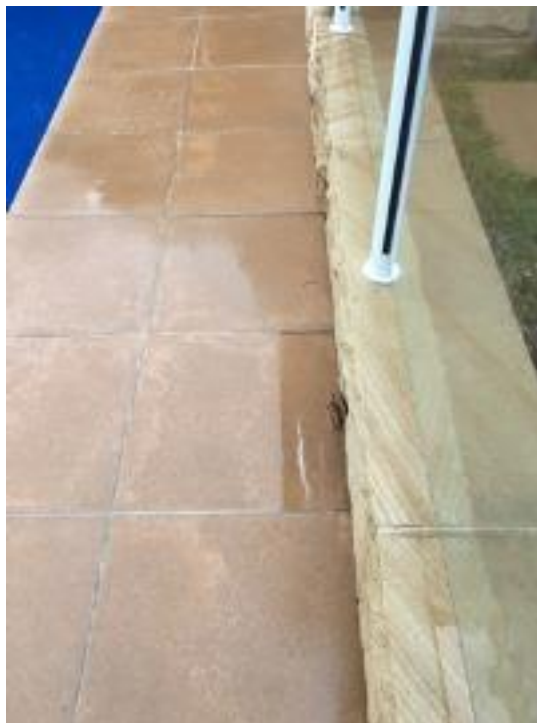
Efflorescence leaching out of the floor tiles and mortar joints as well as through the body of the floor tiles, within the pool concourse

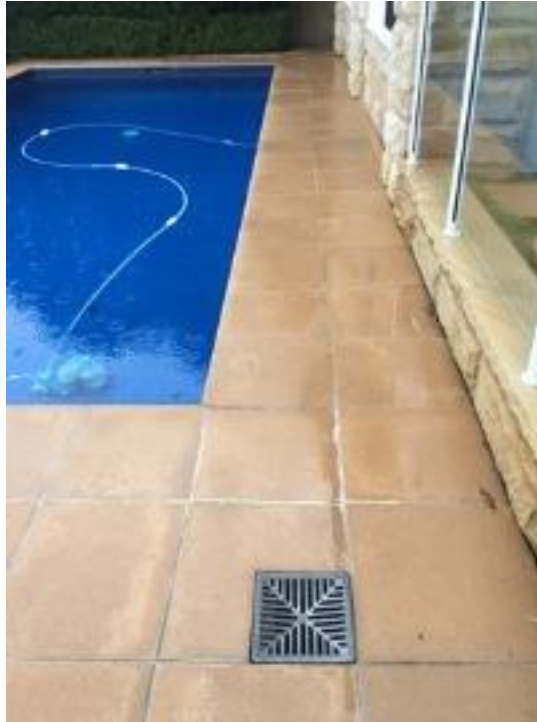
Efflorescence leaching out of the floor tiles and mortar joints within the pool concourse

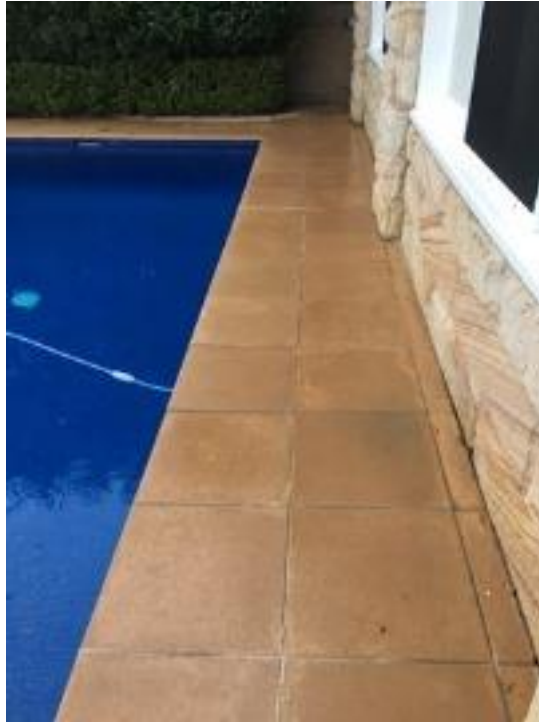
Efflorescence leaching out of the floor tiles and mortar joints within the pool concourse

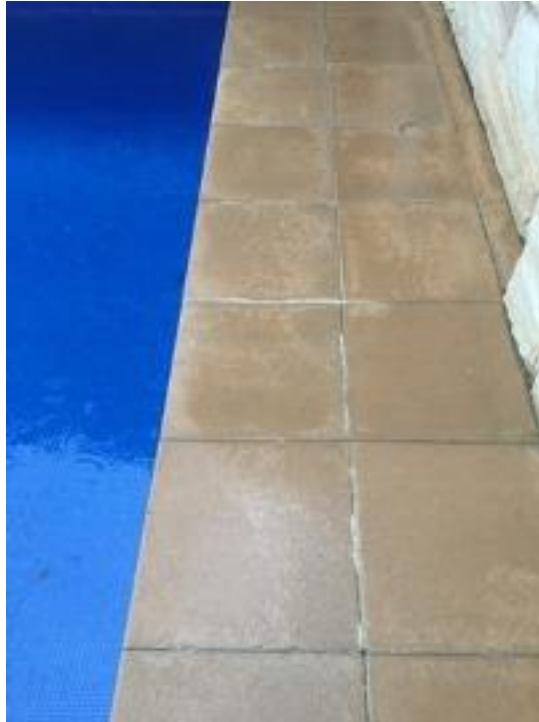
Efflorescence leaching out of the floor tiles and mortar joints within the pool concourse

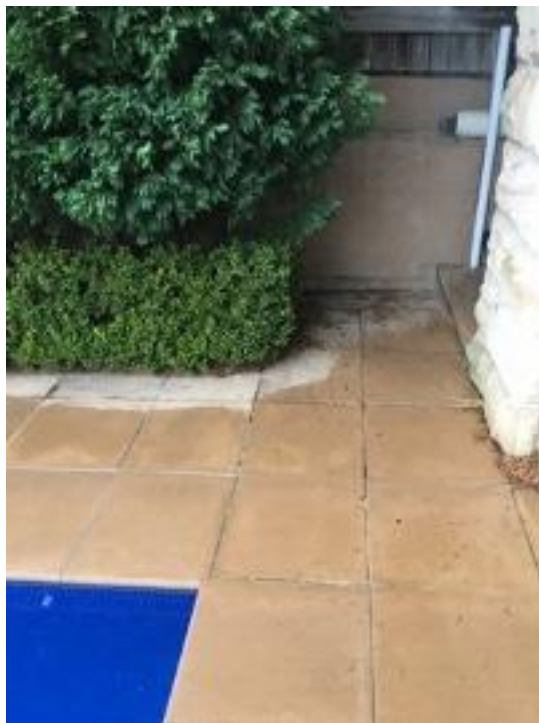
Efflorescence leaching out of the floor tiles and mortar joints within the pool concourse

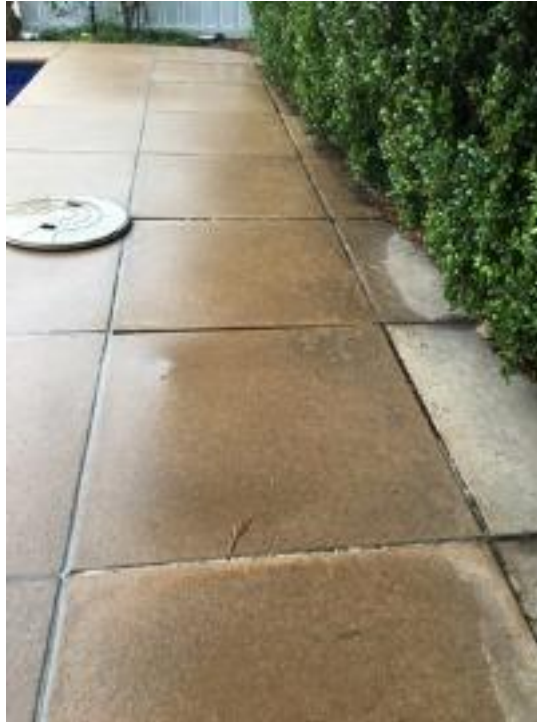
Loose and missing mortar joints / grout, within the pool concourse and pool coping tiles

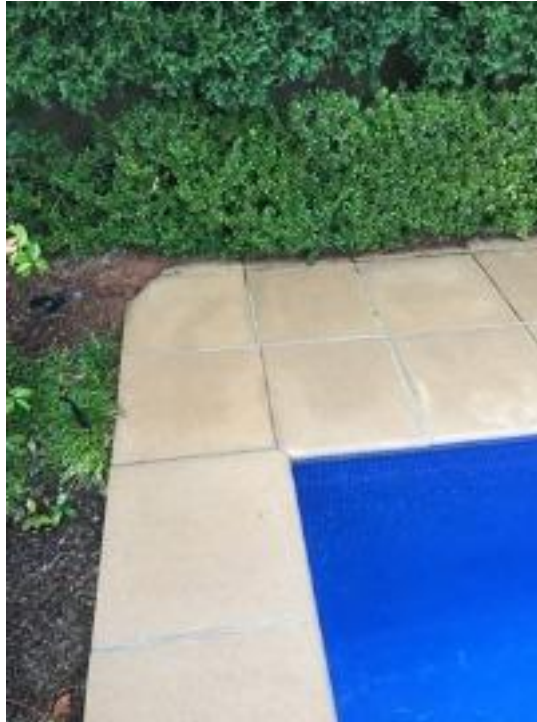
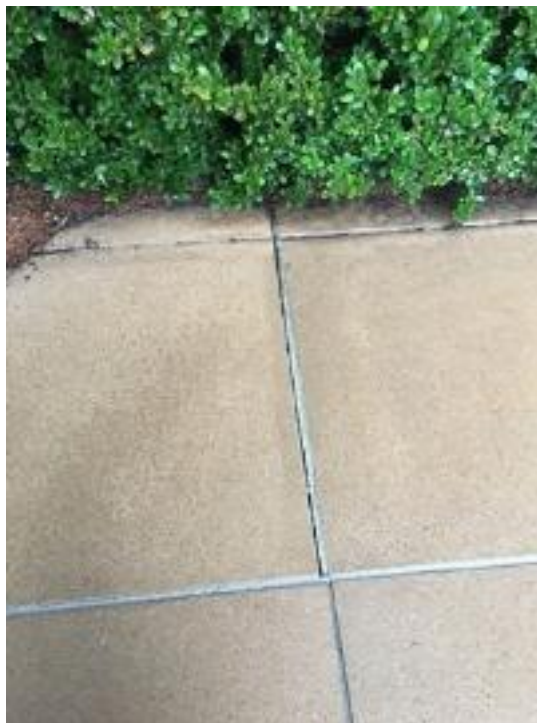
Cracked grout within the pool concourse tiles

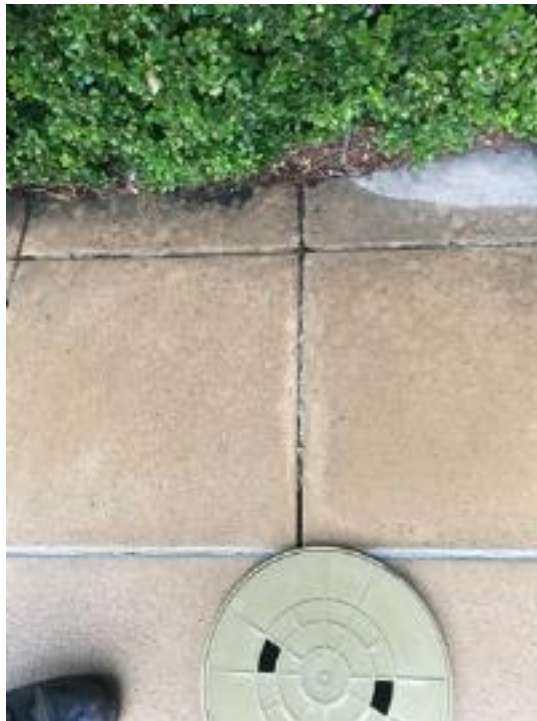
Missing mortar within the floor tiles around the pool skimmer basket

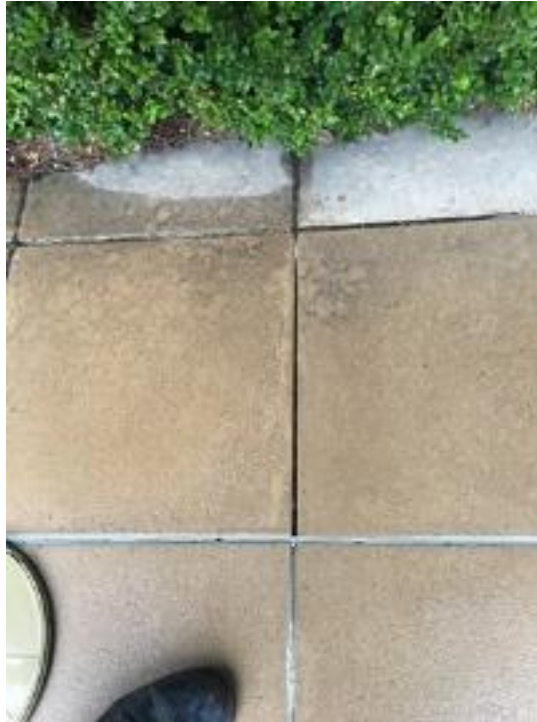
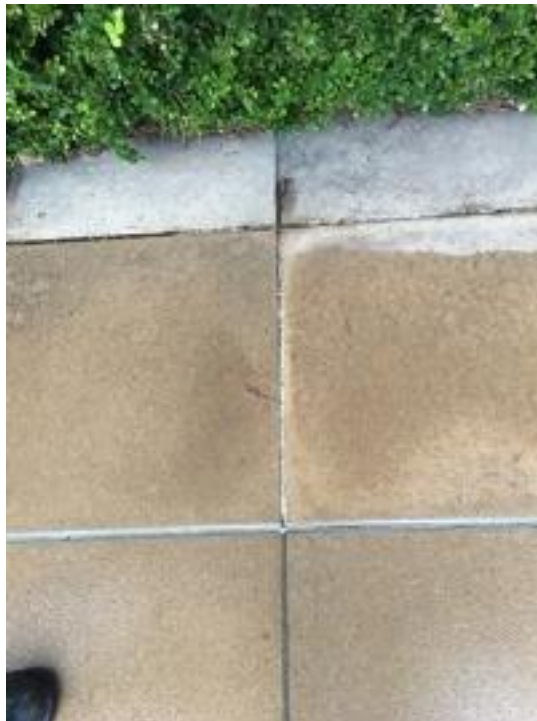
Loose / drummy floor tiles around the pool concourse

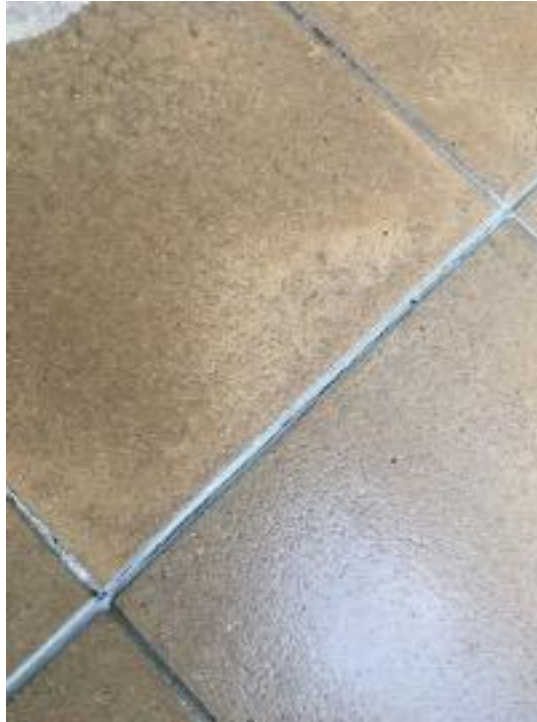
Drummy floor tiles and cracked grout / mortar joints within the pool concourse plus the pool coping tiles and landing, just before the side pathway that is a step up from the pool area

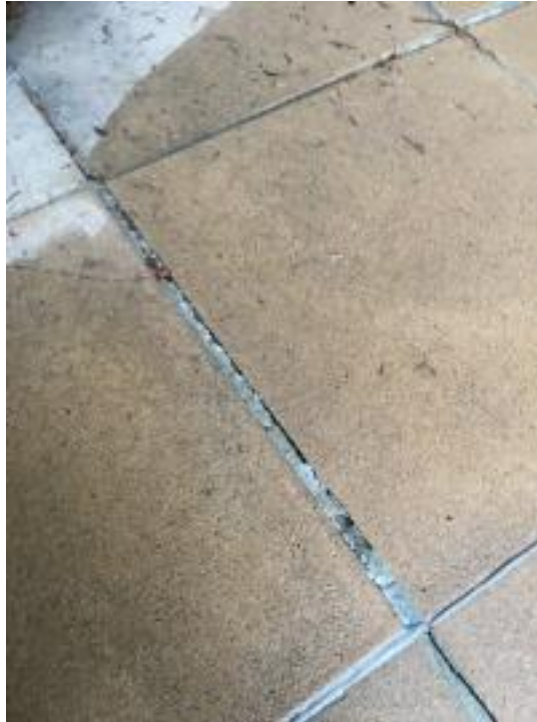
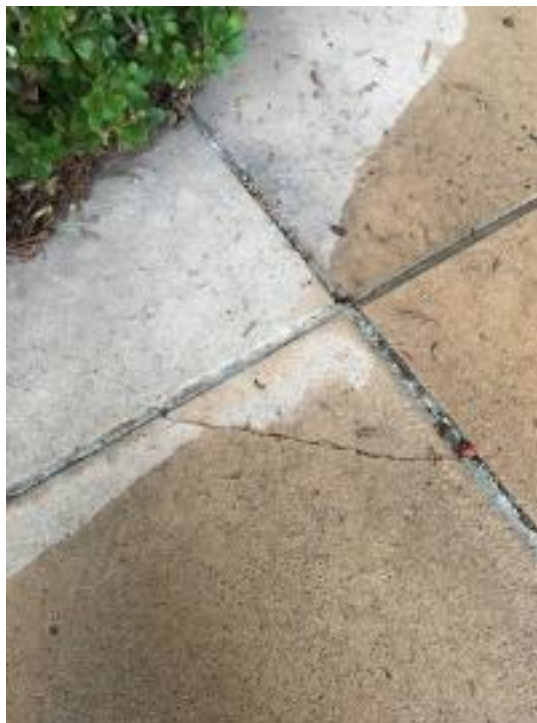
Drummy floor tiles and cracked grout / mortar joints within the pool concourse plus the pool coping tiles and landing, just before the side pathway that is a step up from the pool area

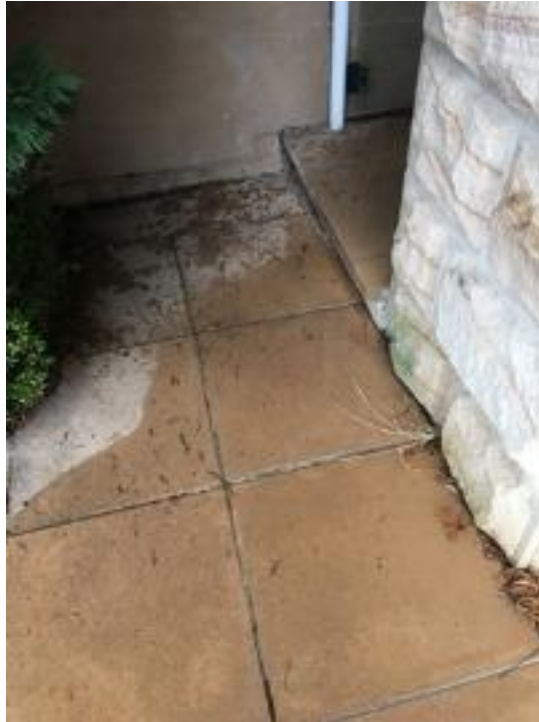
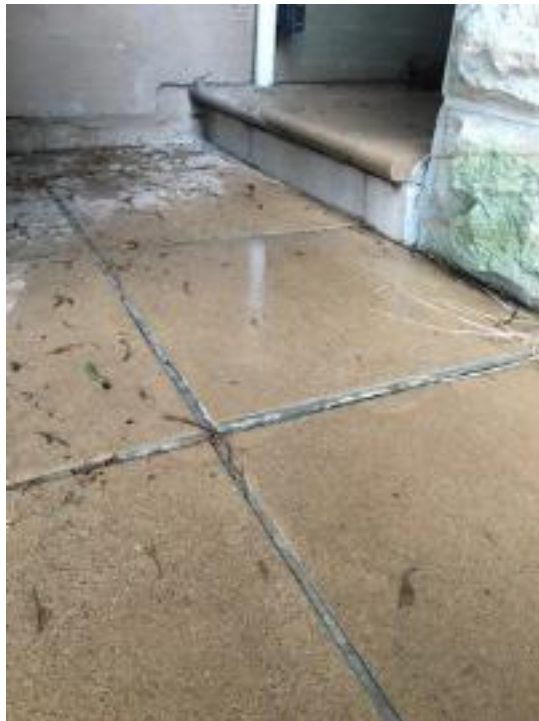
Lifted / drummy floor tiles

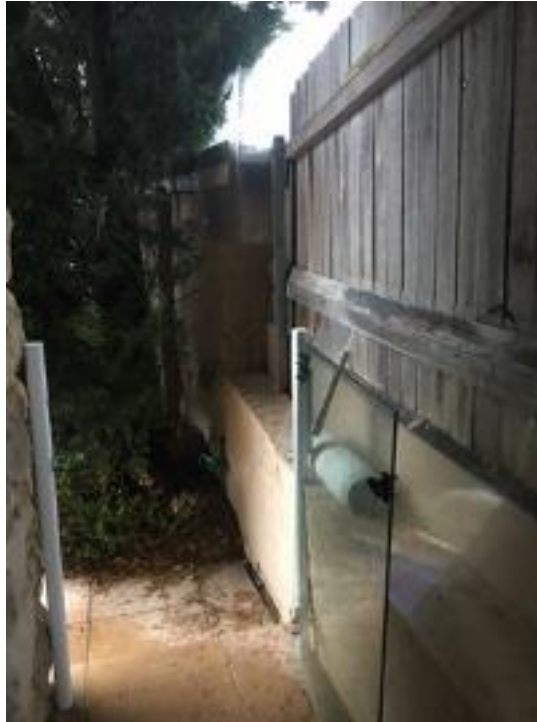
Retaining wall / side boundary wall that is shared between the two properties, is cracked and defective within the brick mortar joints

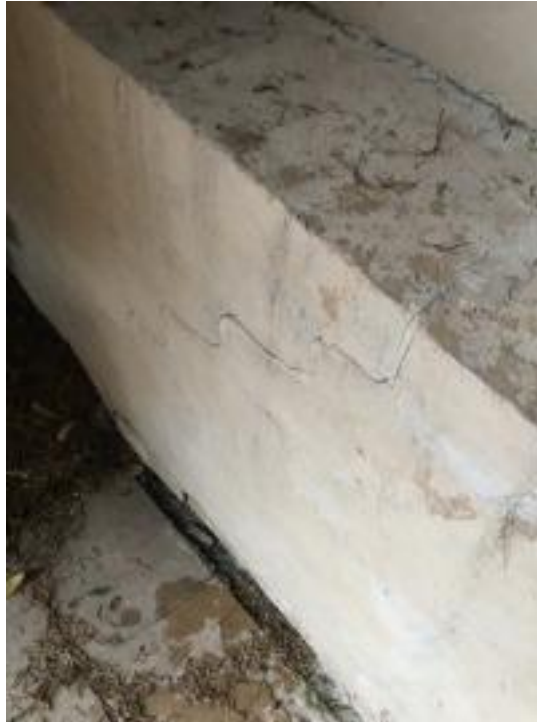
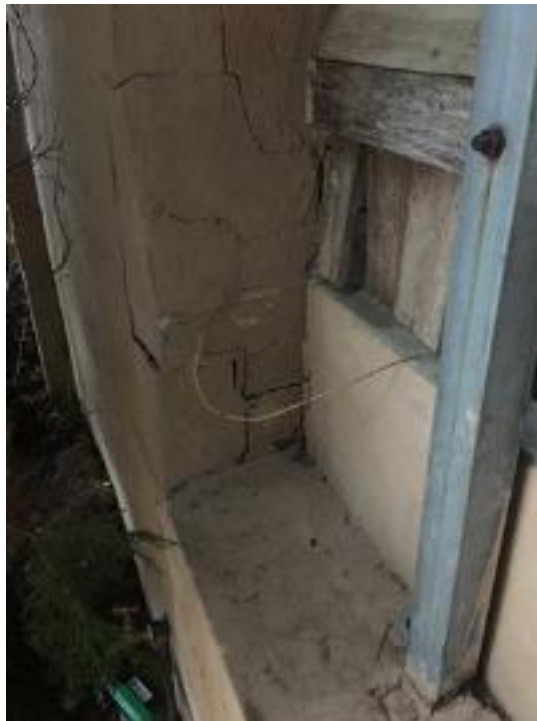
Retaining wall / side boundary wall that is shared between the two properties, is cracked and defective within the brick mortar joints
