# **Dilapidation Report For The Development At: 14 Fairfax Road Mosman NSW 2088**

Dilapidation Report Carried Out On:

12 Fairfax Road Mosman NSW 2088

17<sup>th</sup> June 2019

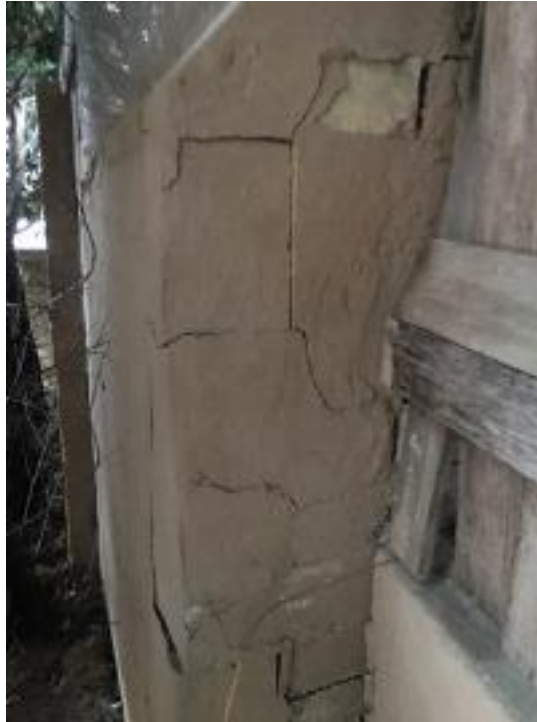
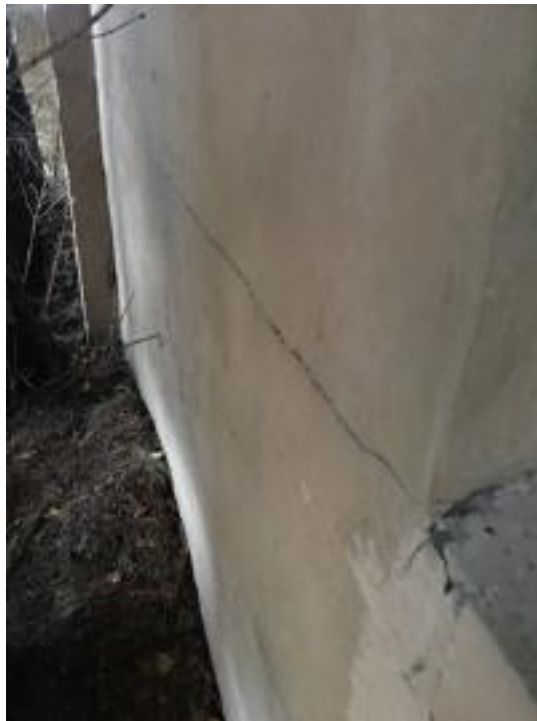
Retaining wall / side boundary wall that is shared between the two properties, is cracked and defective within the brick mortar joints

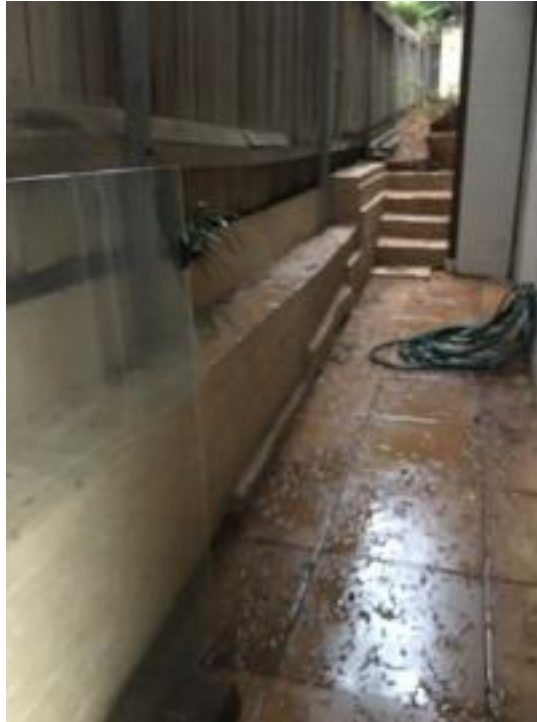
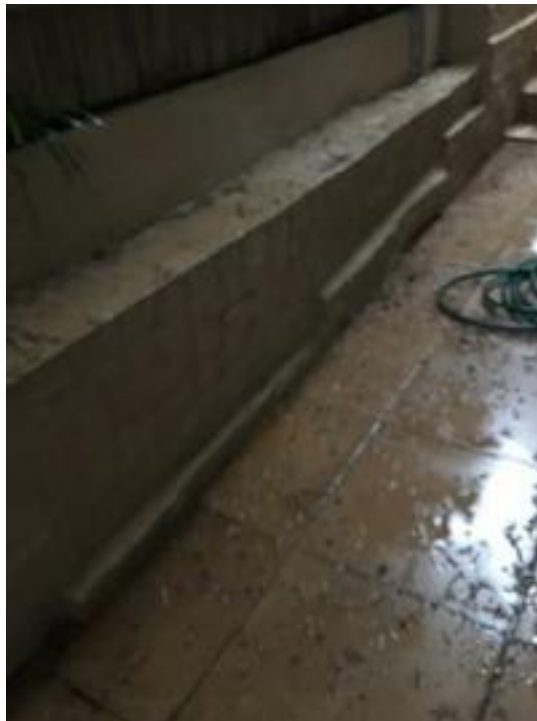
Retaining wall / side boundary wall that is shared between the two properties, is cracked and defective within the brick mortar joints

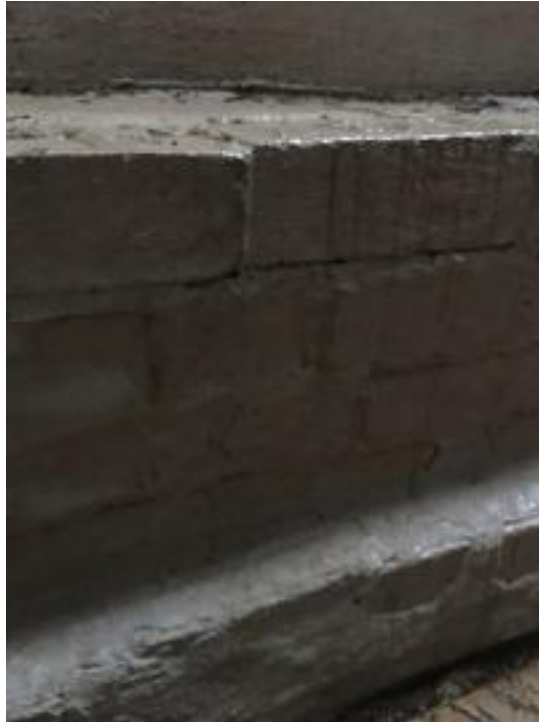
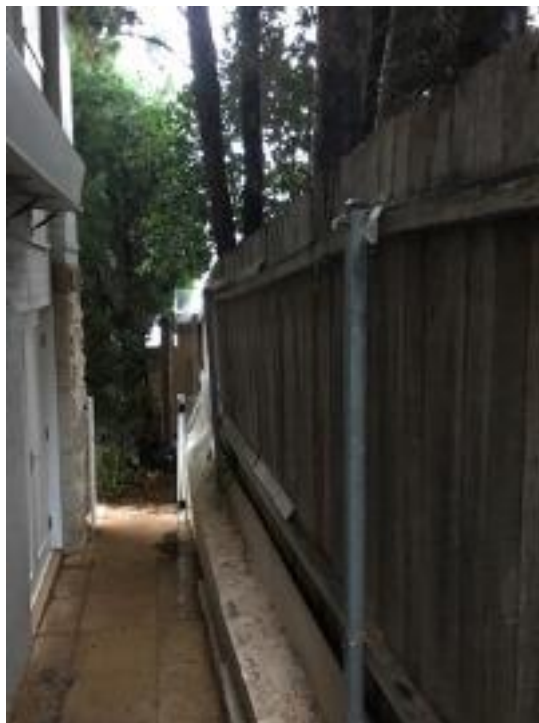
Bowed timber fence and masonry retaining wall

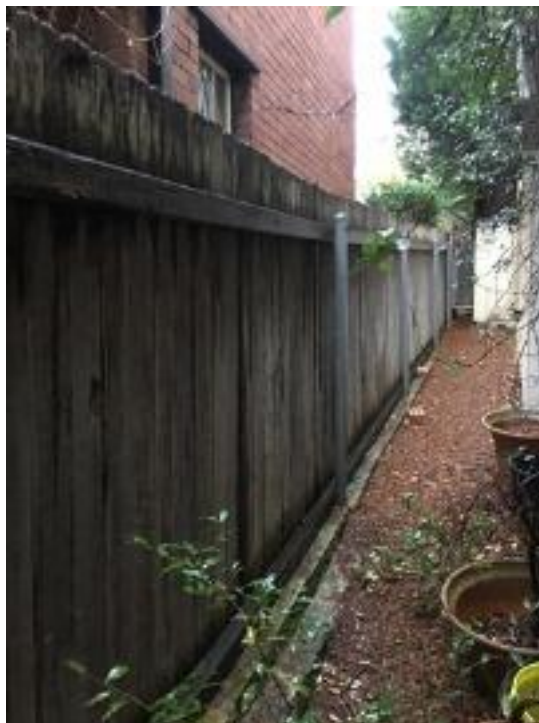
Bowed timber fence

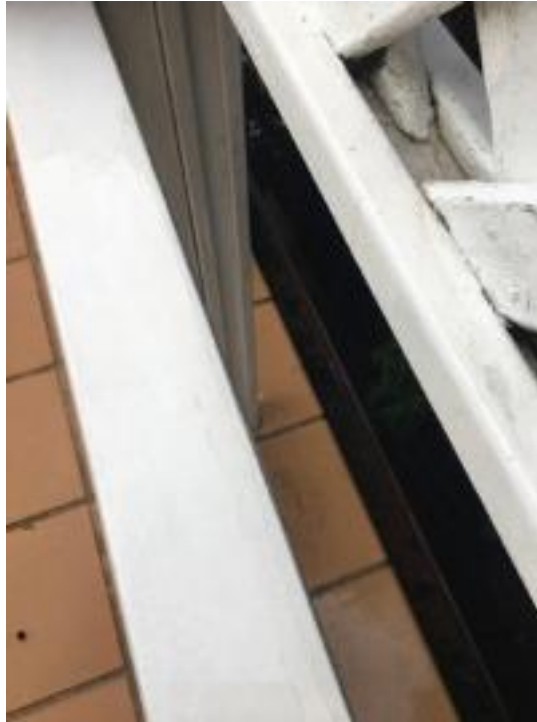
Veranda floor tiles are cracked

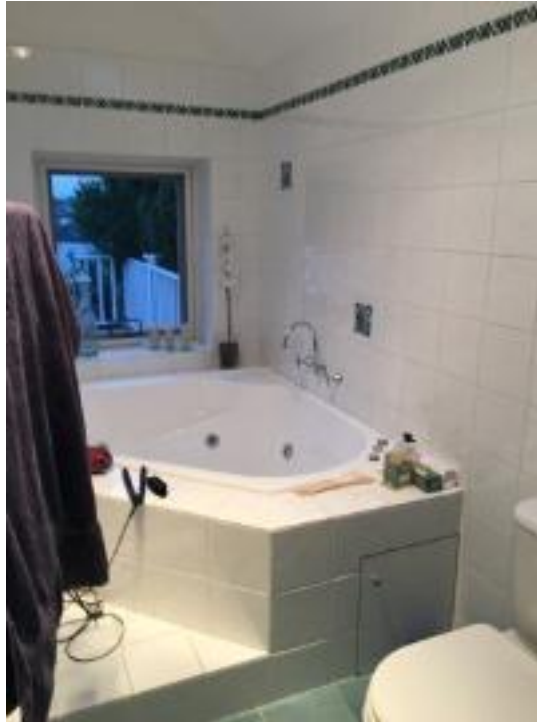
Bathroom wall tiles have minor cracks in the tile joints

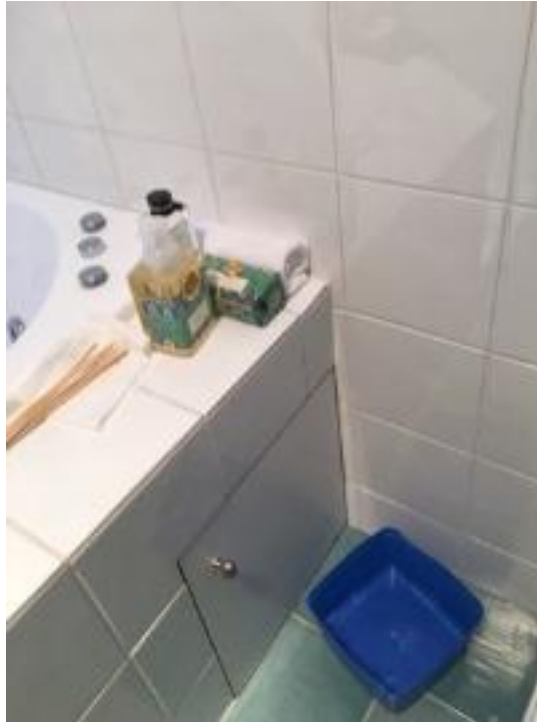
Bathroom wall tiles are chipped and cracked

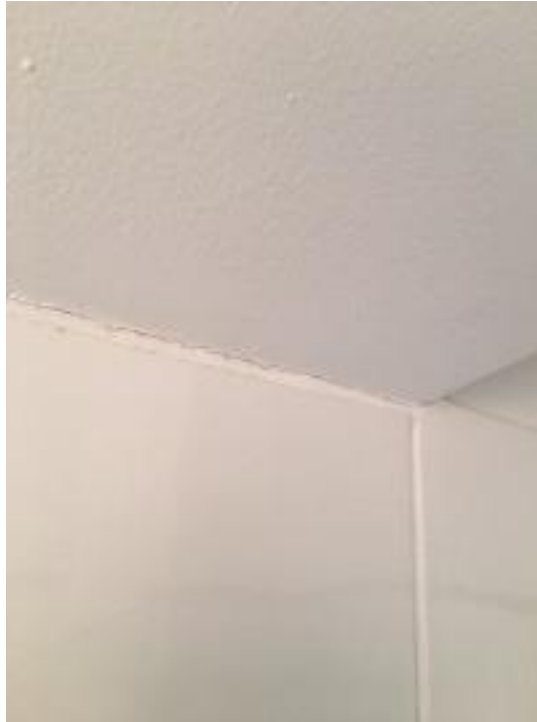
Wall and ceiling junctions within the bathroom have existing hairline cracks within the internal junction

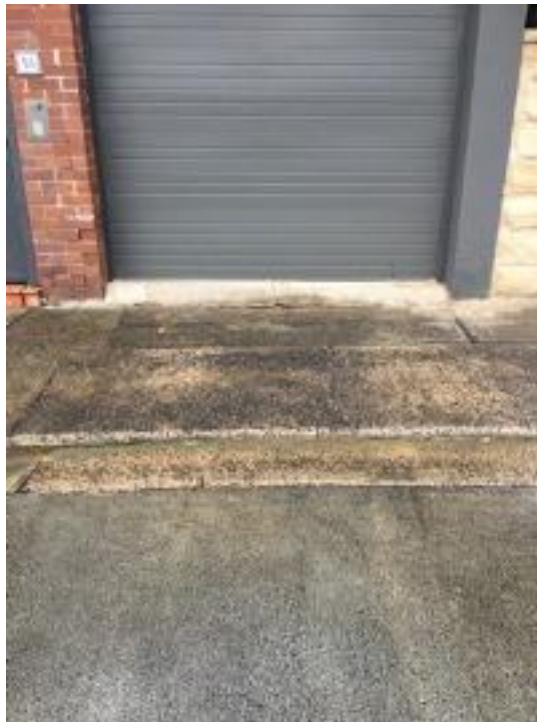
Existing crack in the concrete footpath, plus the curb and gutter in front of the garage of 14 Fairfax Road Mosman

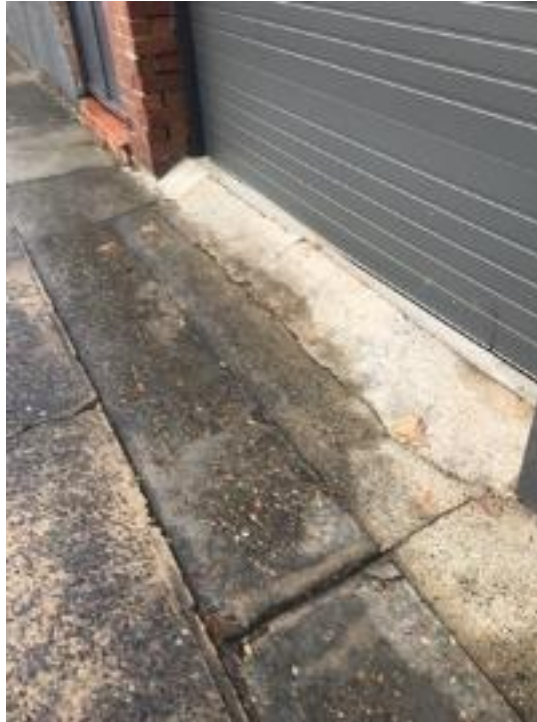
Footpath has excessive cracks within the old and new concrete footpaths

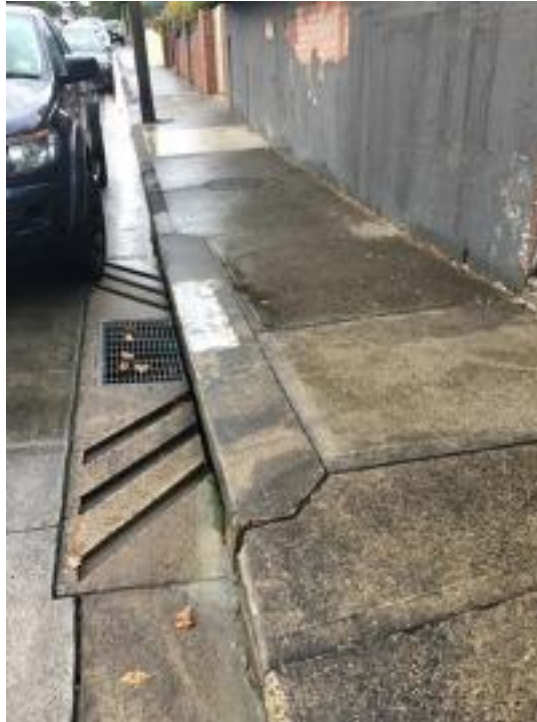
The curb and gutters are damaged with chips, and large sections of the concrete are missing from the curb and footpath junctions

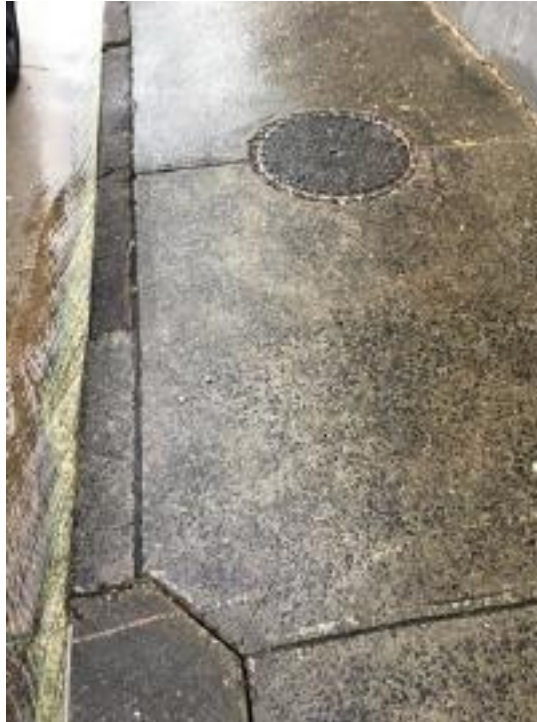
The curb and gutters are damaged with chips, and large sections of the concrete are missing from the curb and footpath junctions

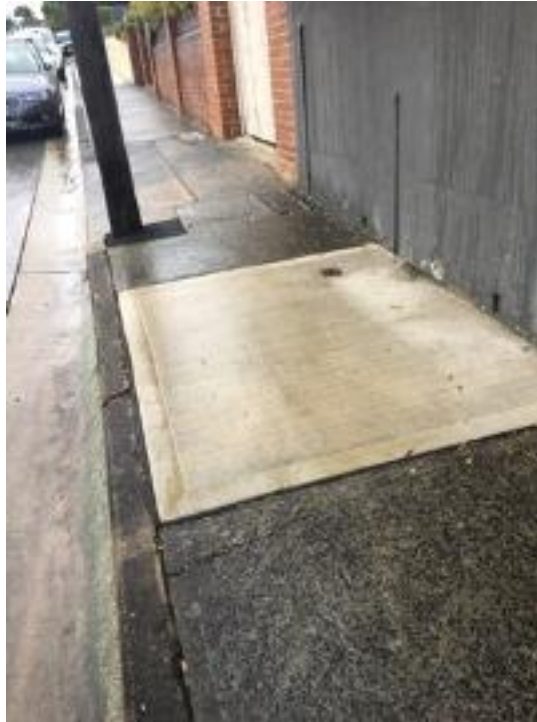
The curb and gutters are damaged with chips, and large sections of the concrete are missing from the curb and footpath junctions

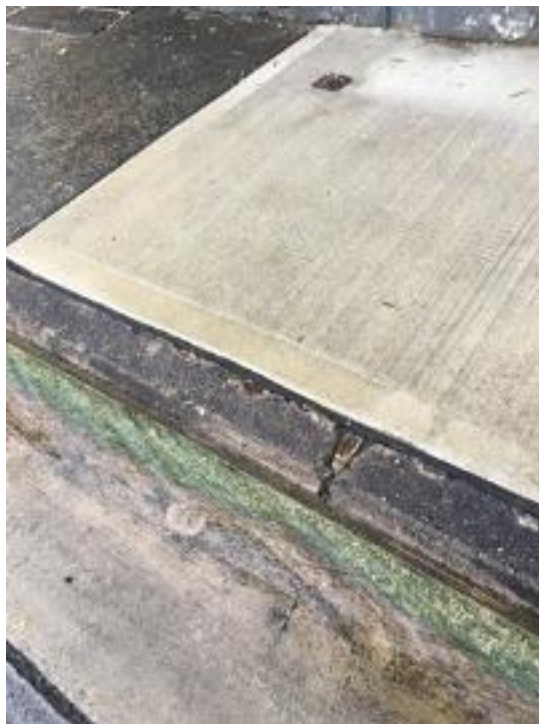
The curb and gutter are defective / cracked
