Pre-Lease Condition Report For The Property At:

229 Brisbane Water Drive Point Clare NSW 2250

4th May 2022

Prepared by:
The Property Inspectors
Emilio Calandra

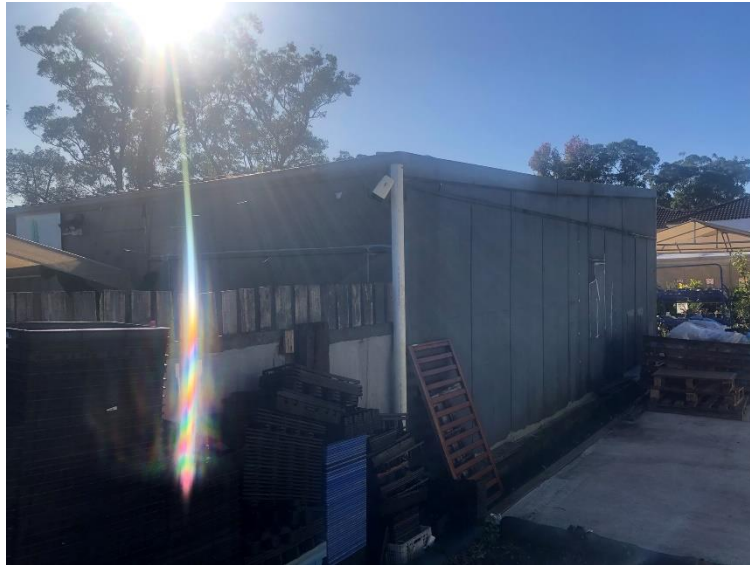
Damaged, cracked and defective fibro and possible asbestos external wall linings.
Damaged, cracked and defective gutters and downpipes.

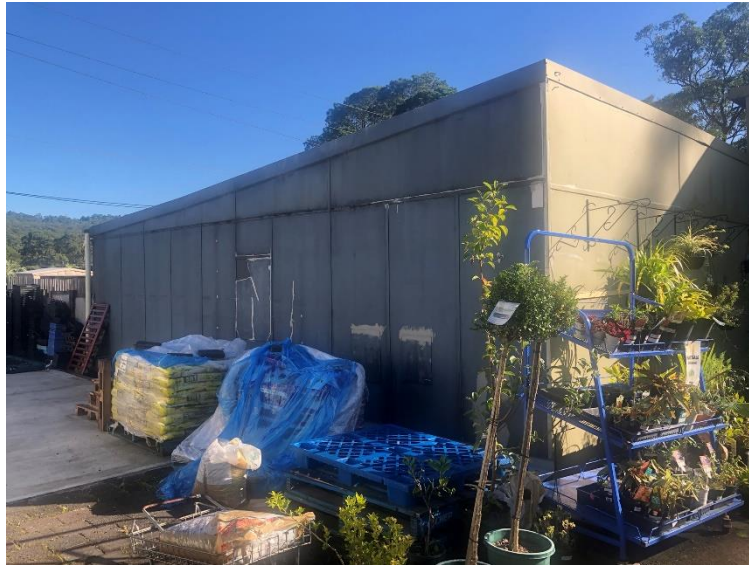
Cracked asbestos / fibro wall linings.

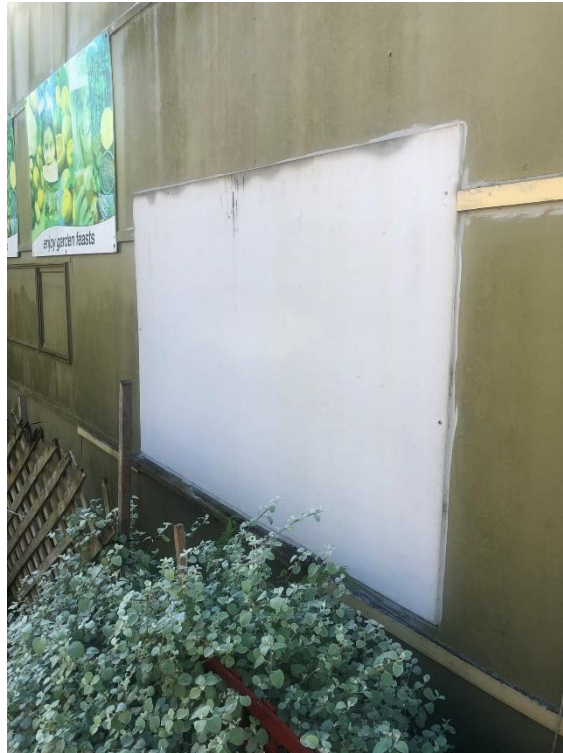
Cracked, damaged and partially repaired fibro / asbestos wall linings.

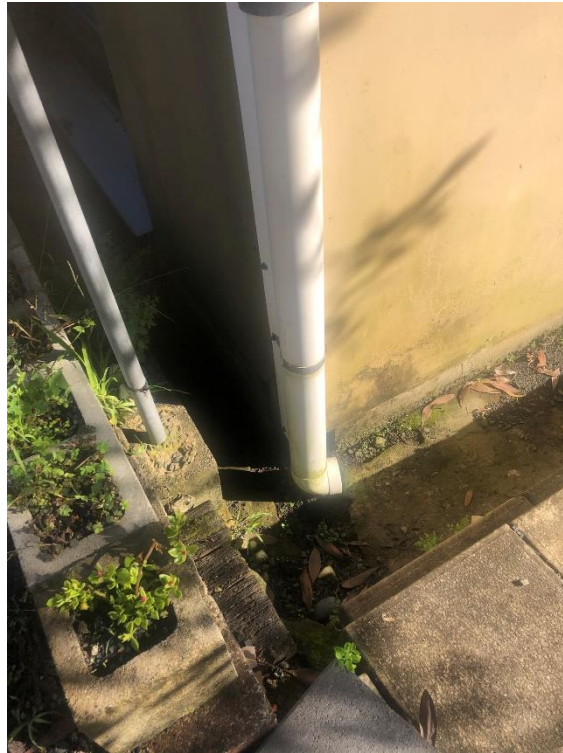
Stormwater system draining onto the floor, water damage and moisture seen within the external walls.

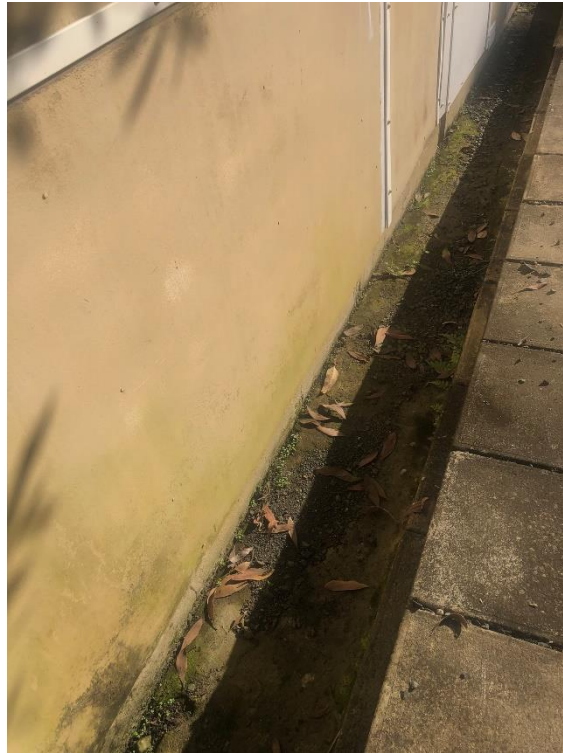
Cracked and damaged wall linings, mould and moisture within the external wall linings.

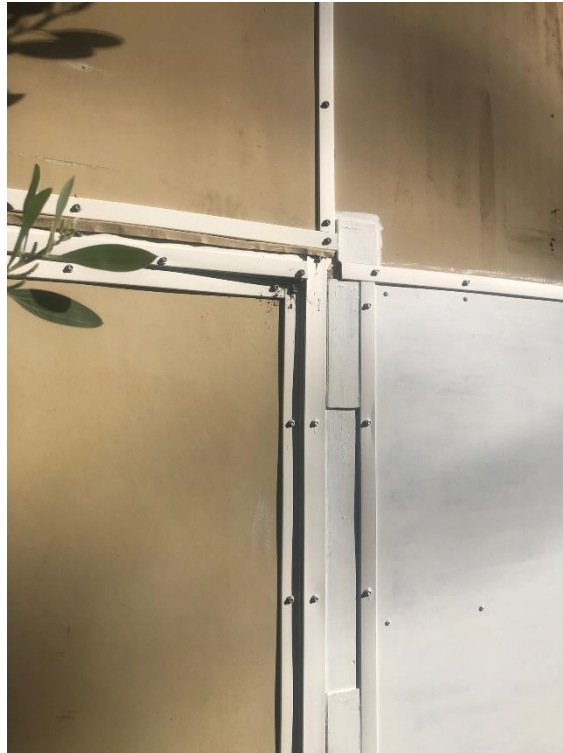
Damaged trimwork and cover panels to the external wall linings.

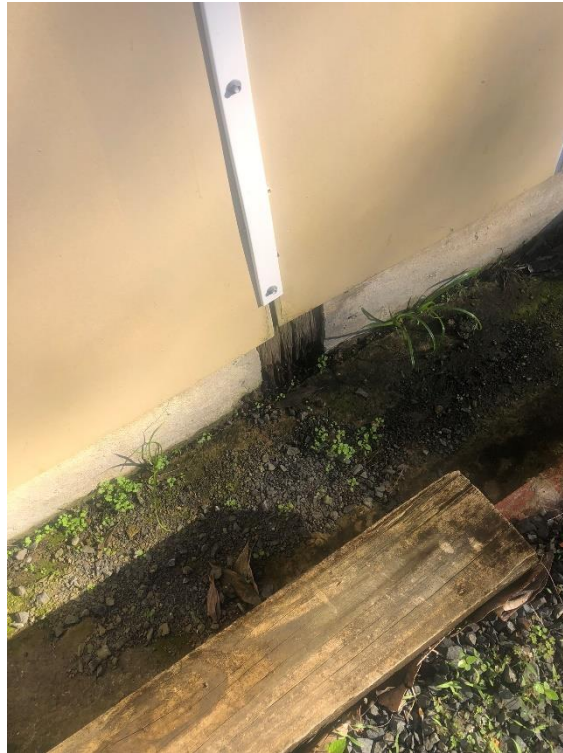
Cracked, damaged and missing fibro / asbestos wall linings and cover panels.

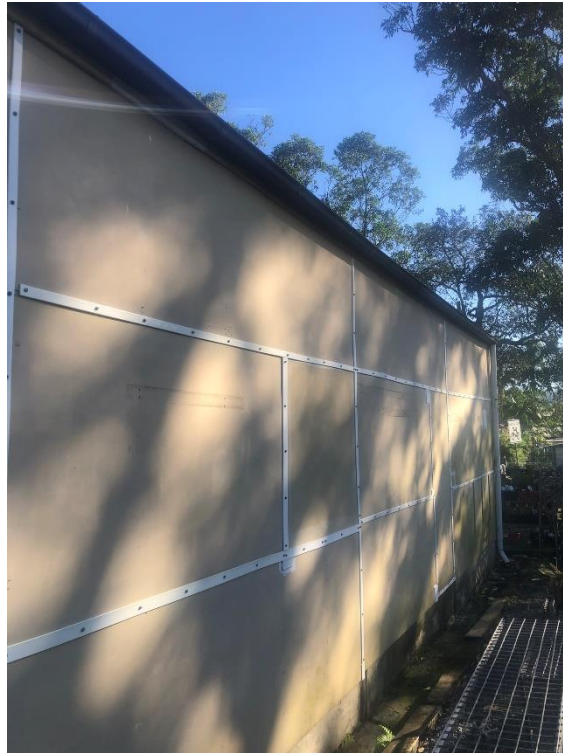
Mould and moisture within the external fibro / asbestos wall linings, together with major wood rot within the timber members that support the structure of the building.

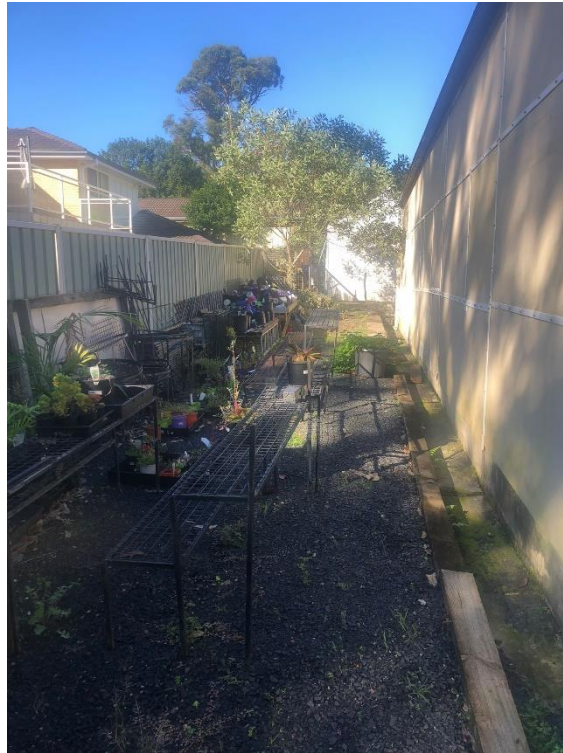
Dilapidated garden beds and pathways and excess mould and moisture seen within the surrounding pathways and wall linings / walls of the main building.

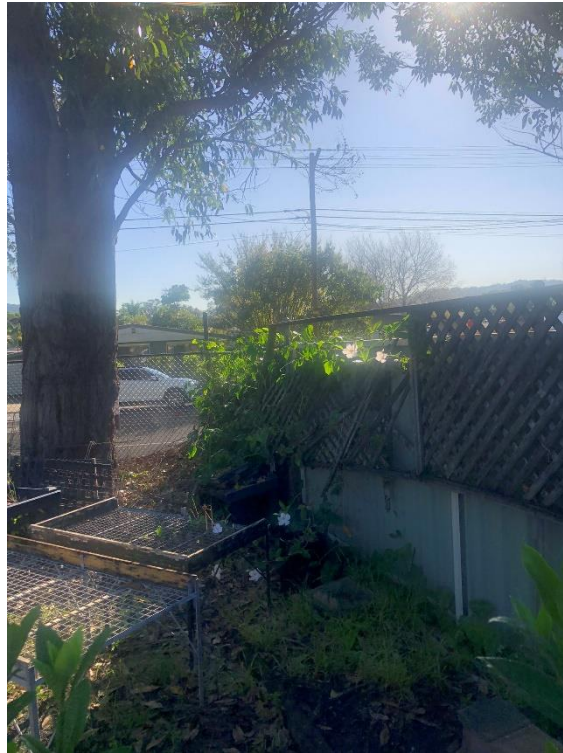
Collapsed lattice, together with damaged fibro wall and fence linings.
Subsided pavers and vegetation within the floor pavers.

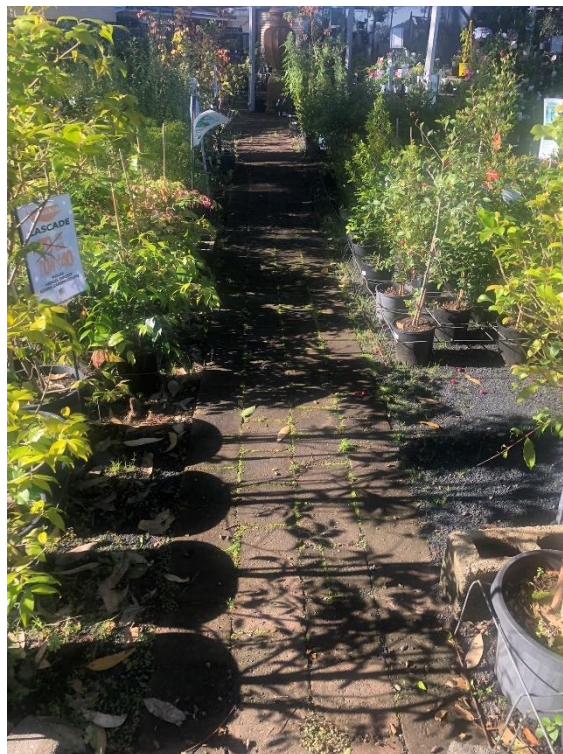
Subsided pavers and vegetation within the floor pavers.

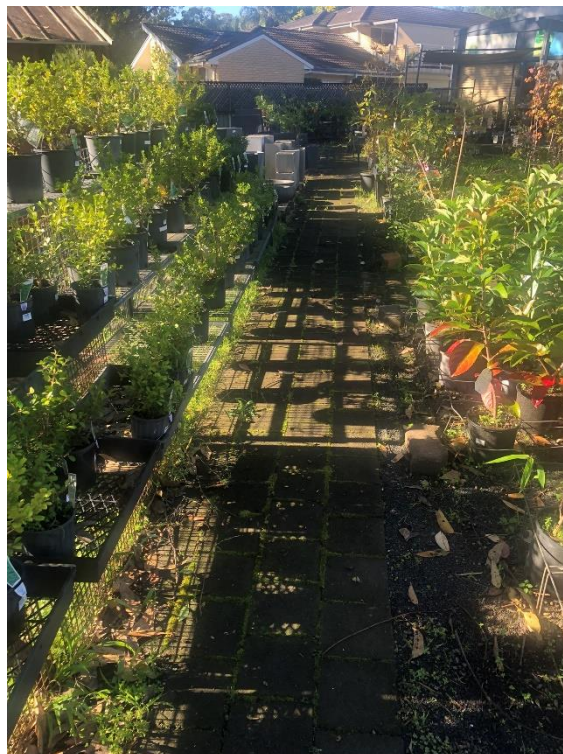
Subsided pavers and vegetation within the floor pavers.

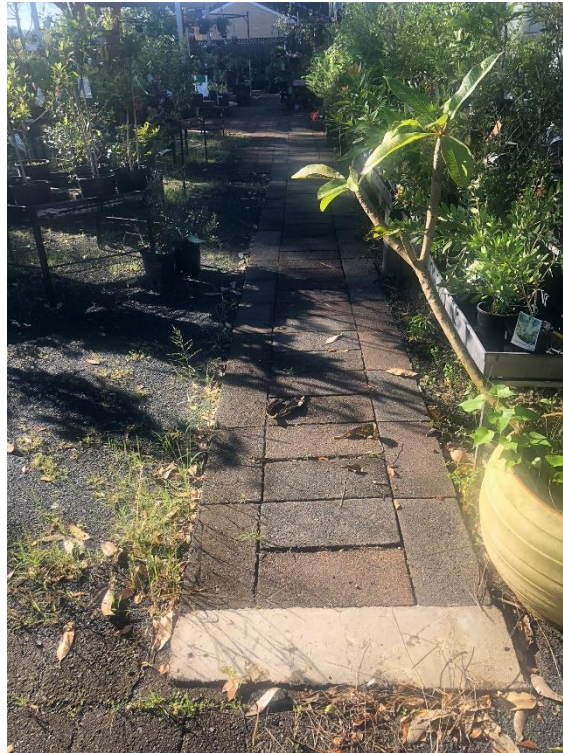
Subsided pavers and vegetation within the floor pavers.
Cracked and damaged wall linings, disengaged timber fascia boards and metal roof cappings.

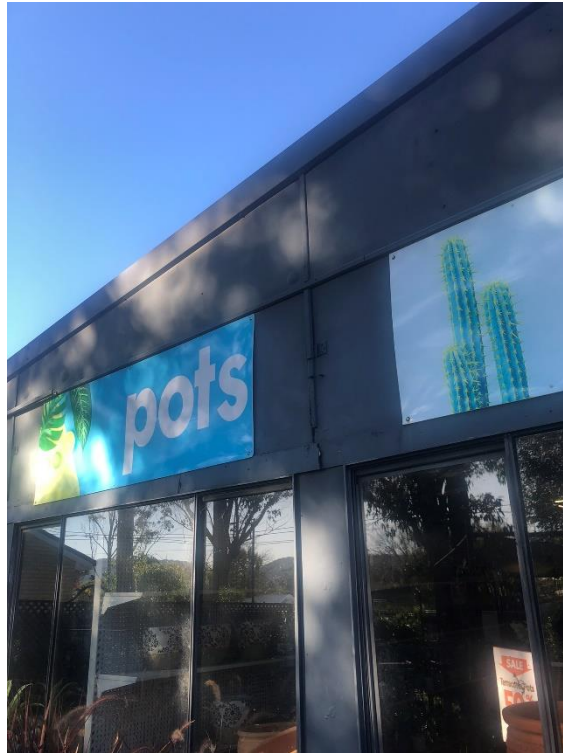
Cracked and damaged fibro / asbestos wall linings above and surrounding the external windows and within the external walls.

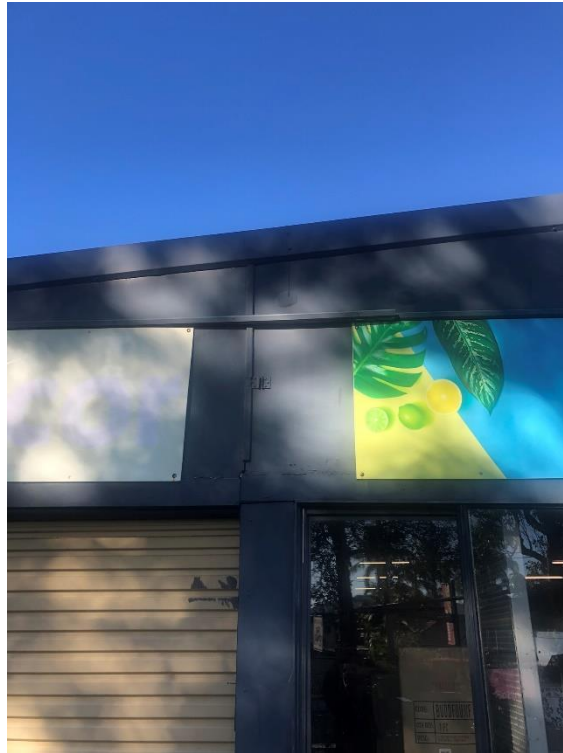
Cracked and damaged fibro / asbestos wall linings above and surrounding the external windows and within the external walls.

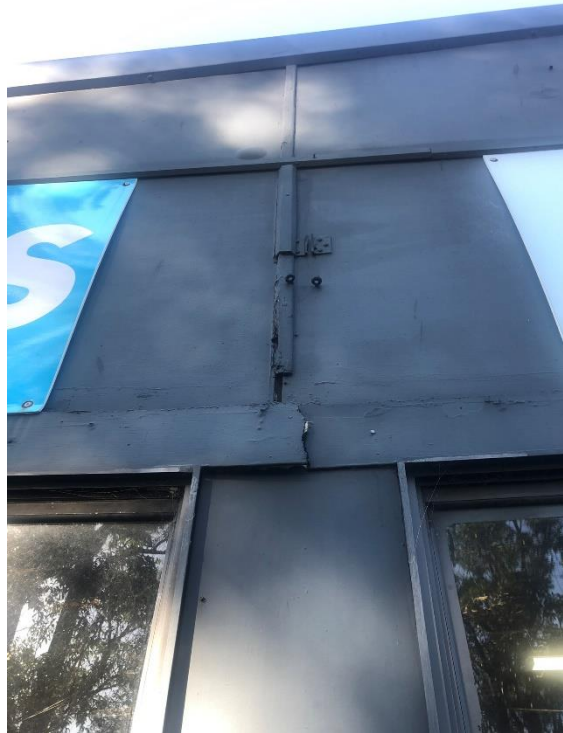
Cracked and damaged fibro / asbestos wall linings above and surrounding the external windows and within the external walls.

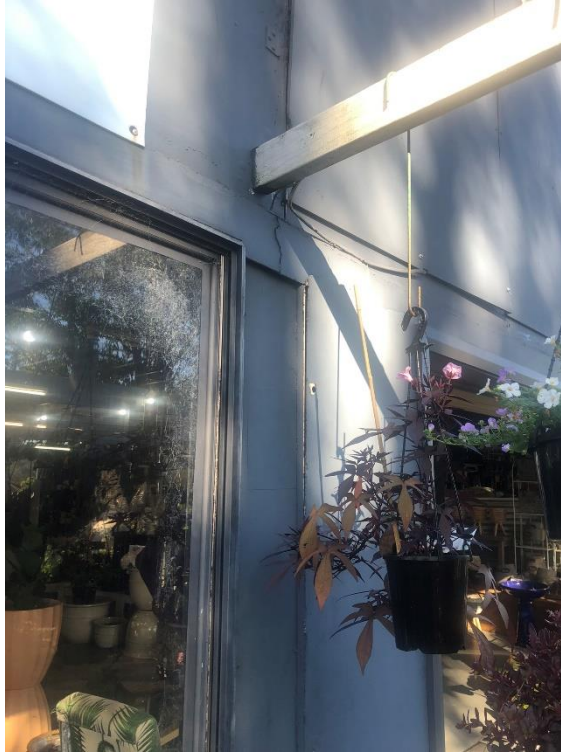
Cracked and damaged fibro / asbestos wall linings above and surrounding the external windows and within the external walls.

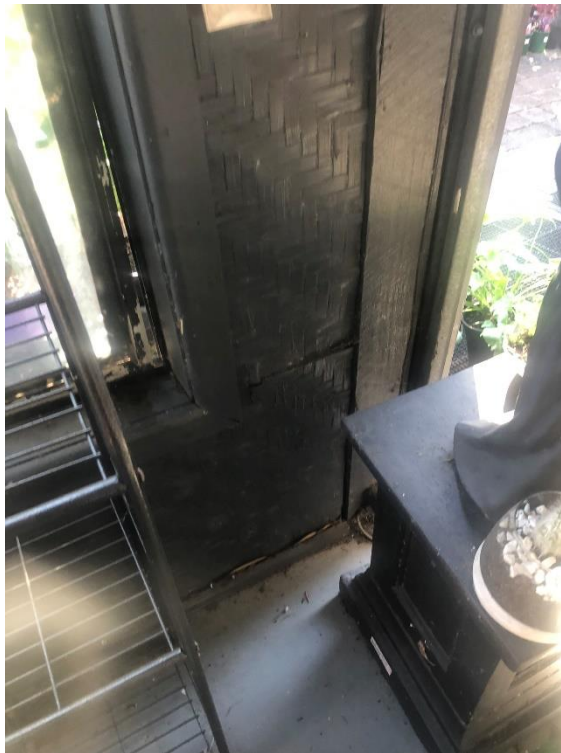
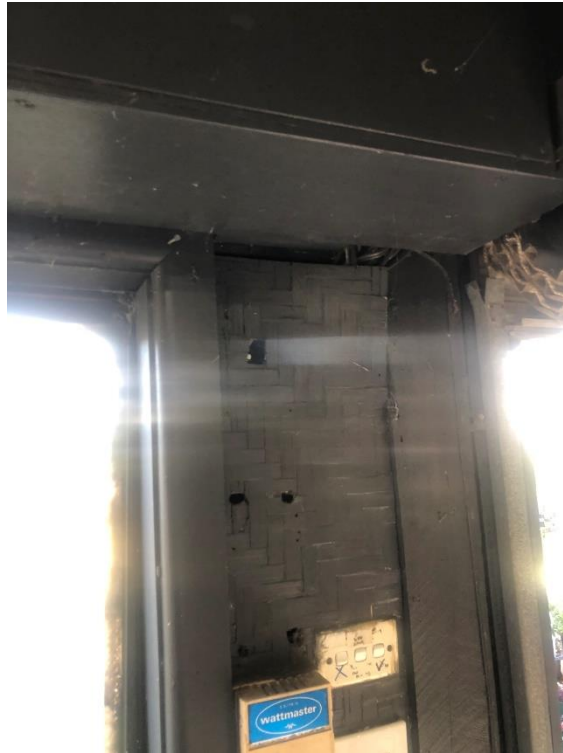
There is excessive moisture within the internal walls, doors and windows of the storeroom.

Moisture seen within the internal storeroom walls, ceiling and bulkhead.

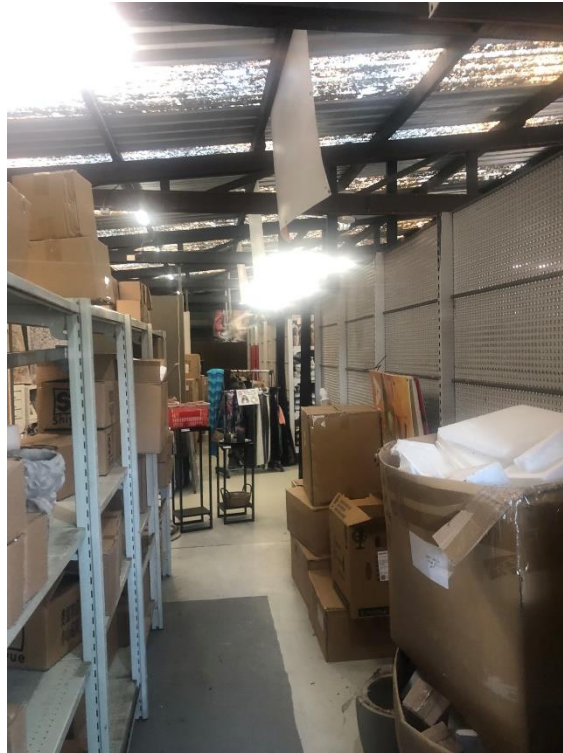
The internal walls and floors within the commercial premises have minor cracks within the concrete floor plus wear and tear within the walls.

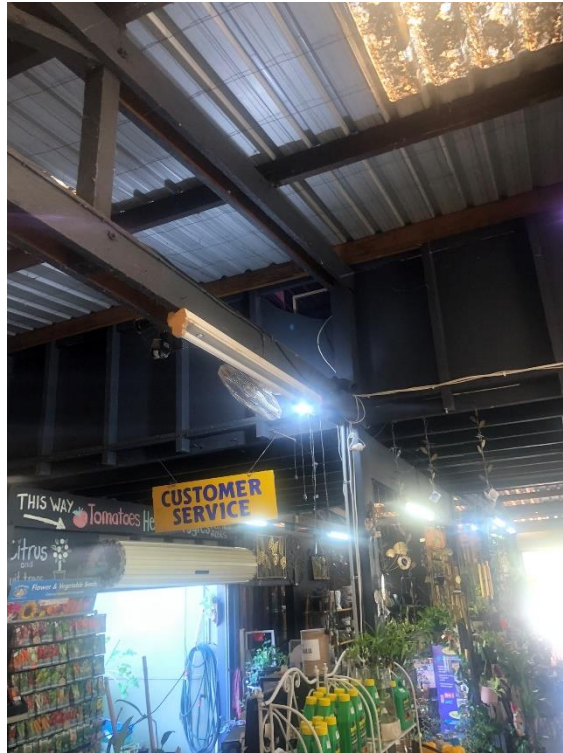
Water entry within the nursery from the roof sheets and skylight junction.

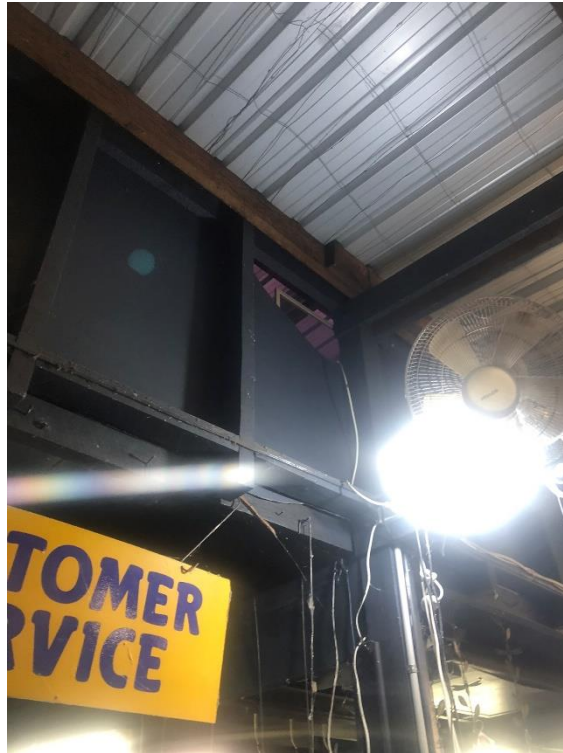
Broken and dmaaged wall linings within the internal elevation of the nursery.

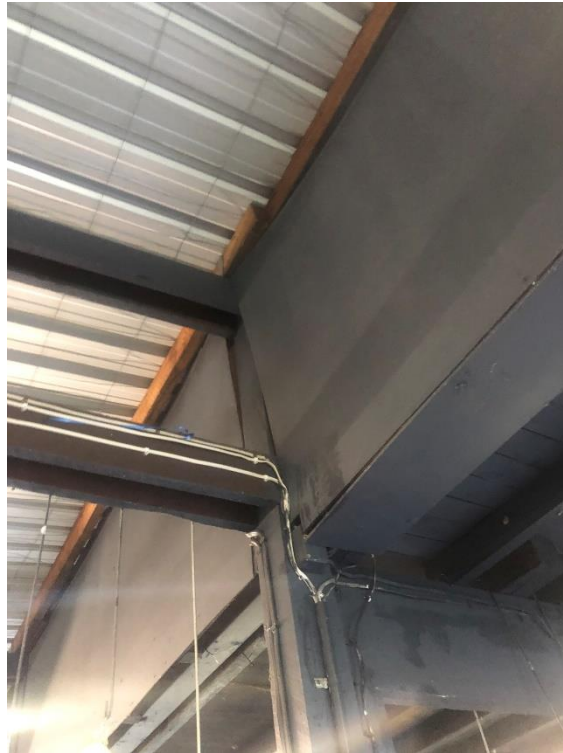
Broken and dmaaged wall linings within the internal elevation of the nursery.

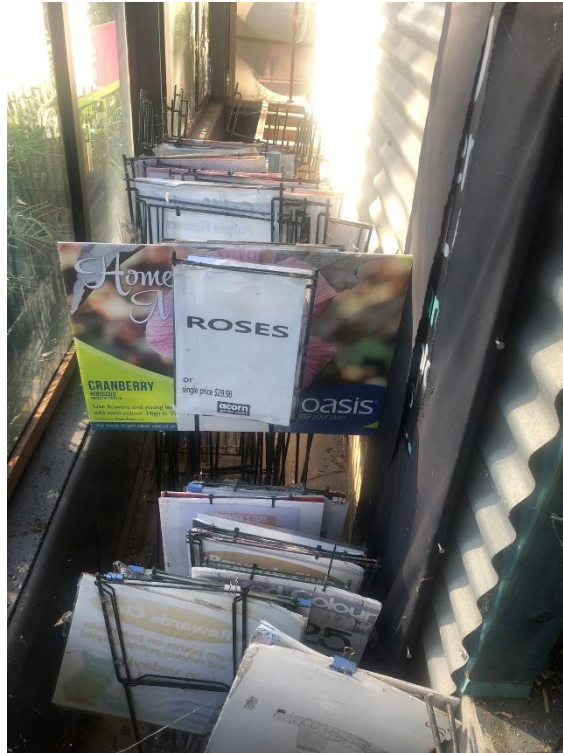
Not all aspects of the storeroom were able to be inspected due to excess personal belongings, but I could see excessive moisture entering the storeroom via the windows and within the internal elevations of the wall.

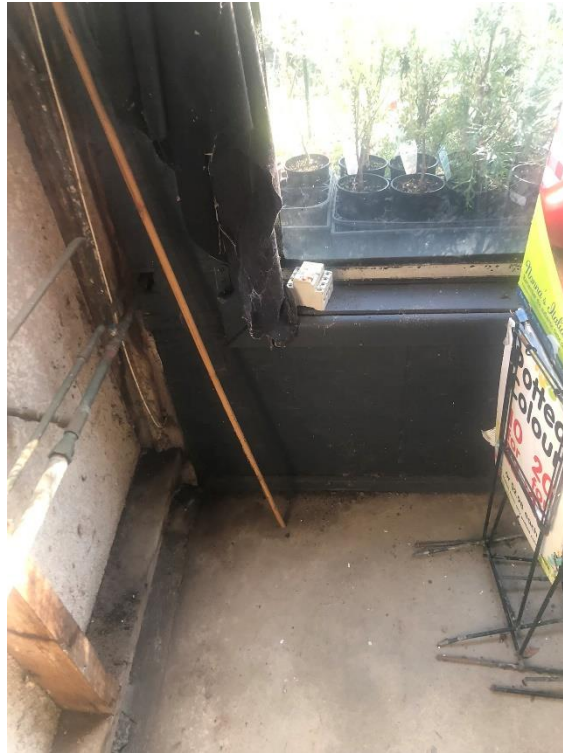
Moisture ingress within the internal walls and storeroom.
Electrical meter box does not comply with current regulations, an overhaul of the entire electrical meter box must be carried out immediately.

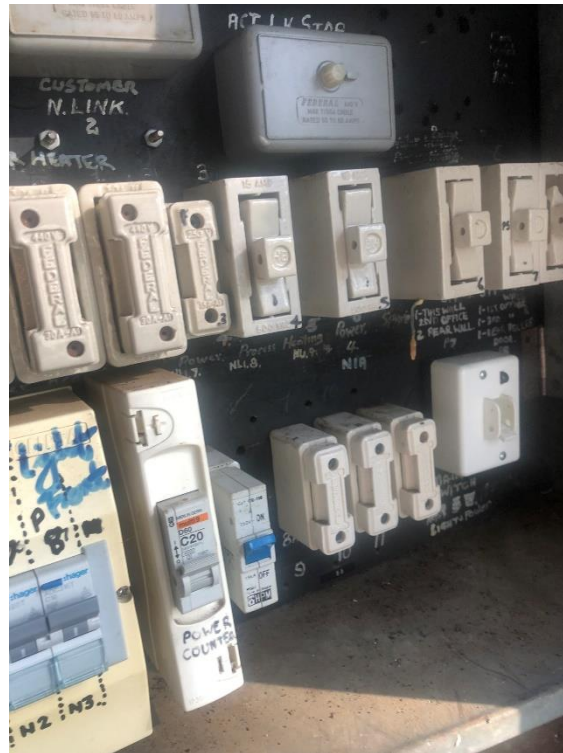
Electrical meter box does not comply with current regulations, an overhaul of the entire electrical meter box must be carried out immediately.

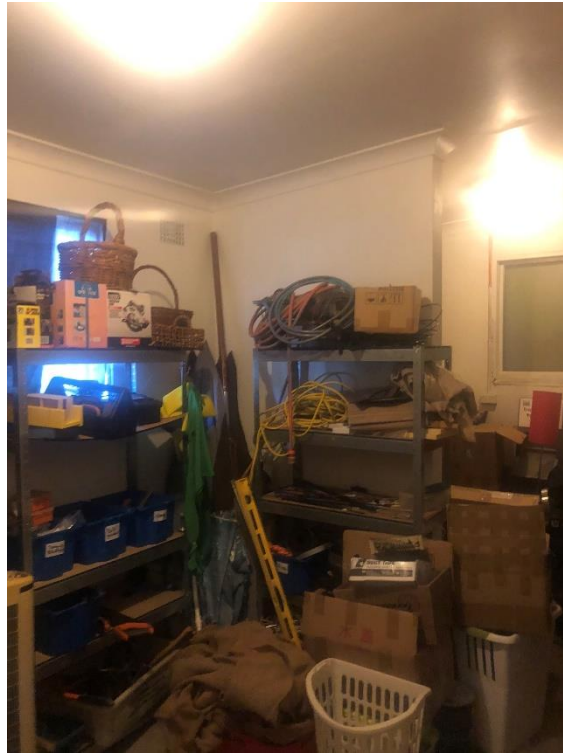
The storeroom was overfilled with personal belongings, no major defects were found, minor hairline cracks were seen within the internal plasterboard ceilings and wall linings.
No access was available to the roof void on the day of my inspection.

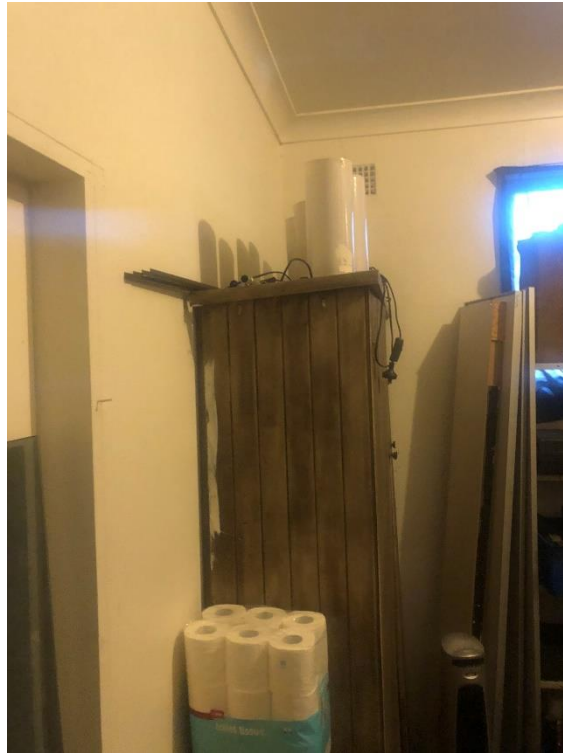
Moisture within the internal walls, all within 1m of photograph taken.

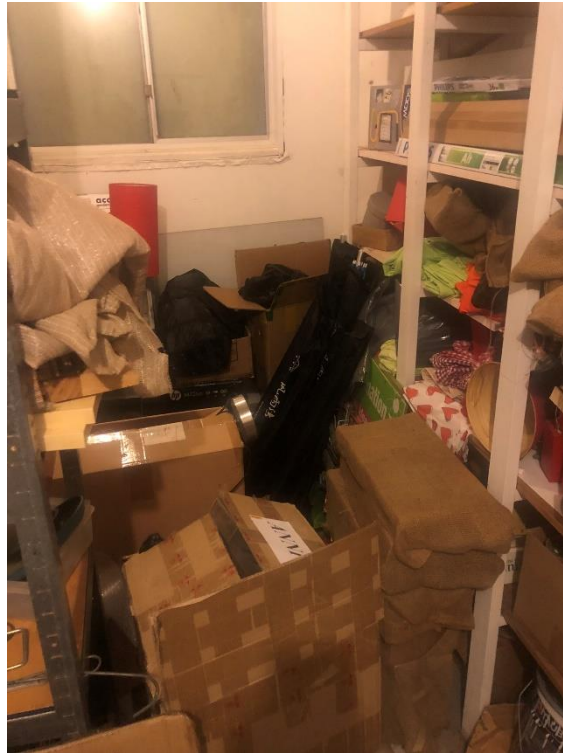
Floors were concealed and covered within the storeroom by the current tenants belongings.
Moisture and dampness seen within the internal masonry walls within the storeroom.

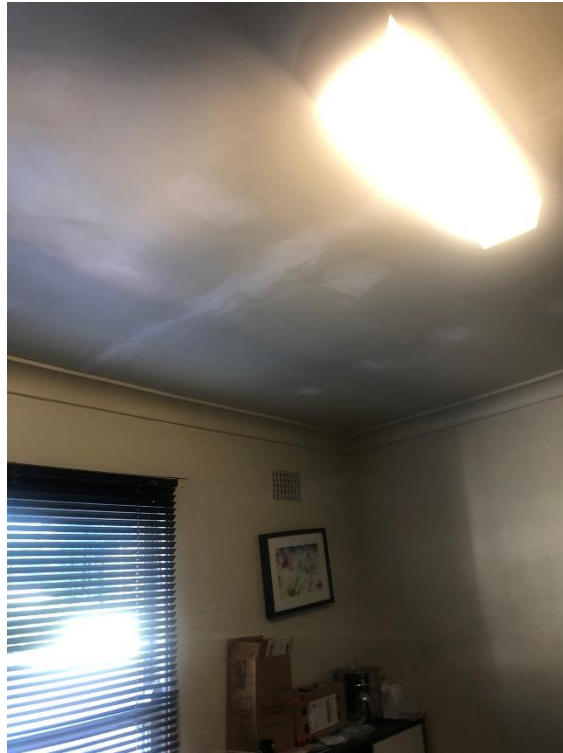
Patched ceilings, incomplete setting and paintwork, together with moisture damage within the plasterboard ceilings and walls.

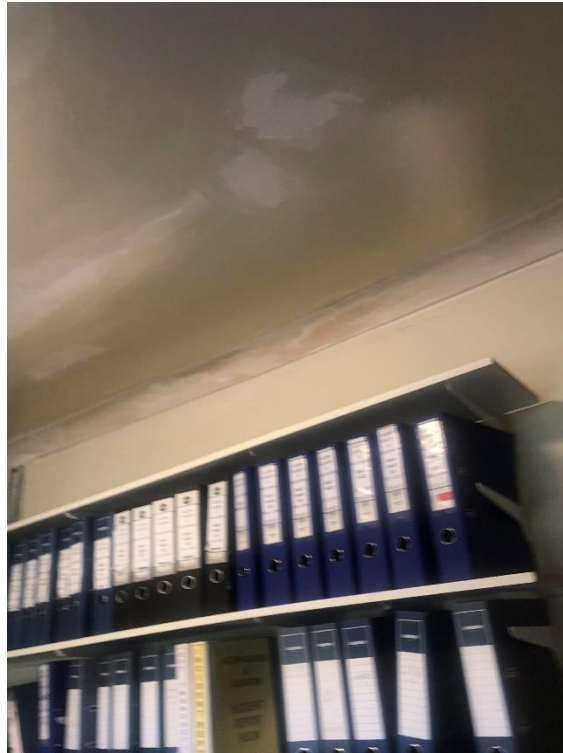
Mould, moisture and dampness within the office walls, cornices and ceiling.

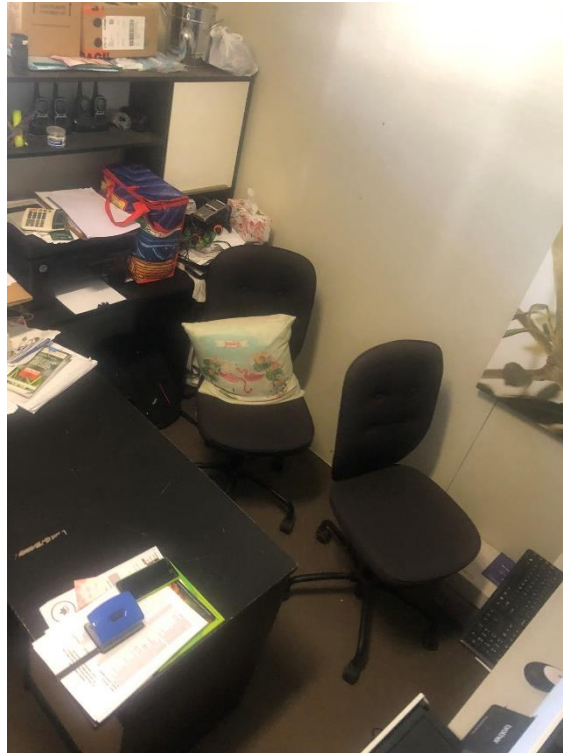
Mould within the internal plasterboard wall linings in various locations within the office.

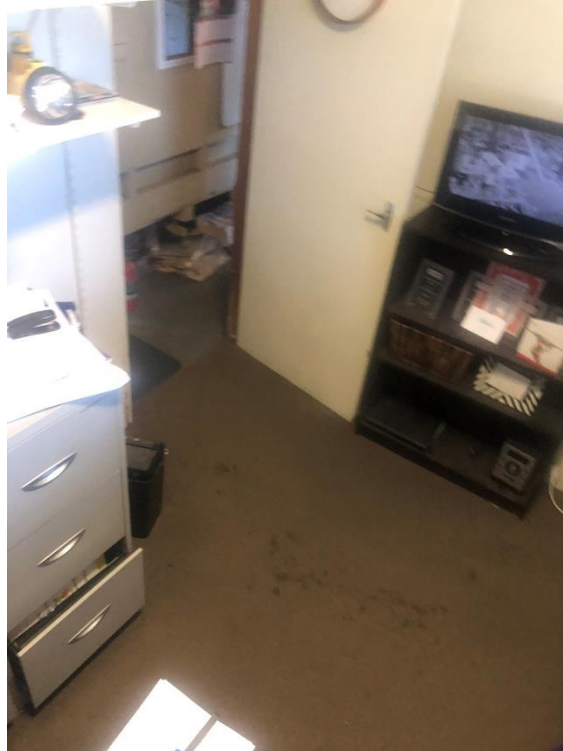
Cracked internal junction of the office wall linings and cornices, together with a significant spring / bounce in the floor beneath the doorway.

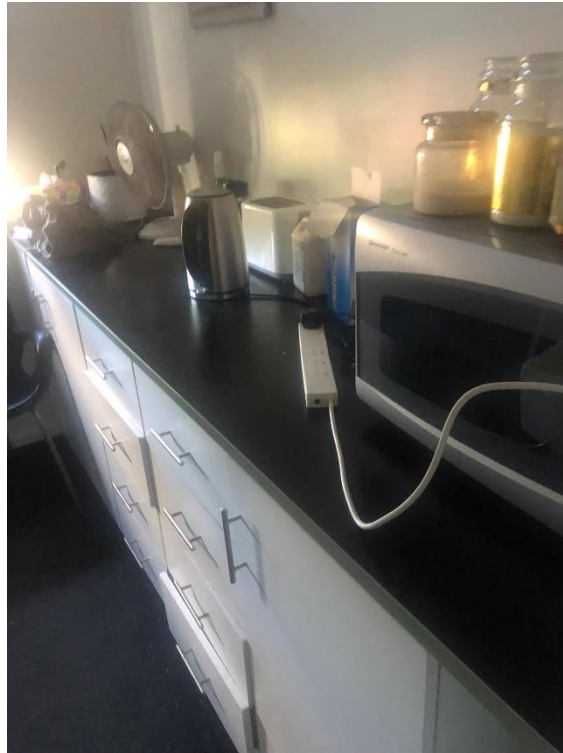
Kitchen joinery in need fo repair, door and drawer fronts and hinged doors strike up against each other.

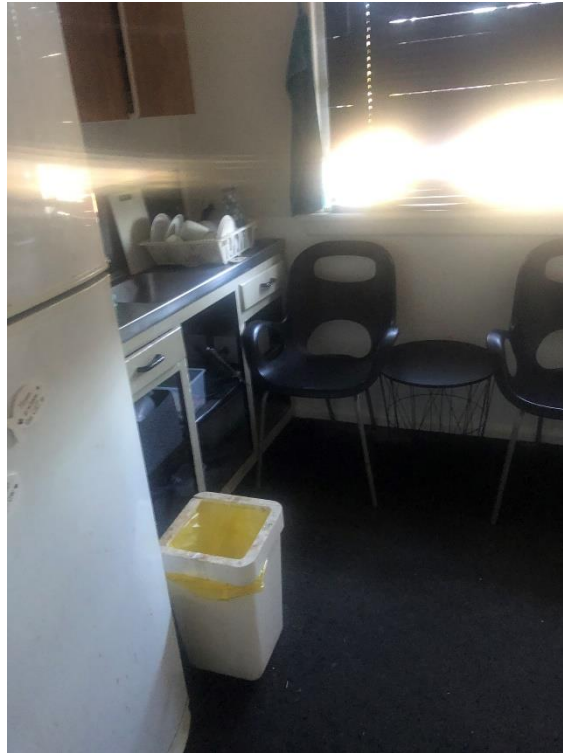
Missing kitchen doors and drawer fronts.

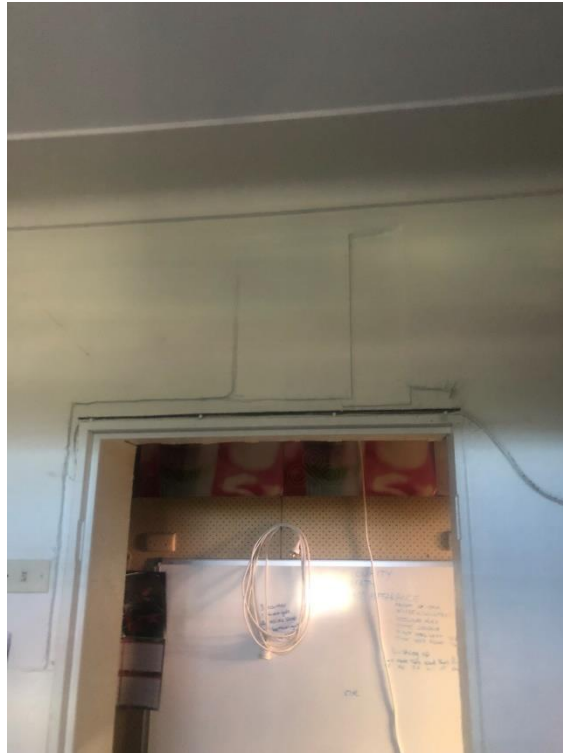
Cracks within the internal wall linings above the door and adjacent to the CCTV camera system.

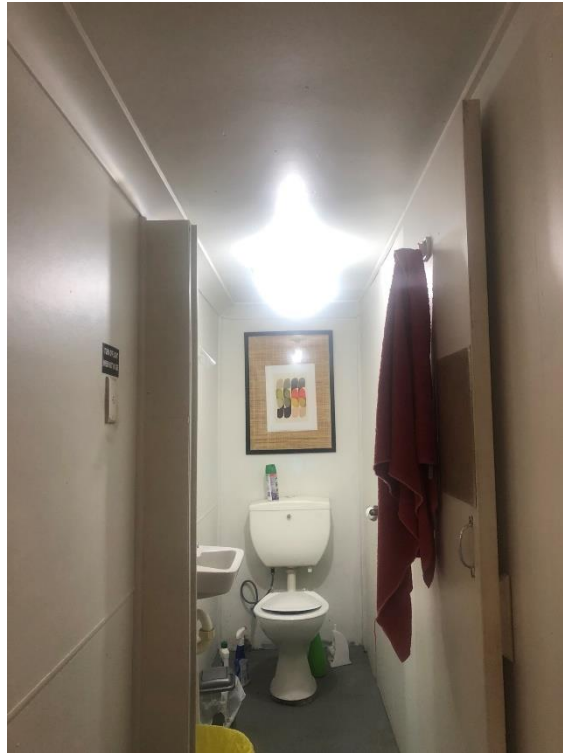
Mould and moisture within the men's bathroom wall linings and timber framing.
It looks like the men's and women's bathroom area was flooded / submersed under a significant quantity of water for a significant period of time.

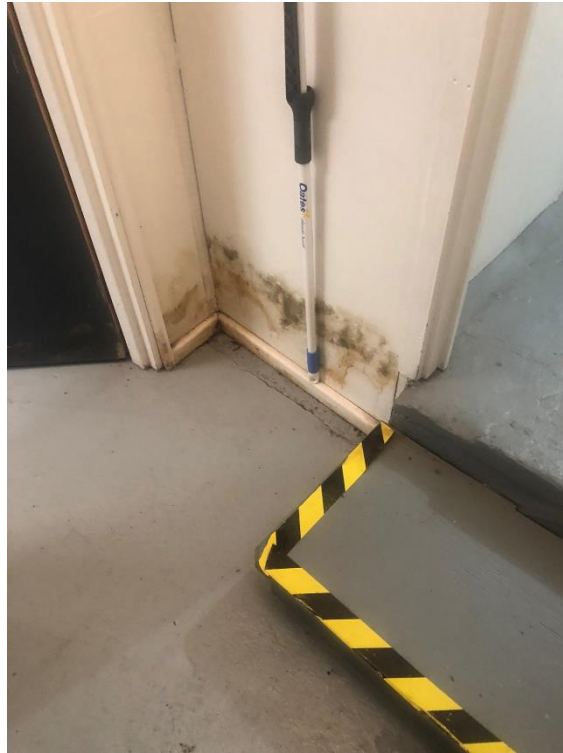
Hallway leading to bathroom has mould and moisture present within the wall linings.

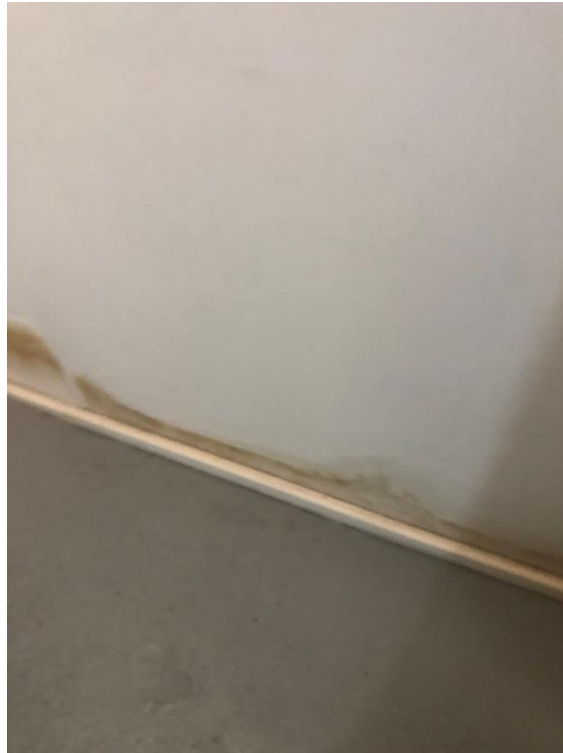
Mould and moisture within the wall linings.

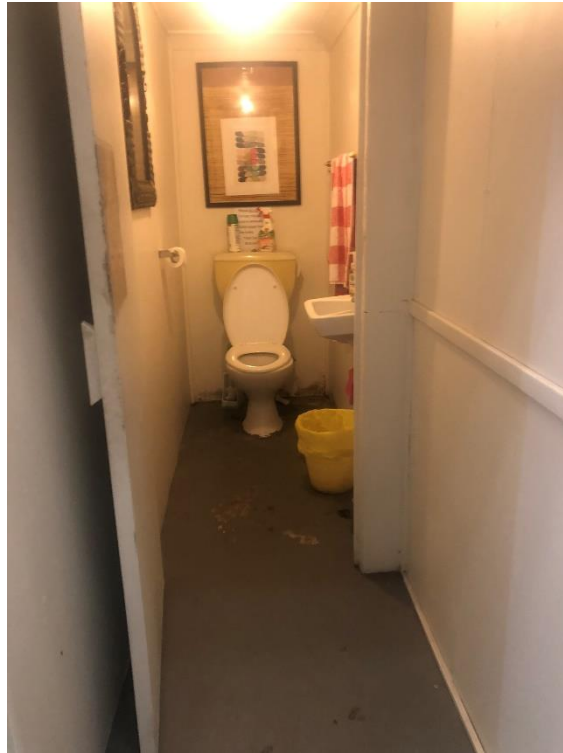
Moisture within the second bathroom.

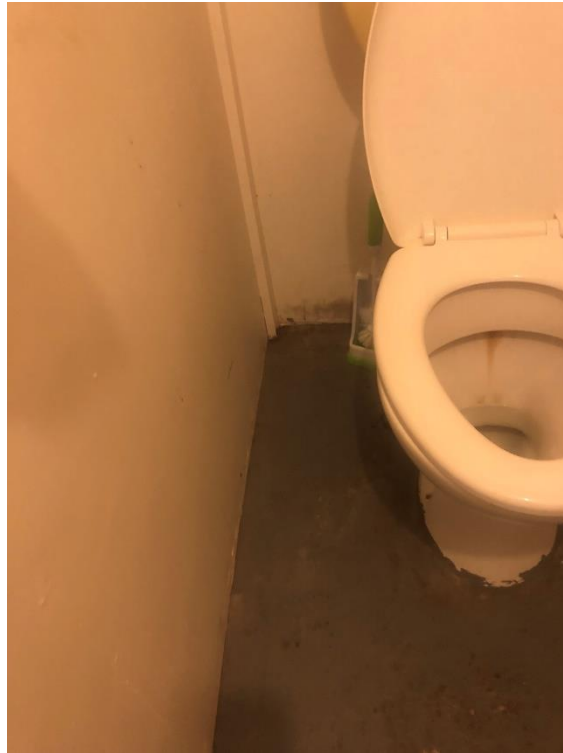
Mould and moisture within the wall linings and floor junctions.
Cracks within the bathroom floor.

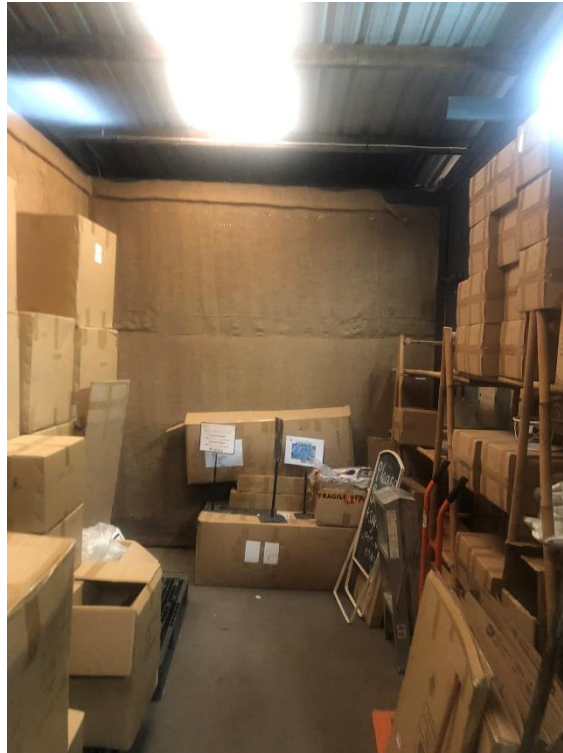
Storeroom appears to have leaks occurring within the metal deck roof sheets and polycarbonate roof sheets.

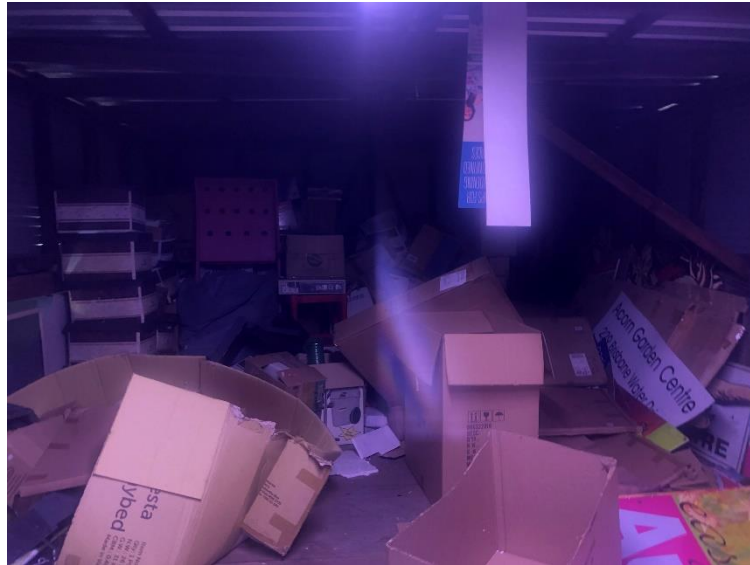
First floor loft / storage area has excess personal belongings which obstructed access and my line of sight, no major defects were seen within these areas, however minimal access was available on the day of my inspection.
