# **Dilapidation Report For The Development At: 26 Edwards Bay Rd, Mosman**

## Dilapidation Report Carried Out On:

24 Edwards Bay Road

30<sup>th</sup> April 2026

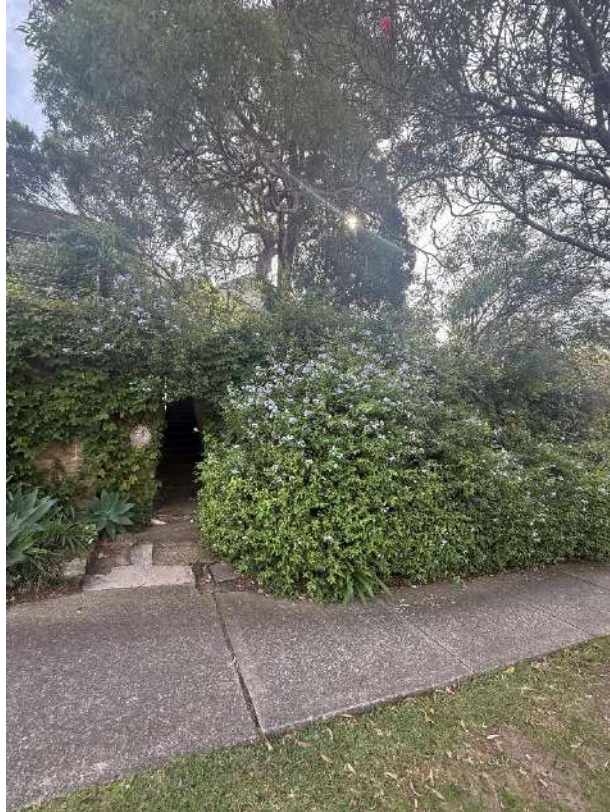
Footpath cracked and damaged in various locations

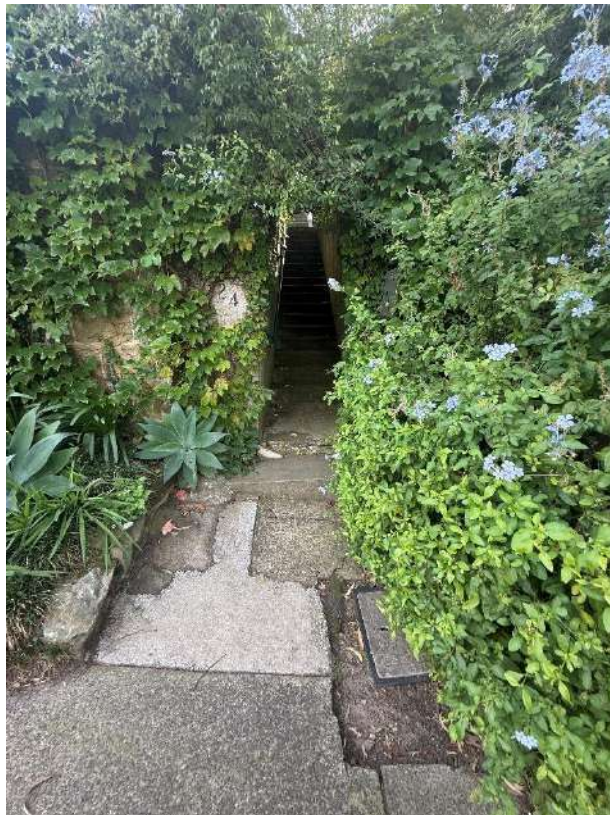
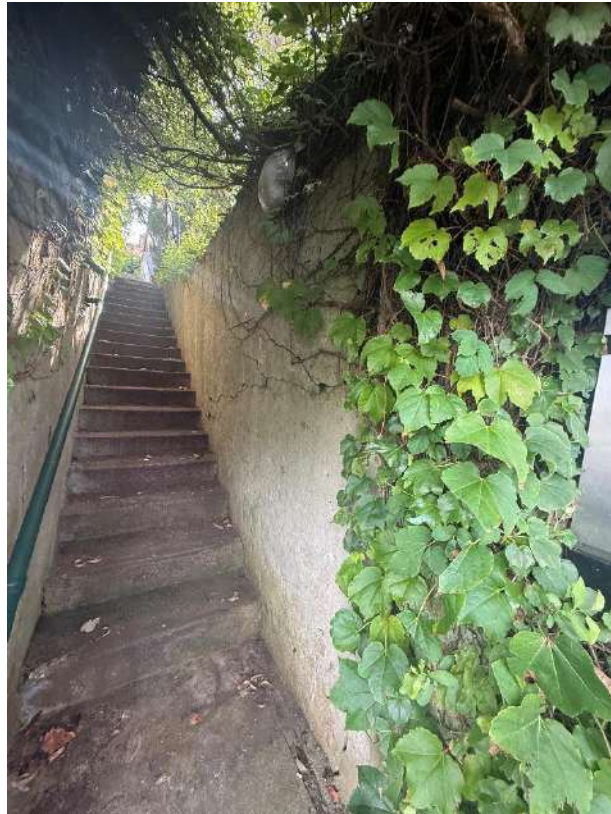
Left and right masonry walls on either side of entry stairs are structurally cracked horizontally and vertically within the masonry walls

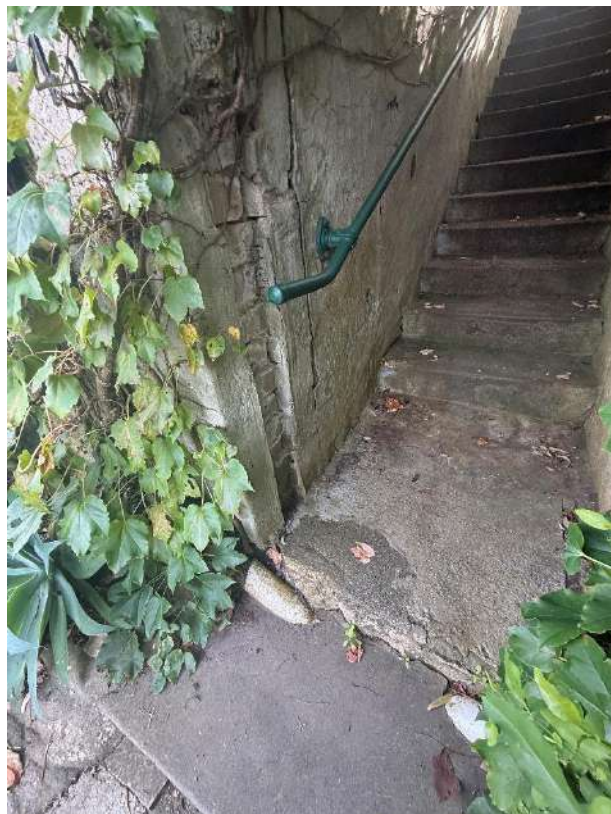
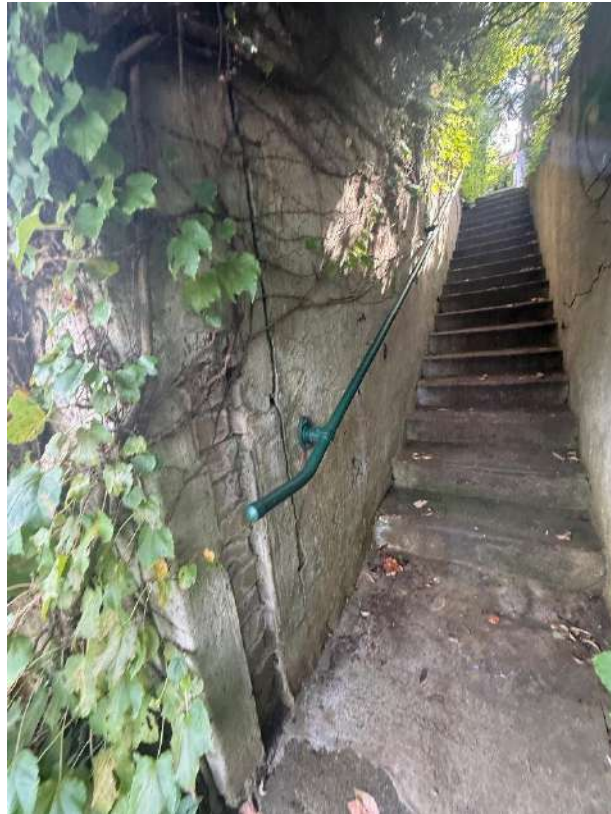
Left and right masonry walls on either side of entry stairs are structurally cracked horizontally and vertically within the masonry walls

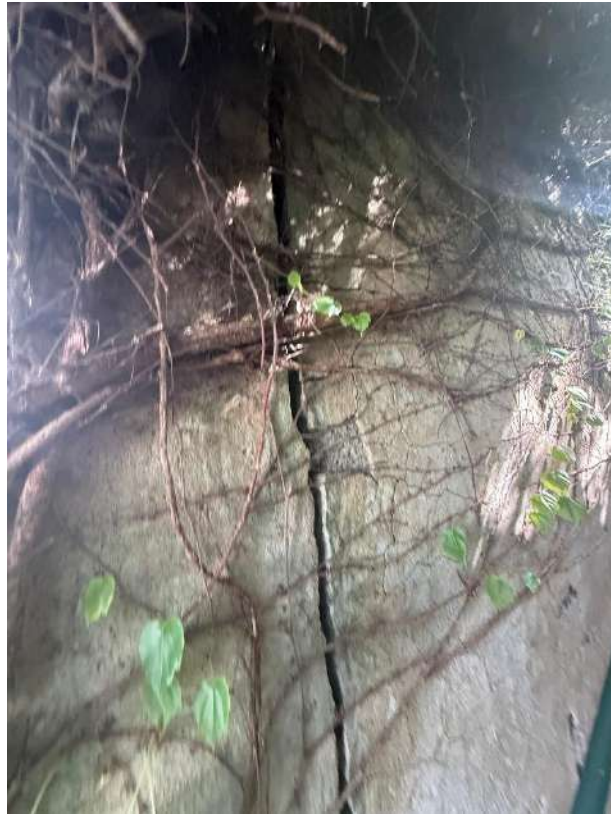
Left and right masonry walls on either side of entry stairs are structurally cracked horizontally and vertically within the masonry walls

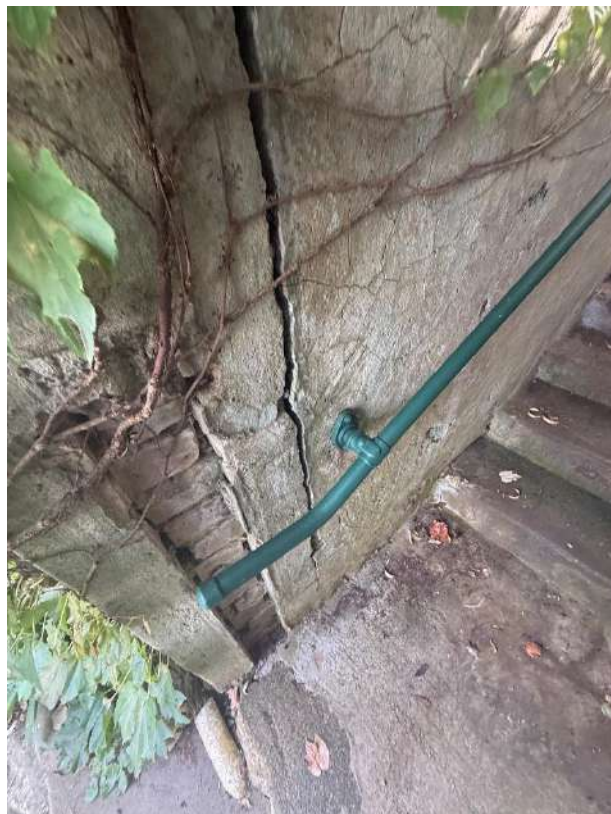
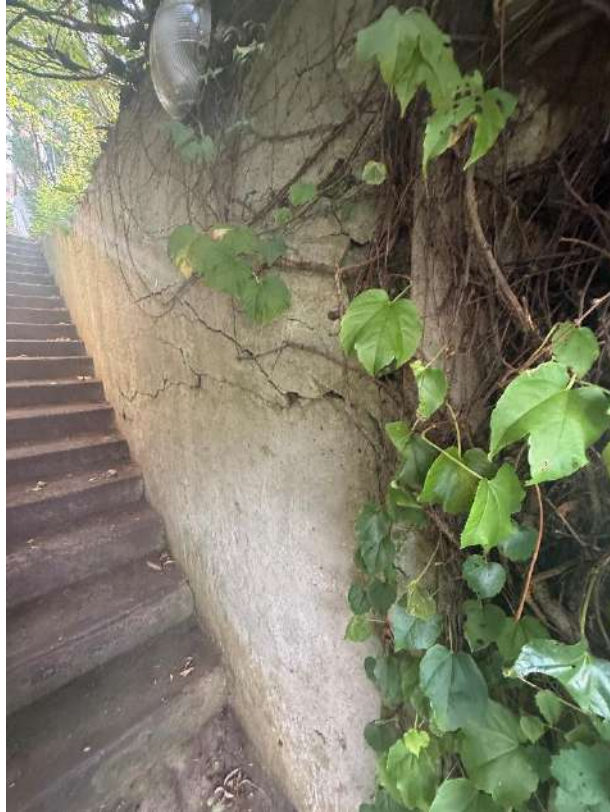
Left and right masonry walls on either side of entry stairs are structurally cracked horizontally and vertically within the masonry walls

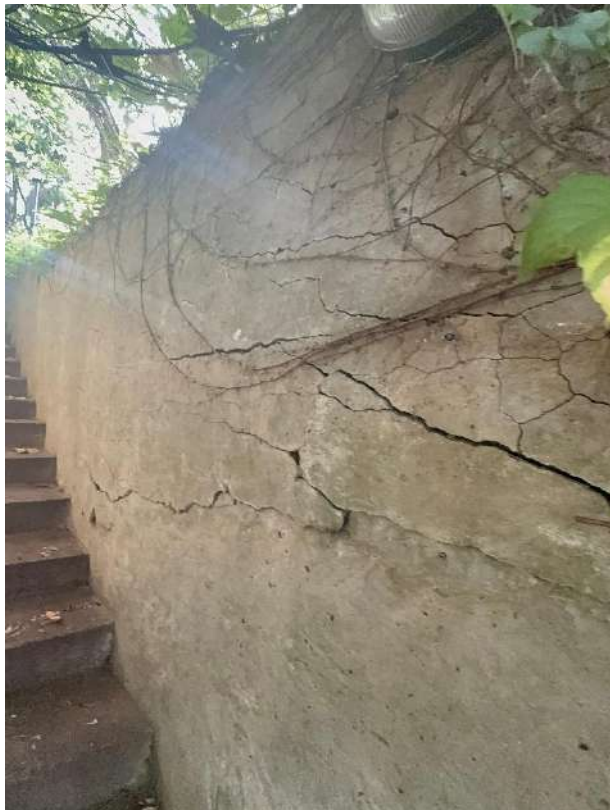
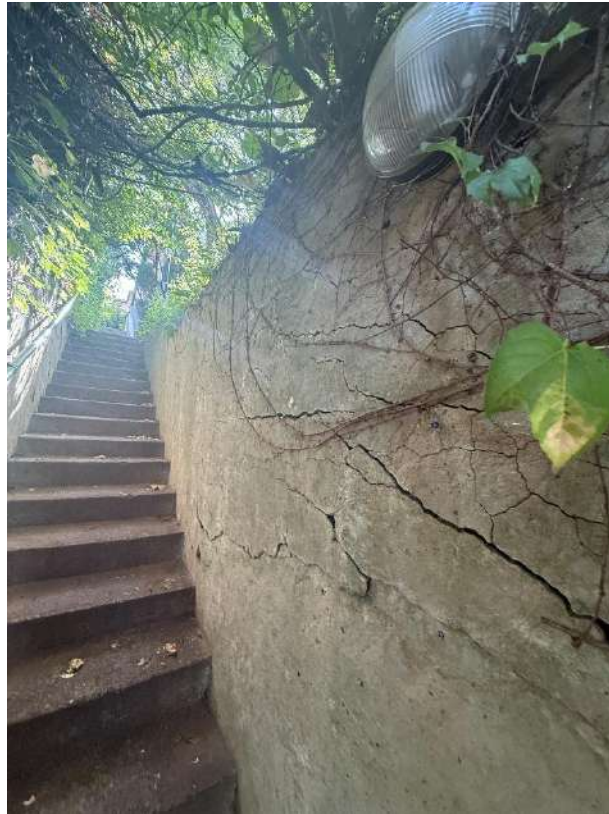
Left and right masonry walls on either side of entry stairs are structurally cracked horizontally and vertically within the masonry walls

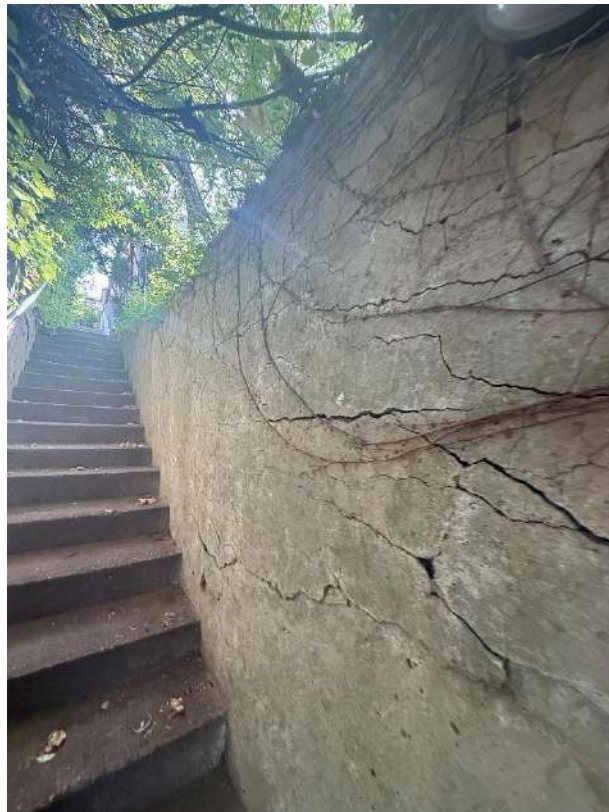
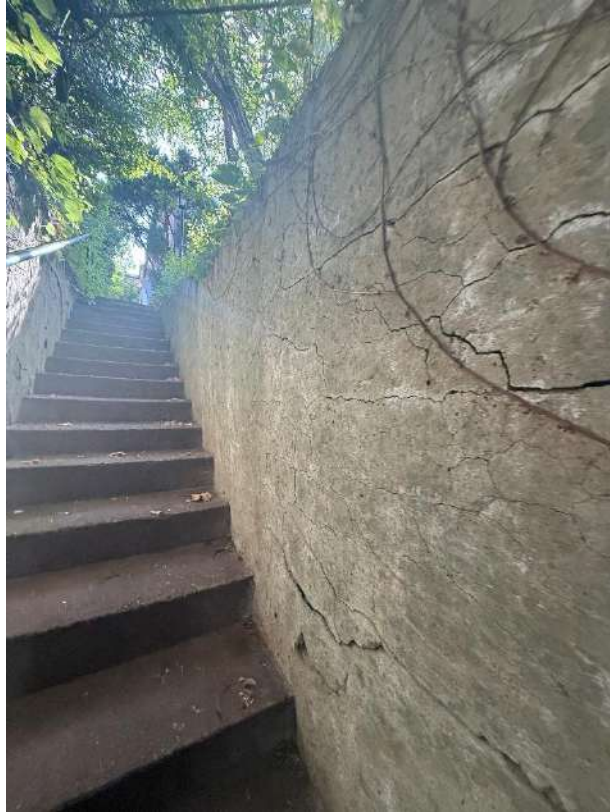
Left and right masonry walls on either side of entry stairs are structurally cracked horizontally and vertically within the masonry walls

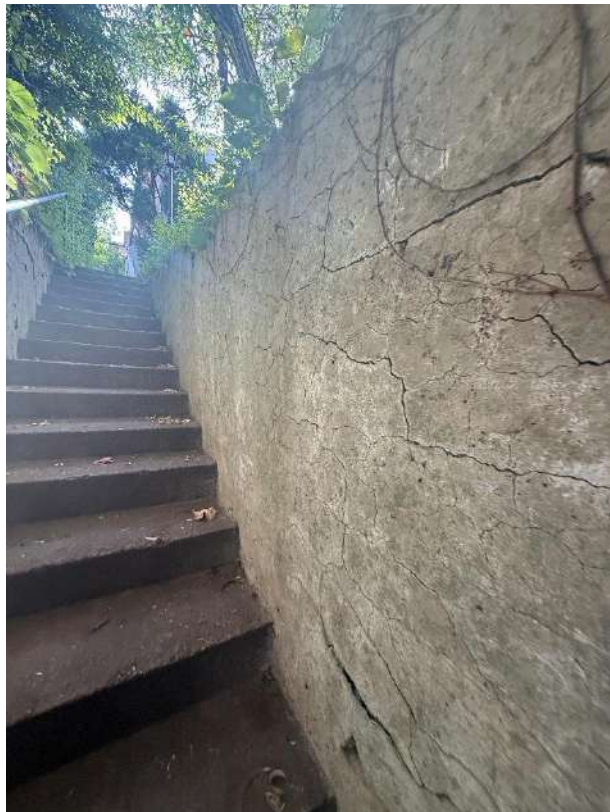
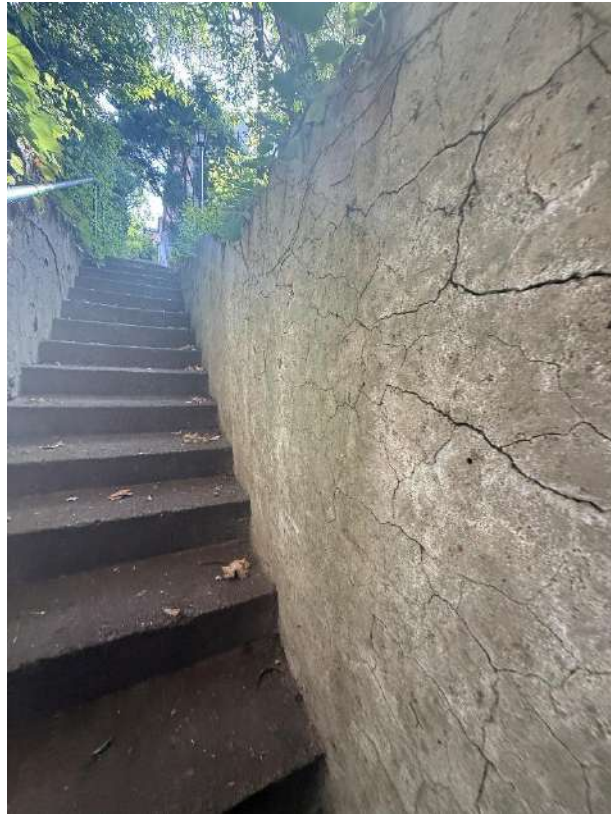
Left and right masonry walls on either side of entry stairs are structurally cracked horizontally and vertically within the masonry walls

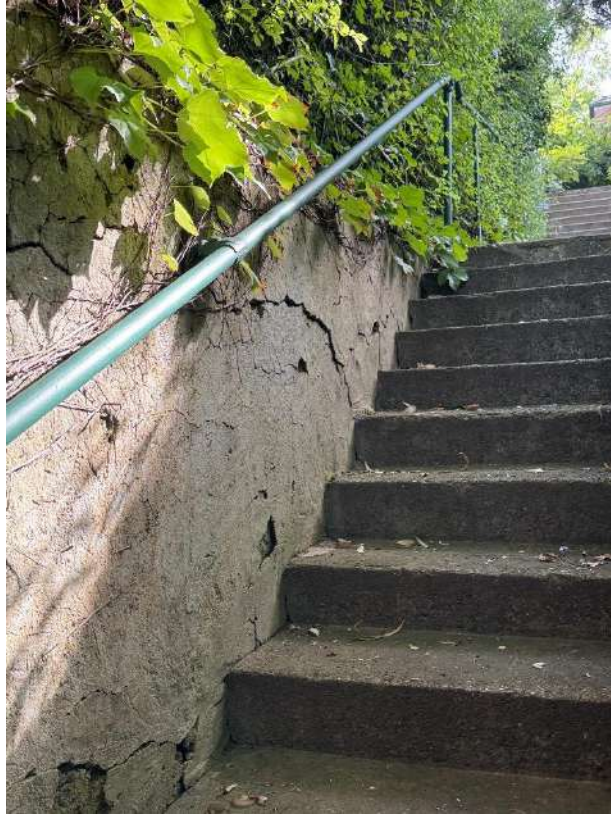
Left and right masonry walls on either side of entry stairs are structurally cracked horizontally and vertically within the masonry walls

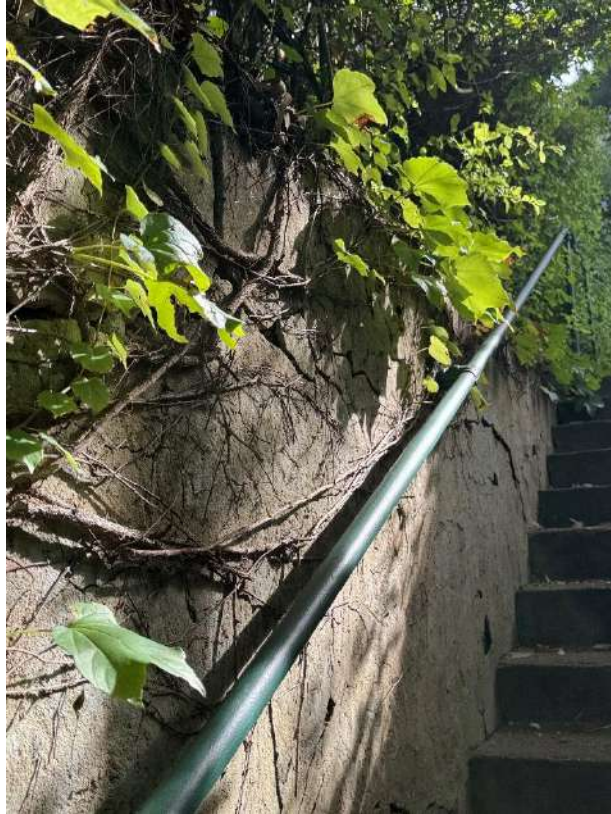
Left and right masonry walls on either side of entry stairs are structurally cracked horizontally and vertically within the masonry walls

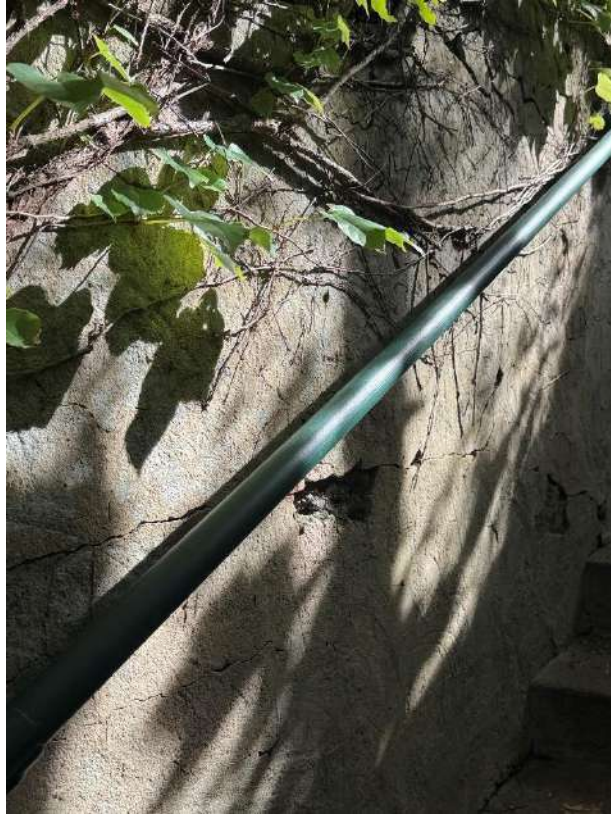
Left and right masonry walls on either side of entry stairs are structurally cracked horizontally and vertically within the masonry walls

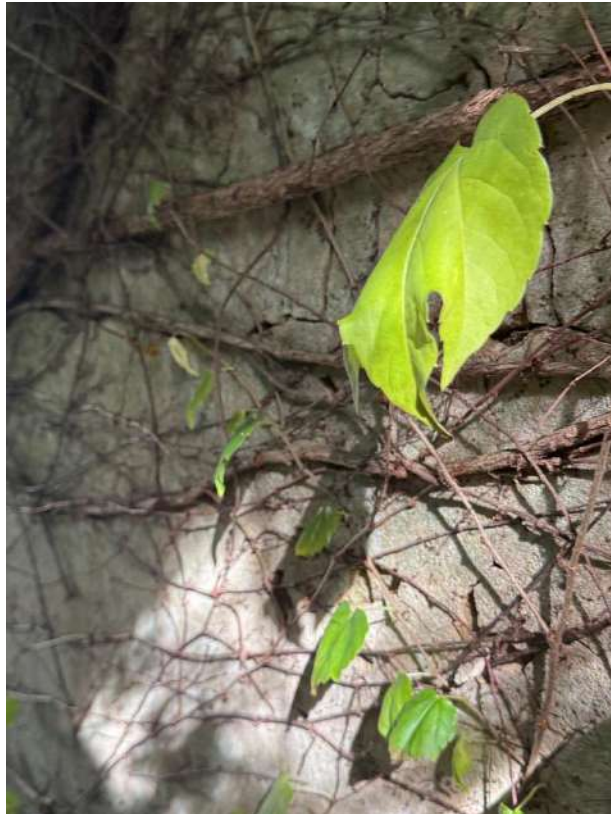
Left and right masonry walls on either side of entry stairs are structurally cracked horizontally and vertically within the masonry walls

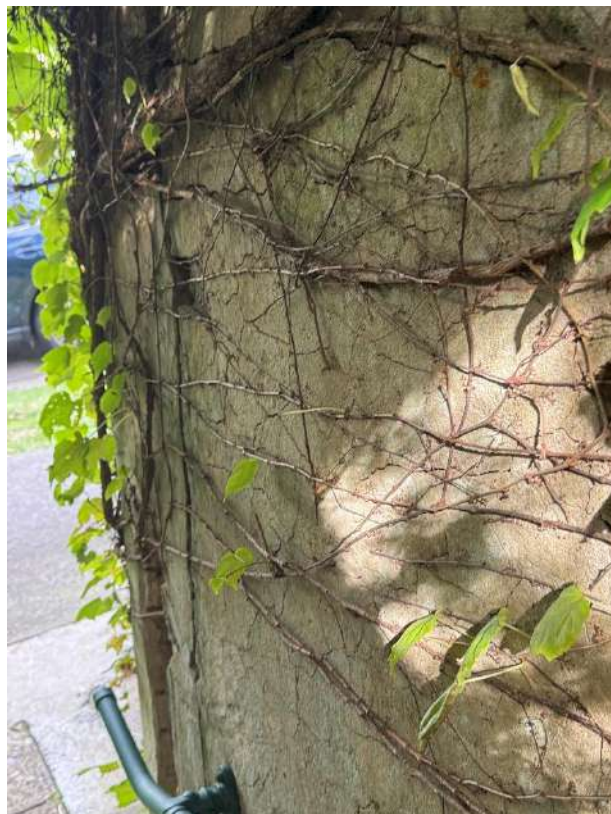
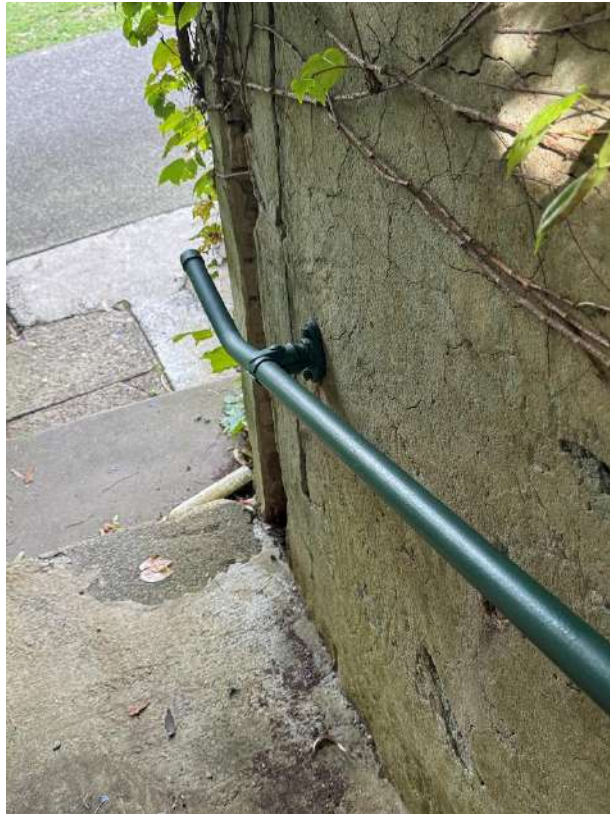
Left and right masonry walls on either side of entry stairs are structurally cracked horizontally and vertically within the masonry walls

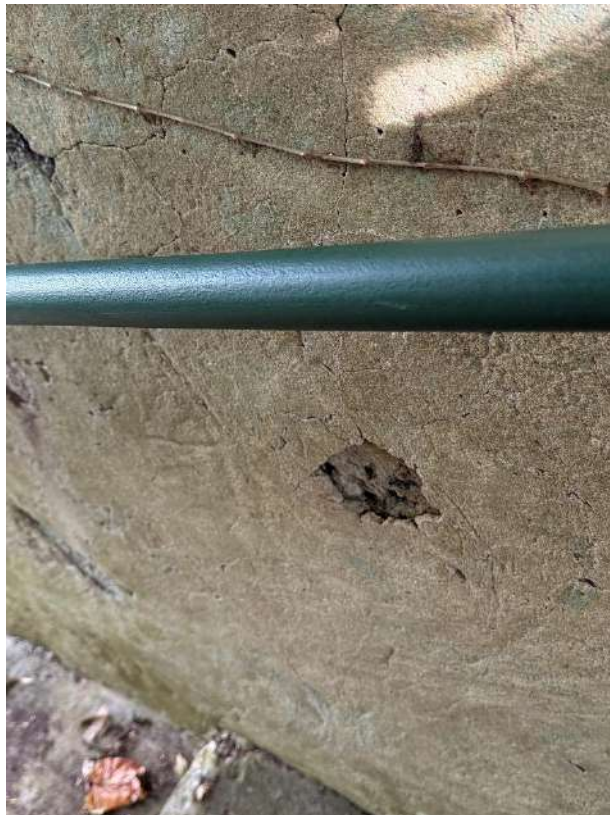
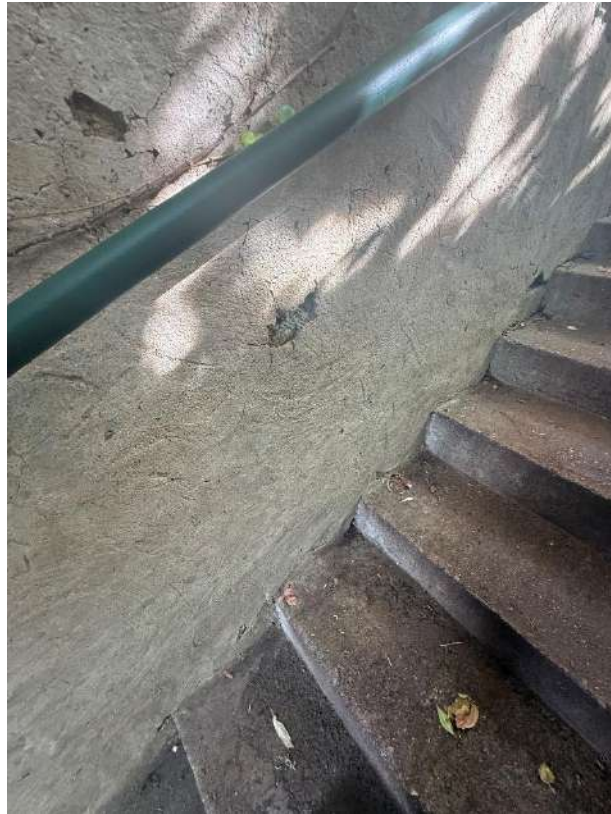
Left and right masonry walls on either side of entry stairs are structurally cracked horizontally and vertically within the masonry walls

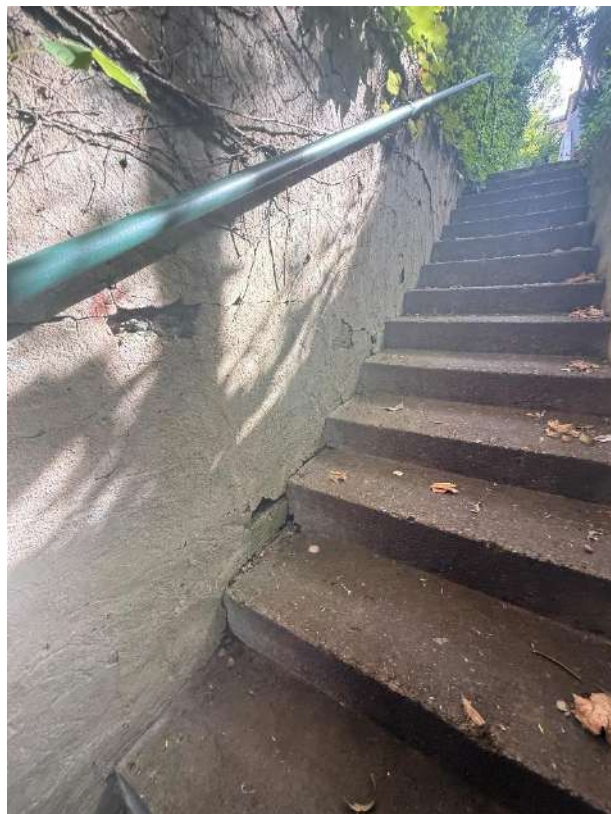
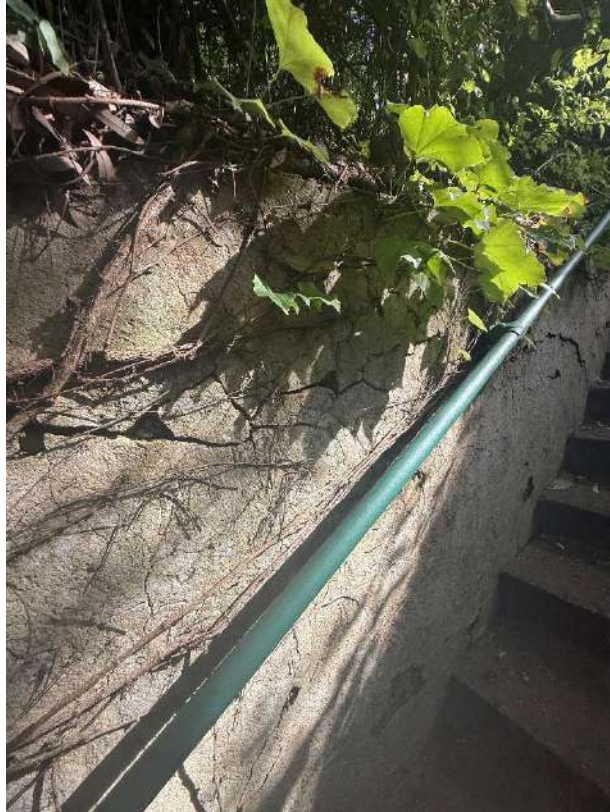
Left and right masonry walls on either side of entry stairs are structurally cracked horizontally and vertically within the masonry walls

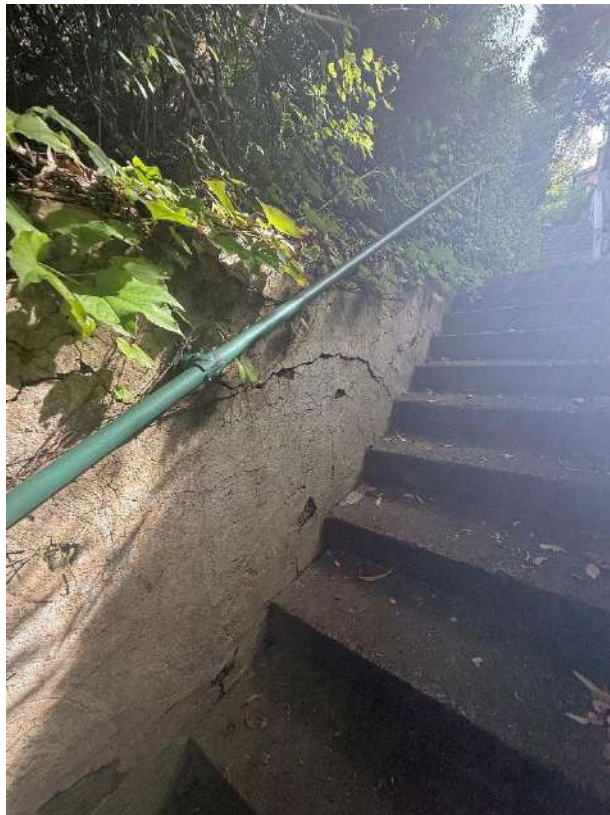
Left and right masonry walls on either side of entry stairs are structurally cracked horizontally and vertically within the masonry walls

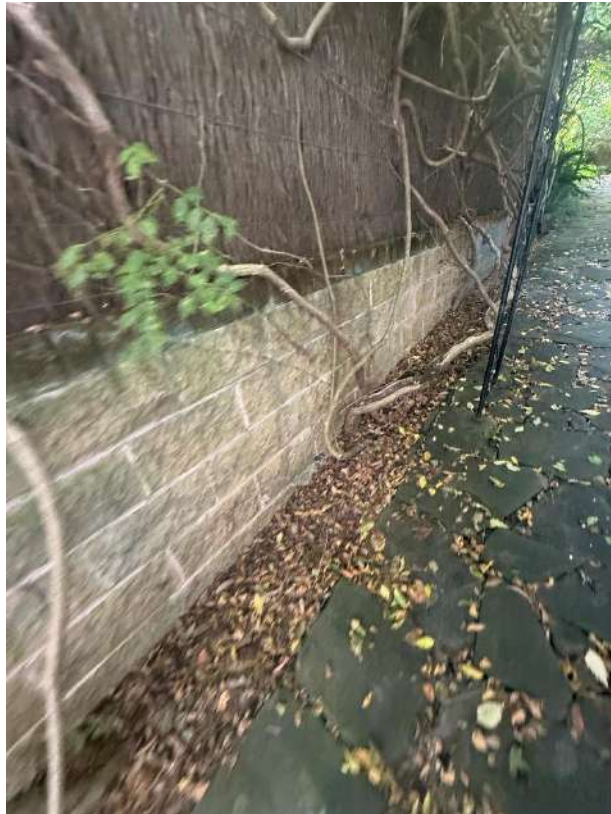
Cracks within the sandstones flagging floor finish

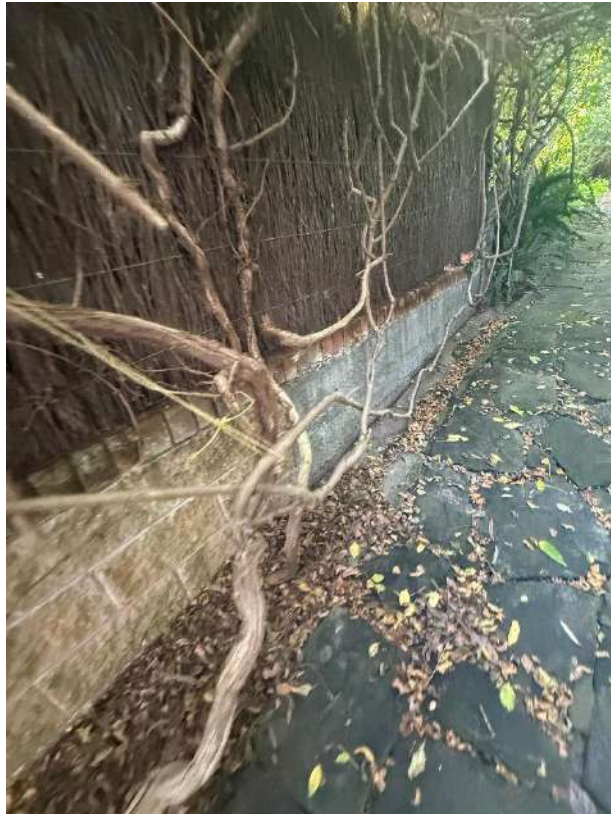
Hairline cracks within the blockwork along the boundary line

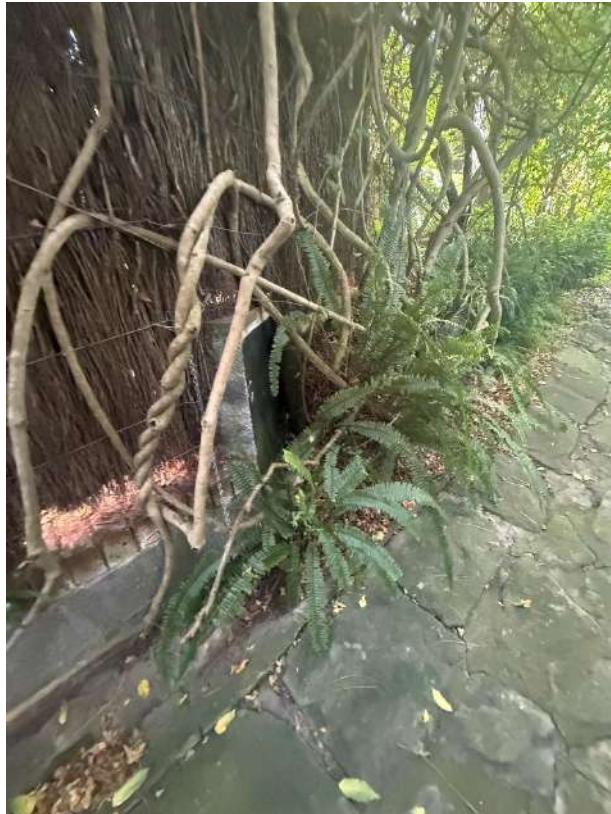
Cracks within the sandstone flagging floor finish

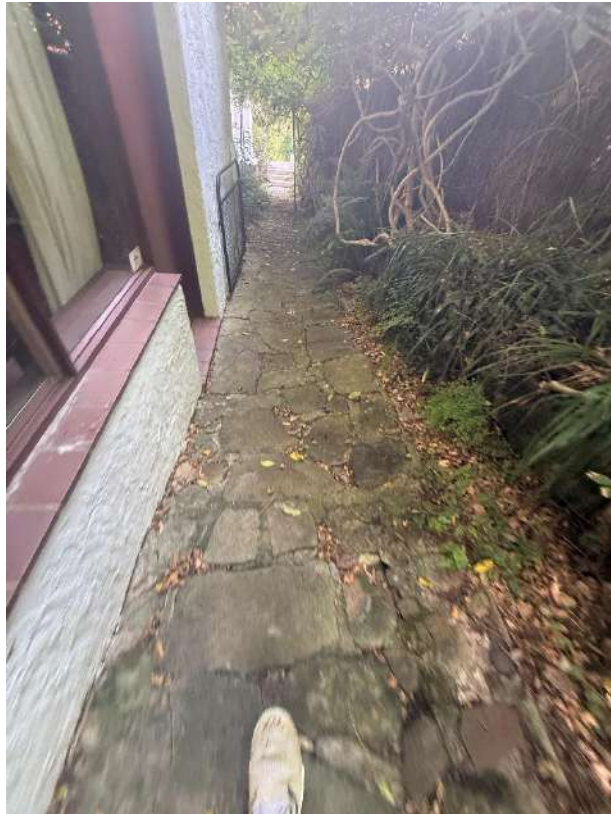
Cracks within the sandstone mortar joints

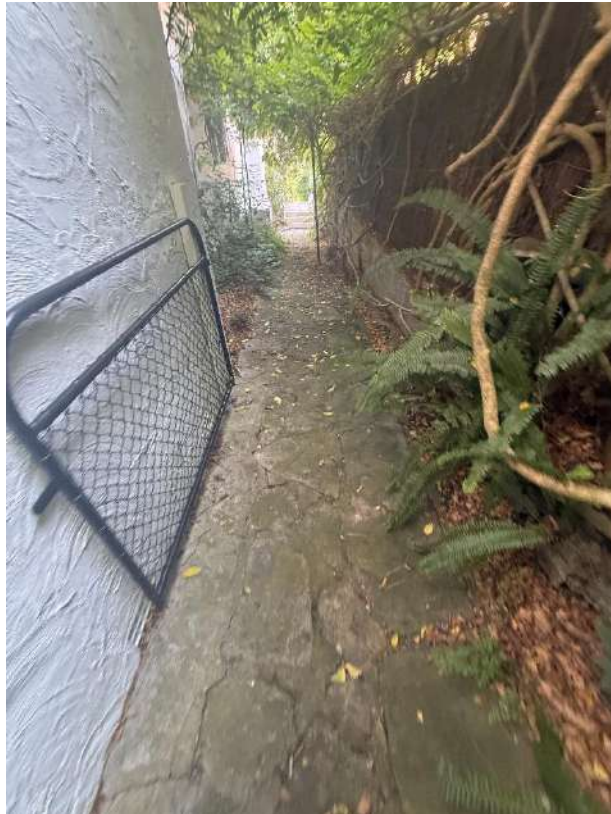
Cracks within the sandstone mortar joints

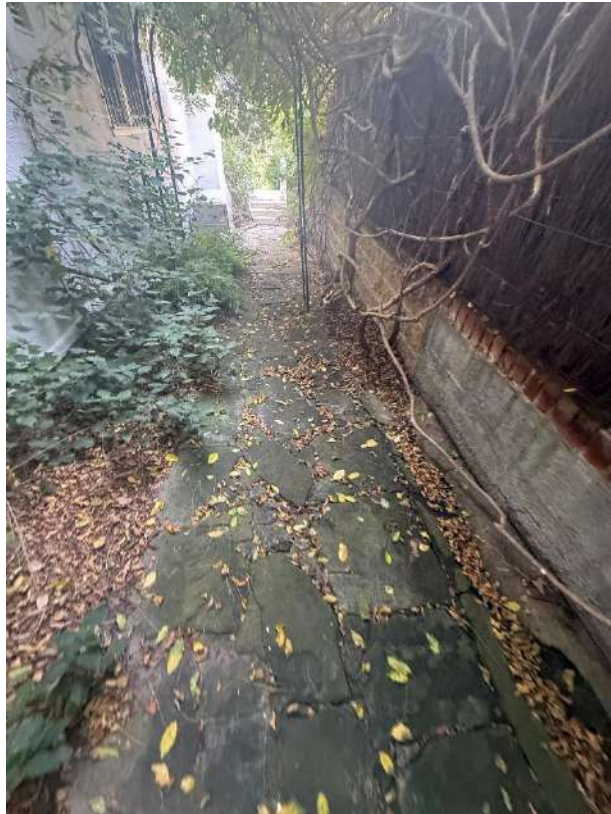
Cracks within the sandstone mortar joints

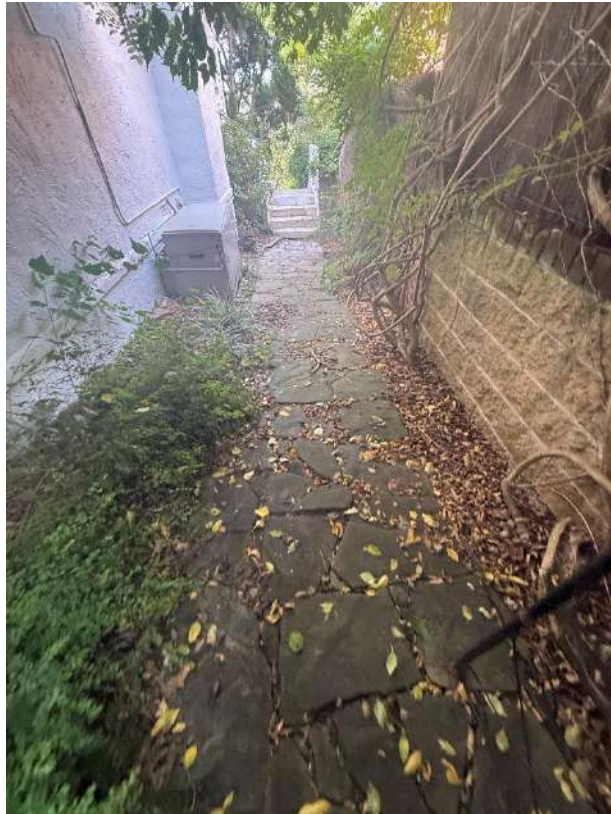
Cracks within the sandstone mortar joints

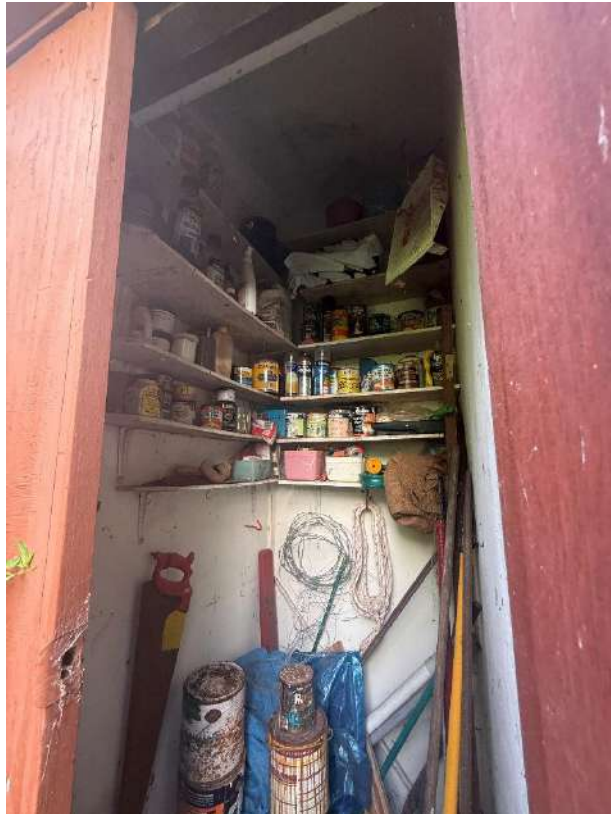
Minor hairline cracks within the outside WC and laundry

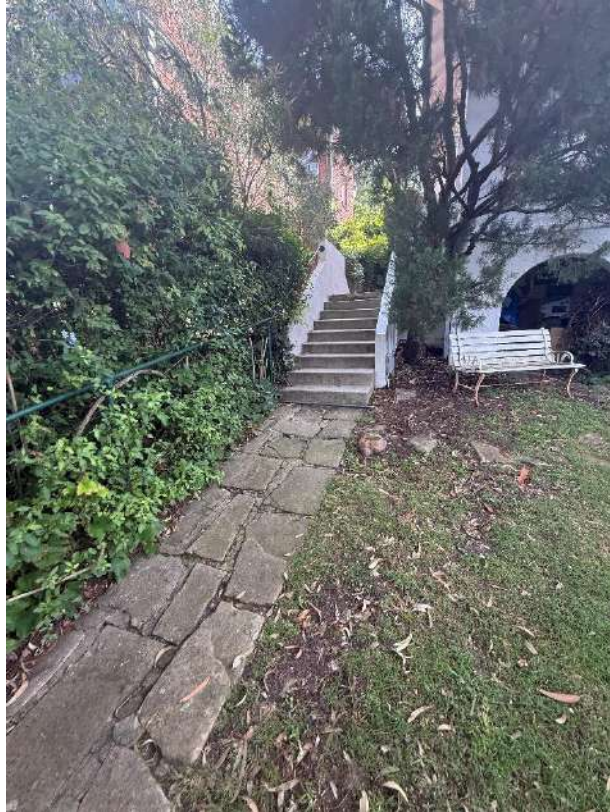
Minor cracks in pathway leading to the front door

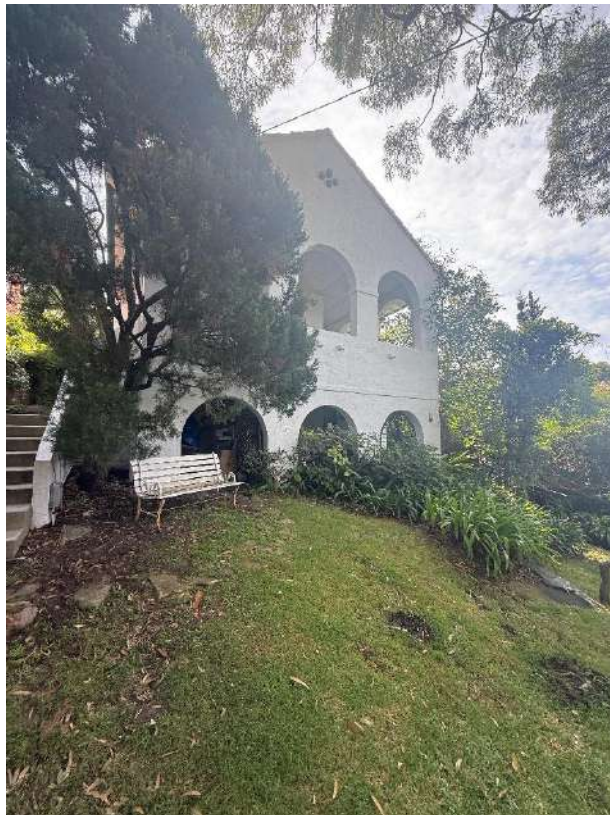
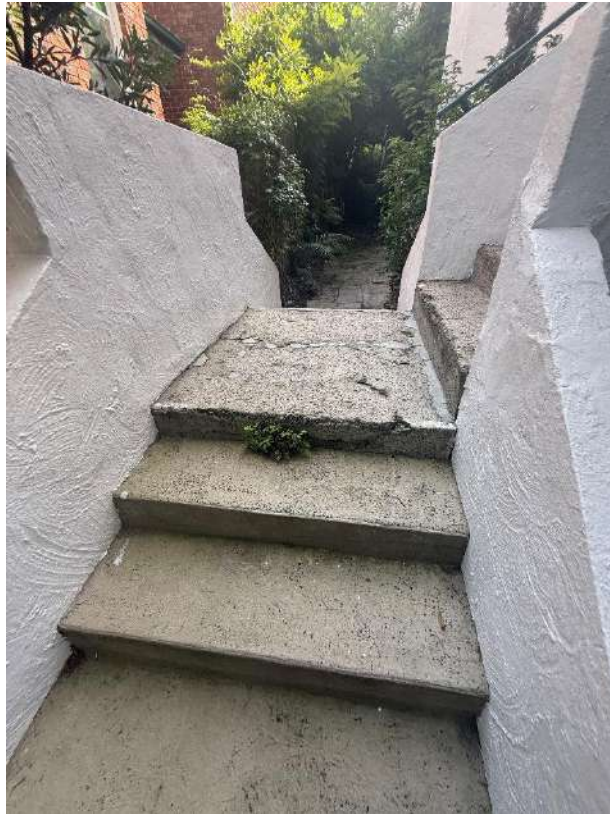
Considerable cracks within the entry stairs and landing leading to the front door

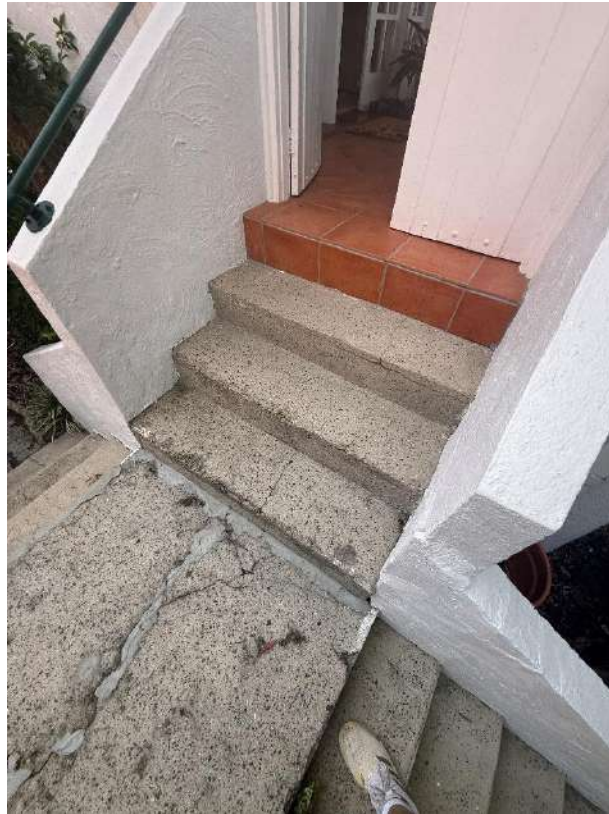
Considerable cracks within the entry stairs and landing leading to the front door

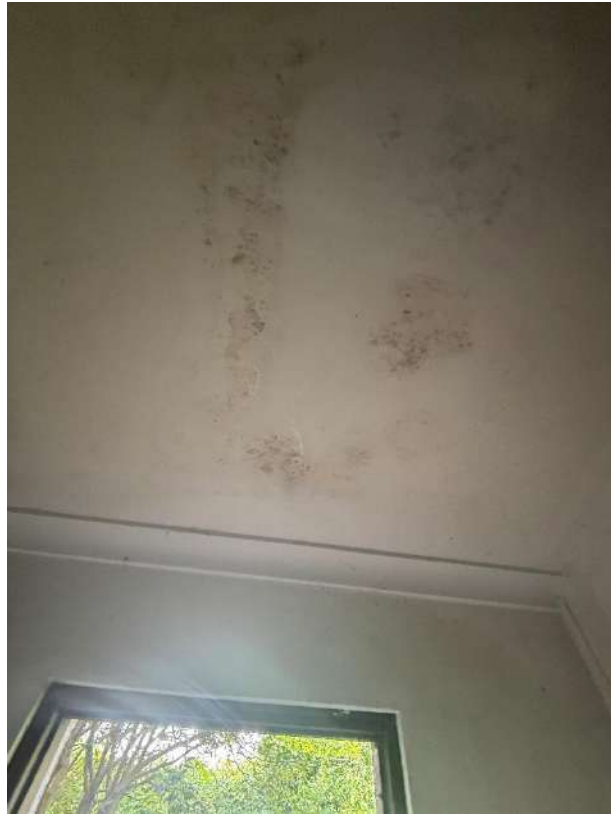
Moisture damage within the ceilings outside bathroom

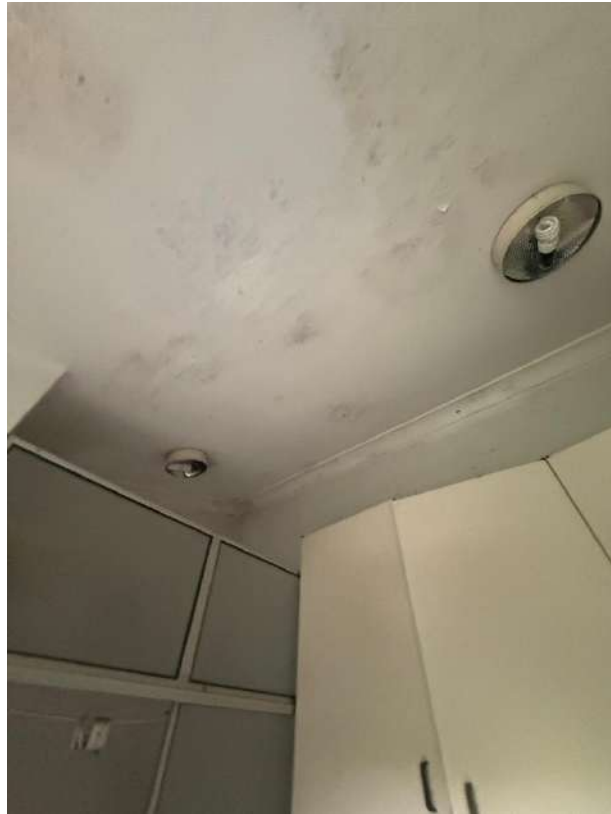
Moisture damage within the ceilings outside bathroom laundry

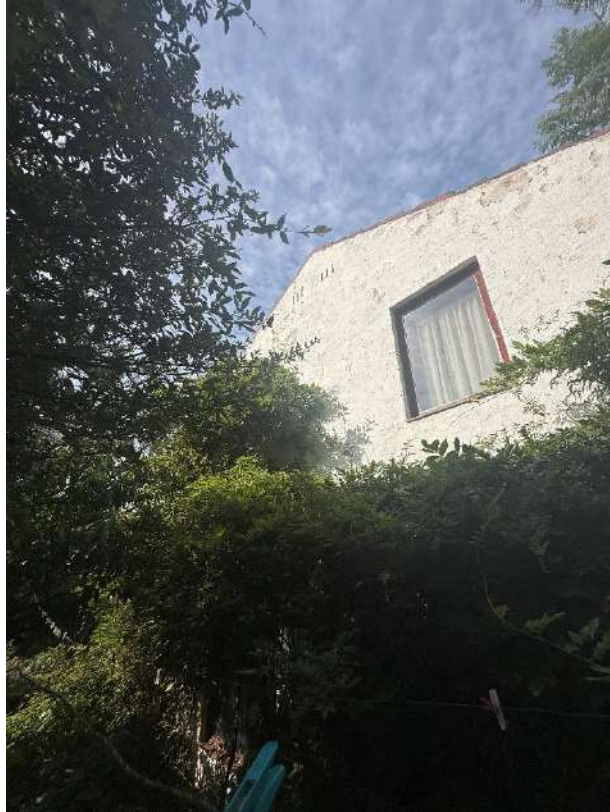
Flaking and cracks seen within the first floor re-elevation masonry walls

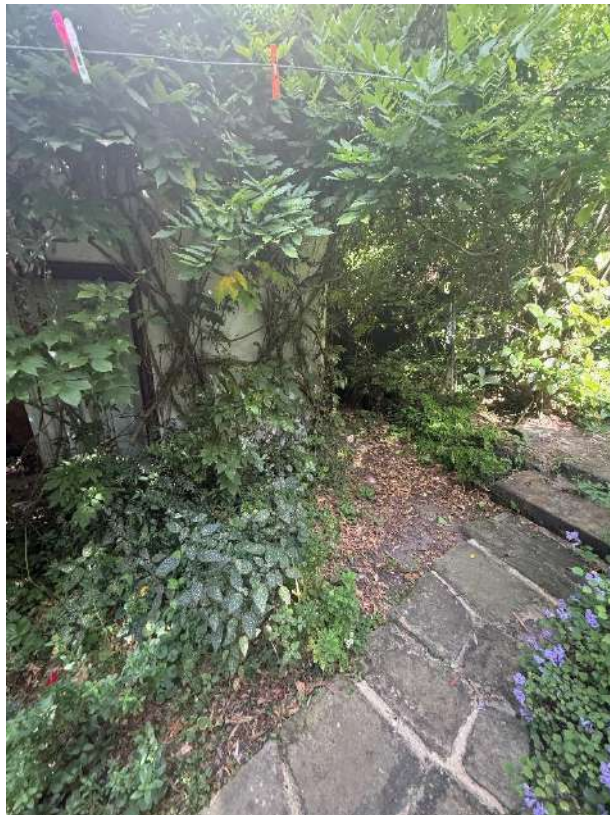
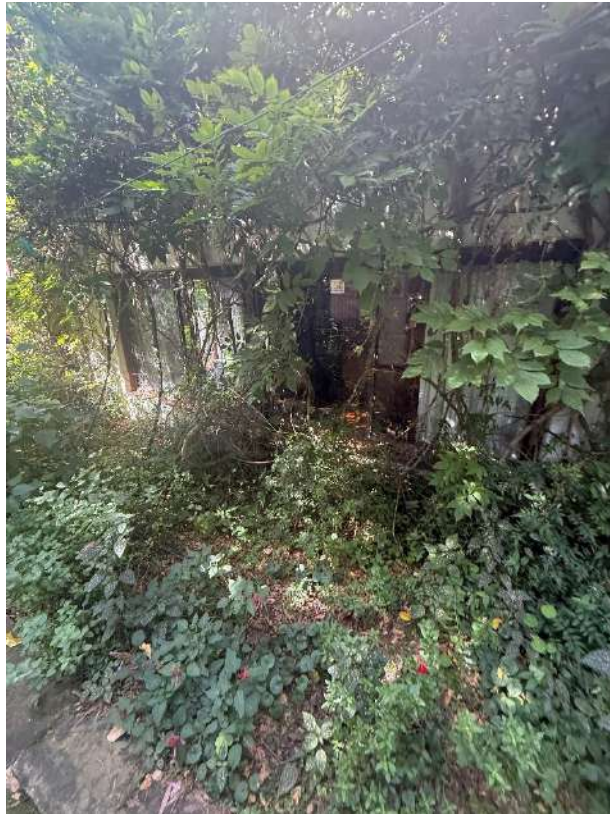
Dilapidated timber boundary fence

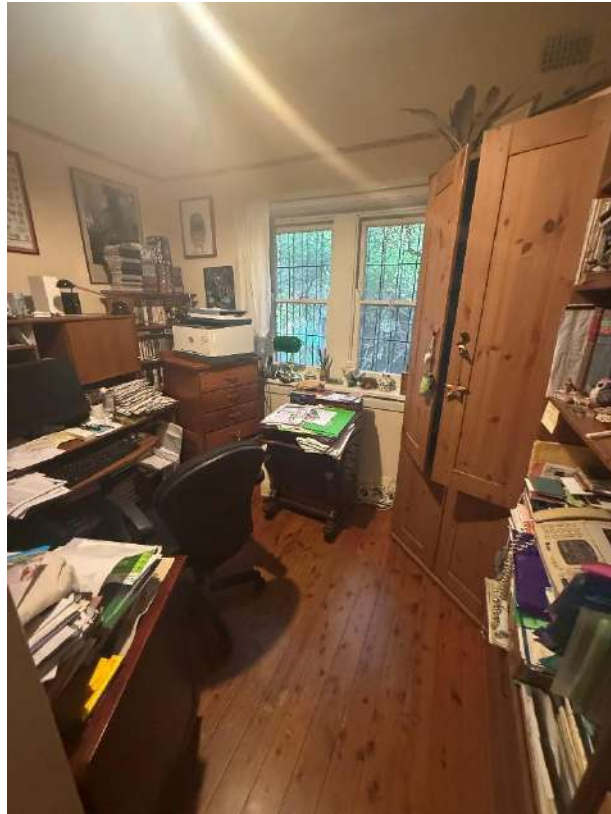
No cracks sighted

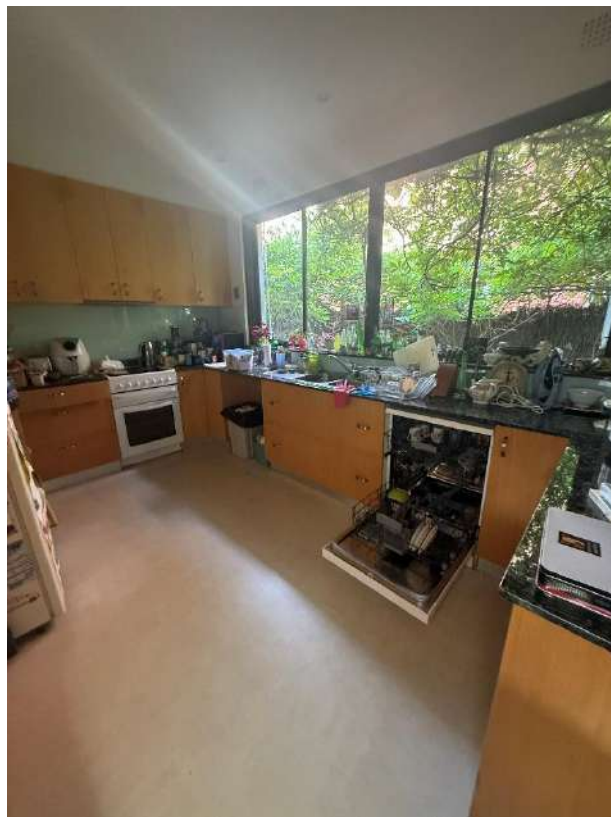
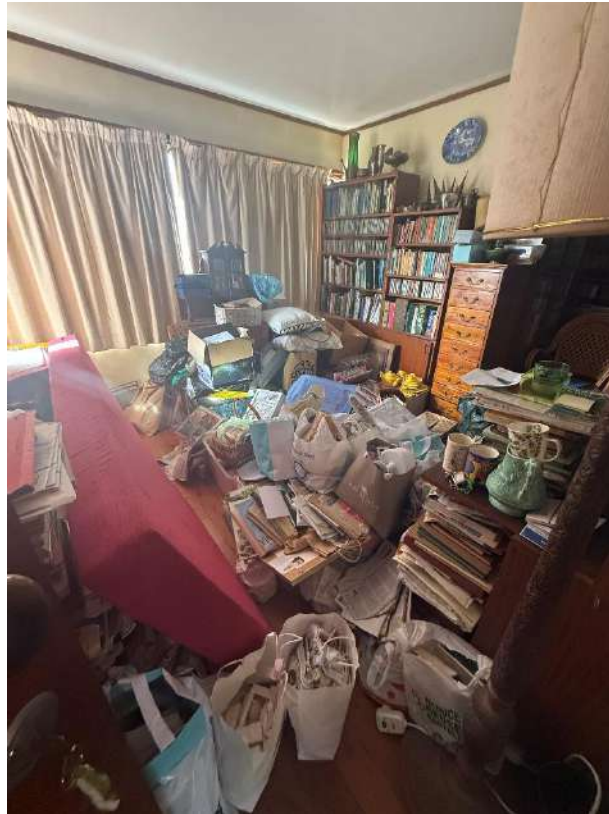
No cracks sighted. However, home is overfilled with personal belongings throughout the internal elevation obstructing my sight to all walls and floors
