# **Dilapidation Report For The Development At: 26 Edwards Bay Rd, Mosman**

## Dilapidation Report Carried Out On:

24 Edwards Bay Road

30<sup>th</sup> April 2026

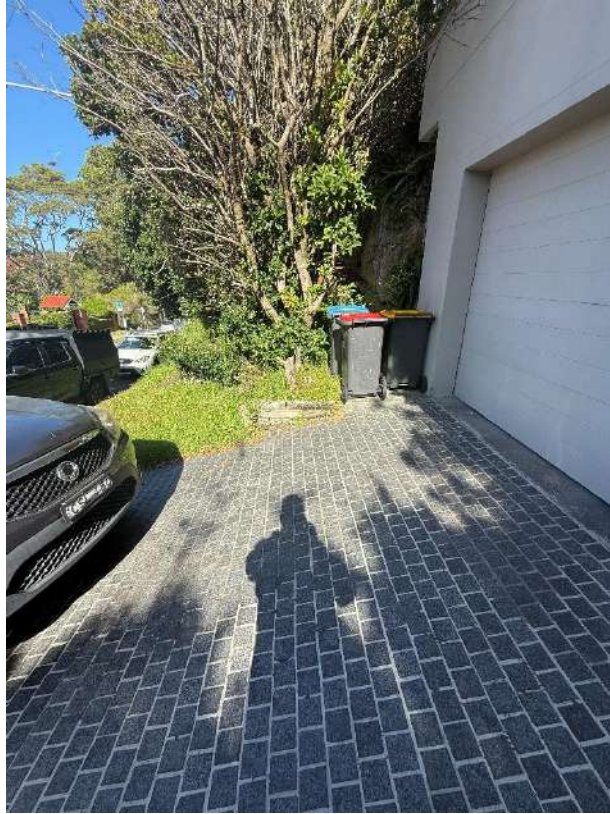
Top-left corner of garage masonry wall minor hairline cracks

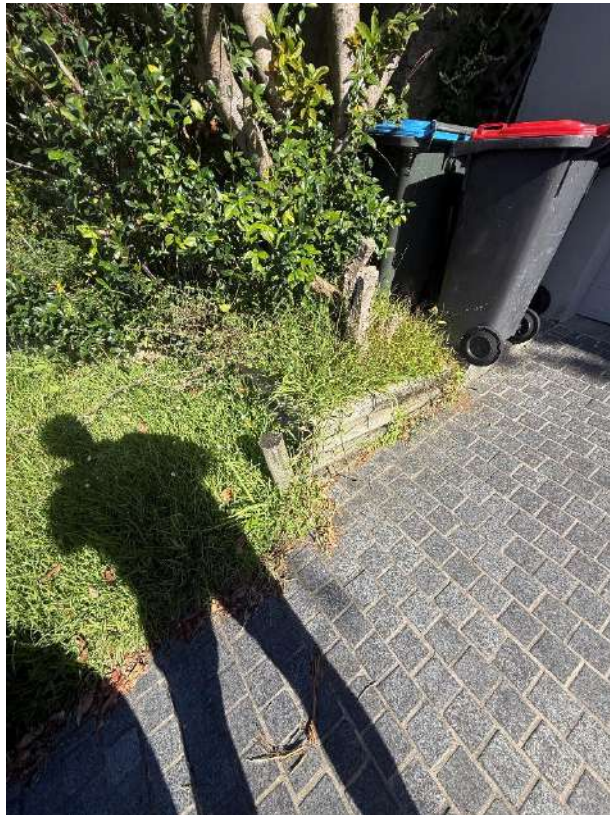
Top-left corner, minor hairline cracks within the masonry wall abutting the sandstone boulder

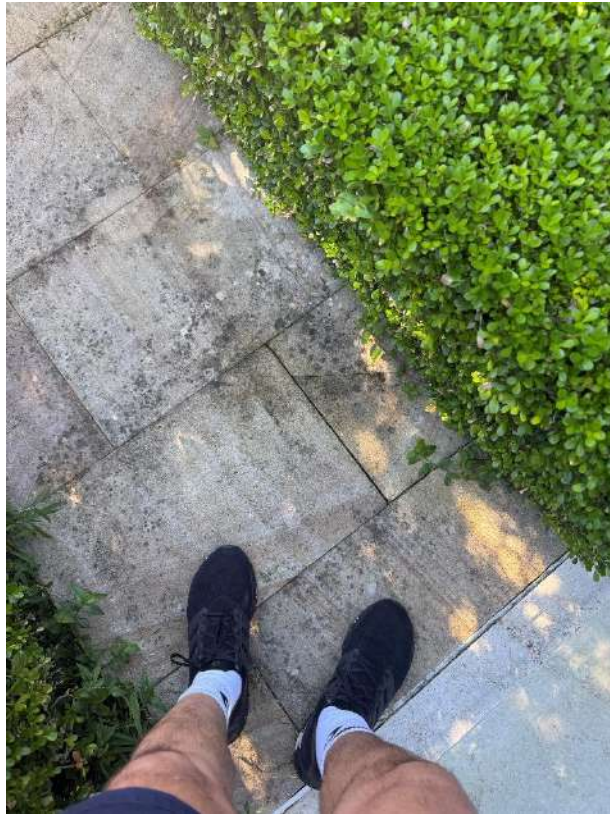
Pathway sandstone flagging cracks running through the sandstone pavers

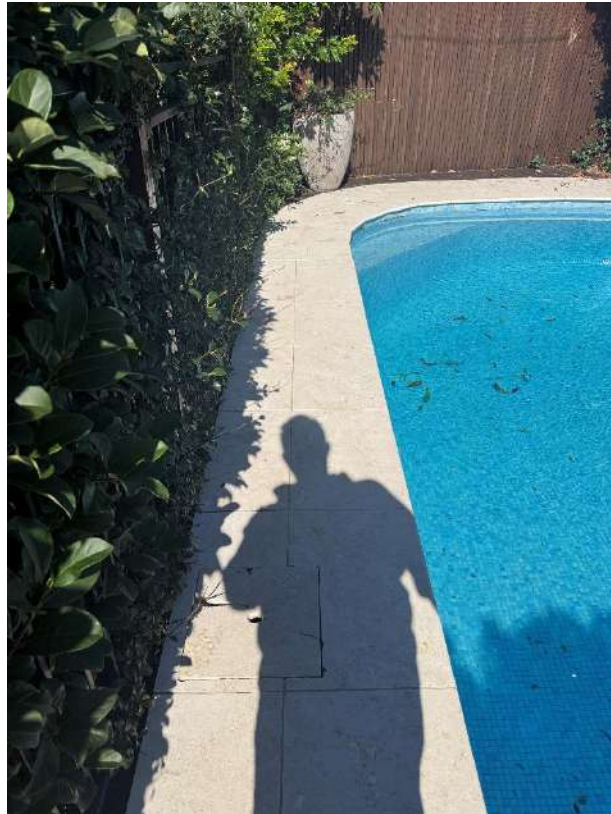
Cracks within the pool skimmer box cover

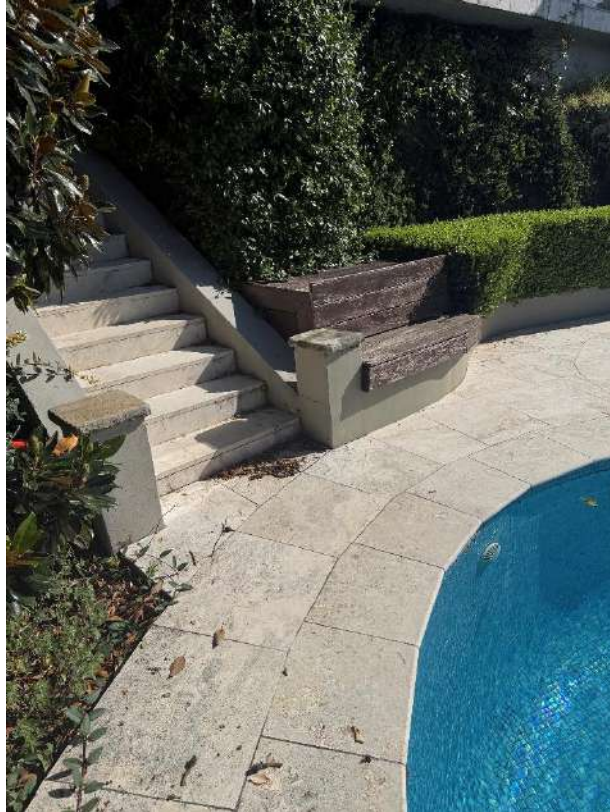
Crack within the staircase side boundary wall and retaining wall junction

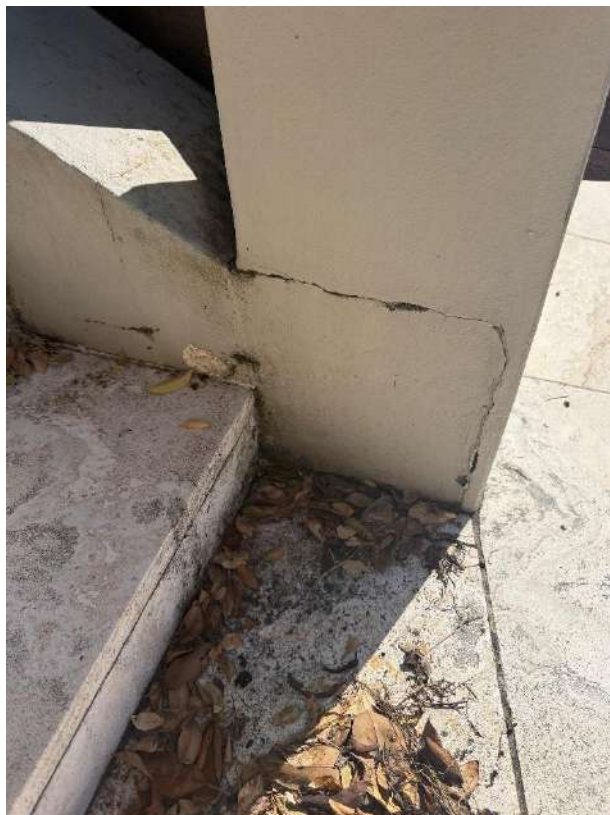
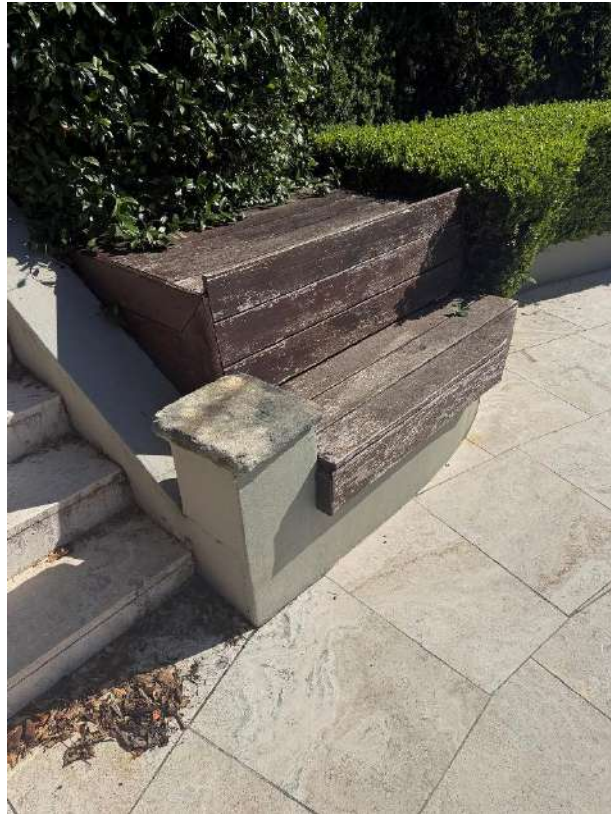
Retaining wall minor horizontal and vertical cracks within the render

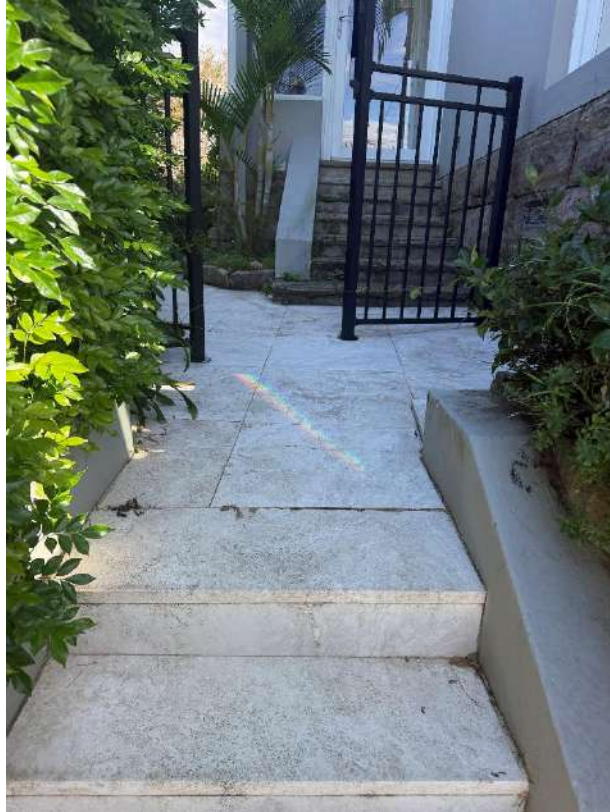
Landing in stairs have cracks through the stone floor tiles

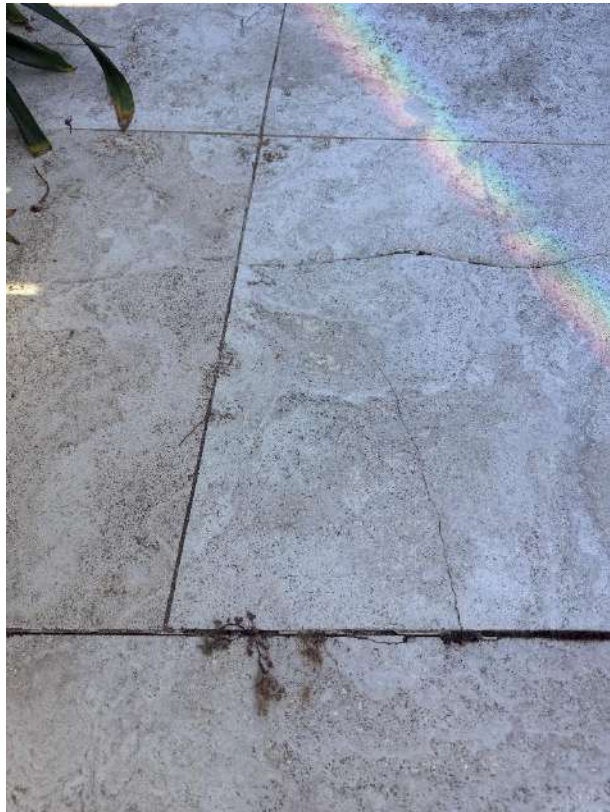
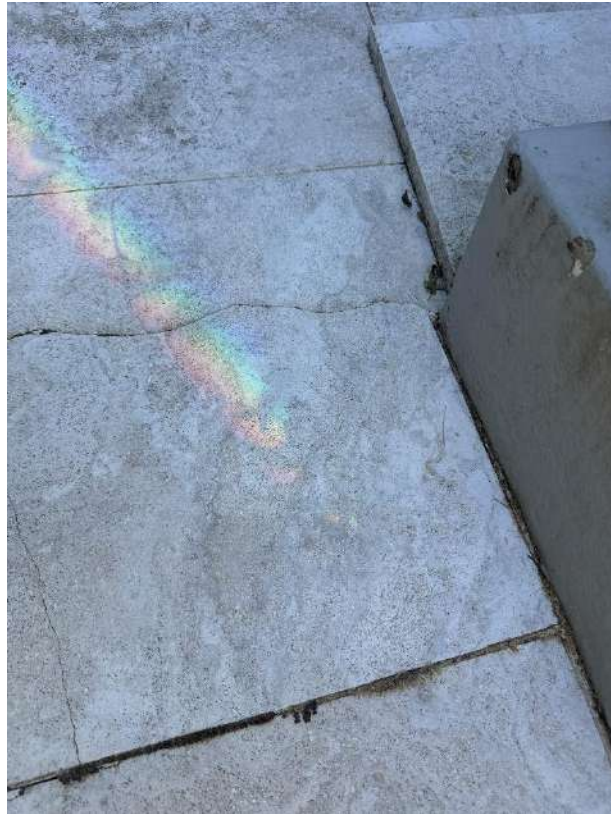
Elevated lifted drummy and cracked floor tiles and pathway

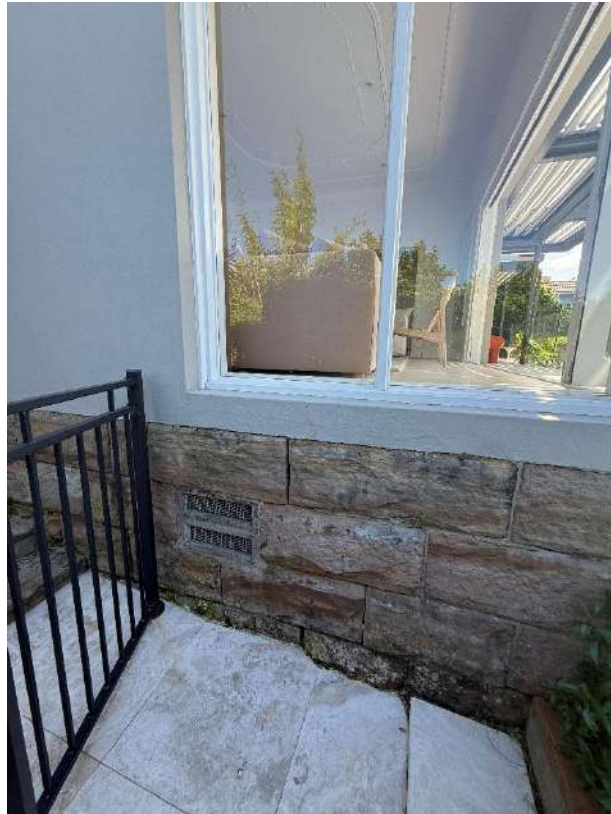
Crack within the external rendered wall below the window

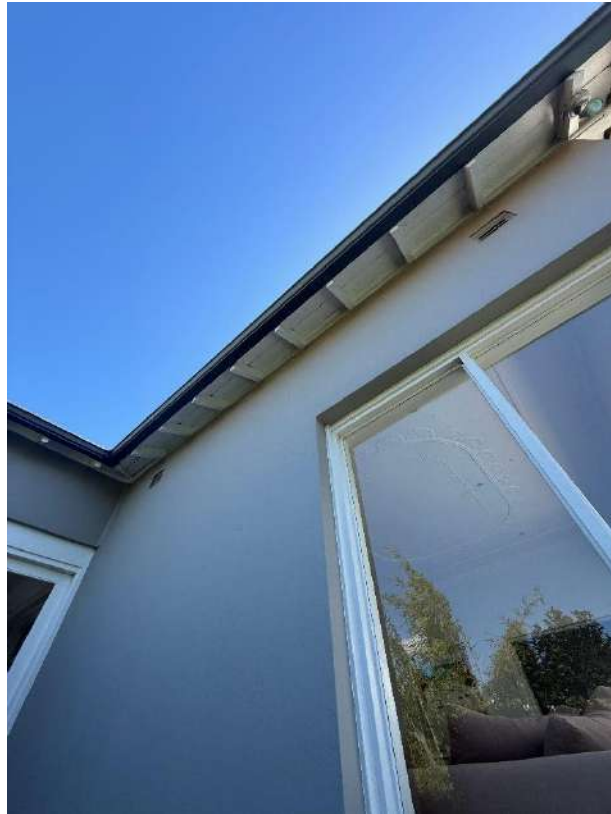
Top-left corner of the window has a vertical and horizontal crack within the external rendered wall

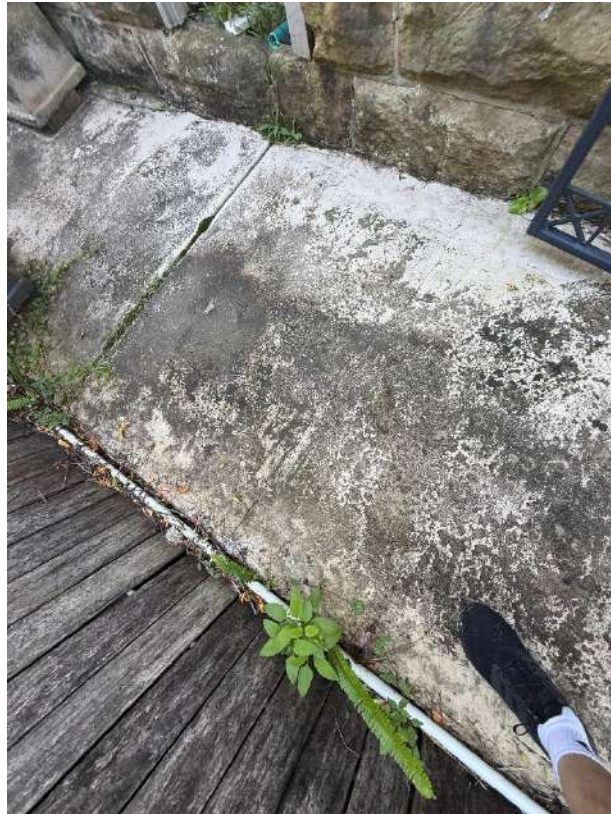
Cracks within the concrete left pathway

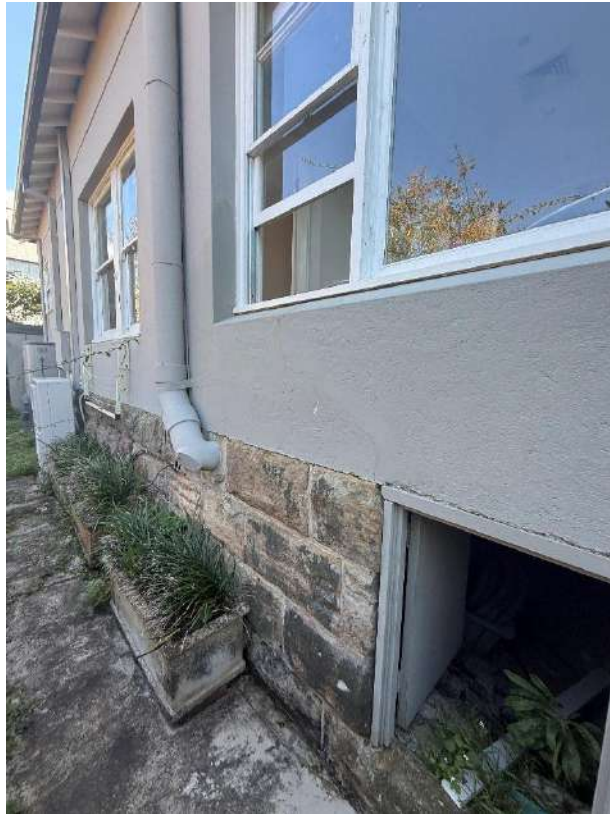
Left elevation of the wall has splayed cracking in the masonry walls

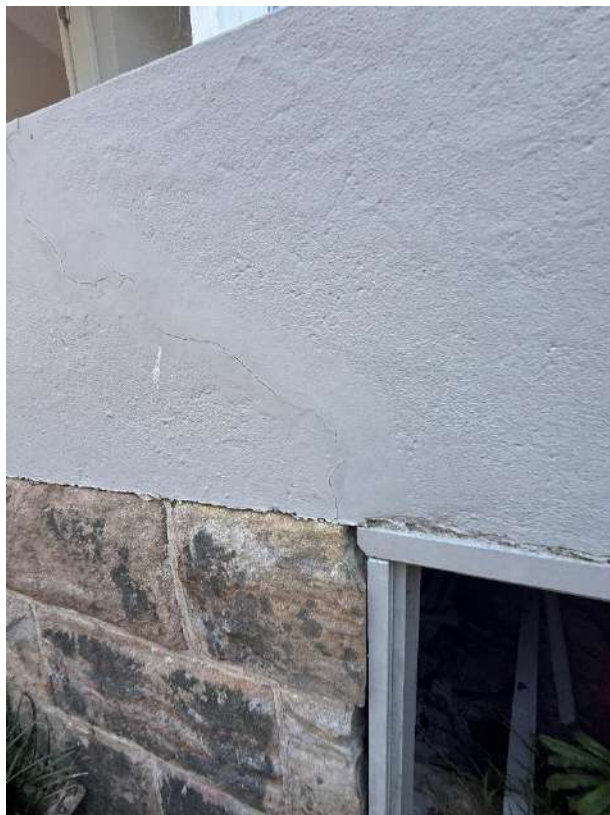
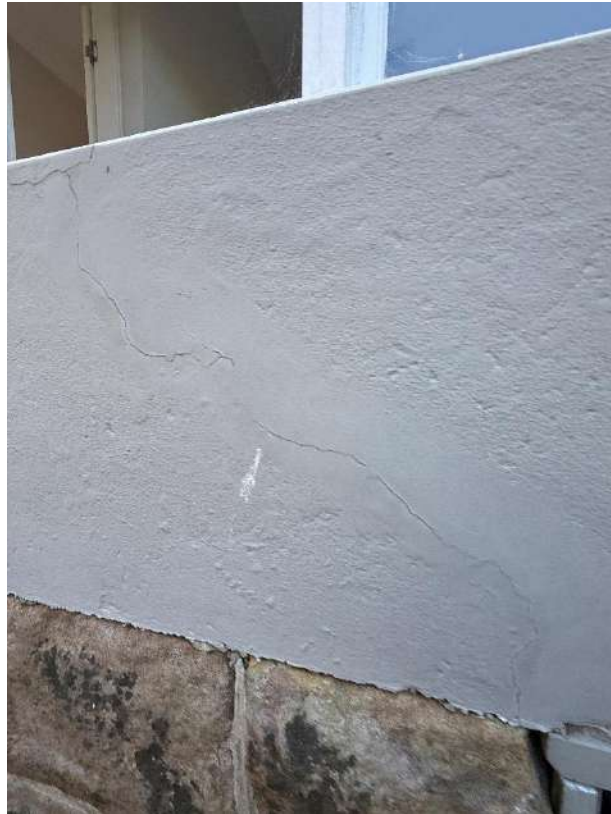
Left elevation of the wall has splayed cracking in the masonry walls

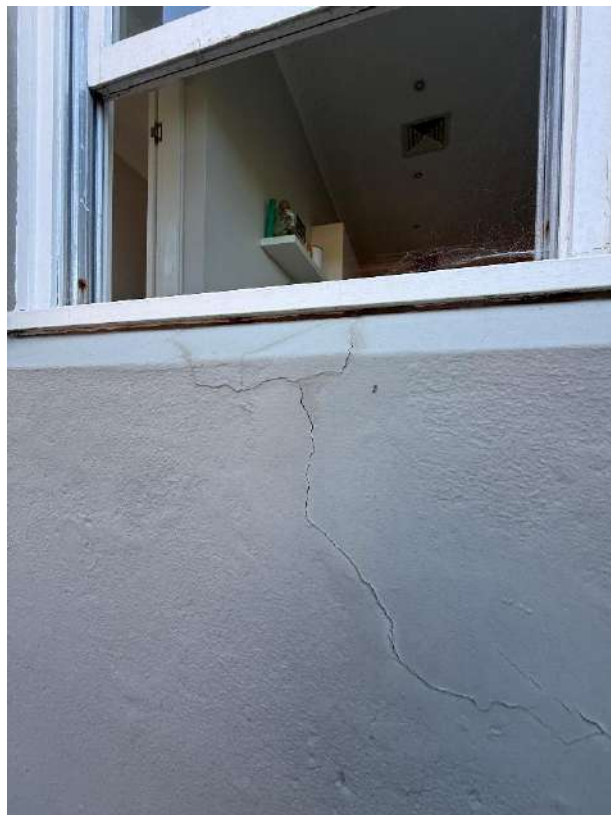
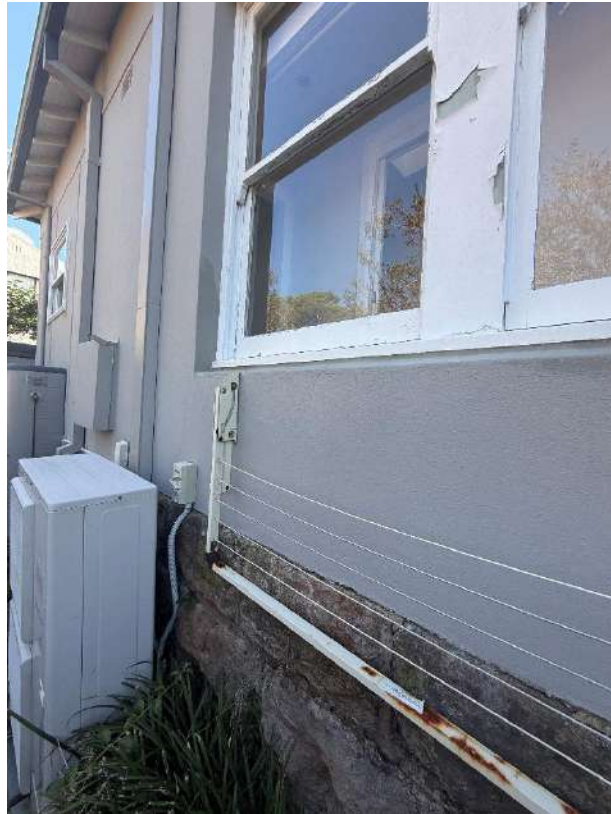
Horizontal and vertical cracks beneath the windows

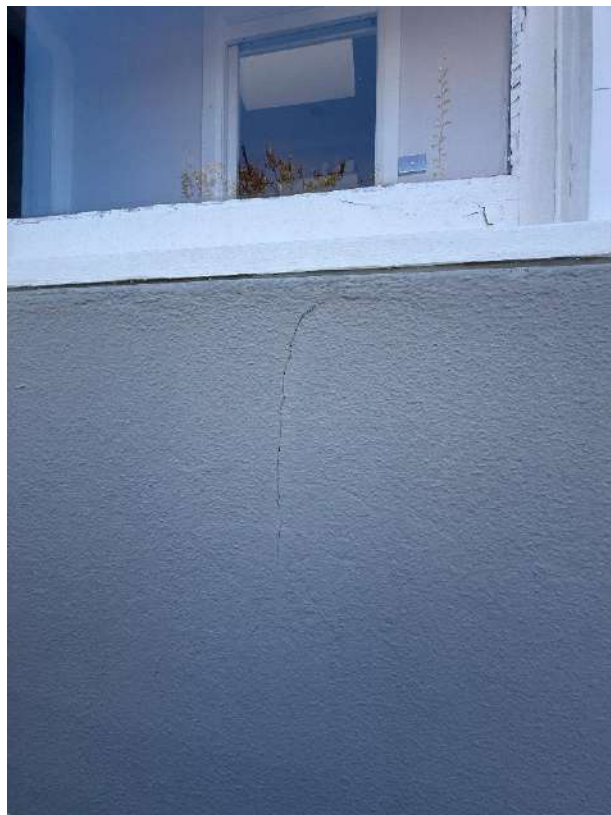
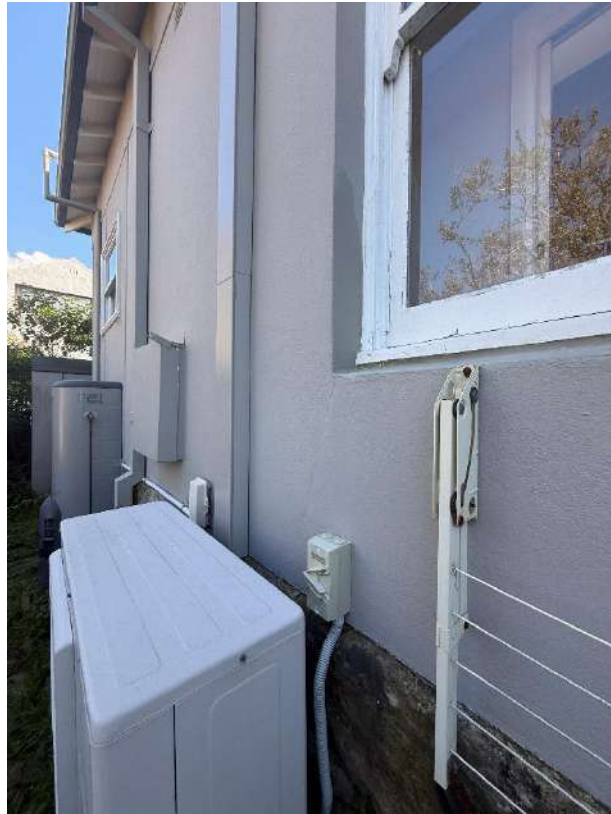
Horizontal and vertical cracks in the masonry wall to the bottom-left of the window

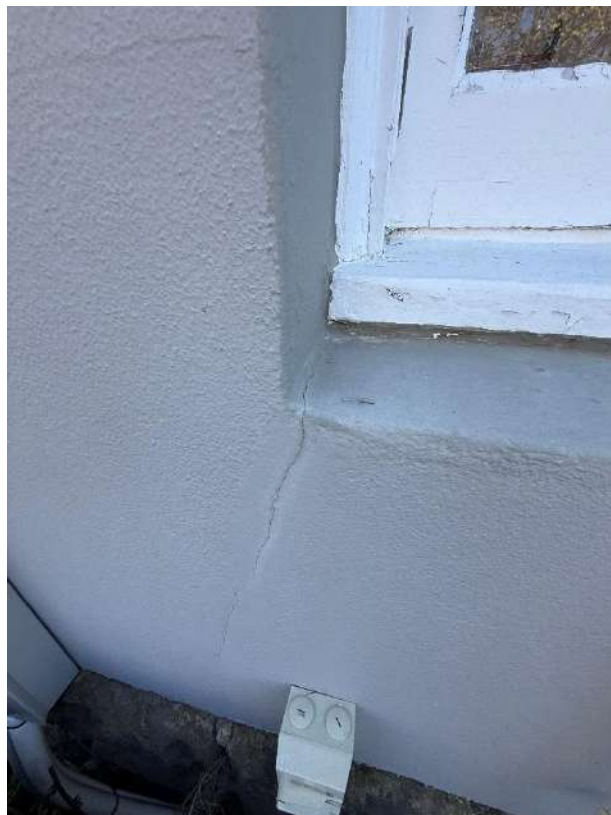
Horizontal and vertical cracks in the masonry wall to the bottom-left of the window

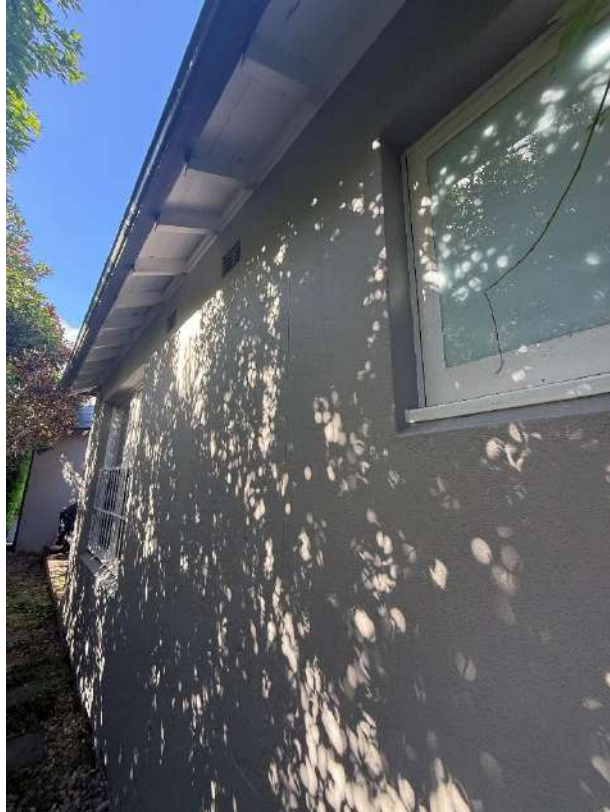
Vertical cracks seen within the external masonry walls running the whole length of the walls from floor to eave linings

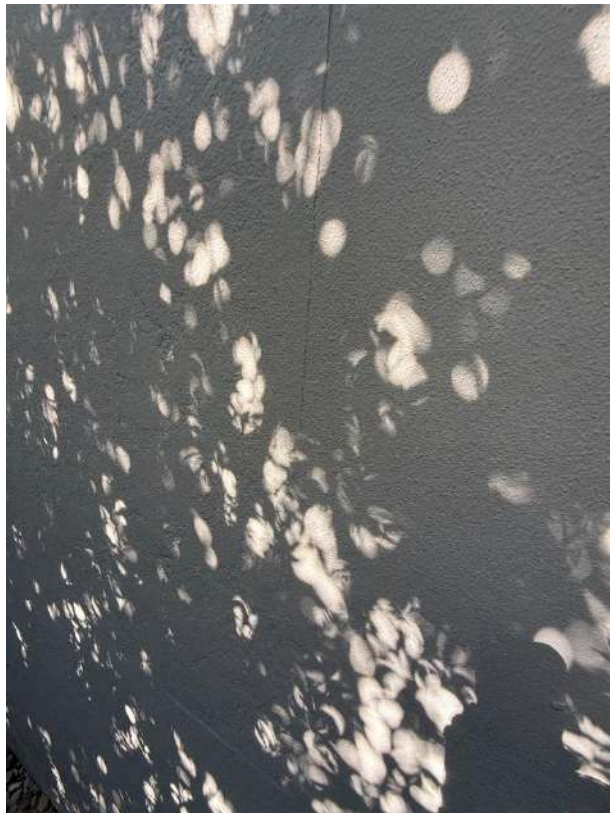
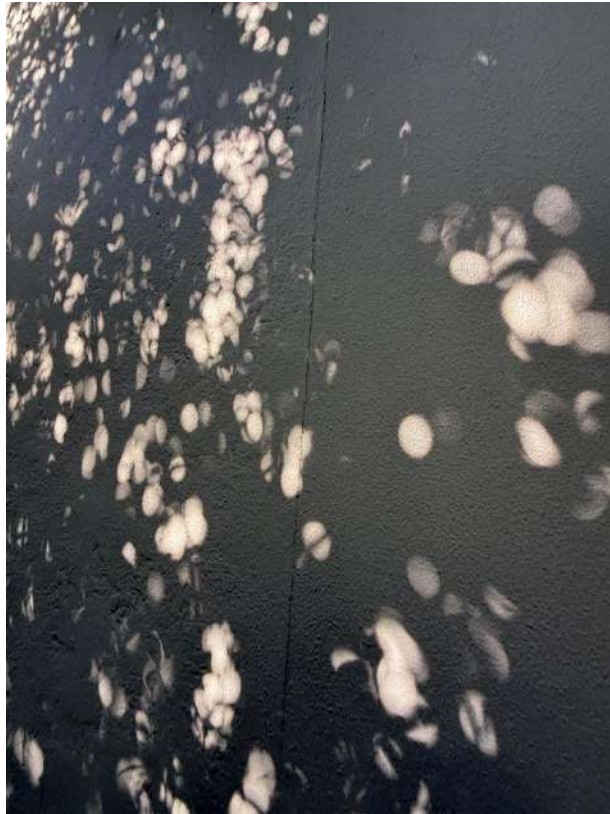
Vertical cracks seen within the external masonry walls running the whole length of the walls from floor to eave linings

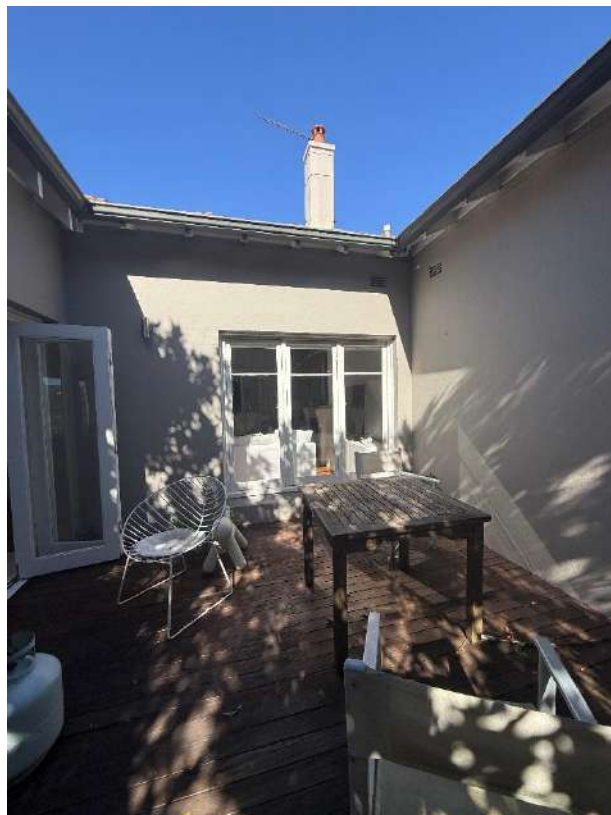
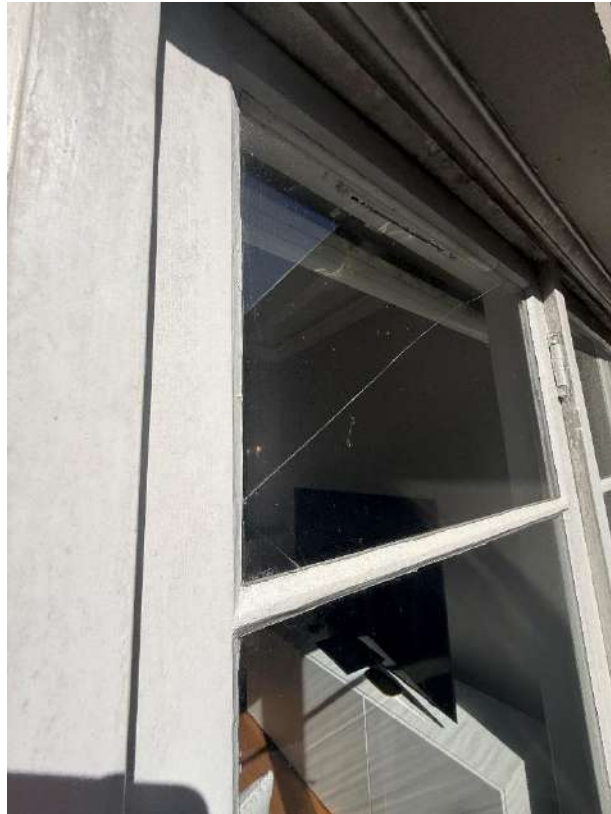
Cracked glass window pane

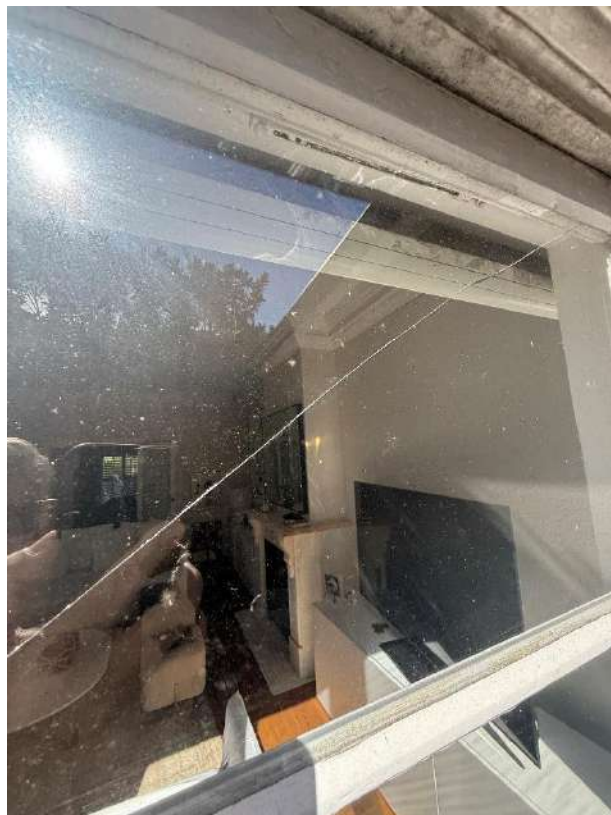
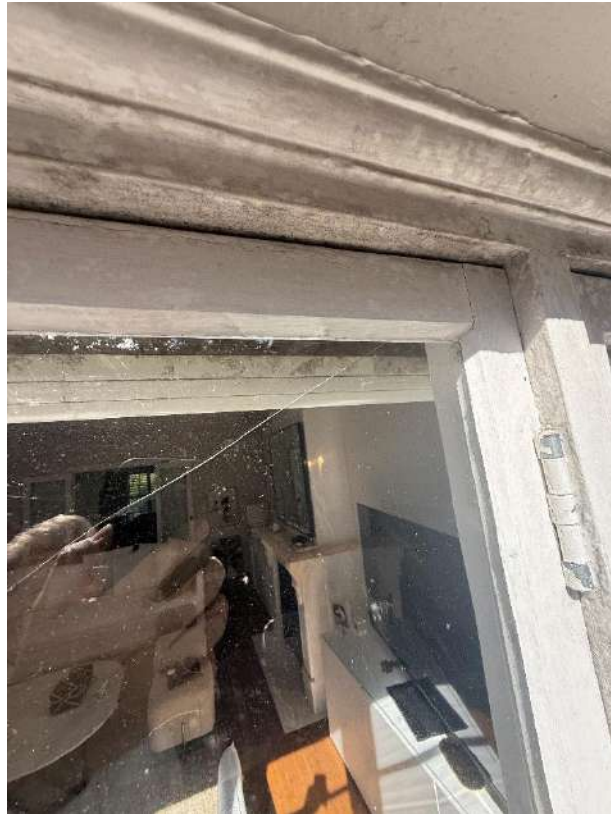
Cracked glass window pane

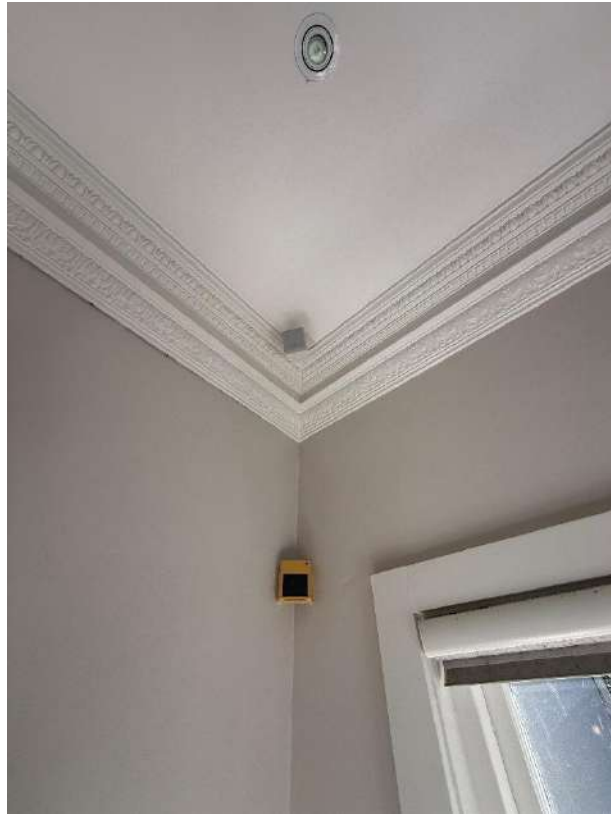
Minor hairline cracks seen within the cornices within the living room ceiling

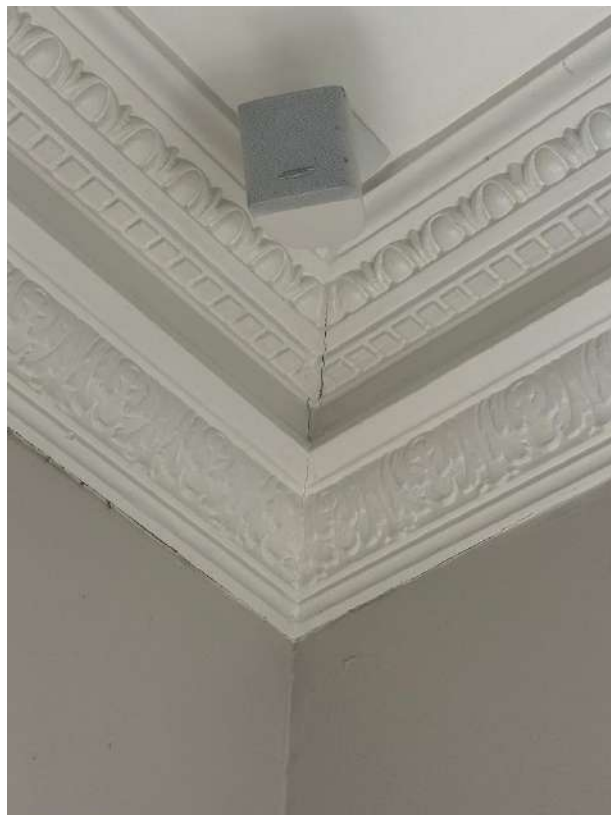
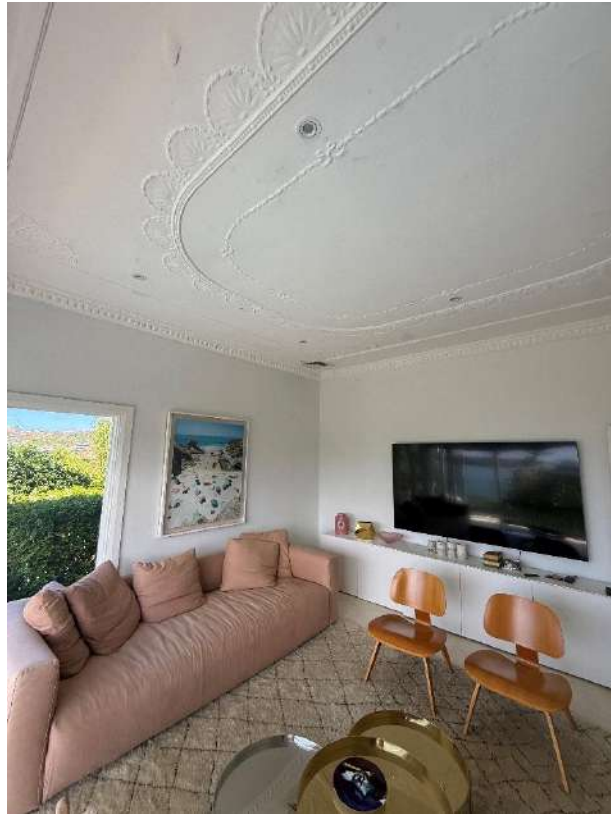
Peeling paint within the living room ceiling and cornices

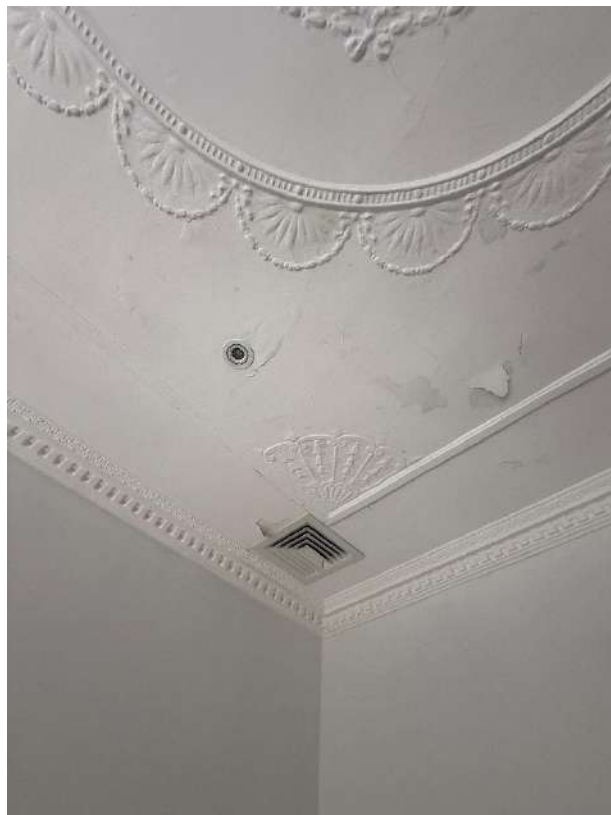
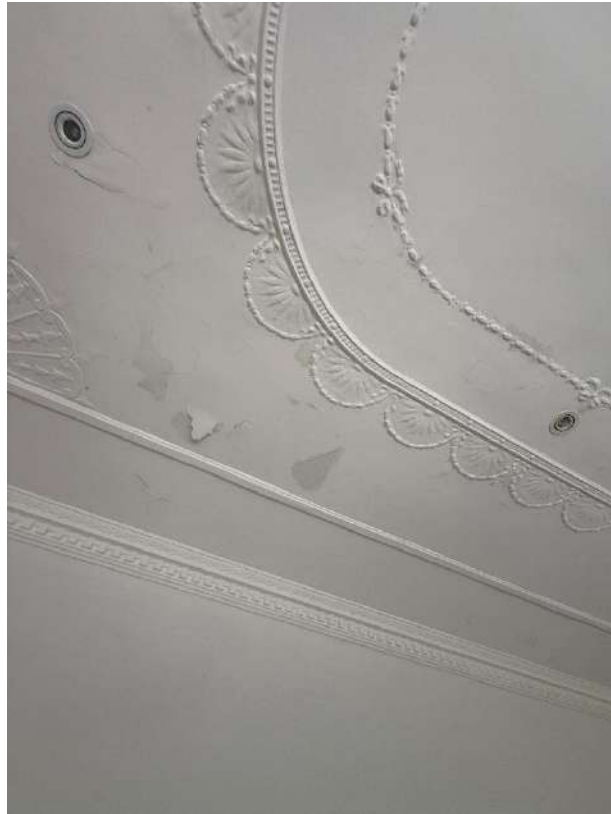
Peeling paint within the living room ceiling and cornices

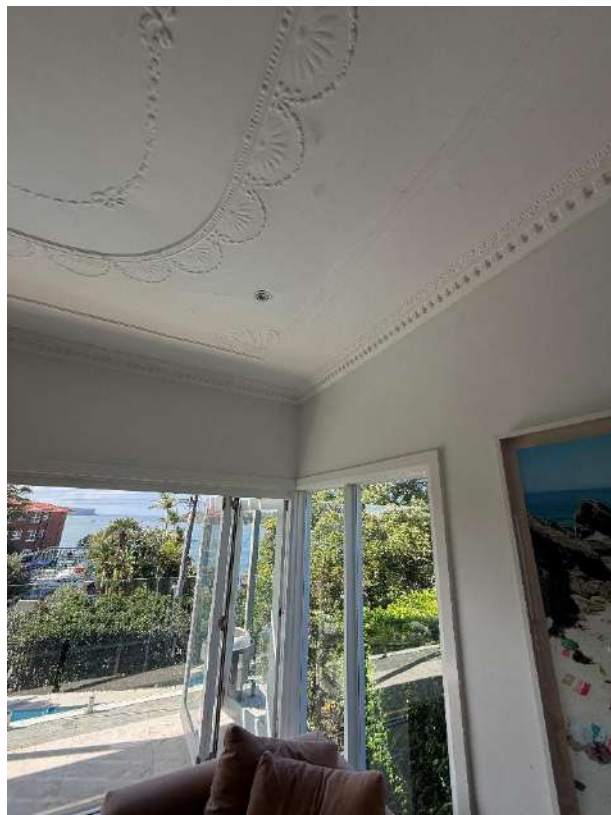
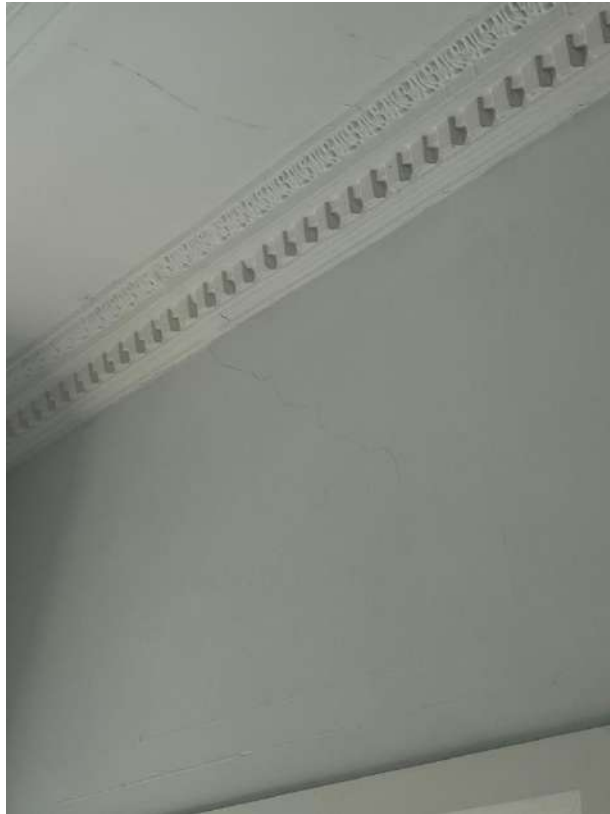
Splayed cracking within the living room walls

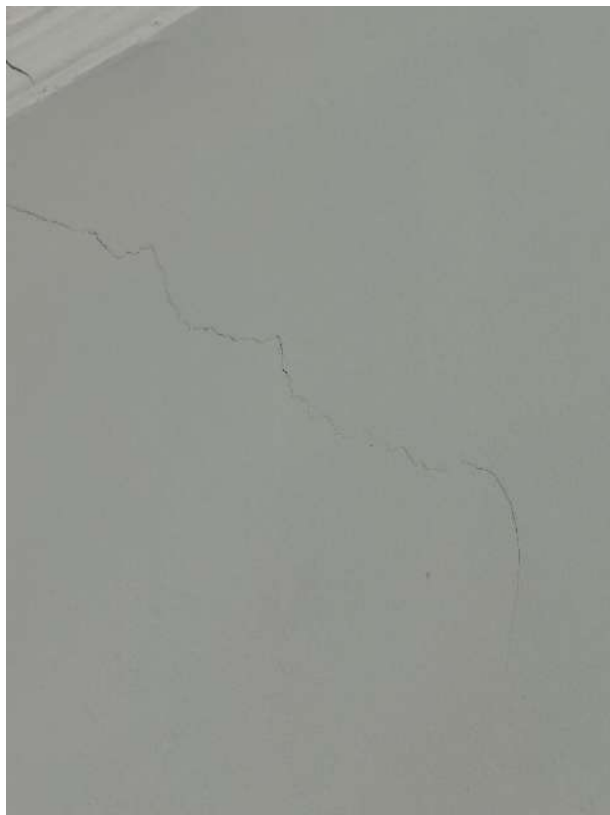
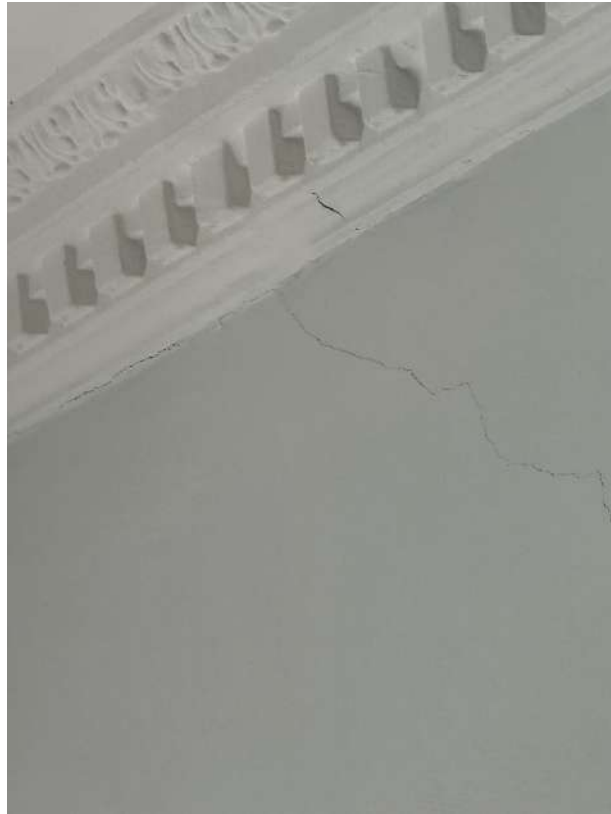
Splayed cracking within the living room walls

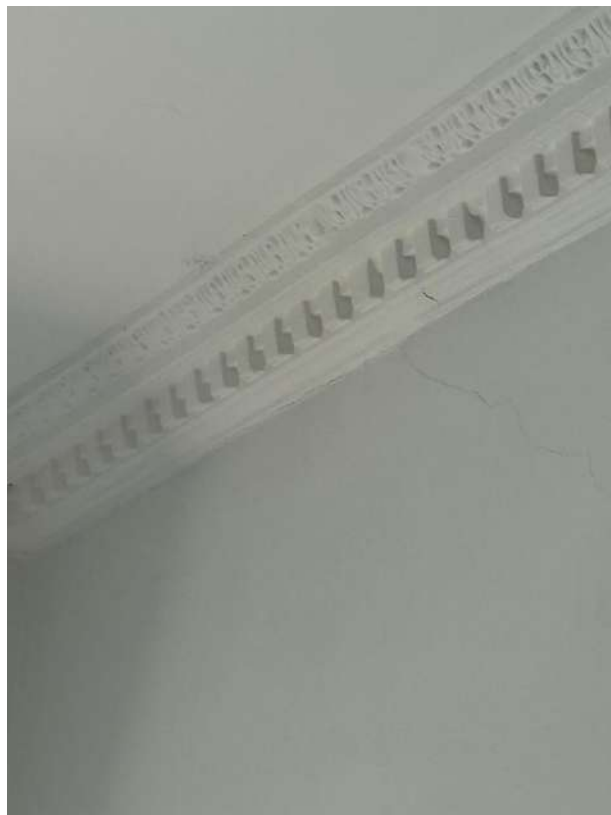
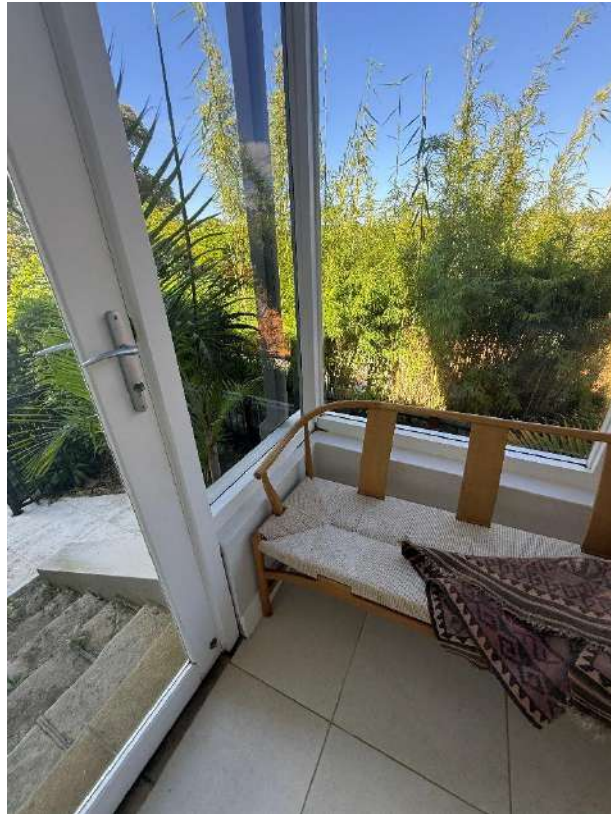
Water ingress within the sunroom window and masonry wall junction

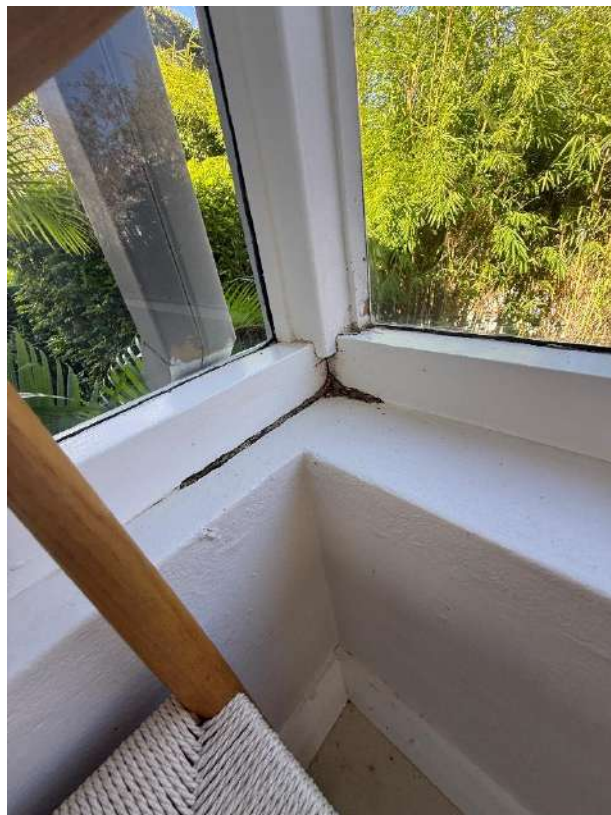
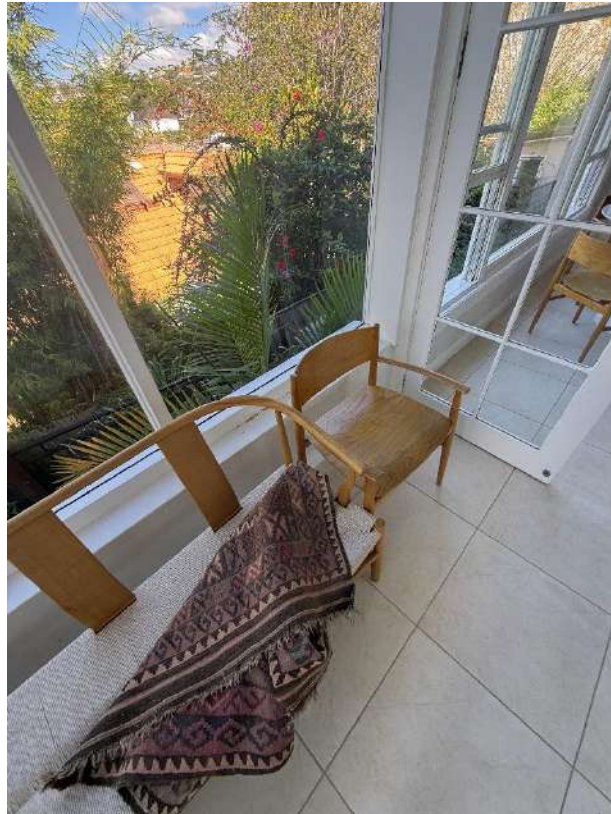
Moisture ingress within the sunroom and wall junction

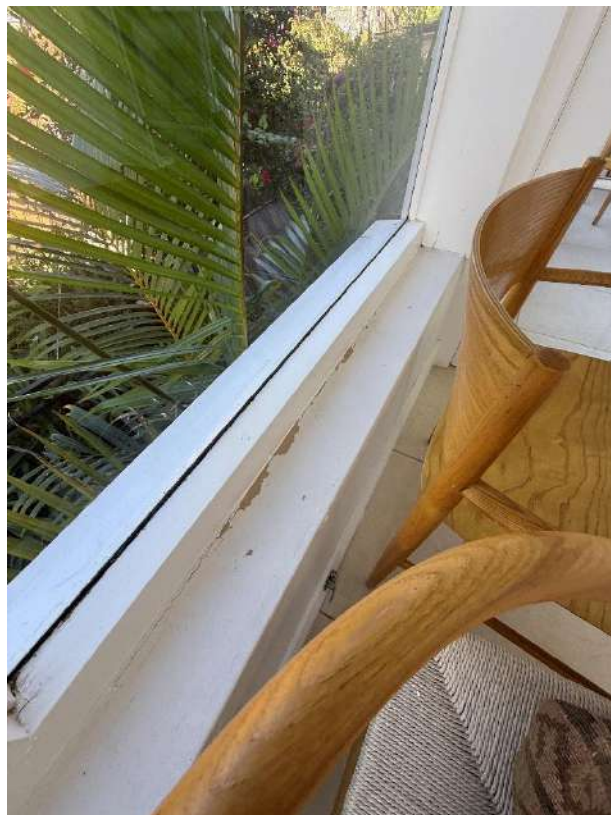
Horizontal cracking within the back office beneath the window frame

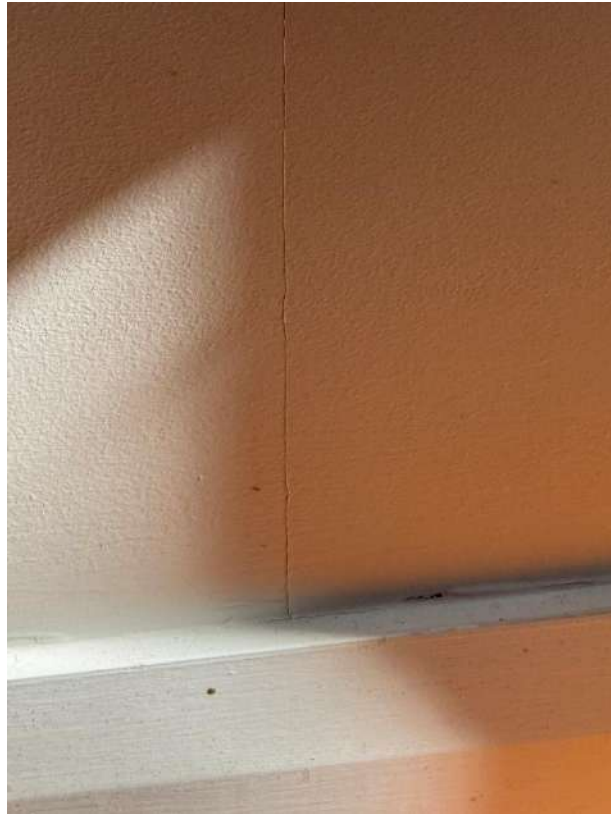
Horizontal cracking within the back office beneath the window frame

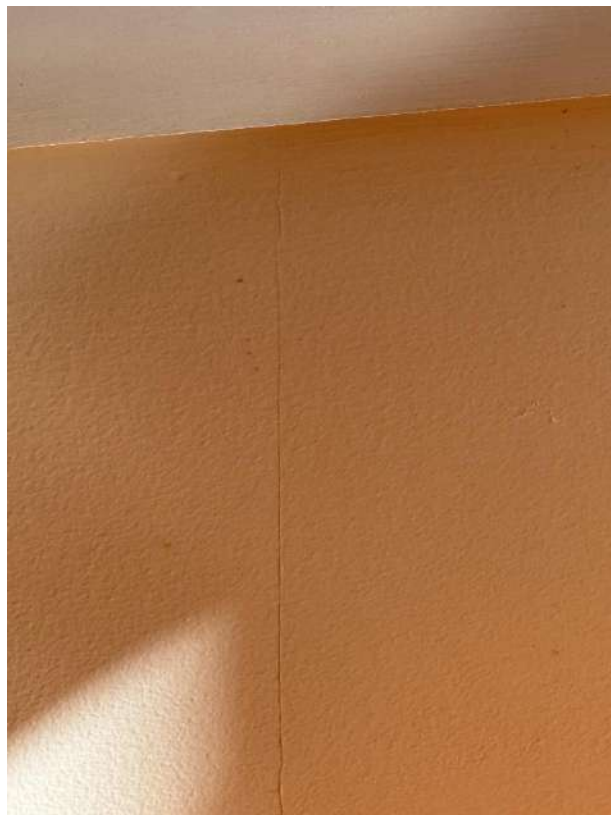
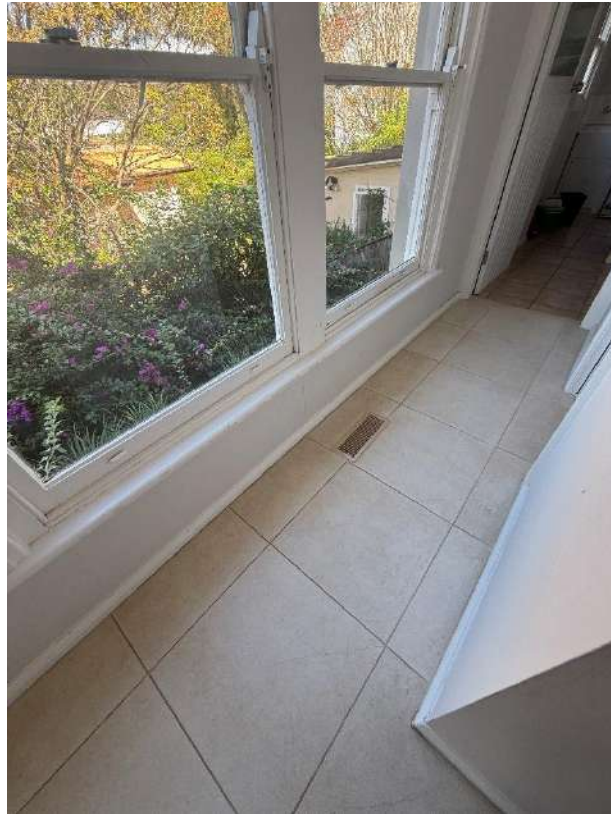
Vertical crack beneath the window within the wall below the double hung window
