# **Dilapidation Report For The Development At: 26 Edwards Bay Rd, Mosman**

## Dilapidation Report Carried Out On:

24 Edwards Bay Road

30<sup>th</sup> April 2026

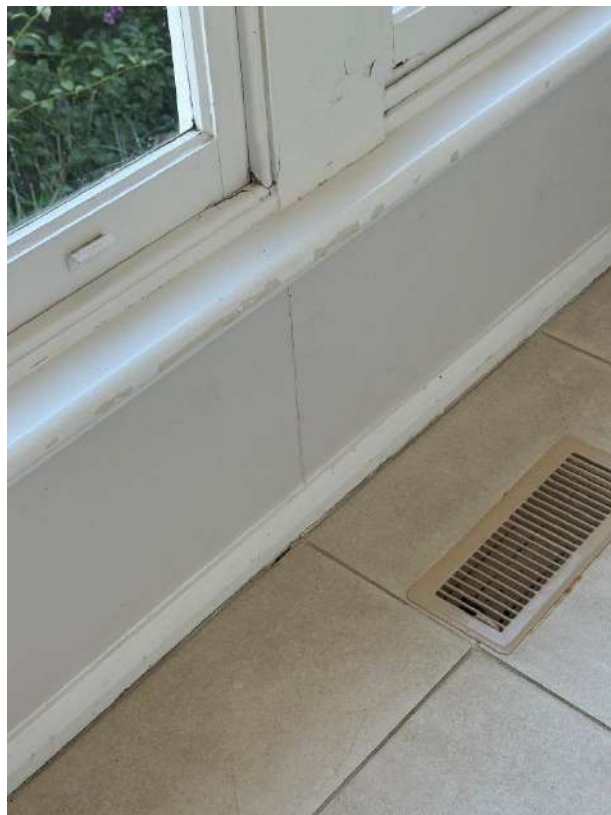
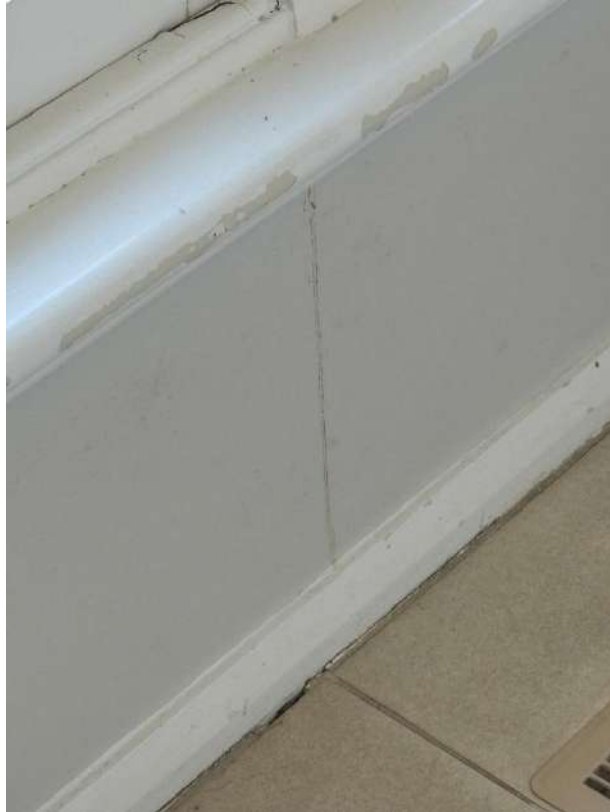
Vertical crack beneath the window within the wall below the double hung window

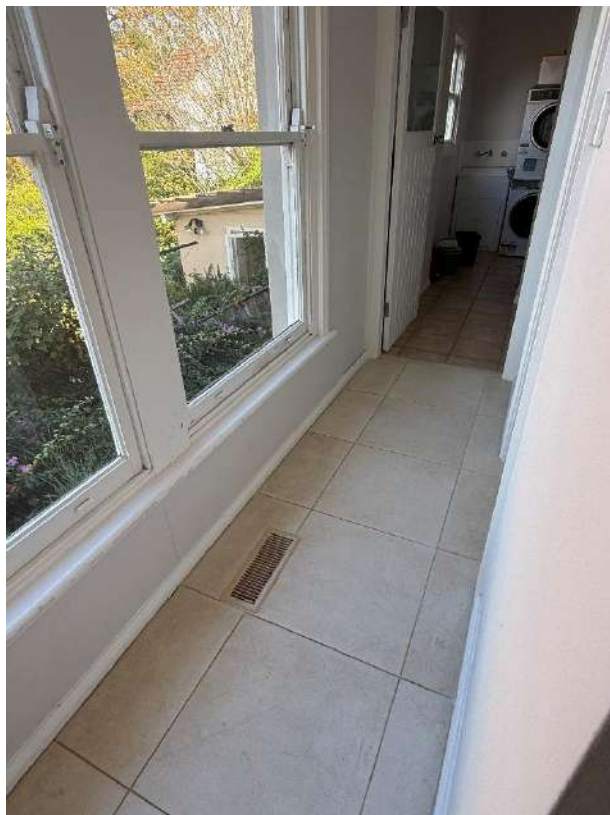
Vertical crack beneath the window within the wall below the double hung window

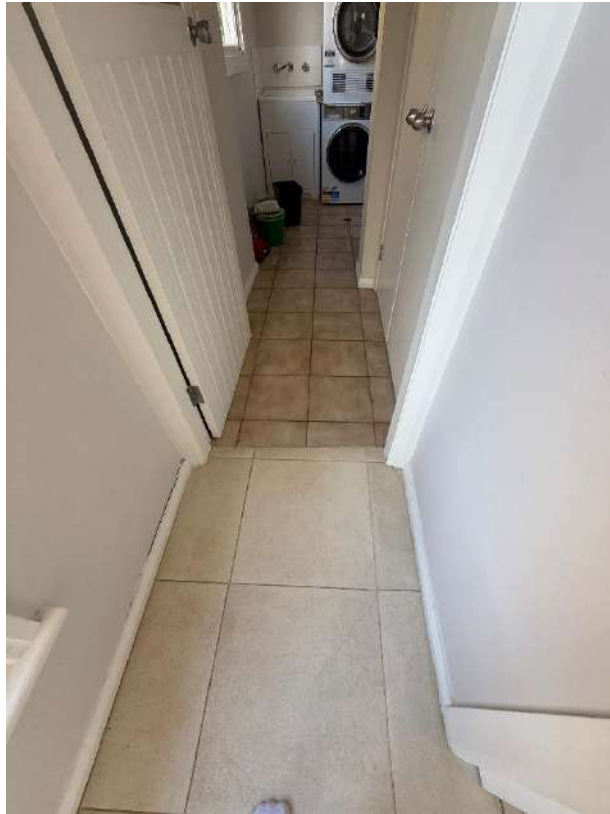
Crack in the floor tiles within the doorway of the laundry

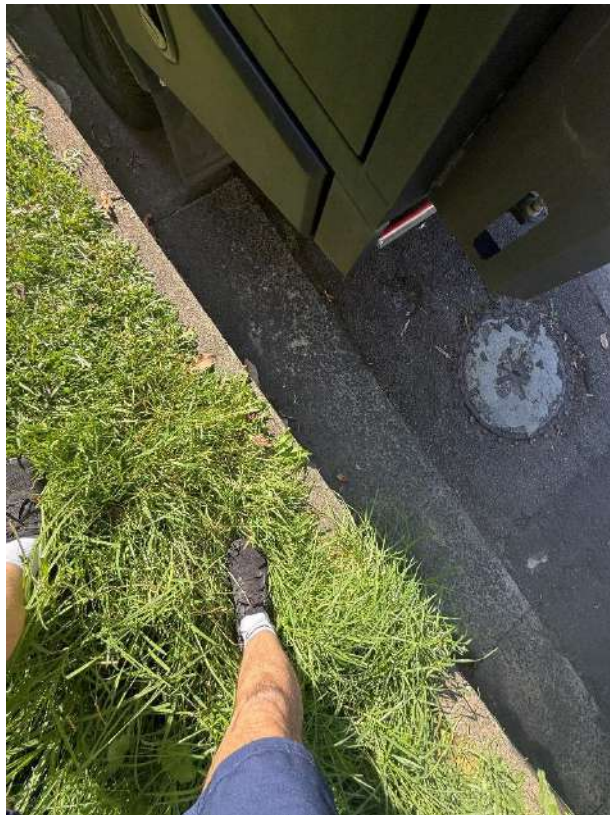
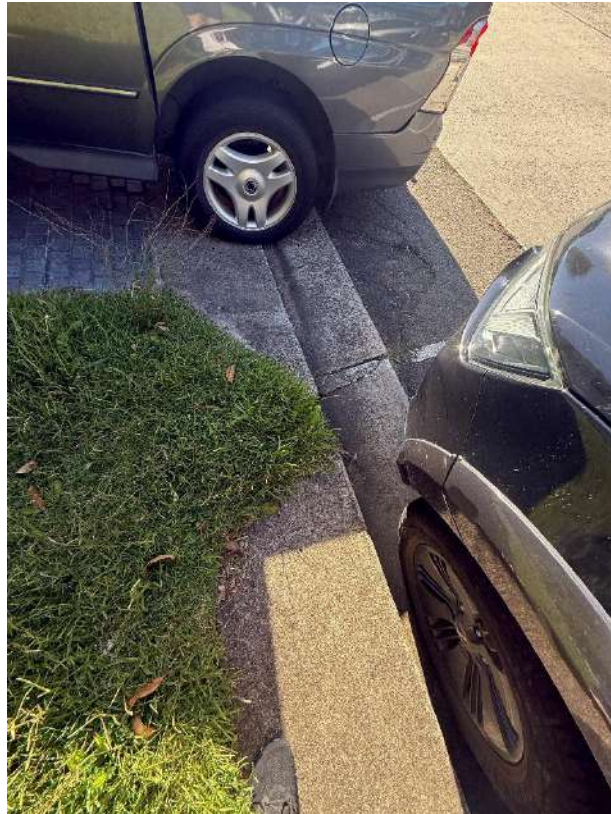
Minor cracks within the concrete curb and gutter

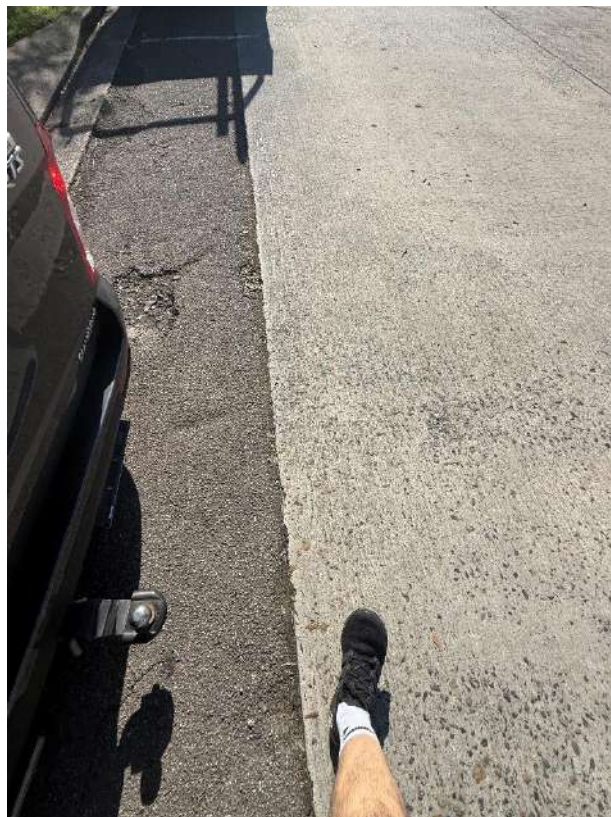
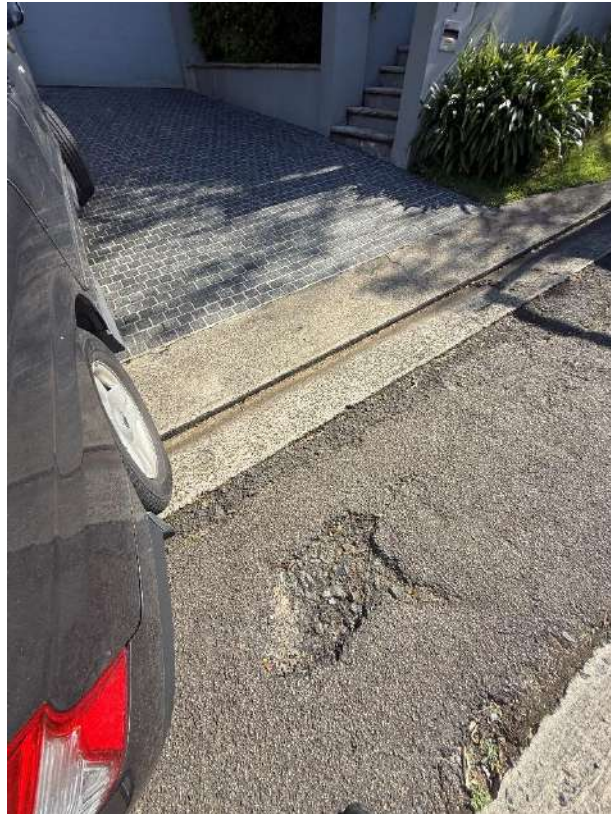
Conditions of bitumen in front of number 1

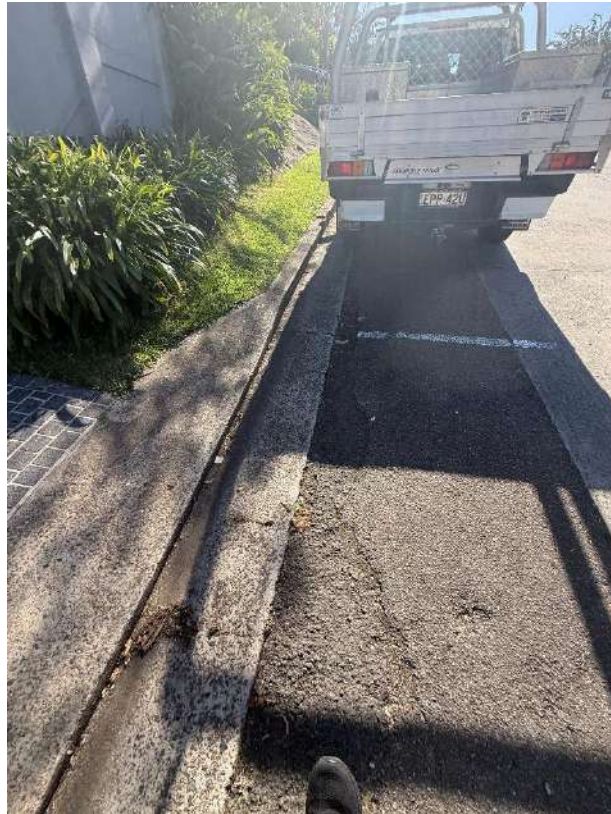
Cracks in curb and gutter

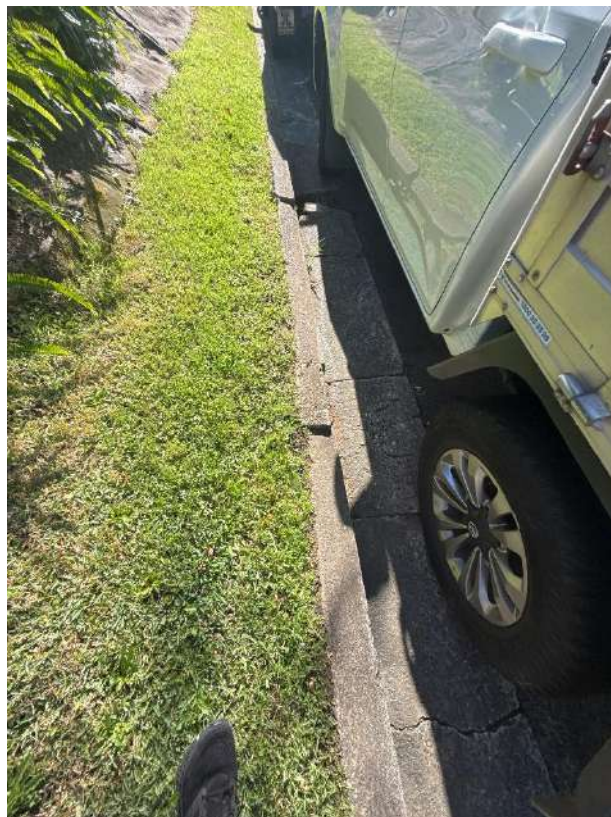
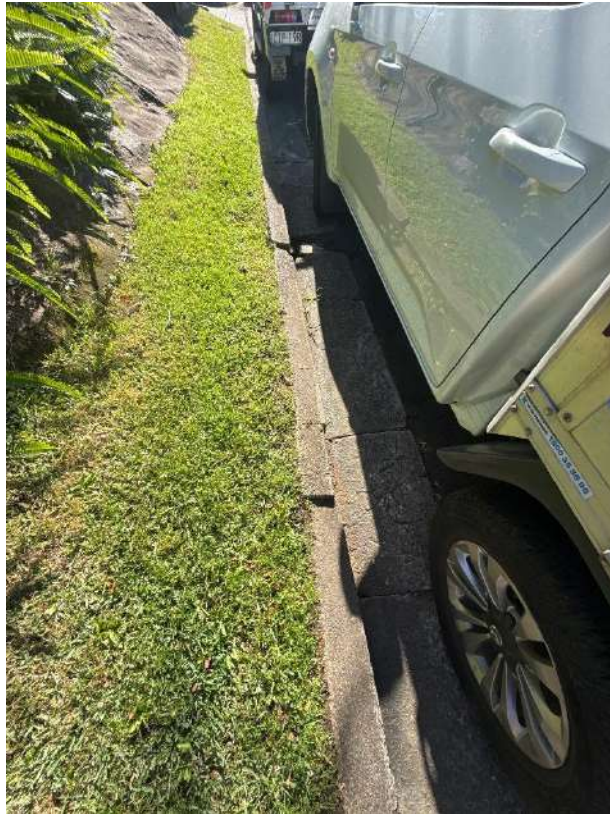
Cracks in curb and gutter

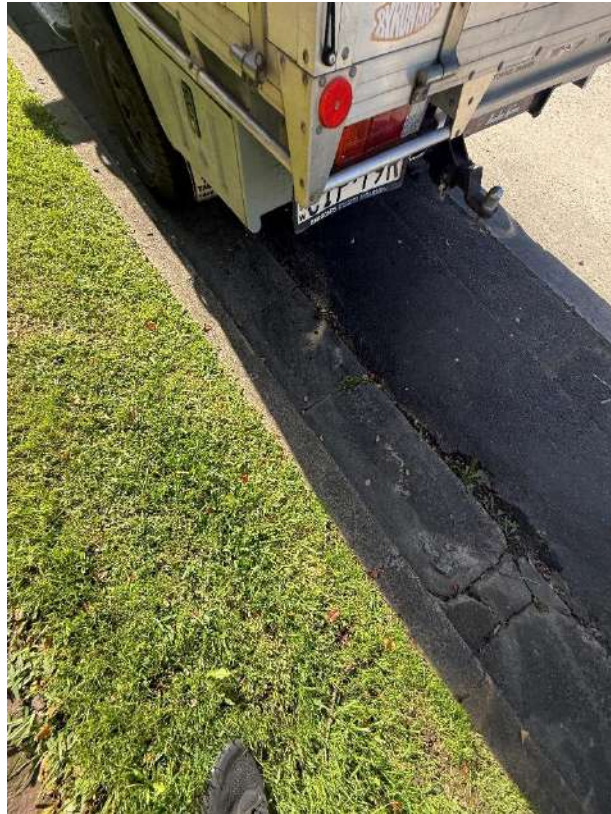
Considerable cracks and damage within the curb and gutter

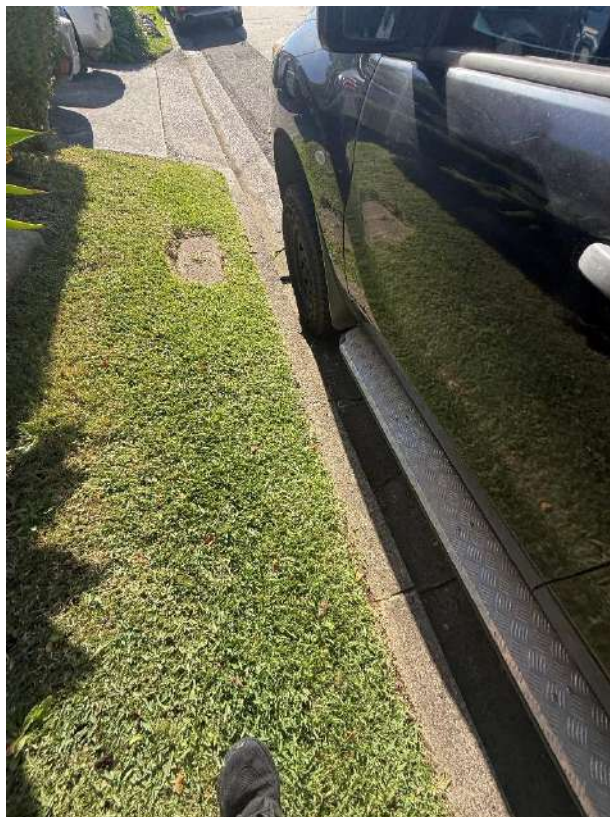
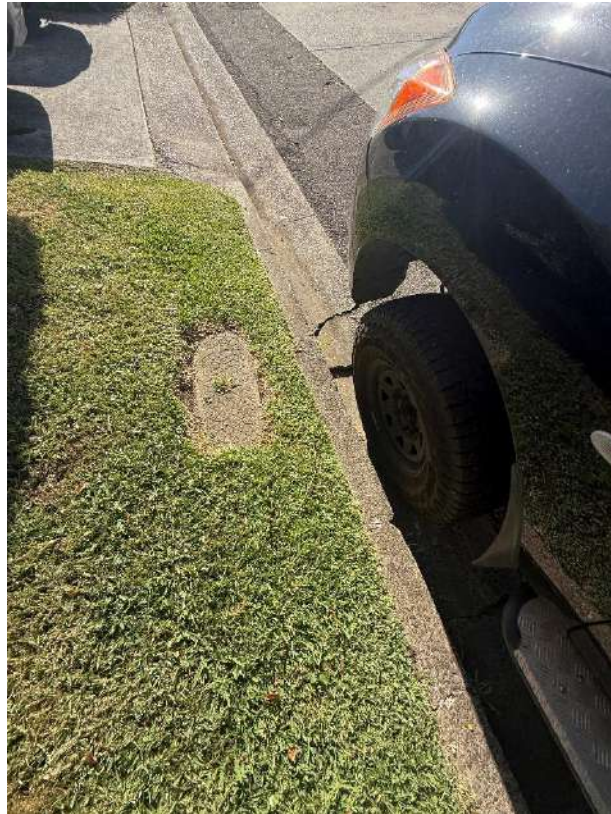
Cracks and damage within the curb and gutter

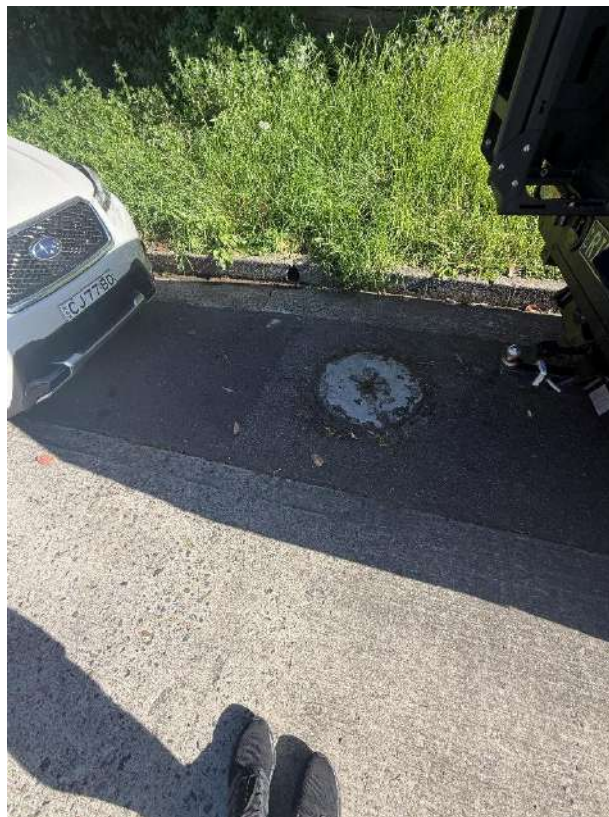
Cracks in the concrete curb and gutter

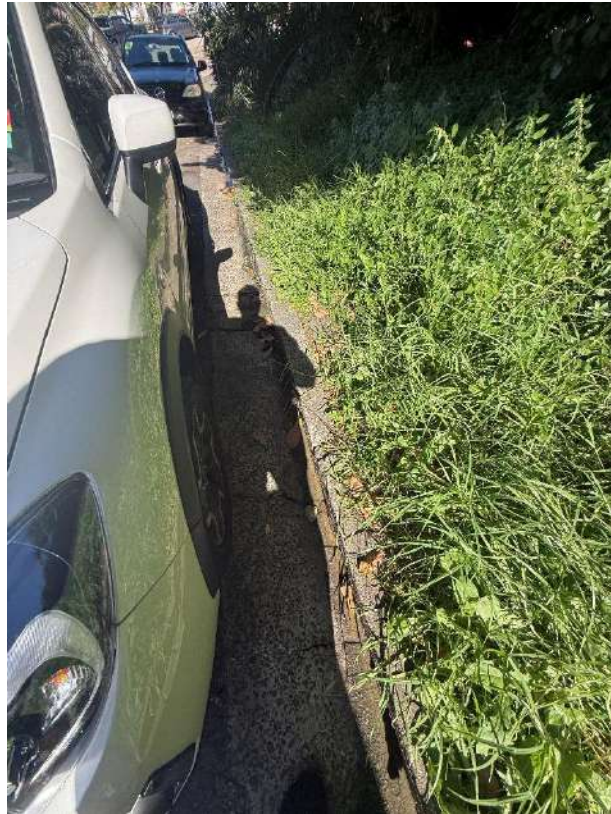
Considerable cracks and damage within the curb and gutter

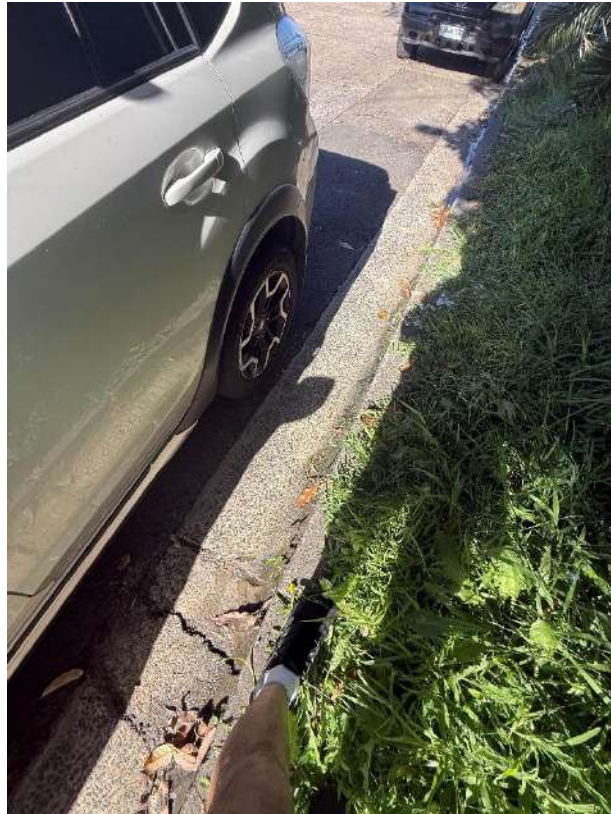
Considerable cracks and damage within the curb and gutter

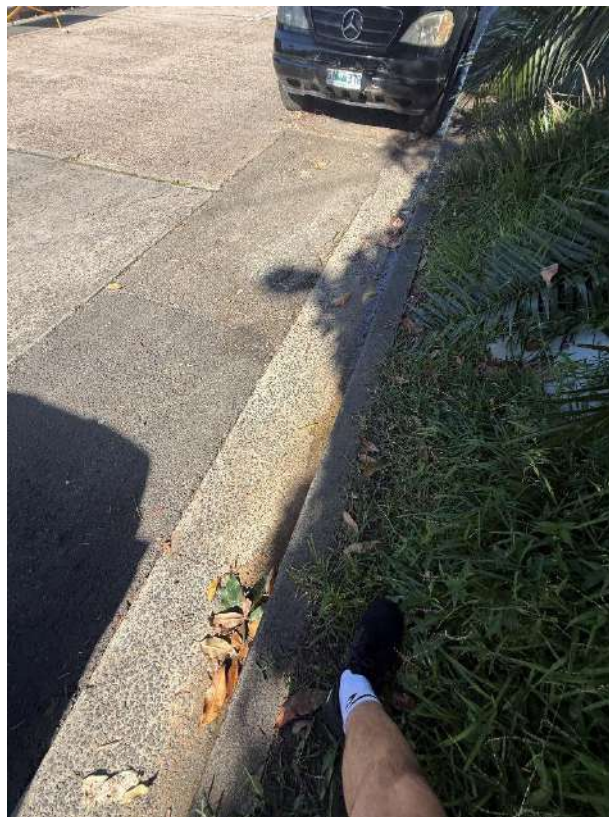
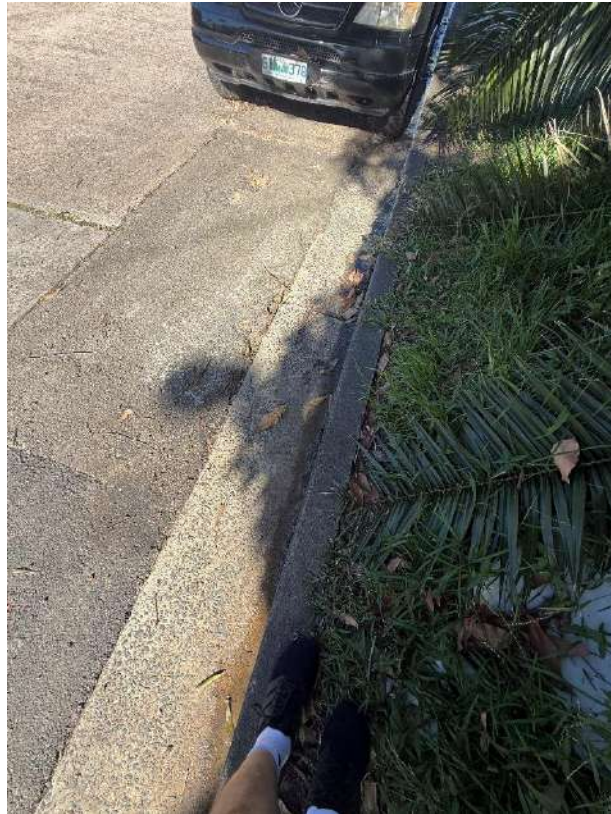
Minor cracks within the concrete curb and gutter

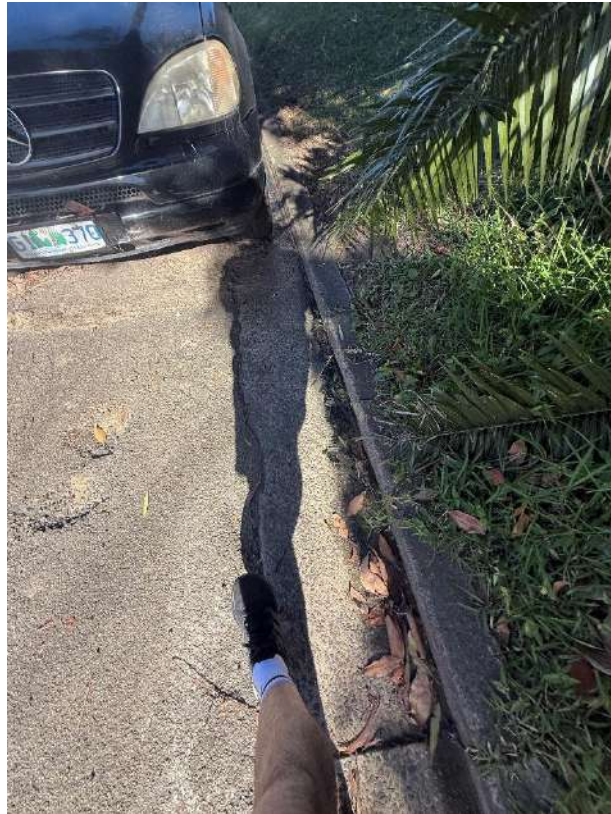
Minor cracks within the concrete curb and gutter

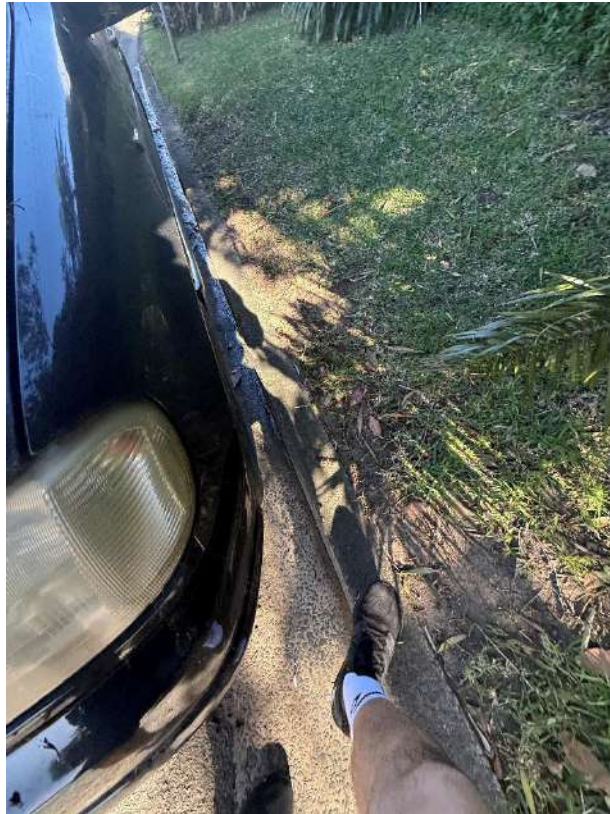
Minor cracks within the concrete curb and gutter

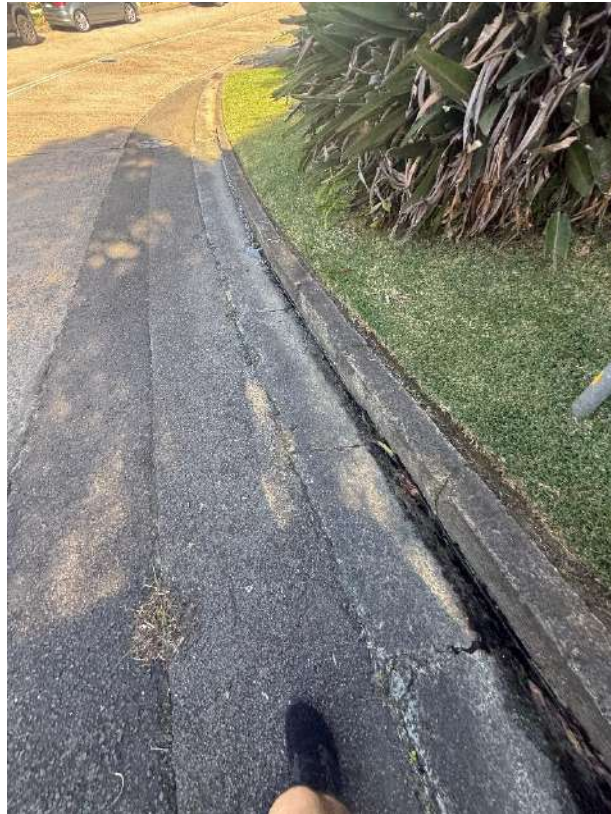
Wear and tear within the concrete curb and gutter

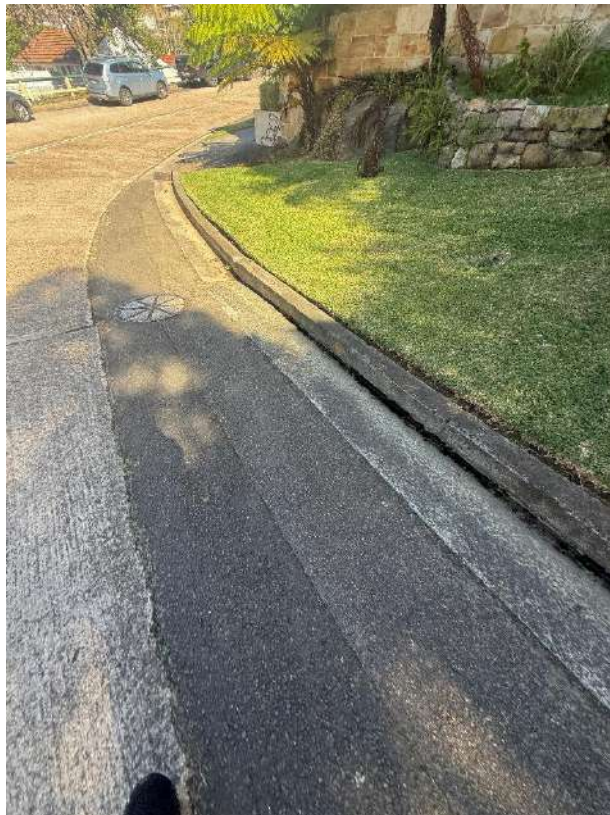
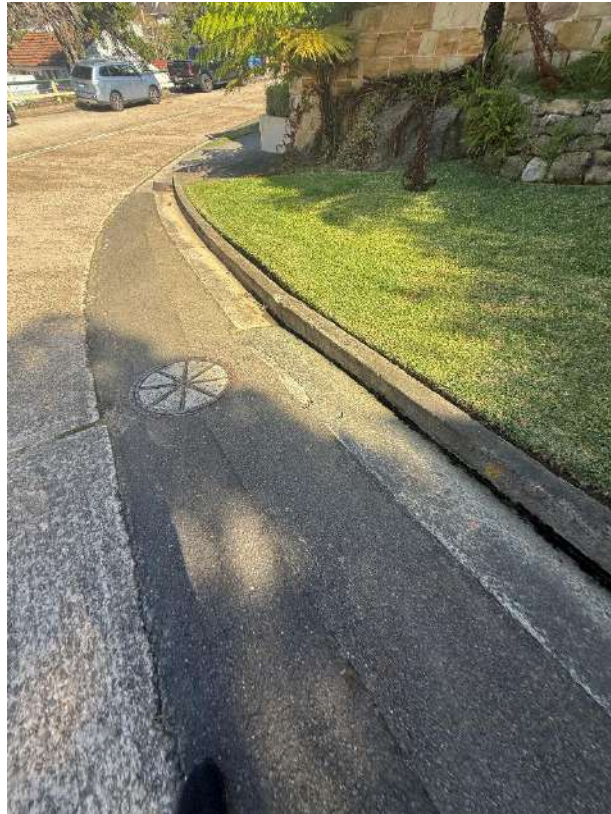
Wear and tear within the concrete curb and gutter

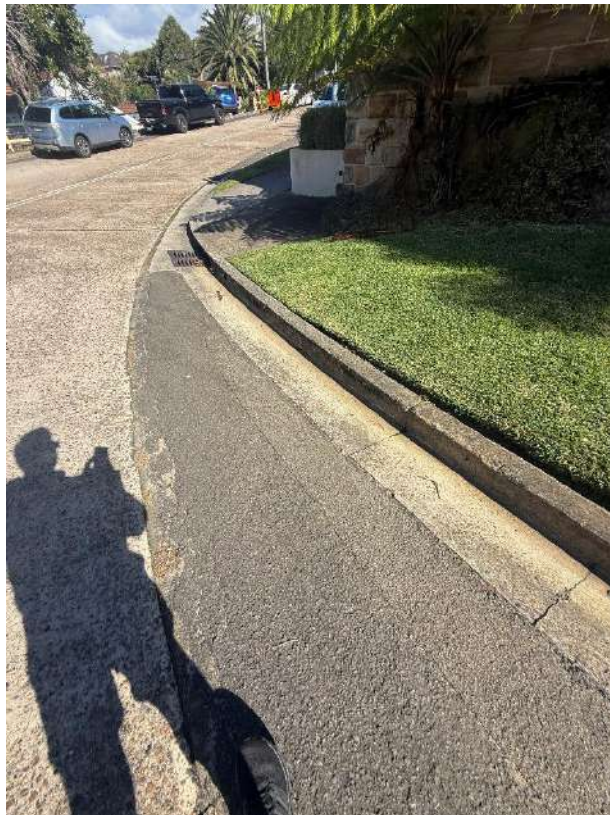
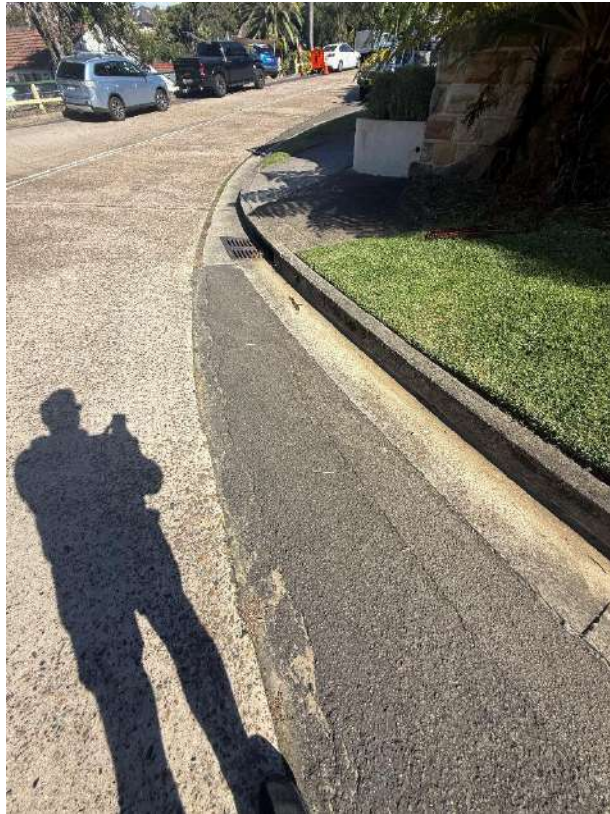
Bitumen cracked

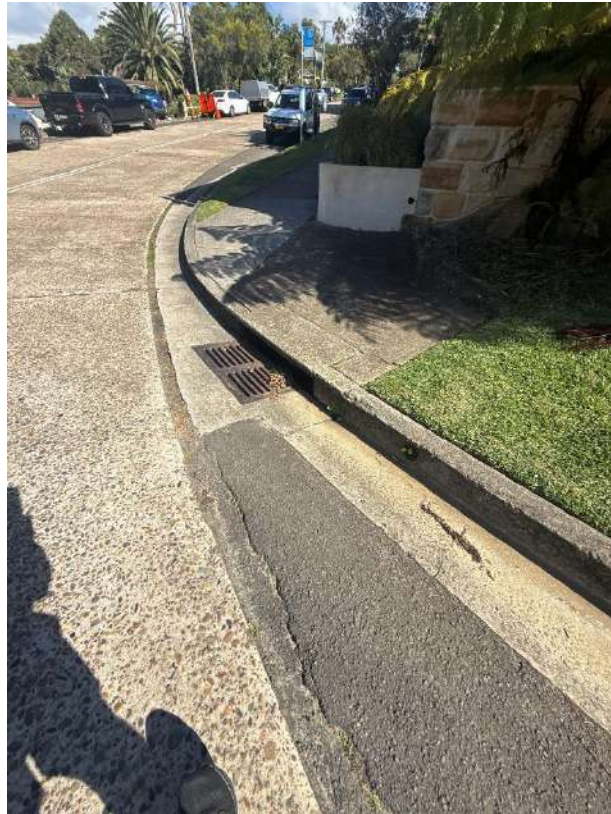
Bitumen cracked

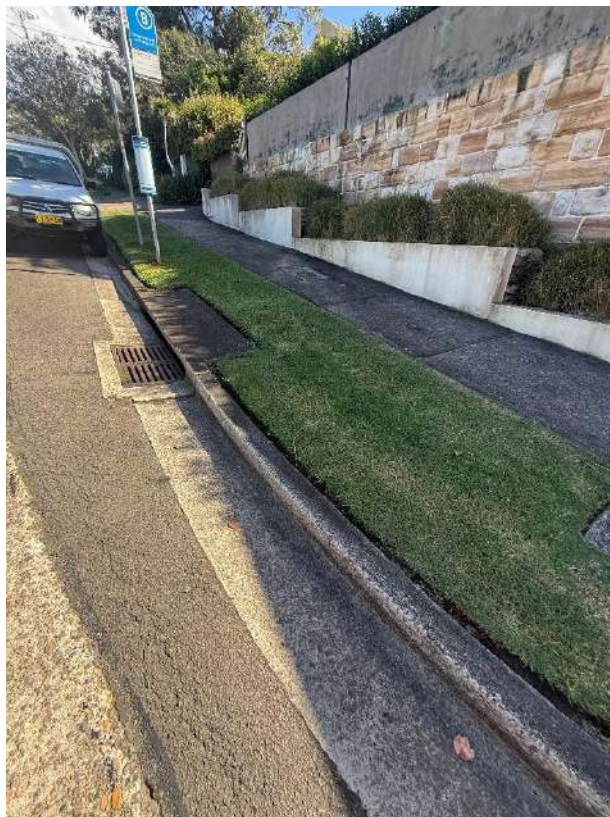
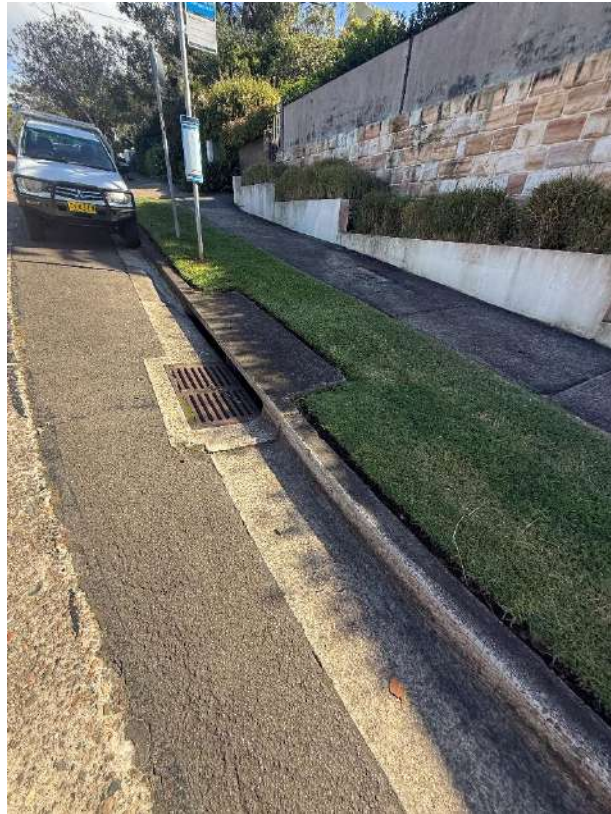
General photos

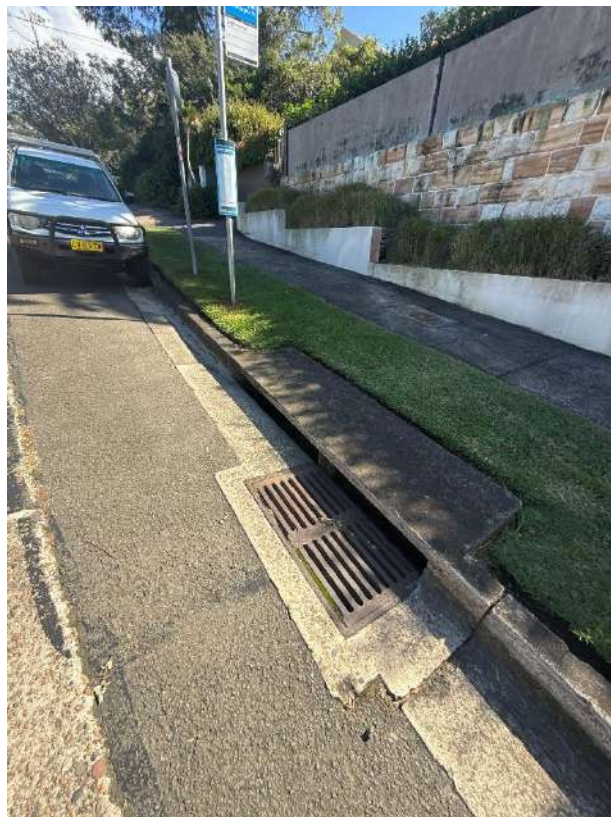
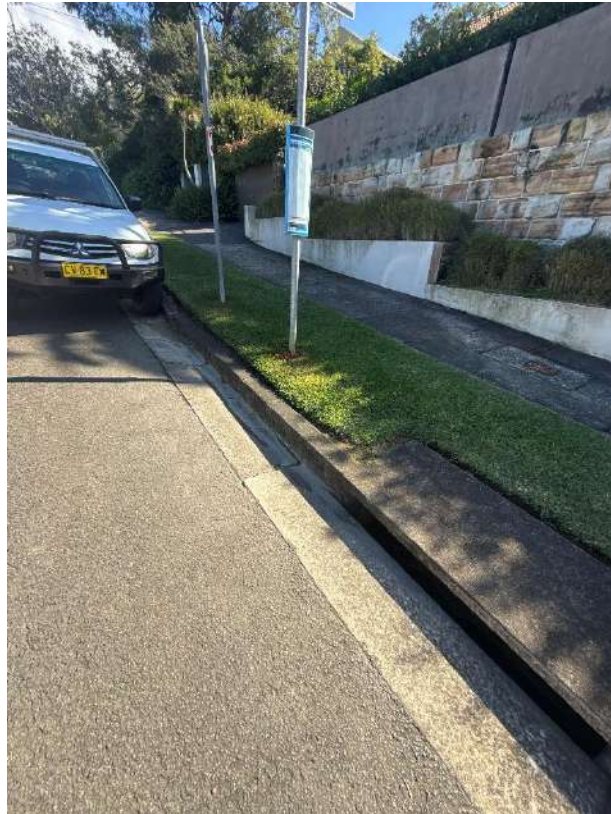
General photos

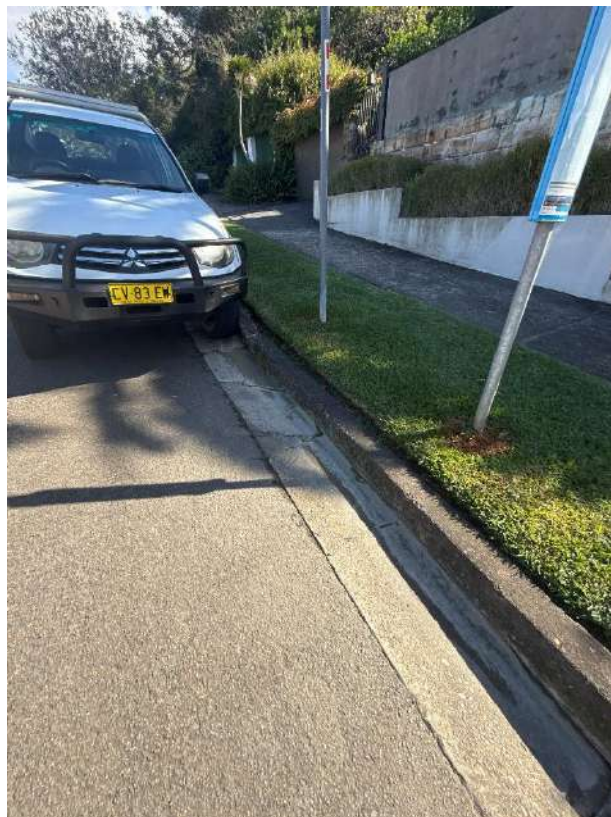
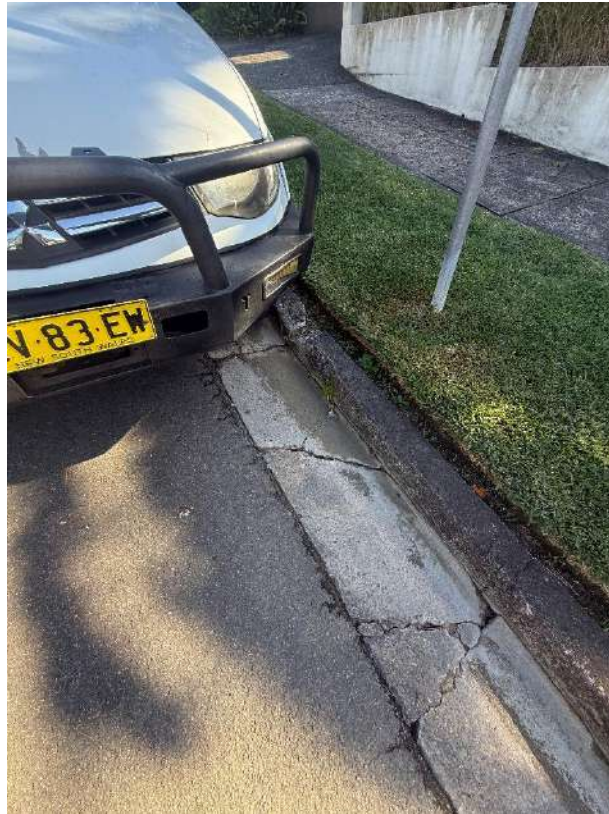
General photos

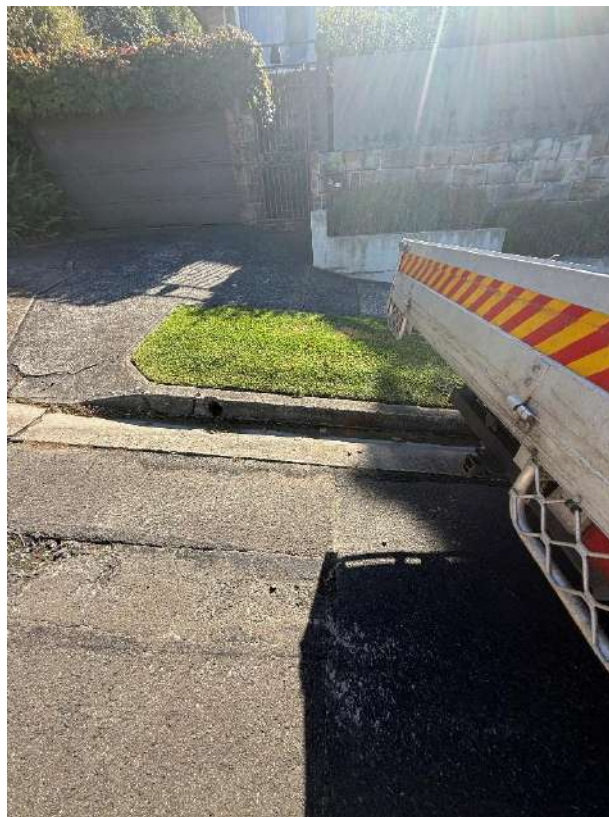
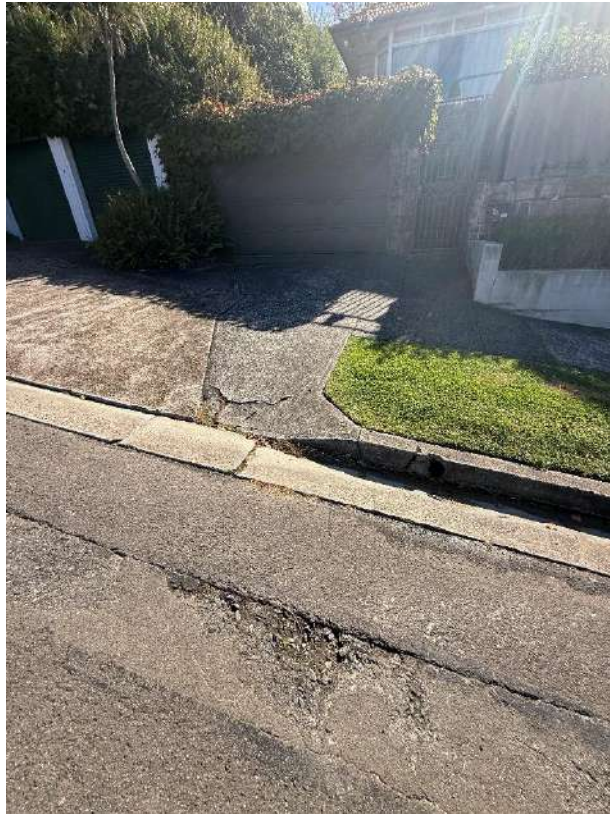
Considerable cracks in the concrete curb and gutter

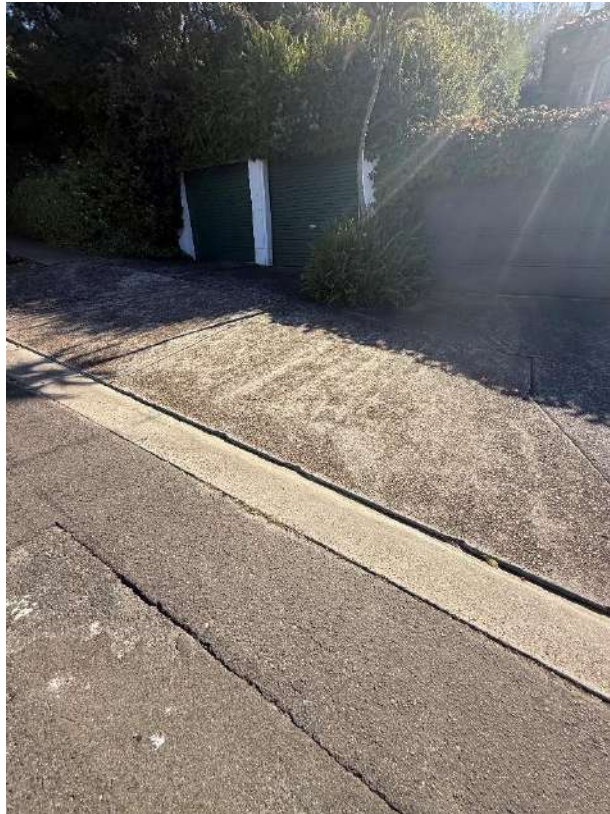
Road in poor condition and cracks within the concrete driveway and curb and gutter

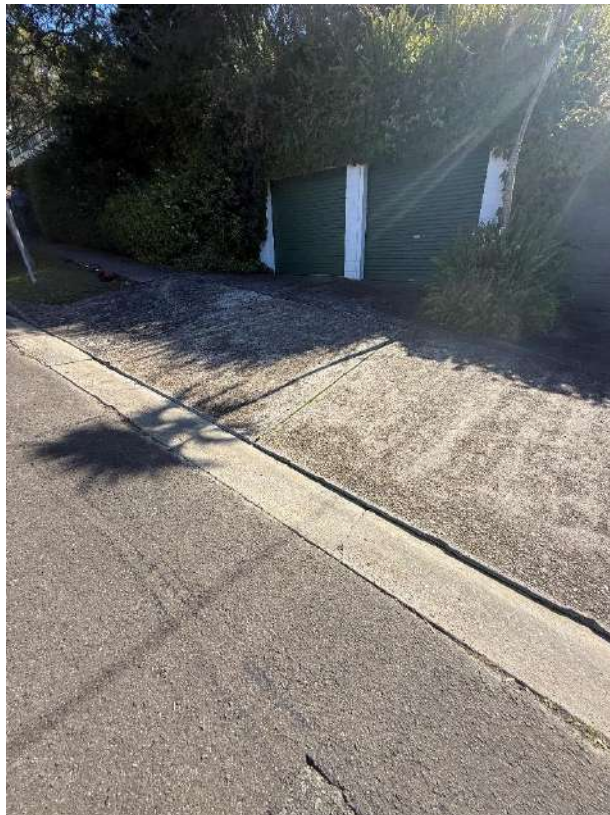
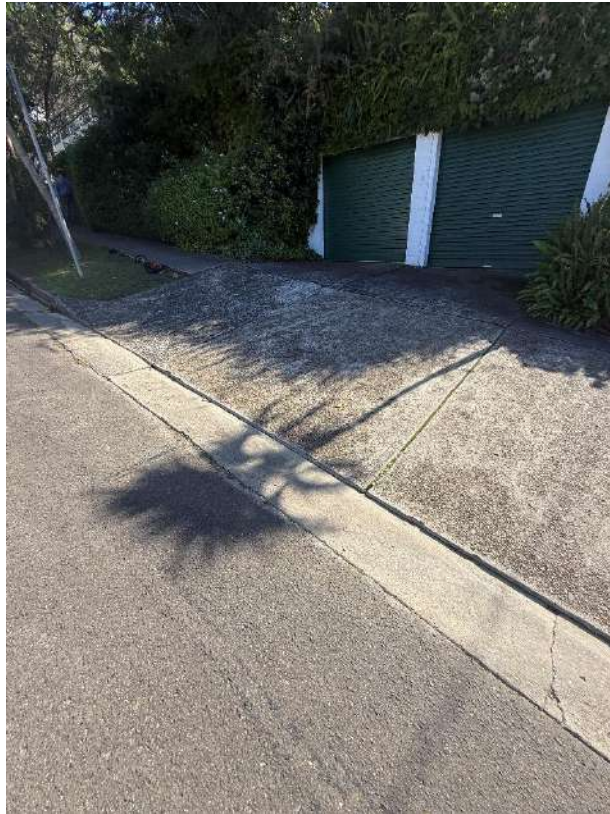
General conditions of the road

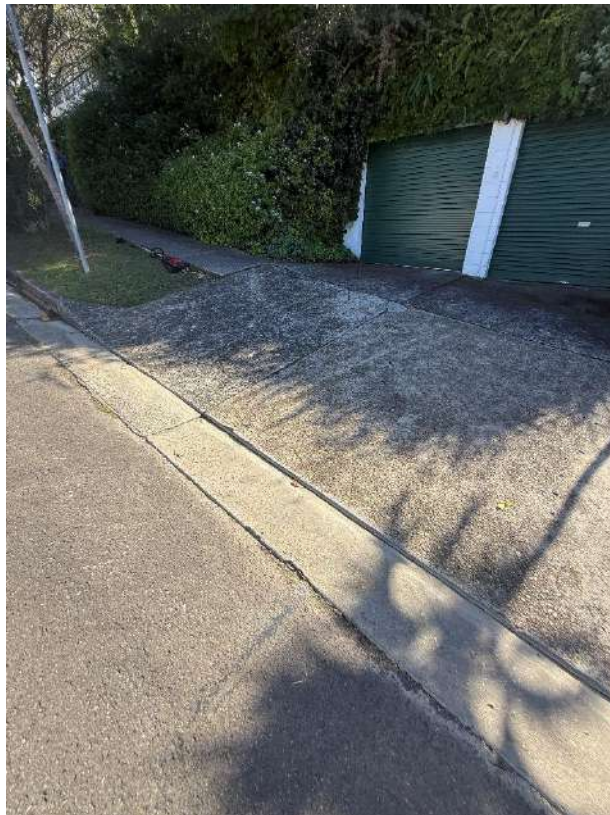
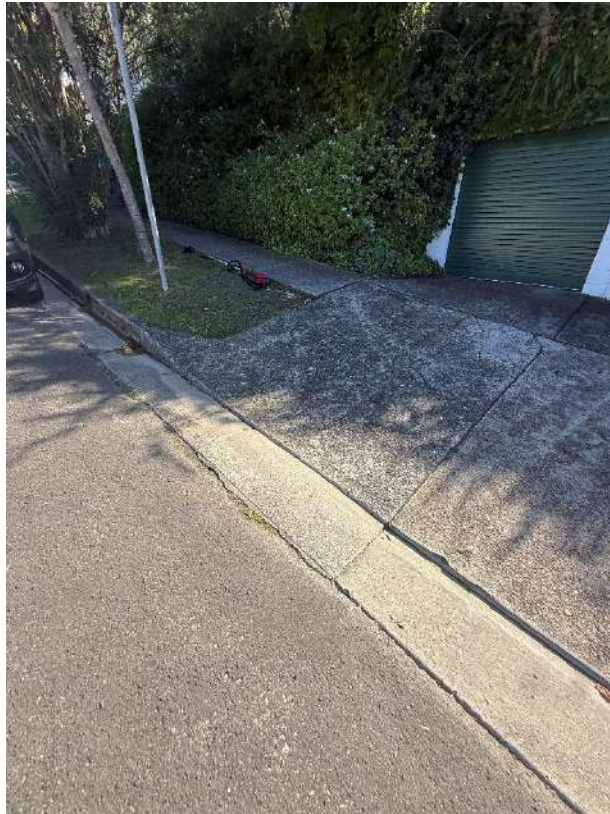
General conditions of the road

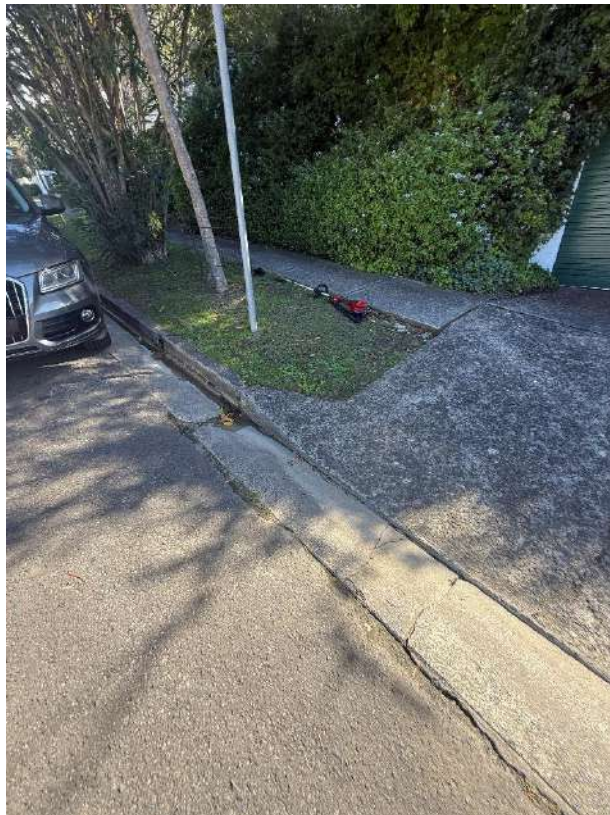
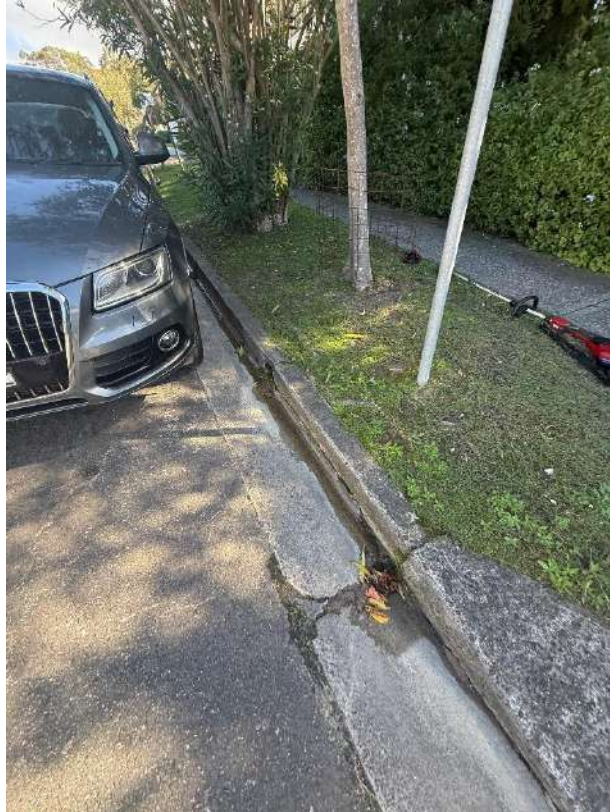
General conditions of the road

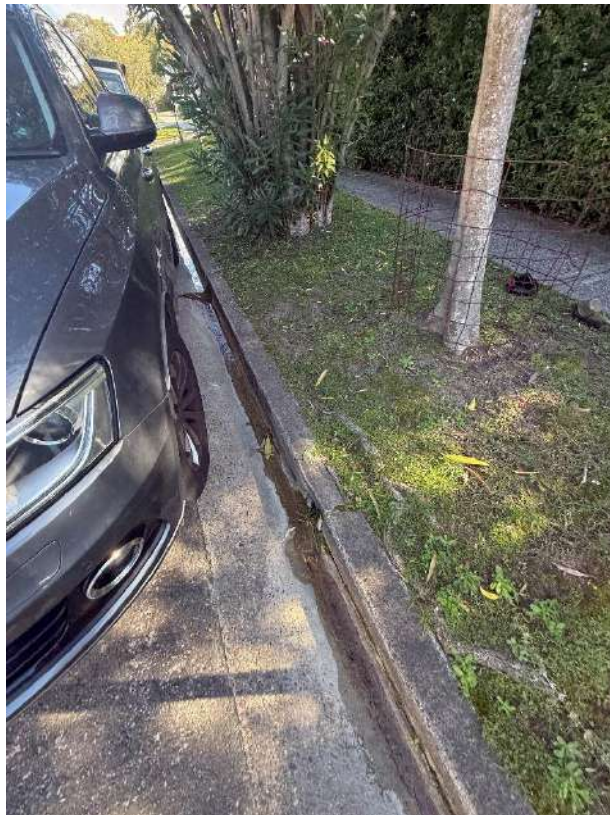
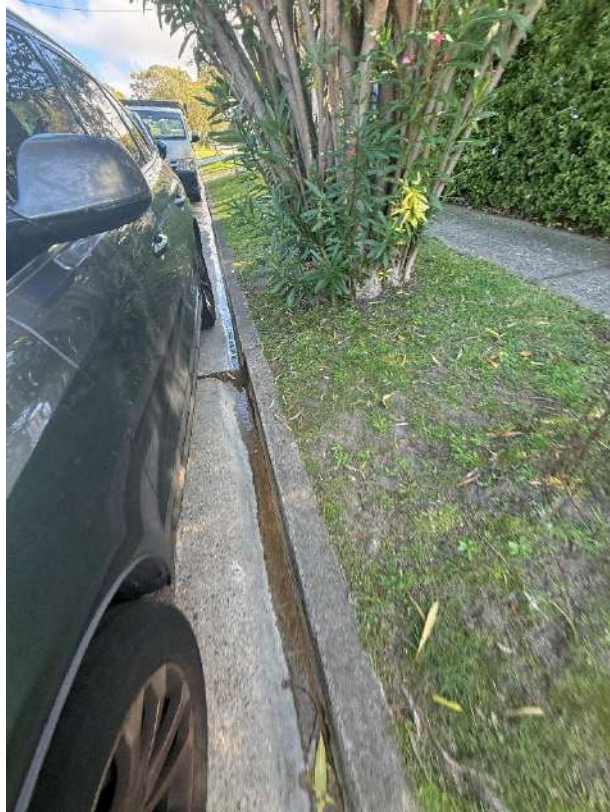
Considerable cracks within the concrete curb and gutter

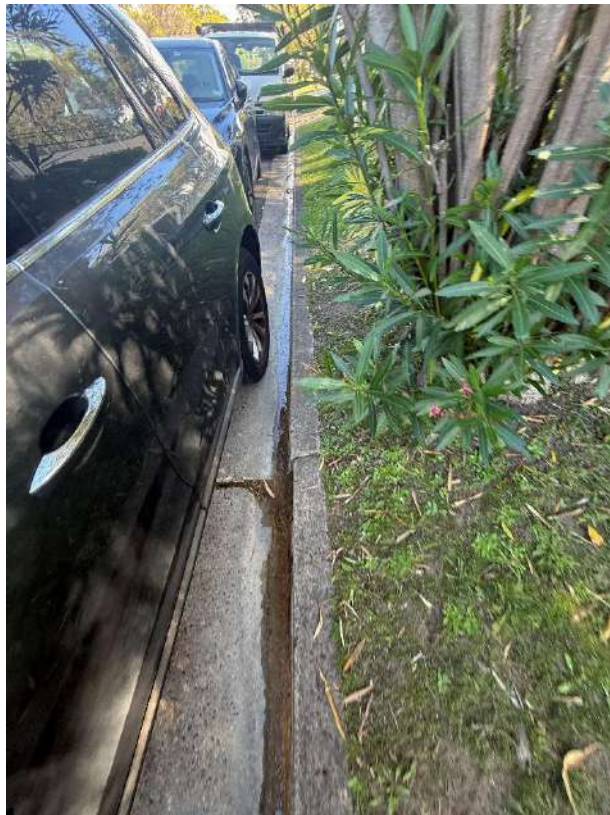
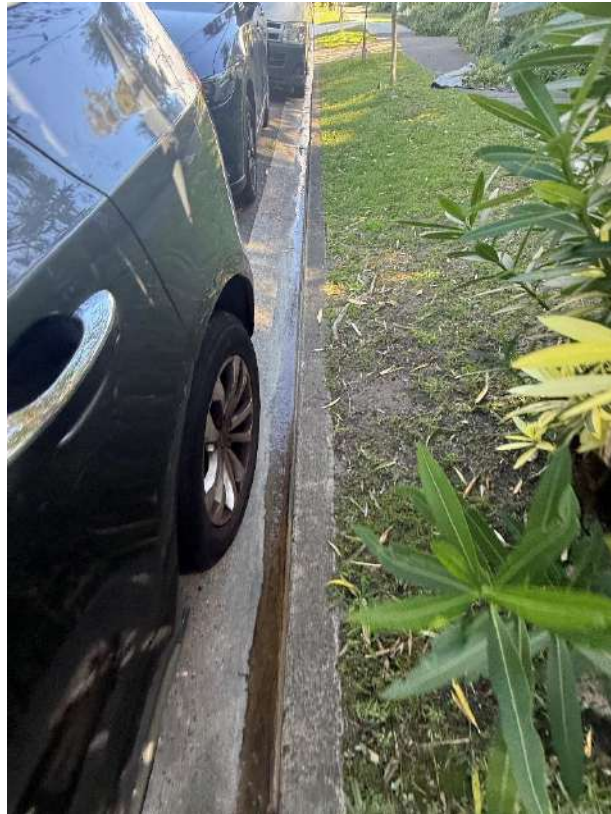
Considerable cracks within the concrete curb and gutter
