# **Dilapidation Report For The Development At: 26 Edwards Bay Rd, Mosman**

## Dilapidation Report Carried Out On:

24 Edwards Bay Road

30<sup>th</sup> April 2026

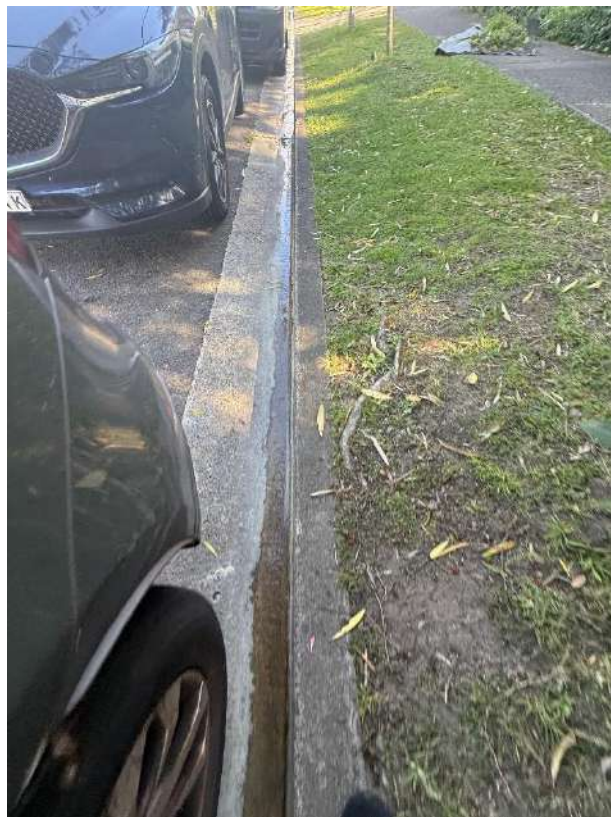
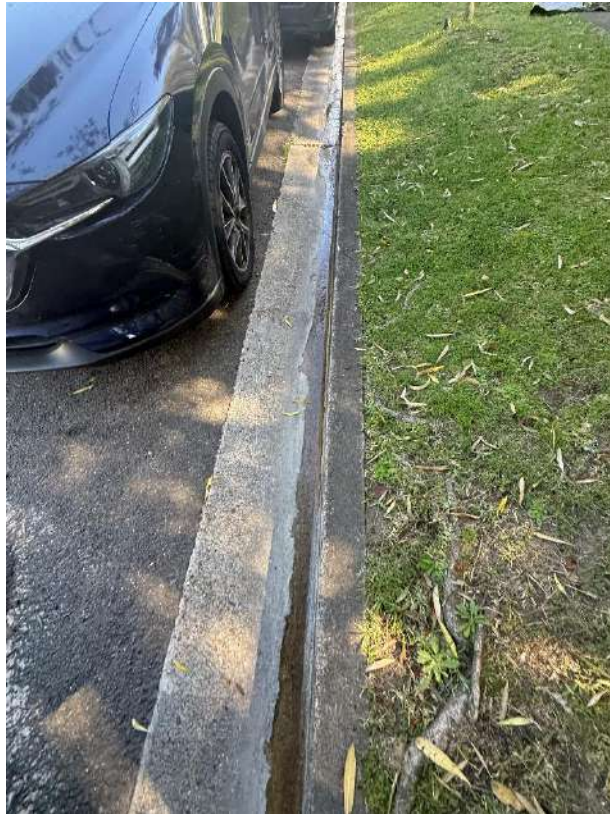
General photos

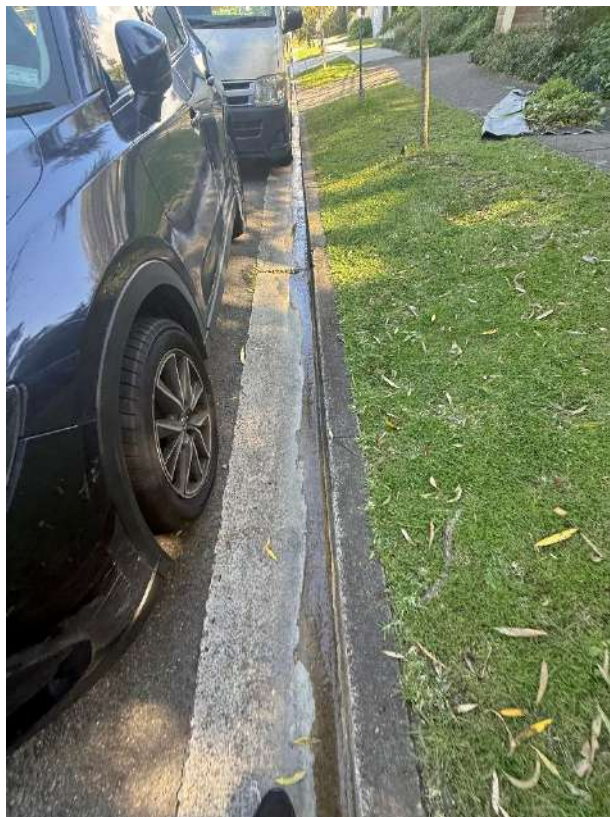
General photos

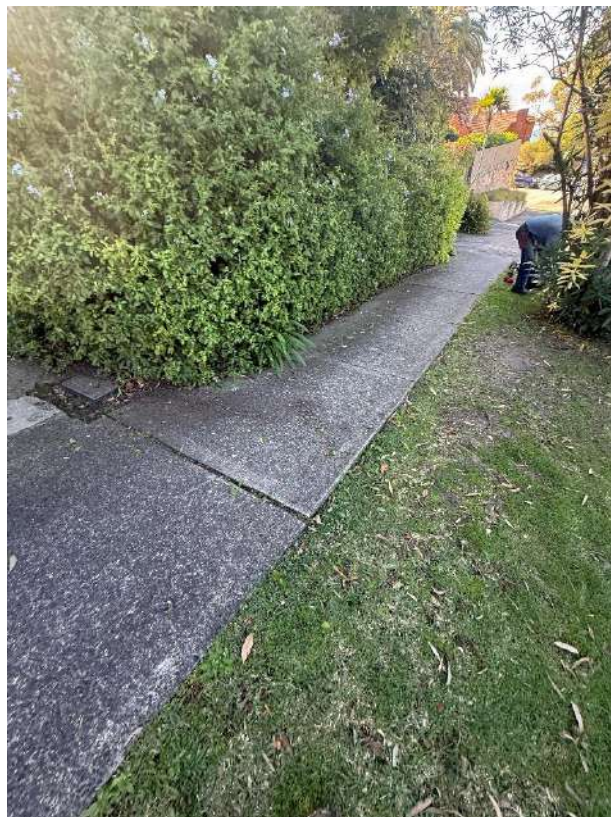
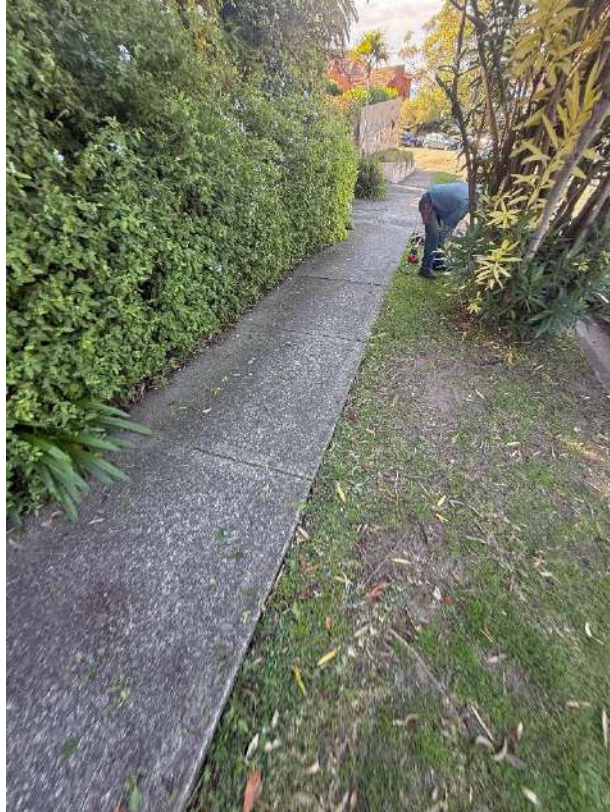
General photos

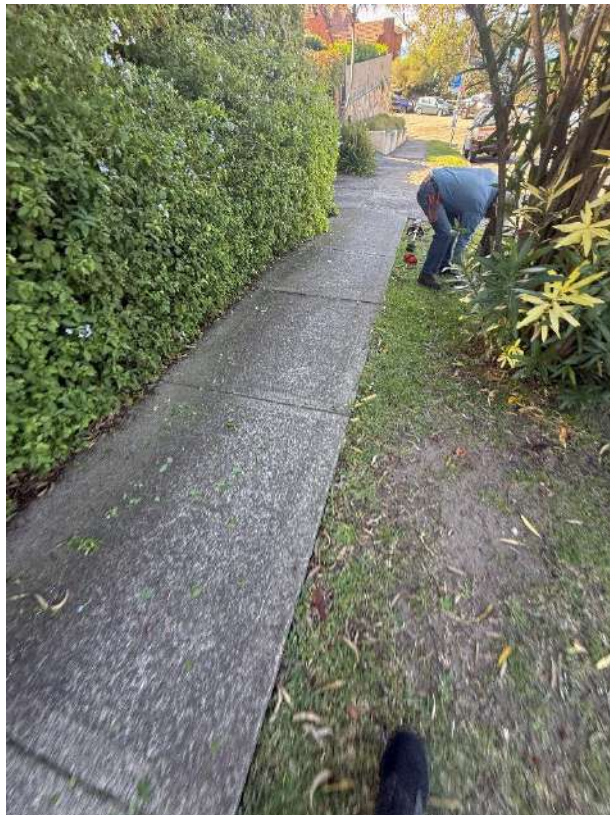
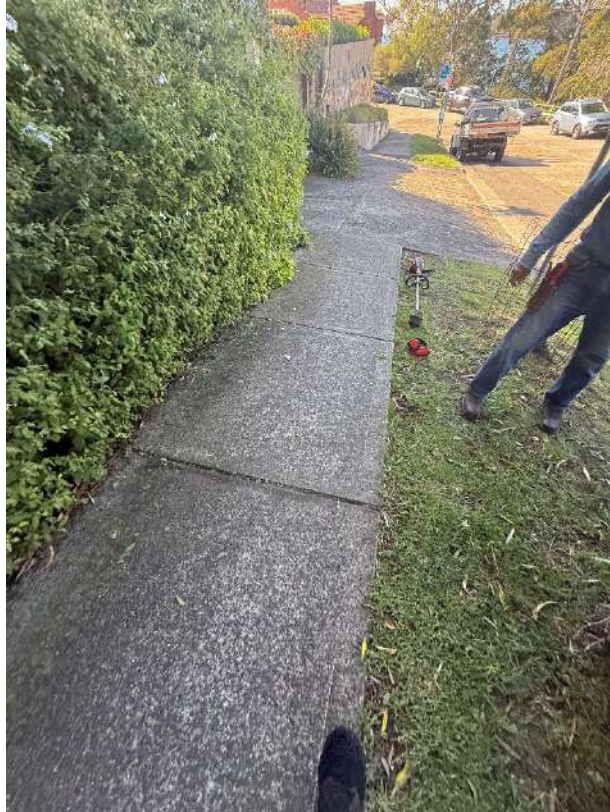
Foot path in good condition

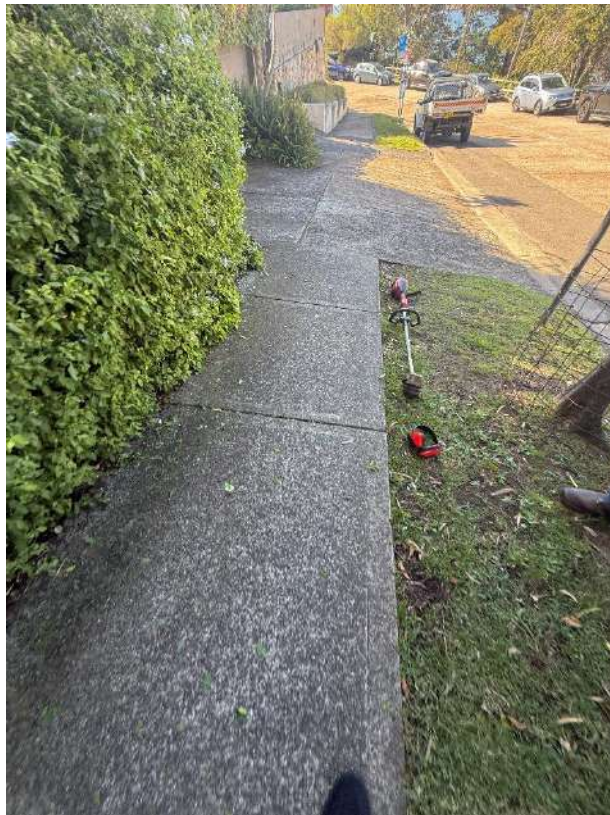
Elevated concrete pavement

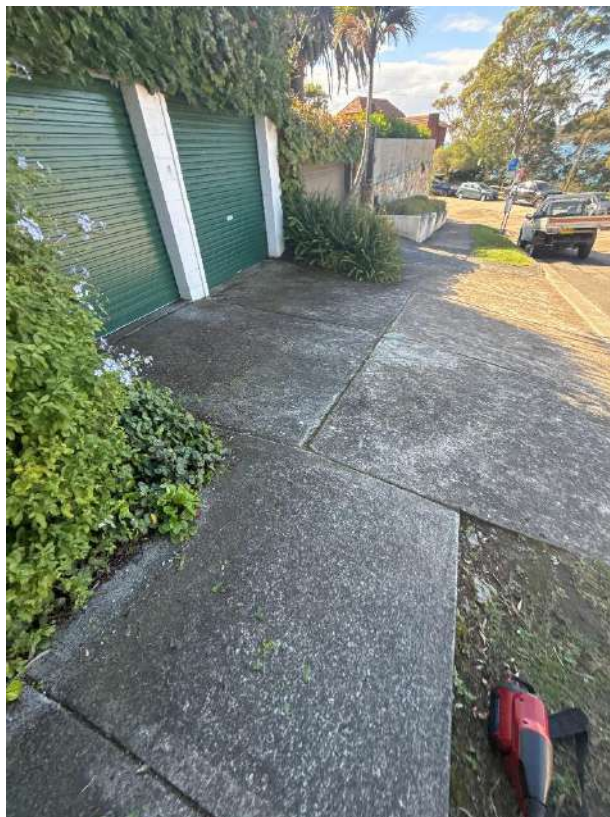
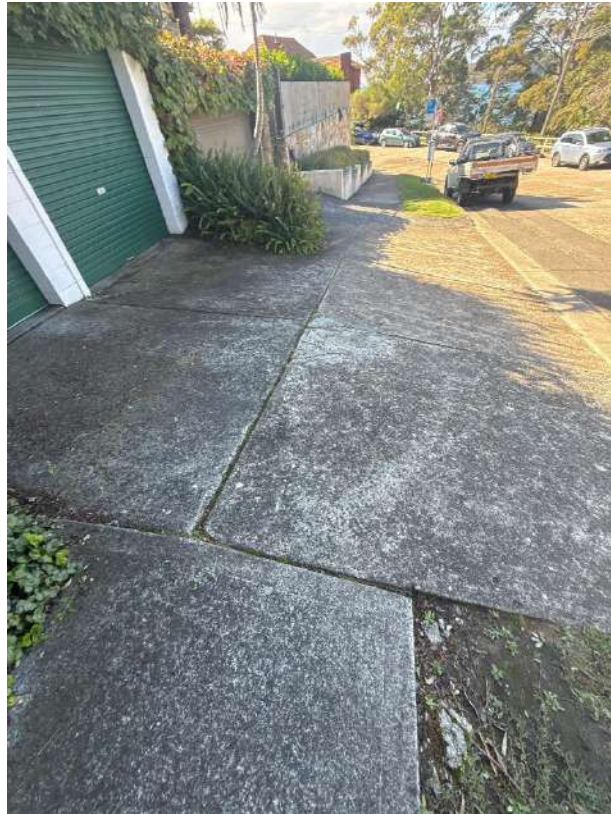
General photos

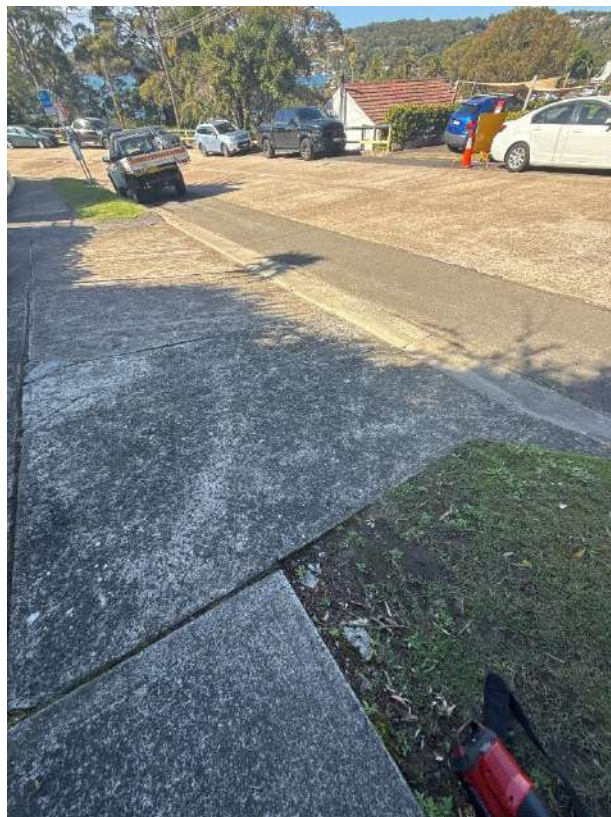
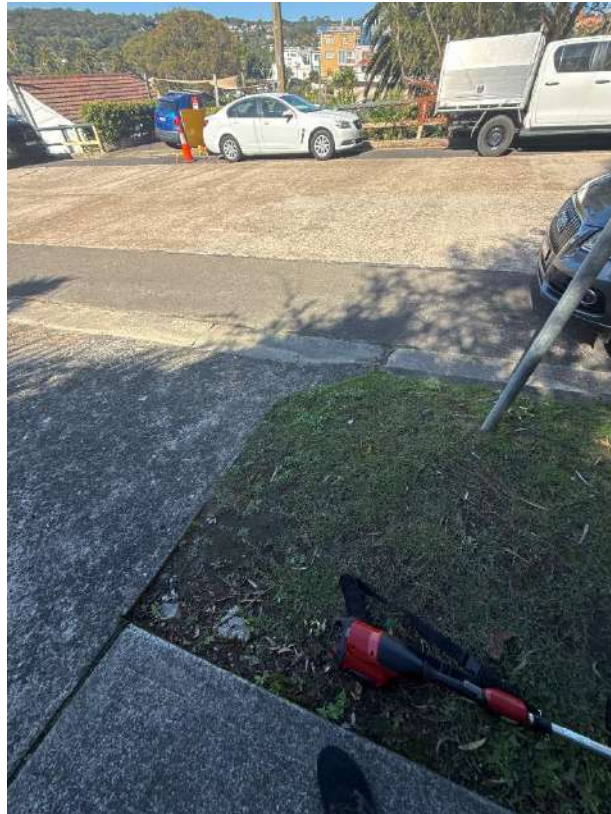
General photos

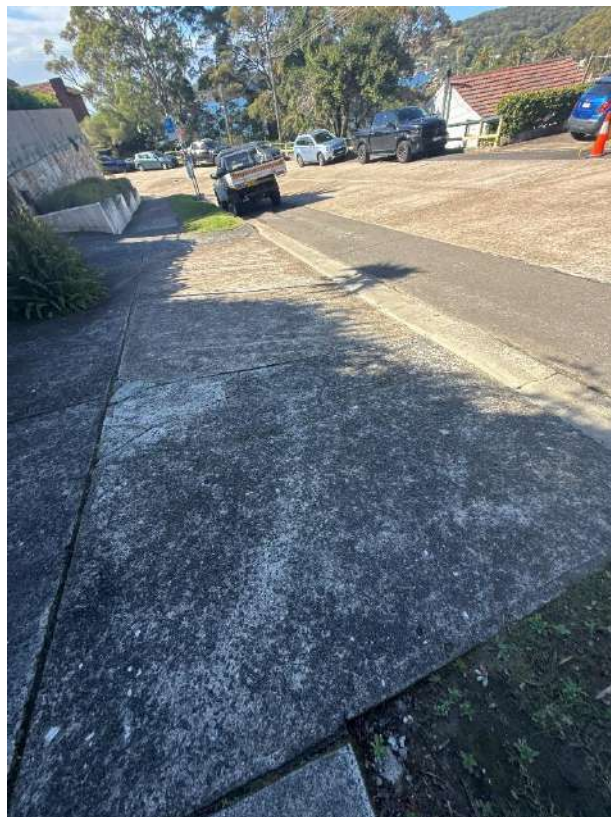
General photos

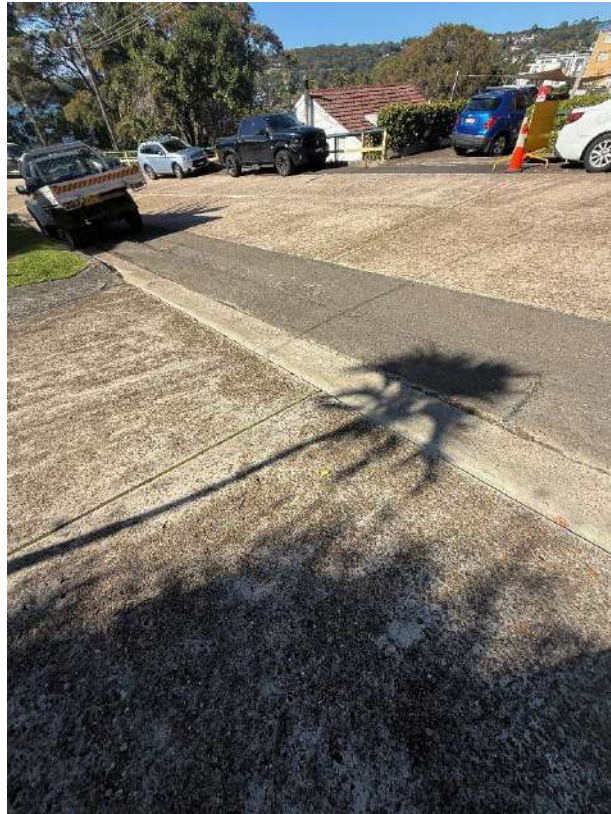
Crack within the concrete driveway and layback

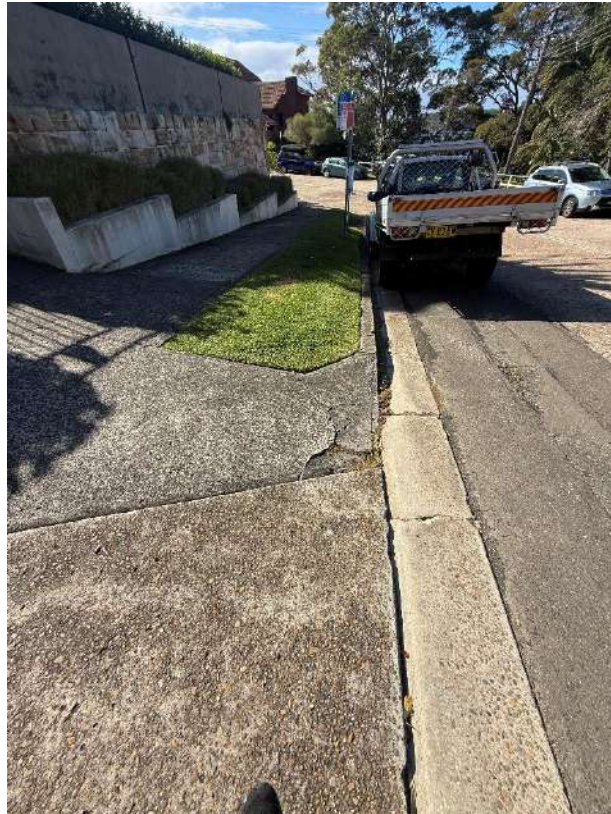
Cracks in the concrete driveway

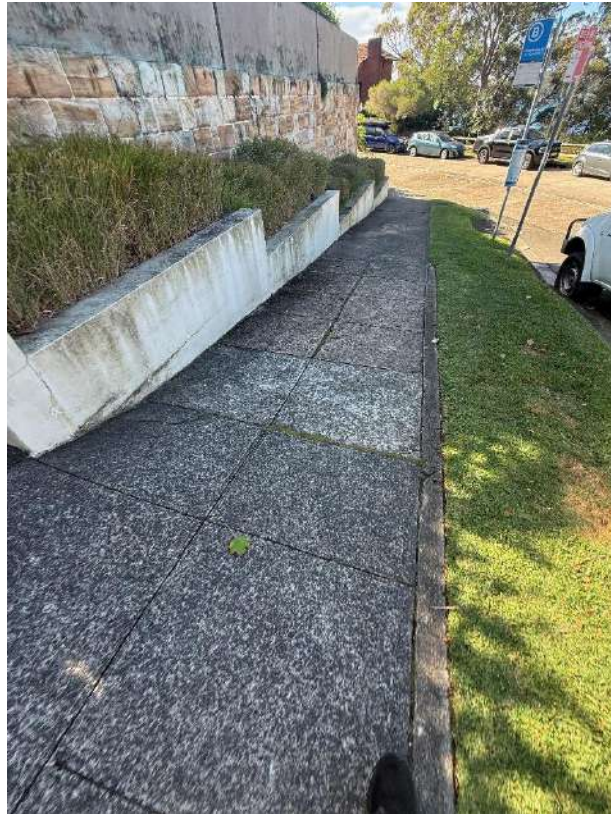
Cracks in the concrete driveway and foot path

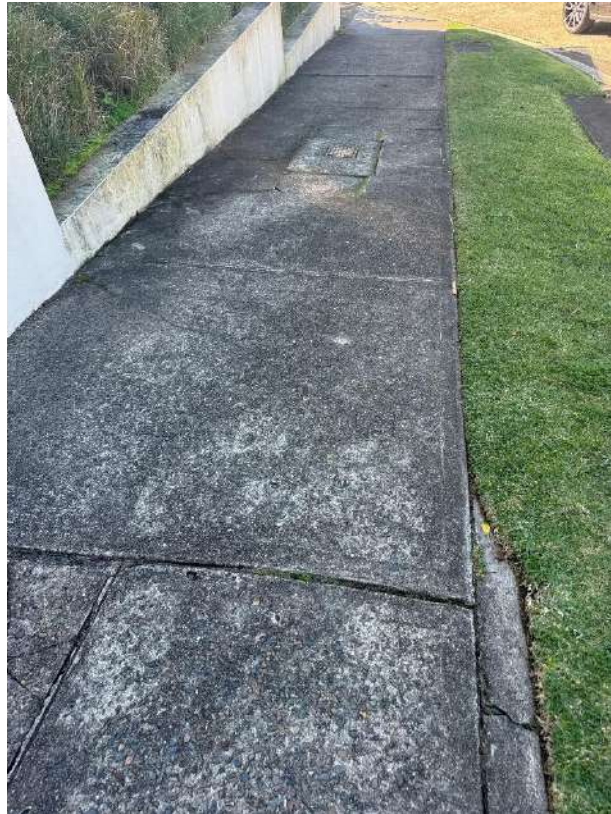
Cracks in the concrete foot path

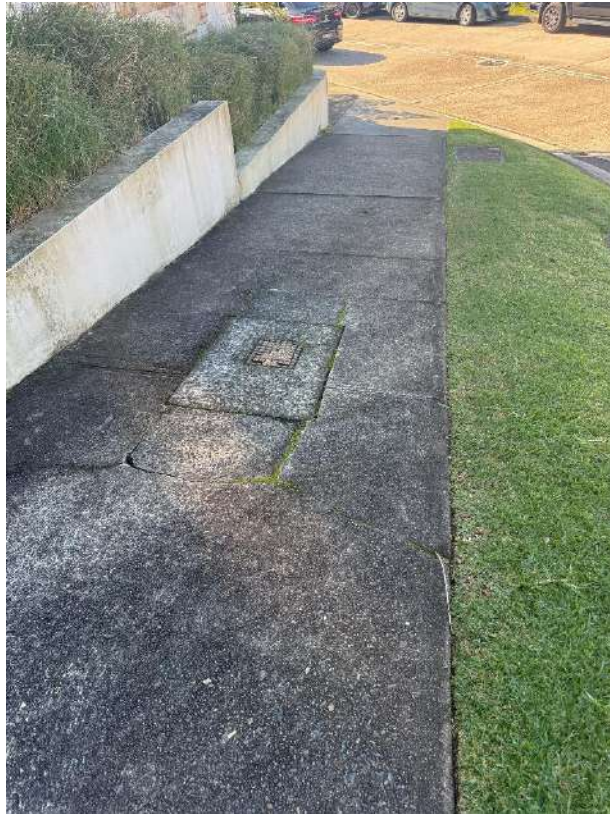
Cracks in the concrete foot path

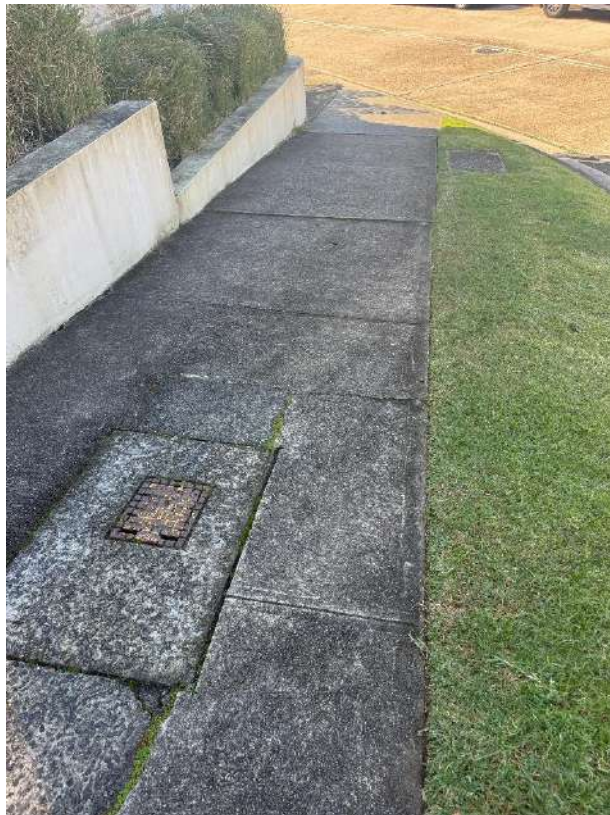
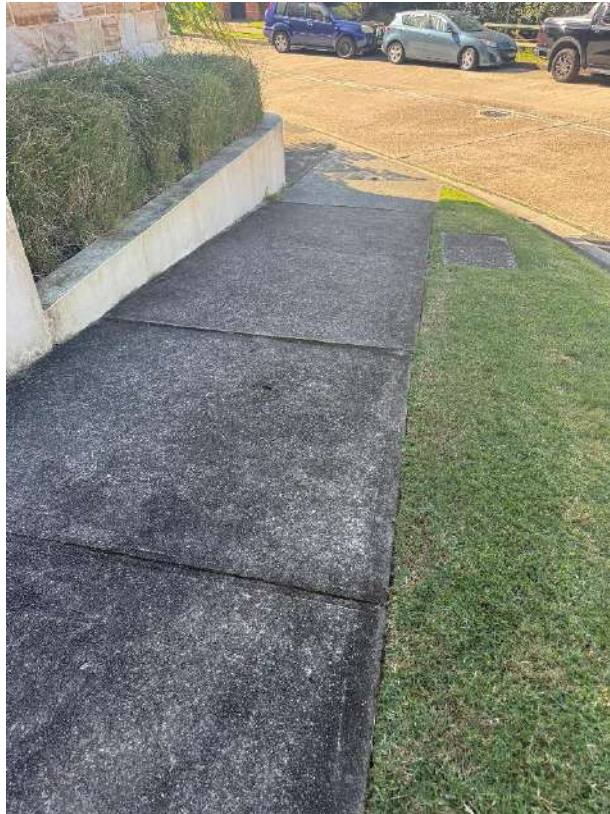
Cracks in the concrete foot path and elevated concrete pathway
